# 2019 Annual Landfill Inspection Report

**Flint Creek Plant  
Southwestern Electric Power Company  
Gentry, AK**

**December 2019**

**Document ID: GERS-19-047**

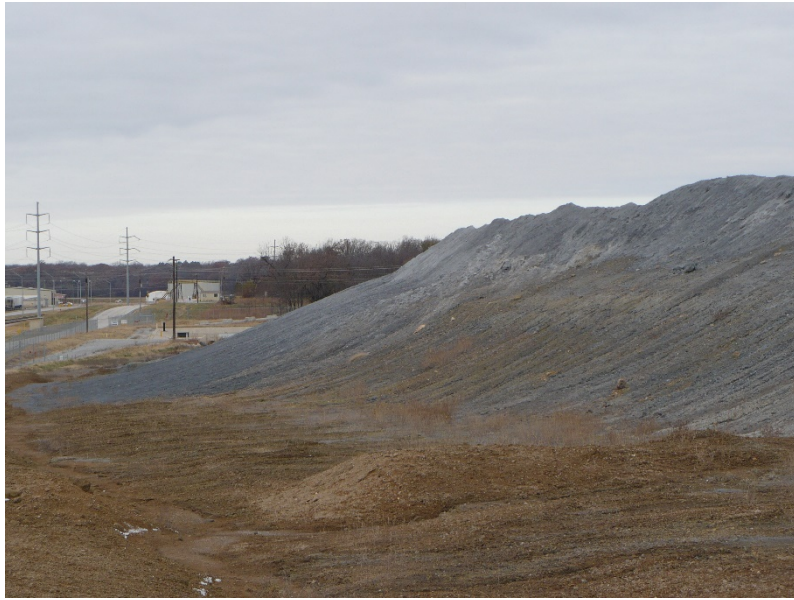
1. No ponding of water was observed on the surface. The material in the Cell is separated from the inactive areas by a low splitter berm. No disposal activities were taking place at the time of the inspection (Photos 1-3).
2. There was no erosion of the CCR material in the active area.
3. No slopes of the Active Area have or require any temporary cover at the time of the inspection.
4. Stormwater runoff from this area is directed into the Contact Water pond via the concrete lined ditches.

Photo #1 – slope of active area

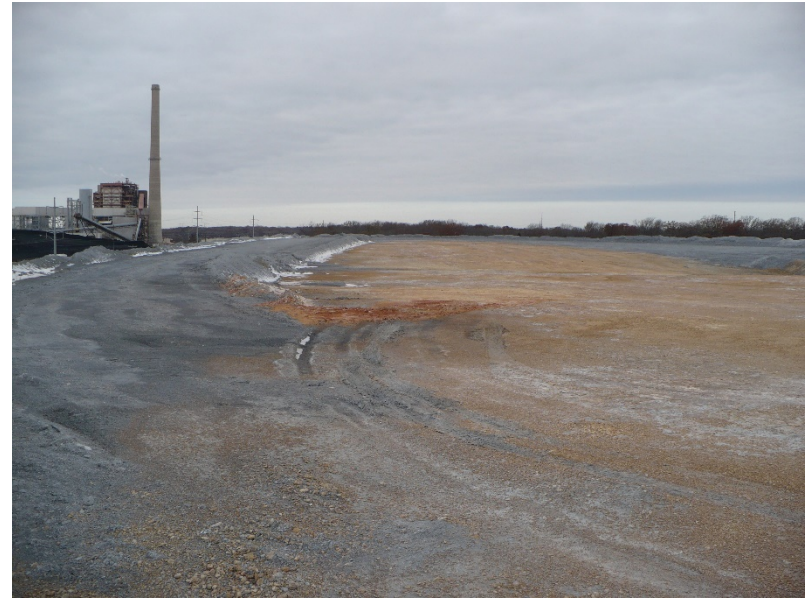
Photo #2 – active area

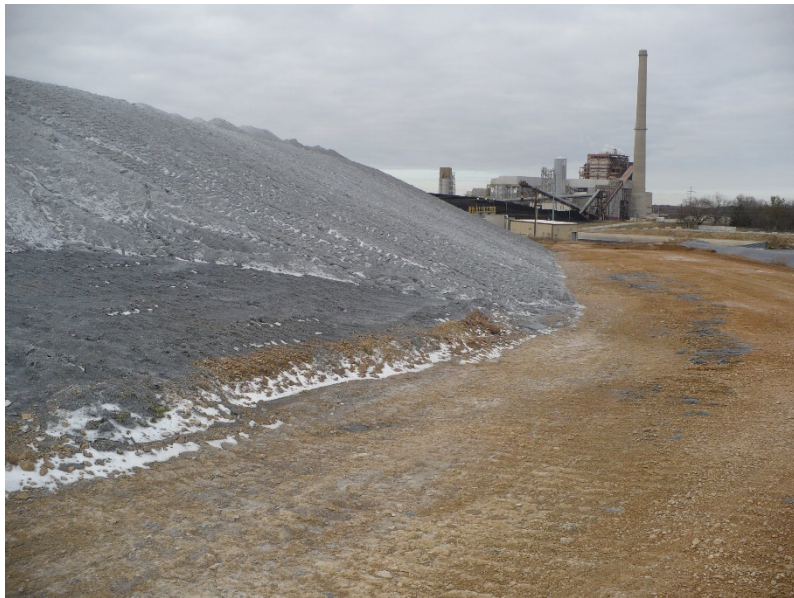
Photo #3 – slope of active area

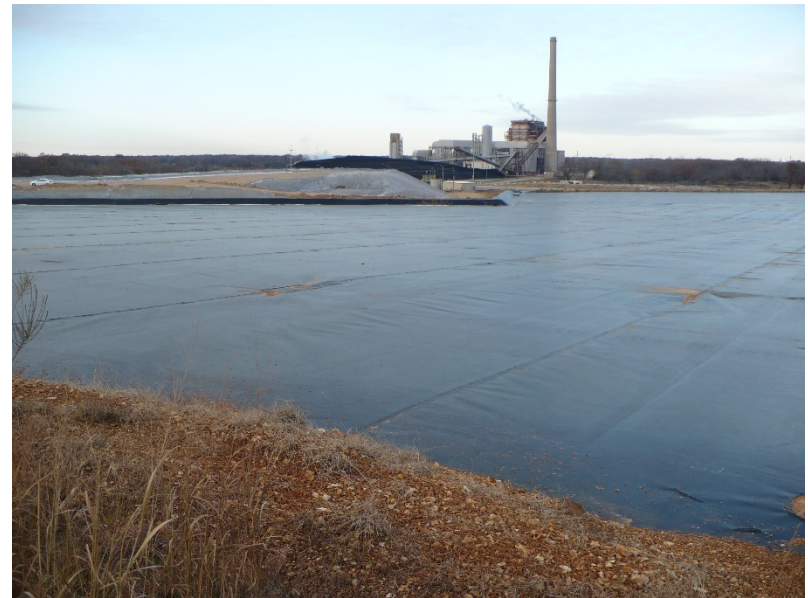
5. The exposed geomembrane was observed only from the perimeter of the cells. There was no apparent significant damage to the exposed geomembrane based on the observation from the perimeter. A complete walk down of the area is recommended prior to placing CCR to ensure the integrity of the liner. (Photos 4 & 5)
6. There was no ponding of water on the surface of the inactive areas. The areas drain to the perimeter stormwater channels.

Photo #4 – exposed liner over inactive areas

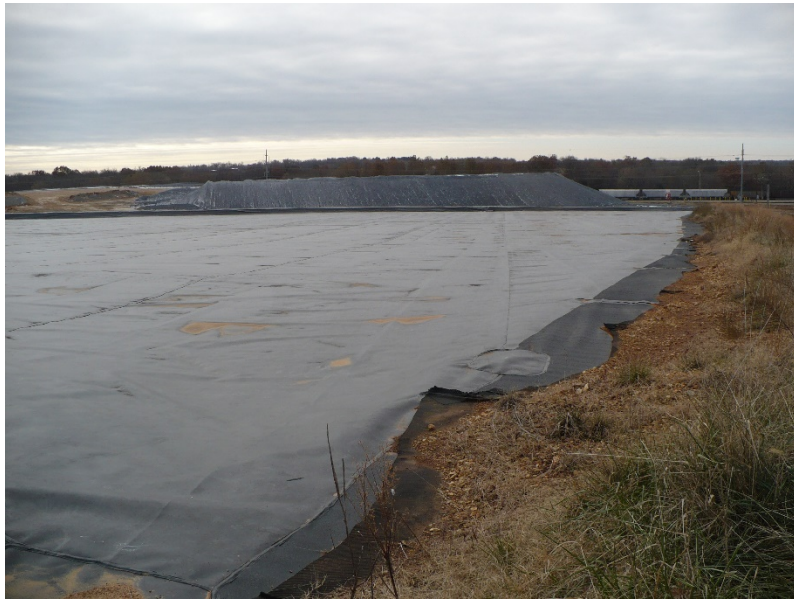
Photo #5 – exposed liner over inactive areas

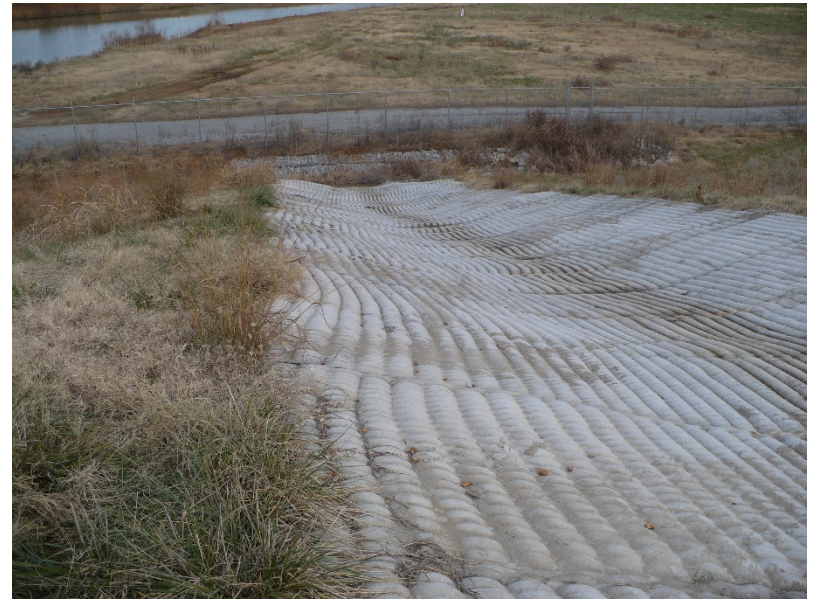
11. The perimeter ditches were in good condition. The ditches are grassed lined and no scour or erosion was observed during the inspection.
12. There are three stormwater letdown channels on the slopes of the landfill (photo 6). These are fabriform-lined and there were no observed issues with the channel. The channels discharge into a riprap –lined channel to dissipate energy before entering the receiving drainage features.. This was some minor accumulation of sediment at the toe of the northeast letdown as noted in the last inspection (photo 7).

Photo #6 – North fabriform letdown channel

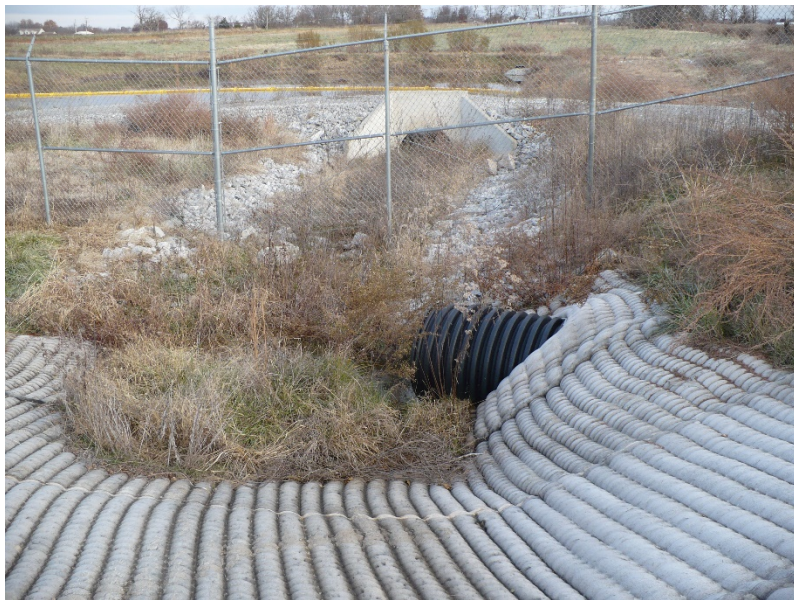
Photo #7 – sediment deposit at outlet of northeast letdown

- 1) Remove sediment from toe of northeast letdown.
- 2) All grassed areas should be mowed at least 2-3 times during the year to facilitate inspections and keep woody vegetation from establishing.
- 3) Repair rodent hole noted on west berm and any others noted during the weekly inspections.

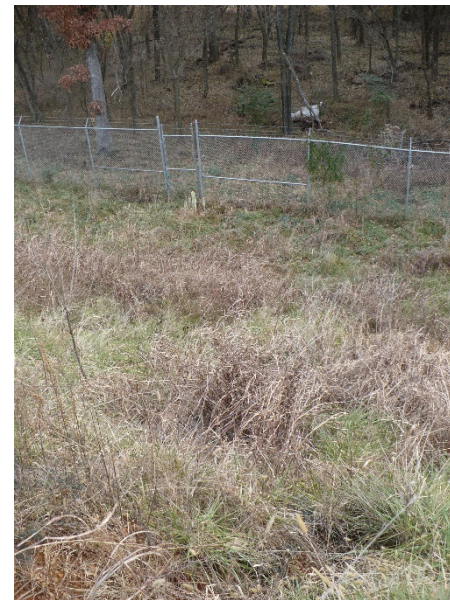
14. The perimeter berm was in fair condition. There was good vegetative cover over the entire exterior slopes of the berm. There was no erosion or displacement of the berm observed during the inspection.
15. The south and east exterior slopes are fairly steep but appeared stable. An erosion gully has started to form on the east berm above monitoring well B-4 (photo 8)
16. The vegetation is well established. However, the vegetation is high since the area was only mowed once during the season.
17. There was one rodent hole observed near the crest of the west perimeter berm (photo 14). The location (shown on Figure 1) is near the southeast corner of the west sediment pond, in line with the riprap spillway section from the pond.

Photo #8 – erosion gully on east containment berm

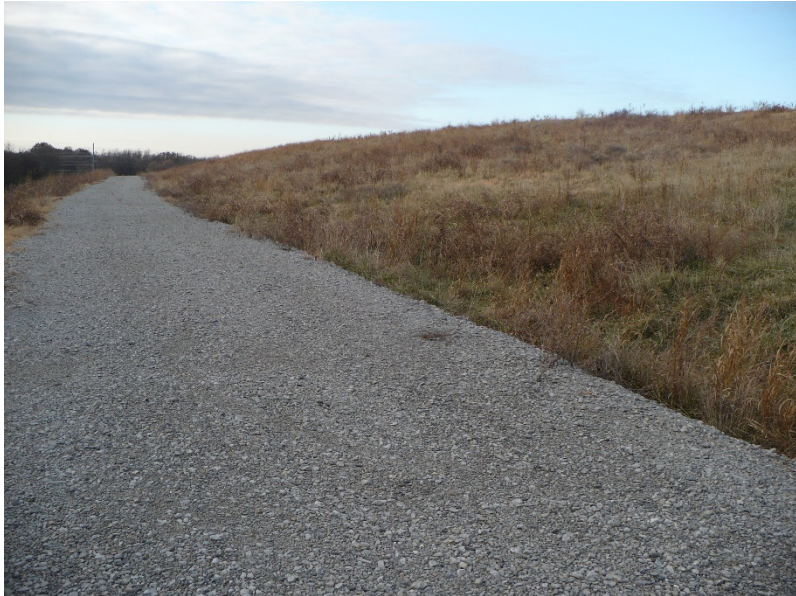
18. Portions of the landfill slopes have received final cover and certified as closed. The condition of these slopes was good. There were no observed erosion gullies, sloughs, or other signs of movement of these areas. All areas had adequate vegetative cover. The vegetation is well established but the grass was high since the area was only mowed once during the season. (photos 9-13)

Photo #9 – final cover –east slope looking south

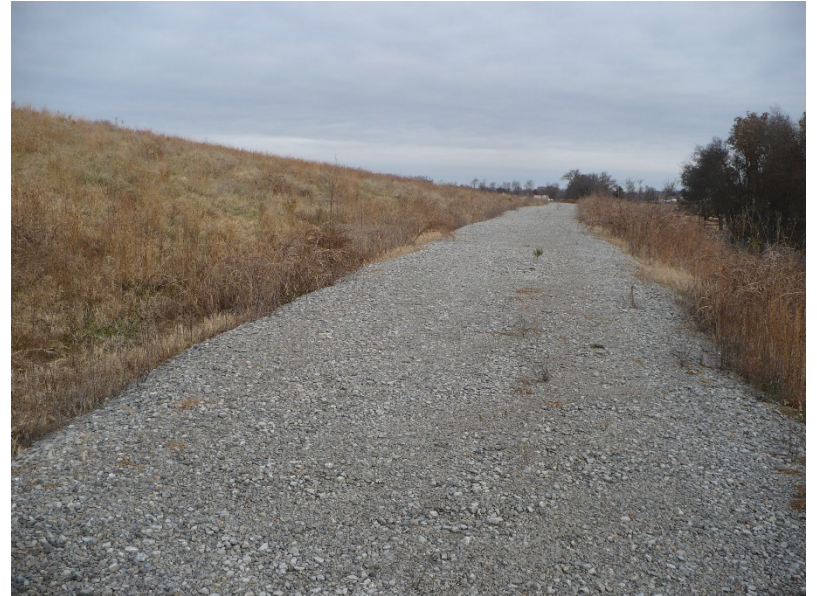
Photo #10– final cover –east slope looking north

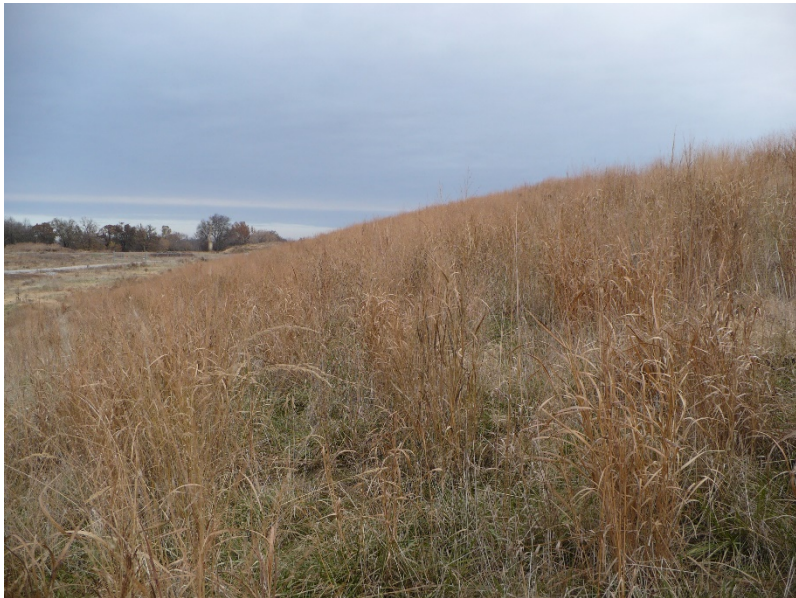
Photo #11 – final cover –west slope looking north

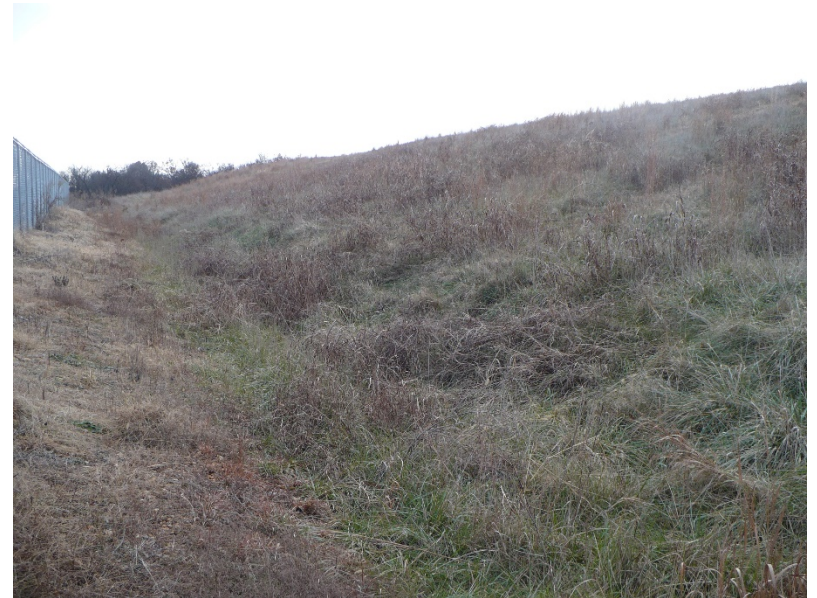
Photo #12 – final cover –north slope looking east

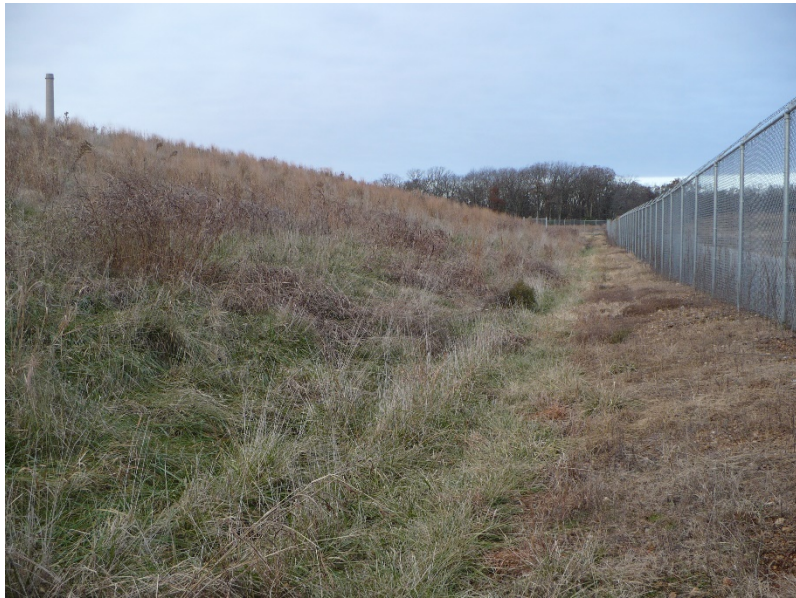
Photo #13 – final cover –north slope looking west

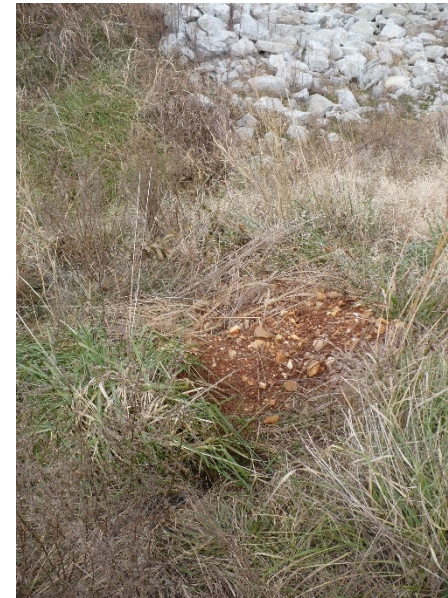
Photo #14 – rodent hole on west containment berm

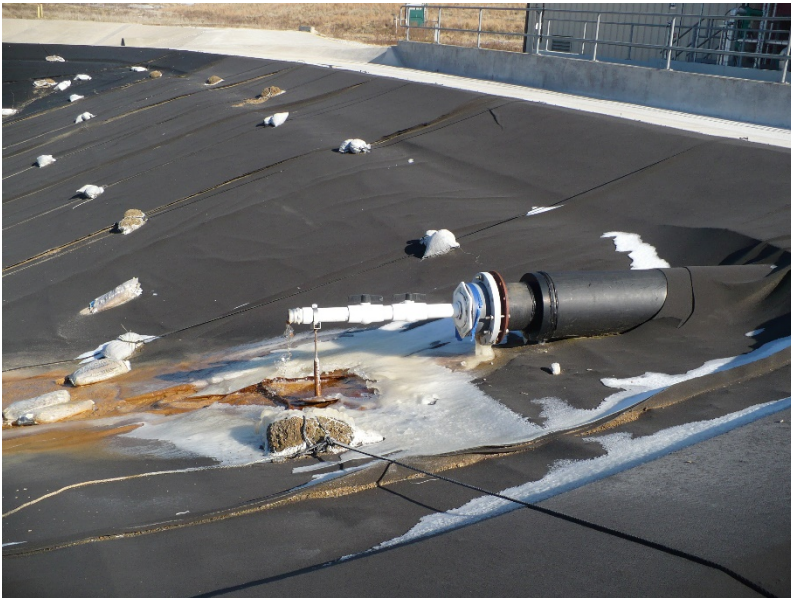
7. There is one active leachate collection pipe that flows into the pond (photo 15). The pipe was visible and only a small volume of leachate (~ 1 gpm) was flowing out of the pipes. The leachate effluent appeared clear.
8. The pond was containing a very low volume of water at the time of this inspection. The protective cover of the interior slopes appeared to be in good condition (photo 16).
9. The contact water portion of the pond complex was full but not at the level to discharge. There was a noticeable sediment delta forming at the north inlet area. There was no such delta at the south inlet area.

Photo #15 – leachate inlet pipe

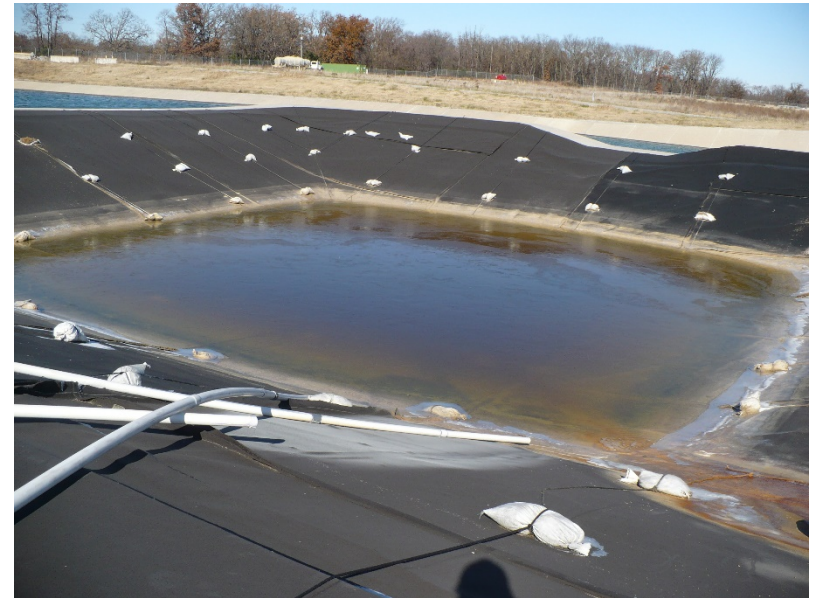
Photo #16 – leachate pond

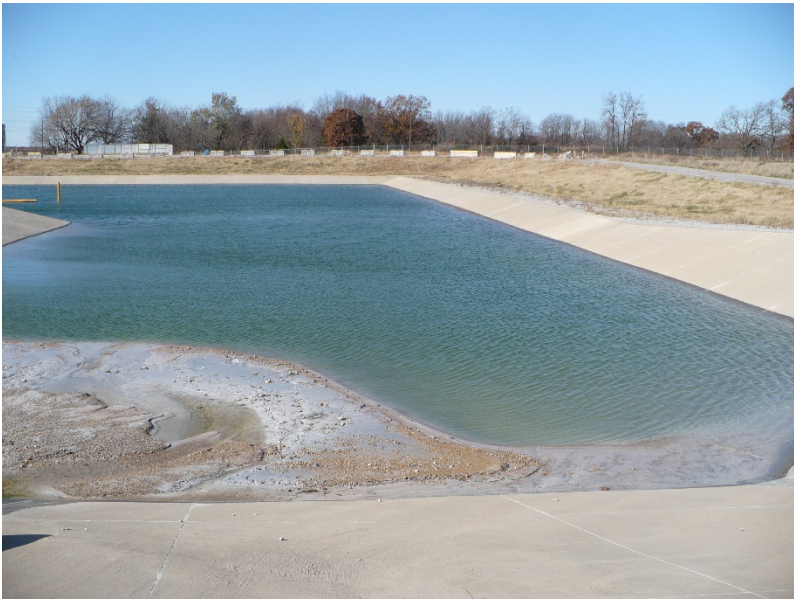
10. The concrete protective cover of the interior slopes of the contact water portion was in good condition (photos 17 & 18). There was no misalignment of the concrete joints. The condition of the caulking material at the joints was good.

Photo #17 – North end of contact water pond

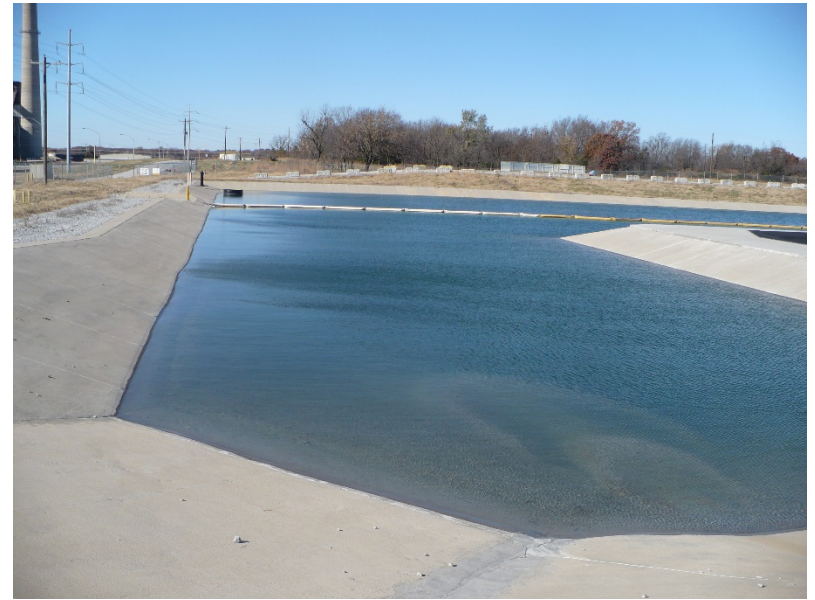
Photo #18– South end of contact water pond

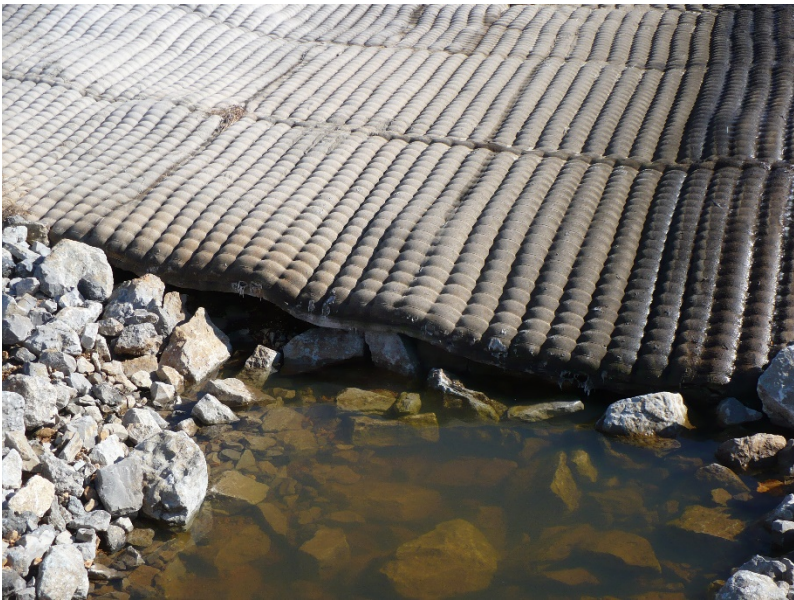
13. The minor erosion and movement of the riprap noted in the last inspection below the letdown channel on the southwest corner of the landfill has been repaired. High flows continue to displace riprap and will continue to expose and allow undercutting of the fabriform (photo 19). Undercutting of the fabriform at the toe did not appear to have significantly changed from the last inspection.

Photo #19 – undermining of SW letdown channel

Continue to monitor the riprap and scour at the toe of the west letdown.
