2020 Annual Landfill Inspection Report

Little Broad Run Landfill

**Mountaineer Plant
New Haven, West Virginia**

**2020 Annual Landfill Inspection Report
(CCR Landfill)**

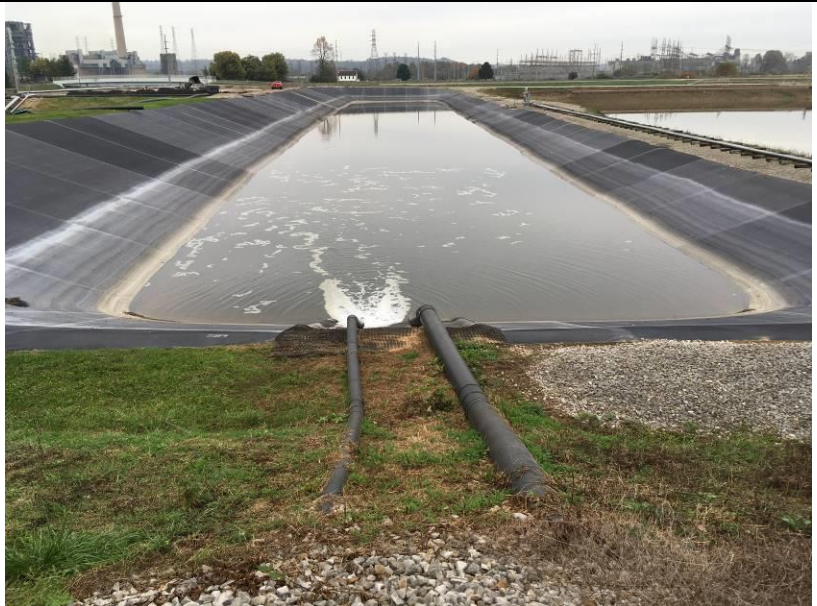
Photo # 1

1. Photograph No. 1 illustrates wastewater pond as part of the entire bottom ash complex. The leachate water from the landfill after going through the leachate collection pond system is discharged into the wastewater pond located at the power plant. The two discharge HDPE pipes (8" and 16" in diameter) are located on the west dike of the pond illustrated in the photograph appeared in good functional condition.

This photograph illustrates landfill leachate surge pond and discharge pipes.

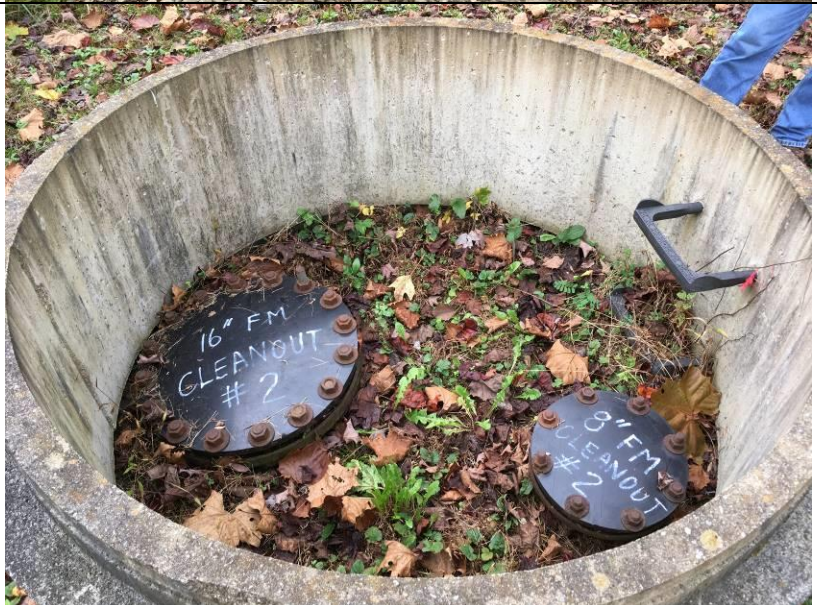
Photo # 2

2. These two discharge pipes are installed between the leachate collection pond and the wastewater pond. There are numerous cleanouts for the discharge pipes between the wastewater and leachate pond. Typical condition of the cleanout and concrete manhole for protection of the cleanouts are illustrated in Photographs No. 2 & 3. All the cleanouts were accessible inside the manhole and appeared in good condition. Minor vegetation along the access to the discharge pipes was present that needs some clearing.

Typical condition of the cleanout #2 and protective concrete collar.

1. Clear excessive vegetation from the landfill area and along the leachate discharge pipes and cleanouts as noted.
2. Clean out and grade the perimeter ditch of Area 1 for positive drainage where the rock check dam is silted in.
3. Clean out and grade the eastern perimeter ditch of Area 3 for positive drainage where there is standing water.
4. Perform repair and grading of erosion rills in the cover soils of Area 3 along the eastern end.
5. Clean out and grade the western perimeter ditch of Area 3 for positive drainage where there is standing water caused by tire ruts.
6. Clean out the excessive cattail growth from the northwest sediment pond.
7. Backfill, regrade, and compact low areas of the stacker pad and remove any excessive gypsum for positive drainage.

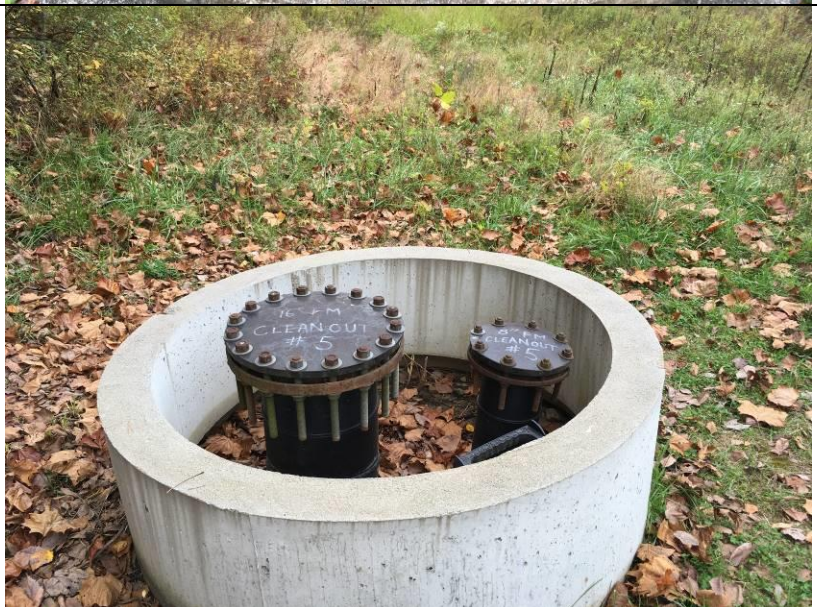
Photo # 3

Typical condition of the cleanout #5 and protective concrete collar.

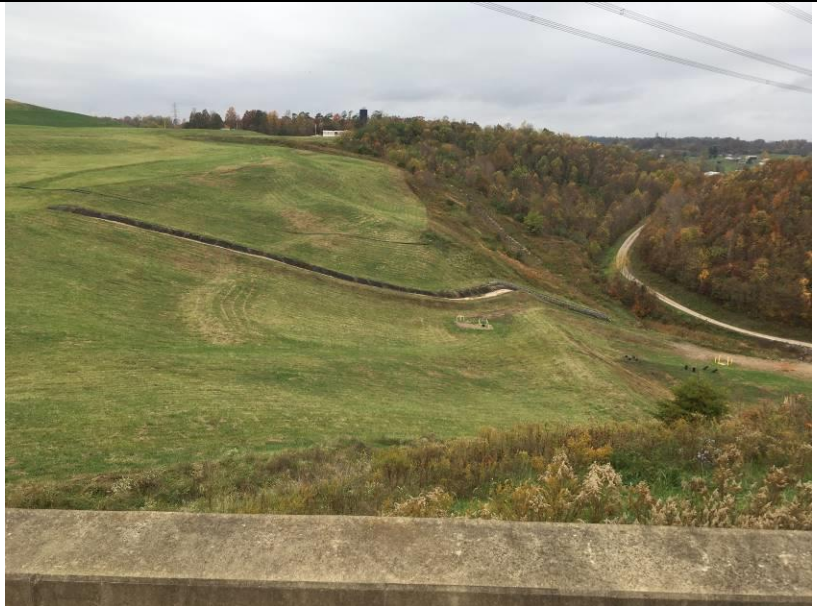
Photo # 4

3. Typical condition of landfill Areas 6 and 7 is illustrated in Photograph No. 4 & 5. Overall landfill Areas 6 and 7 appeared in satisfactory and stable condition with adequate vegetative cover. The perimeter ditches were observed to be in satisfactory and functional condition (Photographs No. 6 and 7). No standing water was observed in the perimeter ditches.

Typical condition of landfill Area 7 vegetative cover.

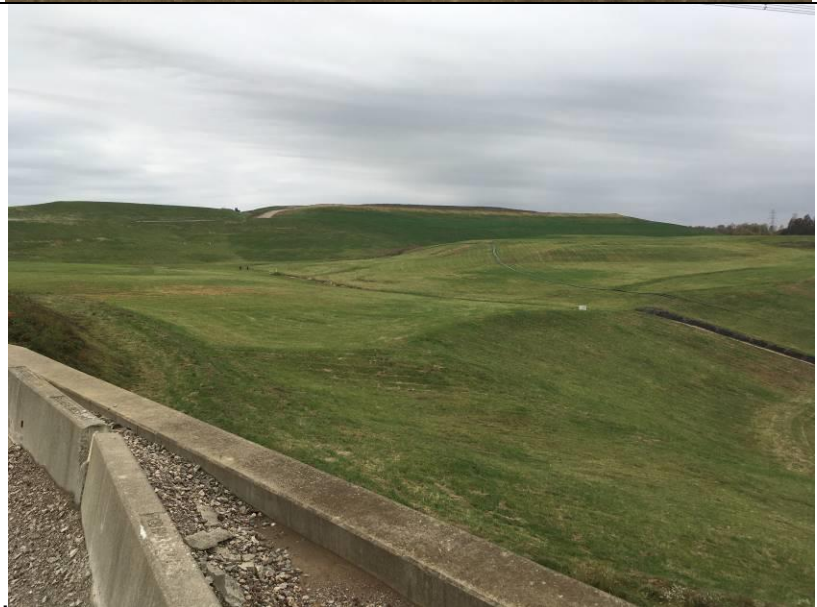
Photo # 5

Typical condition of landfill Areas 6 and 7 vegetative cover.

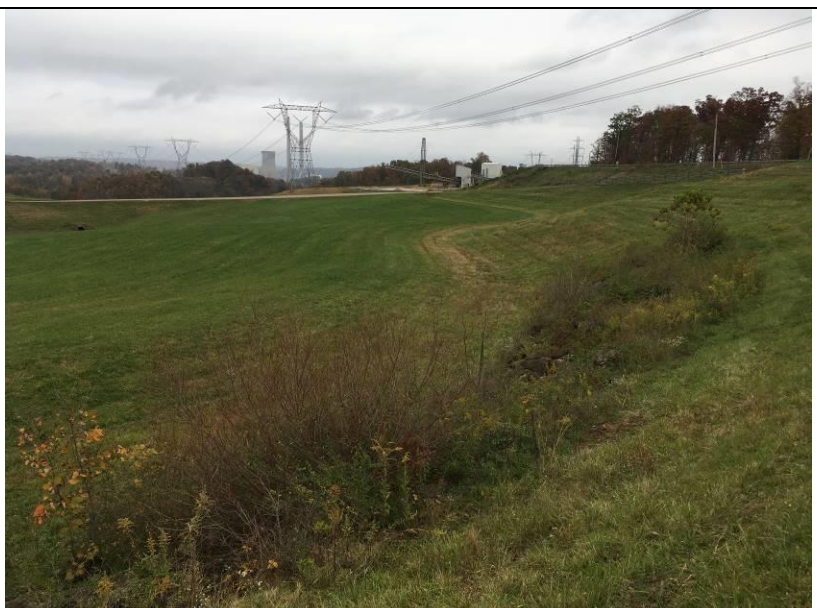
Photo # 6

View along the perimeter ditch of Areas 6 and 7 (looking northeast).

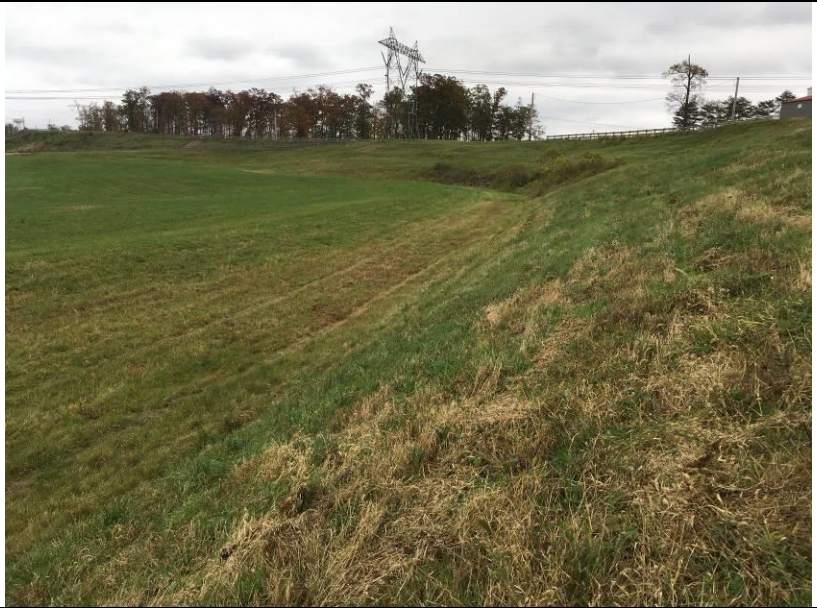
Photo # 7

View along the perimeter ditch of Areas 6 (looking east).

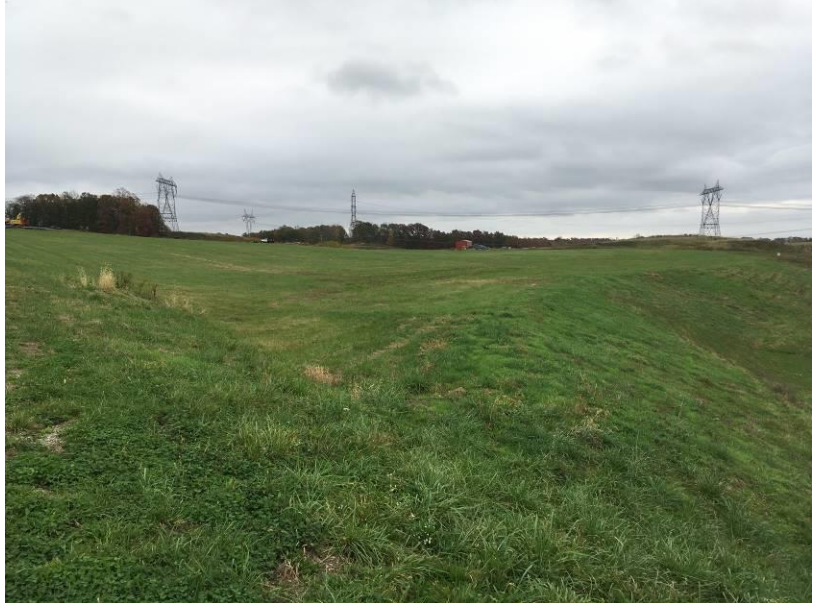
Photo # 8

4. Landfill Area 1 appeared in satisfactory and stable condition (illustrated in Photographs No. 8 and 9). A minor scarp is starting to develop on the outside slope berm. This area had just been re-graded and seeded (Photograph No. 9).

Overall view of Area 1, top of the landfill.

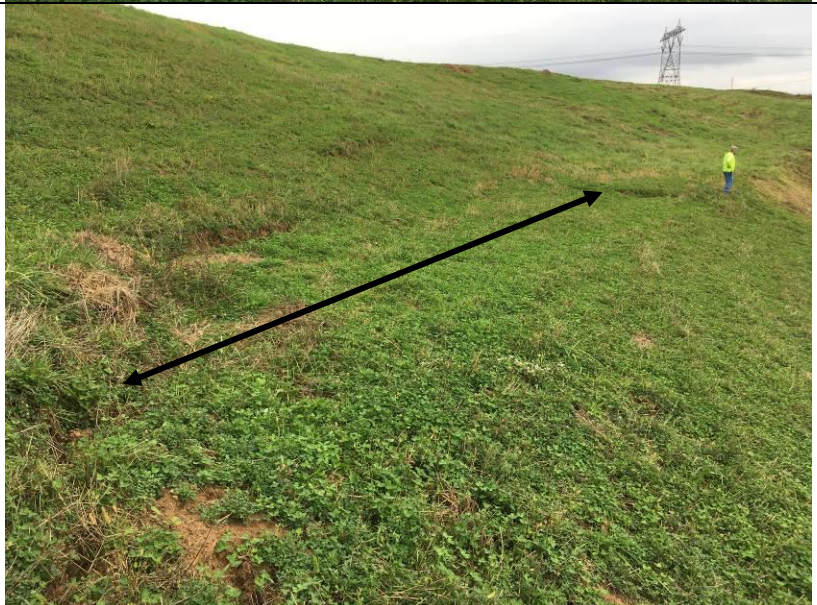
Photo # 9

Overview of Area 1 side slope cover. Notice minor scarp in the cover soils.

- determine the root cause of the existing seepage in Area 3 and develop a permanent remediation plan for Area 3.
2. Monitor poor drainage issues at the gypsum stackout pad to reduce the amount of sediment build up in the sump structure.
 3. Monitor the scarp developing on the Area 1 outside slope berm. This area should be closely monitored for additional movement until a full repair can be completed.

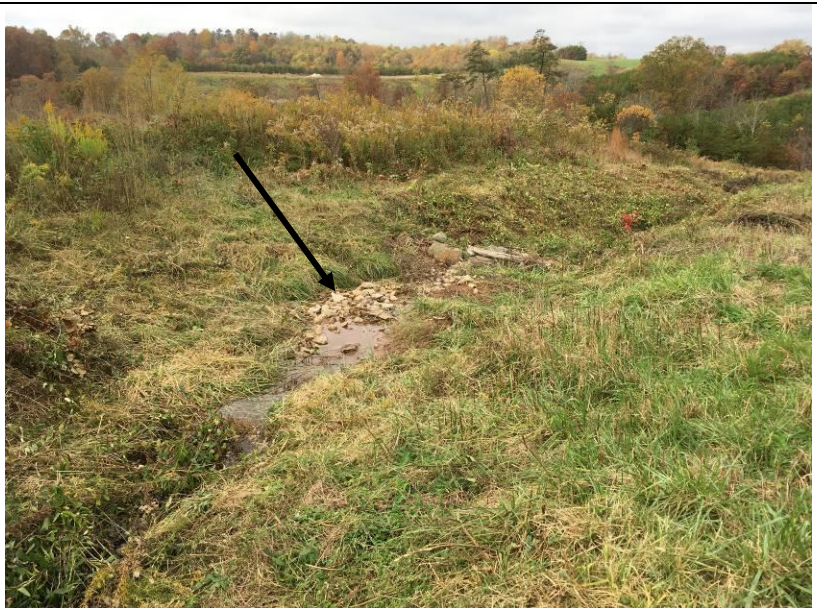
Photo # 10

5. The perimeter ditch around Area 1 is in fair condition with the exception of an old rock check dam that has silted up and is creating standing water (Photograph No. 10).

Overall view of Area 1 Perimeter Ditch Silted In.

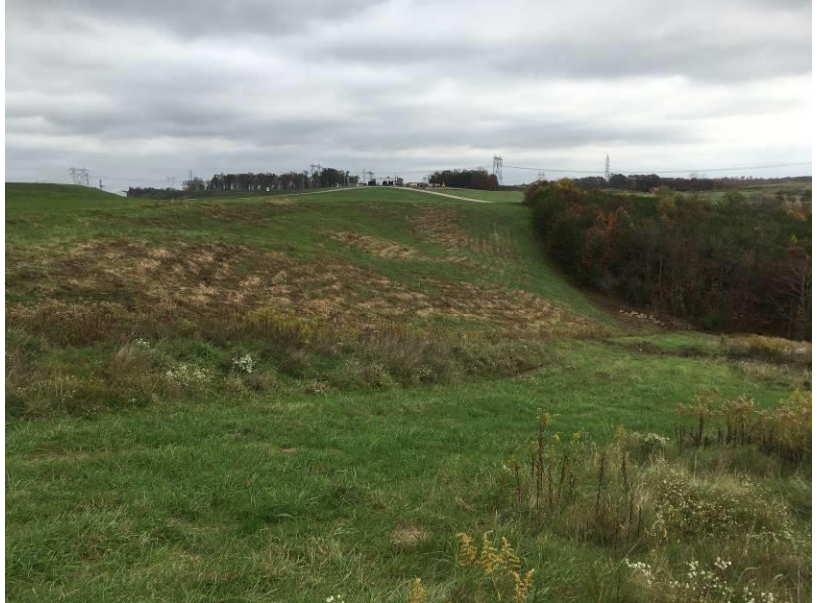
Photo # 11

6. Overall Area 2 appeared in satisfactory and stable condition (Photograph No. 11). The soil cover and vegetation appeared to be in satisfactory condition. The scour area along the left groin ditch near the toe area has been repaired since last inspection (Photograph No. 12).

Overview of Area 2 Vegetative Cover.

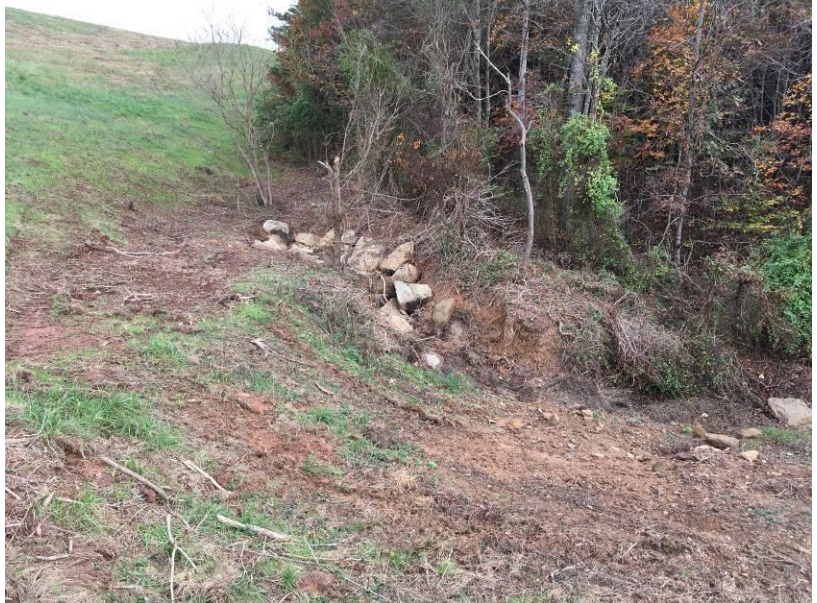
Photo # 12

Overview of Area 2 Side Slope Groin Ditch Near the Toe. Scour Along the Groin Ditch Has been Stabilized With Rip Rap.

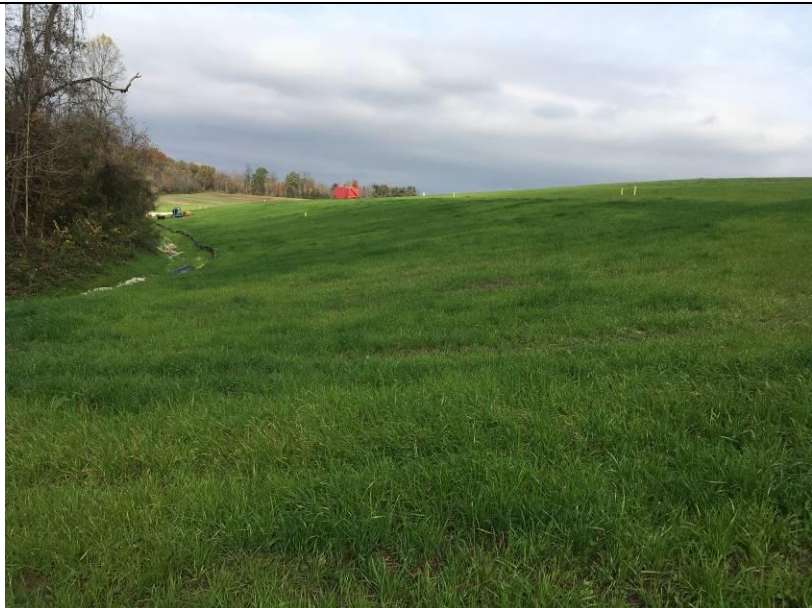
Photo # 13

7. Overall Area 3 appeared in satisfactory and stable condition with good vegetative cover. The slope remediation work for Area 3 is complete (Photograph No. 13). The remediation work consisted of removing unstable fill, placing a layer of geo-grid, place backfill, a drainage layer using geo-composite, and cover soil. The perimeter ditch around Area 3 on the east side is in good and functioning condition with a few low spots with standing water (Photograph No. 14).

Overview of Area 3 Vegetative Cover Looking West.

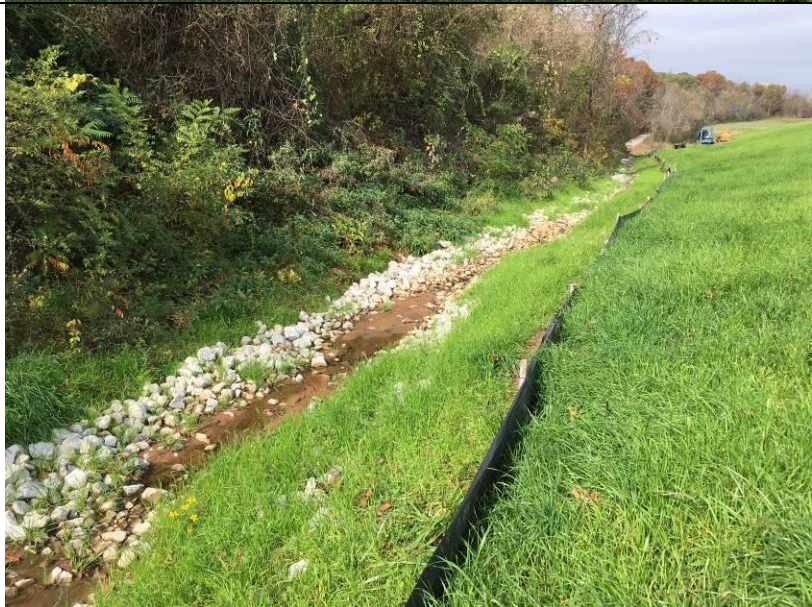
Photo # 14

Overview of Area 3 Perimeter Ditch.

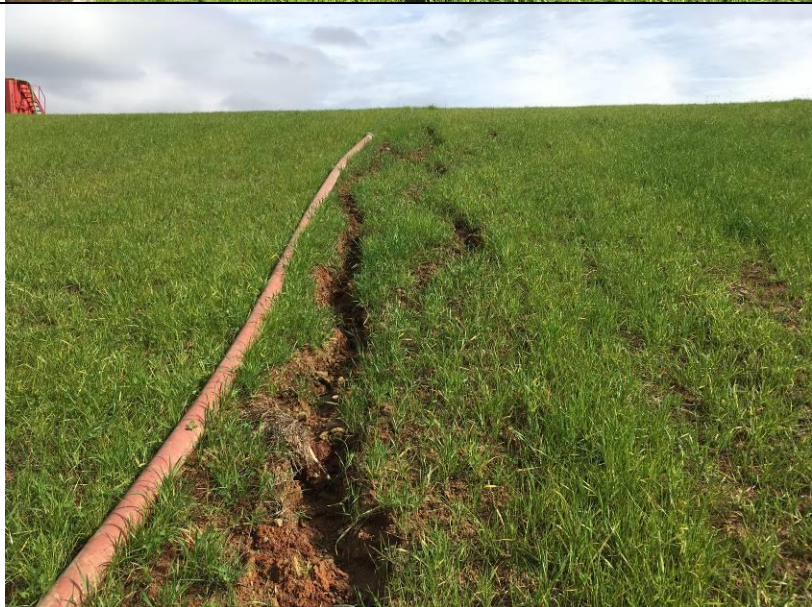
Photo # 15

8. There are some minor erosion rills in the new cover of Area 3 that need to be graded and seeded (Photograph No. 15). The perimeter ditch around the west side of Area 3 has some standing water caused by blockage from tire ruts from recent mowing activities (Photograph No. 16).

Overview of Area 3 Vegetative Cover with Erosion Rills.

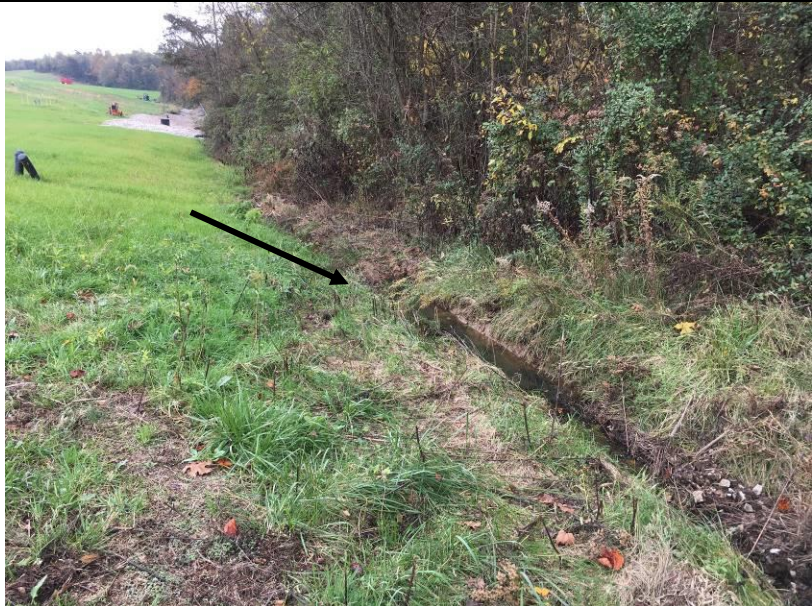
Photo # 16

Overview of Area 3 Perimeter Ditch Blockage Caused By Tire Ruts.

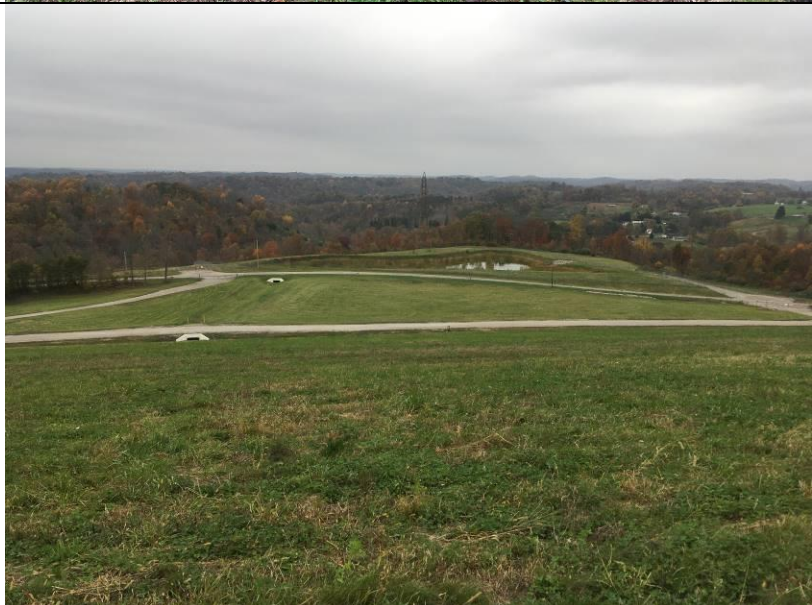
Photo # 17

9. Overall Area 4 appeared in satisfactory and stable condition (Photograph No. 17 and 18). The soil cover, vegetation and rip rap drainage channel appeared to be in satisfactory condition.

Overview of Area 4 Cover and Northwest Sediment Pond in the Background.

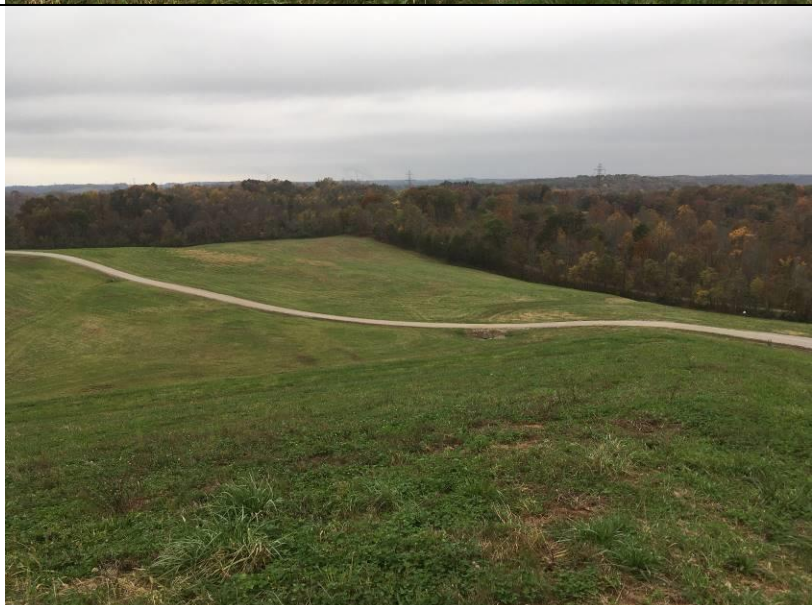
Photo # 18

Overview of Area 4 Cover.

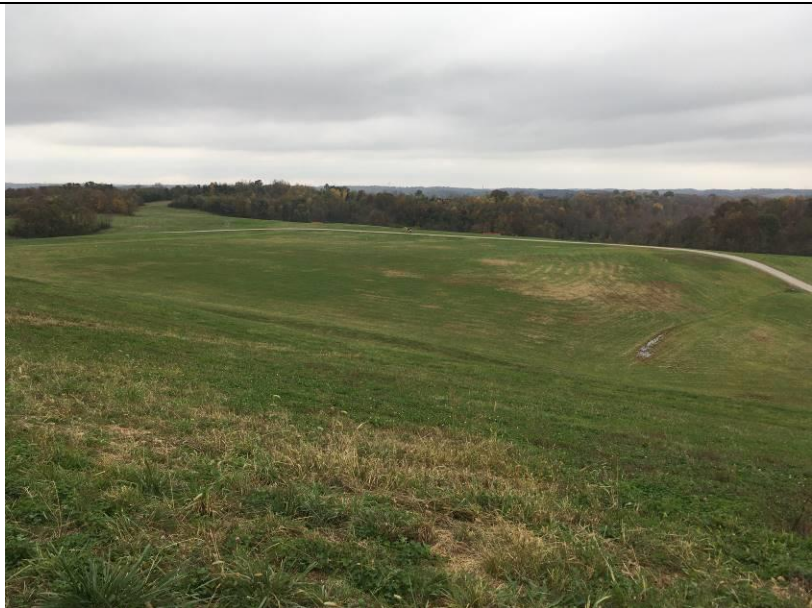
Photo # 19

10. Landfill Area 5 is illustrated in Photograph No. 19. This area and the perimeter access road was in satisfactory and stable condition with controlled vegetation.

Overview of Area 5 Vegetative Cover, Top of Landfill.

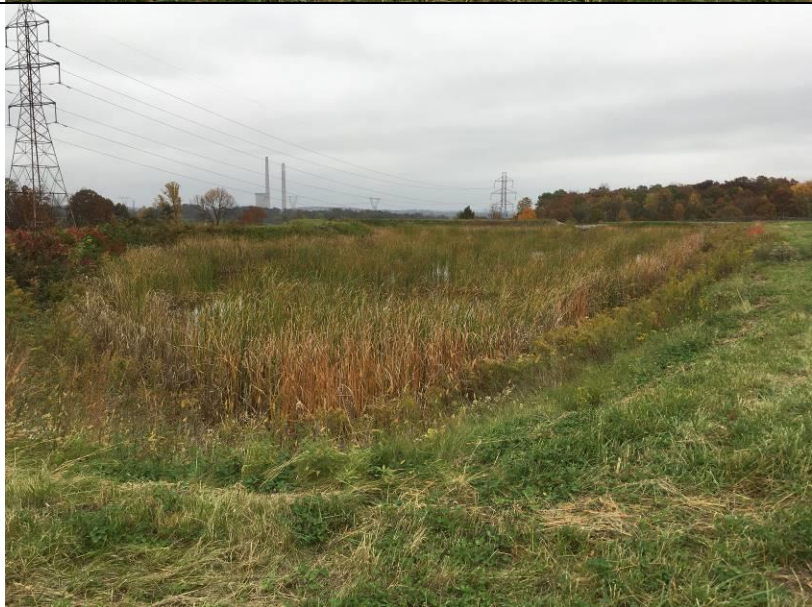
Photo # 20

11. Photograph No. 20 illustrates the northwest sediment pond. Overall, the pond appeared to be functioning as designed and the dikes were in satisfactory and stable condition. Cattail growth was observed throughout the pond area needs to be cleared.

Overview of Northwest Sediment Pond.

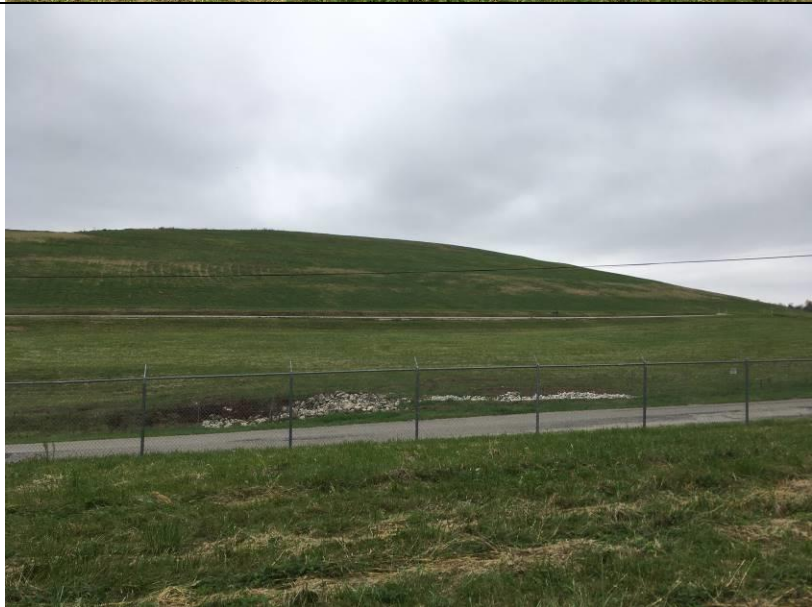
Photo # 21

12. The outside side slope areas of vertical expansion Phase 1A is illustrated in Photograph No. 21. The slope area and perimeter access road were in satisfactory and stable condition with controlled vegetation.

Overview of Side Slope Area of Vertical Expansion Phase 1A.

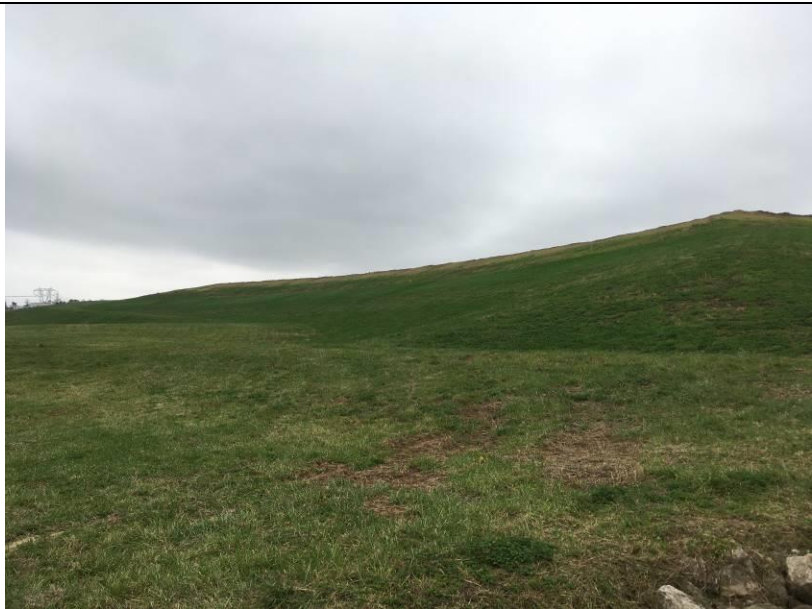
Photo # 22

13. The outside side slope areas of vertical expansion Phase 1B is illustrated in Photograph No. 22. The slope area and perimeter access road were in satisfactory and stable condition with controlled vegetation.

Overview of Side Slope Area of Vertical Expansion Phase 1B.

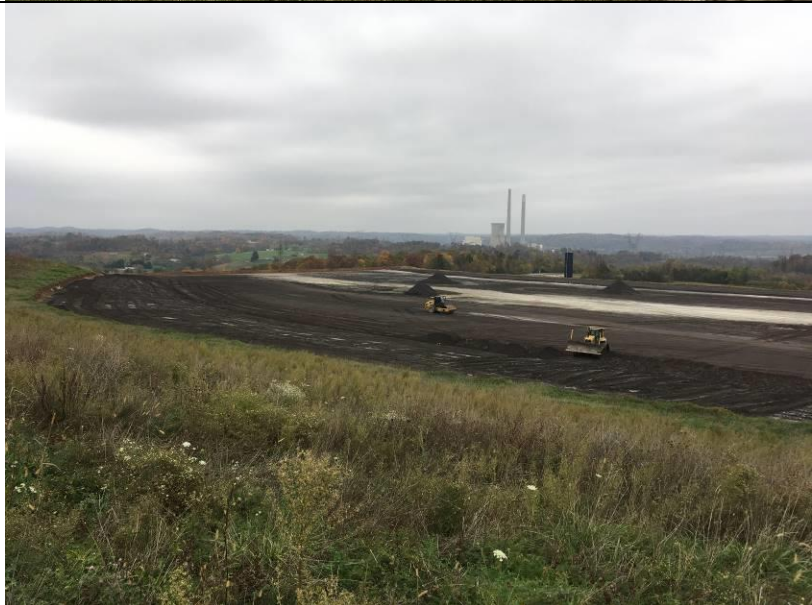
Photo # 23

14. Photograph No. 23 and 24 illustrates Phase 1B of the active landfill which is part of the vertical expansion. This area appeared satisfactory and in compliance with the permit requirements.

Active landfill – Vertical Expansion Phase 1B. Looking Northwest.

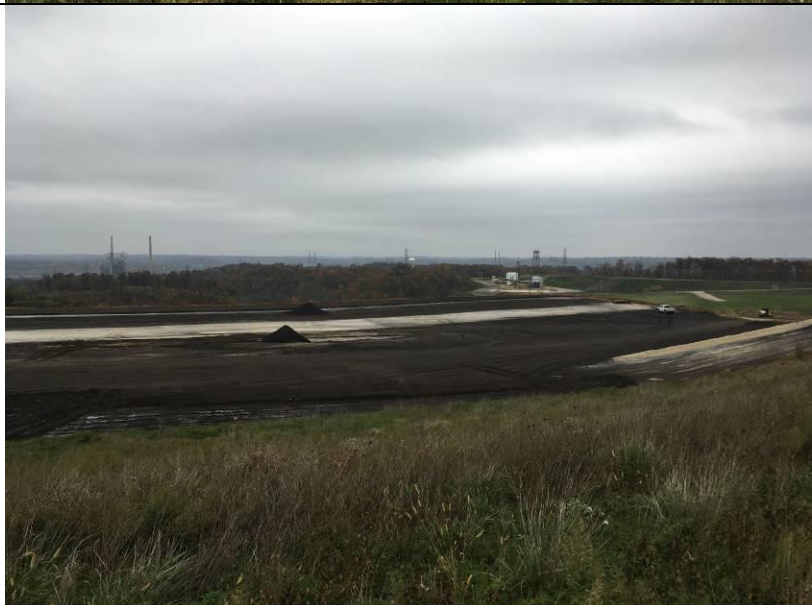
Photo # 24

Active landfill - Vertical Expansion Phase 1B. Looking East.

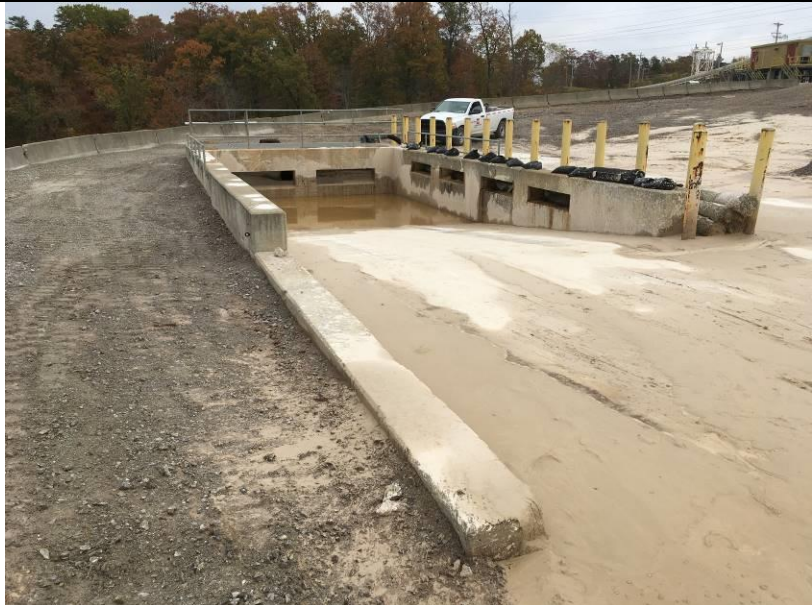
Photo # 25

15. Photograph No. 25 and 26 illustrates gypsum stacker pad. The radial stacker was not in operation at the time of inspection. The stacker pad has some accumulation of gypsum near the sump structure (Photograph No. 26).

Gypsum Stackout Pad. View of the Storm Water Run Off Sump Structure.

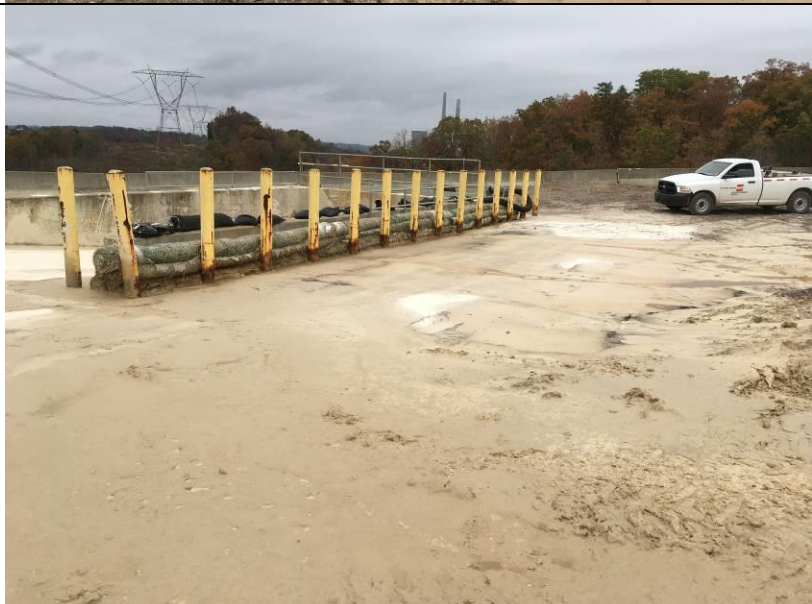
Photo # 26

Gypsum Stackout Pad. View of Gypsum Accumulation Near the Sump Structure.

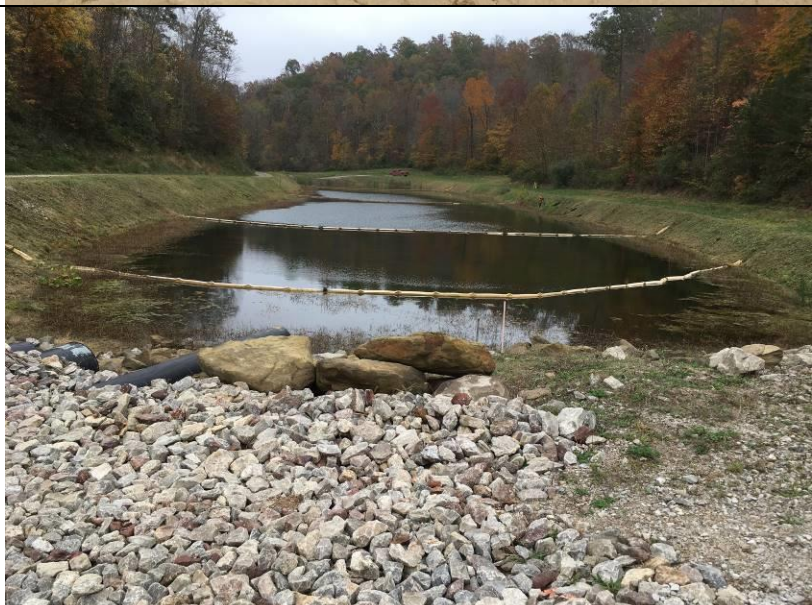
Photo # 27

16. Landfill Area 7 sediment pond is illustrated in Photograph No. 27 appeared to be functioning as designed and in satisfactory condition.
17. The leachate collection system of the landfill is collected in a manhole at the east side of the landfill. Photograph No. 28 illustrates interior of the manhole as a collection point for all the leachate pipes. The leachate pipes appeared satisfactory and in compliance with the permit requirements. Photographs No. 29 and 30 illustrates the two leachate ponds. The ponds appeared in satisfactory and functional condition.

Overview of Area 7 Sediment Pond.

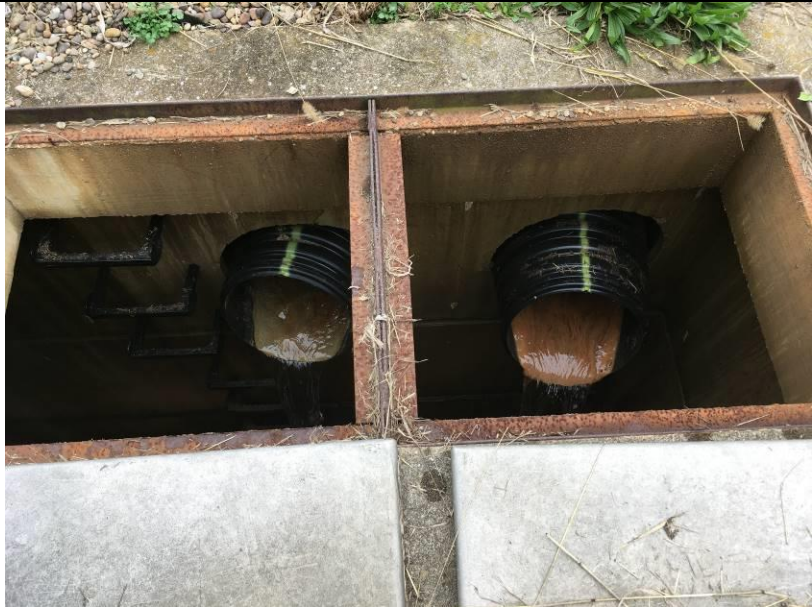
Photo # 28

Landfill Leachate Pipe Collection
Manhole MH-1.

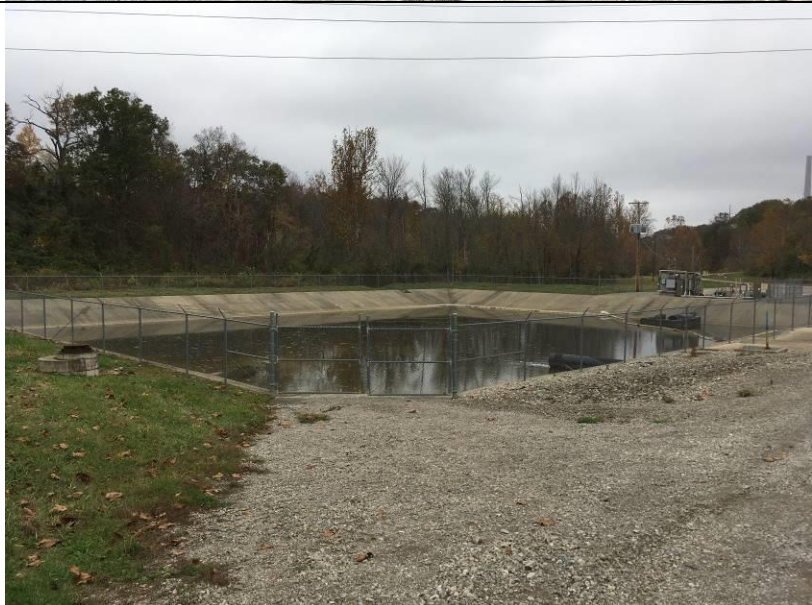
Photo # 29

Leachate Pond 1.

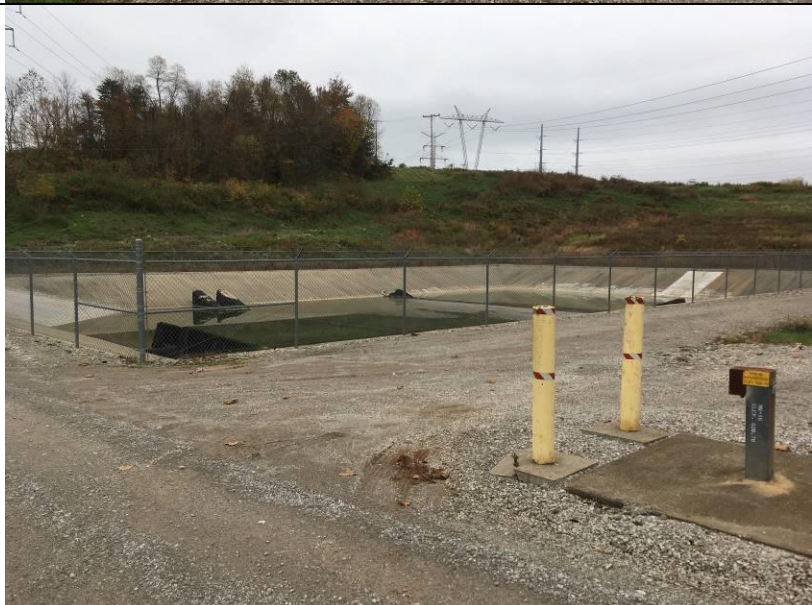
Photo # 30

Leachate Pond 2.
