# **2021 Annual Dam and Dike Inspection Report**

**Primary Bottom Ash Dam**

**Flint Creek Plant**

**Document ID: GERS-21-015**

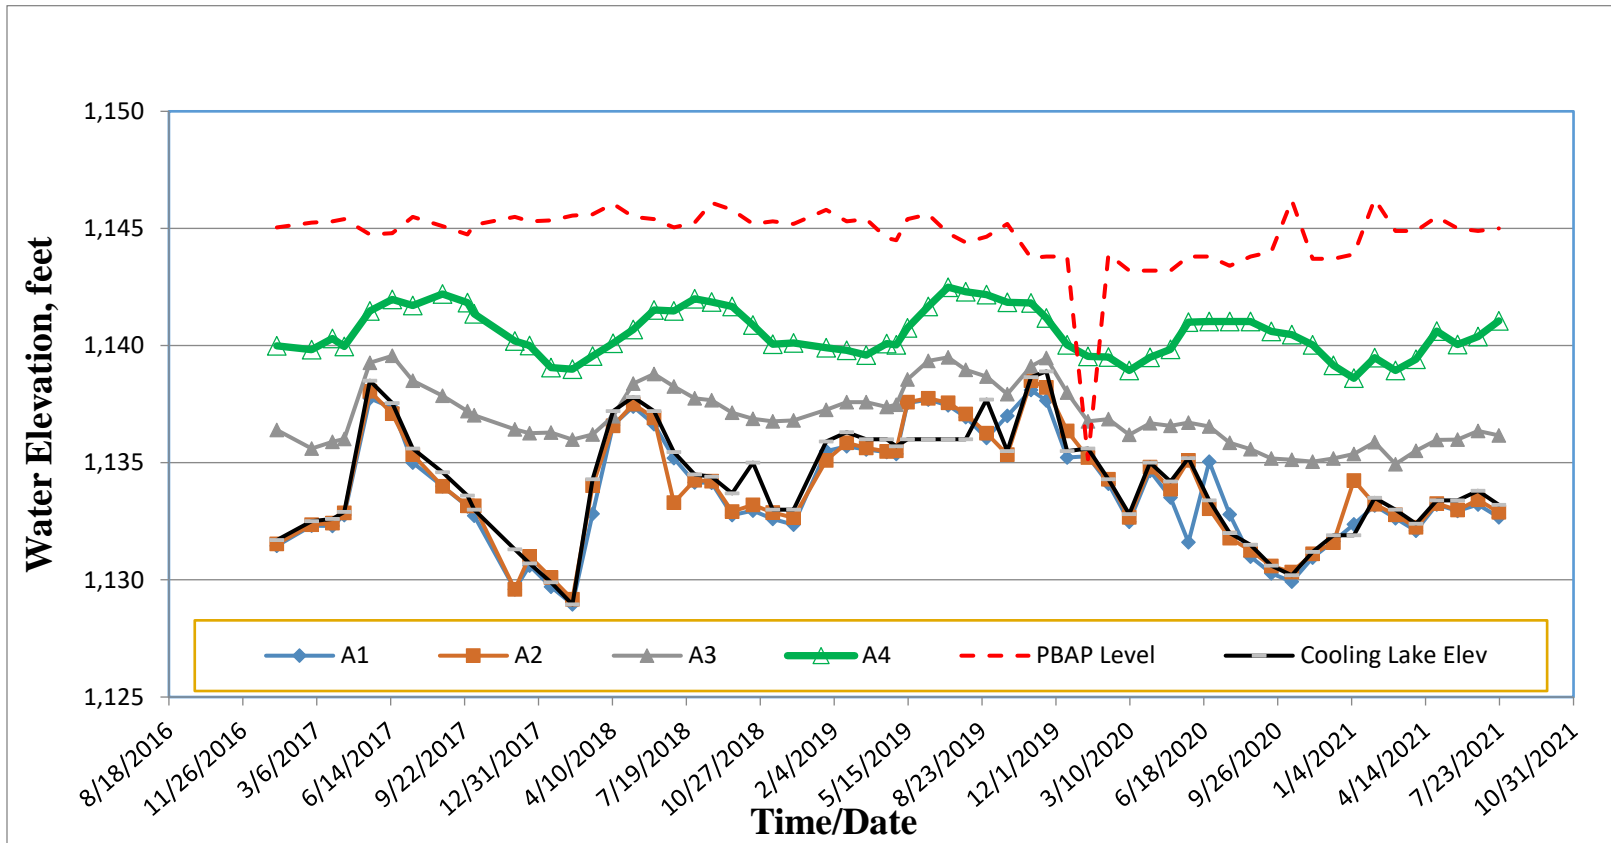
**Figure 3 – Historical Piezometer Data Plot**  
**Primary Bottom Ash Pond**  
**Flint Creek Plant, Gentry, AR**

There are four piezometers located along the crest of the dam as shown on Figure 2. These are the only instrumentation related to this facility. A review of readings since the last inspection and historical readings (2017-2021) indicate the levels are consistent and respond to the fluctuation of the cooling lake level. The piezometers are more influenced by the level of the cooling lake than the elevation of the bottom ash pond. The trend in the historical data between the piezometers reading, lake level, and pond levels are consistent.

Figure 3 is a historical plot of the piezometer readings over the past several years.

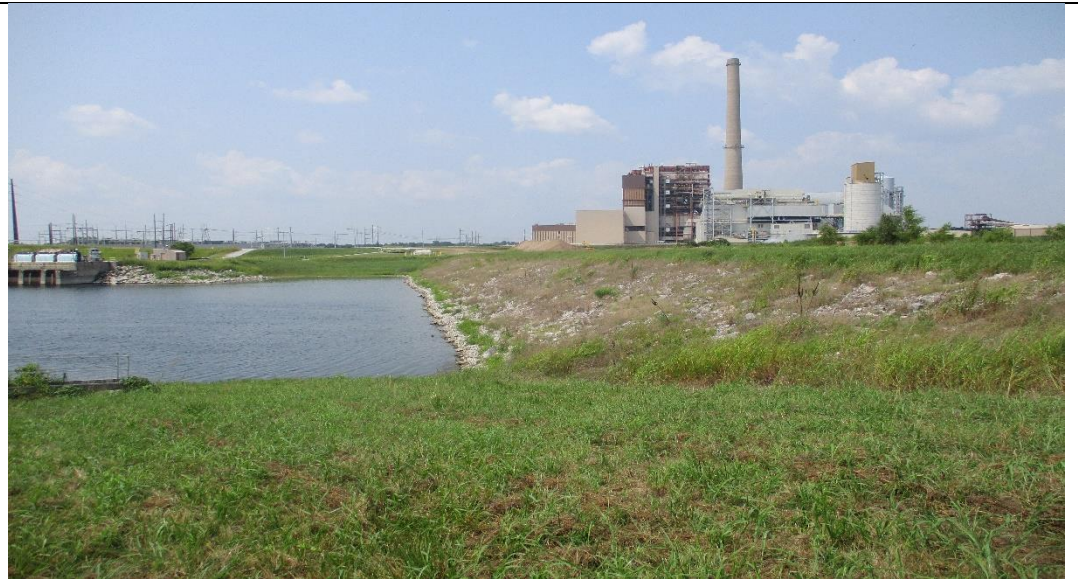
PHOTO #1

- (i) Photograph Nos. 1-3 illustrates the downstream slope of the primary dam. The downstream slope of the primary dam appeared in satisfactory condition. Most of the slope was protected with riprap cover except for the upper 12-15 feet of the slope is covered with vegetation. There was no observed displacement or movement of the riprap. There was no seepage observed along the face of the slope. Slightly overgrown vegetation was observed at the upper section of the slope and vegetation was seen protruding between the riprap.

Downstream slope and the groin (looking north).

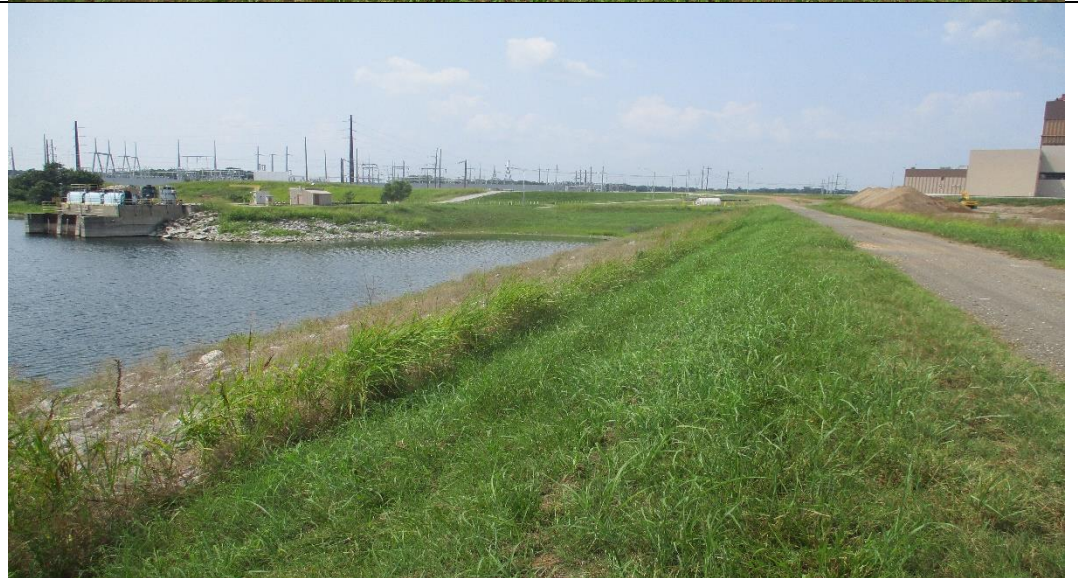
PHOTO #2

Middle section of the downstream slope.

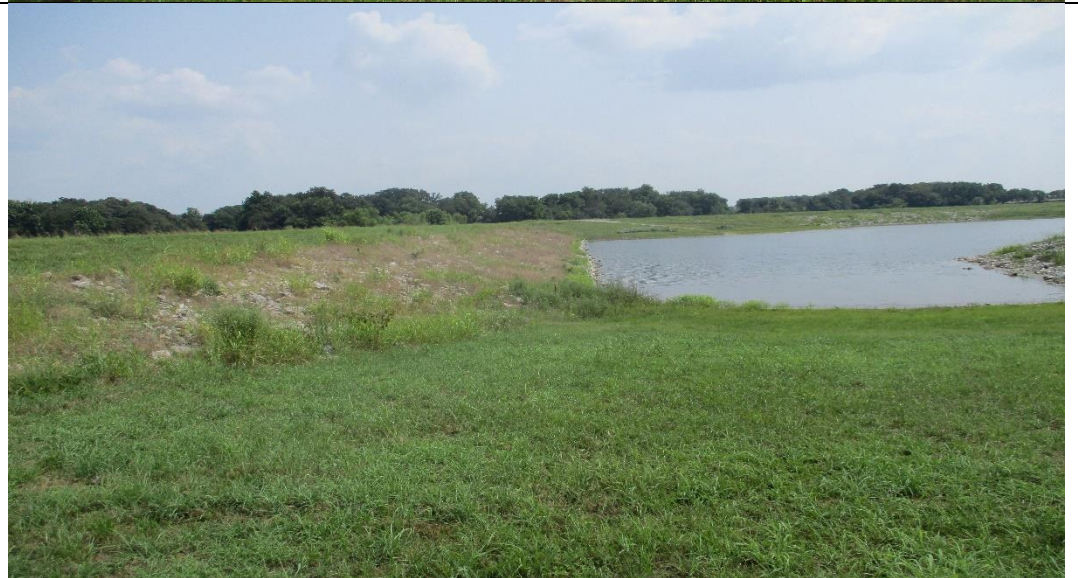
PHOTO #3

Downstream slope and the groin (looking south).

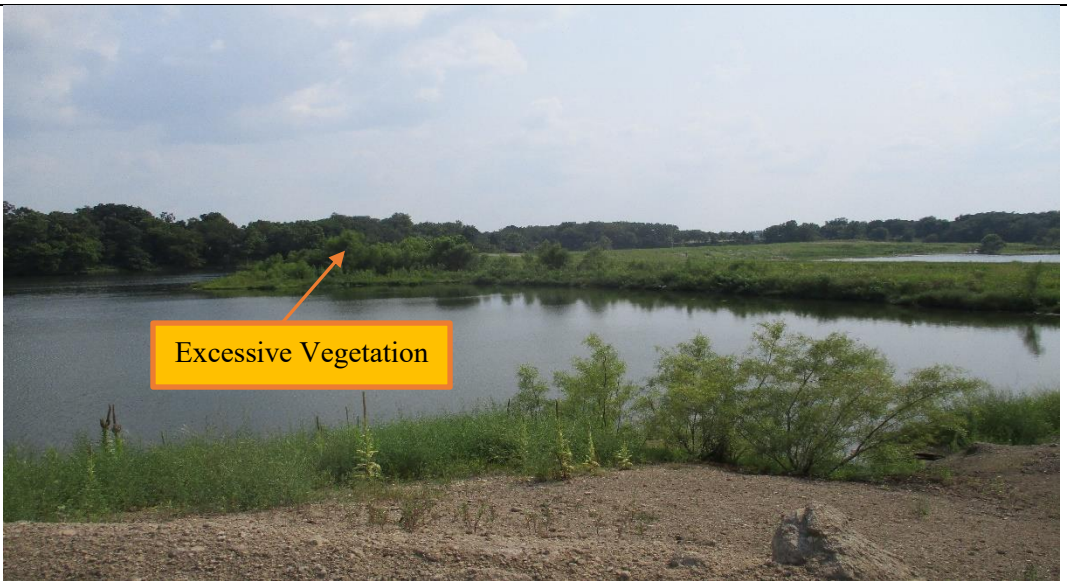
- (ii) Photograph Nos. 4-6 illustrates the condition of the upstream slope. A dredge cell is located adjacent to the north section of the upstream slope. The upstream slope of the primary dam was observed to be in satisfactory condition from the visible riprap up to the crest. Since the pond is used for settling of solids, there is an accumulation of bottom ash stockpile in the north section of the upstream slope at the dredge cell. The north area of the pond is used for operational activities by maintaining and

removal of bottom ash for the beneficial use. The interface of the upstream slope and ash limits was visible and stable. Excessive and overgrown trees were noticed at the south end of the upstream slope.

<p><u>PHOTO #4</u></p> <p>This photograph illustrating southeast area of the upstream slope, excessive vegetation.</p>

In general, there is excessive vegetation on the slopes and mowing should be performed more frequently.

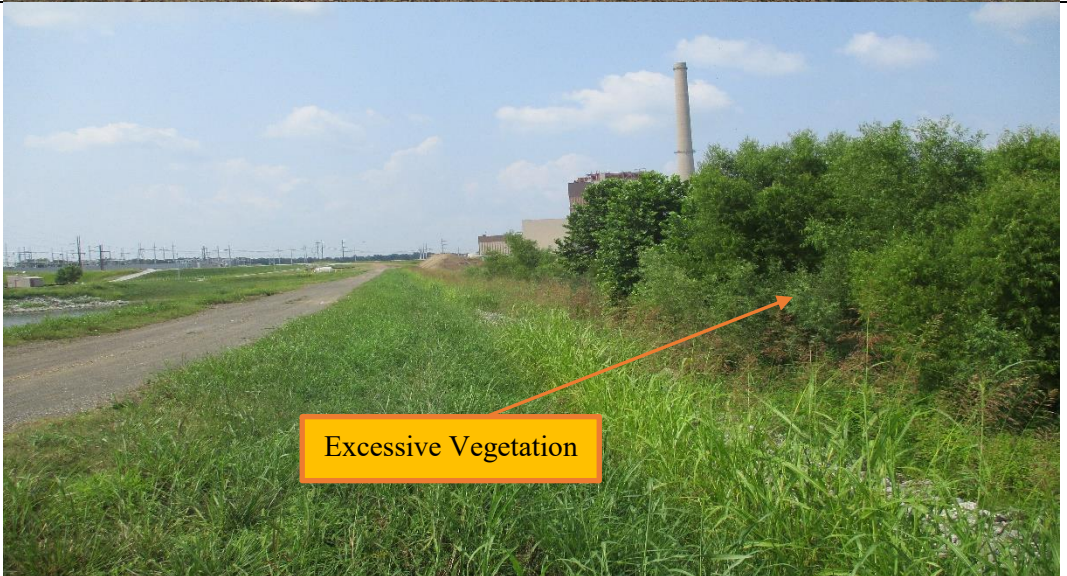
<p>Excessive Vegetation</p> <p>This photograph shows a wide view of a pond or reservoir. The far bank is heavily overgrown with dense green trees and shrubs. An orange arrow points from a yellow box labeled 'Excessive Vegetation' to the dense foliage on the opposite shore. The foreground consists of a gravelly or sandy bank with some sparse vegetation.</p>
<p><u>PHOTO #5</u></p> <p>This photograph illustrates north section of the upstream slope.</p>

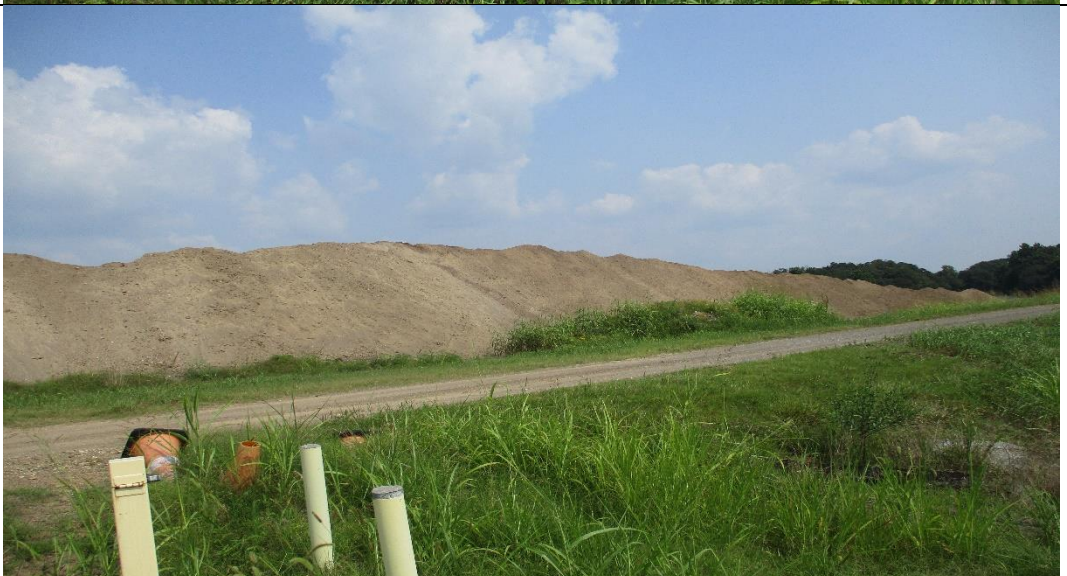
<p><u>PHOTO #6</u></p> <p>Stockpile of bottom ash adjacent to the north section of the upstream slope.</p>

- Continue the vegetation control plan of mowing and spraying.
- Continue maintaining the temporary stockpile and dredge cell so that it is contained within the limited area.
- Avoid any encroachment and overtopping of the dam with bottom ash stockpile.

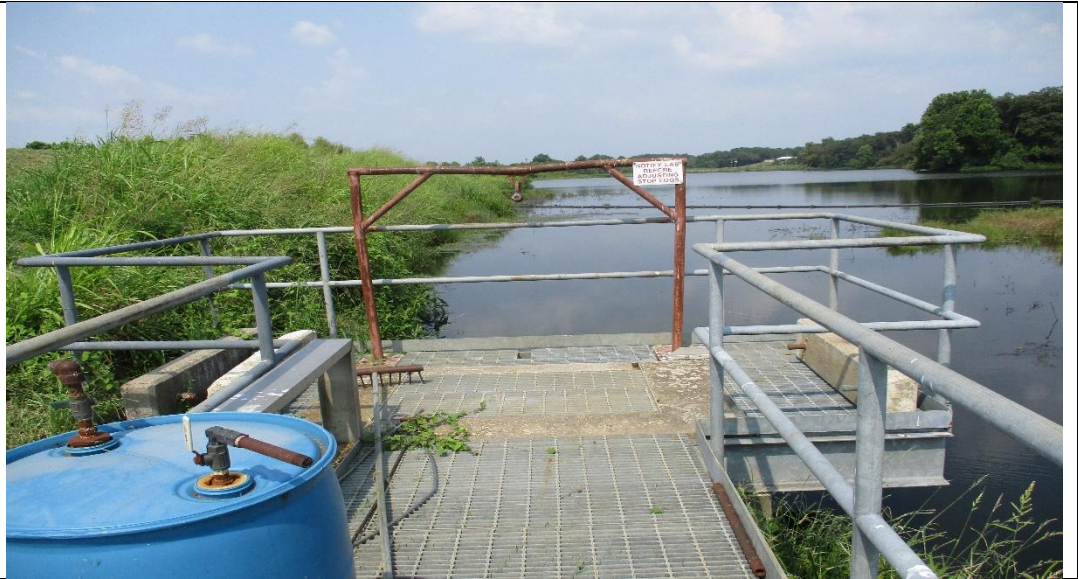
- (iii) Photograph No. 7 illustrates the principal spillway (overflow discharge structure). The principal spillway for the pond is a concrete drop-inlet structure with stop logs used to control the pool elevation. The spillway was in generally fair condition. Flow through the principal spillway was unobstructed (Photograph No. 8).

PHOTO #7  
Overflow discharge structure.

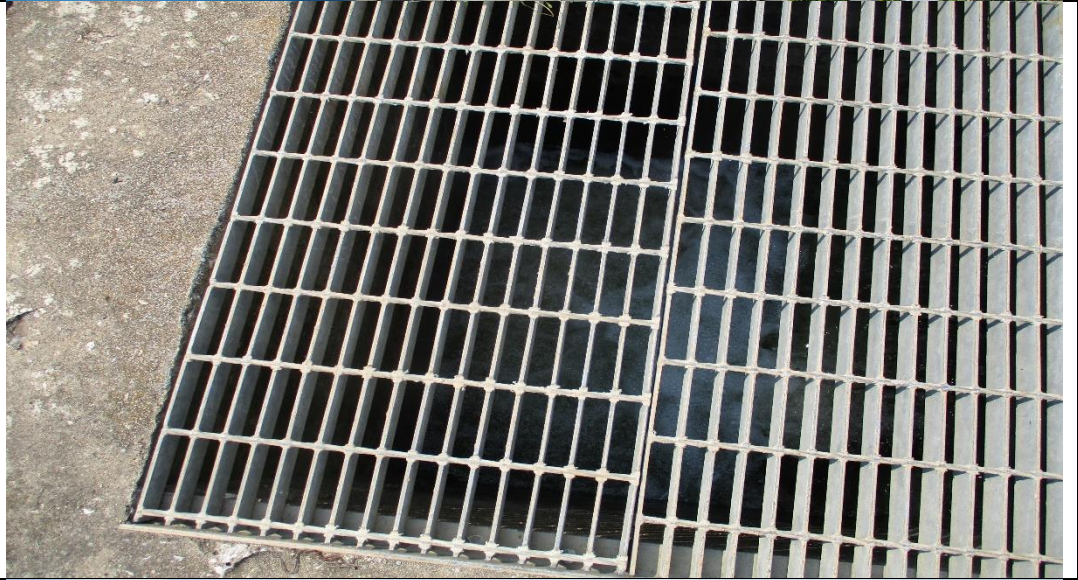
PHOTO #8  
Interior of the discharge structure.

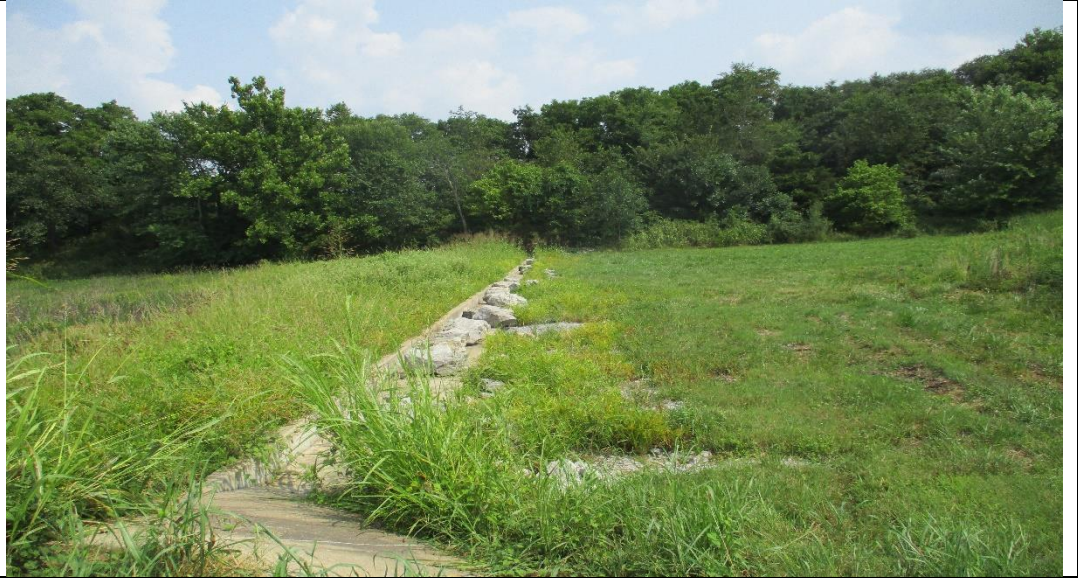
The emergency spillway (Photograph No. 9) is an incised channel in natural ground with a concrete weir control section, 1 ft. in height, across the channel width. The spillway was in generally good condition at the time of inspection. The spillway appeared to be generally stable. Vegetation control in this natural ground area is good.

PHOTO #9  
Emergency spillway concrete sill.

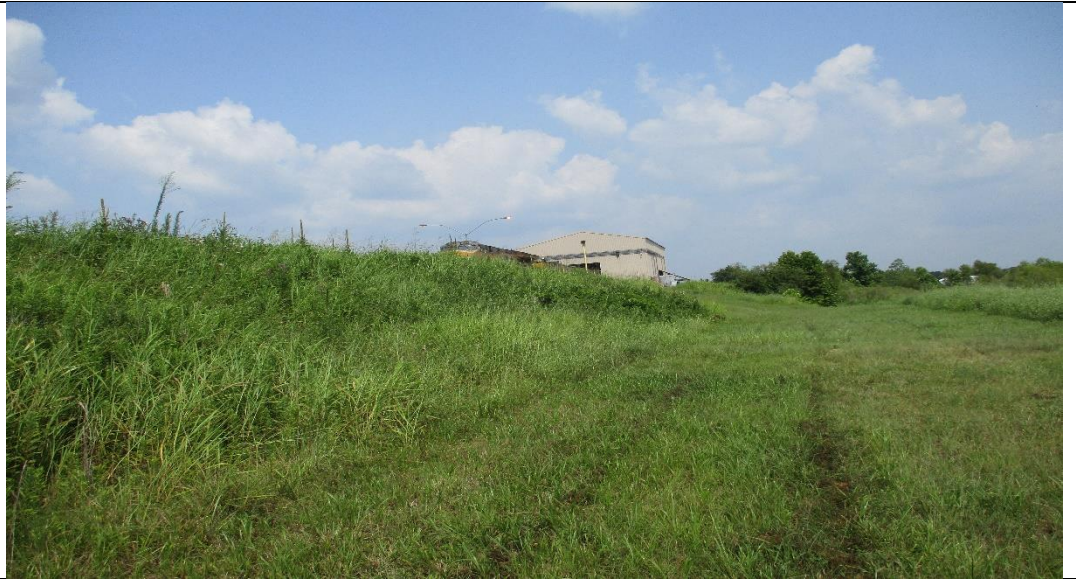
- (iv) Photograph Nos. 10 and 11 illustrates upstream slope of the north dike. North dike crest also support the railroad loop of the coal-yard. The west section of the dike is covered with the dredge cell and most of the slope is covered with the bottom ash. The exposed upper section of the slope is covered with excessive vegetation, but the slope is in stable condition.

PHOTO #10  
Upstream north slope  
(looking east).

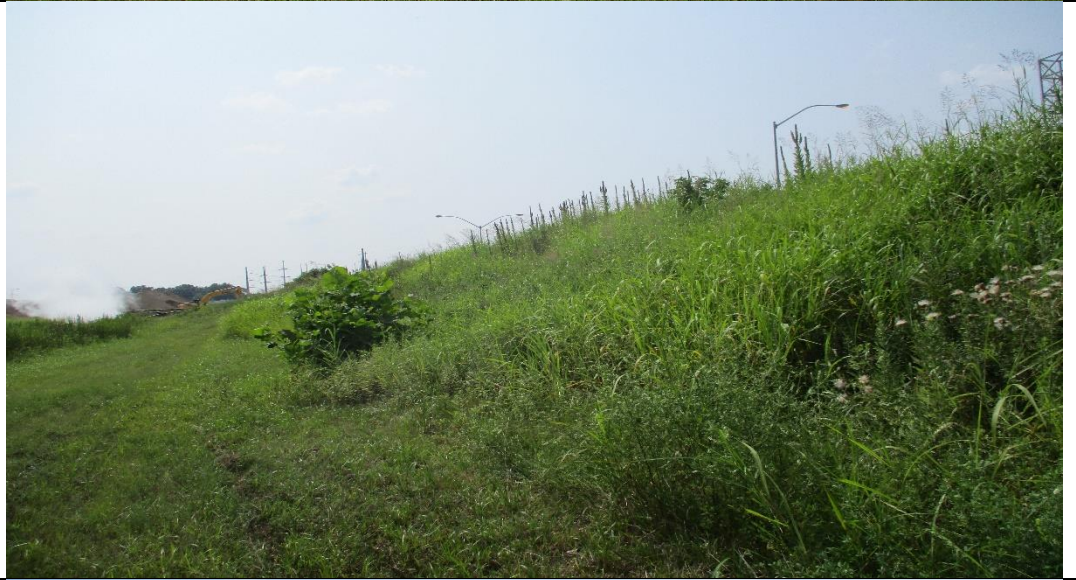
PHOTO #11  
Upstream north slope  
(looking west).

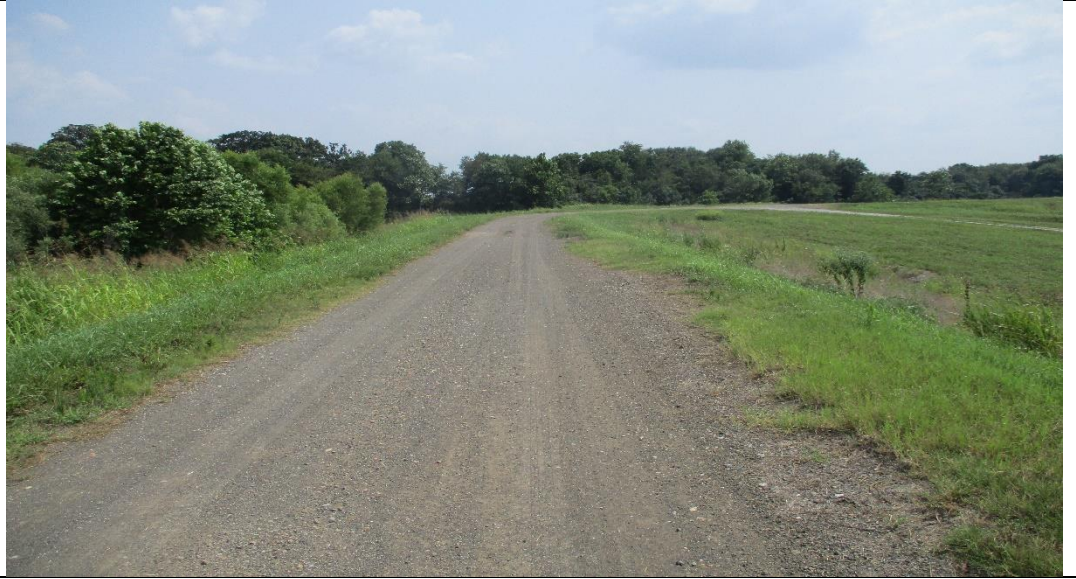
- (v) Photograph Nos. 12 and 13 illustrates crest of the dam. The crest surface of the dam is composed of hard-packed earth topped with bottom ash. Vehicular traffic is maintained across the crest to access the monitoring instrumentation. The crest is in generally good condition with no evidence of misalignment, settlement, or cracking. Some rutting along the crest was noted due to the vehicle traffic (Photograph No. 13).

PHOTO #12  
Crest of the dam (looking south).

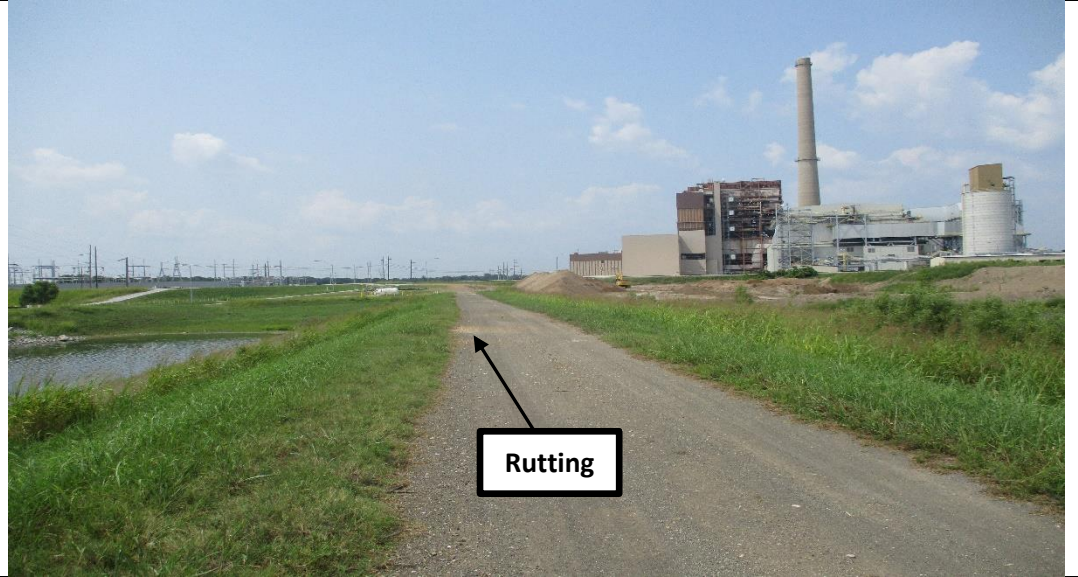
PHOTO #13

Crest of the dam (looking north).

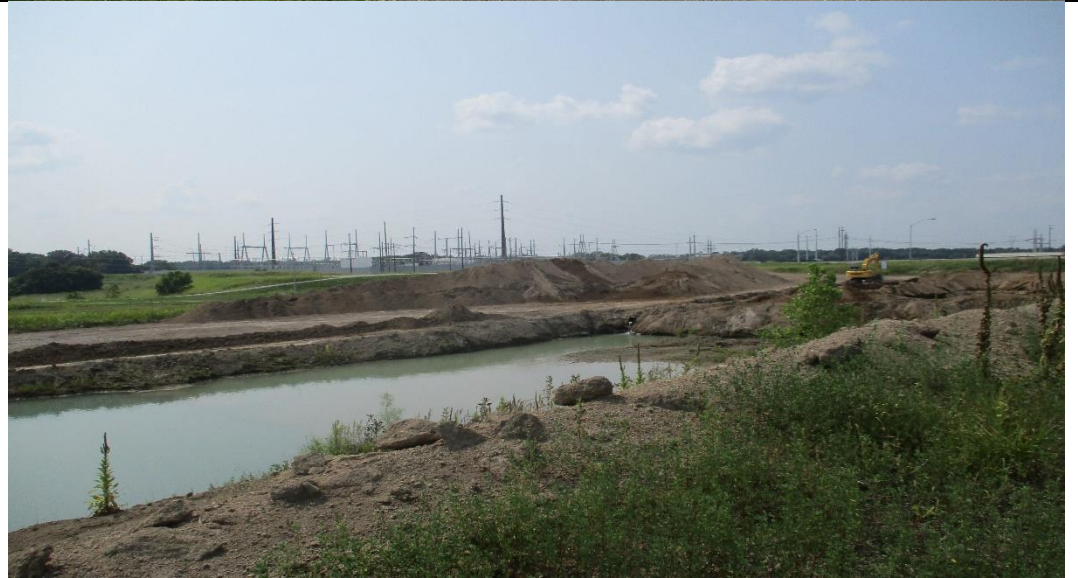
PHOTO #14

- (vi) Partial view of the dredge cell illustrated in Photograph No. 14. The dredge cell is limited to the northwest corner of the pond and properly maintained for the management and transportation of the bottom ash for beneficial use.

Dredge cell (looking northwest).
