2021 Annual Dam and Dike Inspection Report

Bottom Ash Pond Complex

Mitchell Plant

Document ID: GERS-21-017

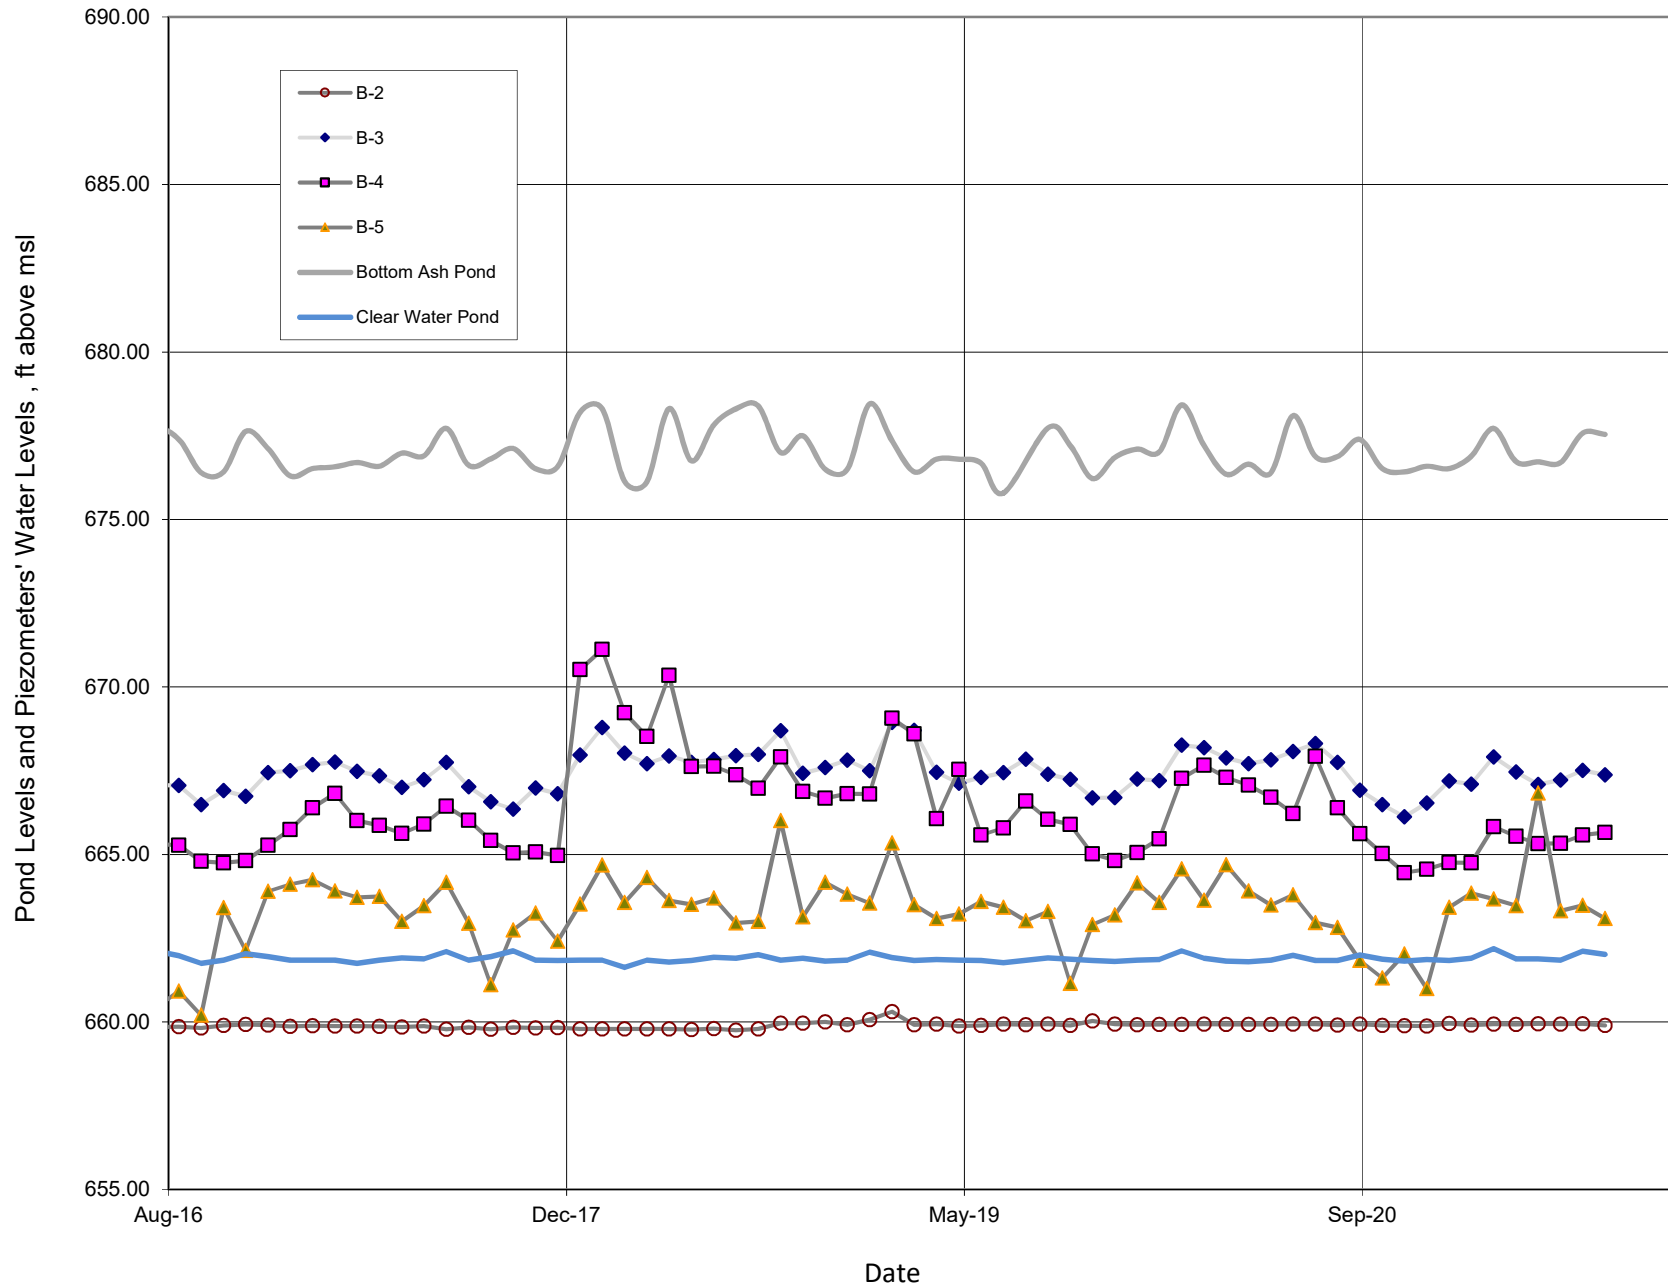
Figure 2 Bottom Ash Pond Complex Piezometers' & Ponds Level

Figure 2 presents the pond water levels as well as the piezometers water levels and rain fall record. Changes in piezometers levels correlate to the bottom ash pond level and to the rain fall intensity except for B-2 located to the north of the pond complex which appears to be dry.

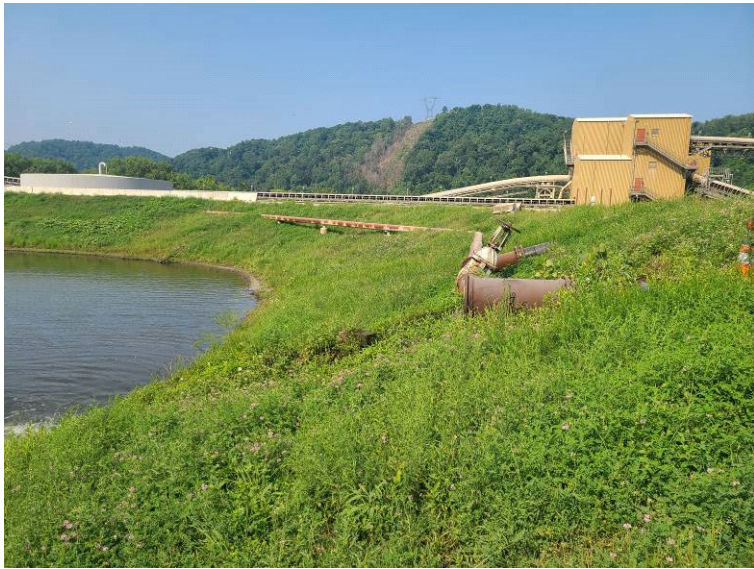
Photo No. 1

3. The interior slopes showed no signs of distress such as sloughing, bulges or erosion. The slopes were not mowed before the inspection as a result of mower malfunction (Observation 1). The rip rap protection along the west and south slope was stable with remnants of sprayed vegetation.
4. The exterior slopes were not mowed before the inspection as a result of mower malfunction. No signs of instability were observed. In general the vegetation were slightly overgrown. There were areas along the west dike where vegetation was sparse (Observation 2).
5. The spillway structure was observed to be functioning properly. The concrete was in good condition and stop logs were available.
6. There were no seepage or wet areas observed along the embankment.

Observation 1: Minor Overgrown Vegetation

Location: North inboard slope of Bottom Ash Pond

- 1) Continue the routine mowing operation. (Observation 1)
- 2) Seed and mulch areas on the outboard slope of the Bottom Ash Pond by replacement of soil and re-seed. (Observation 2)
- 3) Repair animal burrows along the north and east interior dikes of the clear water pond (Observation 3).

Recommendations: Repair by mowing.

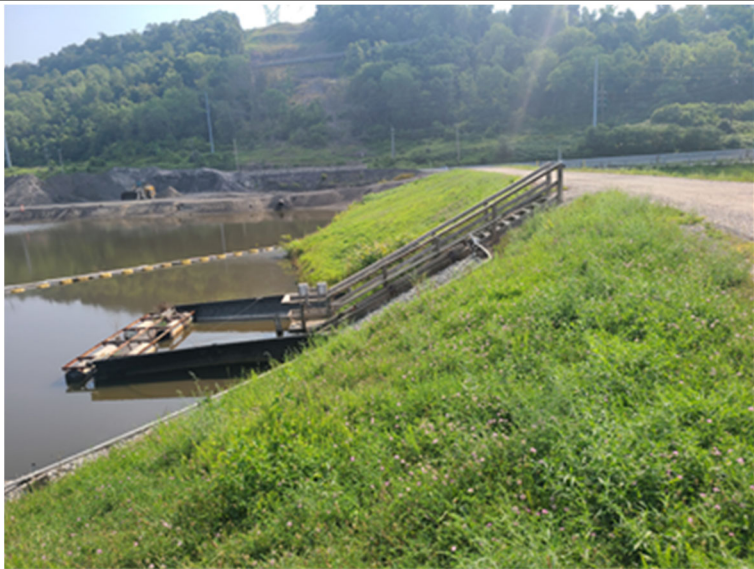
Photo No. 2

Observation 1: Minor Overgrown Vegetation

Location: South inboard slope of Bottom Ash Pond

Recommendations: Repair by Weed eaters or spray

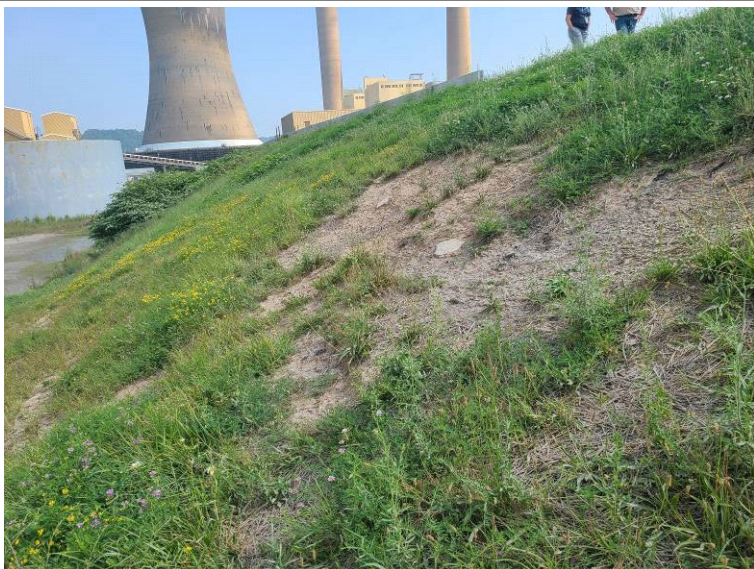
Photo No. 3

Observation 2: Sparse Vegetation

Location: West outboard slope of Clear Water Pond

Recommendations: Repair by Seed & Mulch.

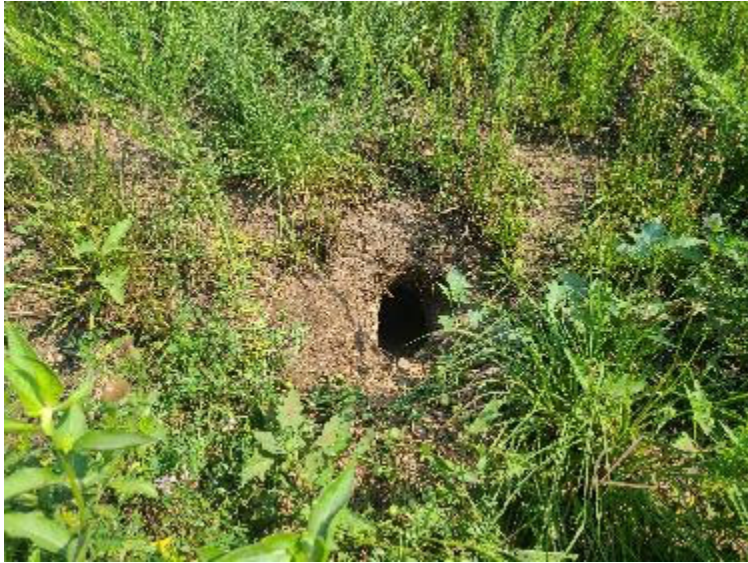
Photo No. 4

2. The interior slopes showed no signs of distress such as sloughing or bulges. The grass was not mowed before the inspection as a result of mower malfunction. Two animal burrows were observed during this inspection along the north and east interior dikes (Observation 3).

Observation 3: Burrow Hole.

Location: North inboard slope of Clear Water Pond

Recommendations: Repair by fill in with soil.

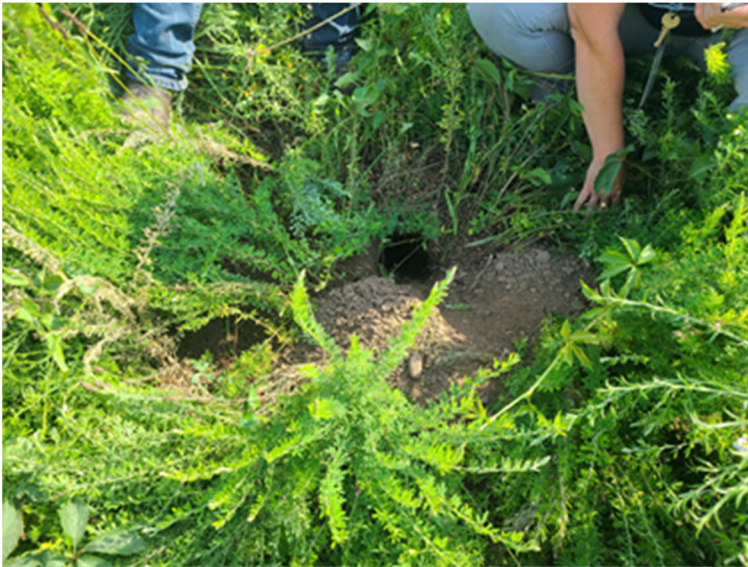
Photo No. 5

Observation 3: Burrow Hole

Location: East inboard slope of Clear Water Pond

Recommendations: Repair by fill in with soil.
