2022 Annual Landfill Inspection Report

Amos FGD Landfill

**John E. Amos Plant
Appalachian Power Company
Putnam County, West Virginia**

Document ID: GERS-22-053

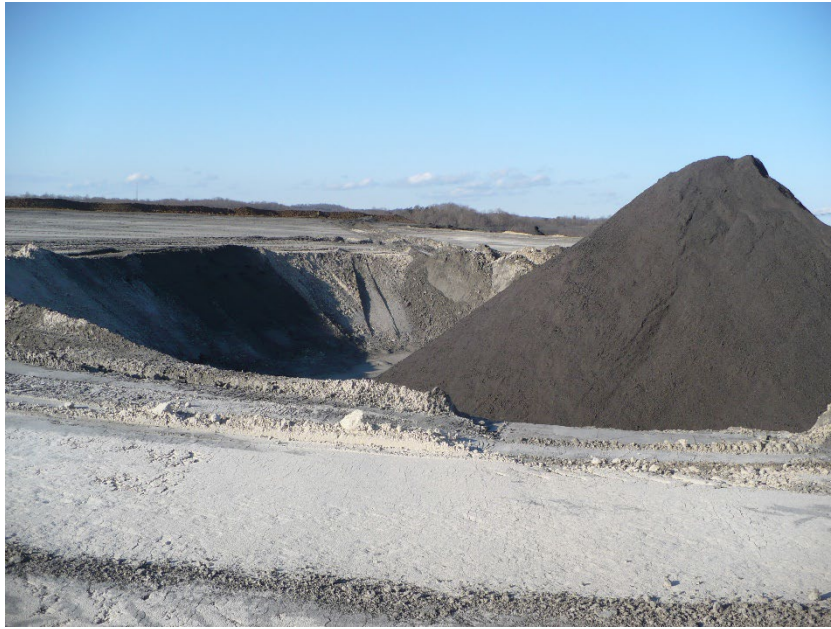
1. During the inspection, the active disposal area was being used for waste placement. The chimney drains were functioning as designed and there was no pooling of contact water around the drains (photos 1 & 2). Waste was being compacted as it was placed.
2. The eastern bowl of Sequence 4 (photo 3), where the noted deficiency is located, has erosion rills in the protective cover layer above the leachate collection geocomposite. This area of Sequence 4 has been isolated from the operating portion of Sequence 4. These erosion rills are not a concern, as future repair work in this area will result in the replacement of this material. The repair work is expected to be completed in 2023.
3. There are some areas within the constructed landfill that have interim/ temporary cover. That cover is good condition and no erosion.

Photo #1 – chimney drain in active area

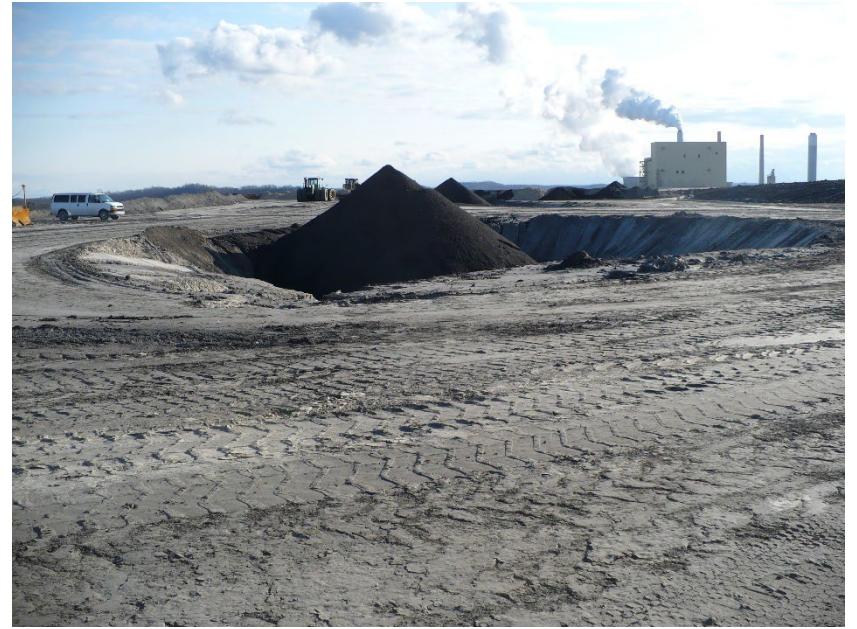
Photo #2 – chimney drain and active area

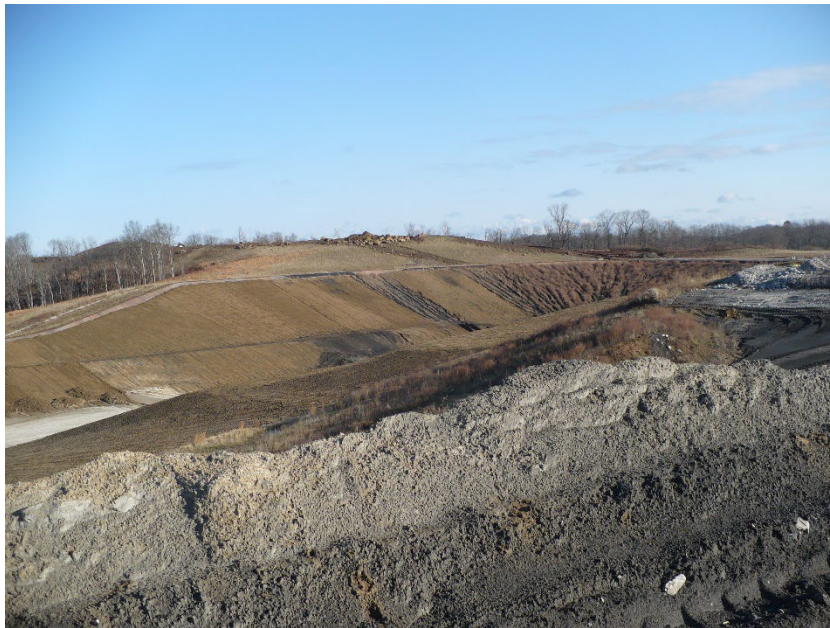
- 6) There is water underneath the liner in the eastern bowl of Sequence 4. The liner system has a network of underdrains designed to collect groundwater and safely convey the water to the sediment collection ponds. It appears that this underdrain system is not functioning as intended in this location and therefore meets the definition of uncontrolled seepage

deficiency. The deficiency was identified on January 15, 2020. Several interim repairs were completed during 2020 but the root cause was not determined and the repairs had not resolved the issue.

Photo #3 –Bowl of Seq 4 to be repaired in 2023

An investigation was undertaken in 2021/2022 and a repair plan has been developed. That work will be conducted in 2023.

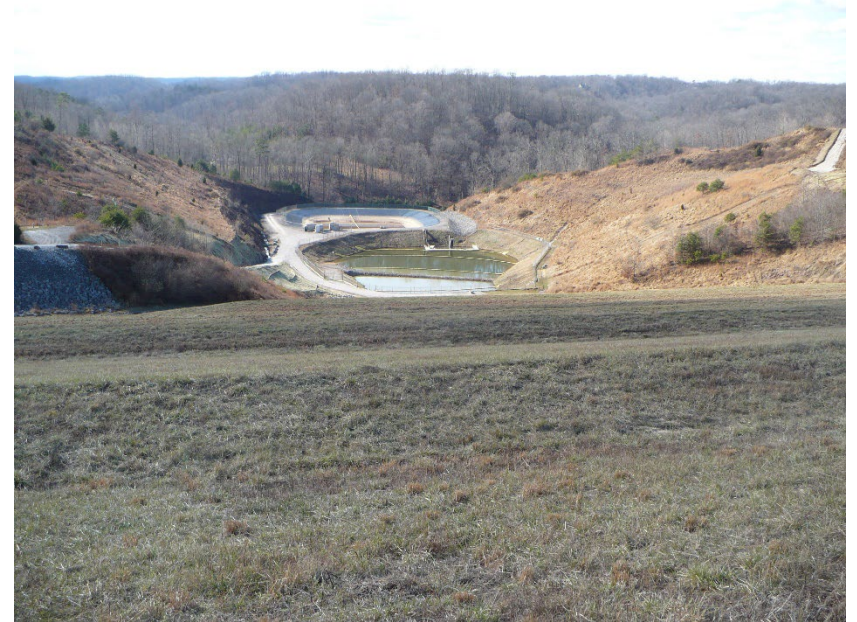
4. The final cover on the southwest slope of the South Valley is in good condition, and dense grass cover vegetation is established (photos 4-6). There were no signs of erosion or instabilities observed.

Photo #4 – closed slope of South Valley and ponds

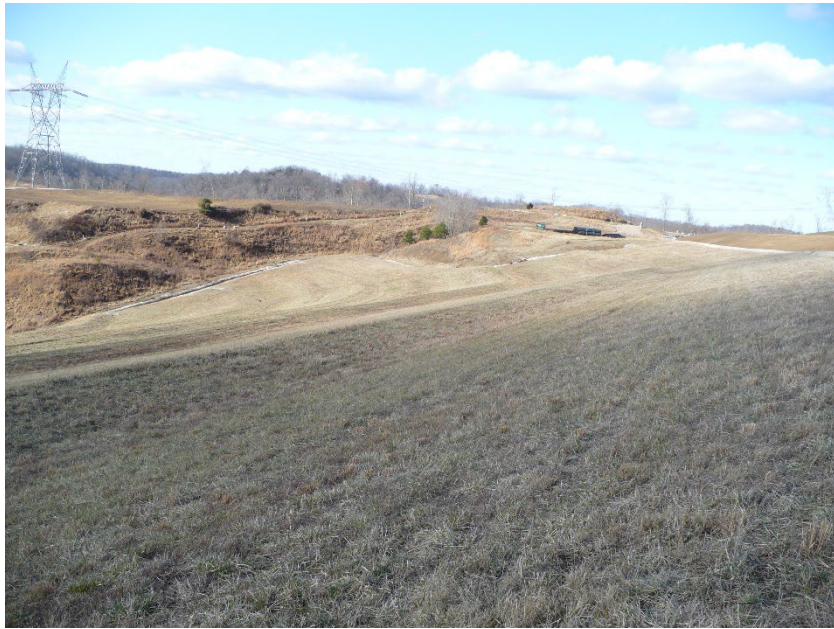
Photo #5 –covered South slope-looking north

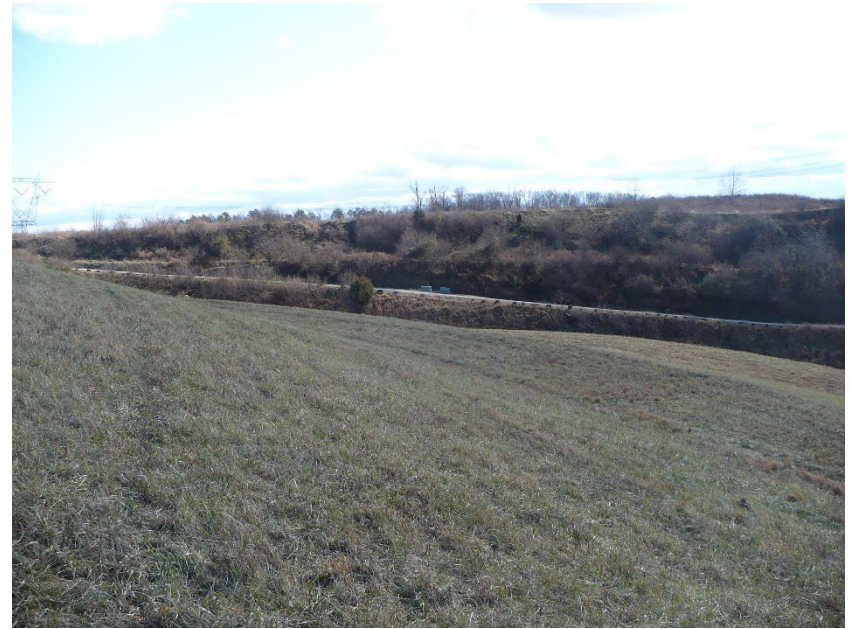
Photo #6 – covered South slope-looking south

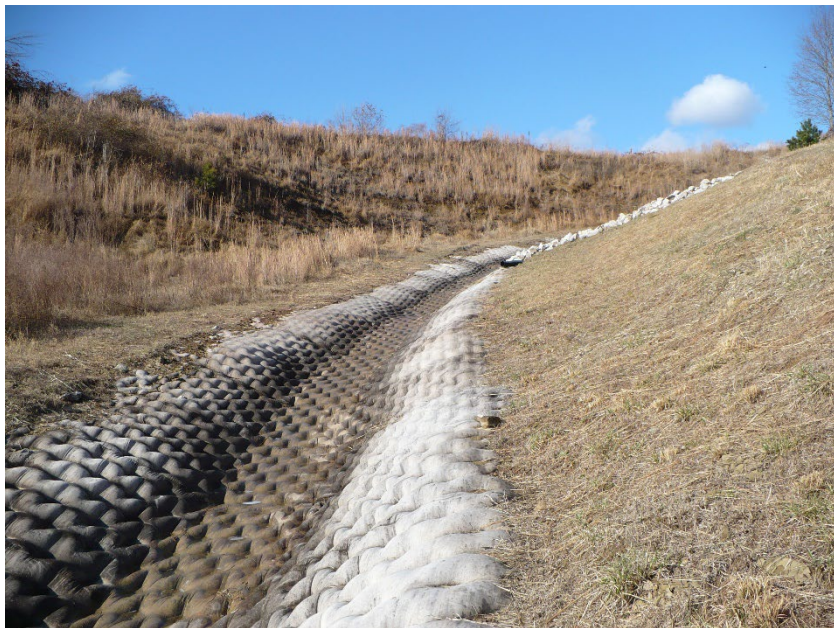
5. The final cover soil drain pipe outlets at the fabric-formed concrete ditch were in good condition with no signs of obstructions or problems. The fabric-formed ditches along both abutments were in good condition (photos 7-10).
6. The recently completed cover along the referenced 950 bench has been seeded and mulched (photos 11-12).

Photo #7 – South valley perimeter ditch-right abutment

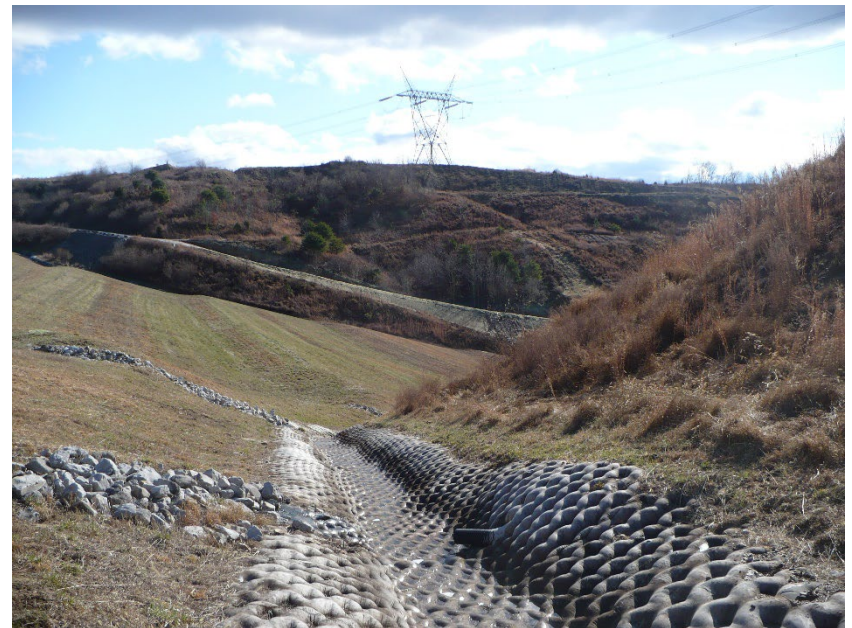
Photo #8 – South valley perimeter ditch- right abutment

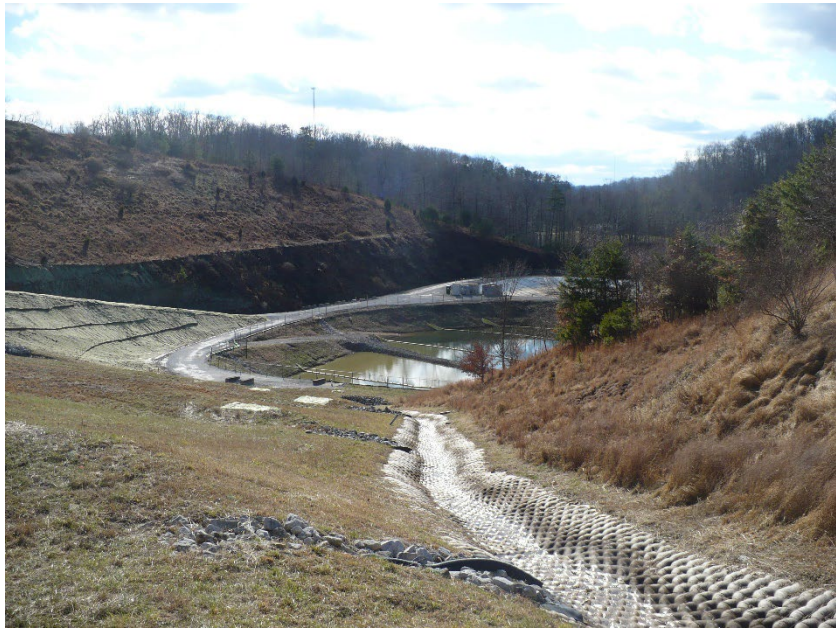
Photo #9 – South valley perimeter ditch-right abutment

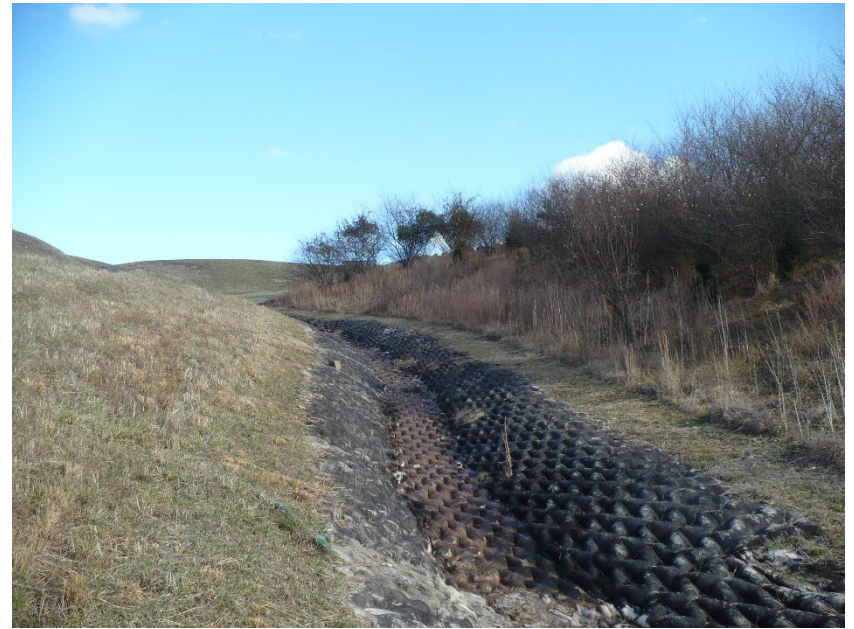
Photo #10 – South valley perimeter ditch-left abutment

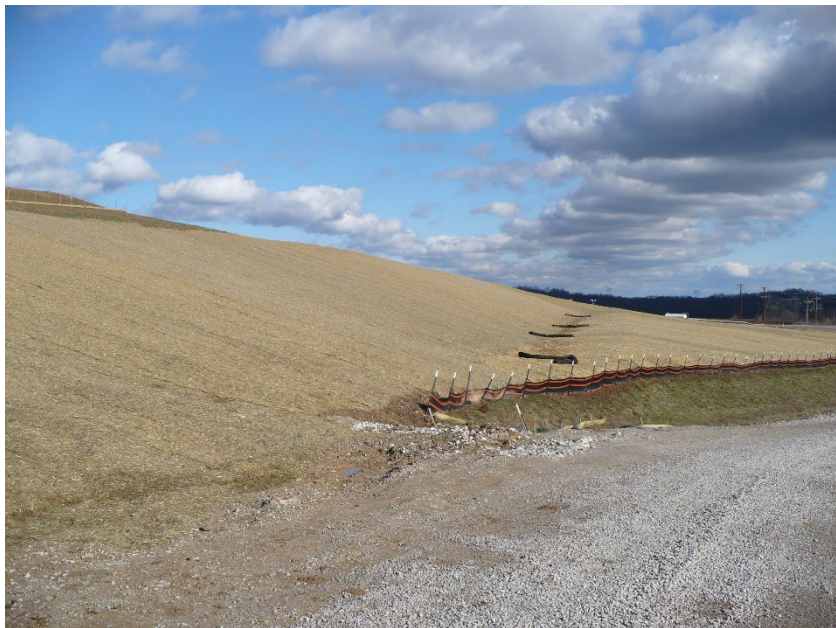
Photo #11 – New cap/cover along 950 bench

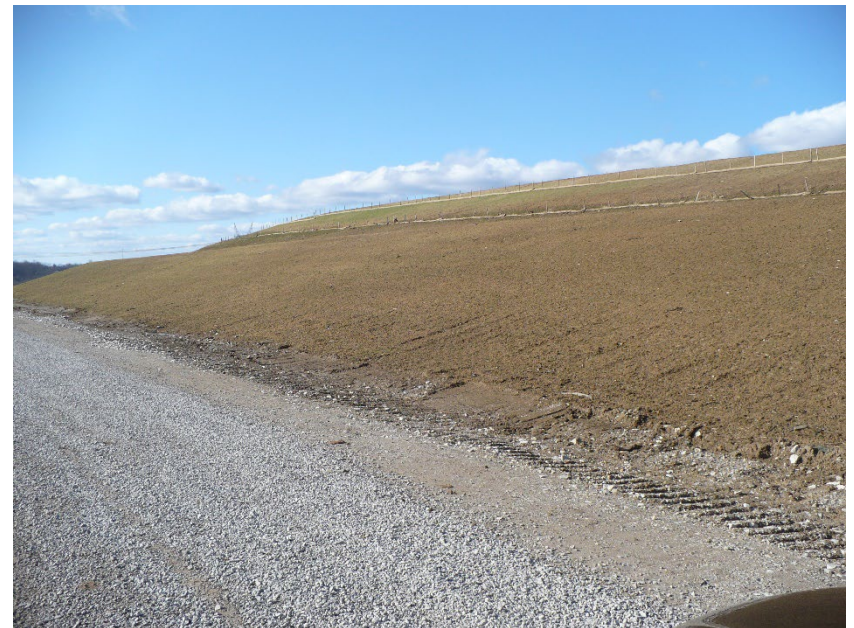
Photo #12 – New cap/cover along 950 bench

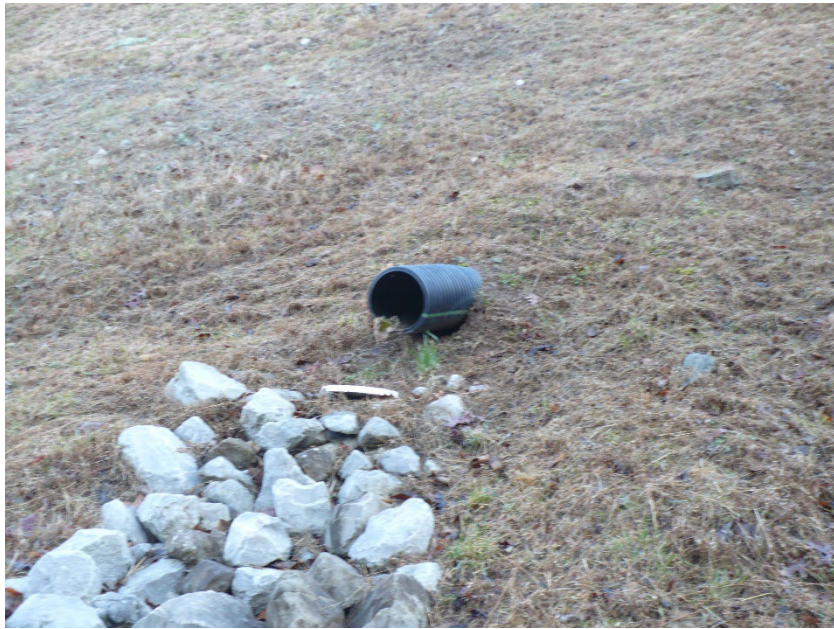
9. The sediment collection ponds were in good condition with no signs of erosion or blockage and appeared to be functioning as designed. Photos 13-14 show the pipe outlet and discharge channel from the North Valley Sediment Pond.
10. The Plateau Sediment Collection Pond was in good condition appeared to be functioning as designed.

Photo #13 –Outlet pipe from North Sediment pond

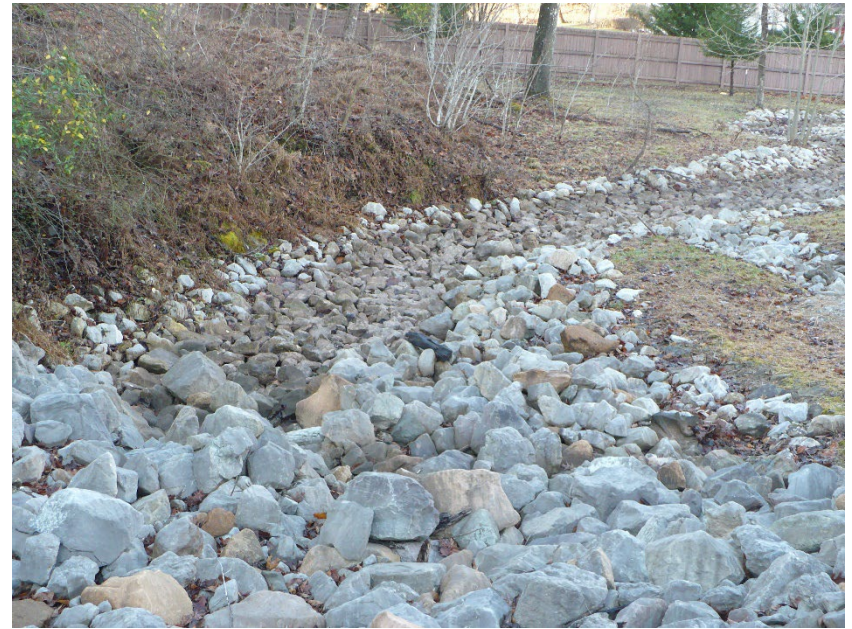
Photo #14 – Outlet channel from North Valley

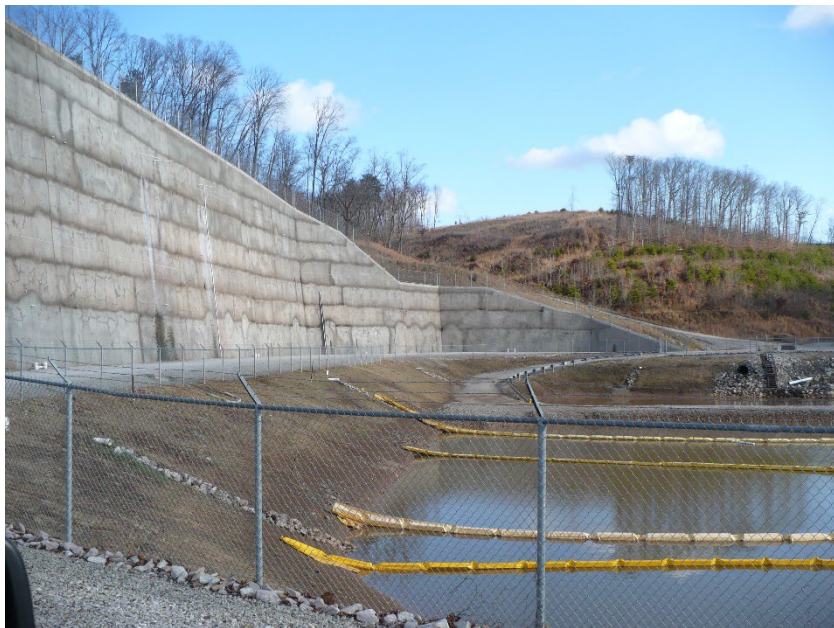
11. The soil nail walls in the North Valley appeared to be in good condition with no visible displacement, spalling or damage based on a view from the toe of the walls. Photos 15-16 show the north valley sediment pond and soil nail wall.

Photo #15 – Soil nail wall and sediment pond –North Valley

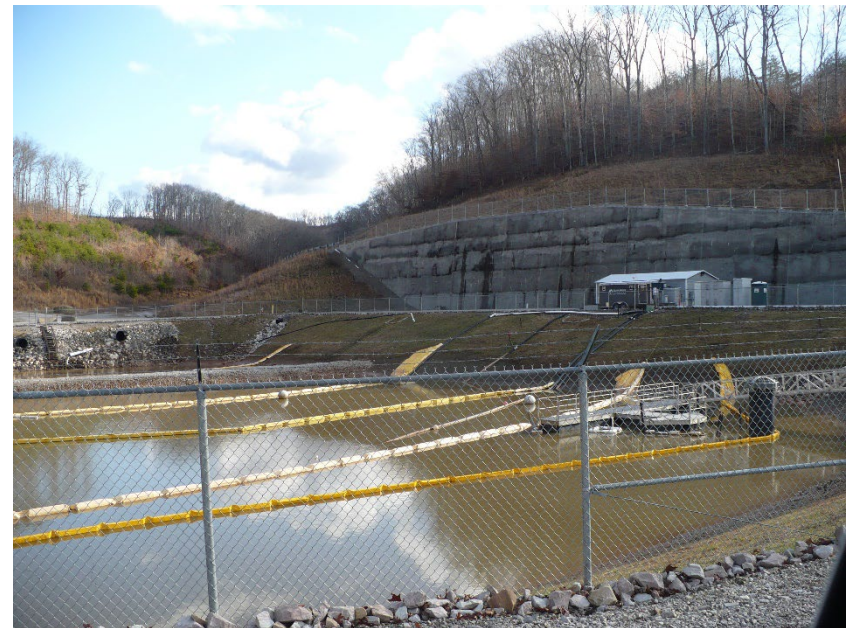
Photo #16 – Soil nail wall and sediment pond-North Valley
