2023 Annual Dam and Dike Inspection Report

Bottom Ash Pond Complex

**John E. Amos Plant
Appalachian Power Co.
Putnam County, West Virginia**

Document Number: GERS-23-040

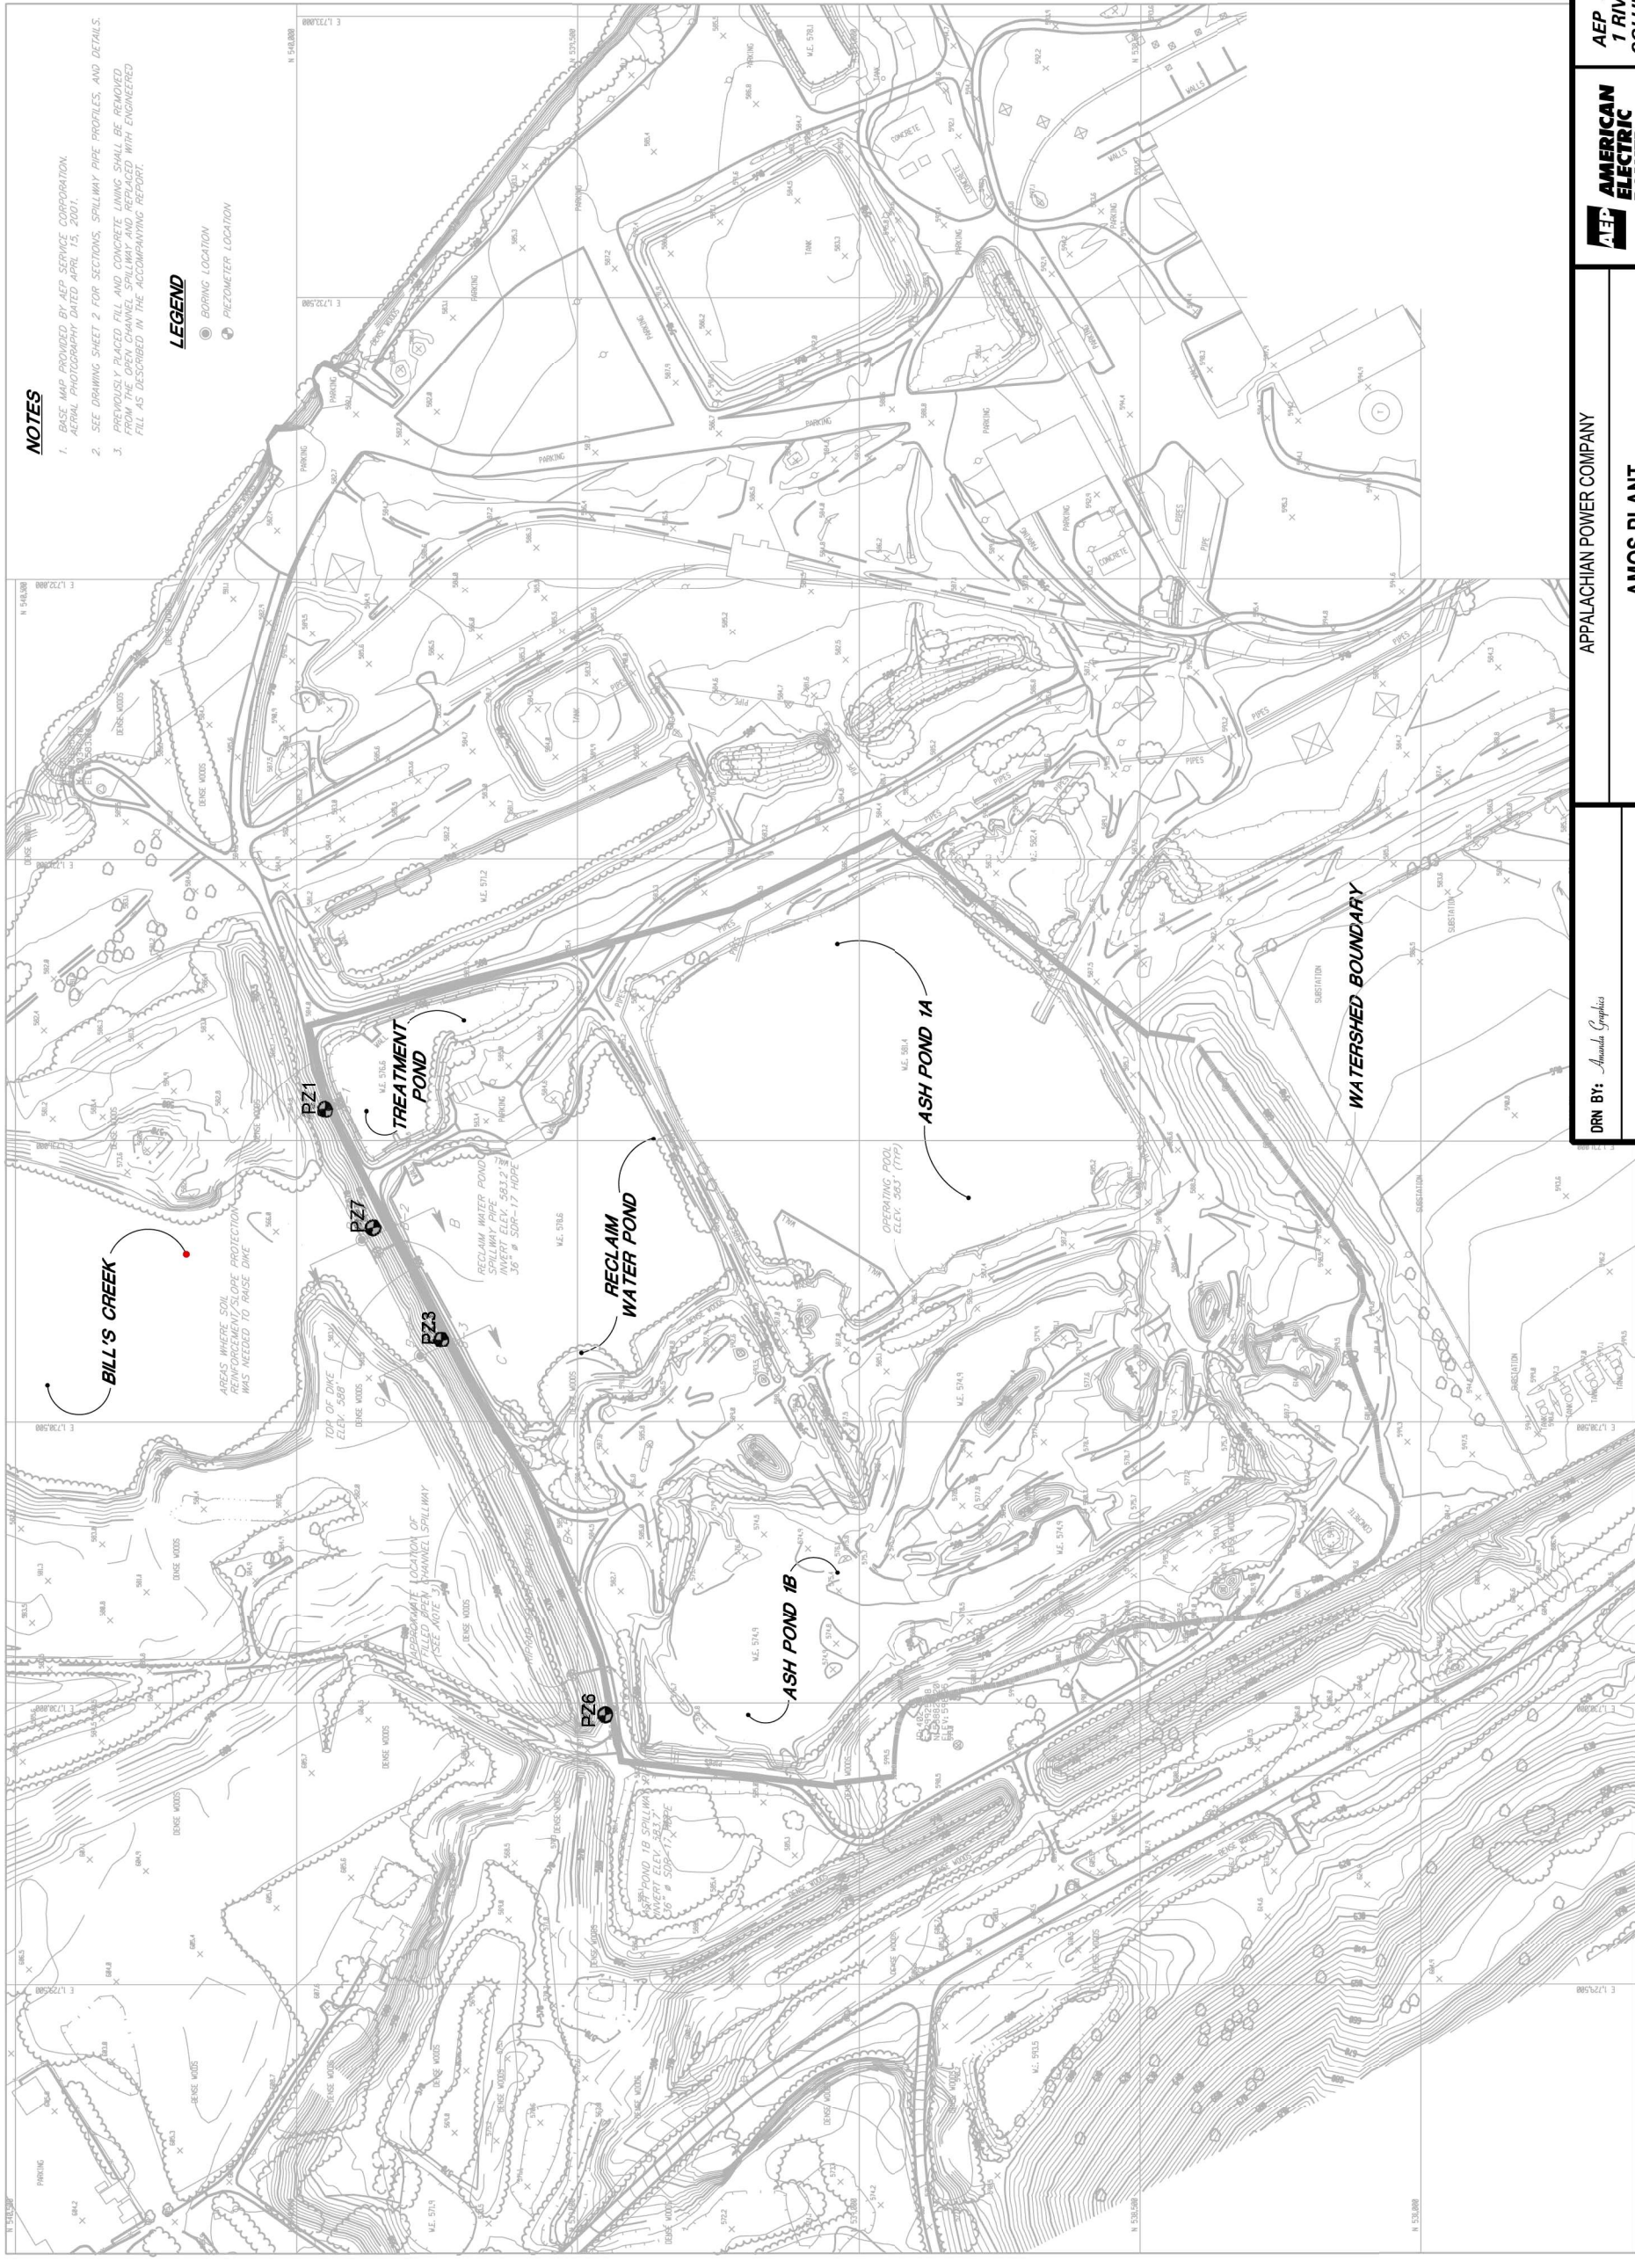
APPALACHIAN POWER COMPANY		AEP SERVICE CORP. 1 RIVERSIDE PLAZA COLUMBUS, OH 43215	
SCARY		AMERICAN ELECTRIC POWER	
AMOS PLANT		WEST VIRGINIA	
DATE: 07/12/2016		FIGURE 2	
SCALE: N. T. S		BOTTOM ASH POND COMPLEX

The location and type of instrumentation is shown on Figure 2 and select piezometers are depicted in cross section along the perimeter dike embankment in Figure 3. The maximum recorded readings of each instrument since the previous annual inspection is shown in the table below.

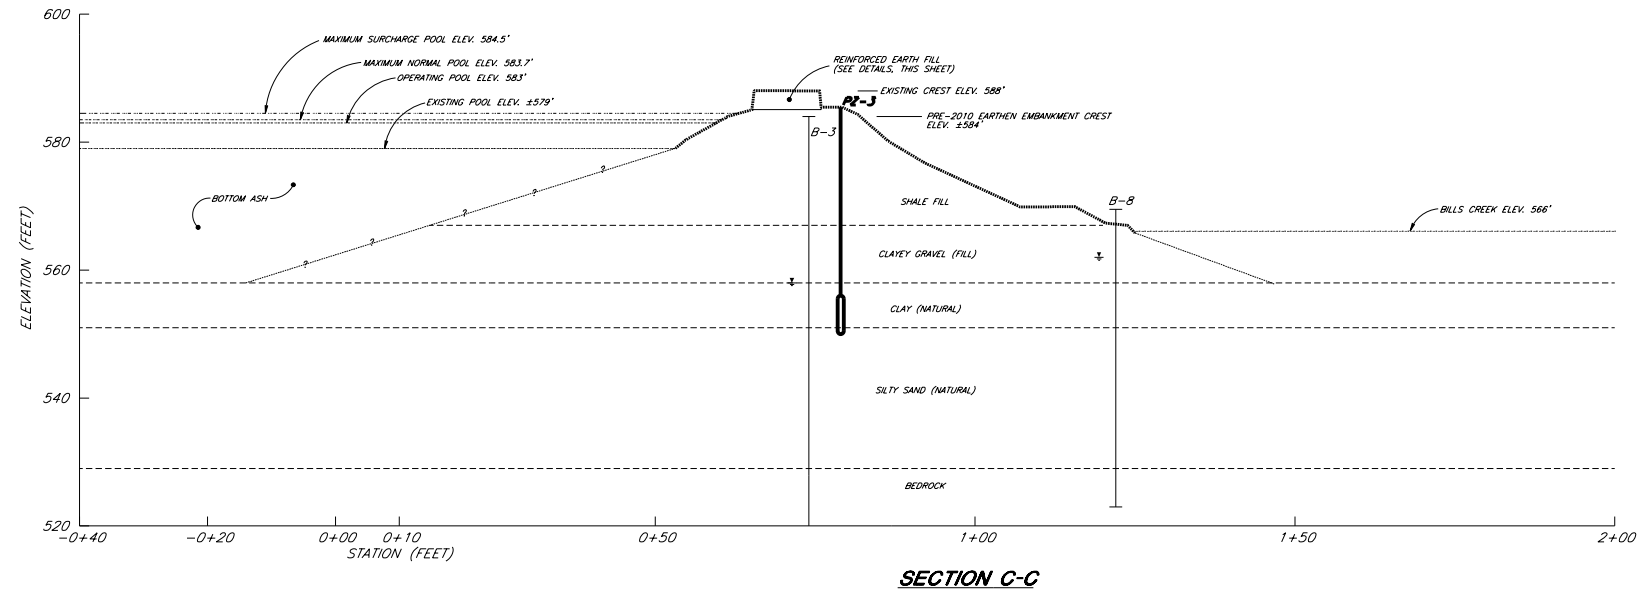
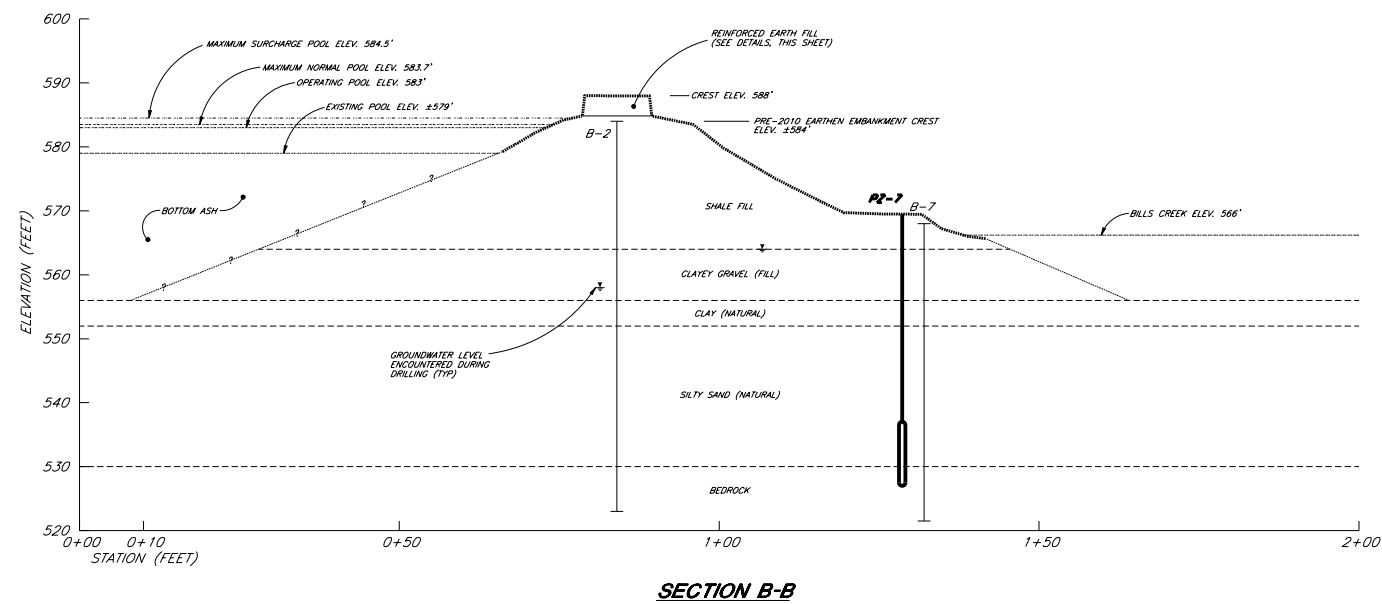
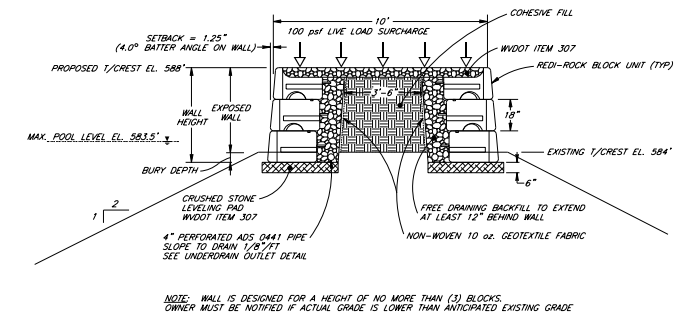
DRN BY: <i>Amanda Graphics</i>	APPALACHIAN POWER COMPANY			AEP SERVICE CORP. 1 RIVERSIDE PLAZA COLUMBUS, OH 43215
DATE: 07/12/2016	SCARY	AMOS PLANT WEST VIRGINIA		
SCALE: N. T. S	EMBANKMENT SECTIONS & DETAILS		FIGURE 3

The north dike of the Reclaim Water Pond and Treatment (Clearwater) Pond is approximately 800 feet long. The height of the dam is about 29 feet and the design crest width is 10 feet using concrete block face filled with compacted cohesive soil. The top of the dike is at elevation 588.0 feet with the natural ground surface beneath the dikes is at about elevation 559 feet. Field measurements indicate that dam side slopes are 2.5:H to 1:V (Figure 3).

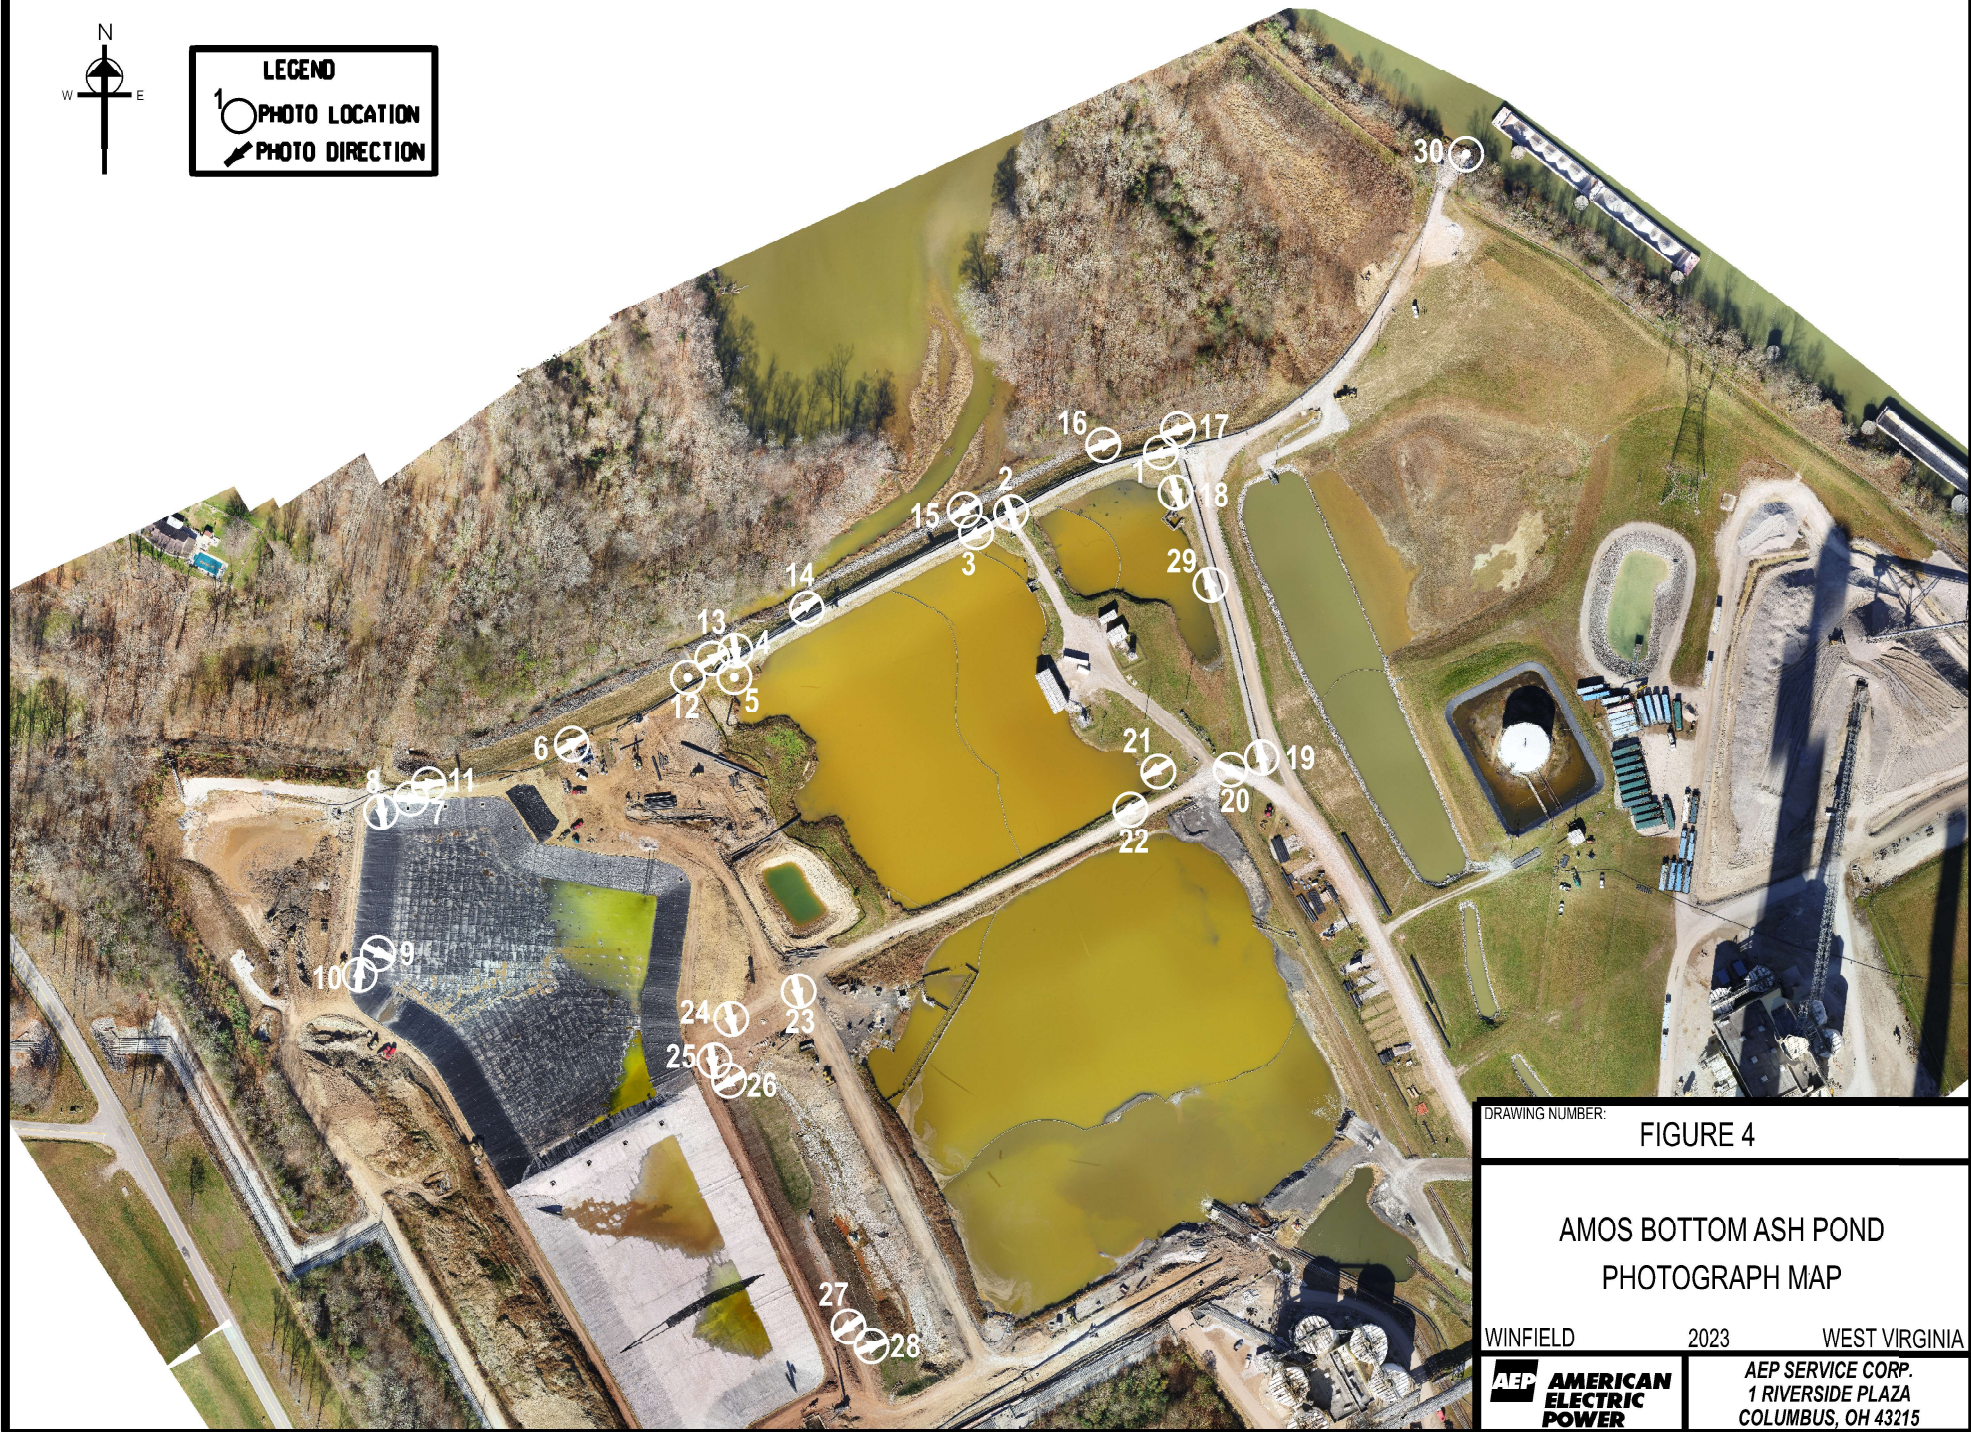
DRAWING NUMBER: **FIGURE 4**

A visual inspection of the Bottom Ash Pond Complex was conducted to identify any signs of distress or malfunction of the impoundment and appurtenant structures. The inspection also included hydraulic structures. Specific items inspected included all structural elements of the dam such as inboard and outboard slopes, crest, and toe; as well as appurtenances such as the outlet structure at the Wastewater Pond, Reclaim Pond and the primary decant structure located within the Treatment (Clearwater) Pond. Photographs of the inspection are in Attachment A with photograph locations shown in Figure 4.

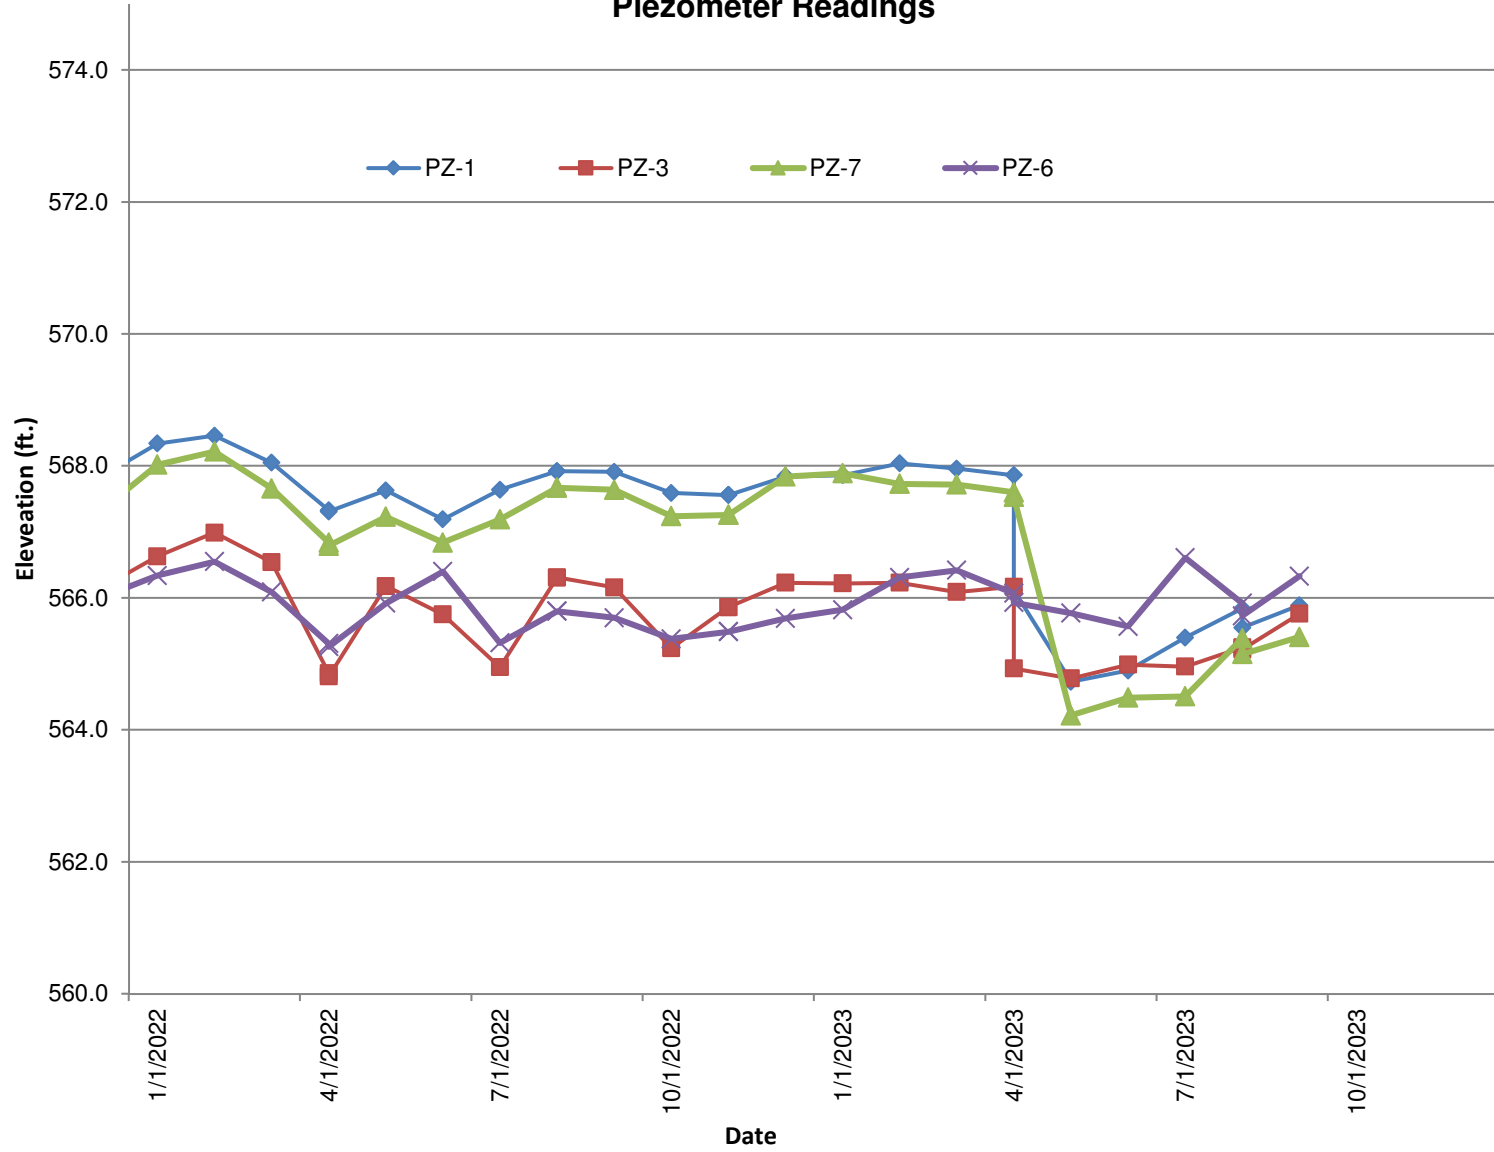
FIGURE 5
John E Amos Plant
Bottom Ash Pond
Piezometer Readings

The elevations of pond water levels have varied as ponds come in and out of service as part of the closure and repurposing project. The piezometer water levels have remained fairly constant with no adverse trends observed that would impair the structural stability of the perimeter dike. It is noted that PZ-1, PZ-3, and PZ-7 have reduced level that coincides with the lowering of the pool in the Reclaim and Clearwater Ponds as part of closure and repurposing activities. Piezometer hydrographs are shown in Figure 5.

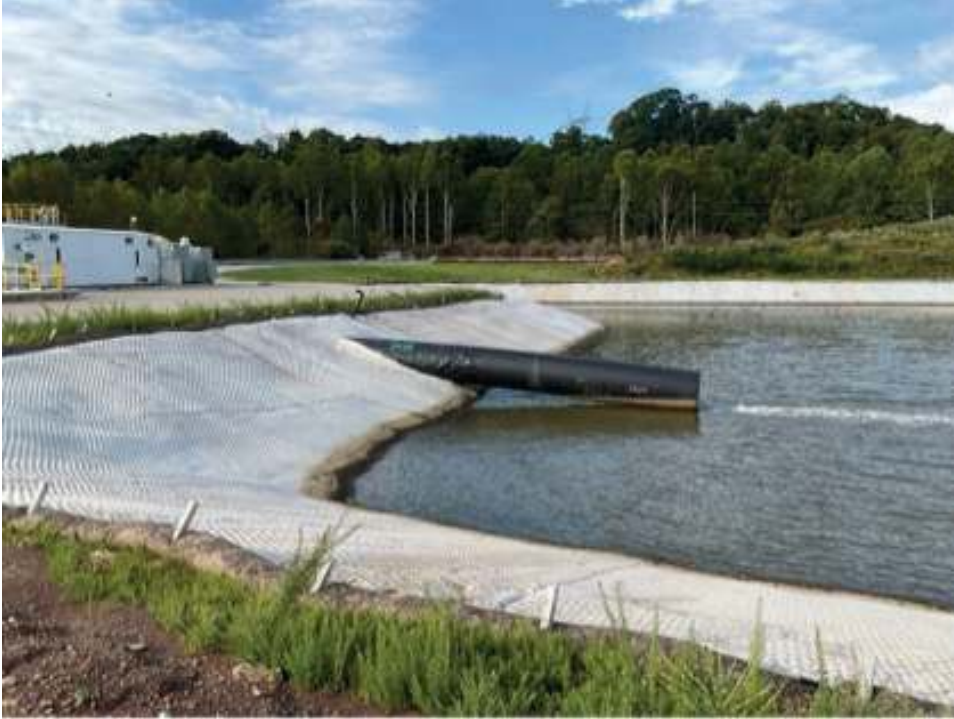
Notes: General condition of inlet discharge to the Wastewater Pond

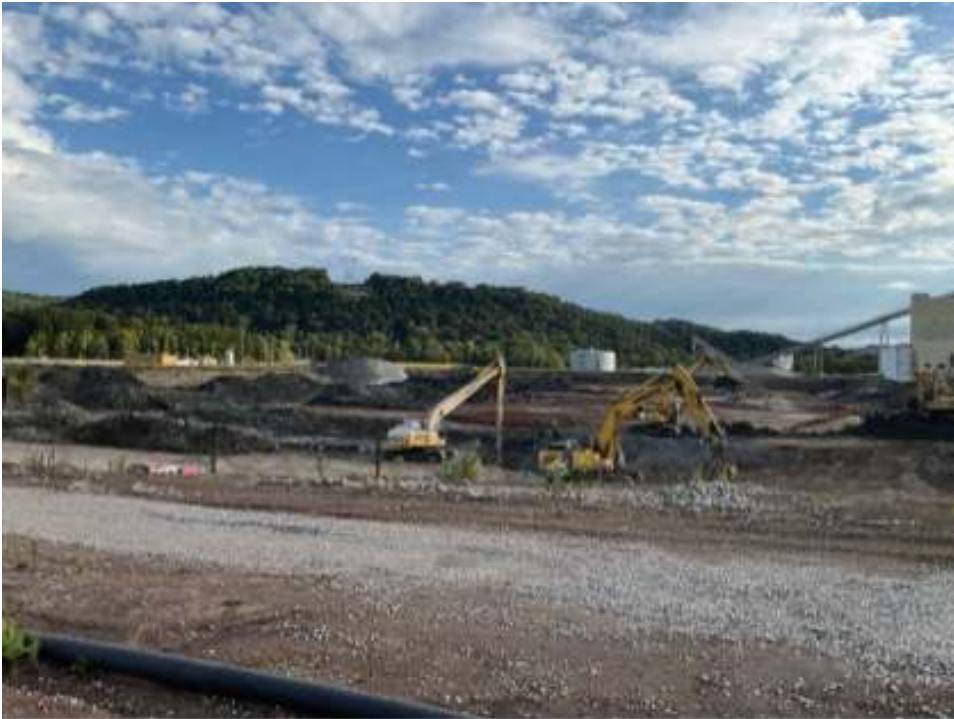
Notes: Overview of construction activities in BAP 1A

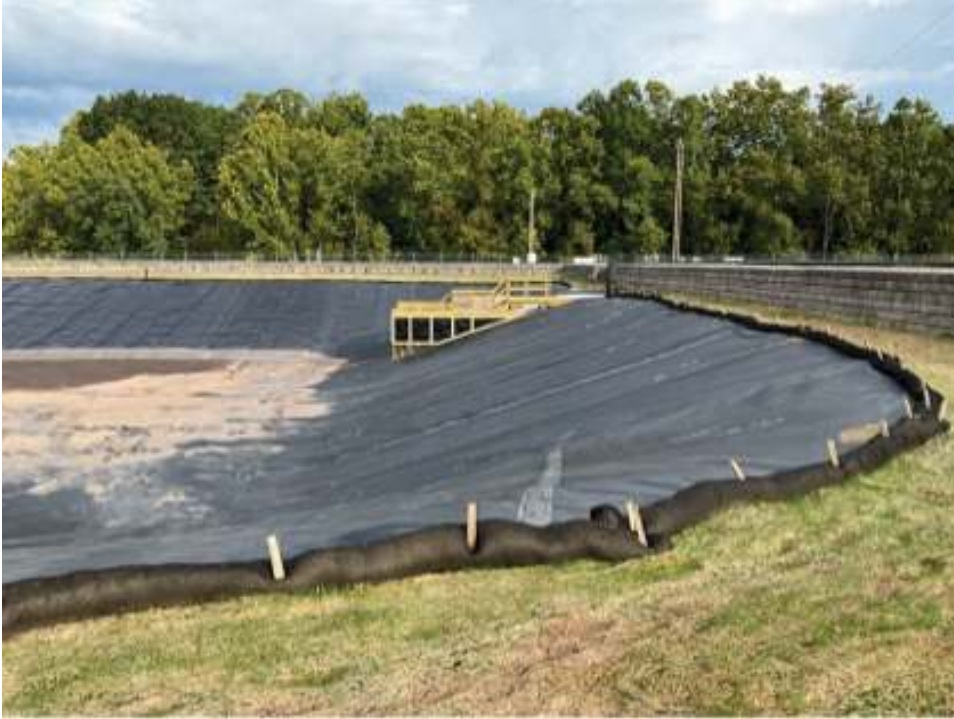
Photo #: 29

Notes: General condition of new outlet structure in the Clearwater Pond

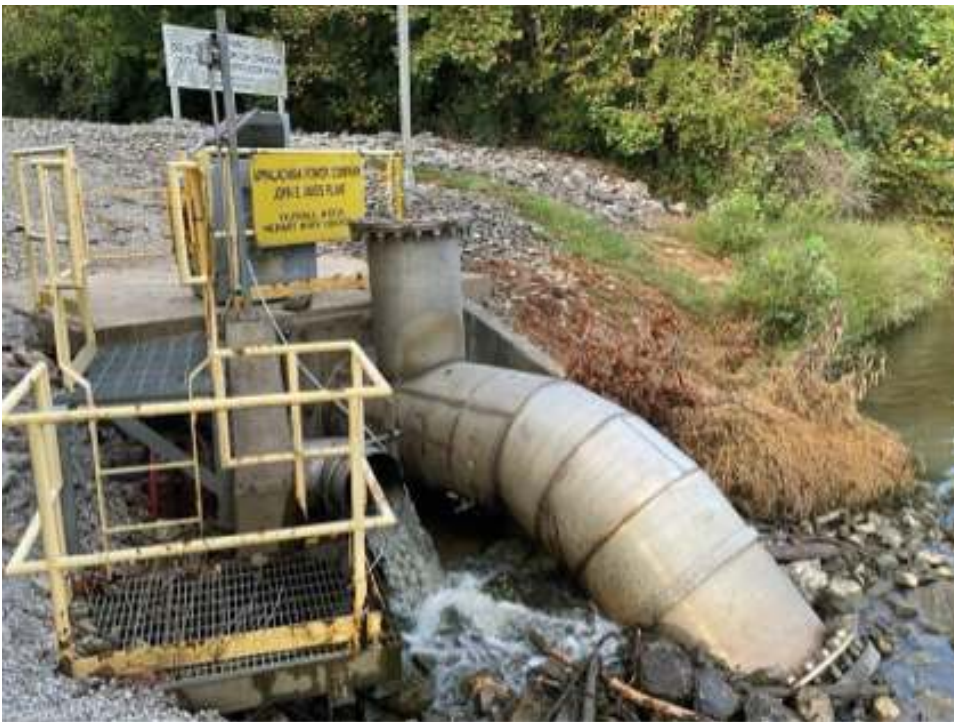
Photo #: 30

Notes: General condition of wastewater discharge diffuser at the Kanawha River. Storm water discharge next to diffuser pipe.
