2019 Annual Dam and Dike Inspection Report

Fly Ash Pond

**John E. Amos Plant
Appalachian Power Co.
Putnam County, West Virginia**

Document Number GERS-19-011

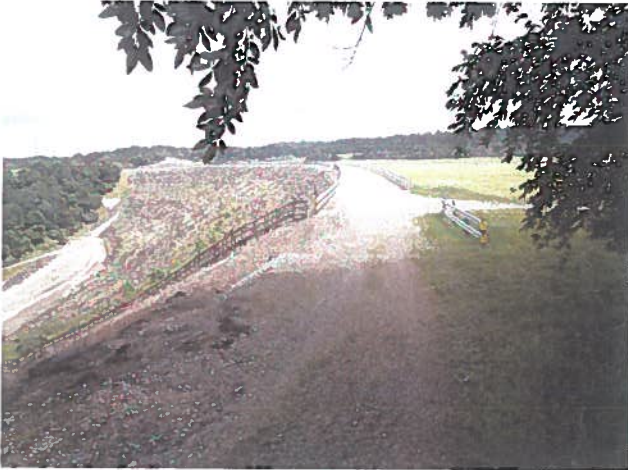
1. There were no visual signs of settlement, misalignment, erosion, or bulging on the crest or the upstream slope. No animal burrows were noted on the upstream slope. The upstream slope was well vegetated and is controlled by timely mowing. The guardrail was also observed to be in excellent condition. (Photos 1, 2 and 3)

Photo 1 – Typical view showing good conditions of crest.

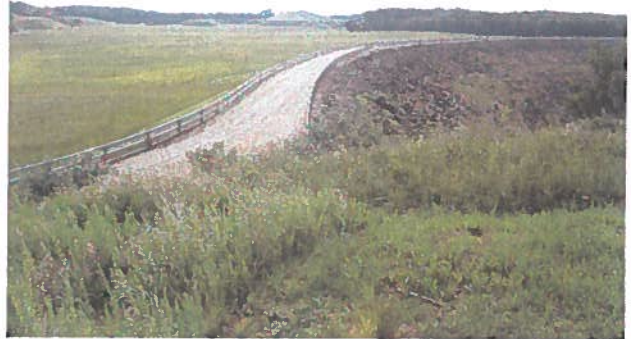
Photo 2 – Typical view showing good conditions of crest and a partial view of the capped covered pond area showing good vegetative control and maintenance.

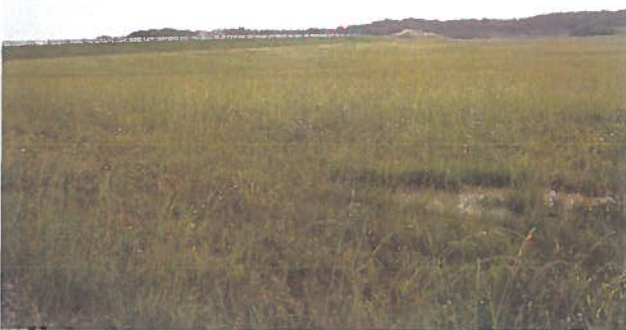
Photo 3 – Typical view of the upstream face and closed portion of the impoundment showing good vegetative cover.

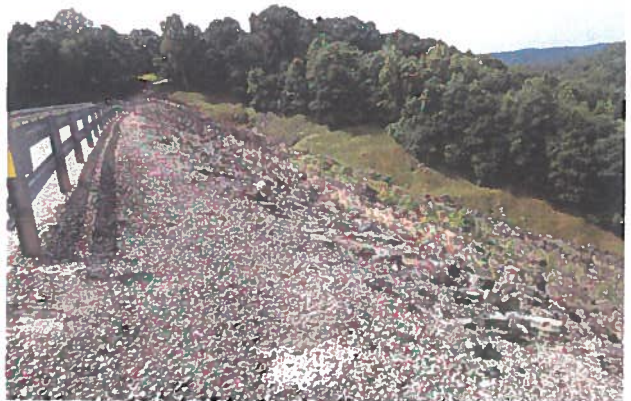
2. No erosion was observed along the upstream left and right groin ditches or the abutments above 716 feet bench. Both of the abutments within 25 ft. from the center of any of the groin ditches have been cleared of shrubs and small trees. (Photos 4 and 5)

Photo 4 – Typical view showing good conditions of the left groin and stairwell access to piezometers PP10s and PP10d.

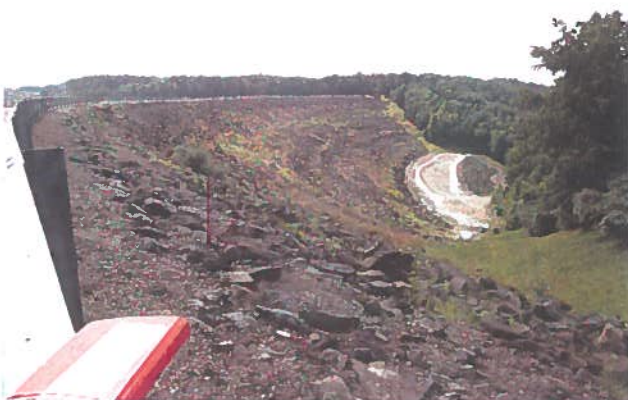
Photo 5 – Typical view showing good conditions of the right groin.

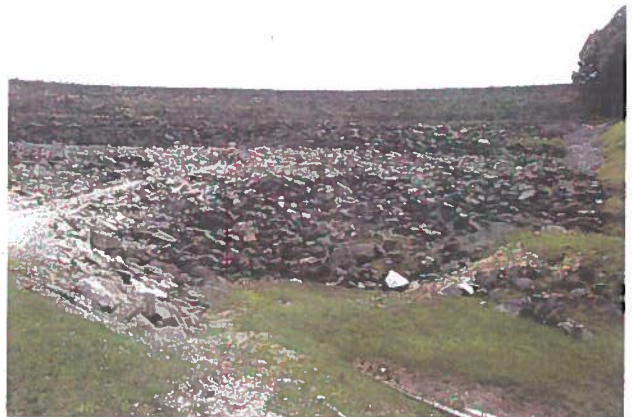
3. The entire face of the downstream slope was well protected from erosion with large-boulder size sandstone and shale riprap and was generally in fair to good conditions. There were no noticeable signs of movement or slides in the oversize riprap. Most of the vegetation on the downstream slope had been controlled by the application of a herbicide. (Photo 6)

Photo 6 – Typical view showing good conditions of the downstream face showing the oversized rip rap.

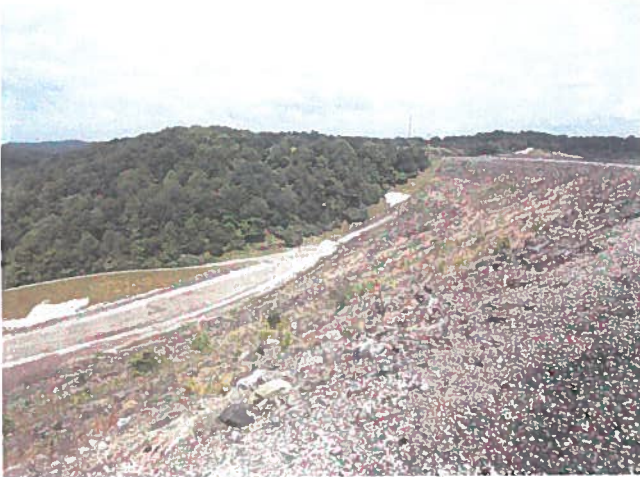
4. The seepage areas near the right groin ditch were still present. The seeps are believed to be originated from the abutment bedrock based on the 2007 geotechnical investigations that revealed a permeable layer of sandstone at about the same elevation. The surficial slip within this seepage area has been repaired and stabilized. Another seep at a higher elevation was noted and the seepage water was observed to be clear (i.e. no suspended sediment). Another surficial slip was observed along the site access road as part of the plant's seven-day inspection and has been repaired and mitigated. (Photos 7 and 8)

Photo 7 – Typical view showing good conditions of the slip repair in the right groin ditch and a more recent repair along the site access road ramp to the 716 Bench.

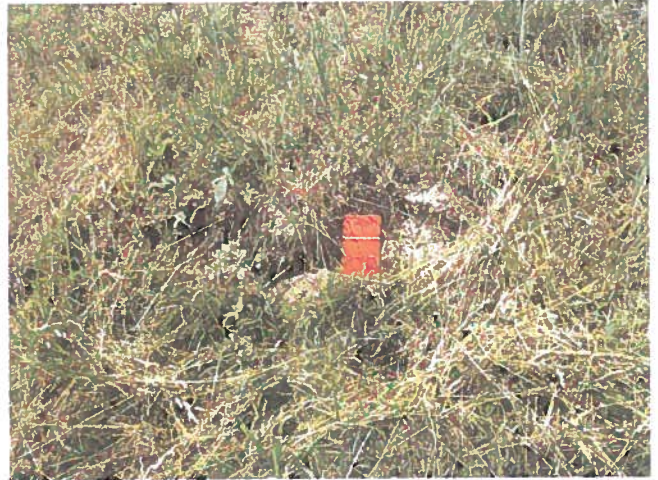
Photo 8– Typical view of along the right groin ditch of the minor slip showing no significant change from previous inspections. Discharge from this area was estimated to be 0.25 gpm and was visually clear.

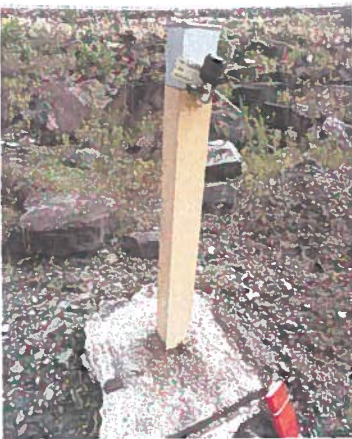
5. Another area of seepage near PZ-94-1 remains unchanged from last year's inspection. The concrete pad for the piezometer is undermined and is no longer in contact with the ground. (Photo 9)

Photo 9-Typical view of piezometer 94-1 showing piezometer-tag number and locked casing protector. The concrete pad is undermined and requires replacement.

1. Control of the vegetation (i.e. mowing and spraying) should continue on its current regularly scheduled basis.
2. Piezometer 94-1 requires a new concrete pad and must be installed by a WV licensed driller.
3. Geotechnical Engineering will be developing additional recommendations for implementing engineering controls to assist the plant in mitigating erosion of the bedrock spillway as it transitions to the natural channel.
4. Work with AEP Geotechnical Engineering and AEP Civil Lab to have the piezometers not part of the monitoring of the dam to be properly abandoned.

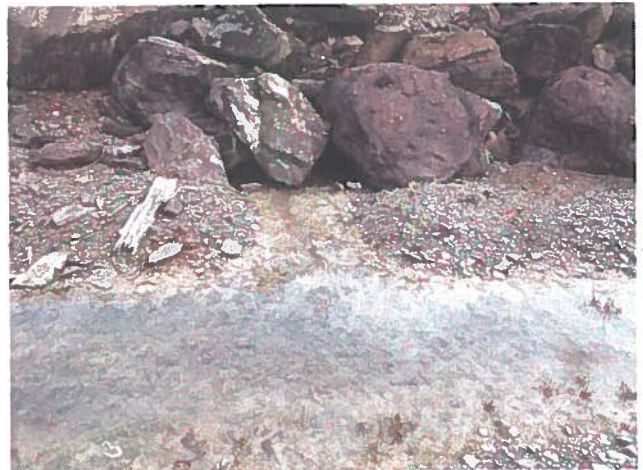
6. The right and left groin seepage weirs were free flowing and clear with an estimated discharge of 8 gpm and 10 gpm, respectively.
7. The surface of the 716 bench was generally in excellent condition. There were no visual signs of settlement, misalignment or erosion that would indicate any instability with the earthen fill. Seepage is observed along the 716 bench at the base of the dam's slope and appears to be consistent with respect to

their location and discharge (less than ½ gpm). The discharge was visually clear except for algae and no sediment was observed to be deposited at the seep's point of emergence. (Photos 10 and 11)

Photo 10- Typical view of the wet weather spring along the toe of the downstream face at the 716 bench.

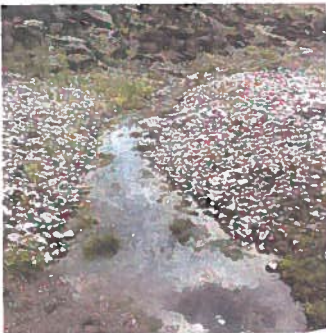
Photo 11- Typical view of the 716 drainage ditch to right groin ditch.

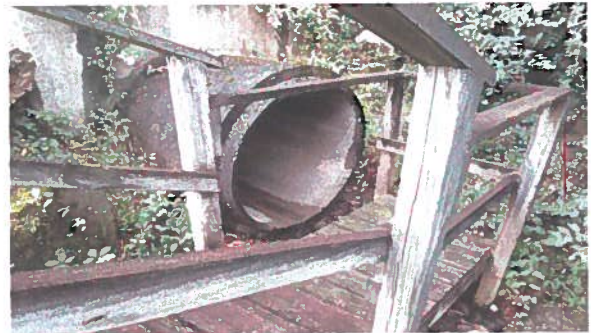
8. A minor amount of seepage was observed to discharging from the former (Stage 1 Dam Raising) decant structure. The seepage was estimated to be 0.5 gpm and was visually clear. (Photo 12)
9. The seepage collection basin at the toe was clear and appeared to be functioning as intended. (Photo 13)
10. The new surface water spillway has experienced moderate erosion as it transitions to the natural channel but is stable and clear of debris for the length of its bedrock channel.

Photo 12- Typical view of the closed primary discharge pipe from the stage one raising. The discharge from the pipe was estimated to be 0.5 gpm and was visually clear.

1. The seepage along the right groin and left groin pipe weirs should continue to be measured on a monthly basis.
2. The piezometers should continue to be measured for static water levels on a monthly basis.
3. The discharge from the original decant concrete discharge pipe should be monitored (flow and visual

clarity) on a monthly basis to determine if this is a seasonal wet weather spring discharge.

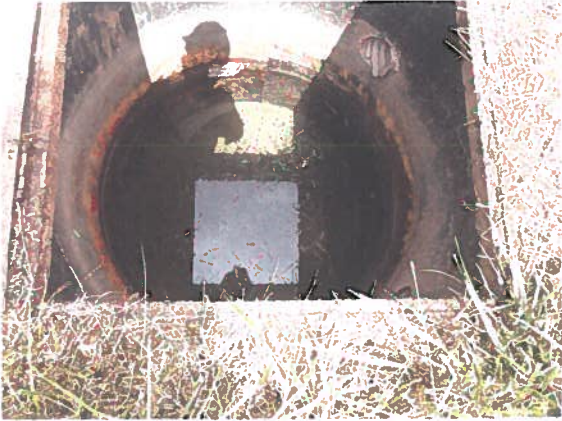
Photo 13- Typical view of the stilling basin that collects seepage from the foundation drainage blanket.
