# 2019 Annual Landfill Inspection Report

**Little Broad Run Landfill**

**Mountaineer Plant  
New Haven, West Virginia**

**2019 Annual Landfill Inspection Report  
(CCR Landfill)**

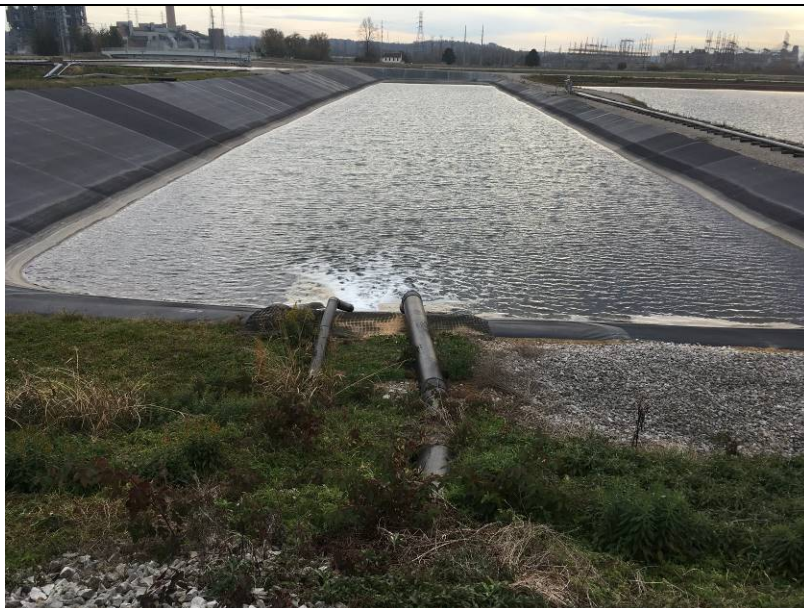
Photo # 1

1. Photograph No. 1 illustrates wastewater pond as part of the entire bottom ash complex. The leachate water from the landfill after going through the leachate collection pond system is discharged into the wastewater pond located at the power plant. The two discharge HDPE pipes (8" and 16" in diameter) are located on the west dike of the pond illustrated in the photograph appeared in good functional condition.

This photograph illustrates landfill leachate surge pond and discharge pipes.

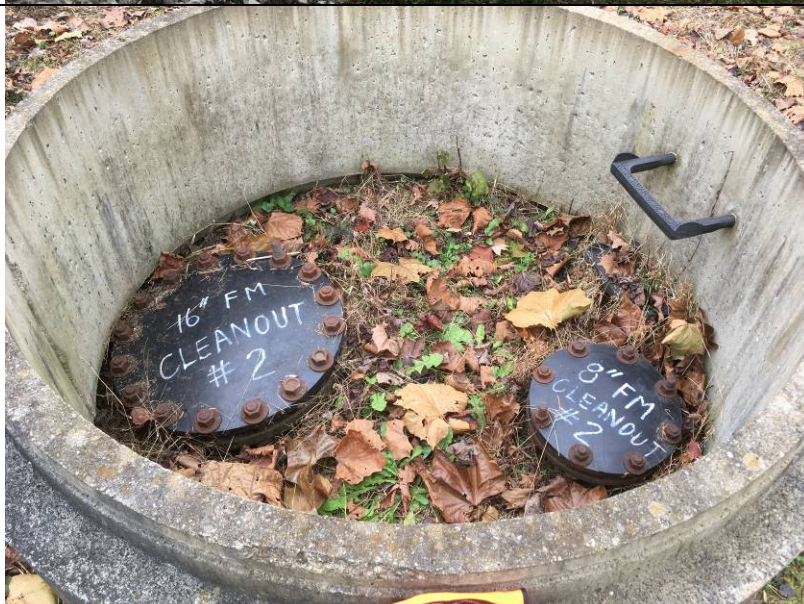
Photo # 2

2. These two discharge pipes are installed between the leachate collection pond and the wastewater pond. There are numerous cleanouts for the discharge pipes between the wastewater and leachate pond. Typical condition of the cleanout and concrete manhole for protection of the cleanouts are illustrated in Photographs No. 2-4. All the cleanouts were accessible inside the manhole and appeared in good condition. Minor vegetation along the access to the discharge pipes was present that needs some clearing.

Typical condition of the cleanout #2 and protective concrete collar.

1. Clear excessive vegetation from the landfill area and along the leachate discharge pipes and cleanouts as noted.
2. Perform repair of erosion cut in Landfill Area 2 along the downstream groin area near the toe.
3. Complete the final grading and top soil cover work in Area 3. Establish a good vegetative layer over the area to prevent erosion.
4. Backfill, regrade, and compact low areas of the stacker pad and remove any excessive gypsum for positive drainage.
5. Clean out precipitate accumulation in the leachate pipes. Perform inspection of the leachate pipe using confined space camera.
6. Engineering should evaluate the precipitates chemistry to determine the process/cause.

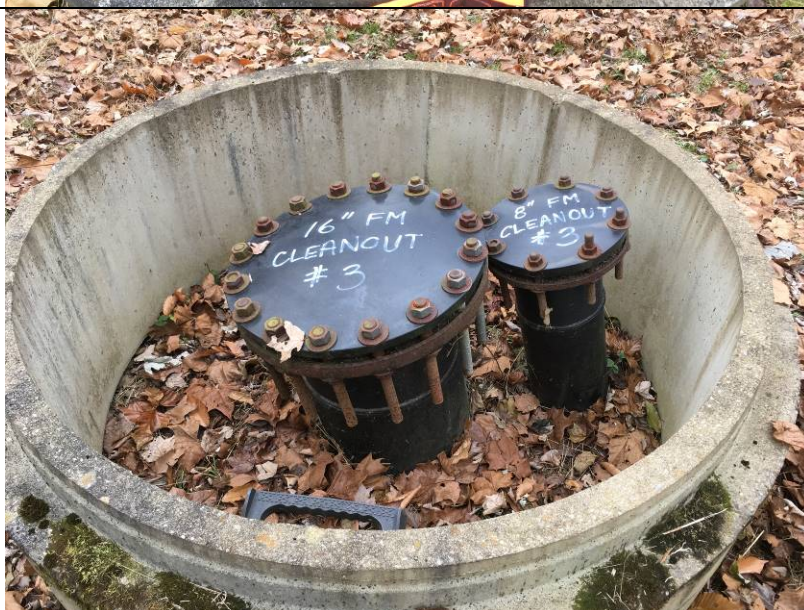
Photo # 3

Typical condition of the cleanout #3 and protective concrete collar.

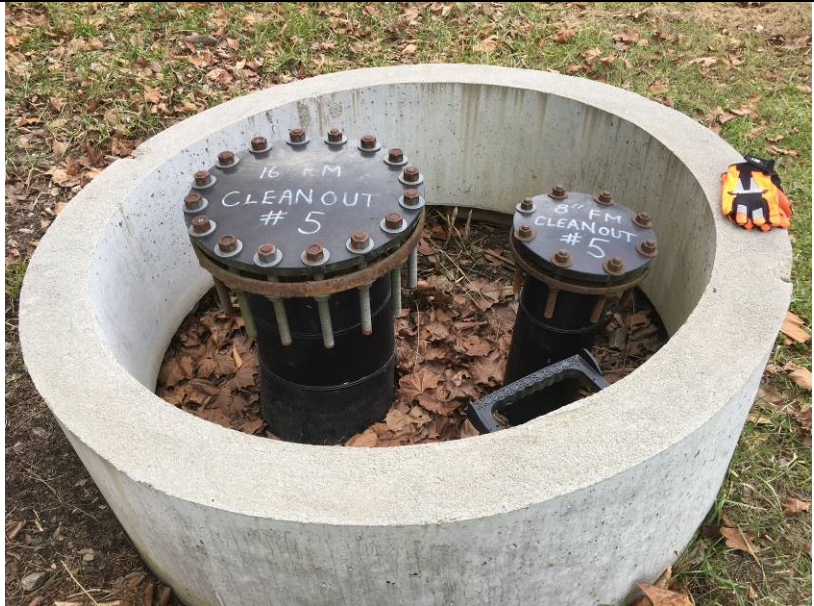
Photo # 4

Typical condition of the cleanout #5 and protective concrete collar.

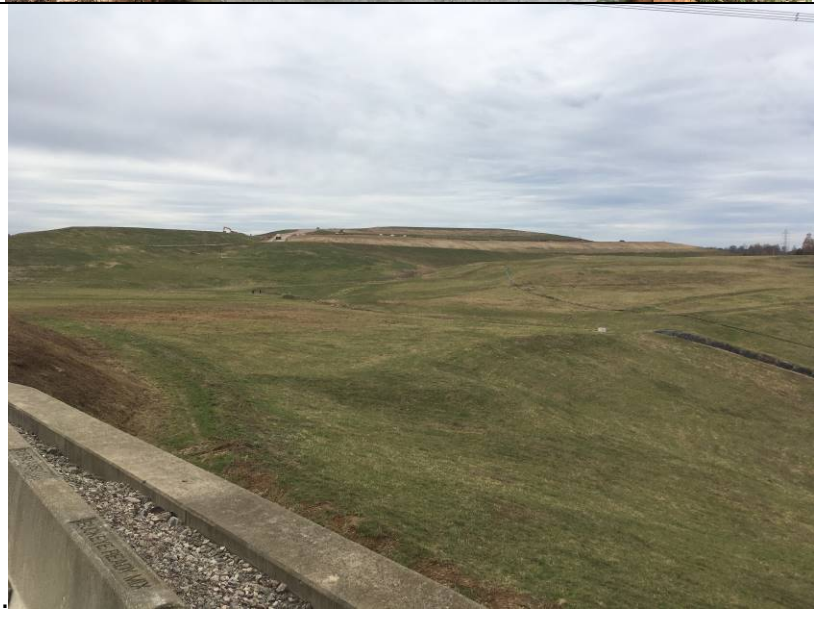
Photo # 5

3. Typical condition of landfill Areas 6 and 7 is illustrated in Photograph No. 5. Overall landfill Areas 6 and 7 appeared in satisfactory and stable condition with adequate vegetative cover. The perimeter ditches were observed to be in satisfactory and functional condition (Photographs No. 6 and 7). No standing water was observed in the perimeter ditches.

Typical condition of landfill Areas 6 and 7 vegetative cover.

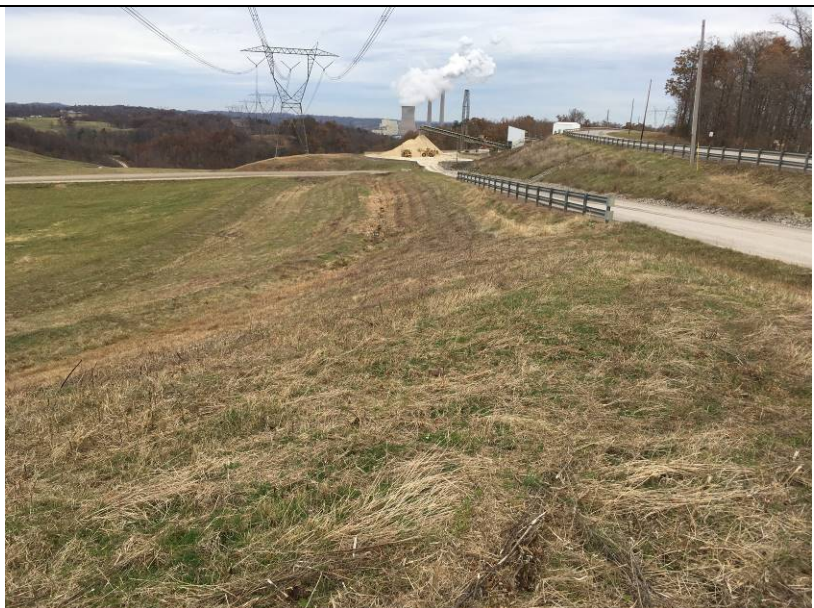
Photo # 6

View along the perimeter ditch of Areas 6 and 7 (looking northeast).

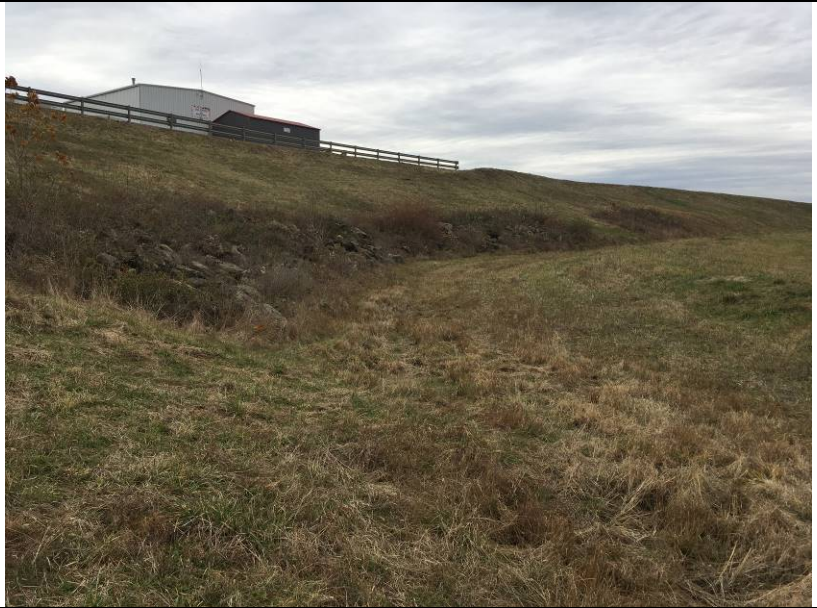
Photo # 7

View along the perimeter ditch of Areas 6 and 7 (looking west).

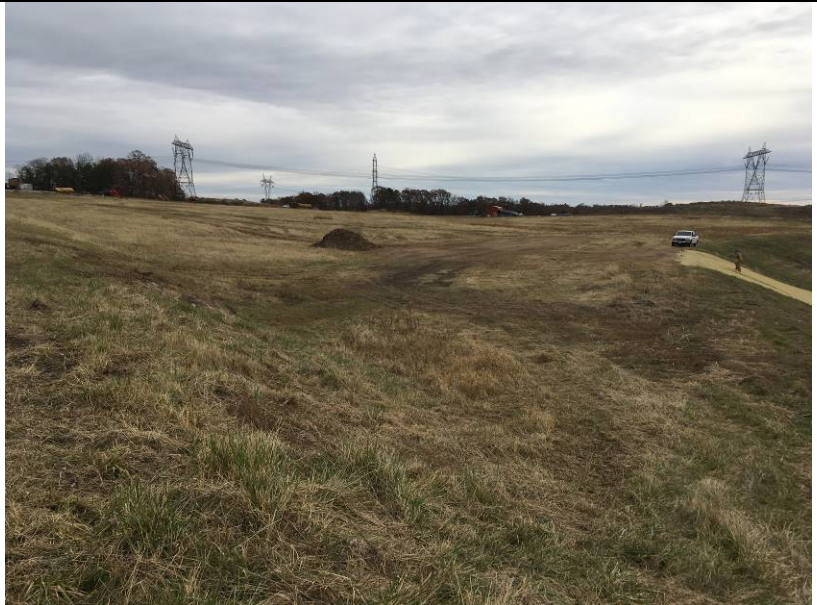
Photo # 8

4. Landfill Area 1 appeared in satisfactory and stable condition (illustrated in Photographs No. 8 and 9). A repair to the outside slope berm had just been completed and the slope area has been graded and seeded (Photograph No. 9).

Overall view of Area 1, top of the landfill.

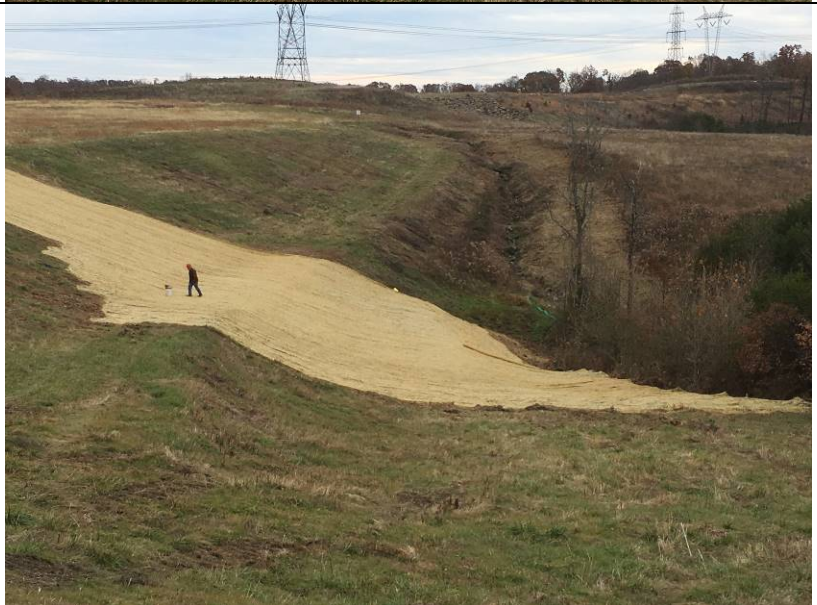
Photo # 9

Overview of Area 1 side slope cover.

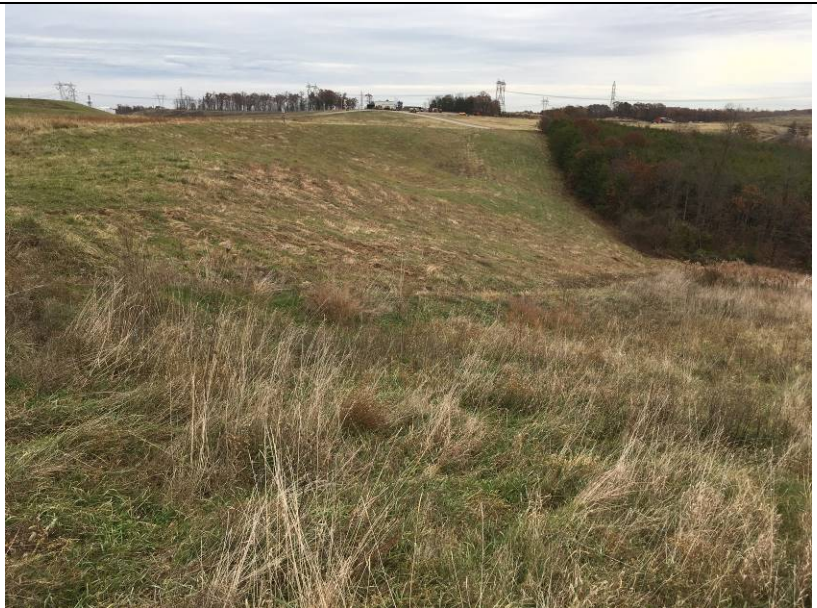
Photo # 10

5. Overall Area 2 appeared in satisfactory and stable condition (Photograph No. 10). The soil cover and vegetation appeared to be in satisfactory condition. There is significant scour along the left groin ditch near the toe area that needs to be addressed (Photograph No. 11).

Overall view of Area 2 side slope vegetative cover.

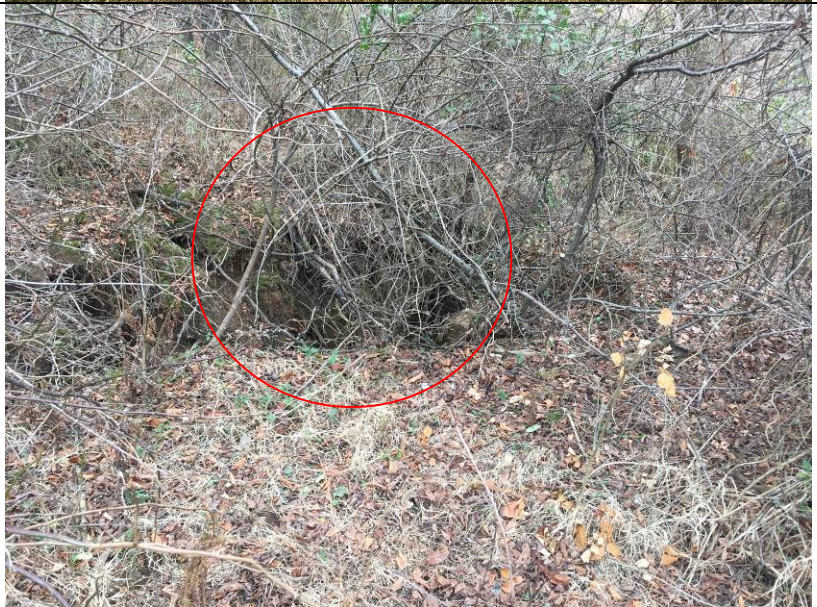
Photo # 11

Overview of Area 2 groin ditch near the toe. There is significant scour along the groin ditch.

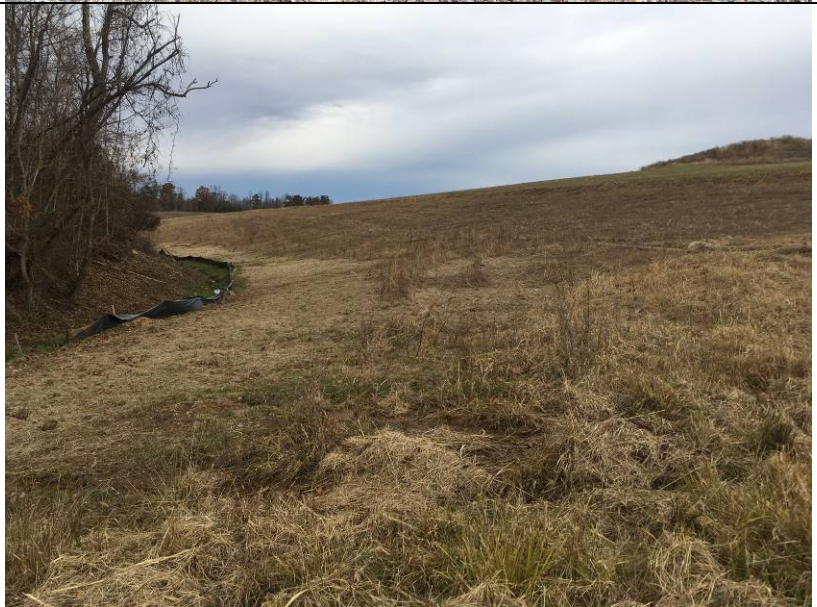
Photo # 12

6. The slope remediation work for Area 3 is almost complete (Photograph No. 12). The remediation work consisted of removing unstable fill, placing a layer of geo-grid, place backfill, a drainage layer using geo-composite, and cover soil. The area still needs final grading and top soil cover to provide a base for a good vegetative cover. This area still has minor seepage that will need further monitoring and reporting. Adjacent area to the south also indicates seepage (Photograph No. 13). The toe ditch indicates ongoing iron color seepage from this area. This area needs monitoring and also further investigation.

Overview of Area 3 side slope vegetative cover.

1. After completing remediation at Area 3 of the landfill, continue monitoring and inspecting the performance of remedial work and seepage management. Investigate to determine the root cause of the existing seepage in an area adjacent to the area been remediated.
2. Monitor poor drainage issues at the gypsum stackout pad to reduce the amount of sediment build up in the sump structure.

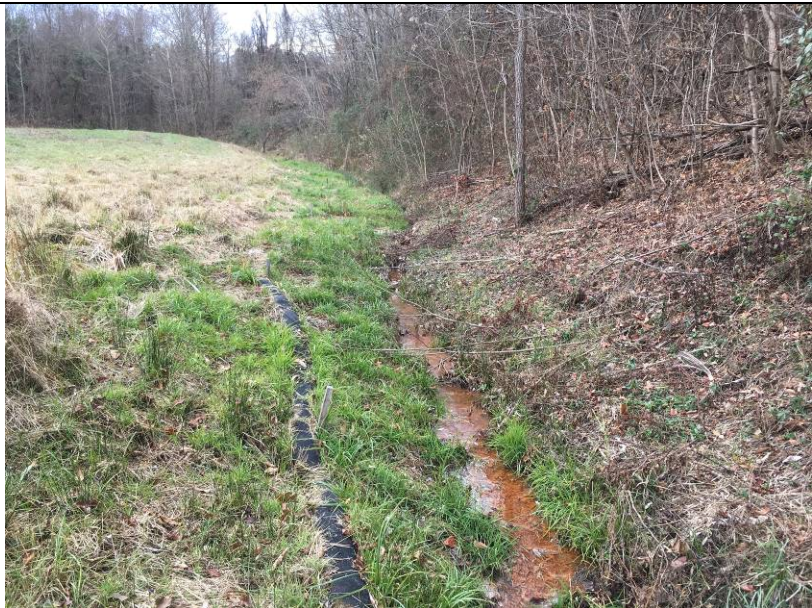
**Photo # 13**

Overview of Area 3 perimeter ditch looking south.

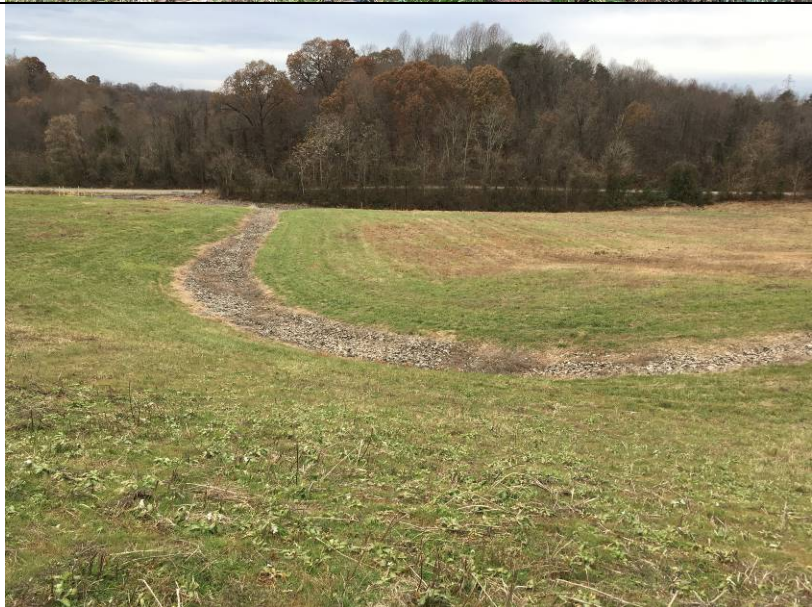
**Photo # 14**

7. Overall Area 4 appeared in satisfactory and stable condition (Photograph No. 14 and 15). The soil cover, vegetation and rip rap drainage channel appeared to be in satisfactory condition.

Overview of Area 4 drainage channel.

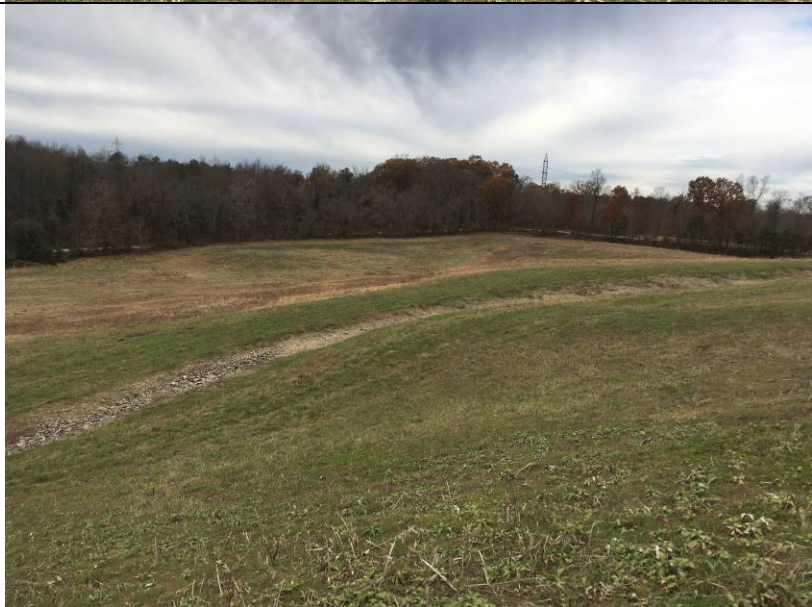
**Photo # 15**

Overview of Area 4 vegetative cover, top of landfill.

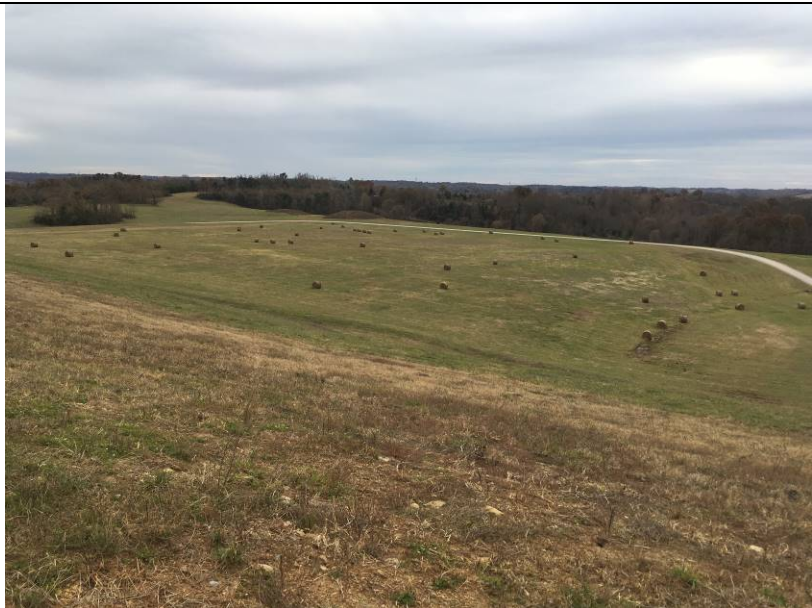
Photo # 16

8. Landfill Area 5 is illustrated in Photograph No. 16. This area and the perimeter access road was in satisfactory and stable condition with controlled vegetation.

Overview of Area 5 vegetative cover, top of landfill.

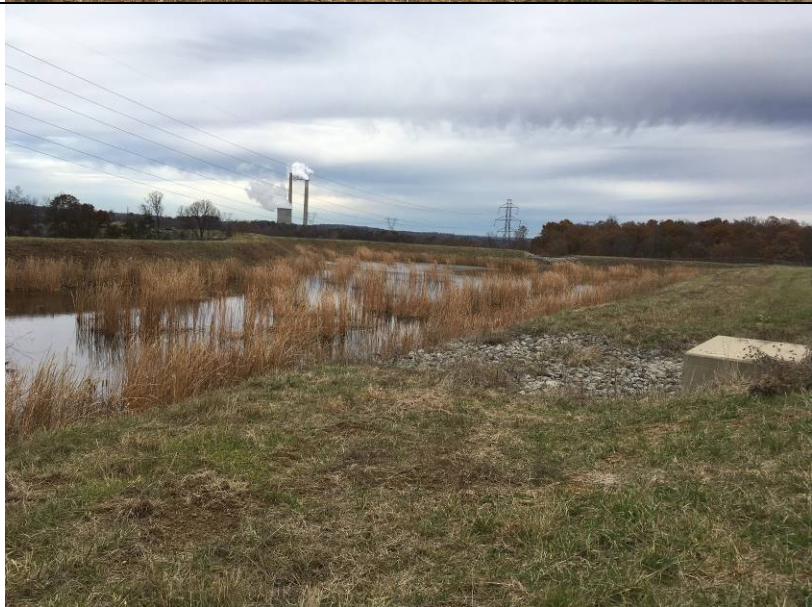
Photo # 17

9. Photograph No. 17 illustrates the northwest sediment pond. Overall, the pond appeared in functional and the dikes were in satisfactory and stable condition. Some cattail growth was observed throughout the pond area needs to be cleared.

Overview of Northwest sediment pond.

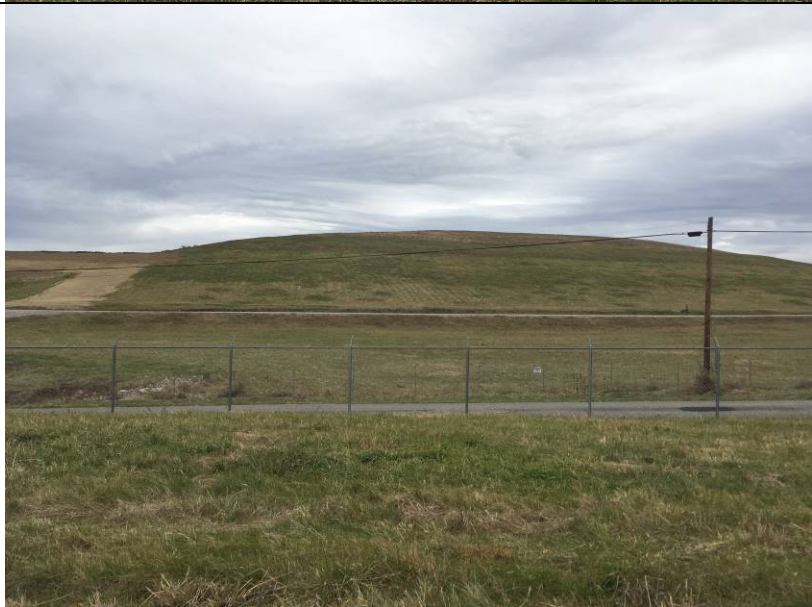
Photo # 18

10. The outside side slope areas of vertical expansion Phase 1A is illustrated in Photograph No. 18. The slope area and perimeter access road were in satisfactory and stable condition with controlled vegetation.

Overview of Area 4 and side slope area of vertical expansion Phase 1A.

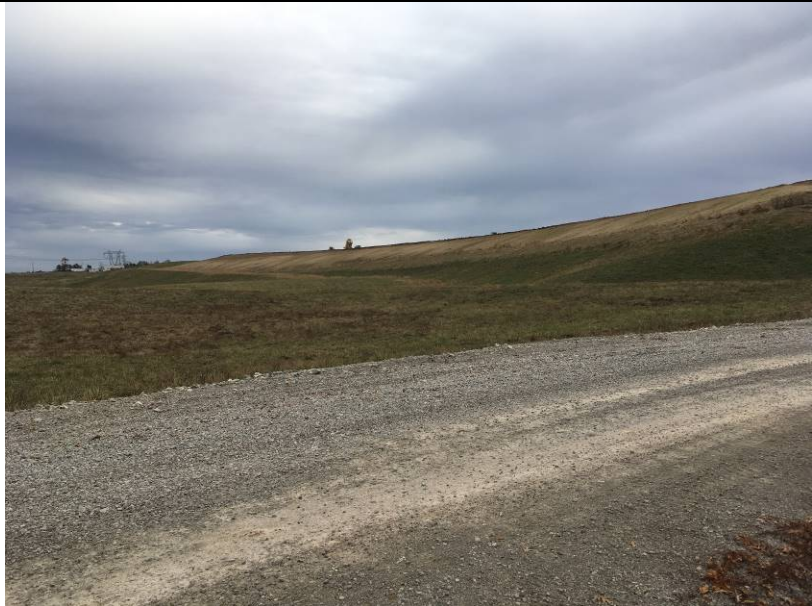
Photo # 19

11. The outside side slope areas of vertical expansion Phase 1B is illustrated in Photograph No. 19. The slope area and perimeter access road were in satisfactory and stable condition with controlled vegetation.

Overview of side slop area of vertical expansion Phase 1B.

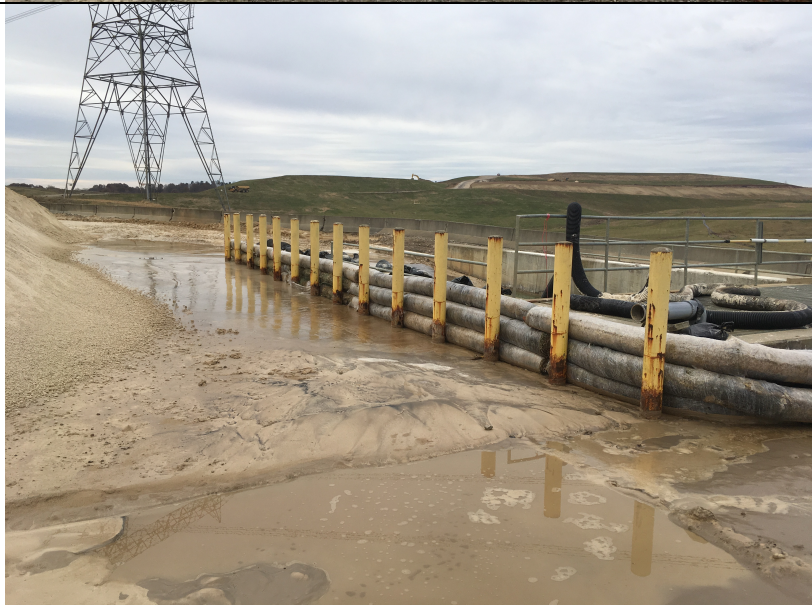
Photo # 20

12. Photograph No. 20 illustrates gypsum stacker pad. The radial stacker was in operation at the time of inspection. Stacker pad had some water ponding issues and accumulation of gypsum in some areas near the sump structure (Photograph No. 21).

Gypsum Stackout Pad. View of Ponding Water and Gypsum Accumulation near the Sump Structure.

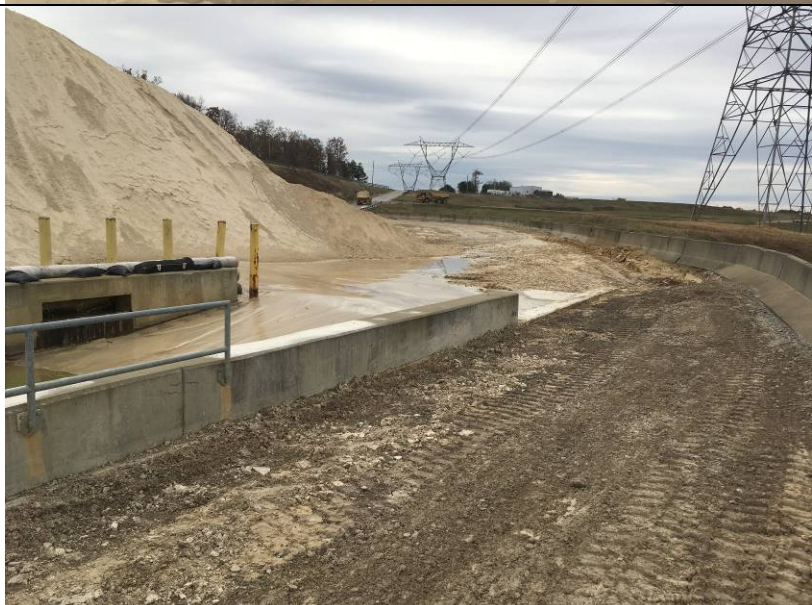
Photo # 21

Gypsum Stackout Pad. View of Ponding Water and Gypsum Accumulation near the Sump Structure.

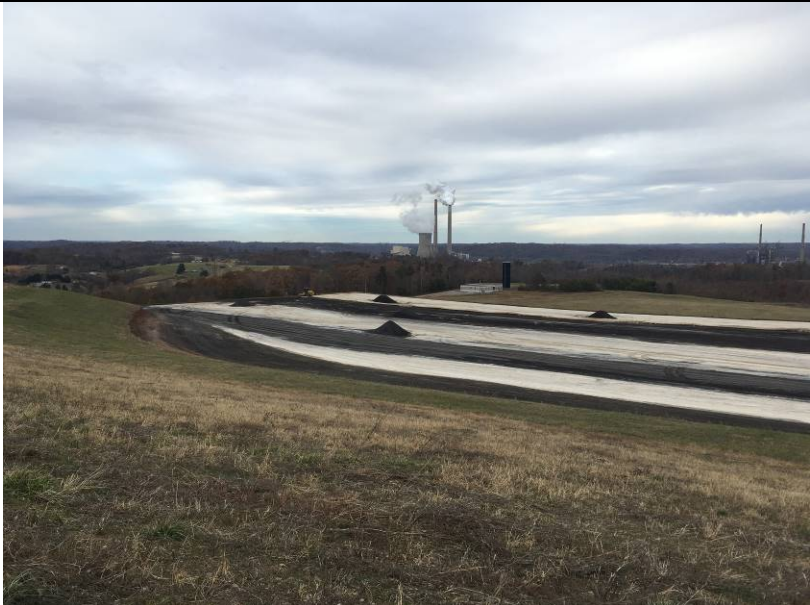
Photo # 22

13. Photograph No. 22 and 23 illustrates Phase 1B of the active landfill which is part of the vertical expansion. This area appeared satisfactory and in compliance with the permit requirements.

Active landfill - Vertical Expansion Phase 1B. Looking Northwest.

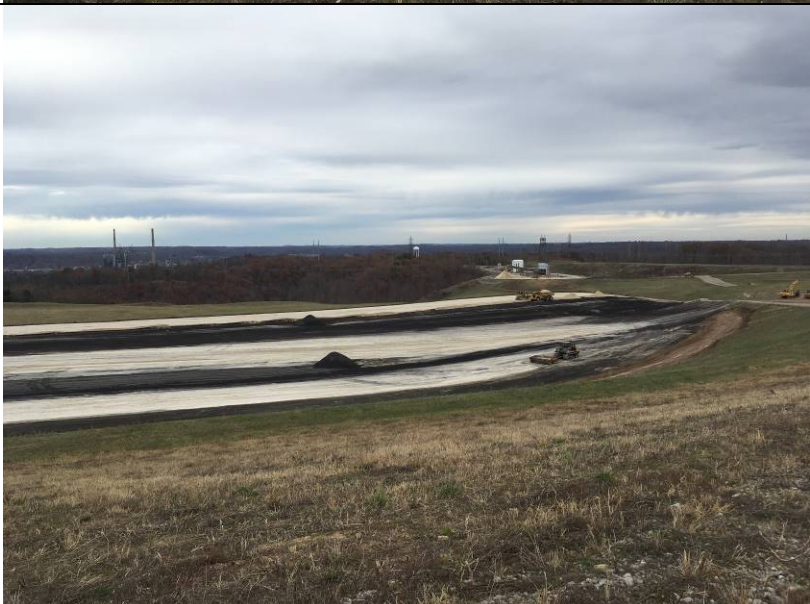
Photo # 23

Active landfill – Vertical Expansion Phase 1B. Looking East.

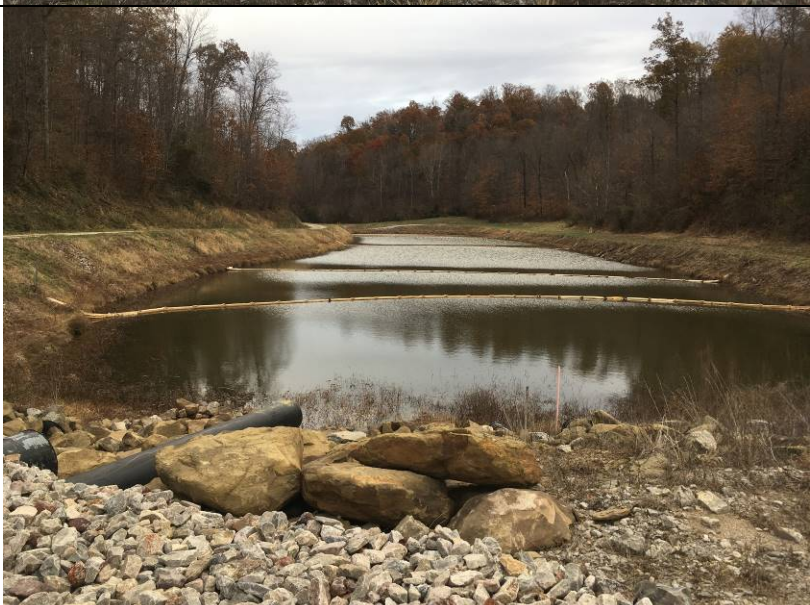
Photo # 24

14. Landfill Area 7 sediment pond is illustrated in Photograph No. 24 appeared to be functioning as designed and in satisfactory condition.
15. The leachate collection system of the landfill is collected in a manhole at the east side of the landfill. Photograph No. 25 illustrates interior of the manhole as a collection point for all the leachate pipes. Based on observations, the leachate pipes indicated accumulation and buildup of precipitates inside the pipes. Photographs No. 26 and 27 illustrates the two leachate ponds. The ponds appeared in satisfactory and functional condition.

Overview of Area 7 Sediment Pond.

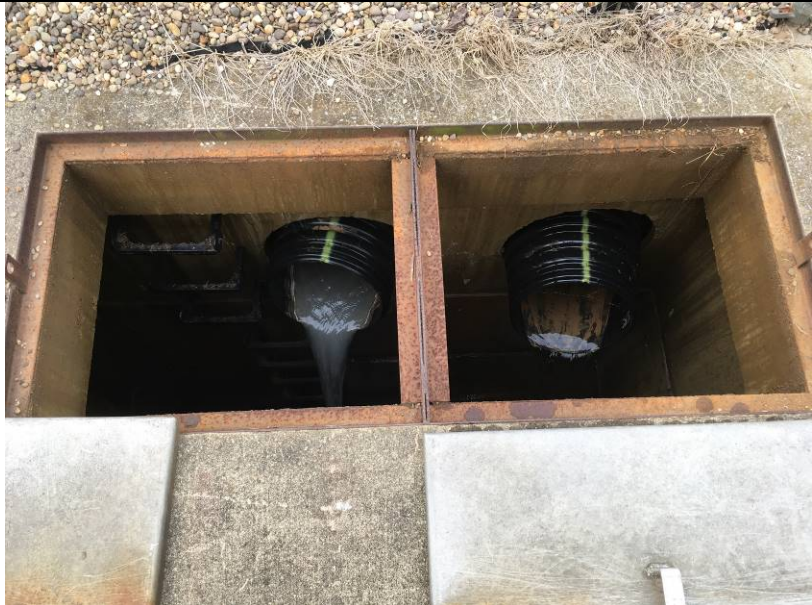
Photo # 25

There was, however, a noted deficiency pertaining to the lower leachate underdrain discharge at MH-1. The deficiency related to high TSS numbers identified as part of regular monitoring and inspections in March of 2019. Several video inspections and high pressure jetting activities were performed in the spring and summer of 2019. There was no video evidence of broken lines and the jetting activities removed a lot of solids build up in the pipe. Eventually the lines cleared up and the TSS numbers came down to normal levels.

Landfill Leachate Pipe Collection  
Manhole MH-1.

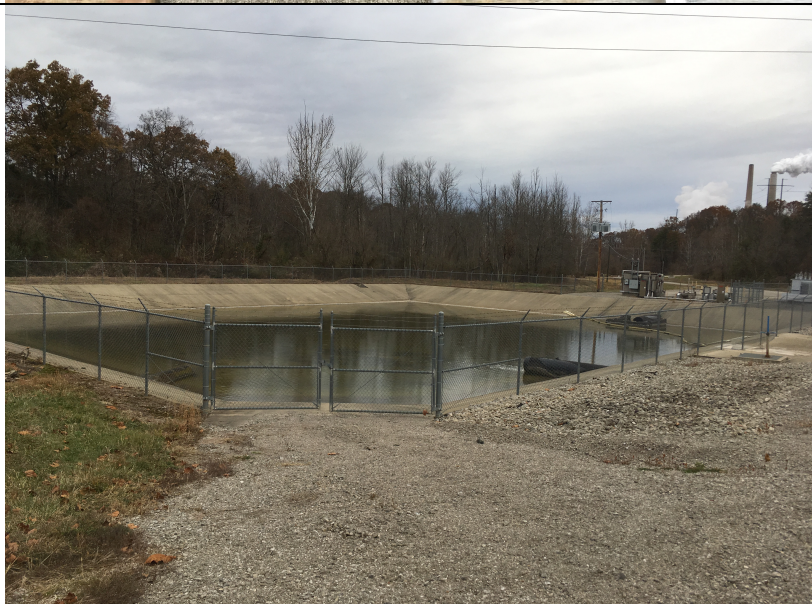
Photo # 26

Leachate Pond 1.

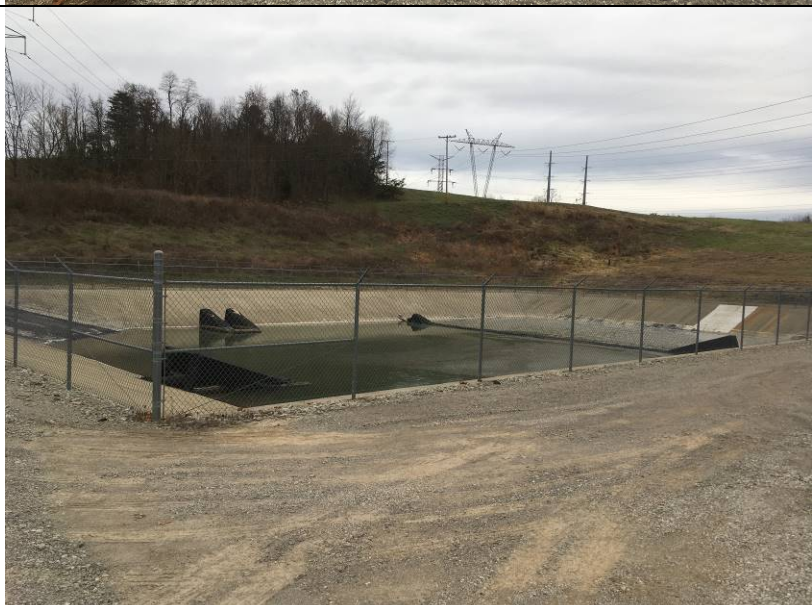
Photo # 27

Leachate Pond 2.
