SAFETY FACTOR ASSESSMENT PERIODIC 5-YEAR REVIEW

Bottom Ash Complex

Mountaineer Plant
New Haven, West Virginia

Geotechnical Engineering Report

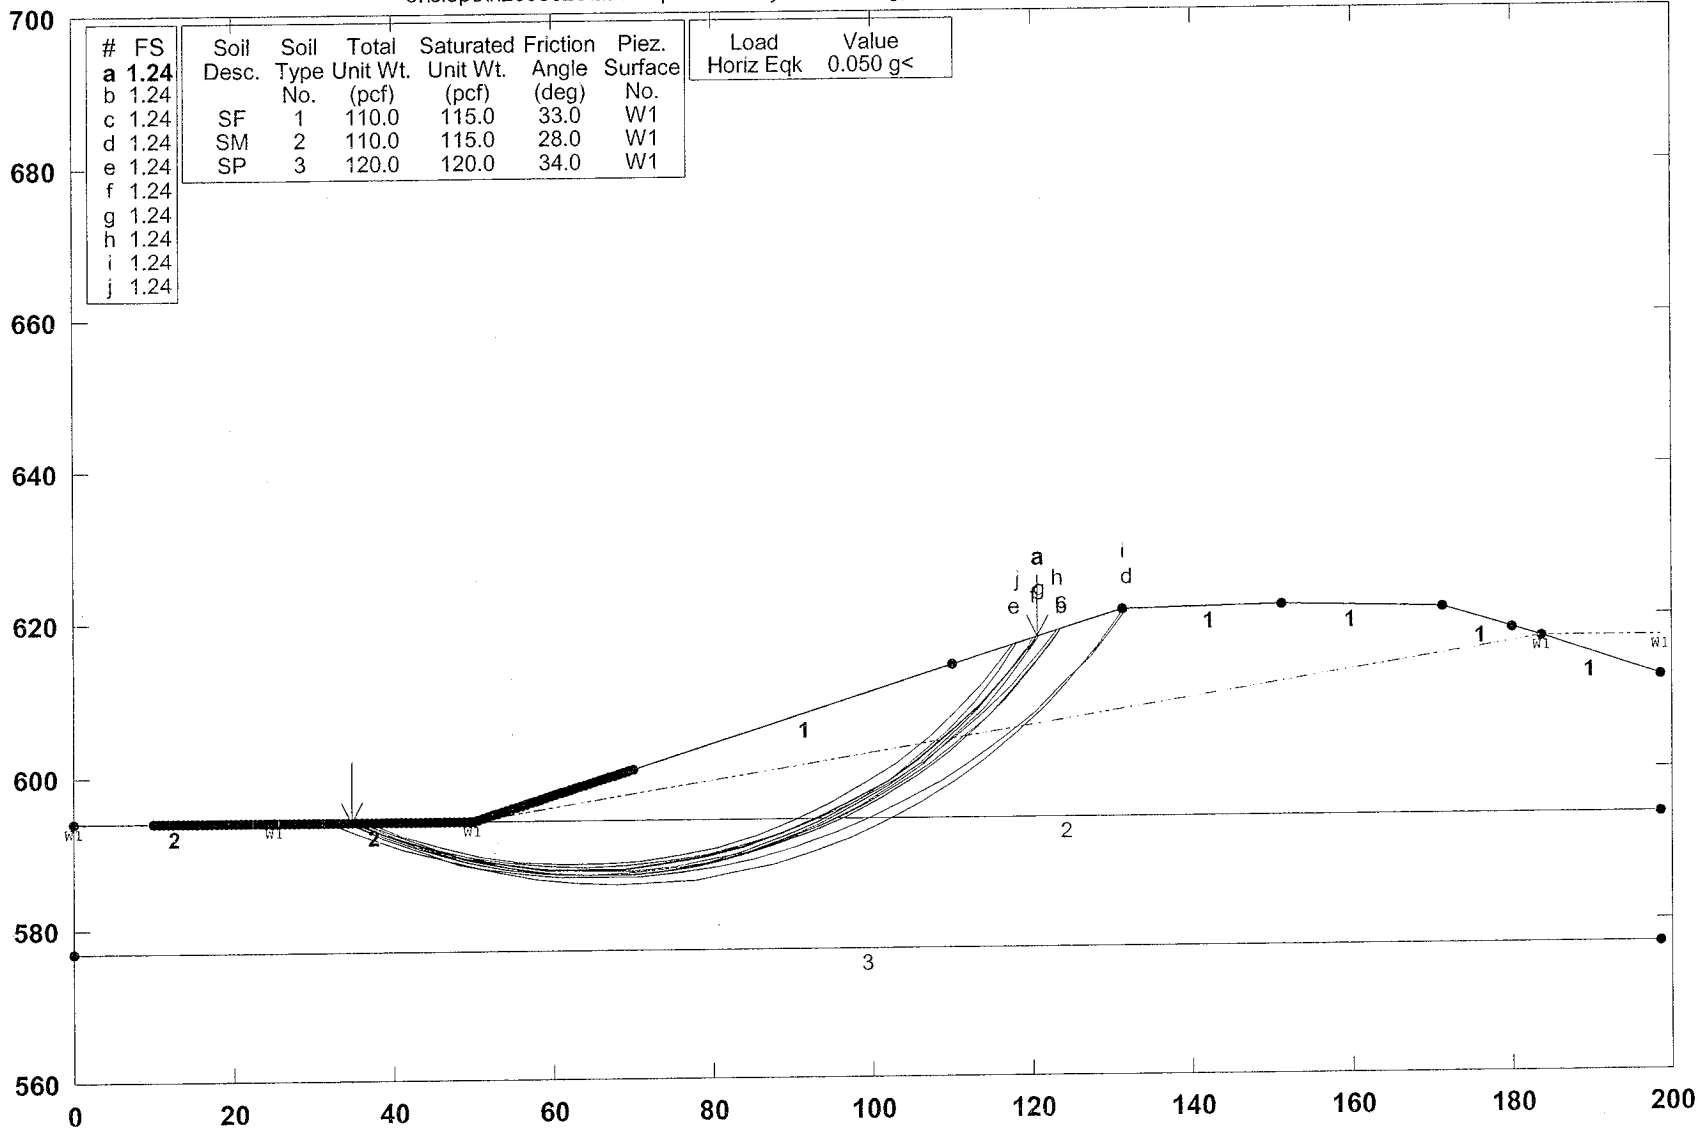
AEP / Mountaineer BAP Complex, C/S A-A', Downstream Slope, Long term, Earthquake

Slope Stability Case	Minimum Factor of Safety from Slope Stability Analyses		Required Minimum Factor of Safety	Exhibits ²
	Upstream	Downstream		
Long-Term, Steady-State at Maximum Storage Pool Elevation 617 Feet ¹	1.91	N/P ³	1.5	B
Long-term with Seismic Loading ¹	1.48	1.24	1.0	C, D

PCSTABL7 FSmin=1.24

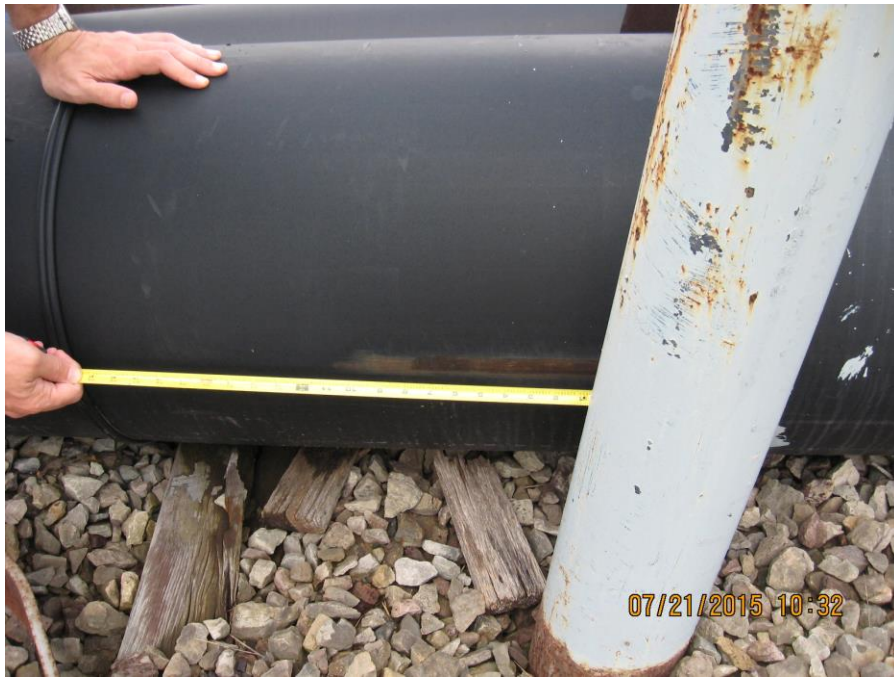
Photo 9: Bottom Ash Ponds: evidence of movement along bottom ash inlet pipes due to thermal expansion.

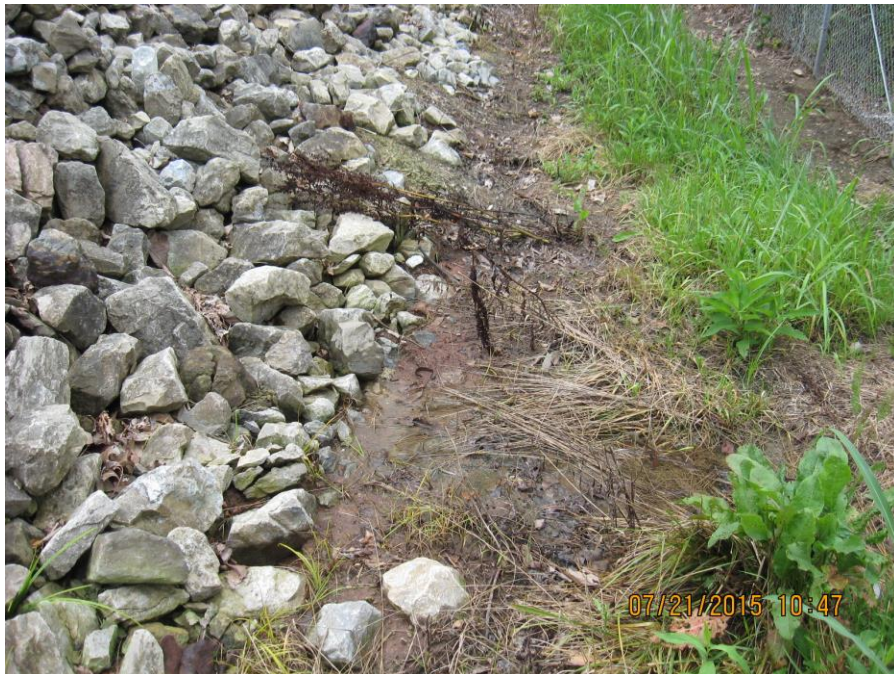
Photo 16: Bottom Ash Ponds, north dike: water near the exterior toe.

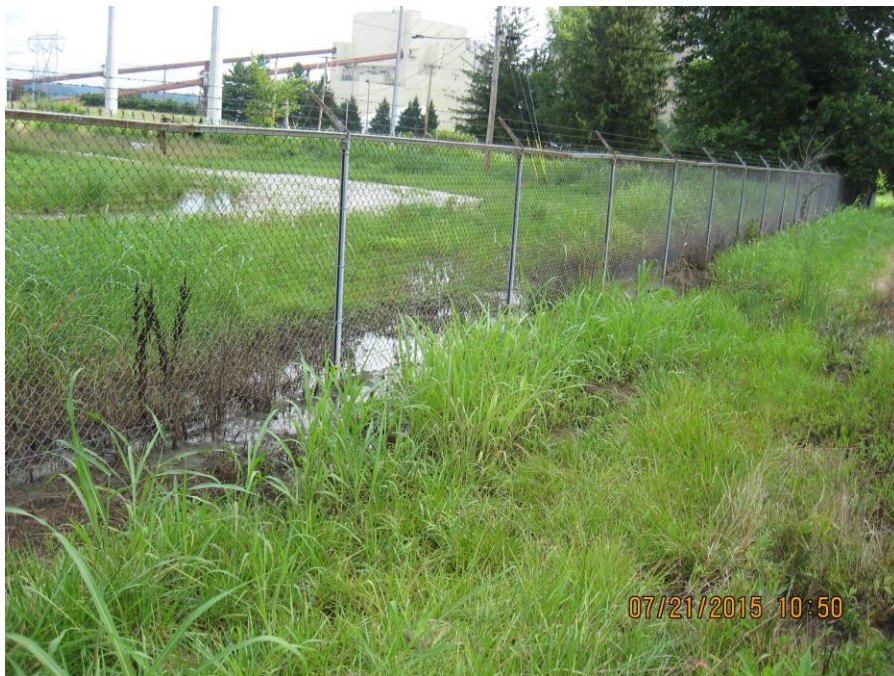
Photo 18: Bottom Ash Ponds, north dike: water near the exterior toe.

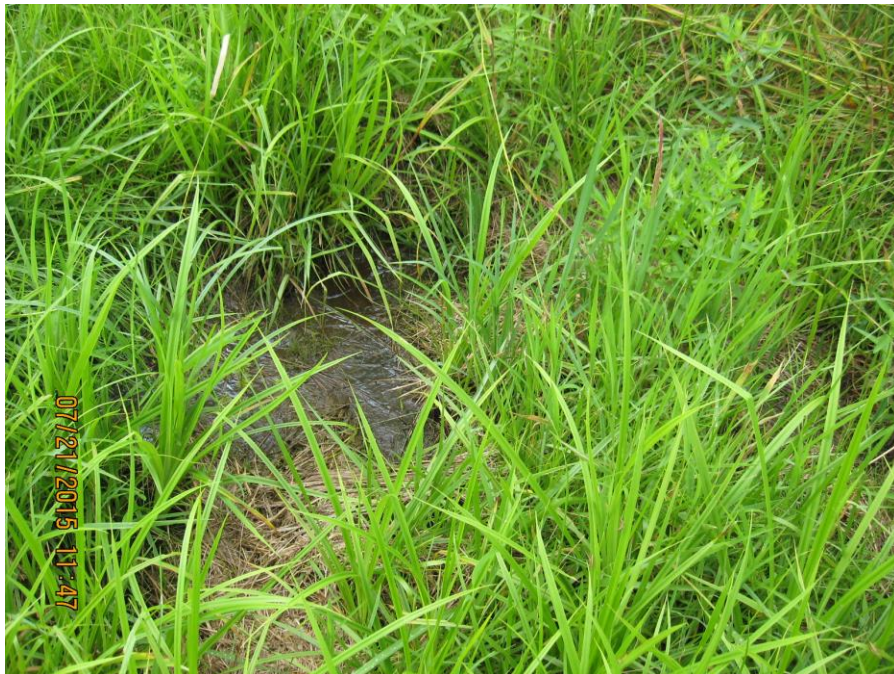
Photo 46: East Wastewater Pond, east dike: water along exterior toe.

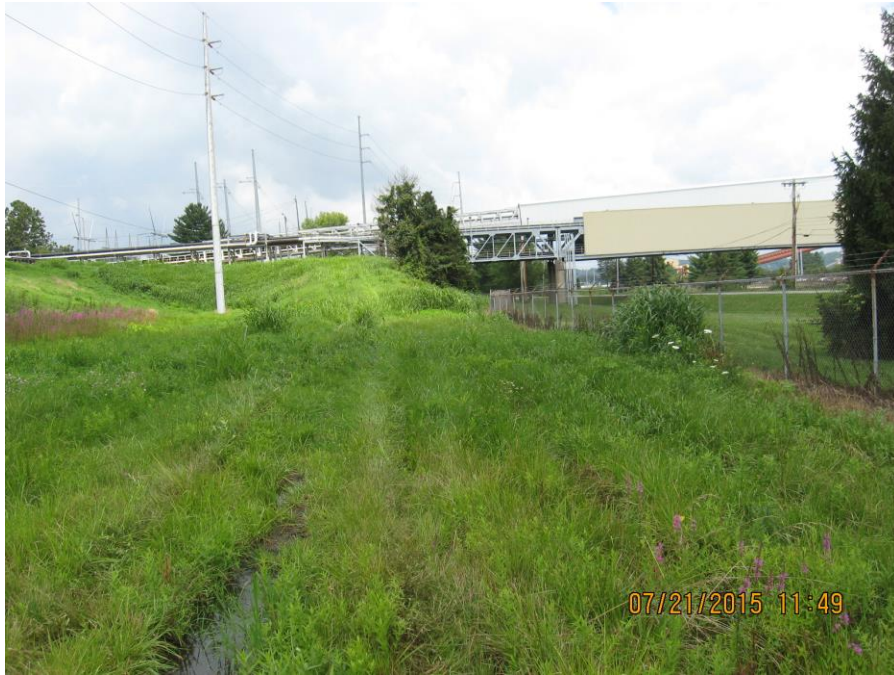
Standing water was observed along the downstream toe of the eastern dike of the East Bottom Ash Pond, which was also noted in our 2009 report. It was previously speculated that this water was the result of seepage through the dike; however, long-term groundwater readings obtained from monitoring wells located at the toe of the embankment indicate groundwater levels at a depth of about 25 feet below the existing ground surface. After further consideration, it is likely that the standing water observed in this area is the result of poor drainage and surficial grading, and that the water can likely be attributed to surficial runoff. Terracon recommends that the area in question be re-graded to improve drainage and that continued monitoring take place following the grading operations to ensure that the problem has been adequately resolved.

Photo 49: East Bottom Ash Pond, east dike: water along exterior toe.
