2020 Annual Landfill Inspection Report

H.W. Pirkey Power Plant
American Electric Power Service Company
(SWEPCO)
Hallsville, Texas

Document ID: GEVR-20-023

Date of Inspection: November 5, 2020

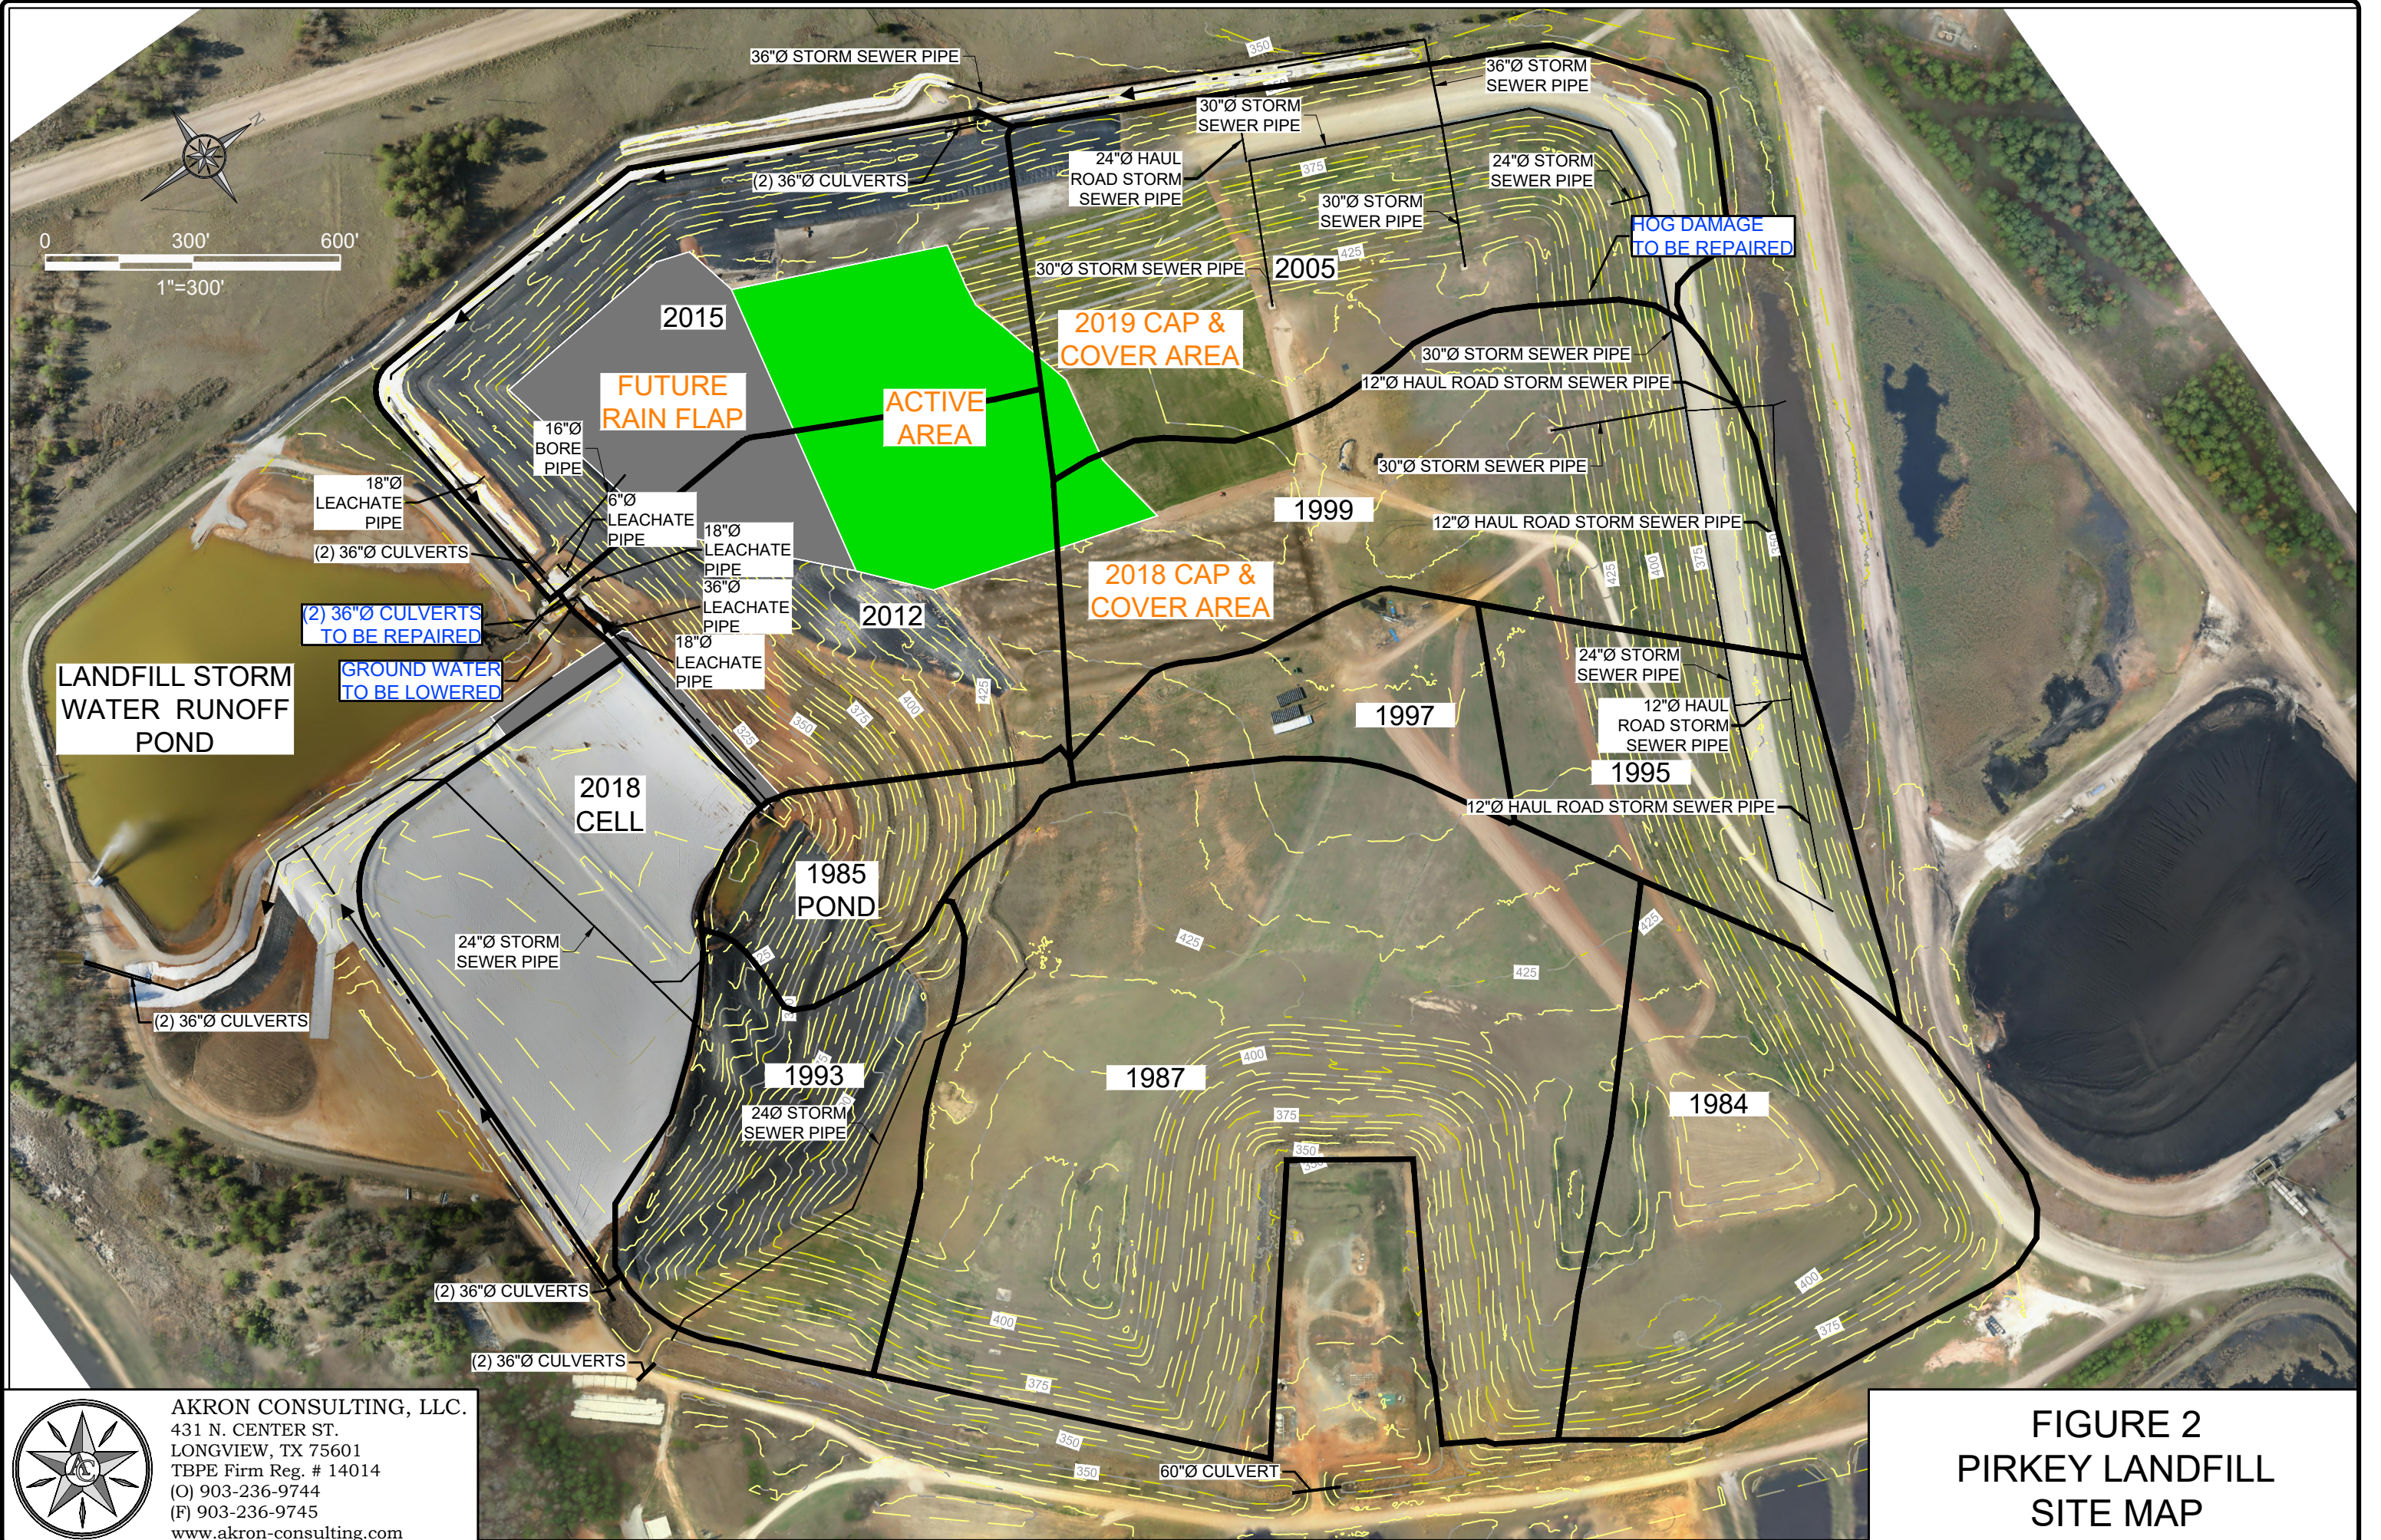
FIGURE 2
 PIRKEY LANDFILL
 SITE MAP

(2) 36"Ø CULVERTS TO BE REPAIRED

GROUND WATER TO BE LOWERED

HOG DAMAGE TO BE REPAIRED

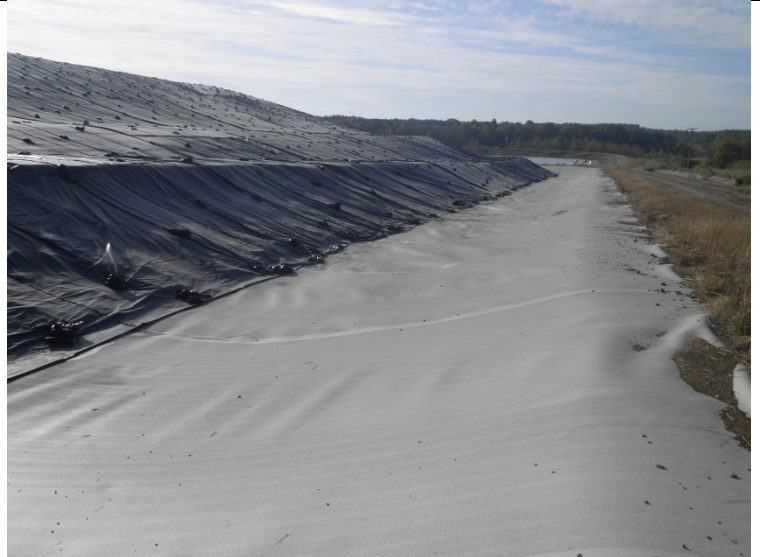
PHOTO #1

17. A contact water ditch runs along the western edge of the landfill area and is lined with a geomembrane. The ditch was observed to be clear of any obstructions and will be reclaimed as part of the 2020 cap and cover project.

View of the contact water ditch along the west side of the 2015 Cell

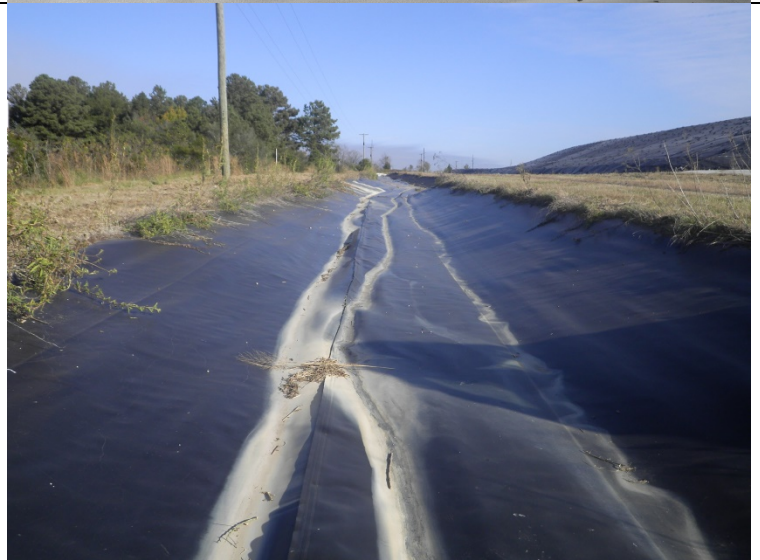
PHOTO #2

18. A non-contact storm water ditch which is located along the western edge of the landfill is lined with a geomembrane material. Runoff from the 2005 Cell is collected into a 36-inch-diameter conduit and this conduit discharges into the non-contact water ditch. An earthen berm armored with riprap material has been placed at the end of the non-contact water ditch to divert flow away from the toe area of the Landfill Runoff Pond Dam. Small holes about 2 inches in diameter have been cut into the geomembrane to allow any trapped groundwater under the geomembrane to drain and prevent floating of the geomembrane liner.

View of the non-contact water ditch along the west side of the 2015 Cell

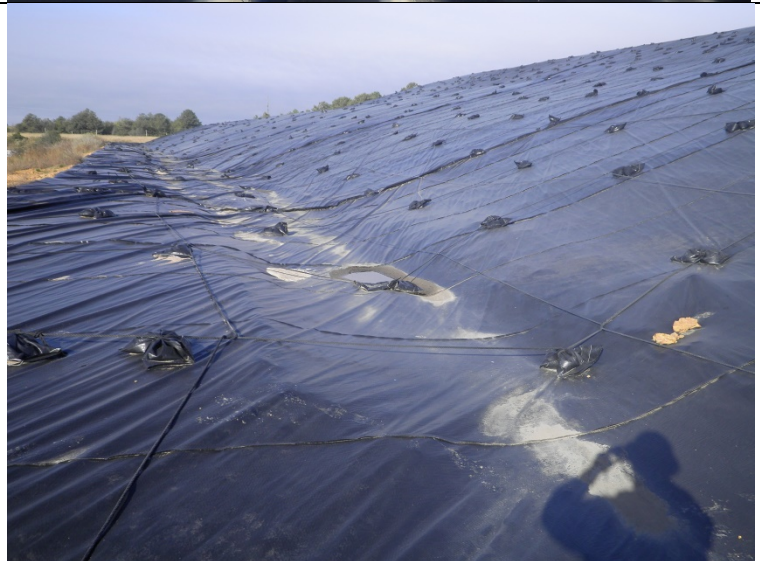
PHOTO #3

19. A non-contact storm water ditch runs along the western edge and southern edge of the landfill that is covered with a rain flap material. Runoff from the lower outside slope of the 2015 Cell is collected into a lined ditch and then discharges into the non-contact water ditch on the western side of the landfill.

View of the non-contact water rain flap ditch along the south side of the 2015 Cell

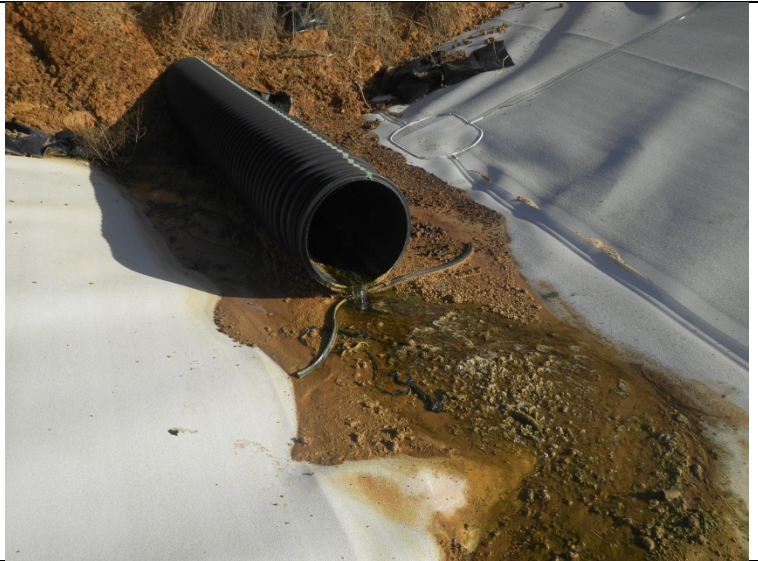
PHOTO #4

View of the 18" Leachate Pipe Outlet
from the 2015 Cell

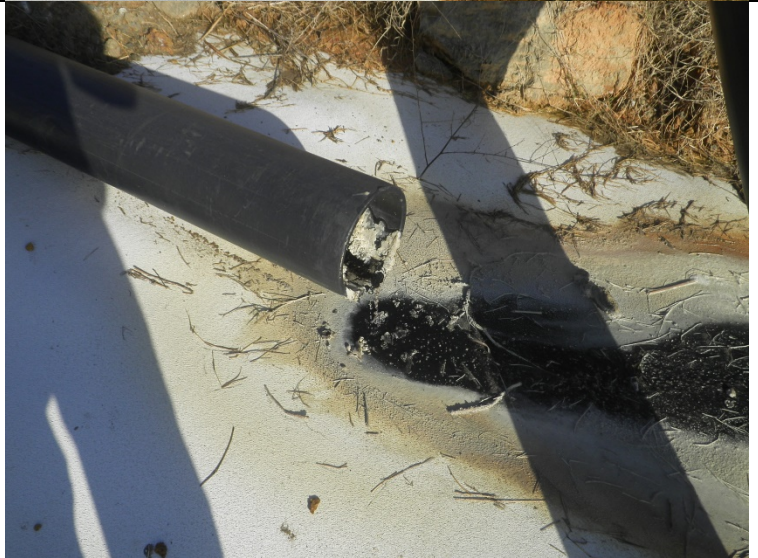
PHOTO #5

View of the 6" Leachate Pipe Outlet
from the 2015 Cell

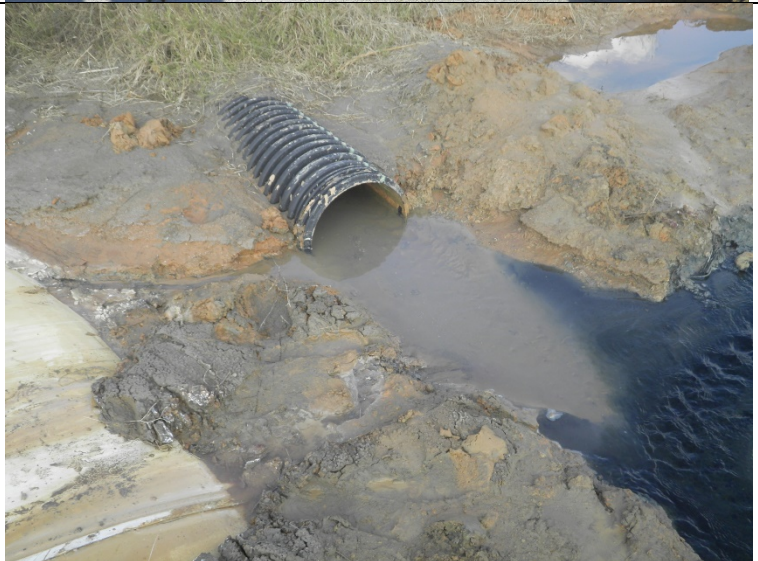
PHOTO #6

View of the 18" Leachate Pipe Outlet
from the 2012/2015 Cell

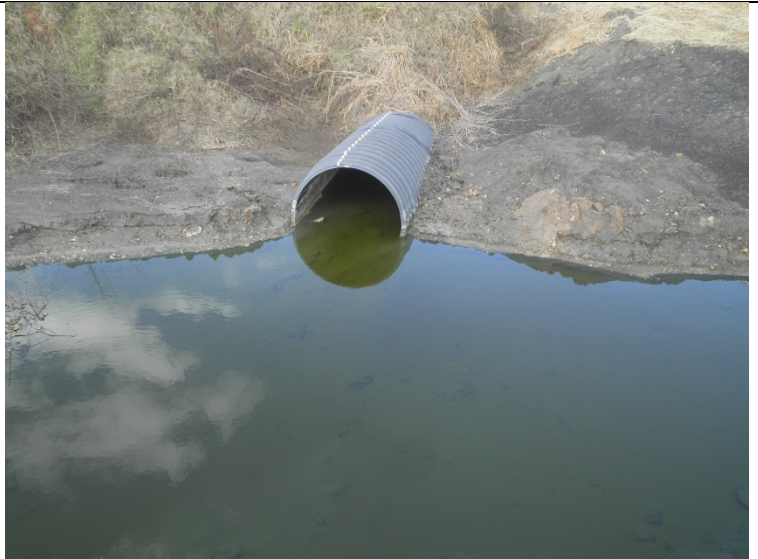
PHOTO #7

5. The 36-inch-diameter and 18-inch-diameter leachate collection discharge pipe outlets near the south end of the 2012 Cell were unobstructed and free-flowing.

View of the 36" Leachate Pipe Outlet
from the 2012 Cell

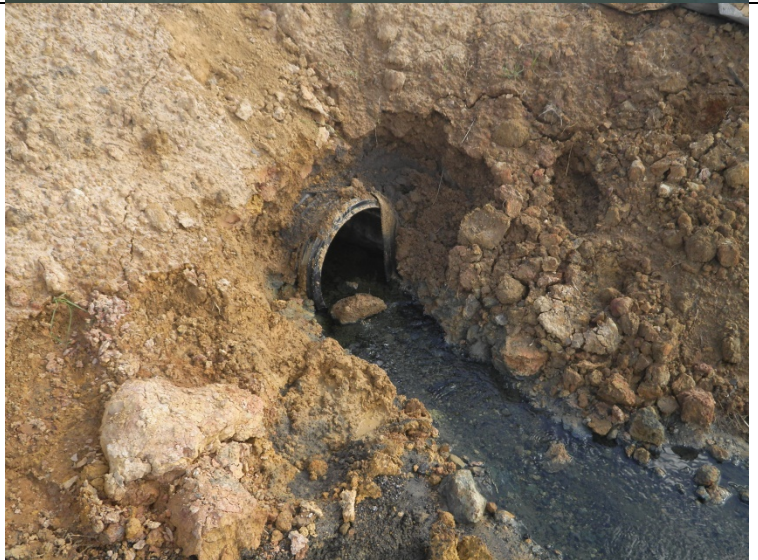
PHOTO #8

View of the 18" Leachate Pipe Outlet
from the 2012/2018 Cell

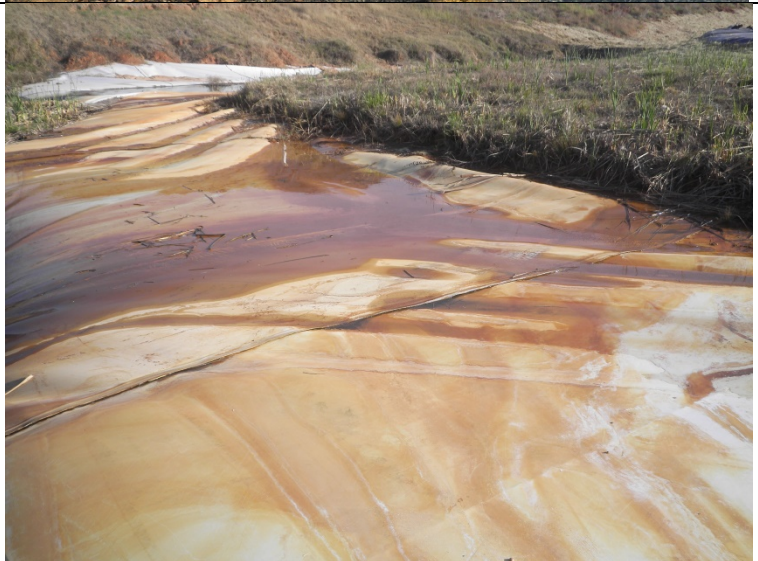
PHOTO #9

8. The 1993 Cell was still covered with a geo-membrane rain flap material that appeared to be in good condition.
9. There is standing water at the surface near the groundwater interceptor drain manhole on the southern side of the landfill. Groundwater is also pushing up on the liner system in the perimeter ditch near the groundwater interceptor drain manhole. According to plant personnel, the groundwater in this area will be lowered once the Landfill Runoff Pond is lowered.

View of the high groundwater under
the perimeter ditch liner

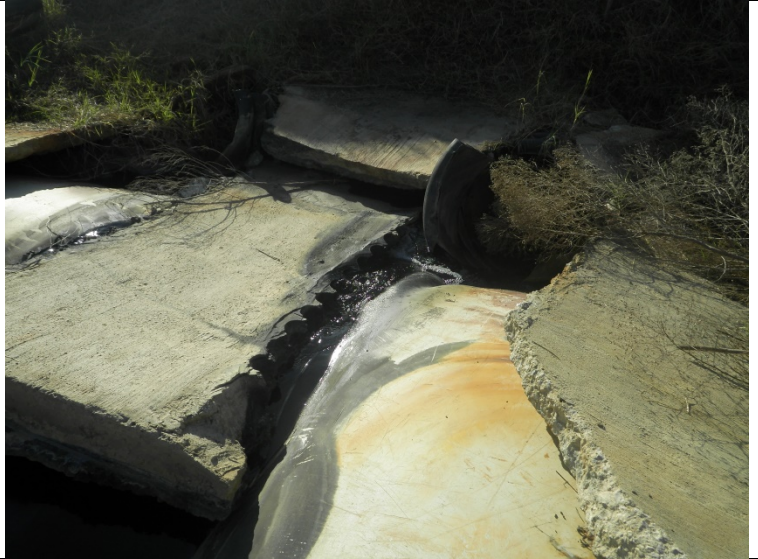
PHOTO #10

15. Concrete slope protection installed on the inlet side of two, 36-inch-diameter culverts, which discharge leachate and contact water into the Landfill Runoff Pond was observed to be broken and distressed. The geomembrane landfill liner extends underneath the entire length of the culverts and does not appear to be damaged. An access road is present over the top of the culverts. According to plant personnel, this will be repaired as part of the 2021 cap and cover project.

View of the broken concrete near the inlet of the dual 36" culverts that drain into the Landfill Runoff Pond

- 1) Remove the broken and distressed concrete slab slope protection at the inlet of the two, 36-inch-diameter culverts. After removing the concrete slab, inspect this area for any damages. After inspection, replace the inlet of the culverts.
- 2) Drain the ground water pipes at the south end of the landfill into the Landfill Runoff Pond.
- 3) The hog rutting damage on the north slope of the 2005 Cell should be repaired. Any bare areas should be re-seeded. The ponded water in the north perimeter ditch should be pumped around the landfill with the recently installed pump.

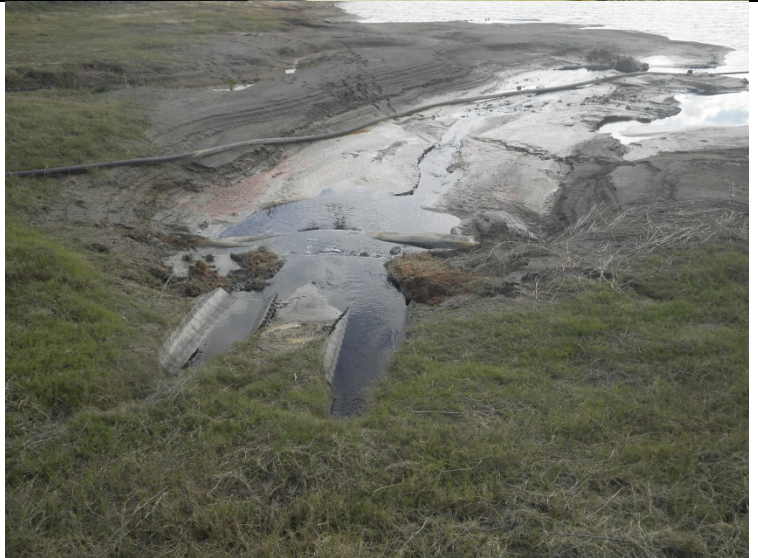
PHOTO #11

View of the downstream end of the dual 36" culverts that drain into the Landfill Runoff Pond

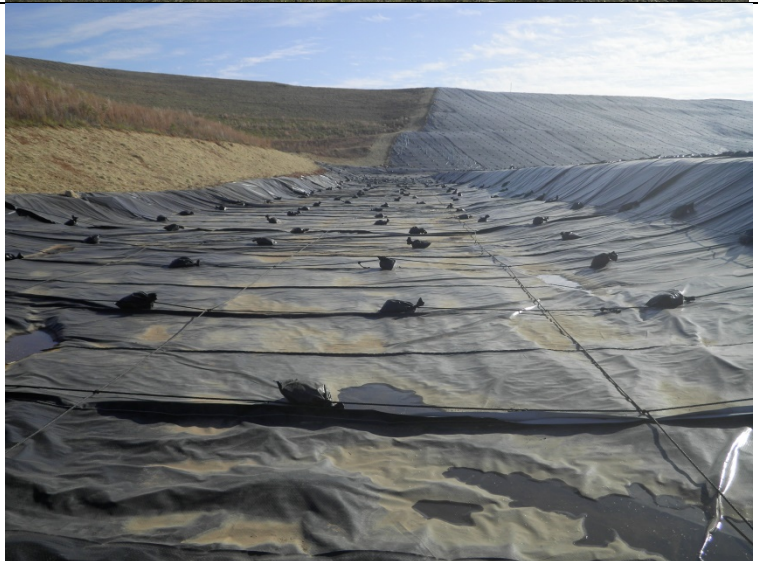
PHOTO #12

6. A temporary soil cover consisting of a red sandy-clay material has been placed for an erosion protection measure on the south slope. The vegetation on this area was in good condition. In addition to the soils cover, the lower adjacent area has been recently covered with a geo-membrane rain flap material for erosion protection. All disturbed soil areas were re-seeded and hay mulched as part of this installation.

View of the recently installed rain flap below the southern slopes

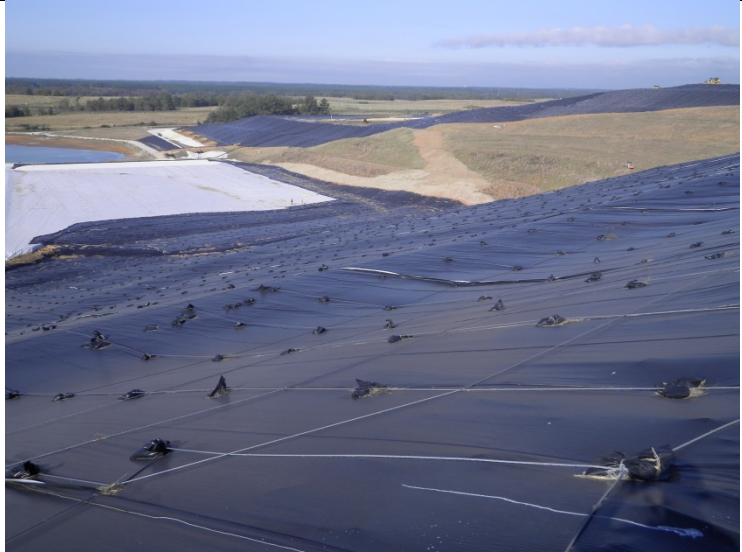
PHOTO #13

View of the rain flap in the 1993 and 2012 Cells, alongside the 2018 Cell

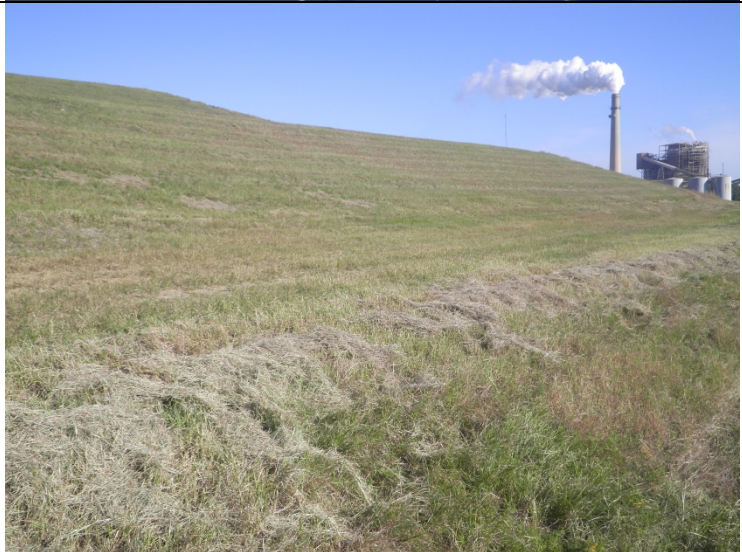
PHOTO #14

View of the eastern slopes

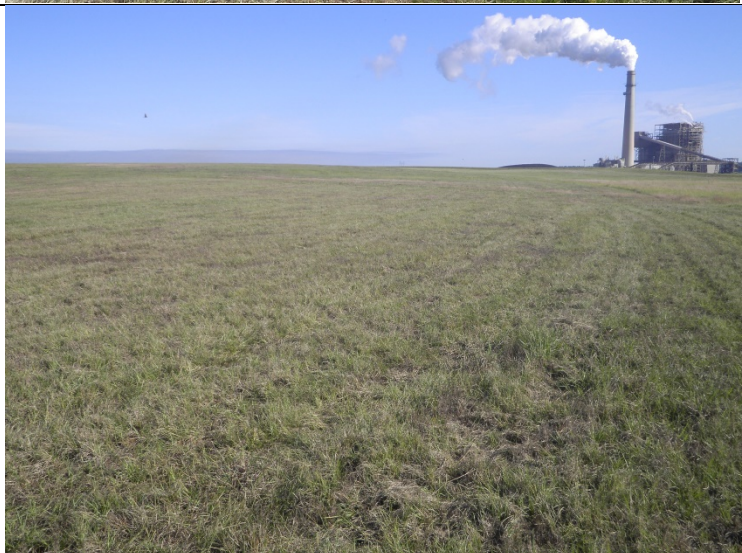
PHOTO #15

View of the southern top of the landfill
(typical condition)

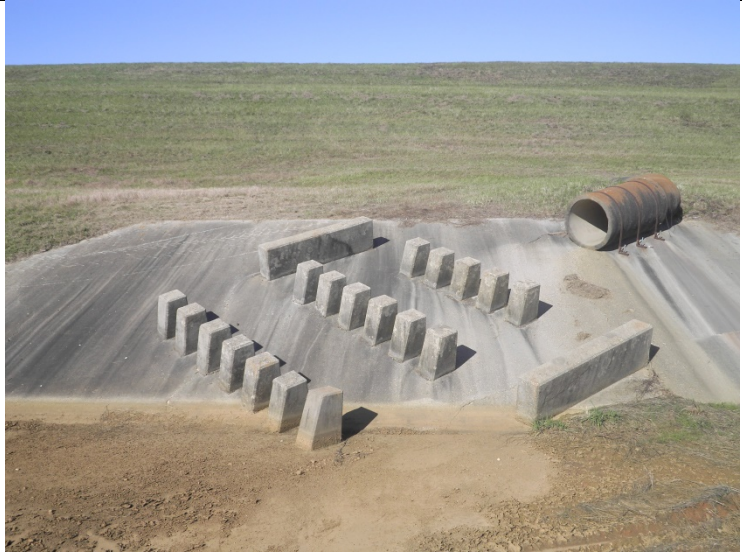
PHOTO #16

View of the energy dissipater of the letdown in the northeast corner with maintained vegetation

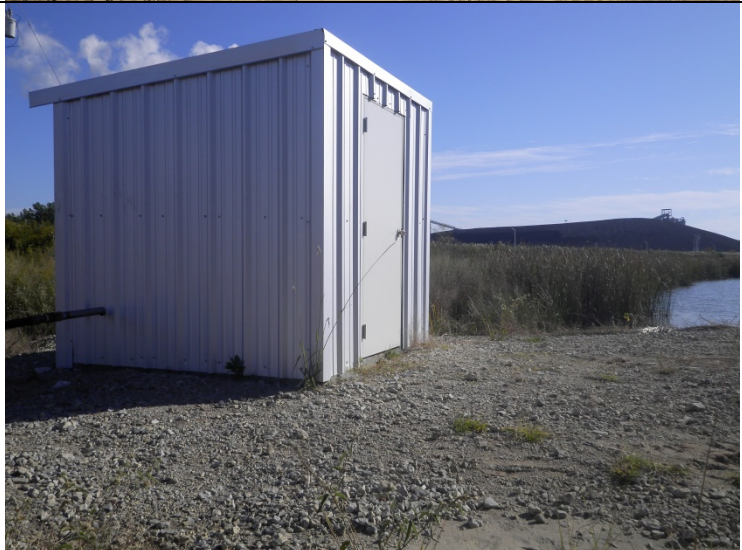
PHOTO #17

View of the recently installed pump house to pump water from the north side of the landfill around the landfill

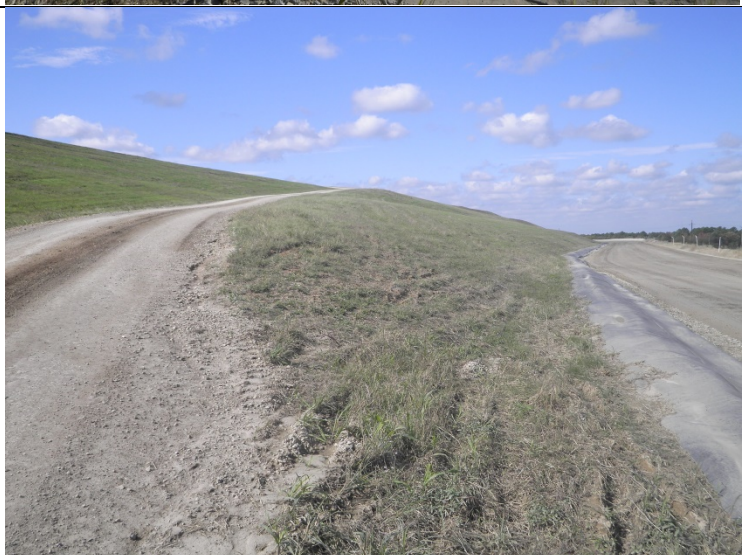
PHOTO #18

View of the north slope and access road

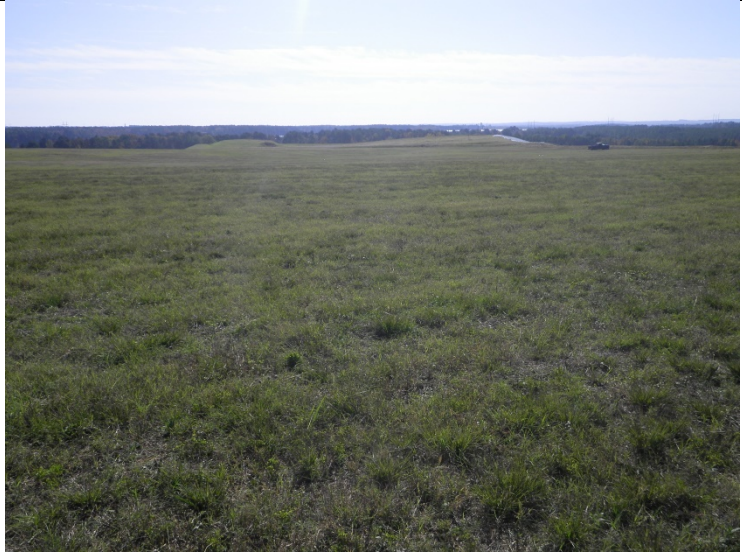
PHOTO #19

7. The western-most top portion of the 2012 Cell area was covered with 18-inches of topsoil to complete the 2018 cap system at the end of 2019, and the vegetation is in good condition. As noted previously, a second area to the west was also capped and covered with ClosureTurf at the end of 2019.

View of the 2018 cap and cover area with topsoil and vegetation in good condition

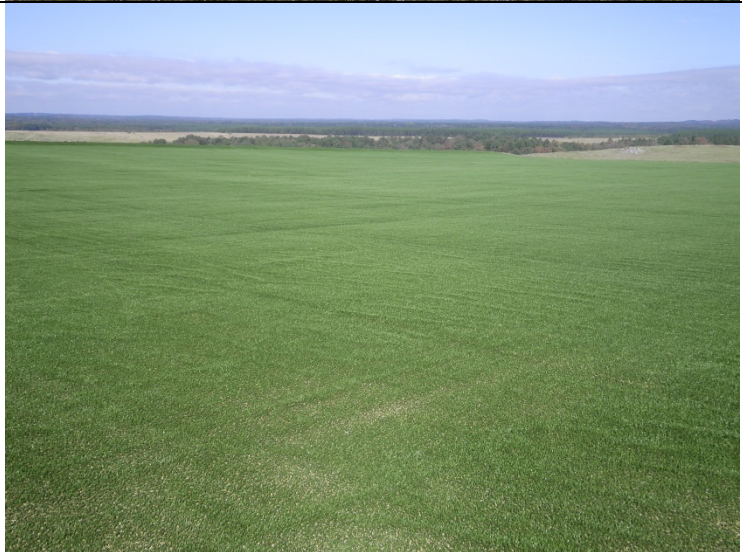
PHOTO #20

View of the top of the 2019 cap and cover area with ClosureTurf

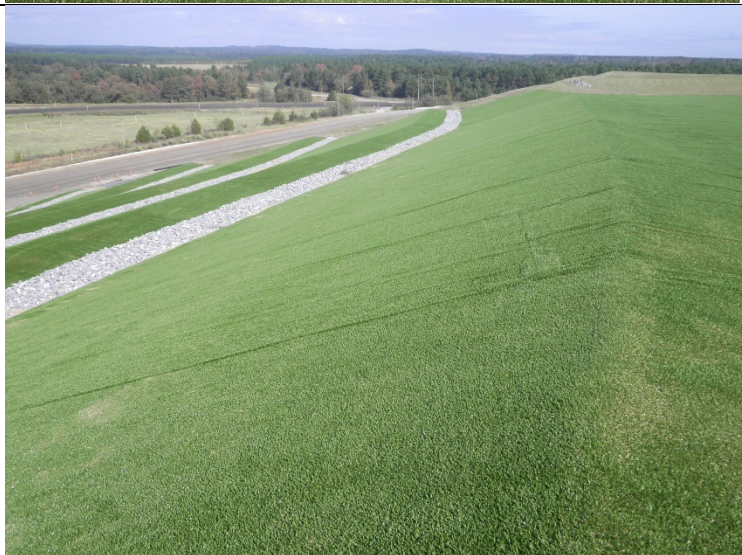
PHOTO #21

View of the slopes of the 2019 cap and cover area with ClosureTurf

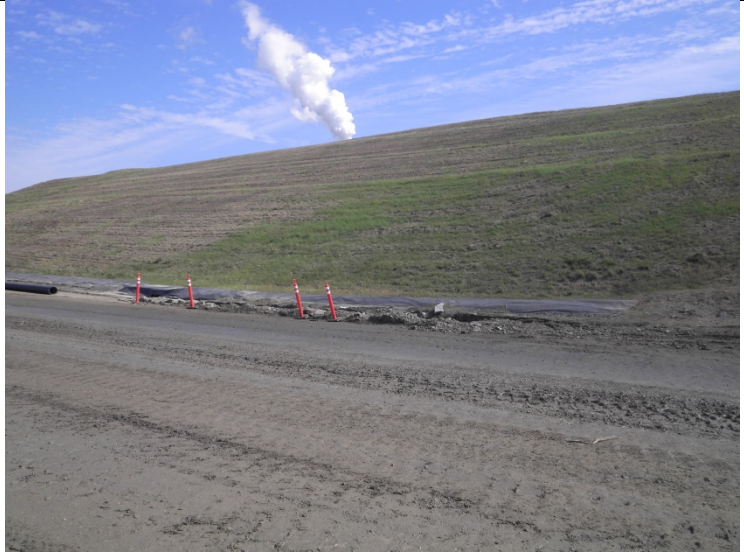
PHOTO #22

View of west slopes

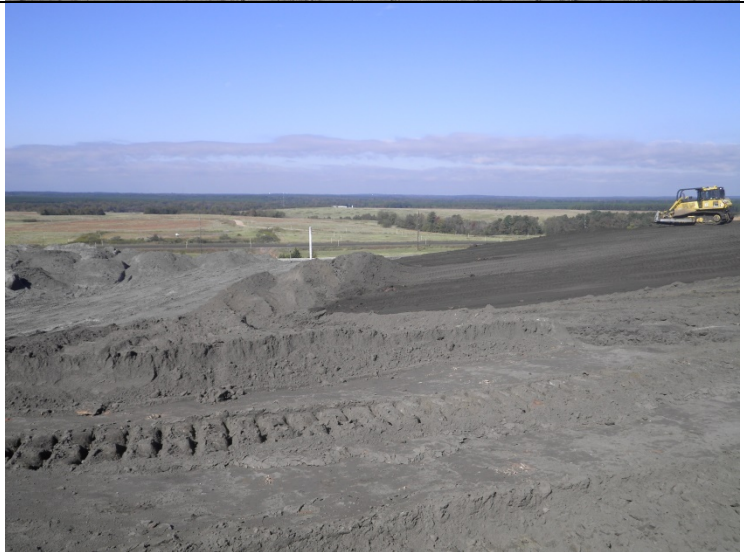
PHOTO #23

10. During the inspection, the lower portion of the active area was being re-graded so that a geo-membrane rain flap could be installed. The chimney drains were functioning as designed and there was no evidence of pooling water around the drains. In general, the chimney drain consists of bottom ash placed by filling in a 10-foot-diameter circle with a perforated drainpipe wrapped in filter fabric placed in the center that is connected to the leachate discharge pipes.
11. The CCR materials are being placed and graded in such a manner that any runoff from the active landfill area is collected, contained and drained through the chimney drain system.
12. The lower slopes of the 2015 active cell have been covered with a 20-mil geomembrane rain flap material for erosion protection and to minimize contact water in the perimeter ditches. This will be replaced with ClosureTurf in the near future.

View of active area
