2020 DAM AND DIKE INSPECTION REPORT GEVR-20-014

WELSH POWER PLANT CCR ASH PONDS

CASON, TEXAS

INSPECTION DATE October 12, 2020

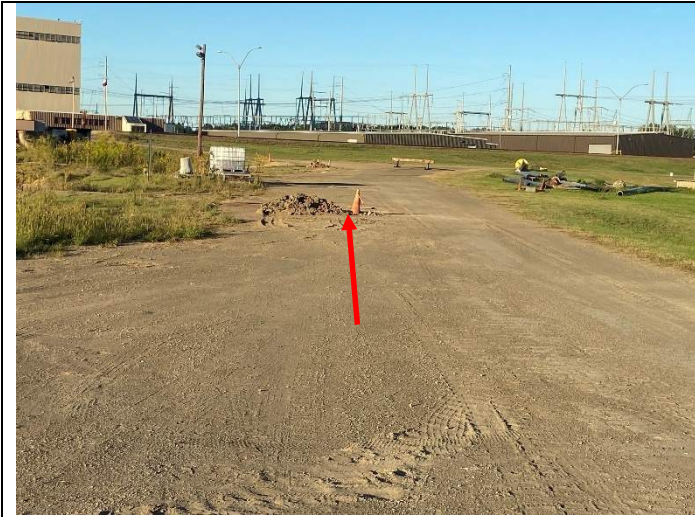
(i) (Photographs 1-4) The crest of the embankment appeared in good condition. The crest was level, and there were no obvious signs of settlement, cracking, or instabilities. The crest has effectively been widened and the upstream slope overbuilt through the placement of ash material over time. Delineation between the original crest and the overbuilt upstream slope is not readily apparent in the field. As a result of the overbuilt upstream slope, field observations are of the ash material and not of the original earthen embankment. Erosion gullies have formed at the upstream shoulder, however the gullies are not considered significant since they have developed in the overbuild material. Scrub vegetation has become established along the upstream shoulder of the overbuild. Geotechnical borings had recently been drilled in the crest in order to characterize embankment materials to support a slope stability study of future loading conditions when the pond will be excavated of ash material.

Photograph 1: View along crest, looking left. Arrow points to location of recent boring locations.

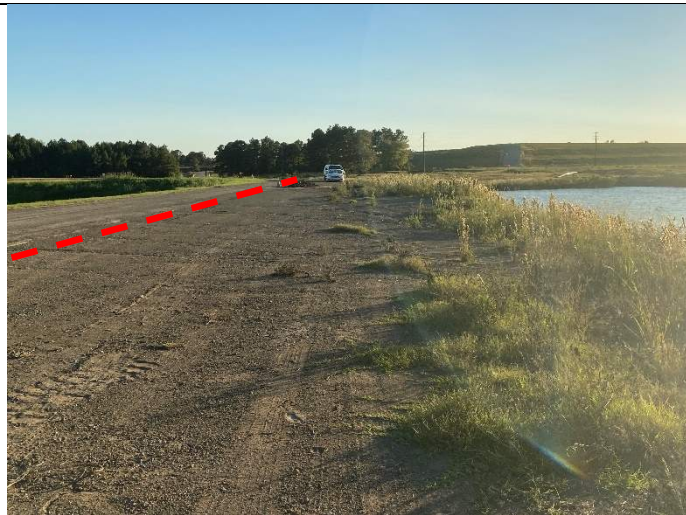
Photograph 2: View along upstream slope, looking right. Superimposed line approximates the original crest upstream shoulder, thus demonstrating the extent of overbuild which has occurred over the original upstream slope.

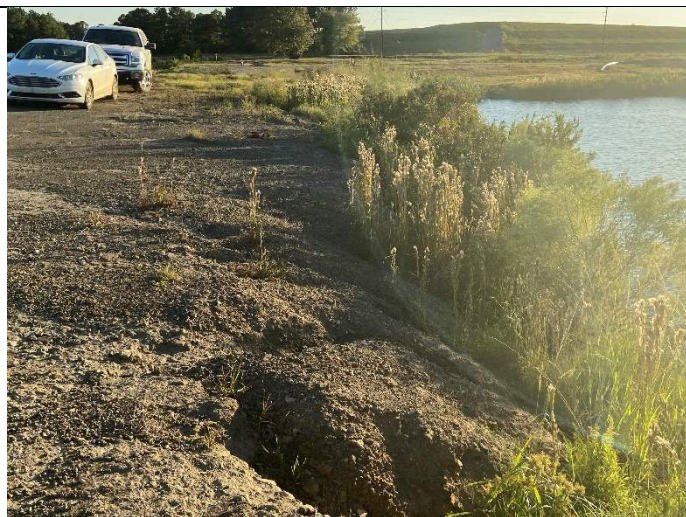
Photograph 3: Close-up view of upstream edge of upstream slope overbuild. Note erosion gullies. Since gullies have formed in the overbuild material, they are not considered problematic.

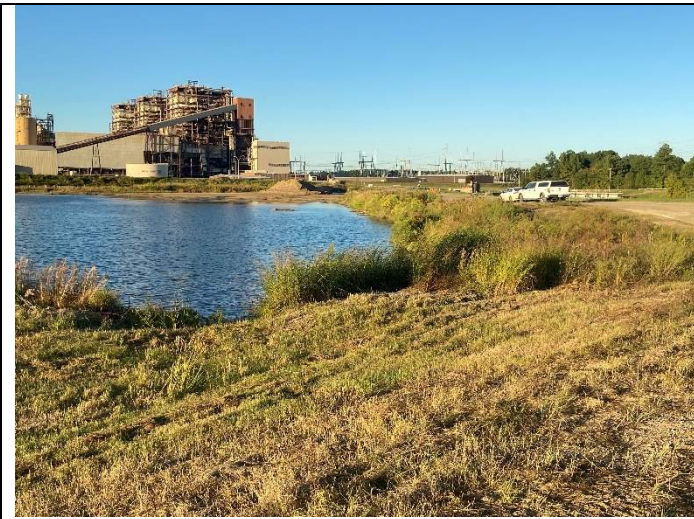
Photograph 4: Overview of upstream slope and crest, looking left, as seen from the right end of the dam.

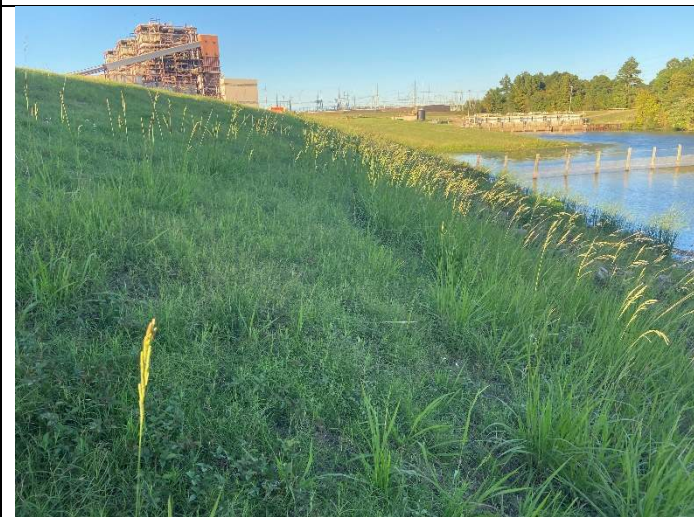
- (ii) (Photographs 5-7) The downstream slope appeared in fair condition. There were no signs of slides, sloughs, or other slope instabilities. No seepage areas were observed. Vegetation coverage was heavy, and with the dam not having been mowed within the past 1 to 2 months, the vegetation precluded a complete visual inspection. Multiple animal burrows were observed at mid slope, just above the rock riprap armoring along the water line (Photograph 7). In this same area, the slope appeared to flatten to create a small horizontal bench approximately 8 feet wide, just above the rock riprap. The groin between where the downstream slope adjoins the downstream slope of the Clearwater Pond's north embankment was heavily vegetated and could not be inspected for erosion.

Photograph 5: Typical view of downstream slope, looking left.

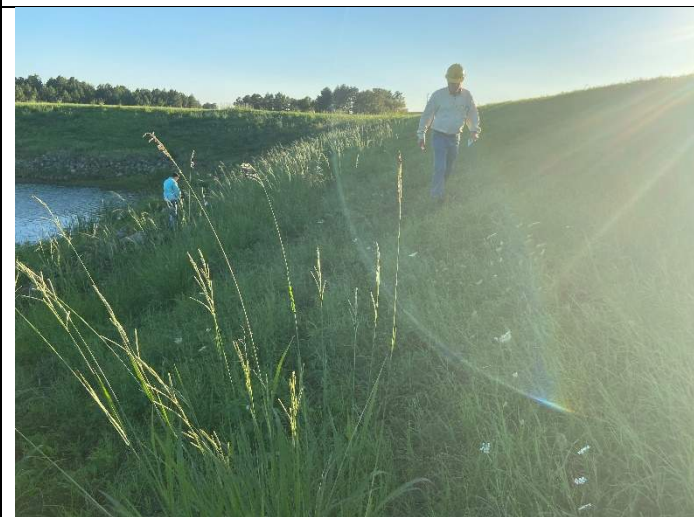
Photograph 6: Typical view of downstream slope, looking right.

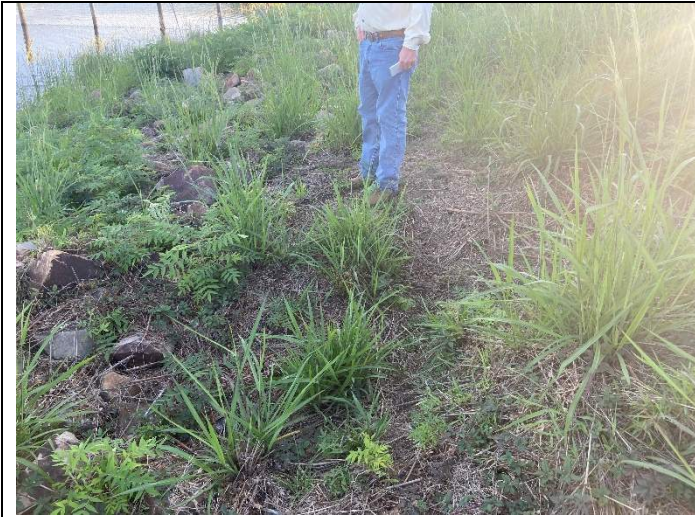
Photograph 7: Example of poor vegetation coverage on downstream slope, near the transition to the rock riprap slope protection. Multiple animal burrows were noted in this area.

1. Maintain vegetation on the downstream slope to a manageable height which allows inspection for irregularities and signs on distress.
2. Repair animal burrows by filling in with compatible material with proper compaction.
3. Construction of the secondary emergency spillway should be documented with as-built drawings. The stage-storage-discharge rating curve for the pond should be updated to reflect the changed hydraulic conditions.
4. The concrete weir inset in the primary emergency spillway channel should be repaired.

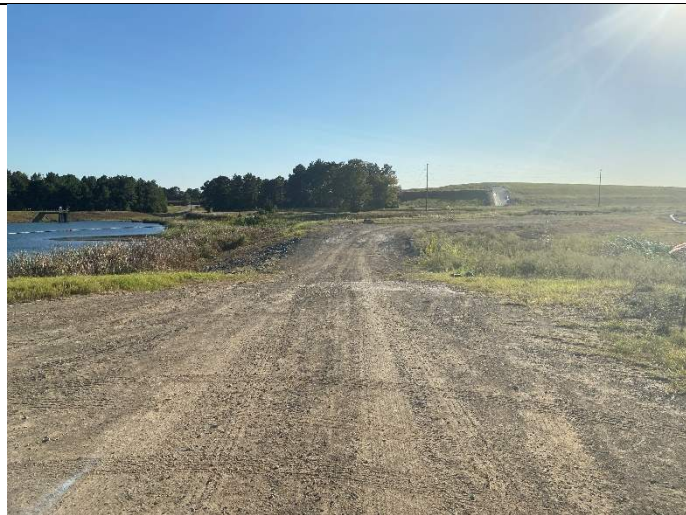
- (iv) (Photograph 8) The secondary emergency spillway has been constructed since the 2019 inspection. The secondary emergency spillway is effectively a lowered section of the embankment crest at the right end of the dam. The spillway bottom width is 30 feet with 10H:1V side slopes and a crest elevation 3 feet lower than the crest of the embankment.

Photograph 8: View along crest, looking right, towards the secondary emergency spillway which had been excavated in the crest/right abutment area. Flow direction is right to left. Clearwater Pond is at left.

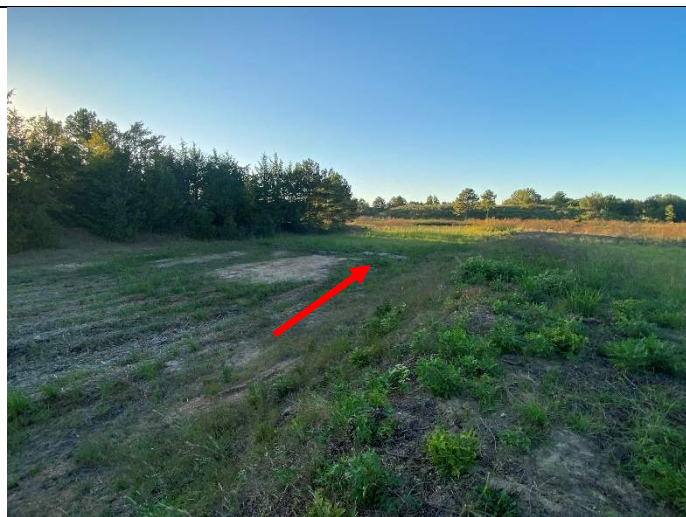
- (iii) (Photographs 9-12) The primary emergency spillway appeared in fair to poor overall condition. The earthen channel had been mowed and was unobstructed. Rutting was noted in the channel, likely from mowing operations. The concrete weir is in poor condition. The weir has partially failed in several areas, with undermining of the weir occurring on the upstream and downstream sides (Photograph 11). In some areas the weir has tilted downstream. A maintenance roadway crosses the downstream end of the spillway before it discharges into the discharge channel (Photograph 12). The roadway has a small culvert to convey local runoff.

Photograph 9: View of primary emergency spillway, looking upstream. Arrow points to overflow weir location. Note rutting at left side of photo.

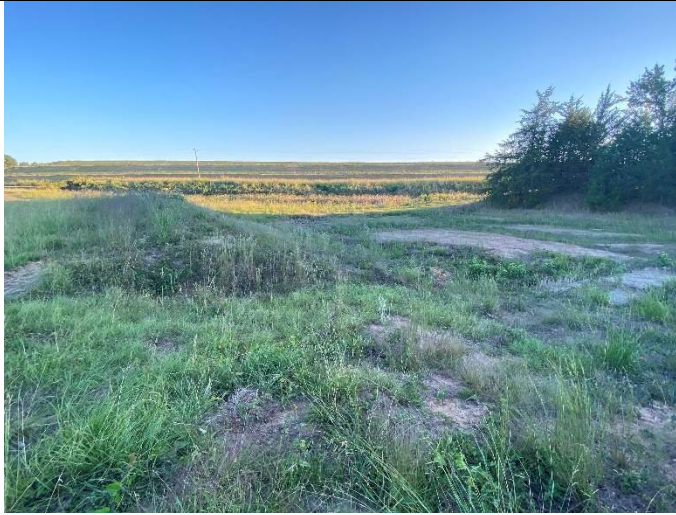
Photograph 10: View of primary emergency spillway, looking downstream, from near the overflow weir location.

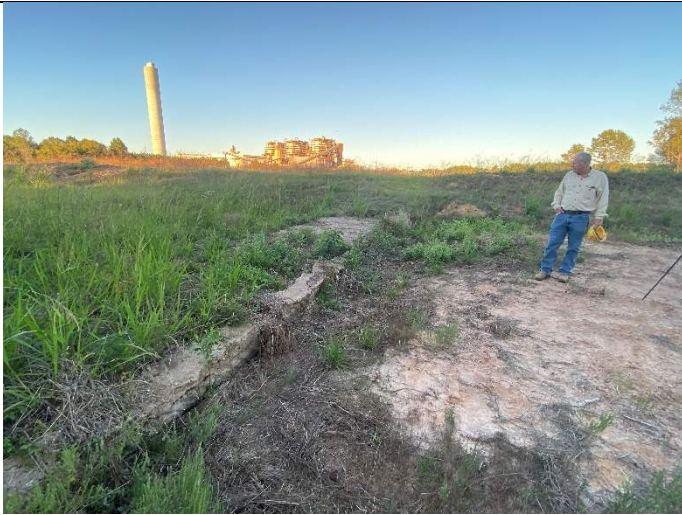
Photograph 11: Close-up view of primary emergency spillway overflow weir. Note undermining damage on upstream and downstream faces, and overall irregularity of the weir.

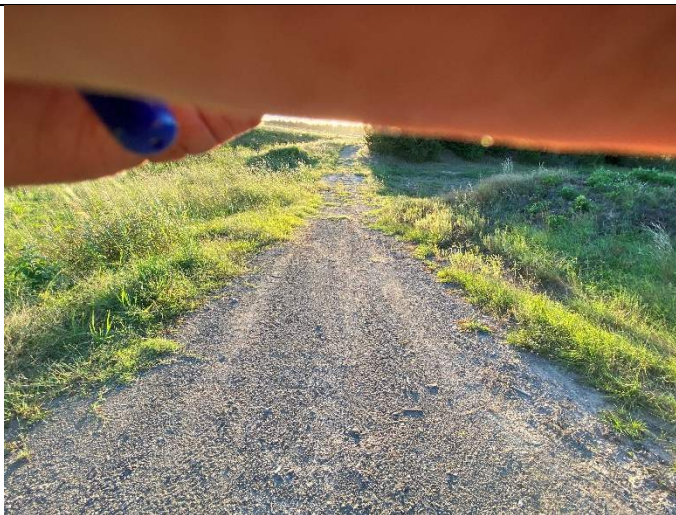
Photograph 12: View of roadway crossing at downstream end of primary emergency spillway.

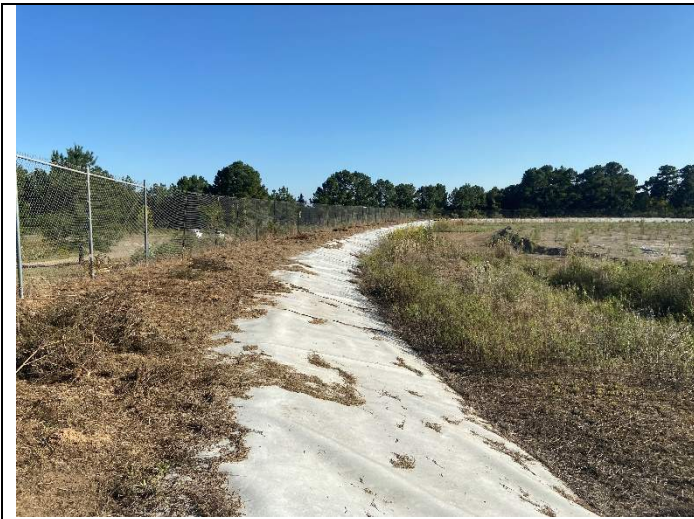
- (i) (Photographs 1-13) The crest of the embankment appeared in fair condition. The crest was level, and there were no obvious signs of settlement, cracking, or instabilities. The east embankment had been mowed, and therefore could be inspected. Multiple animal

Photograph 1: Typical view of upstream slope and crest along east embankment, looking south. Note the crest had been recently mowed in this section

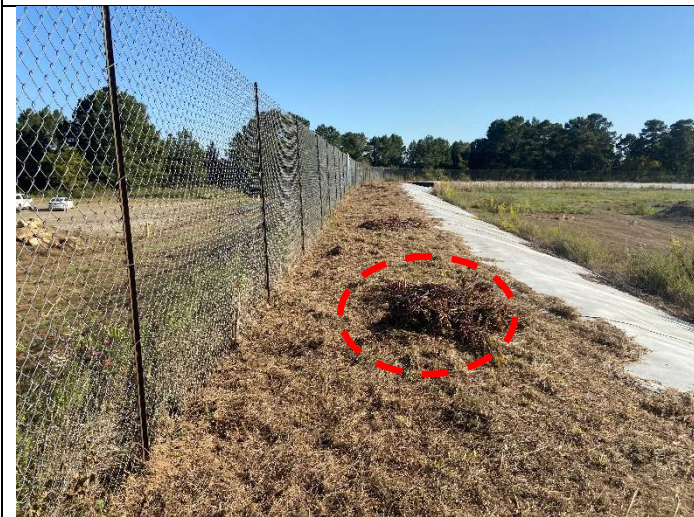
- There is no evidence of distress that would indicate the possibility of sliding, slope instability, settlement, misalignment or cracking of the Bottom Ash Storage Pond embankments. As such, it is concluded that the dikes are performing as designed.
- Vegetation management along the crest was poor. Vegetation management for the downstream slope and principal spillway outlet was satisfactory.
- Multiple animal burrows were noted throughout the crest of the east embankment.

Photograph 2: Example of animal burrowing activity on the crest. East embankment, looking south.

2. Establish proper grass vegetation on the west embankment downstream slope. Reseeding, topsoil, and removal of trees at the toe to prevent shading may be required.
3. Repair animal burrows by filling in with compatible material with proper compaction.

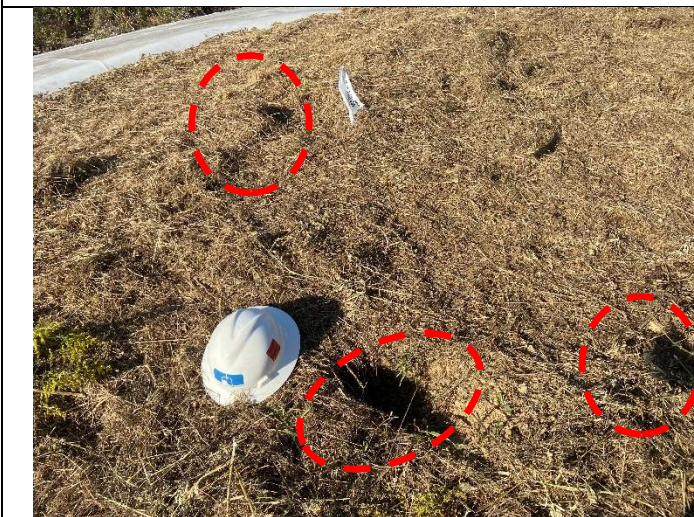
Photograph 3: Example of multiple animal burrows which were visible after the crest had been mowed.

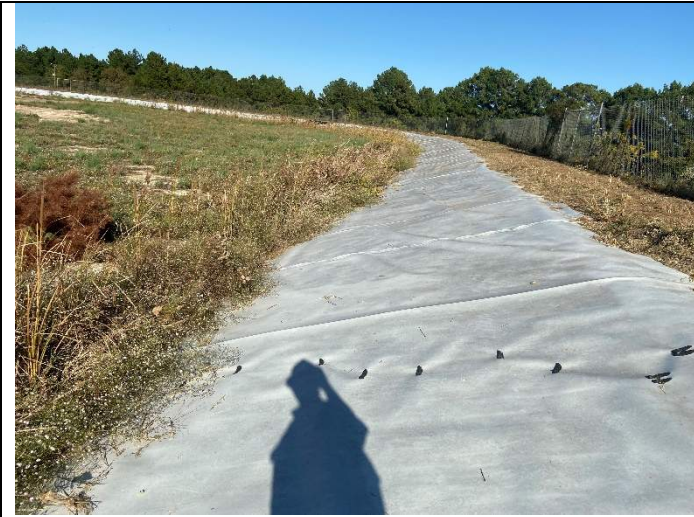
- (ii) (Photographs 1, 4, 5, 6, 8, 11, 13) The upstream slope was in good overall condition. There were no signs of slides, sloughs, or other slope instabilities. The upstream slope is mostly buttressed with ash material. The upstream slope is lined with a white geosynthetic liner throughout the pond. Several areas were noted where the liner had bubbled up, however these areas were stepped on to test the subgrade below and in all areas the subgrade was firm. No tears or separations at the liner joints were observed. Minor abrasion damage was noted on the later at the equipment access gate on the north side (Photograph 14). Woody vegetation is growing along the liner toe-in in multiple locations (Photograph 5). Ash management within the pond is good (Photograph 21).

Photograph 4: Typical view of upstream slope and geosynthetic liner. East embankment, looking east.

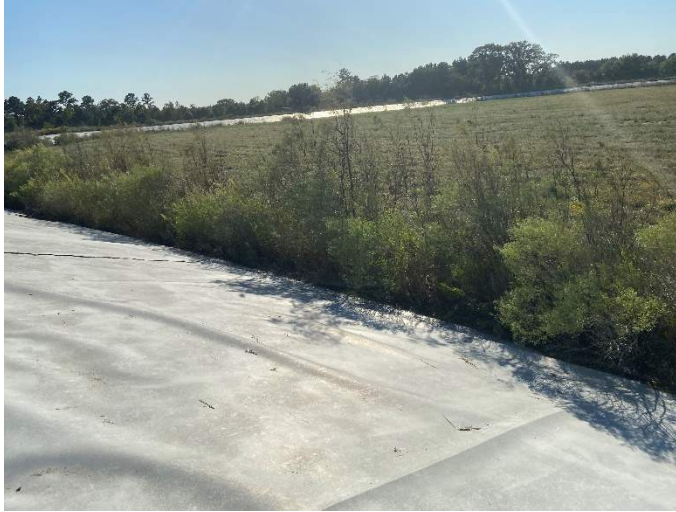
Photograph 5: Example woody vegetation growing at toe of geosynthetic liner toe-in on upstream slope.

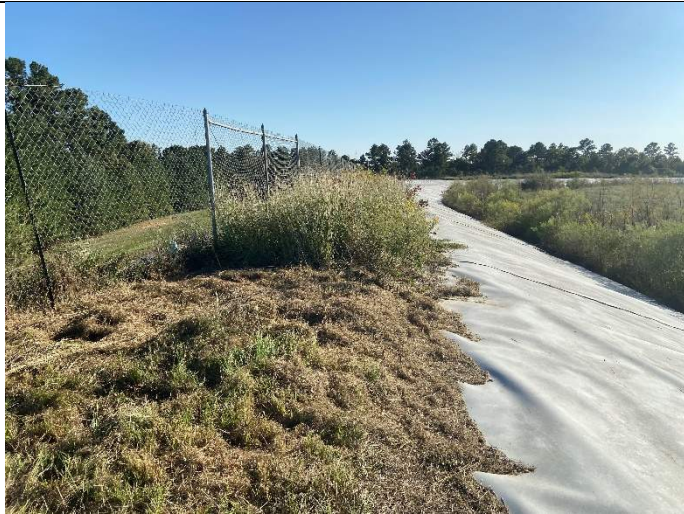
burrows were noted and flagged along the east embankment. The crest of the south, west, and north embankments was heavily overgrown with vegetation and had not been mowed, therefore these areas could not be inspected (Photographs 6, 11, 13). The crest fencing generally appeared straight, and was typically overgrown with vegetation. The distance between the fence and the geosynthetic liner is typically less than 10 feet, which may affect mowing operations.

Photograph 6: View of crest where mowing operation had stopped. Beyond this point, the crest of the embankment was overgrown with vegetation and could not be thoroughly inspected. East embankment, near transition to south embankment.

1. Maintain vegetation throughout the embankment to a manageable height which allows inspection for irregularities and signs on distress. If the crest fence prohibits adequate

equipment access adjacent to the geosynthetic liner, consider removal or relocating the fence off the embankment.

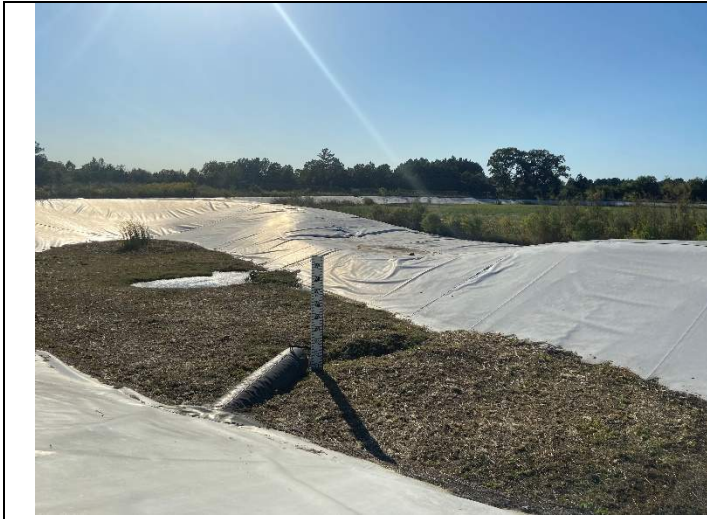
- (iv) (Photograph 7) The principal spillway appeared in good overall condition. The inlet basin was dry at the time of the inspection and the floor of the inlet basin was mowed, and the staff gage was visible. The inlet weir and geosynthetic liner appeared level.

Photograph 7: View of principal spillway outlet pipe and control weir at southeast corner of pond.

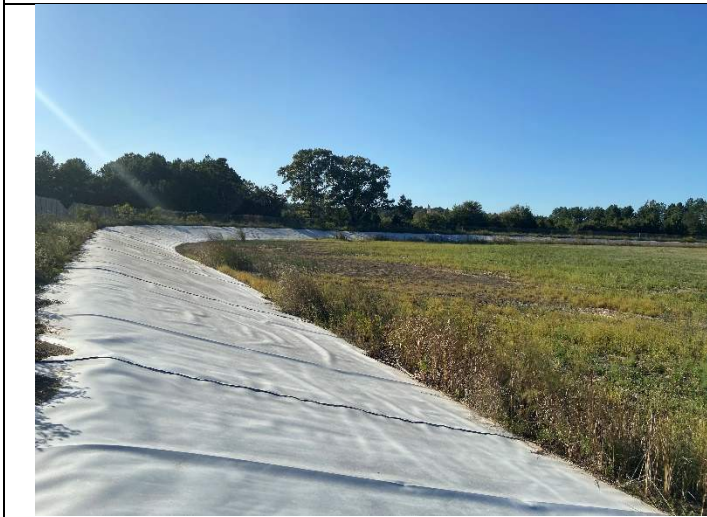
Photograph 8: View of upstream slope along south embankment, looking west.

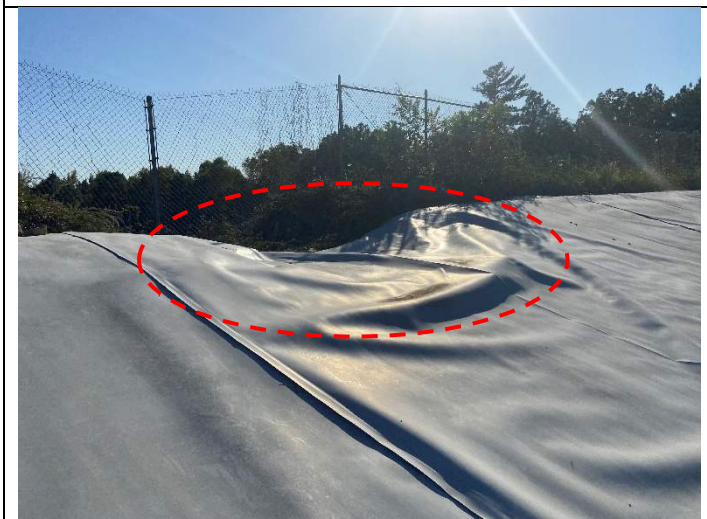
- (v) (Photograph 9-10) The emergency spillway appeared in good overall condition. The geosynthetic liner on the upstream slope and control weir was bubbled. The outlet channel was stable and lined with rock riprap. It was noted the crest fencing would partially obstruct the spillway if it were engaged.

Photograph 9: View of emergency spillway weir. Note bubbling of geosynthetic liner.

- Monitor the Bottom Ash Storage Pond geosynthetic liner for excessive bubbling, warping, tears, or joint separation. If any of these conditions develop, perform repairs immediately.

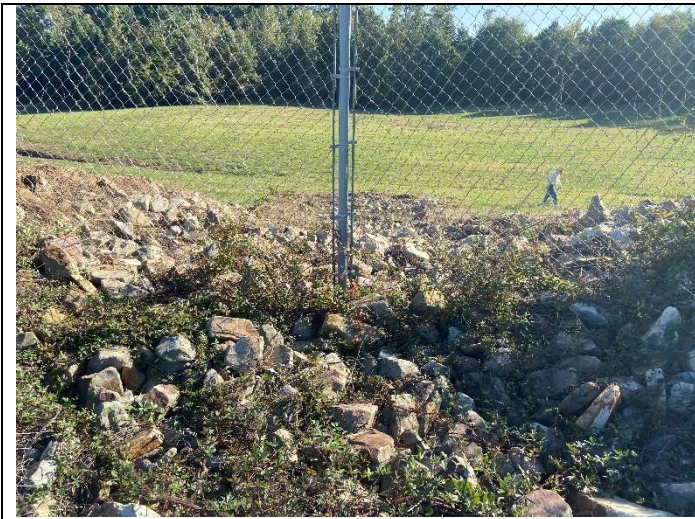
Photograph 10: View of emergency spillway outlet channel, looking downstream. Note crest fence partially blocks the spillway weir.

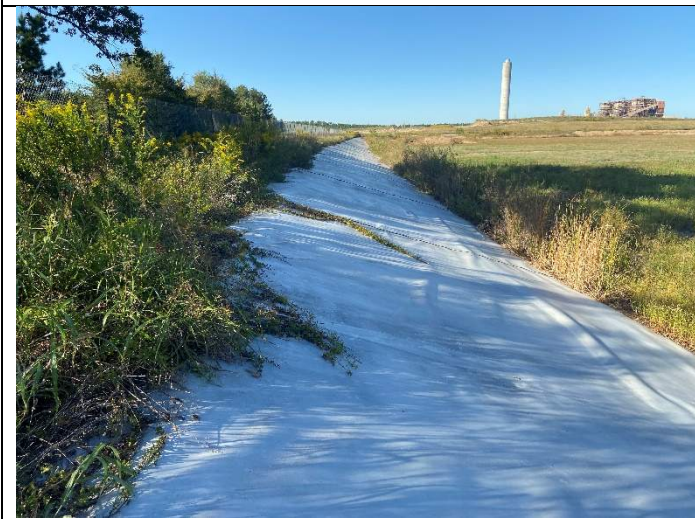
Photograph 11: Typical view of crest and upstream slope on west embankment. Note crest is overgrown with vegetation.

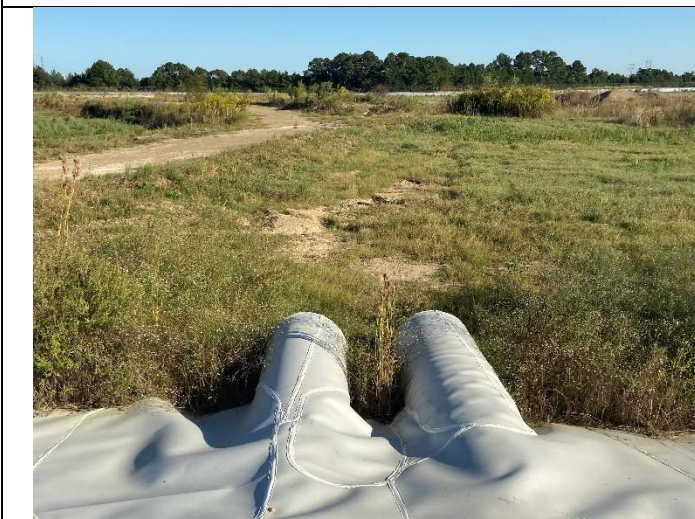
- (vi) (Photograph 12) Pipe culverts are located at the northwest corner of the pond, which are part of the landfill storm water control system and discharge into the pond. The culverts appeared clear of obstructions and in good and functional condition.

Photograph 12: View of stormwater inlet pipes entering northwest corner of pond.

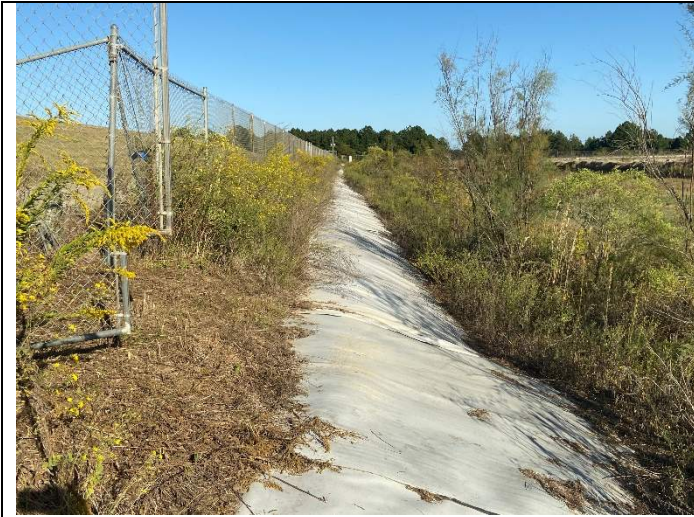
Photograph 13: Typical view of crest and upstream slope on north embankment. Note crest is overgrown with vegetation.

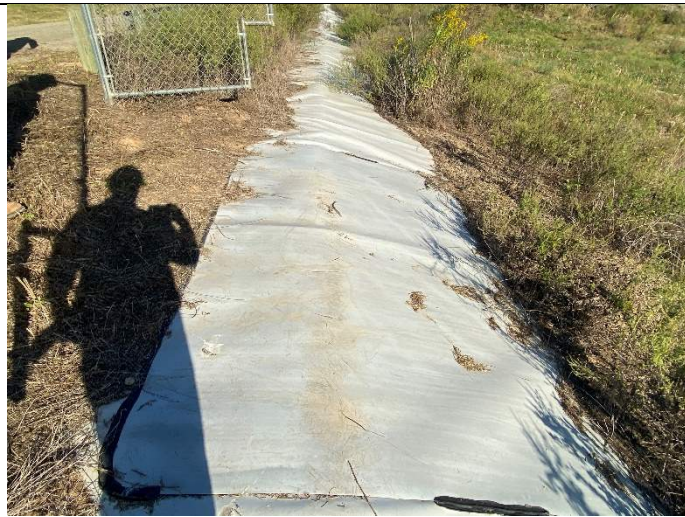
Photograph 14: View of minor abrasion damage of the geosynthetic liner where equipment enter pond through gate at left.

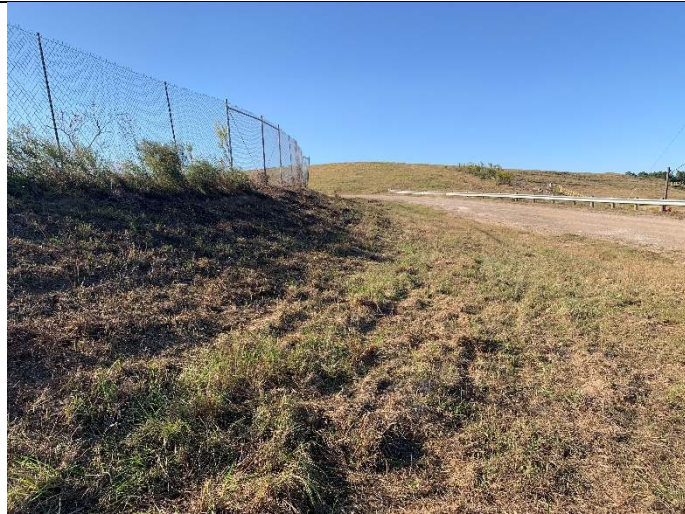
- (iii) (Photographs 15-20) The downstream slope was in good overall condition. There were no signs of slides, sloughs, or other slope instabilities. No seepage areas were observed. Vegetation coverage was fair to good, with the dam having been recently mowed. Vegetation coverage on the west embankment was fair to poor; this area of the embankment is shaded by trees and prevents good grass cover from establishing.

Photograph 15: Typical view of downstream slope of east embankment, looking north

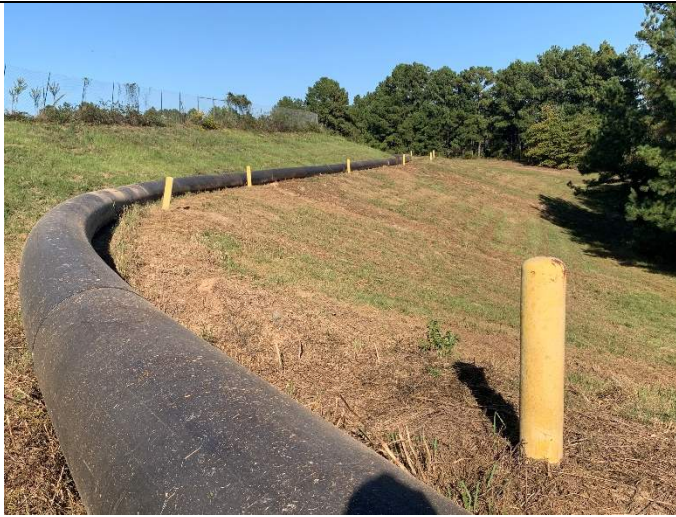
Photograph 16: Typical view of downstream slope and conveyance piping, along east embankment looking east. Note slope is well mowed.

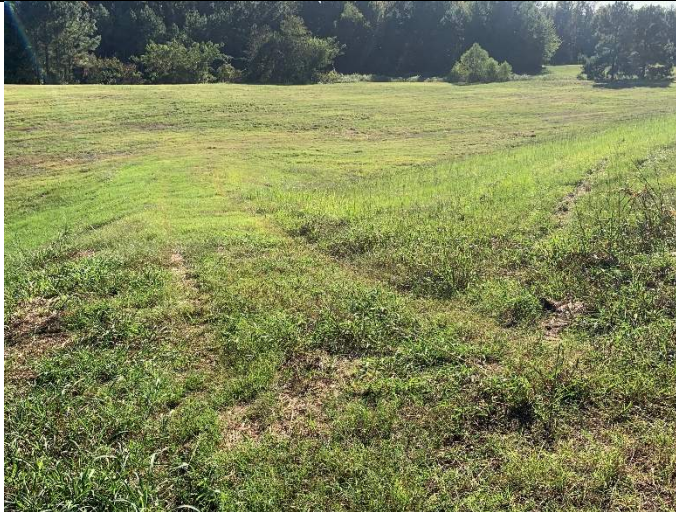
Photograph 17: View of access ramp leading up to crest at southwest corner of pond.

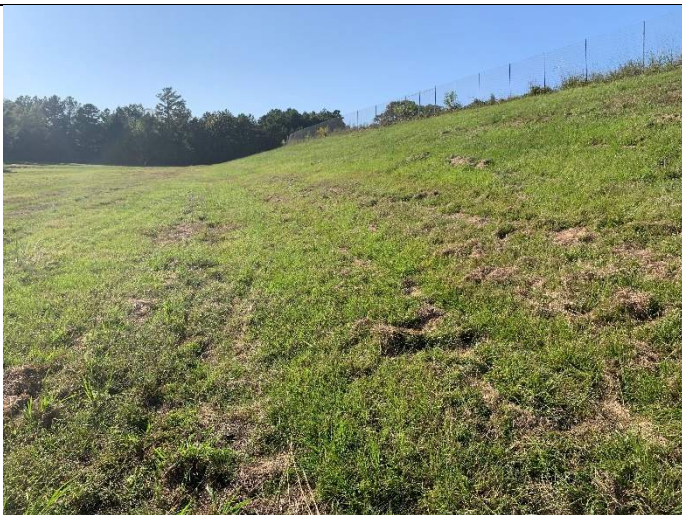
Photograph 18: Typical view of downstream slope of south embankment, looking west.

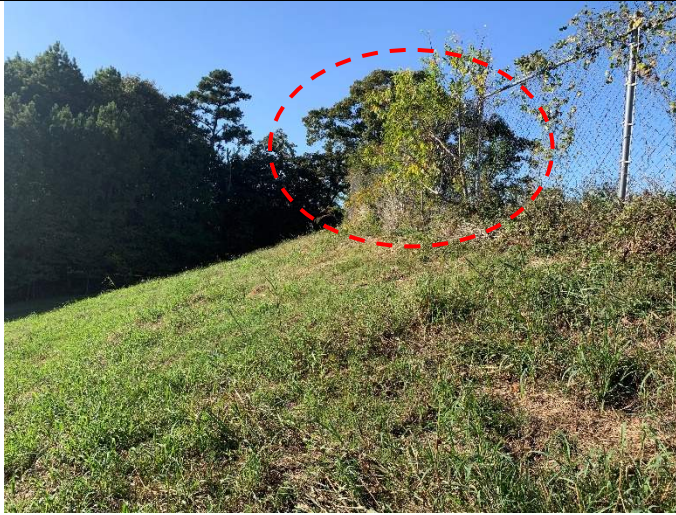
Photograph 19: View of vine vegetation growing in crest fence, as seen from downstream slope.

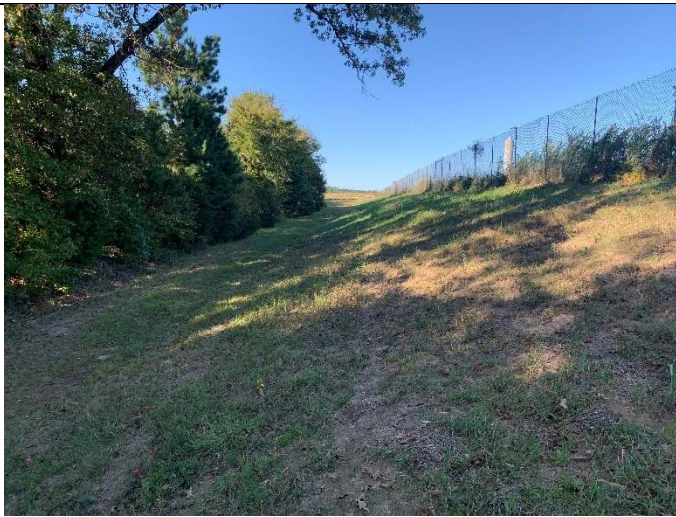
Photograph 20: Typical view of downstream slope of west embankment, looking north.

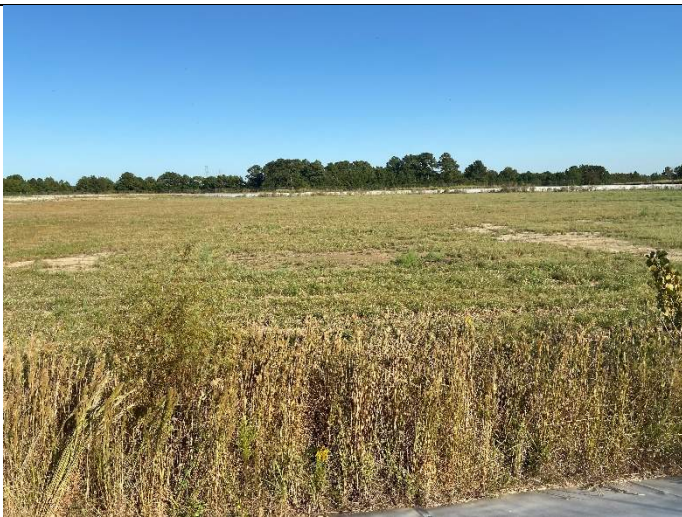
Photograph 21: View across pond, looking west from west embankment. Ash management operations appear good.

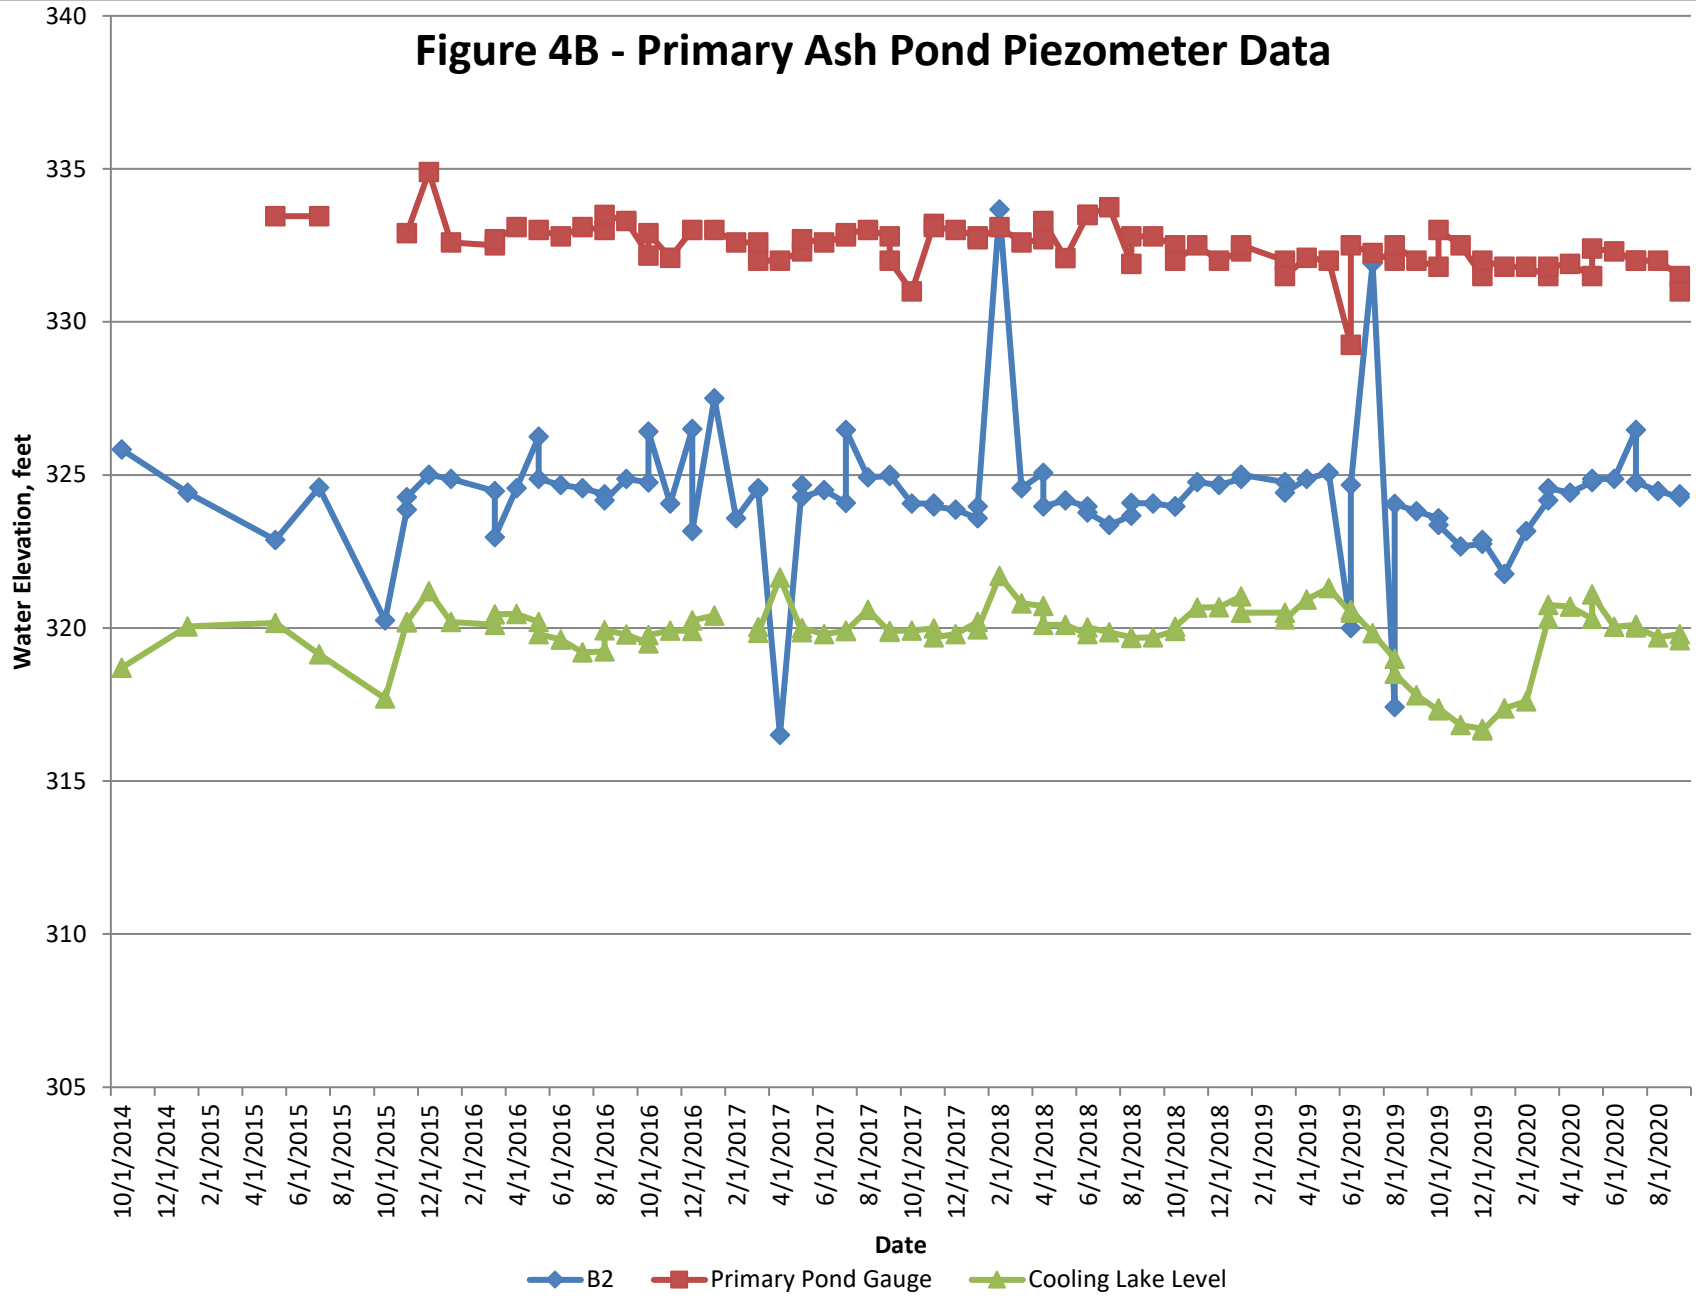
Figure 4B - Primary Ash Pond Piezometer Data

The monitoring instrumentation for the Primary Ash Pond consists of one (1) active piezometer (B-2) located through the main embankment area. There is no monitoring instrumentation for the Bottom Ash Storage Pond (Winston Pond). The location of the instrumentation is shown on Appendix D, Figure 4A. The maximum and minimum readings of Piezometer B-2 since the last annual inspection, a time period of September 2019 to September 2020, were 326.47 ft msl and 321.77 ft msl, respectively. Piezometer B-2 levels appeared consistent from month to month, and reacted to the fluctuation in tailwater levels (i.e. main lake). The results of the measurements of the piezometer is shown in Appendix D, Figure 4B.
