# 2023 Annual Landfill Inspection Report

**CCR Landfill**

**Flint Creek Plant  
Southwestern Electric Power Company  
Gentry, AR**

**Document ID: GERS-23-018**

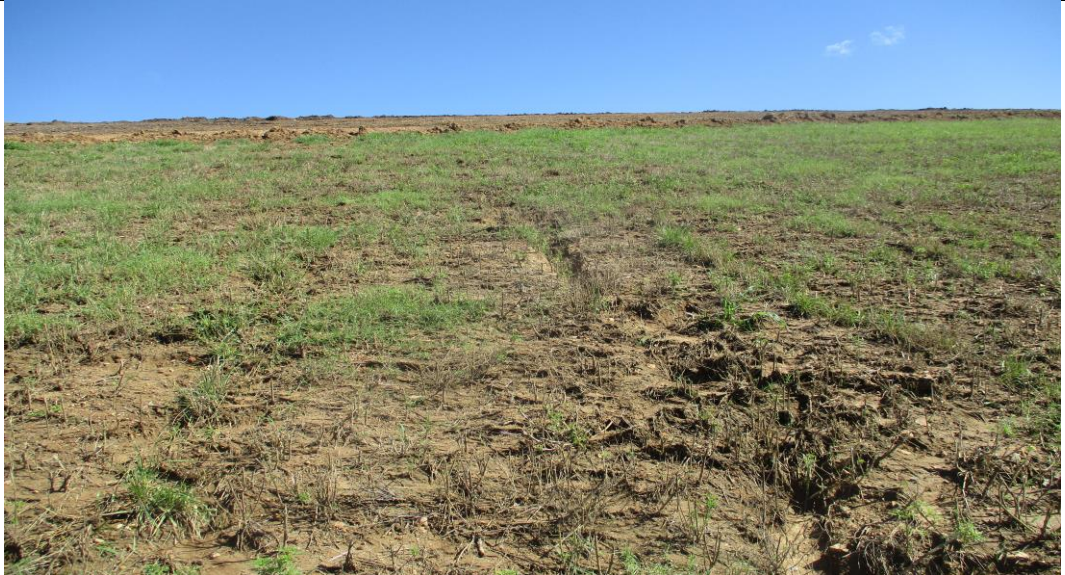
1. The lower west section of the south slope and the drainage ditch (Photograph Nos. 1 and 2) appeared in good and stable condition with controlled vegetation. The toe ditch appeared to have positive drainage without any signs of standing water. A significant size animal hole (Photograph No. 3) was encountered at the lower section and mid-way of the south slope.
2. Minor erosion gullies and surface erosion of the intermediate soil cover was noticed in the middle upper section of the south slope of the landfill (Photograph Nos. 4 and 5). Temporary runoff control measure was implemented midway in the southeast area of the

| <p>Photograph No. 4<br/>South slope erosion<br/>due to lack of<br/>vegetation.</p> | A wide, shallow erosion gully on a south slope. The soil is light brown and appears eroded. Sparse green grass and some dry, brown vegetation are scattered across the slope. The sky is clear blue. |

- 2) Minor erosion gullies at the south slope of the landfill should be repaired by backfilling and/or regrading. The erosion gully at the south side of the landfill should be backfilled and regraded.

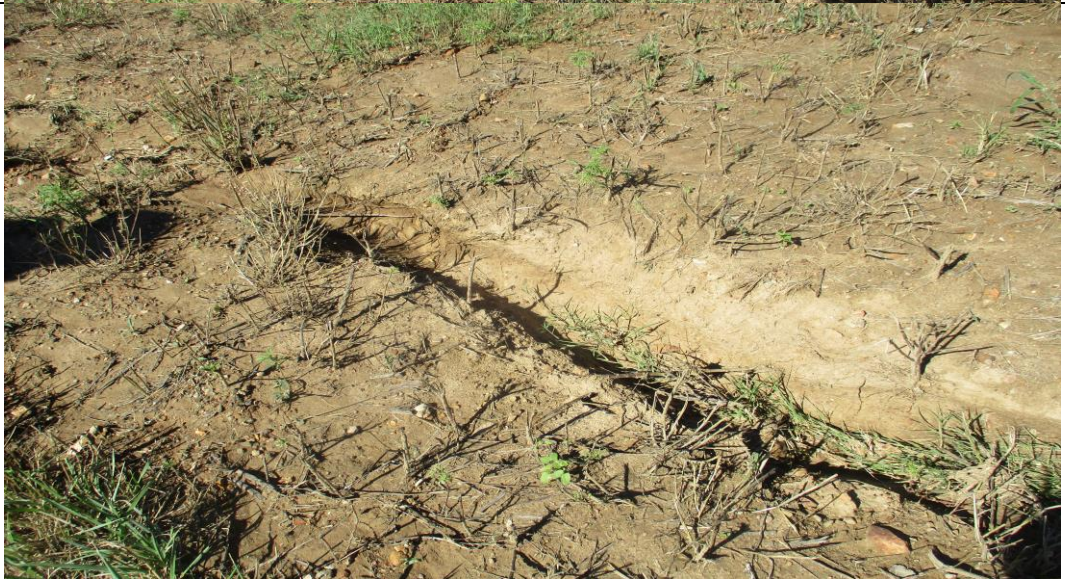
| <p>Photograph No. 5<br/>Erosion gully.</p> | A close-up view of an erosion gully. The soil is light brown and eroded. Several dry, brown roots are exposed and protrude from the soil surface. Some green grass is visible at the bottom of the gully. |

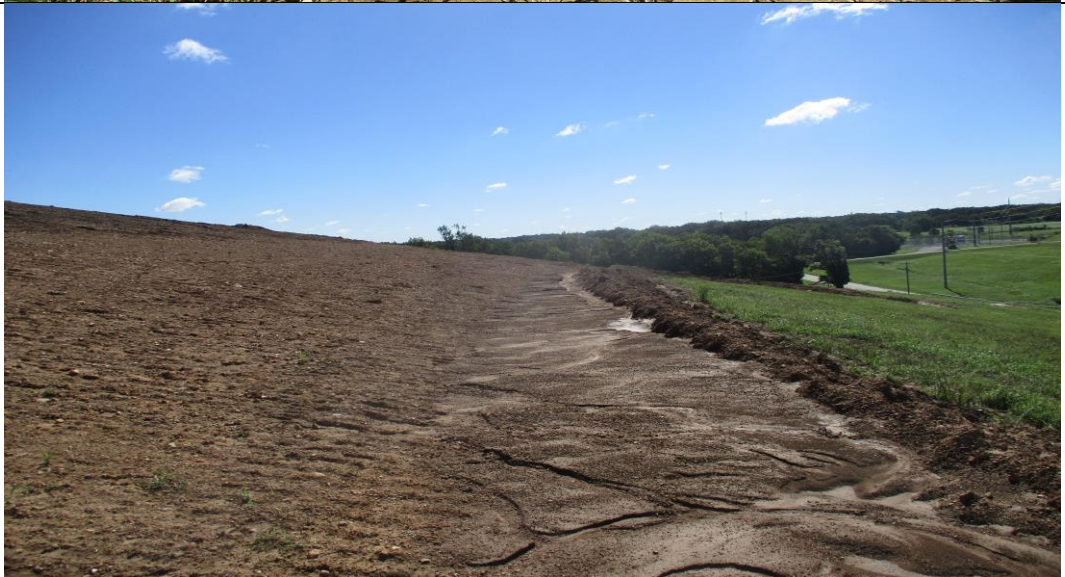
- slope. The Southeast slope intermediate cover was finalized and ready for seeding and mulching (Photograph No. 6) and the south area of the landfill had reached its maximum CCR placement limits and ready for final grading (Photograph No. 7 and 8).

| <p>Photograph No. 6<br/>Southeast area of the<br/>upper slope.</p> | A wide view of the southeast area of the upper slope. The slope is covered in light brown soil with visible erosion patterns, including a large, winding gully. In the background, there is a green field, a fence, and some trees under a blue sky with scattered white clouds. |

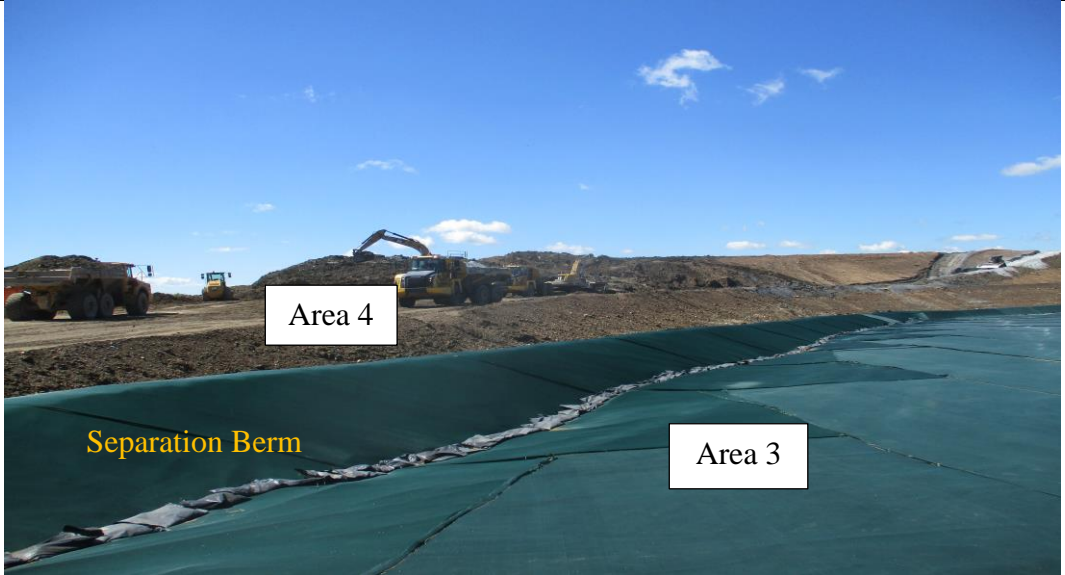
5. At present Area 3 is the only area inactive and protected by rainflap in order to avoid and contact water generation (Photograph No. 16). Area 1 and 2 are close to its disposal capacities except final grading. Area 4 is also getting close to its final capacity with limited space for disposal of CCR waste. There was no ponding of water in the active areas. The active areas (1 and 2) are separated from the inactive area (3) by a low splitter berm all within the waste limits. There was no erosion of the CCR material in the active area and the interim slopes were safe for the operational activities. Intermediate (temporary) soil cover is placed at the south and west slopes. Stormwater runoff from this area is directed into the contact water pond via the concrete lined ditches.

| <p>Photograph No. 16<br/>Area 3 and 4.</p> | <p>Area 4</p> <p>Separation Berm</p> <p>Area 3</p> |

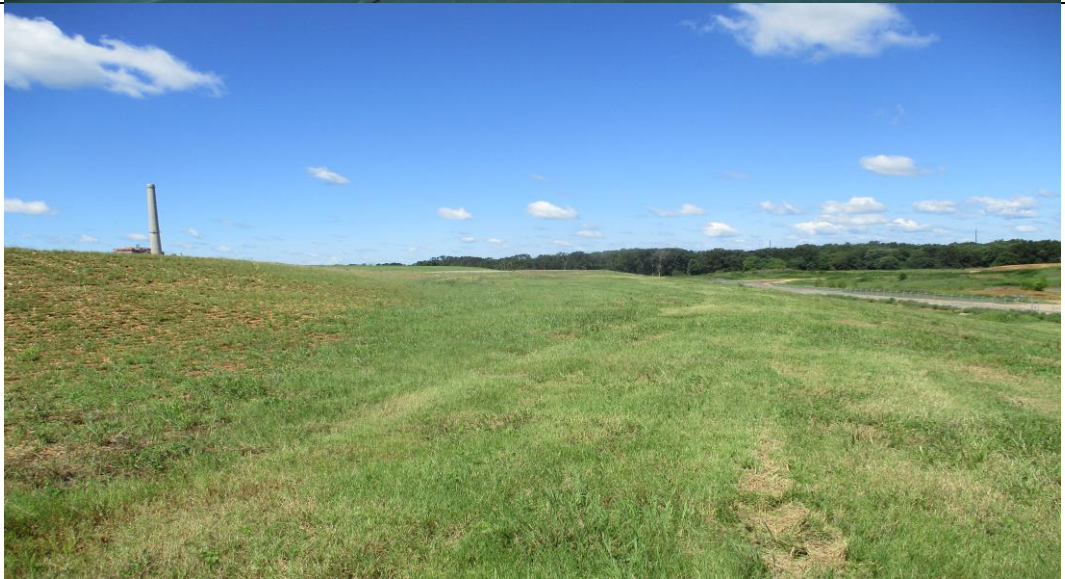
6. Typical condition of the north landfill slope that has final cover and certified is illustrated in Photograph No. 17. The condition of this slope was good. There were no observed erosion gullies, sloughs, or other signs of movement of these areas. All areas had adequate and good vegetative cover. The northeast corner of the landfill slopes is illustrated in Photograph Nos. 18 and 19. A fabriform drainage ditch and a pipe culvert is located at the northeast corner of the Landfill (Photograph No. 18). The fabriform was in good and stable condition. Pipe culvert was free of obstruction and no standing water

| <p>Photograph No. 17<br/>Overall view of the north slope with soil cover.</p> | |

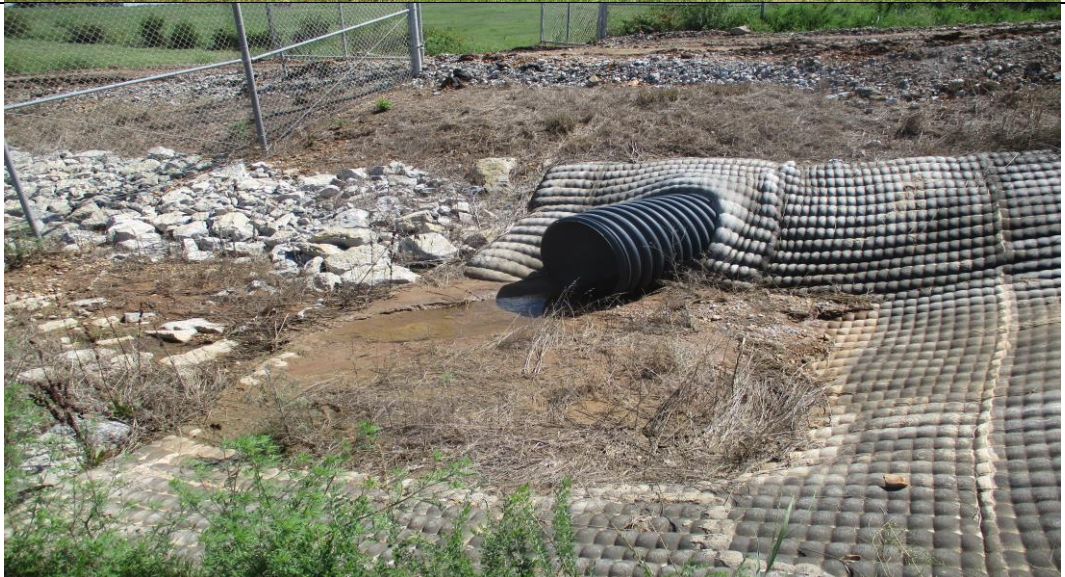
| <p>Photograph No. 18<br/>Drainage channel and pipe culvert located in the northeast corner.</p> | |

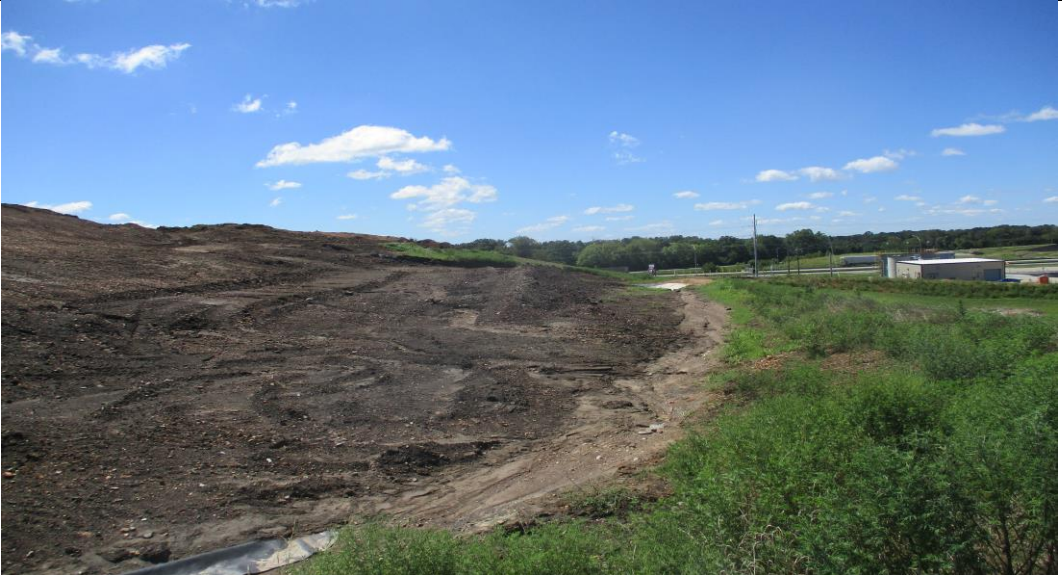
8. Typical condition of the west landfill slope adjacent to Area 2 that consists of CCR material without an intermediate cover (Photograph No. 22). The west perimeter berm adjacent to Area 2 and a separation berm between Areas 2 and 3 is illustrated in Photograph Nos. 22 and 23. In this area the CCR waste appeared to be stacked slightly higher than the CCR grades. The separation berm appeared to be in good condition.

- 3) The intermediate soil cover should be placed in the areas where the CCR waste has reached final grades.
- 4) The placement of CCR waste in Area 2 adjacent to the west perimeter berm was sloped towards the berm. The CCR waste should be graded to the required final grades and the contact water should be contained and routed to the contact water pond without any spillage over the berm.

| <p>Photograph No. 22<br/>Area 2 west side.</p> | |

- 3) CCR waste placement should be properly contained within the landfill areas and contact water should be conveyed via interior temporary ditches and/or piping system as designed.

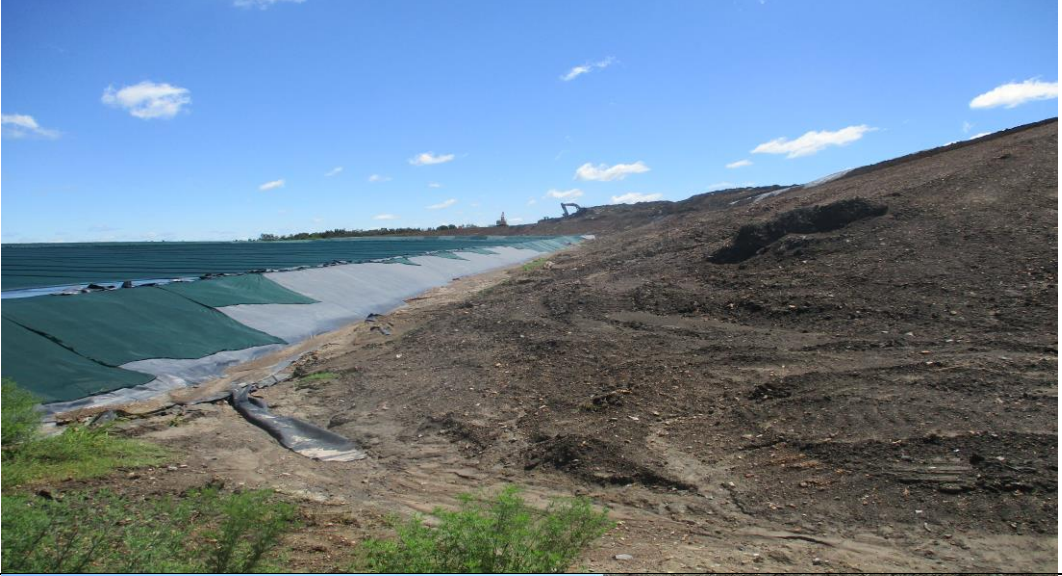
| <p>Photograph No. 23<br/>Area 2 north side.</p> | |

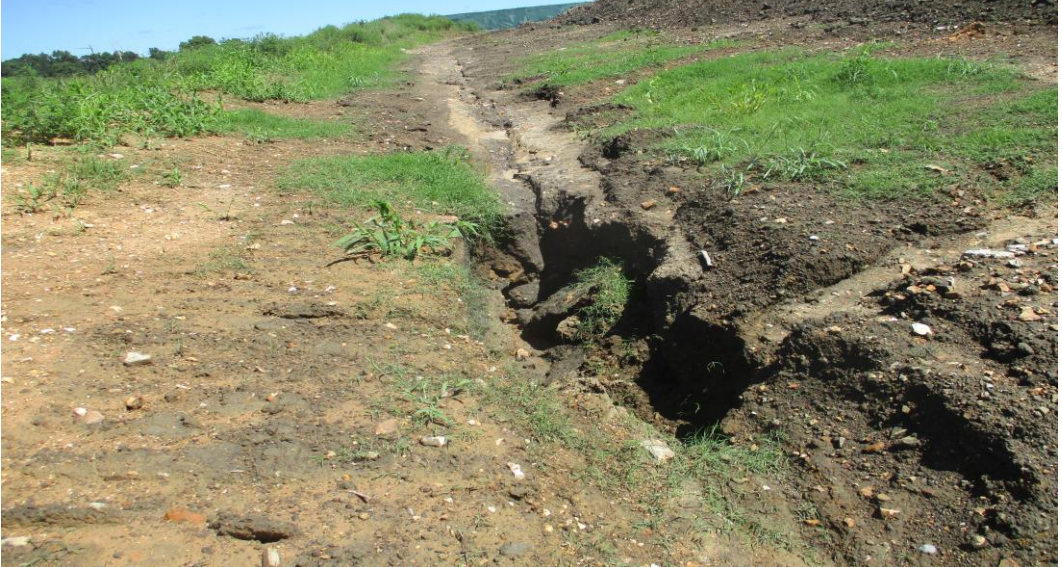
9. A significant erosion gully was encountered along the toe of the west slope, adjacent to Areas 1 and 2 (Photograph Nos. 24 and 25). It appeared that this area may be where runoff may be ponding creating a low spot.

- 5) A significant erosion gully was encountered to the west side along the toe of the slope in Area 2.
- 6) Excessive vegetation, trees, bushes, and minor erosion as noted in the report should be addressed as part of regular maintenance item.

| <p>Photograph No. 24<br/>Erosion gully (looking north).</p> | |
