2023 ANNUAL DAM AND DIKE INSPECTION REPORT

CCR - PRIMARY BOTTOM ASH POND

WELSH POWER PLANT
CASON, TEXAS

July 2023

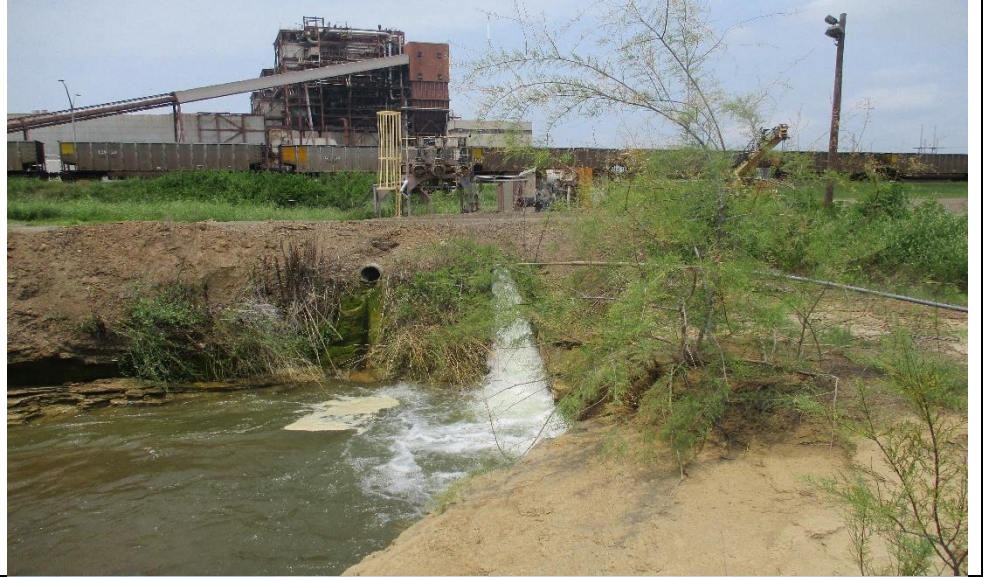
- (i) The two ash discharge pipes are located at the northeast corner of the pond. Other effluent from the plant is discharge at the north dike. All the sluice pipes and base support did not indicate any sign of misalignment, settlement, or deterioration. Overall, the discharge pipes appeared in good functional condition. Photograph No. 1 illustrate the northeast area of the pond where the sluice discharge pipes are located.

Ash sluice discharge pipes in the northeast corner of the pond.

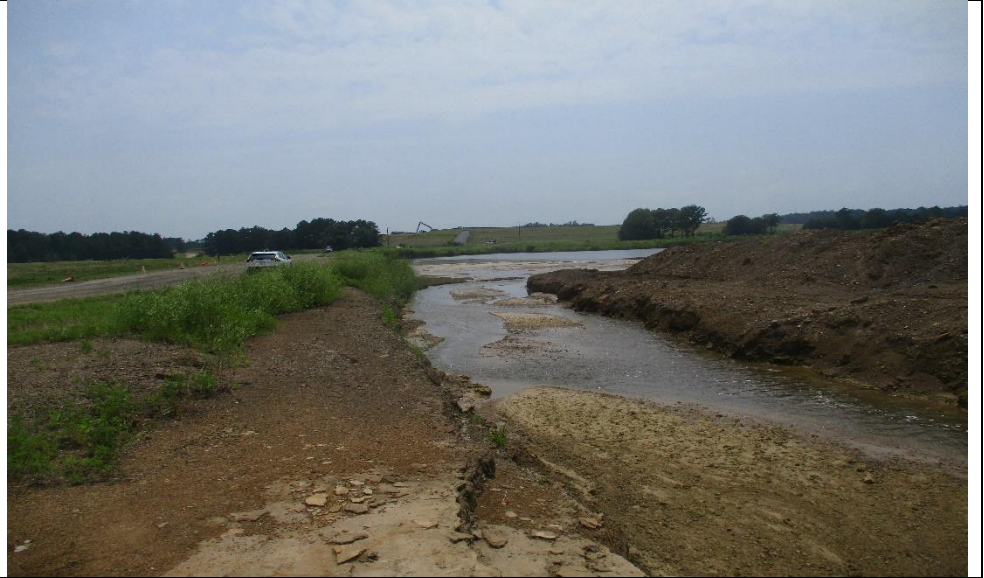
Photograph No. 2

- (ii) Typical condition of the upstream slope, crest, and downstream slope of the east dike is illustrated in Photographs No. 1-8. The dike appeared in satisfactory and stable condition. There were no signs of settlement, misalignment, sloughing or erosion. Slightly overgrown vegetation was noticed along the upstream slope and on the downstream slope at the riprap (Photograph No. 6).

Typical view of Primary Bottom Ash Pond upstream slope and downstream of discharge pipes.

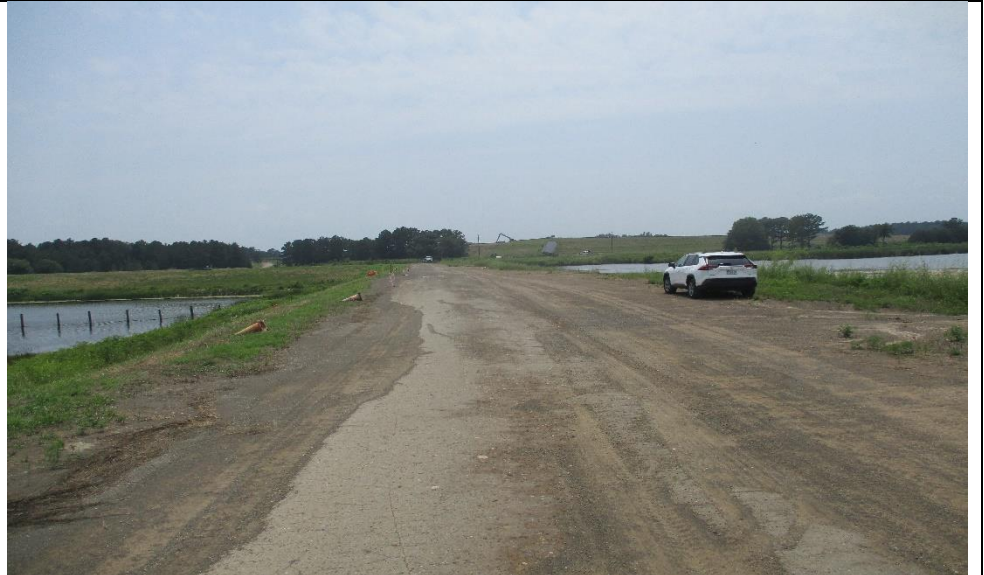
Photograph No. 3

Typical crest of the Primary Bottom Ash Pond.

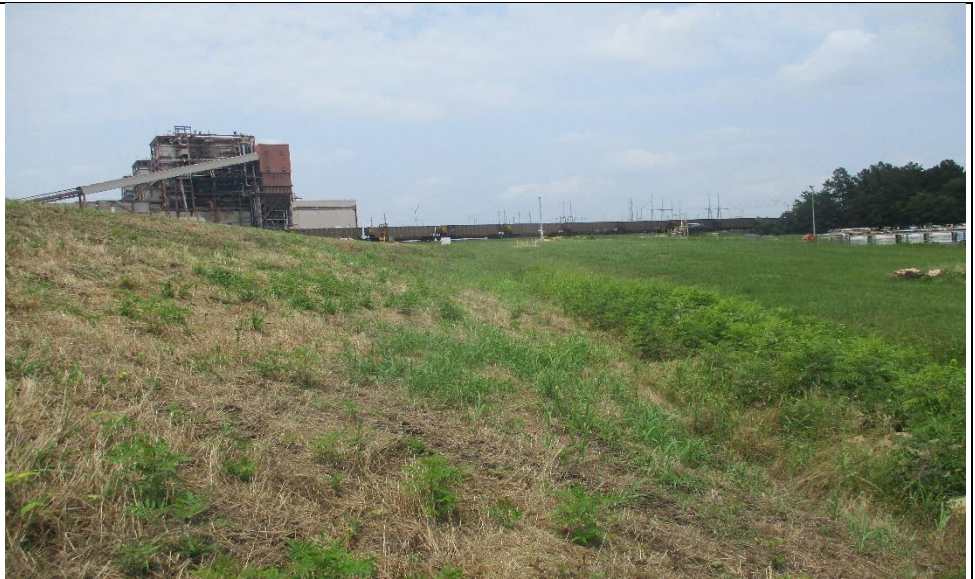
Photograph No. 4
Typical downstream slope
(looking north).

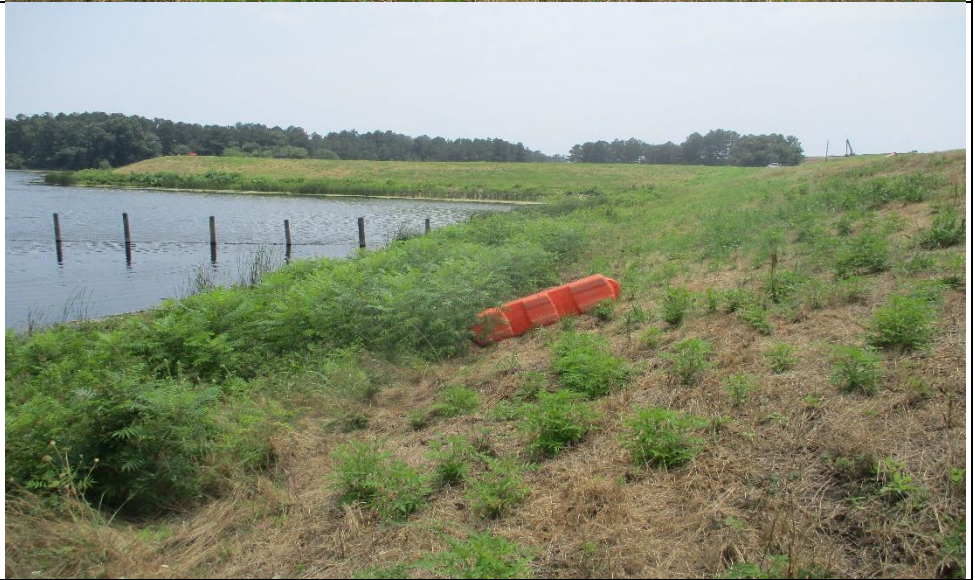
Photograph No. 5
Typical downstream slope
(looking south).

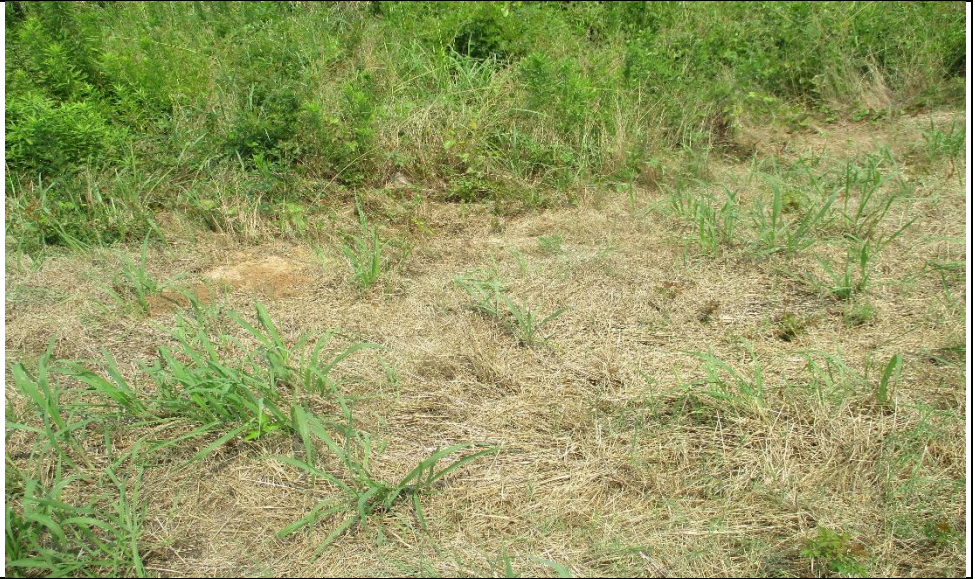
Photograph No. 6
Lower riprap section of the
downstream slope.

- As noted, all the excessive vegetation should be cut down and maintained consistently to control and properly manage it.

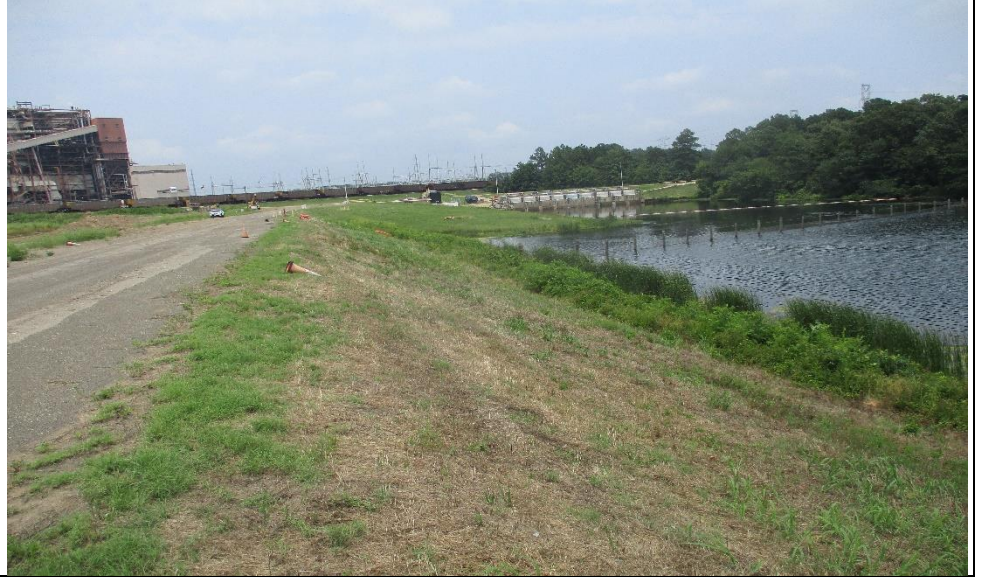
Photograph No. 7

Downstream slope and crest of the east dike.

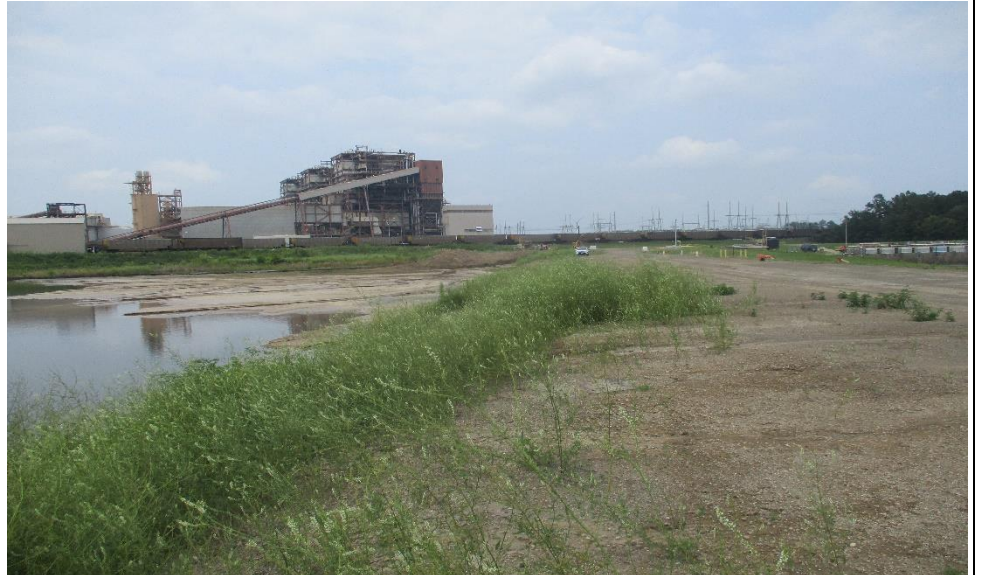
Photograph No. 8

The upstream slope of the east dike and the pond (looking north).

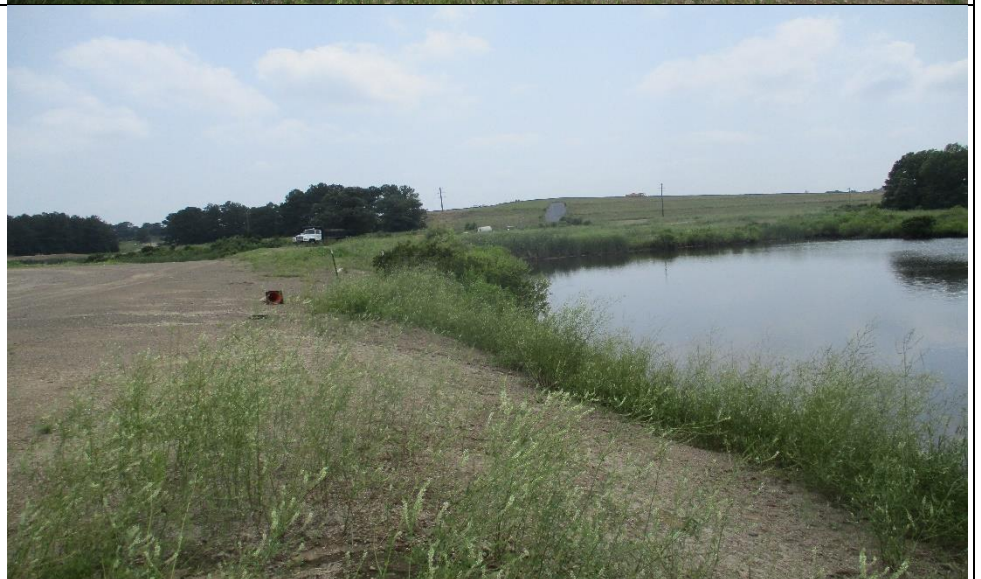
Photograph No. 9

- (iii) Typical view of the south section of the dike is illustrated in Photograph No. 9. Slightly overgrown vegetation was notices along the upstream slope. The dike appeared in good and functional condition without any significant erosion, settlement, or misalignment.

Typical section of the south dike.

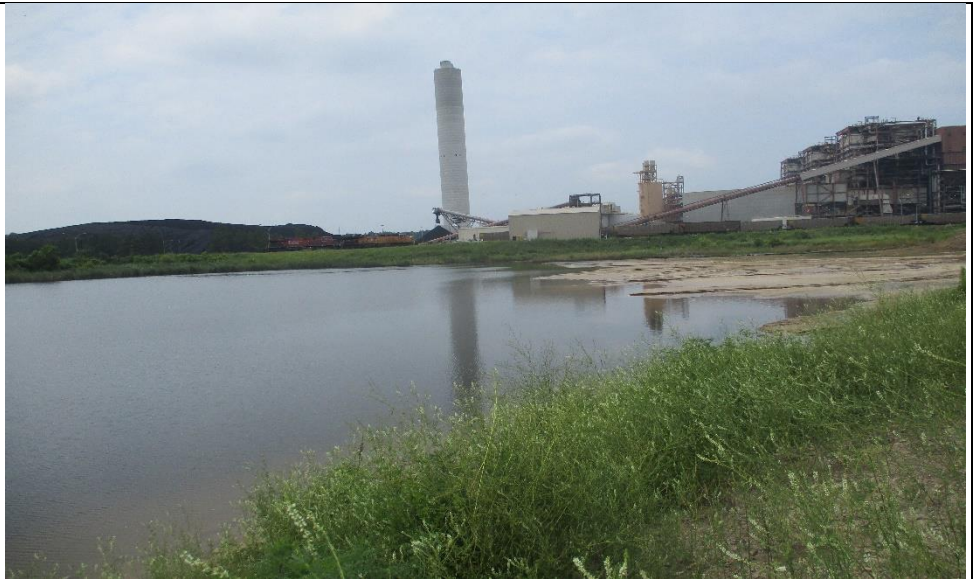
- (iv) Photograph No. 10 illustrate the overall view of the north dike upstream slope. The north dike also supporting the railroad appeared in good and stable condition. Excessive vegetation was noticed covering the upstream slope.

Photograph No. 10
The upstream slope of the north dike supporting the railroad.

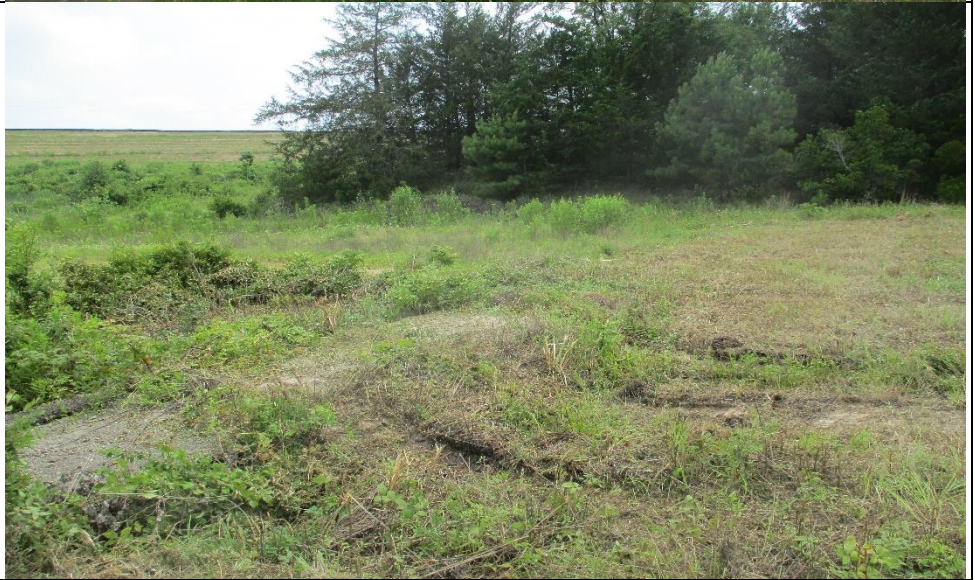
- (iii) Photographs No. 11-13 illustrates the primary emergency spillway located towards the southeast section of the south dike. A concrete weir is located at the spillway was mostly buried in the ground. The primary emergency spillway appeared to be in satisfactory

condition. The secondary emergency spillway (discharge canal) was in satisfactory condition and showed no signs of erosion, misalignment, deterioration, or misplaced rip rap material.

Photograph No. 11
Emergency spillway.

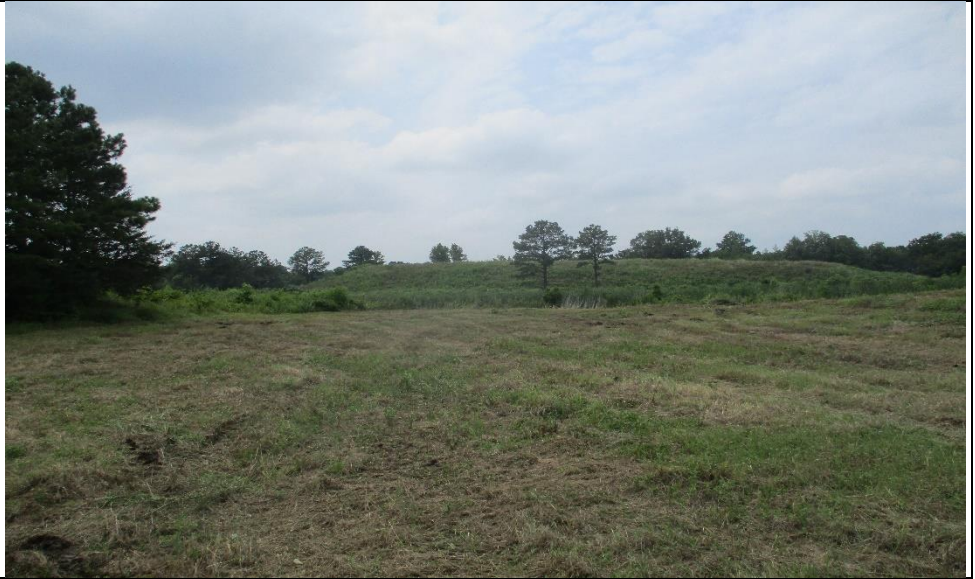
Photograph No. 12
Emergency spillway (looking north).

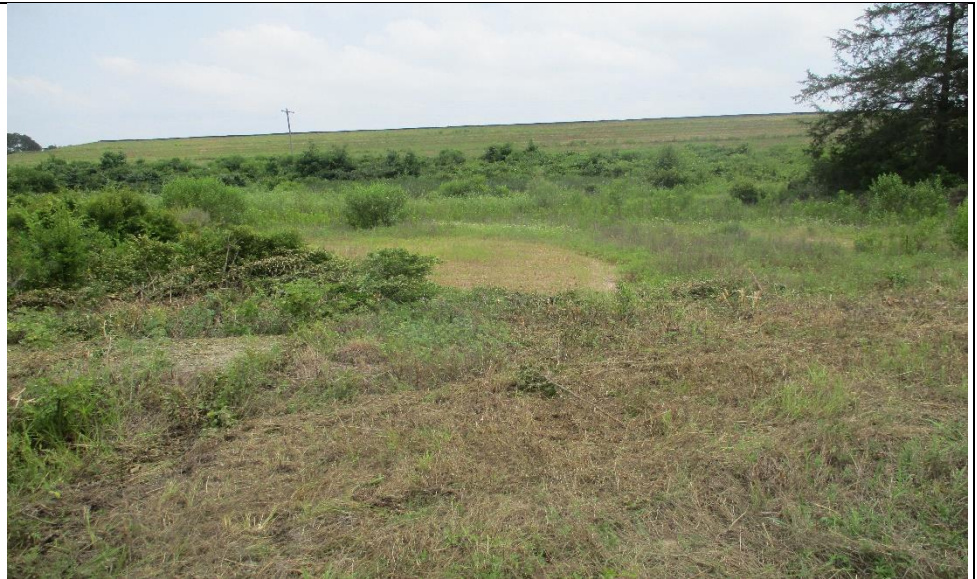
Photograph No. 13
Emergency spillway (looking south)

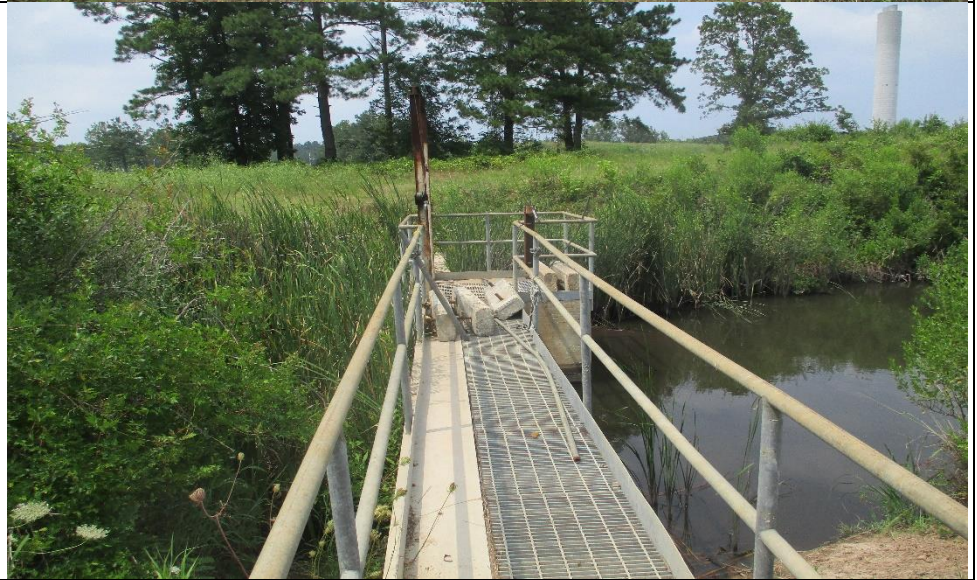
- (iv) A discharge canal is located at the south end of the pond. A typical view of the overflow discharge structure, weir box, and canal are illustrated in Photographs No. 14-16. The canal conveys water from southwest corner of the ash pond to the Clearwater Pond located at the southeast end. The canal indicated positive drainage condition (Photograph No. 16).

Photograph No. 14
Overflow discharge structure.

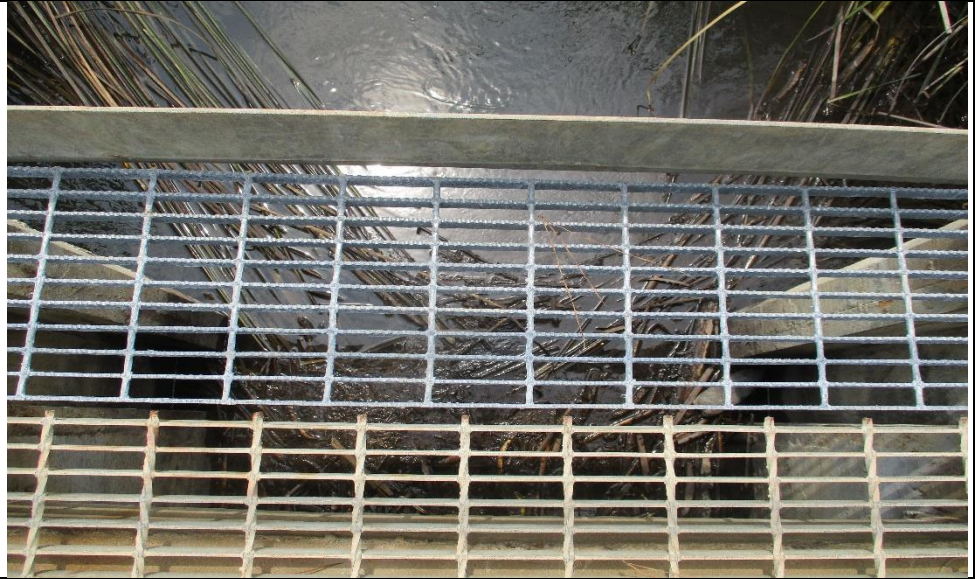
Photograph No. 15
Overflow weir at the discharge structure.

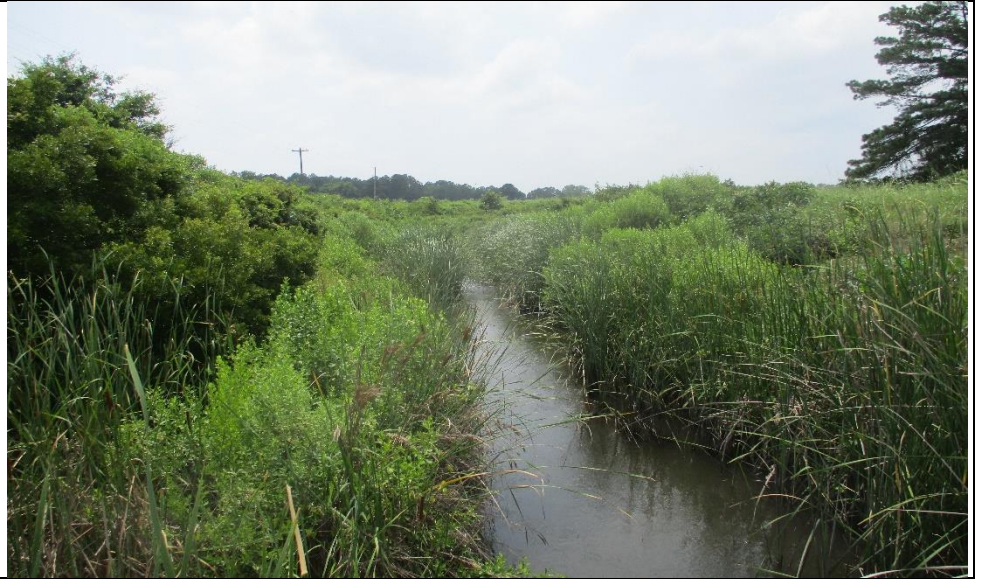
Photograph No. 16
Overflow canal.
