# **2019 Annual Dam and Dike Inspection Report**

**Primary Bottom Ash Dam**

**Flint Creek Plant  
Southwestern Electric Power Company  
Gentry, Arkansas**

**December 2019**

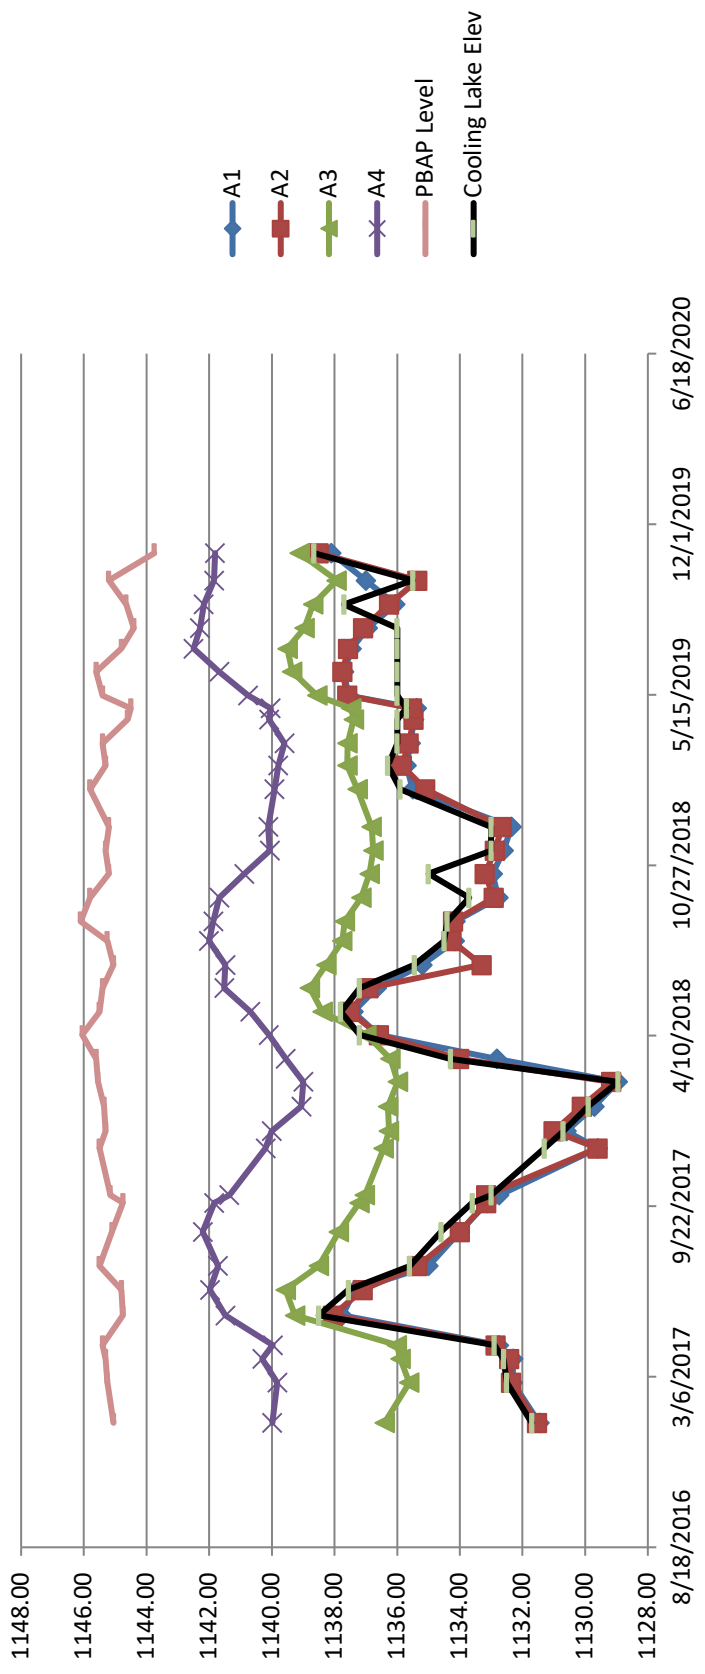
Figure 2 - Piezometer Chart

There are four piezometers located along the crest of the dam as shown on Figure 1. These are the only instrumentation related to this facility. A review of readings since the last inspection and historical readings indicate the levels are consistent and respond to the fluctuation of the cooling lake level. The piezometers are more influenced by the level of the cooling lake than the elevation of the bottom ash pond. Table 1 lists the maximum piezometer reading since the last annual inspection.

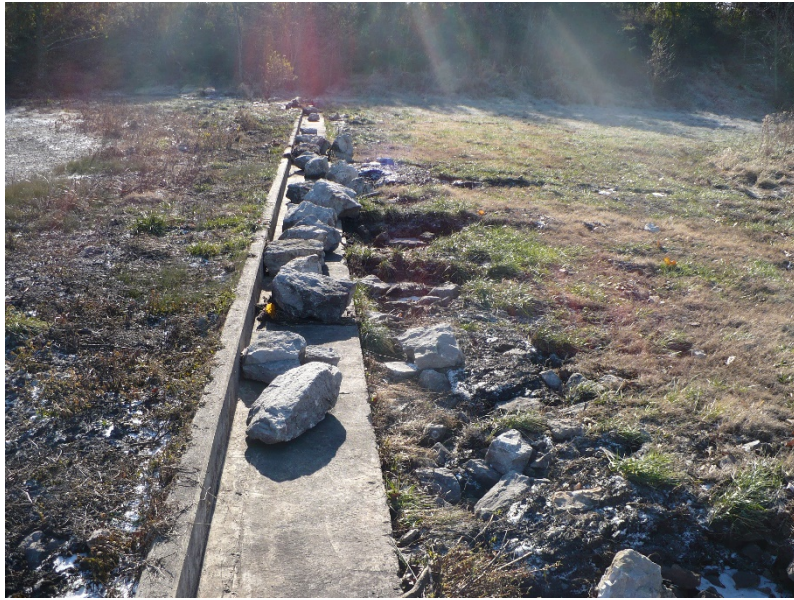
The emergency spillway is an incised channel in natural ground with a concrete weir control section, 1 ft. in height, across the channel width. The spillway was in generally good condition at the time of inspection (photo 1-2). The spillway appeared to be generally stable.

Photo #1 – emergency spillway concrete sill

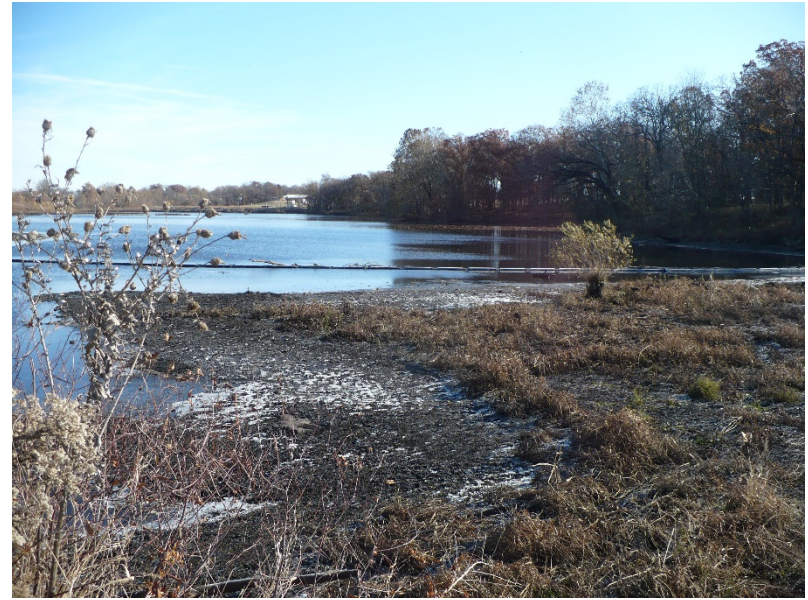
Photo #2 – approach area to emergency spillway

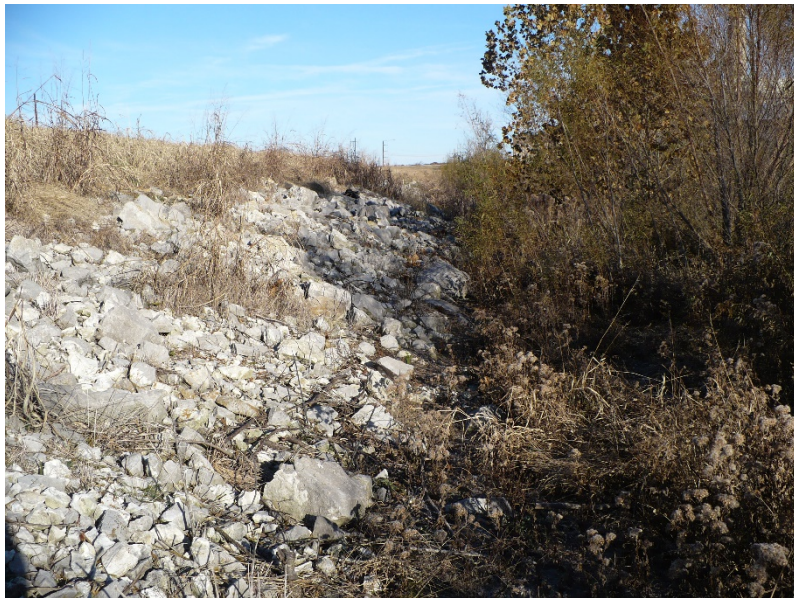
The upstream slope of the primary dam was observed to be in satisfactory condition from the visible riprap up to the crest. Since the pond is used for settling of solids, there is an accumulation of bottom ash over the upstream slope. The operations of ash removal has removed a significant portion of the ash delta and the natural vegetation that established on the ash. The interface of the upstream slope and ash limits was visible and stable. The inspector was able to walk along the interface. (photos 3-5)

Photo #3 –upstream slope looking towards right abutment

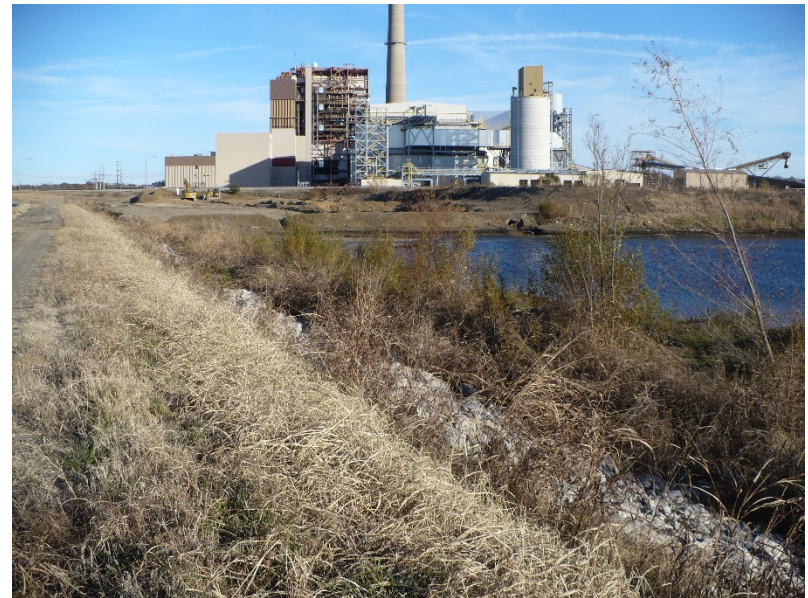
Photo #4 – upstream slope looking towards right abutment

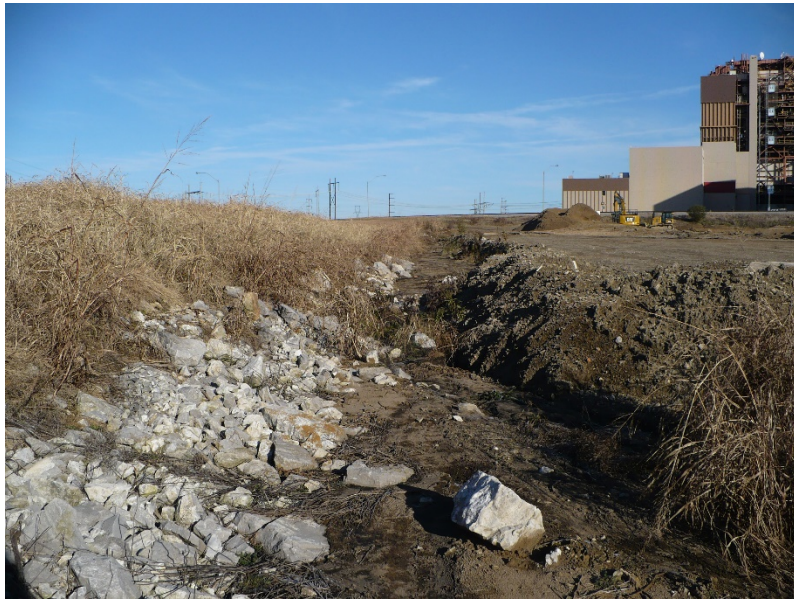
Photo #5 – upstream slope with ash delta

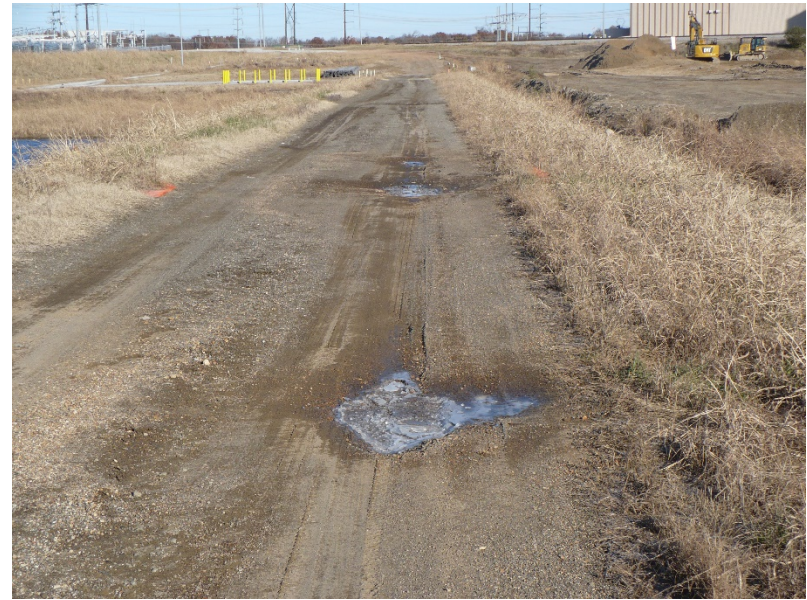
Some rutting along the crest was noted due to the vehicle traffic (photo 6).

Photo #6 – crest of dam

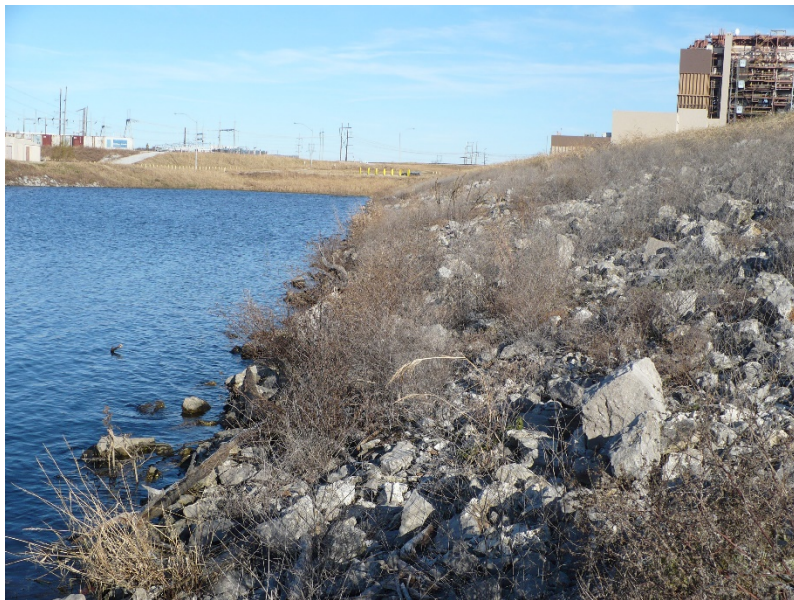
The downstream slope of the primary dam was in satisfactory condition (photo 7). Most of the slope is covered with riprap except for the upper 12-15 feet of the slope length is grass. Woody vegetation within the riprap is being controlled. There was no observed displacement or movement of the riprap. There was no seepage observed along the face of the slope.

Photo #7 – downstream slope looking towards right abutment

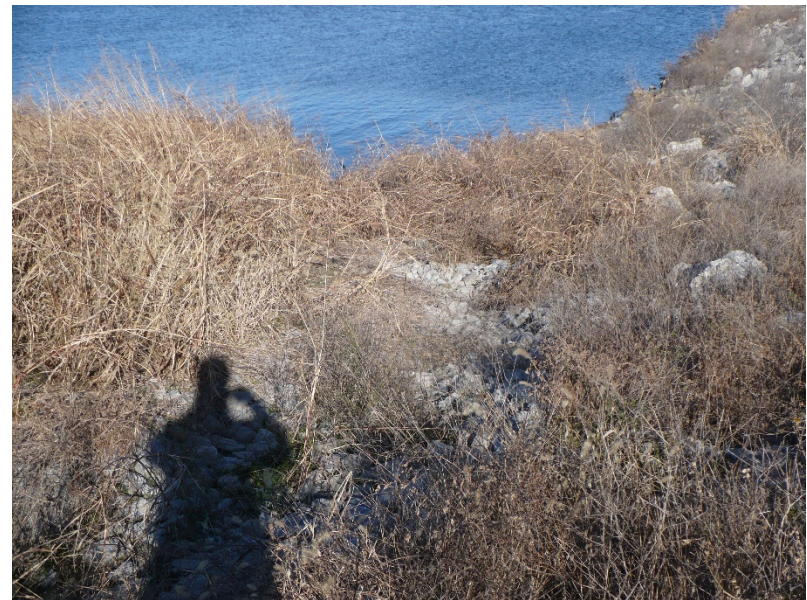
No erosion was observed in either of the groin ditches (photo 8).

Photo #8 – left groin
