2019 Annual Dam and Dike Inspection Report

Bottom Ash Pond Complex

Mitchell Plant

May 23, 2019

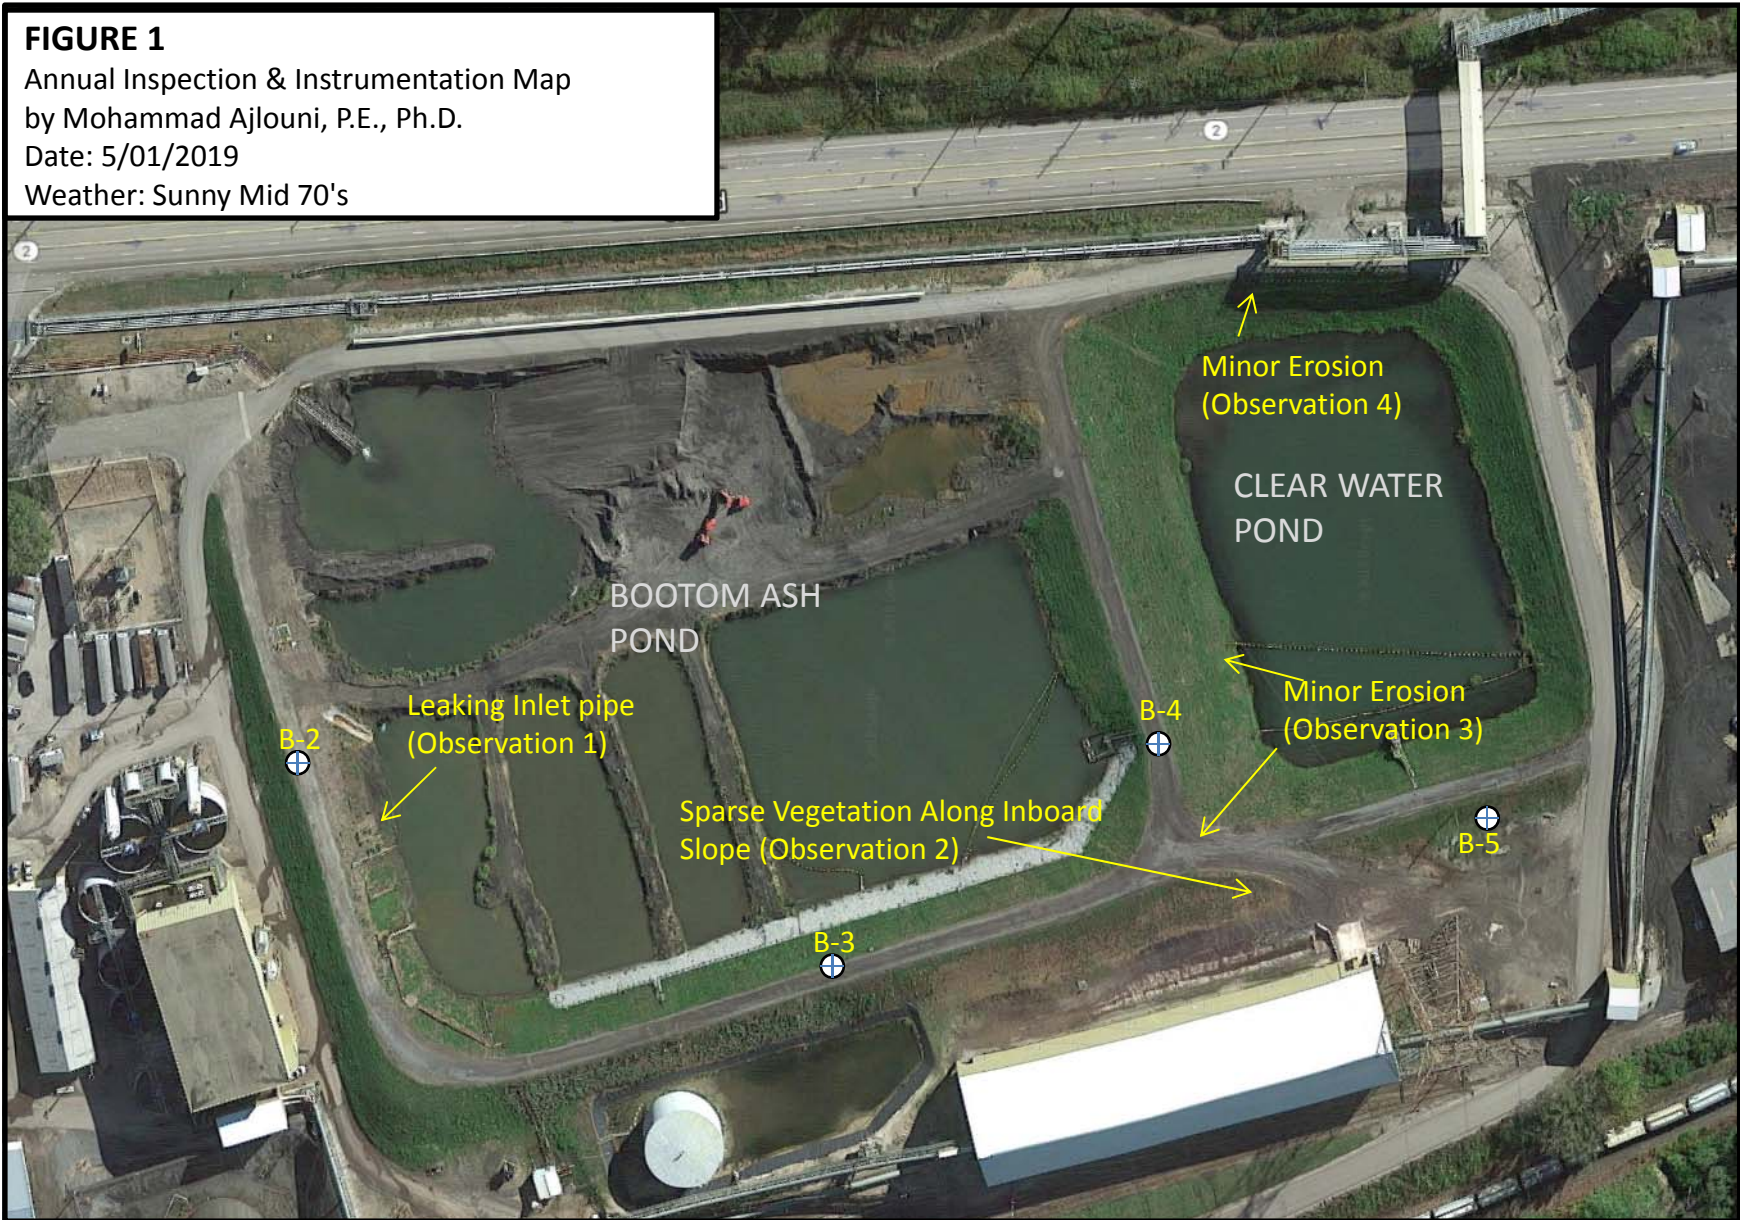
FIGURE 1

Annual Inspection & Instrumentation Map
by Mohammad Ajlouni, P.E., Ph.D.
Date: 5/01/2019
Weather: Sunny Mid 70's

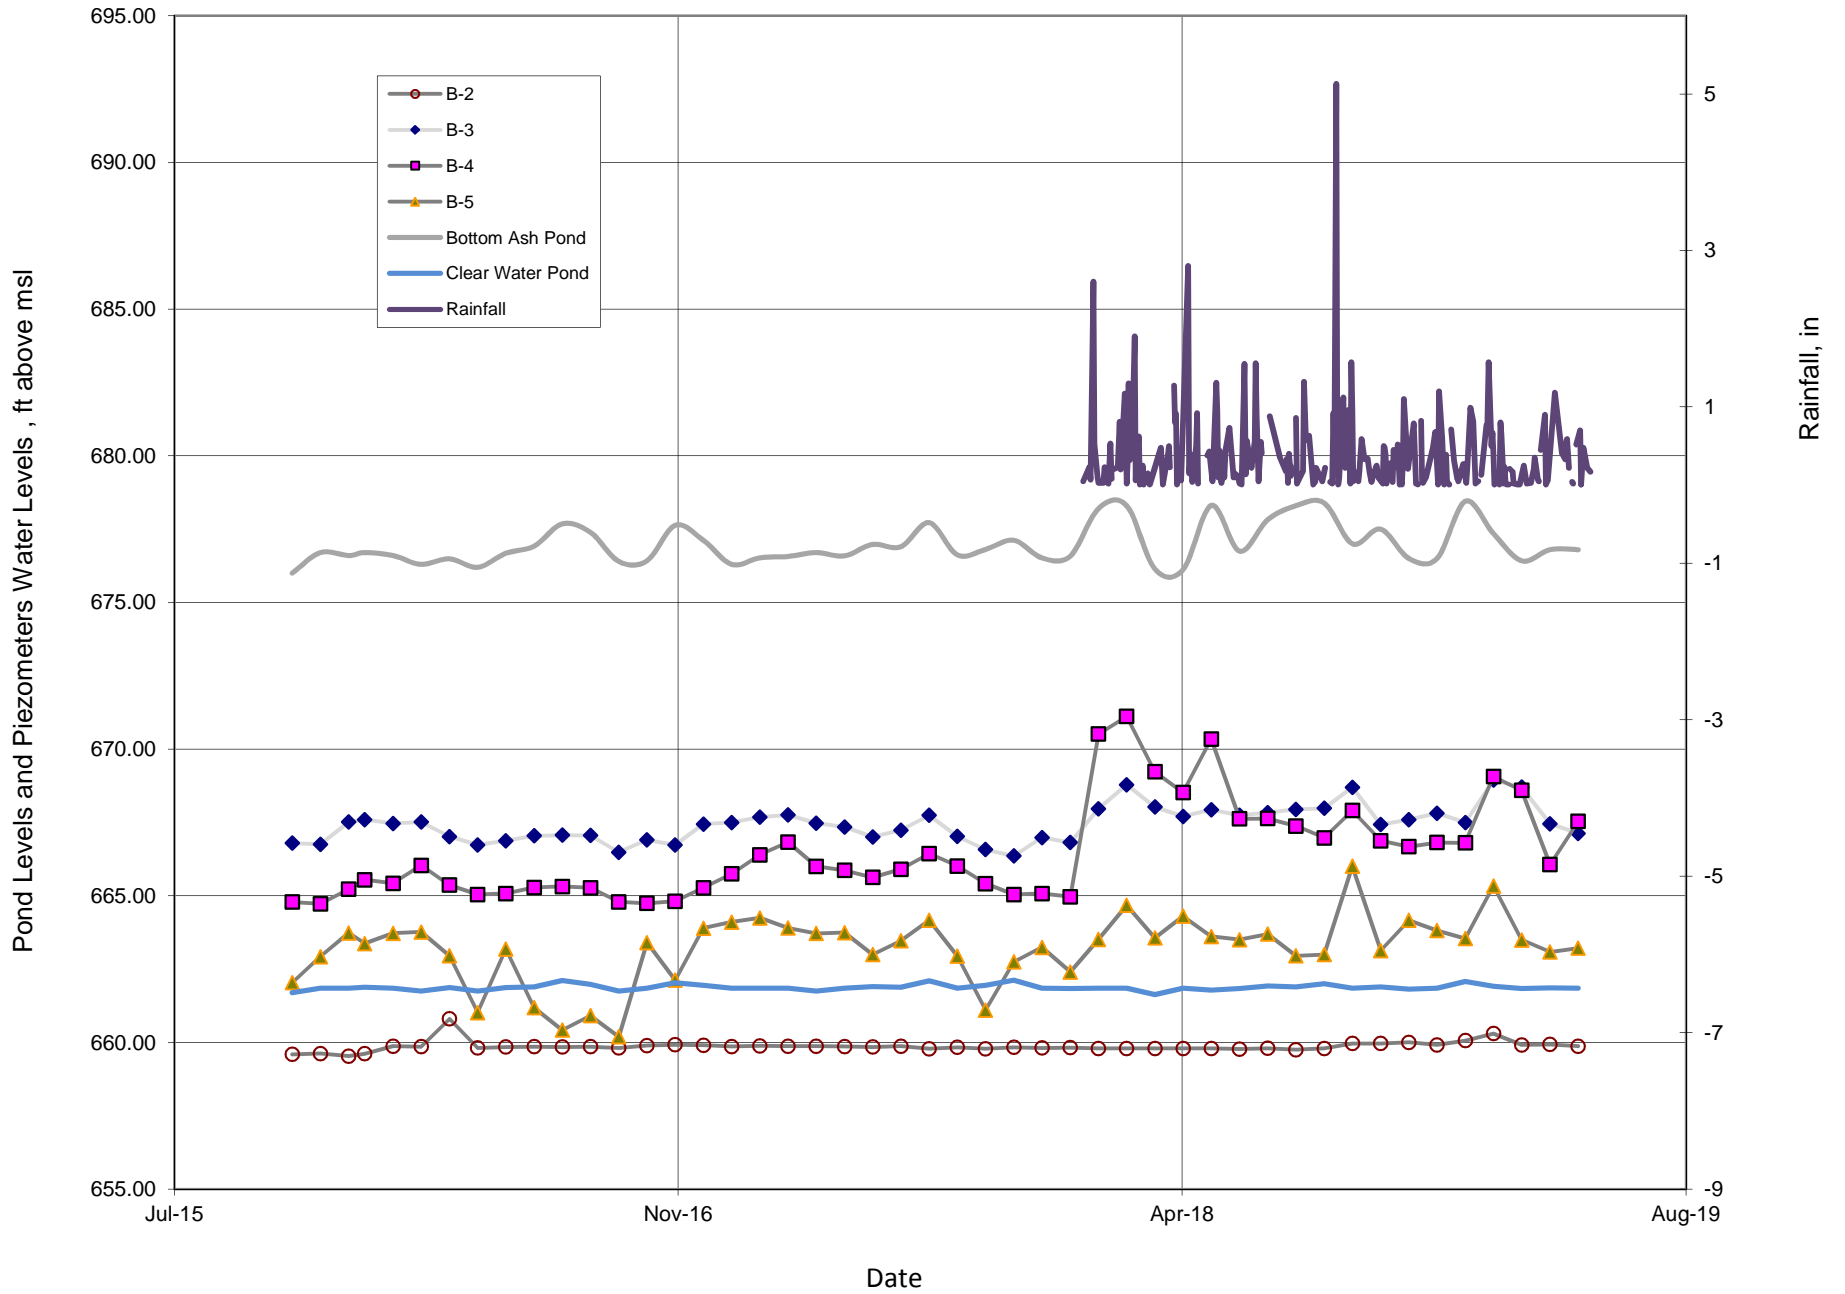
Figure 2 Bottom Ash Pond Complex Piezometers & Pond Levels and Rain Fall Record

Figure 2 presents the pond water levels as well as the piezometers water levels and rain fall record. Changes in piezometers levels correlate to the bottom ash pond level and to the rain fall intensity except for B-2 located to the north of the pond complex which appears to be dry.

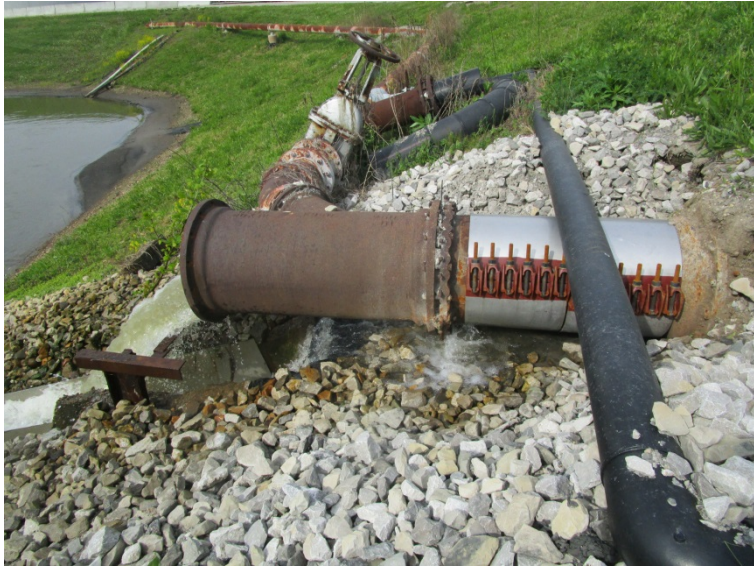
Photo No. 1

4. One of the inlet pipes is leaking, the plant is aware of the leak and already placed PVC liner and some gravel to prevent the leaking water from eroding the slope. The plant is also working to replace the leaking segment of the pipe soon (Observation 1).
5. The exterior slopes were recently mowed. No signs of instability were observed. In general the vegetation was good to fair. There were areas along the west dike where vegetation was sparse (Observation 2).
6. The spillway structure was observed to be functioning properly. The concrete was in good condition and stop logs were available.
7. There were no seepage or wet areas observed along the embankment.

Observation 1: Leaking Pipe

Location: North inboard slope of Bottom Ash Pond

- 1) Continue to work on the pipe leakage repair to prevent erosion of the north inboard slope of the Bottom Ash Pond. (Observation 1).

Recommendations: Repair by replacing leaking section.

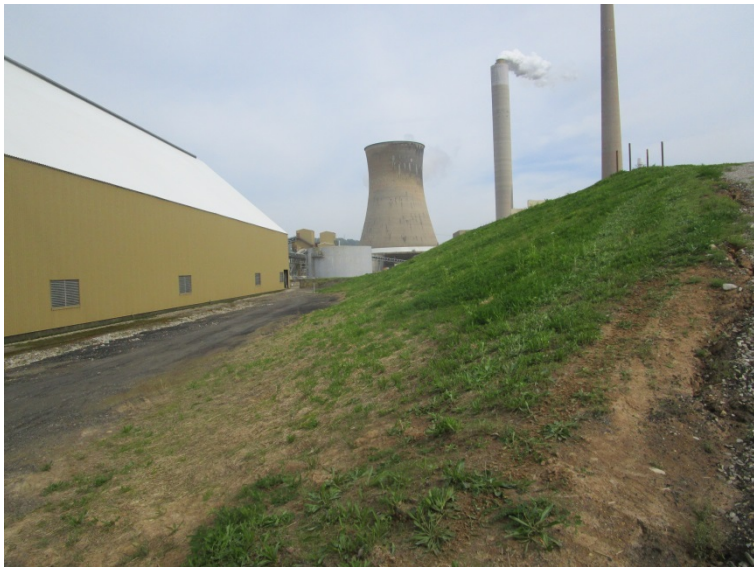
Photo No. 2

Observation 2: Sparse Vegetation

Location: West outboard slope of Clear Water Pond

- 1) Seed and mulch areas on the outboard slope of the Bottom Ash Pond by replacement of soil and re-seed. (Observation 2)
- 2) Repair minor erosions within along the east and northwest of the inboard slope of the Clear Water Pond. (Observation 3 and 4)

Recommendations: Repair by Seed & Mulch.

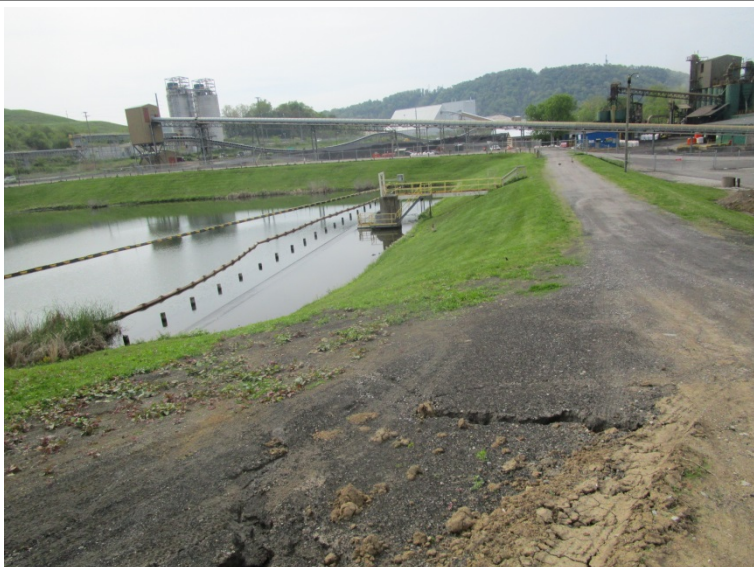
Photo No. 3

Observation 3: Minor Erosion

Location: West inboard slope of Clear Water Pond

Recommendations: Repair erosion by placement of soil.

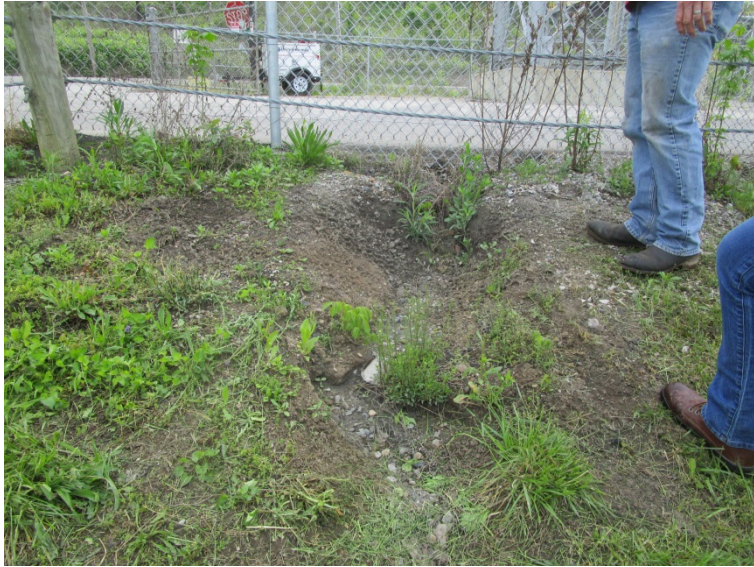
Photo No. 4

2. The interior slopes showed no signs of distress such as sloughing or bulges. The grass was recently mowed. There was one area of minor erosion observed at the northern portion of the dike (Observation 3). An area of erosion was present along the interior slope at the south east portion of the pond which was appeared to be from run off from the adjacent roadway (Observation 4).

Observation 4: : Minor Erosion

Location: East inboard slope of Clear Water Pond

Recommendations: Repair erosion by placement of soil.

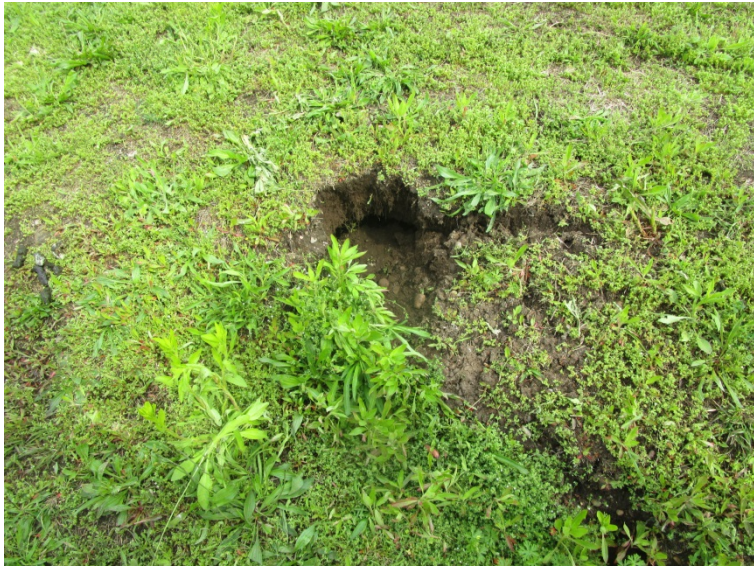
Photo No. 5

Observation 4: : Minor Erosion

Location: North inboard slope of Clear Water Pond

Recommendations: Repair erosion by placement of soil.
