# Dam & Dike Inspection Report

## CCR Ash Ponds

### WELSH POWER PLANT CASON, TEXAS

INSPECTION DATE September 19, 2018

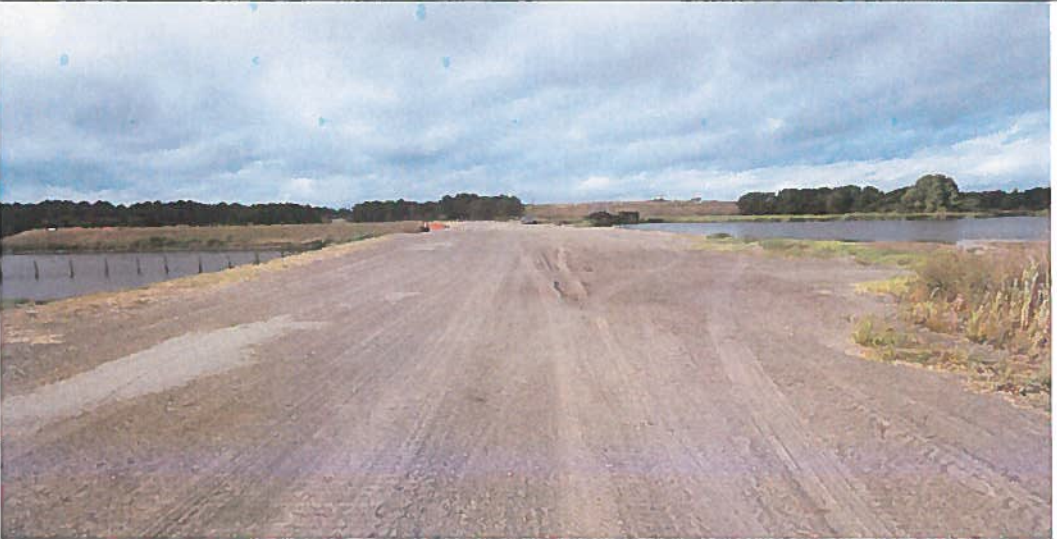
<p><u>Photo #1</u></p>

- (i) Typical condition of the crest and upstream slope is depicted in Photographs No. 1-3. The cooling reservoir is located adjacent to the downstream slope (Photograph No. 1). The dike appeared in good and stable condition. Slightly overgrown vegetation was noticed along the upstream slope. A Significant erosion gully was noticed (Photograph No. 2). The erosion appeared to be in the additional CCR material stockpiled at the edge of the pond and not in the containment dike.

<p>Typical crest of the east dike.</p>

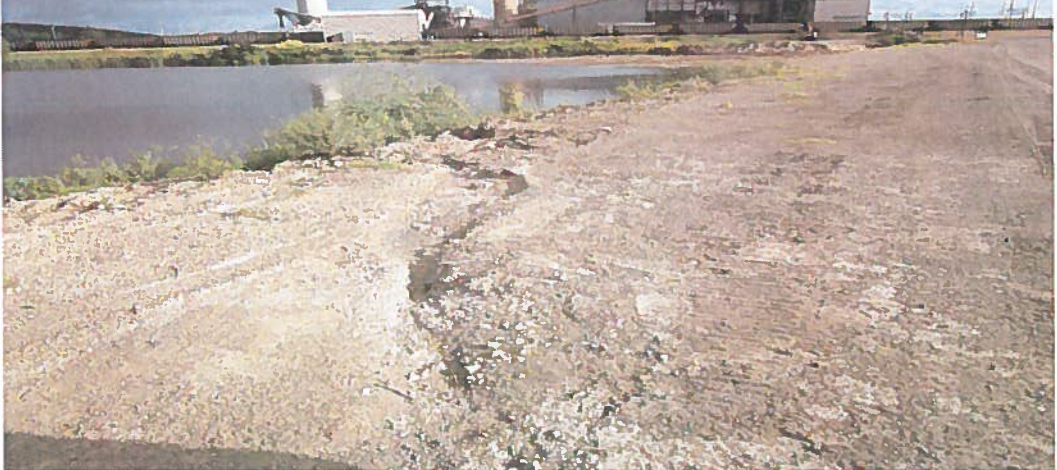
<p><u>Photo #2</u></p>

<p>A significant erosion at the upstream slope.</p>

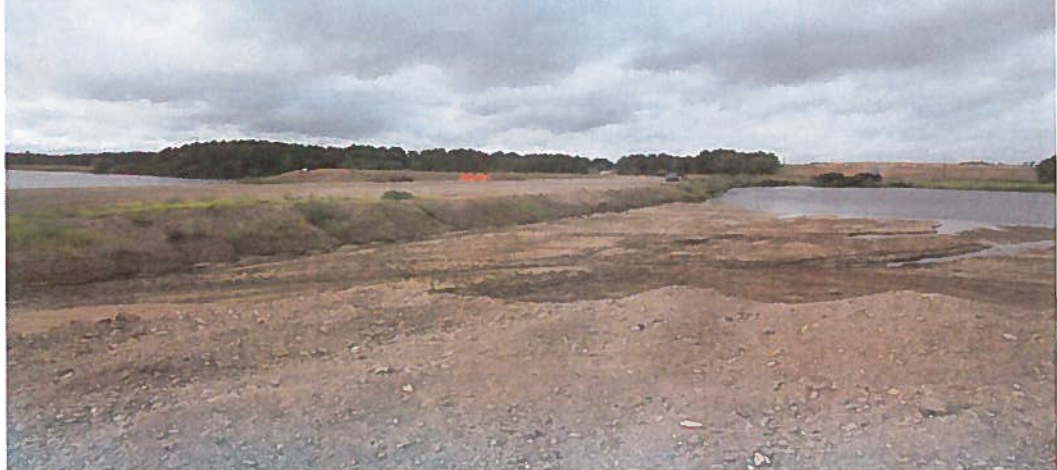
<p><u>Photo #3</u></p>

<p>The upstream slope of the east dike shown in this photograph.</p>

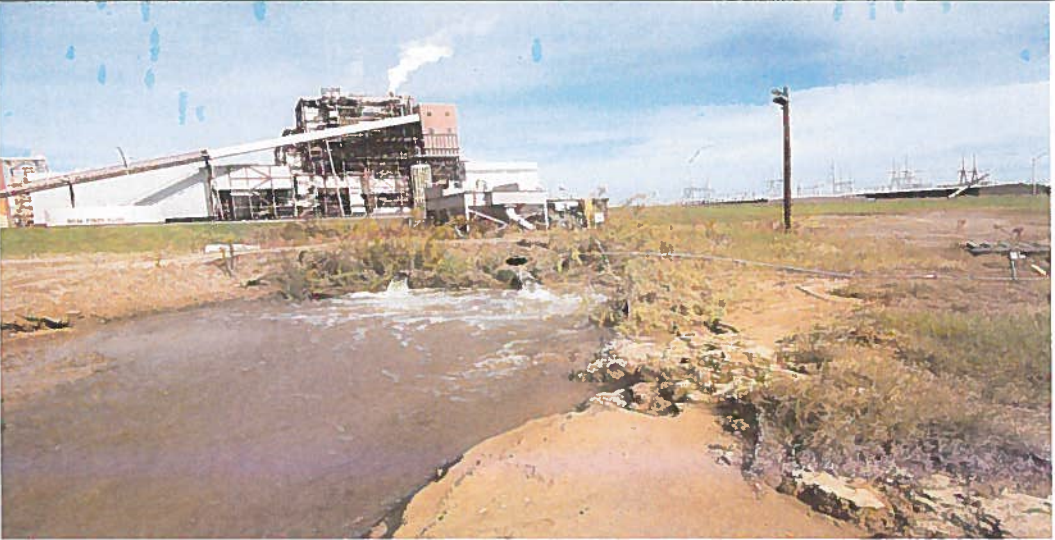
<p><u>Photo #4</u></p>

- (ii) The two ash sluice pipes are located at the northeast corner of the pond (Photograph No. 4). Other effluent from the plant is discharge near the north dike. All the pipes and support structure revealed no sign of misalignment, settlement, or deterioration. Overall, the discharge pipes appeared in good functional condition. Minor vegetation and erosion noticed around the pipes, but the slope appeared in stable condition.

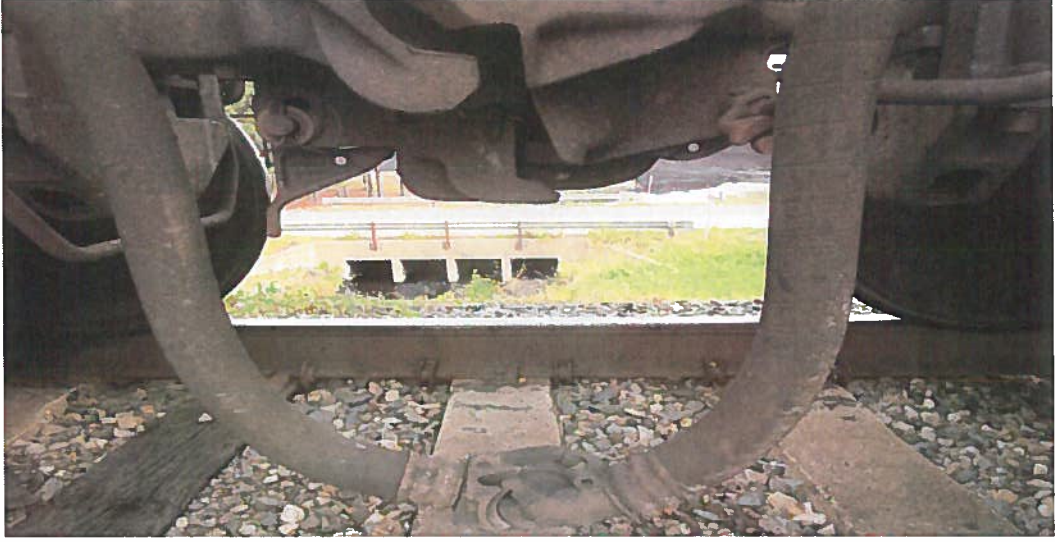
<p><u>Photo #5</u></p>

- (iii) Coal pile is present north of the north dike of the primary pond. A box culvert is present between the coal pile and the north dike of the pond (Photograph No. 5). Residual amount of coal fines travels through the box culvert and accumulates at the toe of the north dike (Photograph No. 6). The plan is to reclaim the coal.

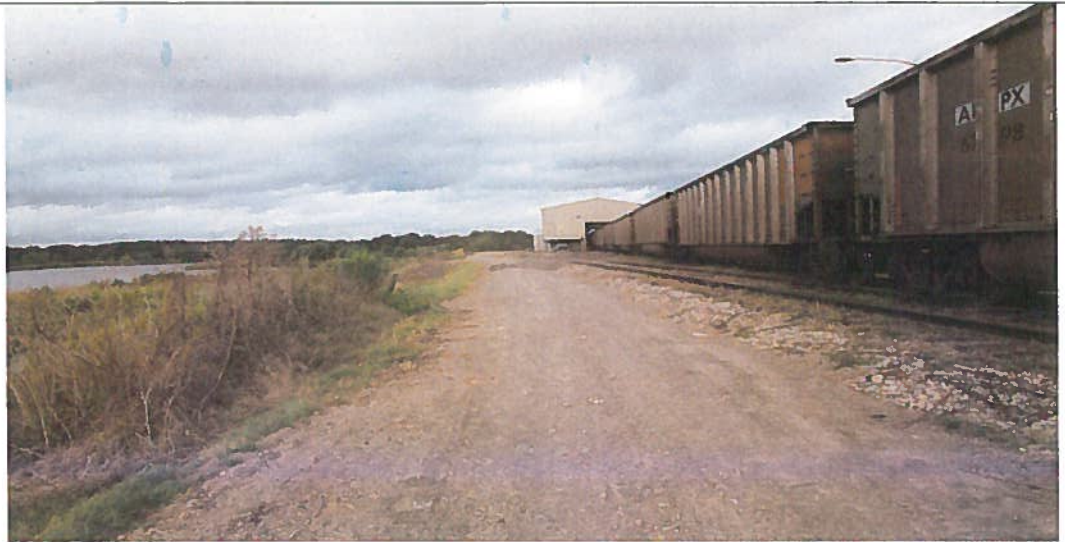
Photo #7

- (iv) Photographs No. 7 and 8 shows the crest and upstream slope of the north dike. The main plant and coalyard are located to the north of the north dike. The dike appeared in good and stable condition. Excessive vegetation was noticed covering along the upstream slope of the dike.

Typical crest at the north dike.

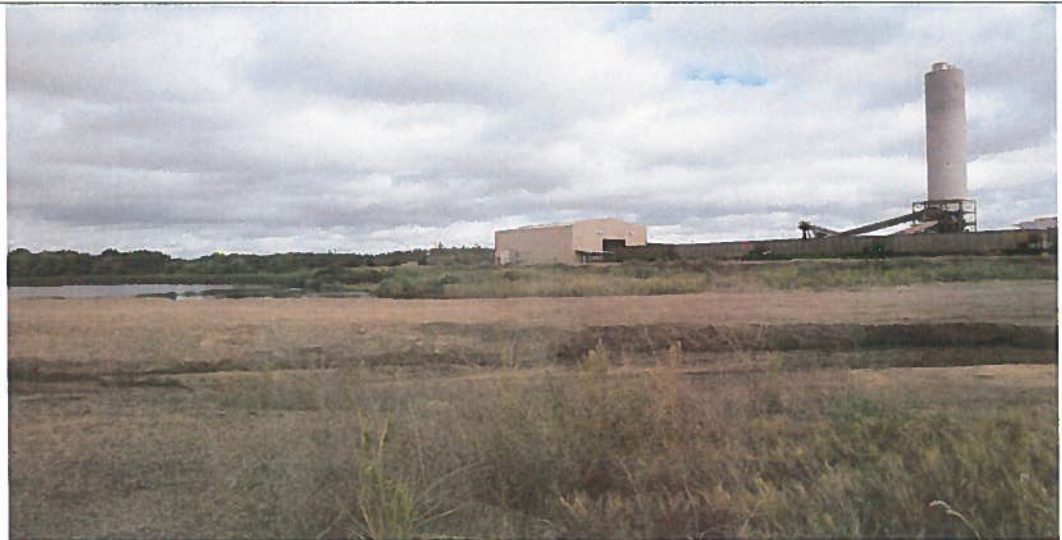
Photo #8

Upstream slope of the north dike (looking west).

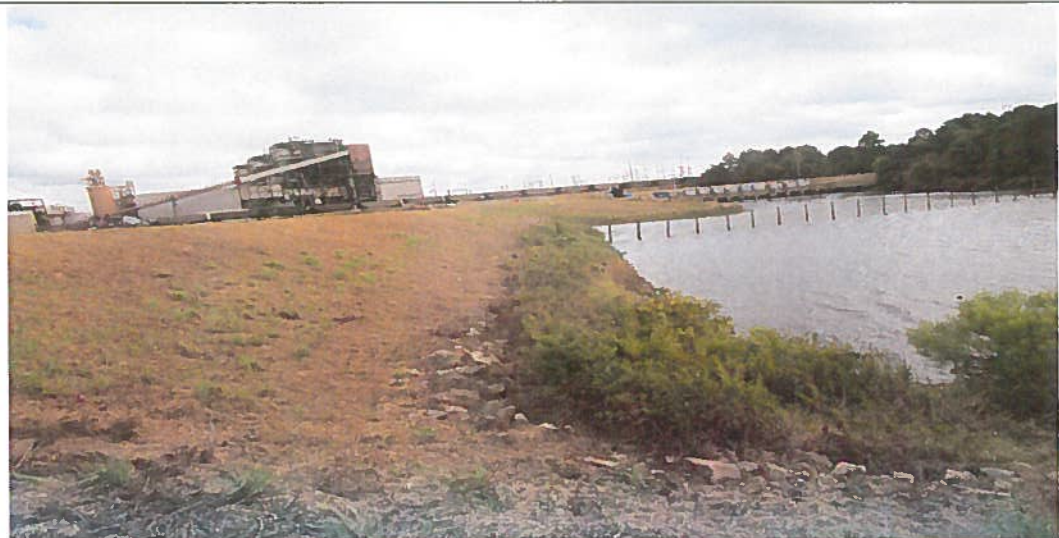
Photo #9

- (v) The downstream slope of the east dike is presented in Photograph No. 9. The riprap along the lower section of the exterior slope is good. Vegetation growth was noticed along the riprapped section of the slope and bare areas were prominent within this slope. Several deep animal burrows (Photographs No. 10-12) were present along this slope just above the riprap.

Downstream slope of the east dike.

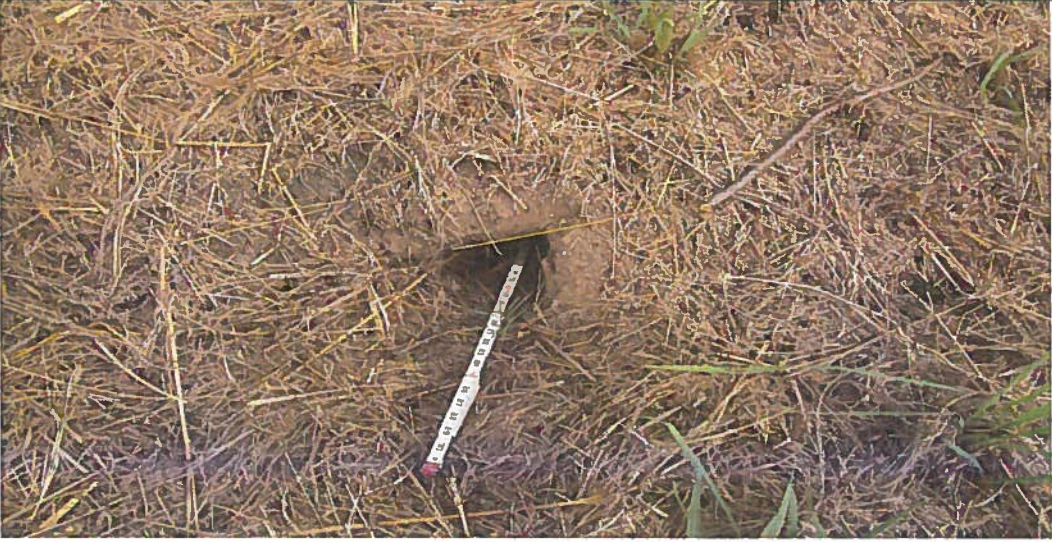
<p><u>Photo #10</u></p>

<p>Animal hole 20” deep.</p>

- As noted, all the excessive vegetation should be cut down and maintained consistently in order to control and properly manage it.
- All the animal burrows should be eliminated and filled them with suitable materials and compacted as necessary.
- Installed a safe access (e.g. stair step, platform) to the staff gauge of the Clearwater pond.
- AEP-Geotechnical Engineering will investigate root cause of the piezometer showing anomalous readings.

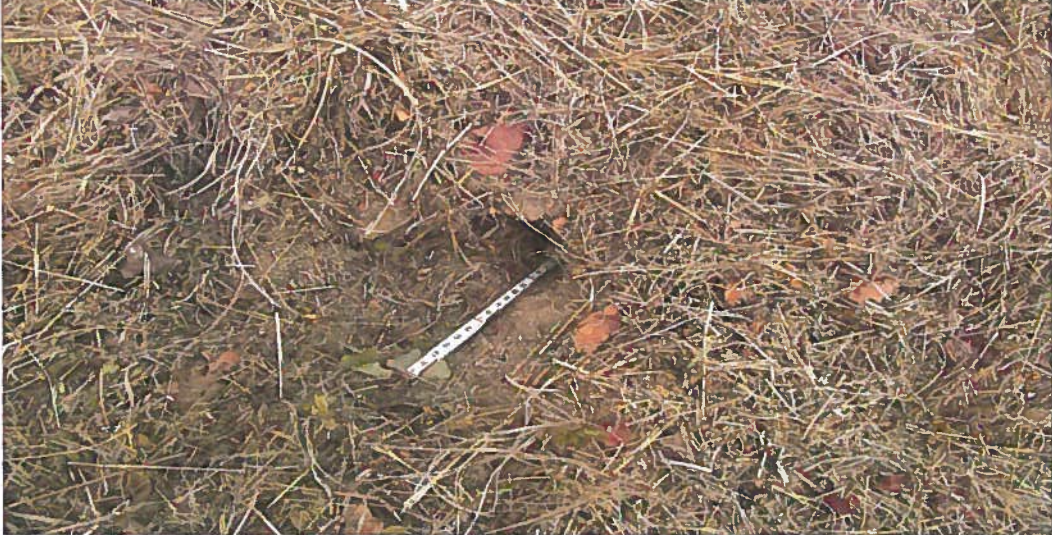
<p><u>Photo #11</u></p>	 
<p>Animal hole 40” deep.</p>

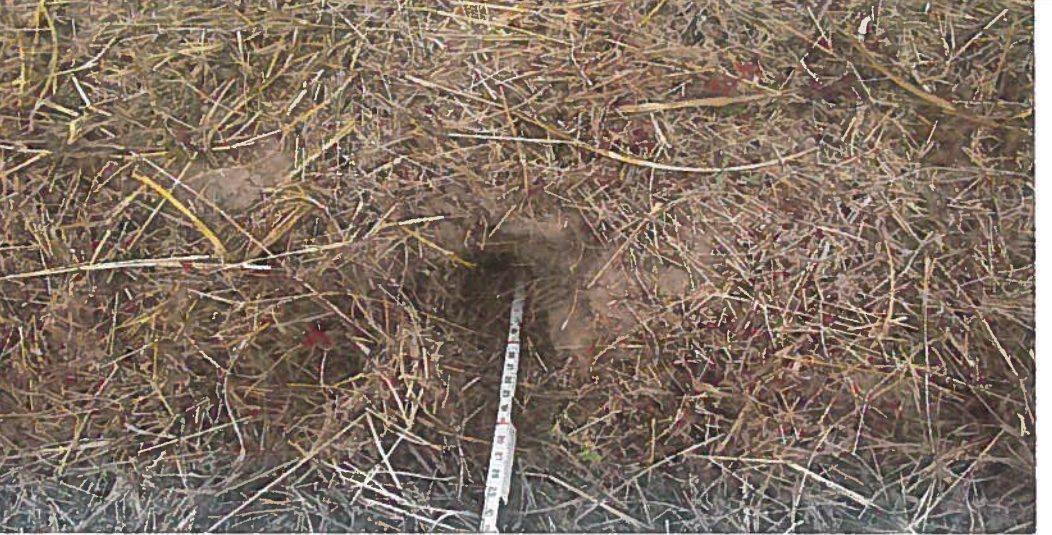
<p><u>Photo #12</u></p>	 
<p>Animal hole 20” deep.</p>

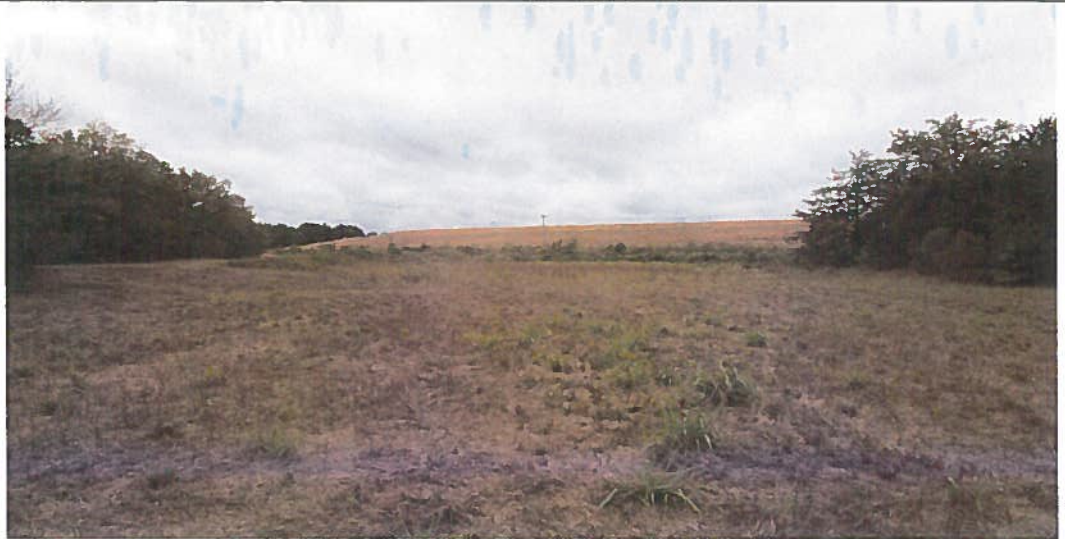
Photo #13

- (vi) Photographs No. 13 and 14 depict the emergency spillway located towards the southeast section of the south dike. The emergency spillway appeared to be functioning as designed and no obstructions noticed that will impair water.

Emergency spillway  
of the primary ash  
pond (looking south).

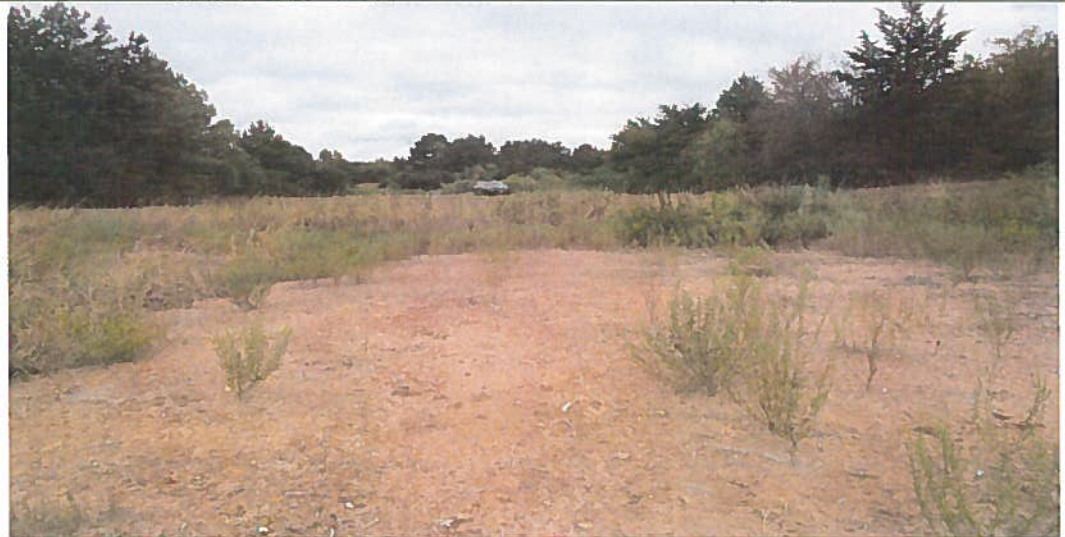
Photo #14

Emergency spillway  
of the primary ash  
pond (looking north).

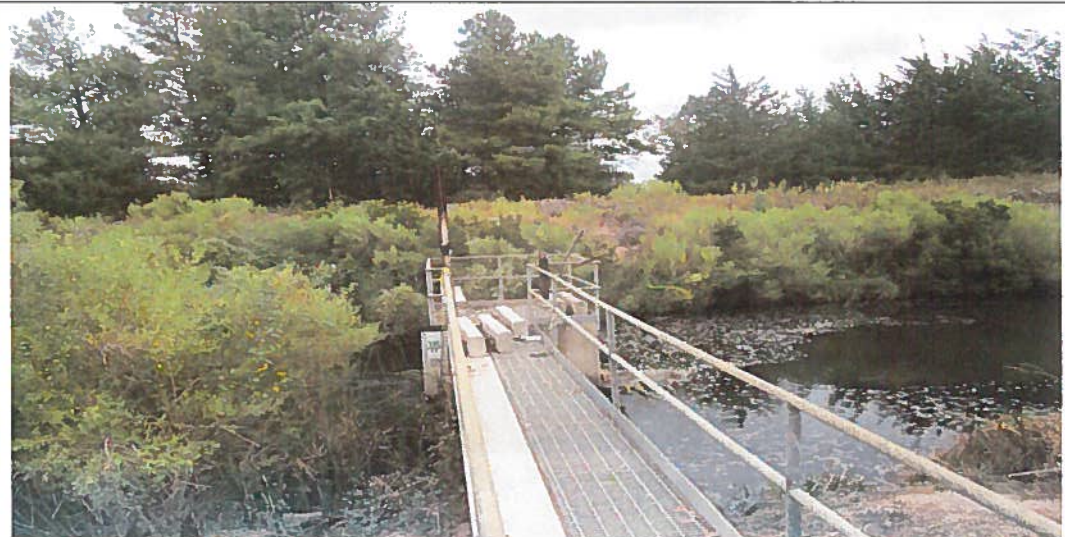
Photo #15

- (vii) An overflow discharge structure is located at the canal (Photograph No. 15). The canal is located at the south end of the pond. A typical view of the canal and overflow structure shown in Photograph No. 15. The discharge structure was functioning as designed and the canal appeared to have positive flow. The canal conveys water from southwest corner of the ash pond to the clearwater pond located at the southeast end. Excessive vegetation was noticed along the banks of the canal.

Overflow discharge  
structure.

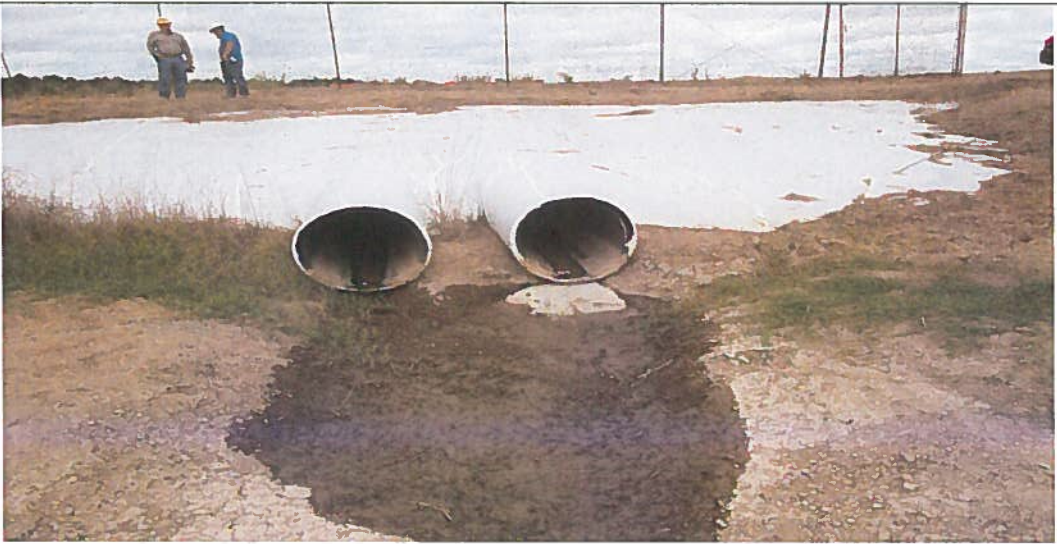
- (i) Two pipe culverts are located at the northwest corner of the pond (Photograph No. 1). The pipe culverts are part of the landfill storm water control system and discharge its contact water into this pond. The pipe culverts appeared clear of obstructions and in good and functional condition.
- (ii) Photograph No. 2 depicts the upstream slope and crest of the west dike. The upstream slope appeared to be in good and stable condition and mostly buttressed with ash. The geosynthetic liner appeared intact and in good condition. The crest appeared in good and stable condition. Slightly overgrown vegetation was noticed within the upstream slope. Photograph No. 3 shows overall condition of the interior of the pond. Ash management

<p><u>Photo #1</u></p> <p>The outlet of the runoff control pipes from the landfill appeared clear and functional.</p>

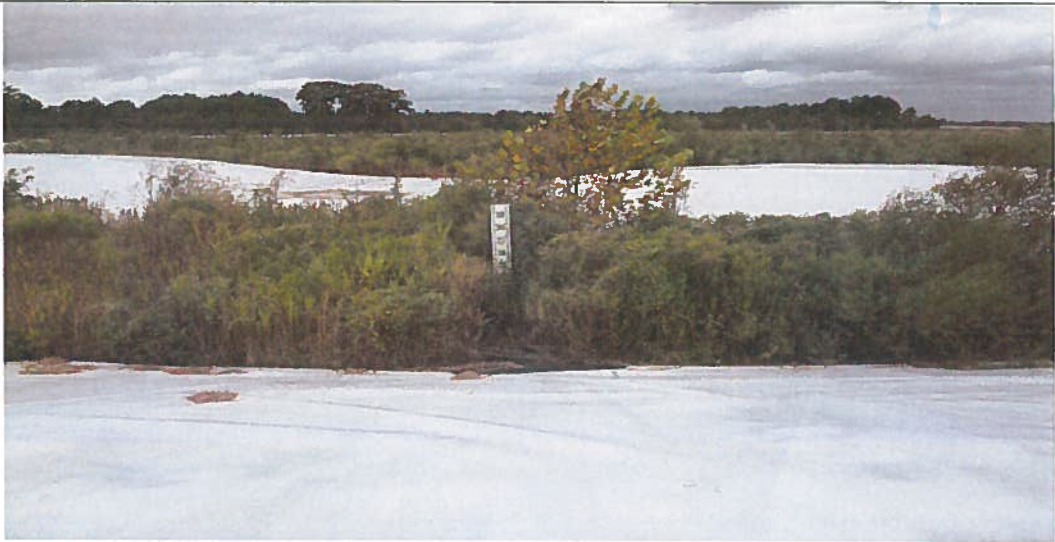
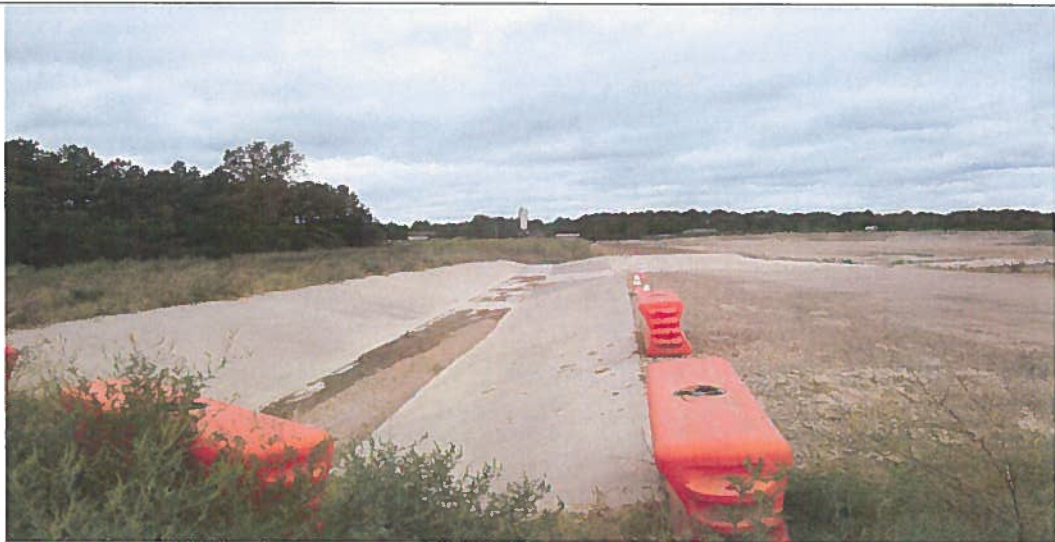
<p><u>Photo #4</u></p>

- (iii) A small area within the pond is used as a clearwater pool that is centrally located at the south dike (Photograph No. 4). Excessive vegetation was noticed within the clearwater pool area. The access to the staff gauge via sloped liner was unsafe, specifically during wet condition.

<p>Clearwater pond.</p>

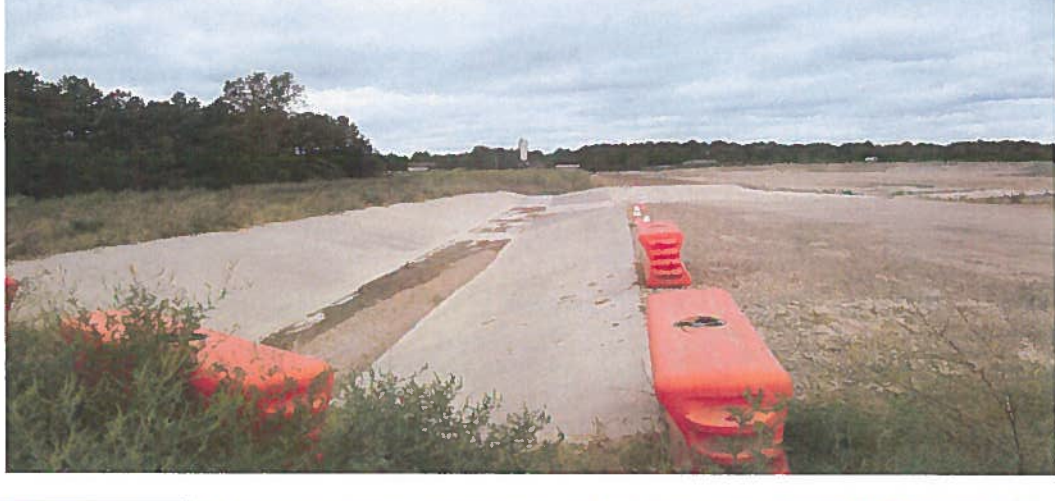
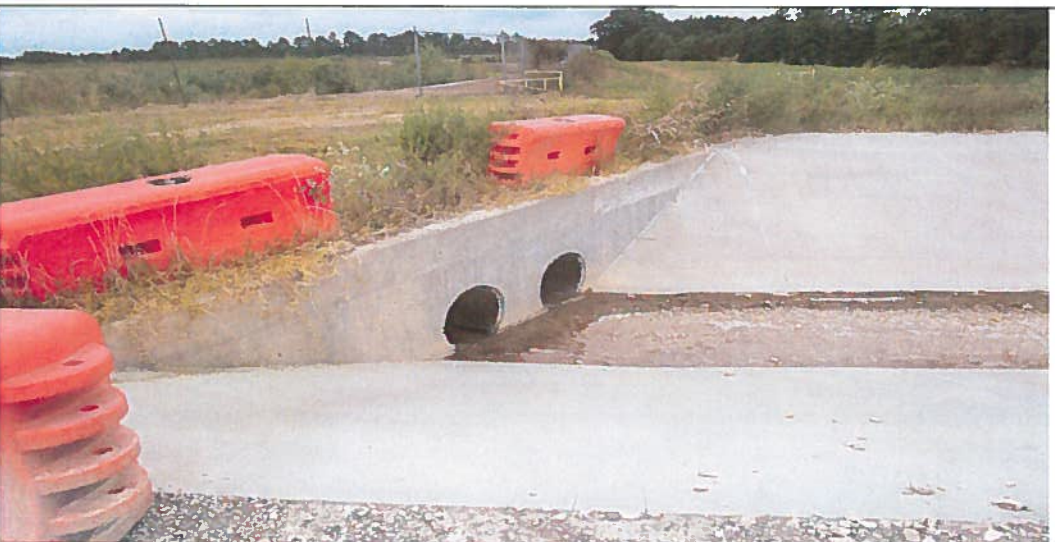
<p><u>Photo #5</u></p>

- (iv) The stormwater and sediment control structure (Photographs No. 5 and 6) appeared in good and functional condition and no standing water was noticed.

<p>Storm-water control structure appeared functional.</p>

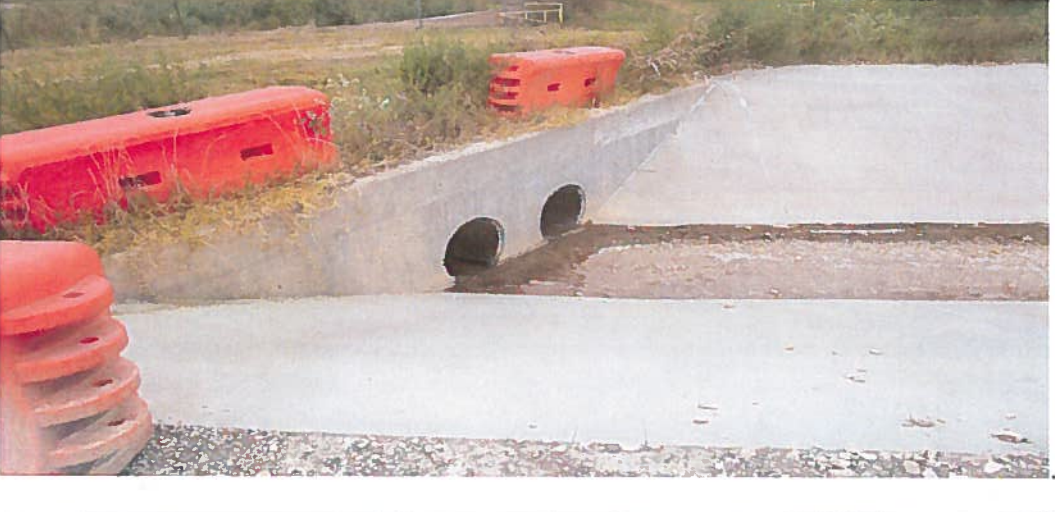
<p><u>Photo #6</u></p>

<p>The inlet of the runoff pipe culverts were clear and indicated positive flow.</p>

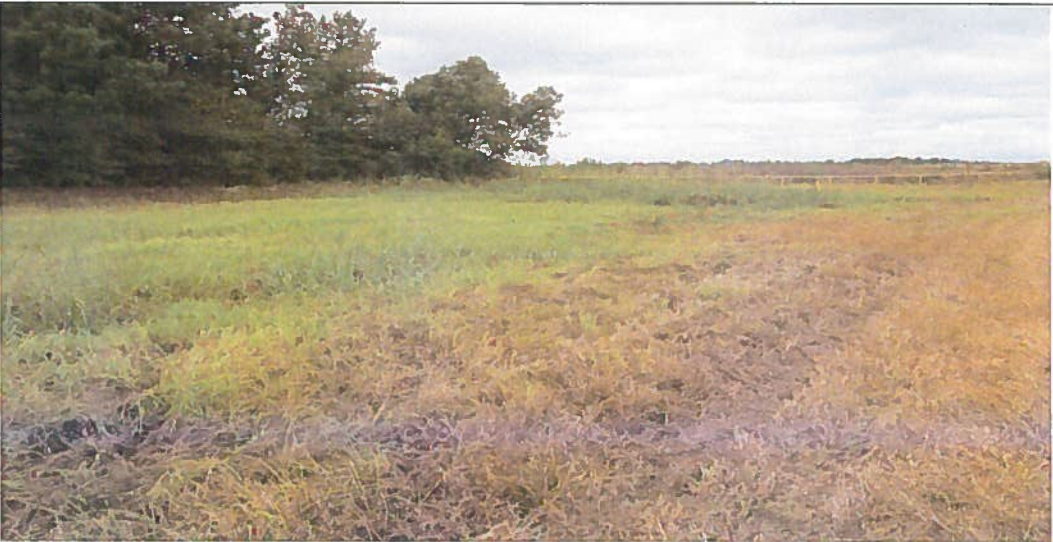
<p><u>Photo #7</u></p>

- (v) The northwest section of the west dike downstream slope is shown in Photograph No. 7. An area adjacent to the downstream slope exhibited tire ruts due to previously soft and wet ground. Typical condition of the downstream slope is shown in Photographs No. 7-9. The slope appeared in good and stable condition.

<p>Minor rutting at the toe of the downstream slope of the west dike.</p>	
<p><u>Photo #8</u></p>

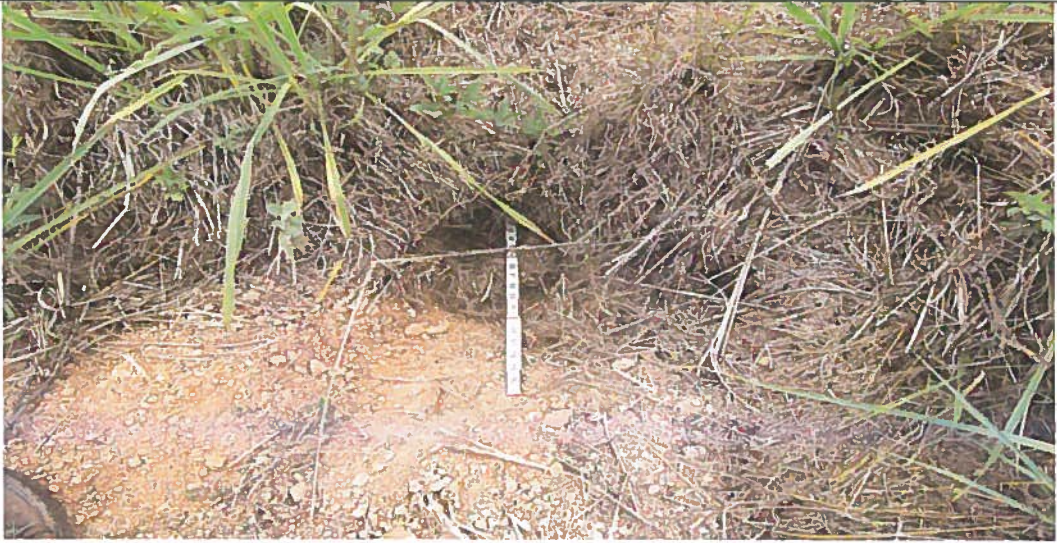
<p><u>Photo #10</u></p>

- (vi) An animal burrow 54-inch deep was encountered at the downstream slope of the east dike (Photograph No. 10).
- (vii) Typical condition of the downstream slope and toe area of the east dike (north section) is depicted in Photograph No. 11. The slope appeared in good and stable condition. The toe area consists overgrown vegetation that could have potential for accumulation of standing water.

A close-up photograph showing a hole in the ground. The hole is filled with reddish-brown soil and some roots. A white measuring stick is placed vertically in the hole for scale. The surrounding area is covered with dry, brown grass and some green weeds.
<p>Significant animal hole.</p>
