2020 DAM AND DIKE INSPECTION REPORT GEVR-20-010

PRIMARY BOTTOM ASH DAM FLINT CREEK PLANT SOUTHWESTERN ELECTRIC POWER COMPANY

GENTRY, ARKANSAS

2020 Annual Dam and Dike Inspection Report

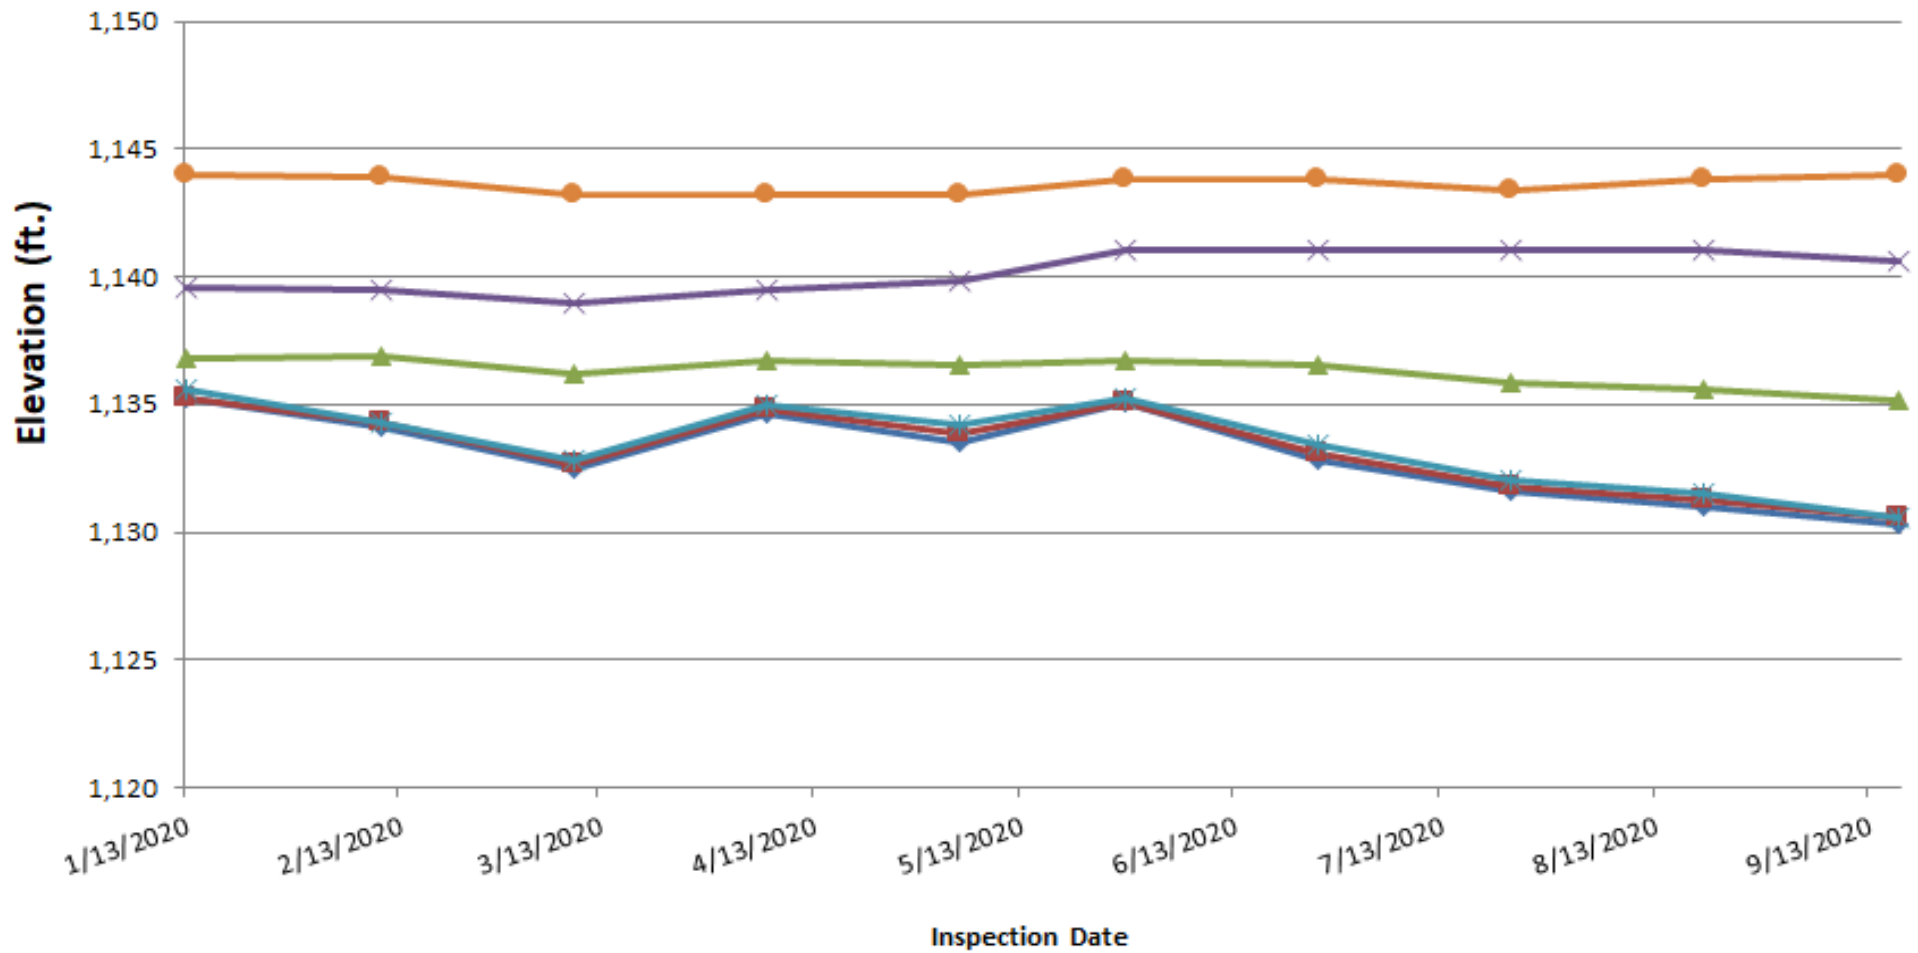
FIGURE 2

There are four piezometers located along the crest of the dam as shown on Figure 1. These are the only instrumentation related to this facility. A review of readings since the last inspection and historical readings indicate the levels are consistent and respond to the fluctuation of the cooling lake level. The piezometers are more influenced by the level of the cooling lake than the elevation of the bottom ash pond. Table 1 lists the maximum piezometer reading since the last annual inspection.

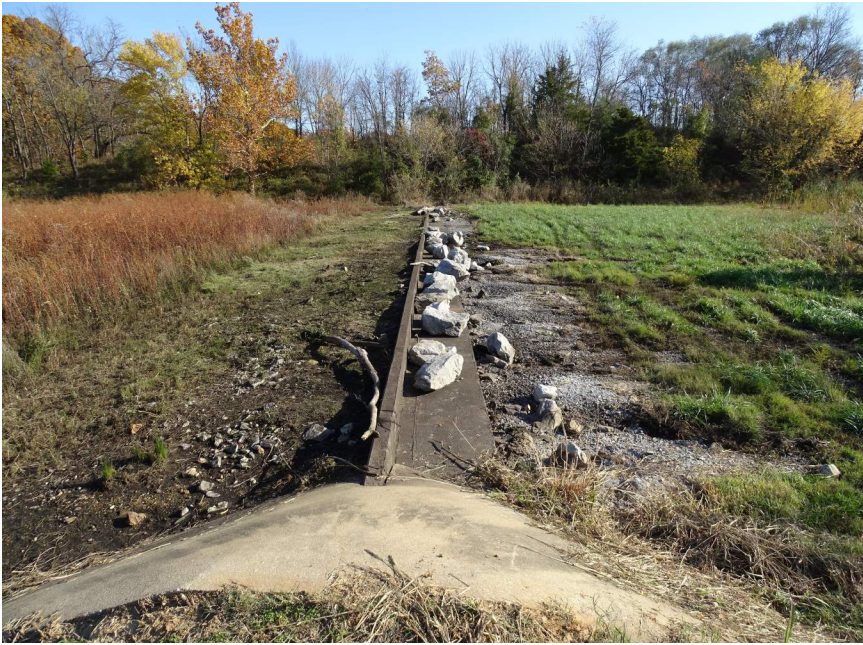
The emergency spillway is an incised channel in natural ground with a concrete weir control section, 1 ft. in height, across the channel width. The spillway was in generally good condition at the time of inspection (photos 1 and 2). The spillway appeared to be generally stable.

Photo #1 - Emergency spillway concrete sill

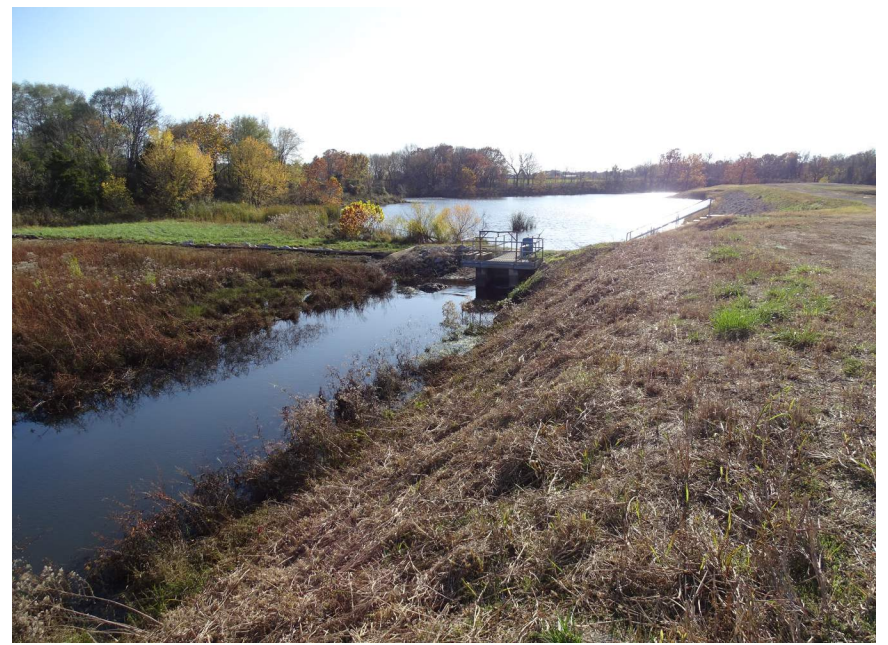
The principal spillway for the pond is a concrete drop-inlet structure with stop logs used to control the pool elevation. The spillway was in generally fair condition. Flow through the principal spillway was unobstructed. As noted earlier, the plant has lowered the operating level of the pond by removing several stoplogs.

Photo #2 - Principal spillway and approach area to spillway

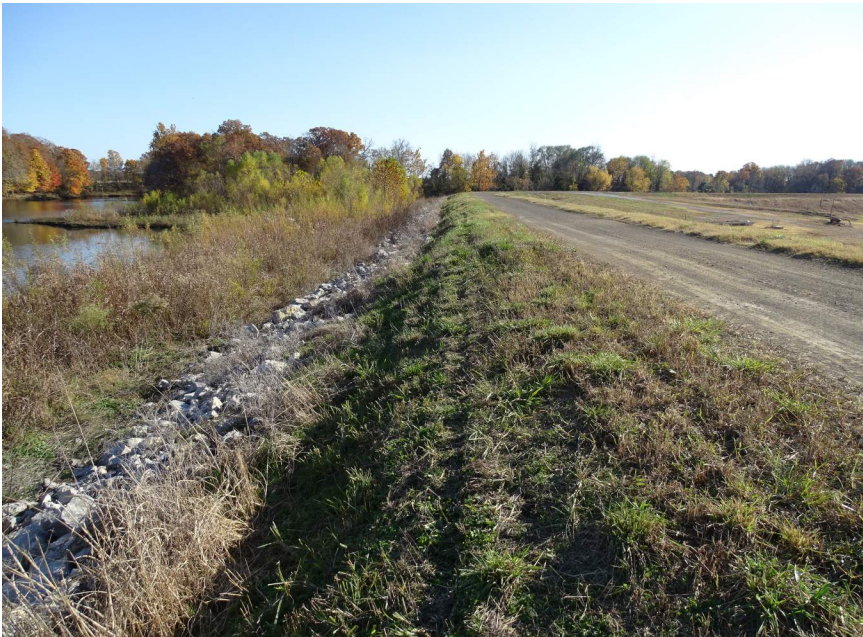
The upstream slope of the primary dam was observed to be in satisfactory condition from the visible riprap up to the crest (photo 3). Since the pond is used for settling of solids, there is an accumulation of bottom ash over the upstream slope. The operations of ash removal has removed a significant portion of the ash delta and the natural vegetation that established on the ash.

There were no signs of sloughing or movement of the upstream slope. No rodent holes or erosion were observed during the inspection. The condition of the riprap was good.

Photo #3 - Upstream slope looking south

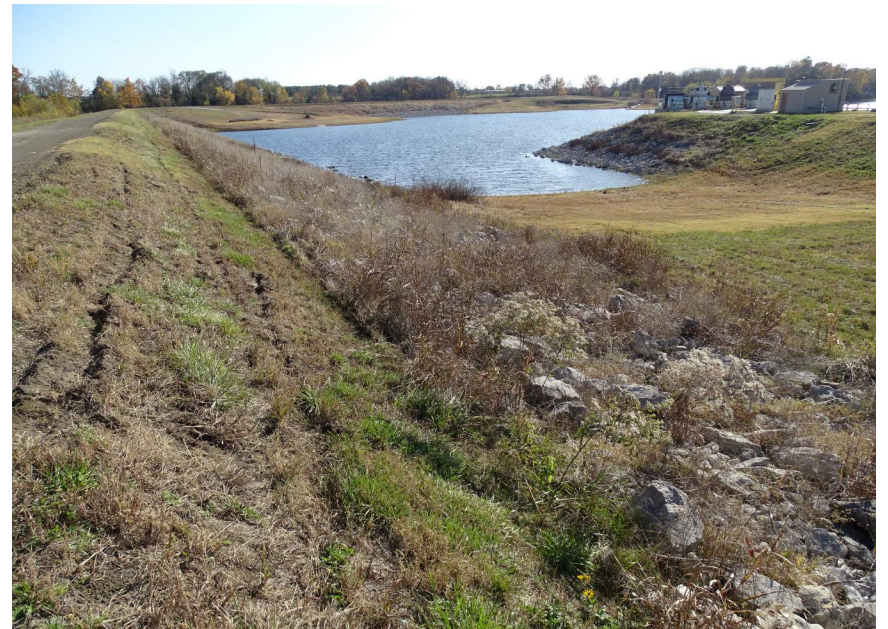
The downstream slope of the primary dam was in satisfactory condition (photo 4-6). Most of the slope is covered with riprap except for the upper 12-15 feet of the slope length is grass. Woody vegetation within the riprap is being controlled. There was no observed displacement or movement of the riprap. There was no seepage observed along the face of the slope.

Photo #4 - Downstream slope looking south

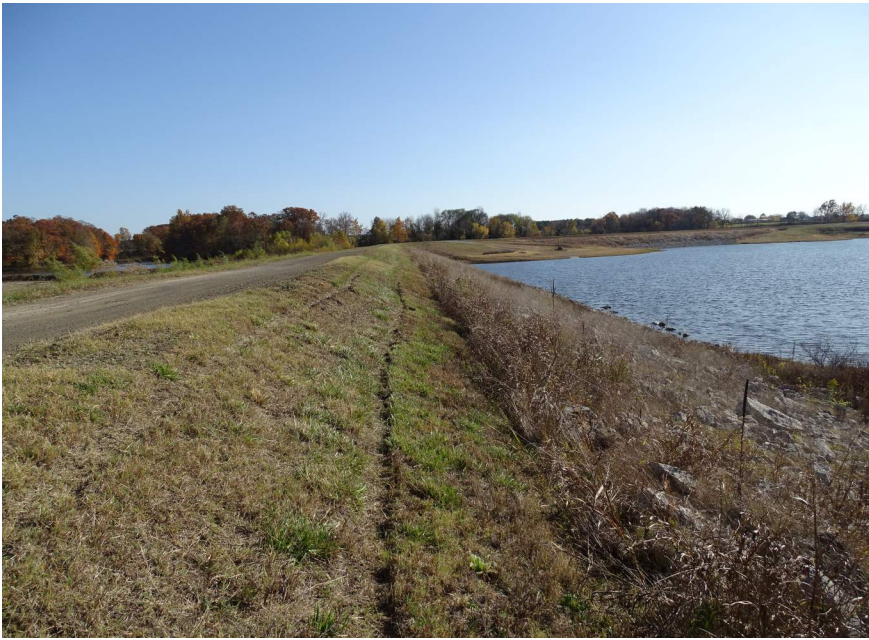
Photo #5 - Downstream slope looking south

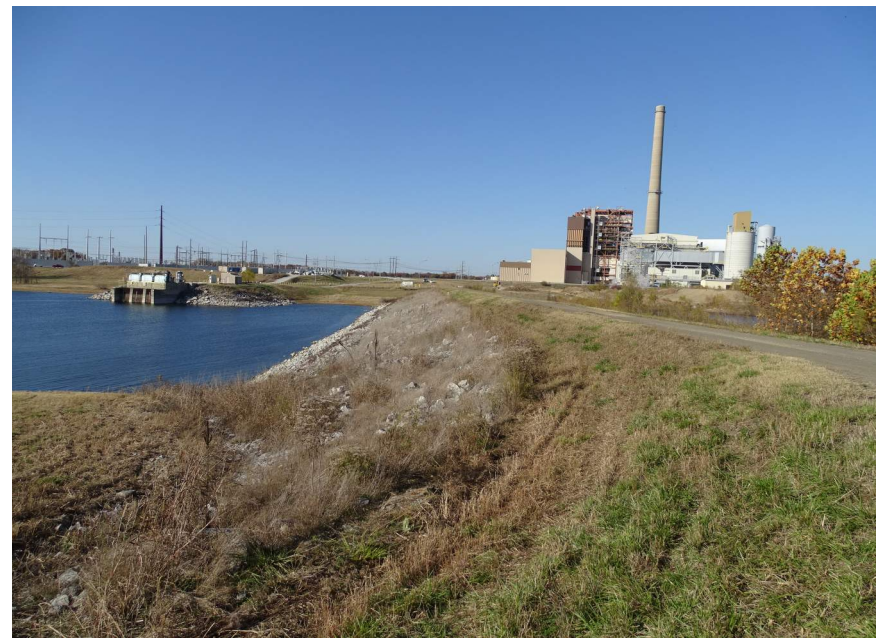
Photo #6 - Downstream slope looking north

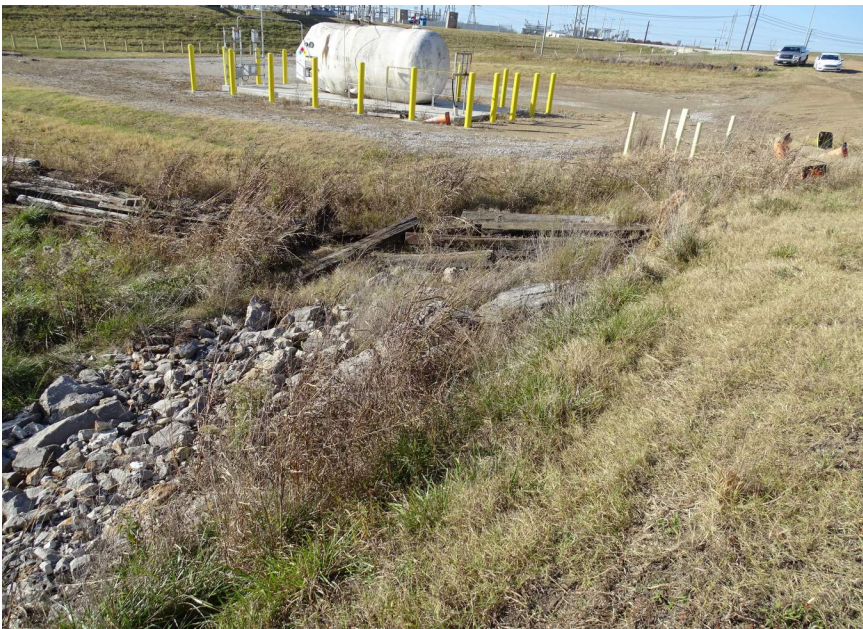
No erosion was observed in either of the groin ditches (photo 7).

Photo #7 - Right, downstream groin
