# 2021 Annual Dam and Dike Inspection Report

**Fly Ash Pond**

**John E. Amos Plant  
Appalachian Power Co.  
Putnam County, West Virginia**

**December 2021**

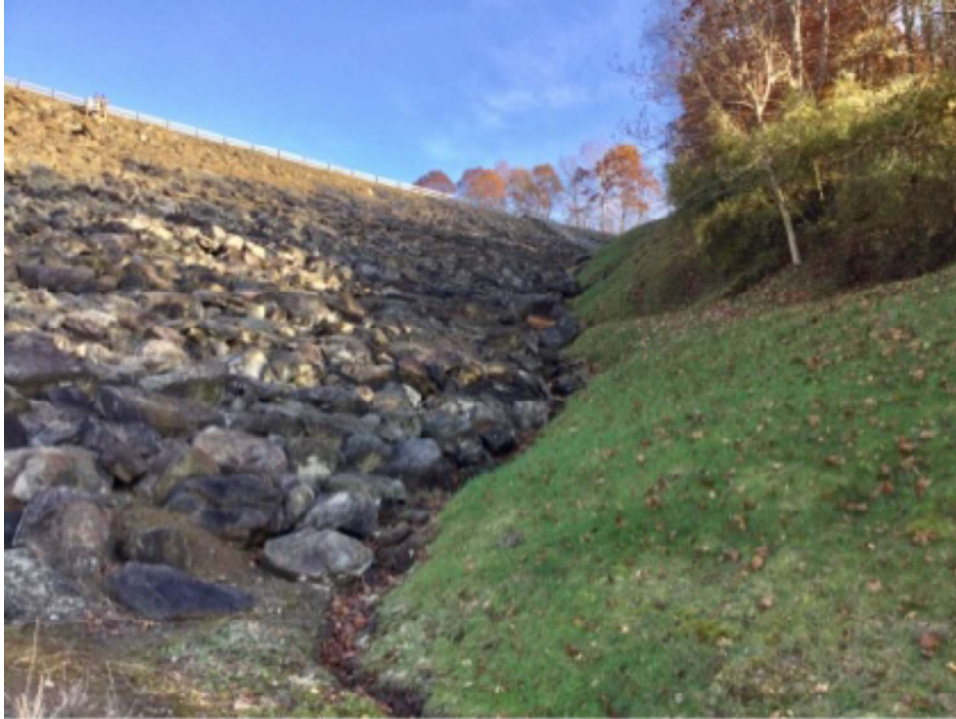
Photo #: 11

Notes: General condition of downstream left groin looking southeast from 716 bench

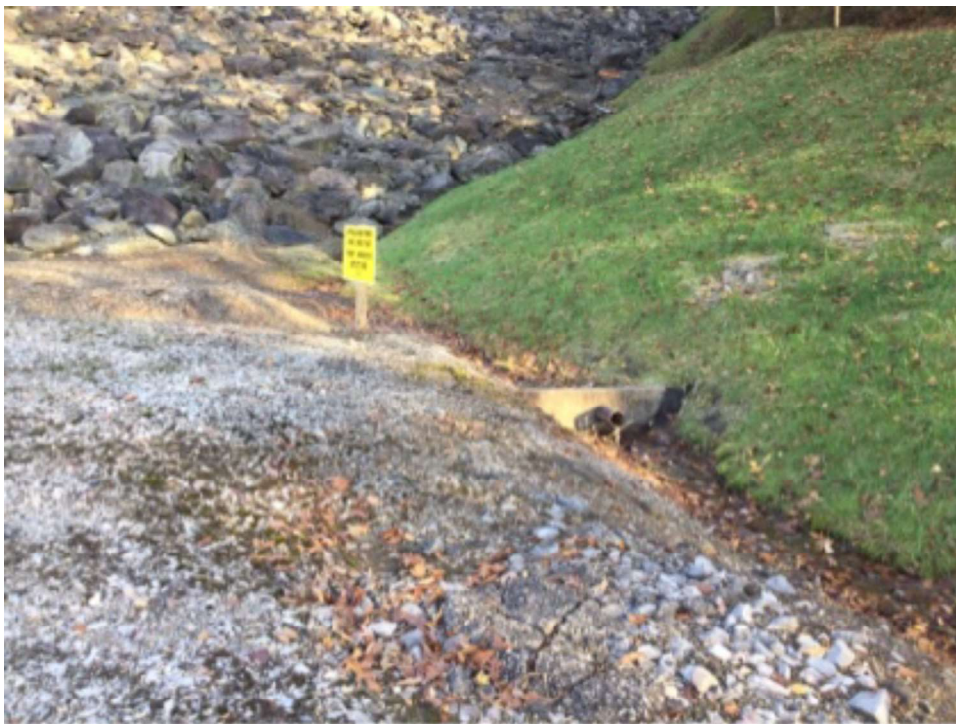
Photo #: 12

4. Another area of seepage near PZ-94-1 remains unchanged from last year's inspection.
5. The right and left groin seepage weirs (Outfall 040 and 041) were free flowing and clear.

Notes: General condition of seep monitoring weir outfall 040 at 716 bench and left groin looking east.

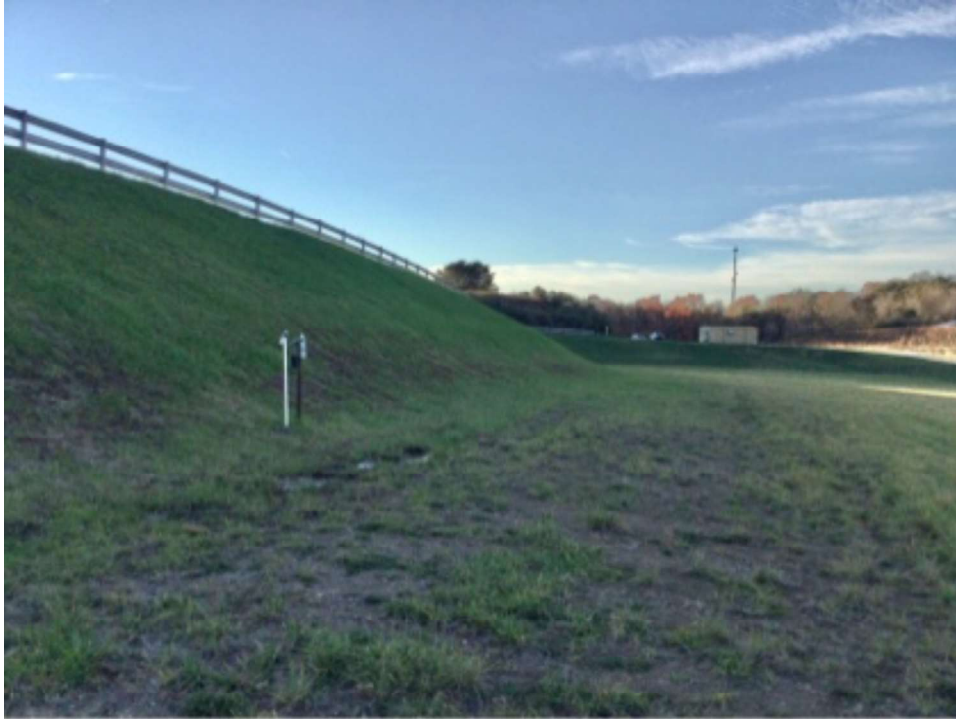
Photo #: 23

10. The upstream slope showed no visual signs of bulges, misalignment, or erosion. No animal burrows were noted on the upstream slope. The upstream slope was well vegetated and is controlled by timely mowing.

Notes: General condition of upstream slope looking northwest

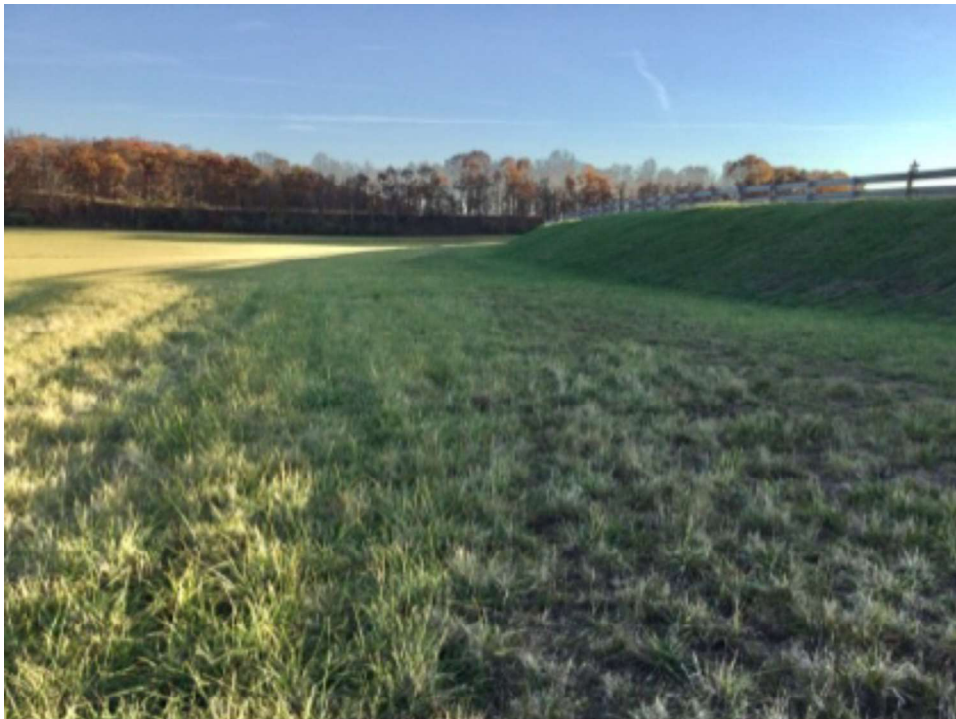
Photo #: 24

Notes: General condition of upstream slope looking southeast
