# 2021 Annual Landfill Inspection Report

**Mitchell Plant**

**Kentucky Power Company and Wheeling Power Company  
Moundsville, West Virginia**

**Document ID: GERS-21-012**

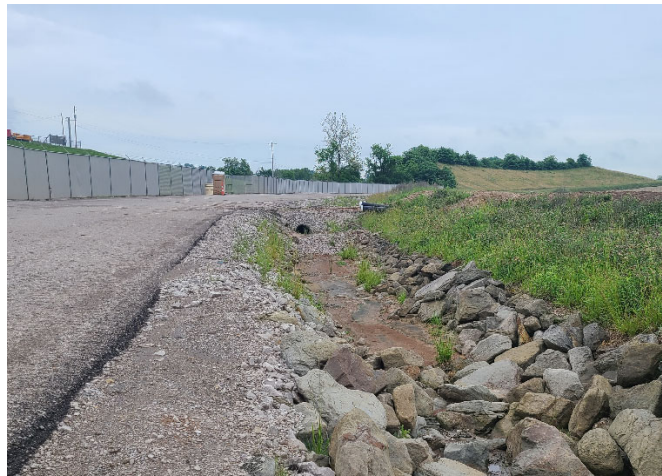
**Photo No. 1**

1. 6-inch-thick layer of the temporary cover was placed in the Phase 1 Area. The area is not actively receiving CCR material for disposal. There was no evidence of standing water, erosion, slope instabilities or uncontrolled seepage. Minor sediments collected in outer ditch north of phase 1 (Photographs 1 and 2).

Observation 1: Sediment Accumulation

Location: Outer Ditch Phase 1

- 1) Periodically remove the vegetation growing in the riprap-lined areas on the upstream slope and downstream toe area of the south pond dam.
- 2) Continue to perform routine maintenance on the leachate pump system components and remove any debris accumulation (leaf litter, sticks, etc.) as necessary for proper operation of the pumping system.
- 3) Clean sediments in outer ditch phase 1

Recommendations: Clean ditch.

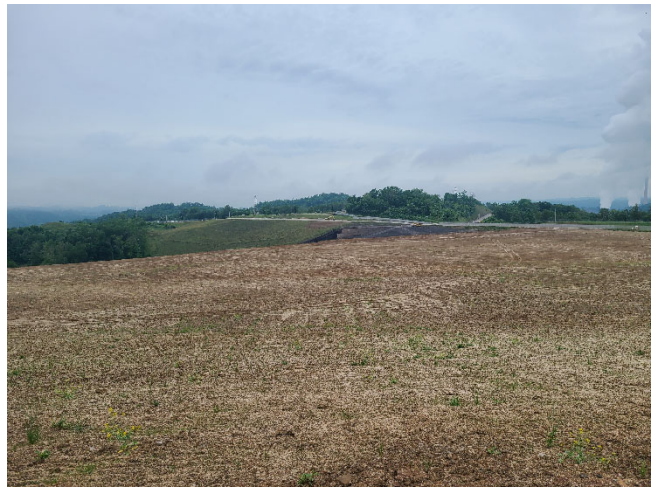
Observation 2: General Conditions:  
temporary soil cover

Location: Phase 1

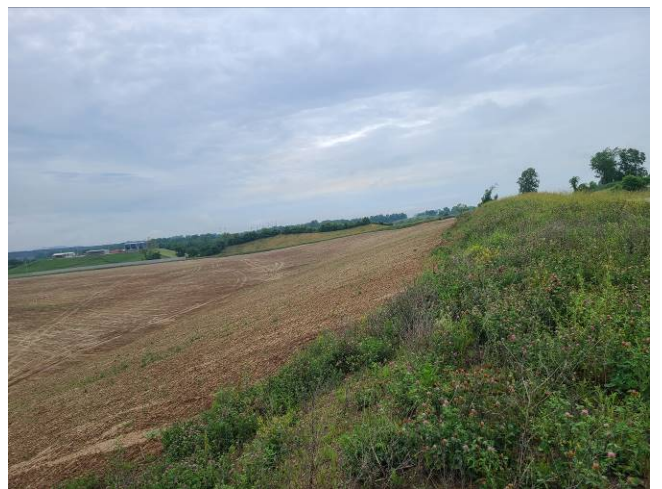
**Photo No. 3**

1. 6-inch-thick layer of the temporary cover was placed in the Phase 2 Area. The area is not actively receiving CCR material for disposal. There was no evidence of standing water, erosion, slope instabilities or uncontrolled seepage. Minor sediments collected in outer ditch north of phase 1 (Photograph 3 and 4)

Observation 3: General Conditions:  
temporary soil cover

Location Phase 2.

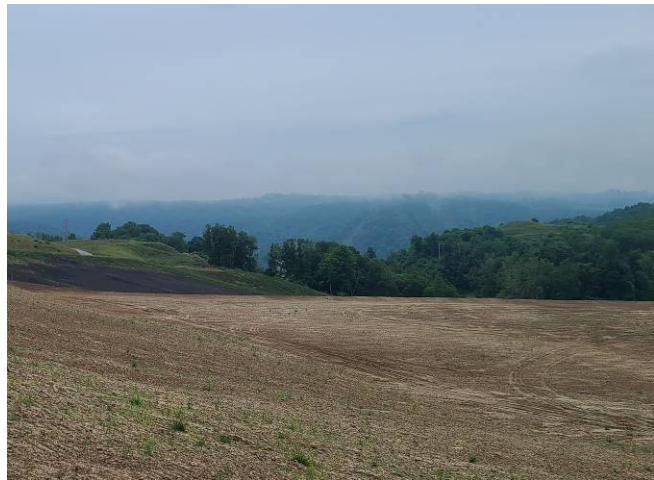
**Photo No. 4**

Observation 3: General Conditions:  
temporary soil cover

Location Phase 2.

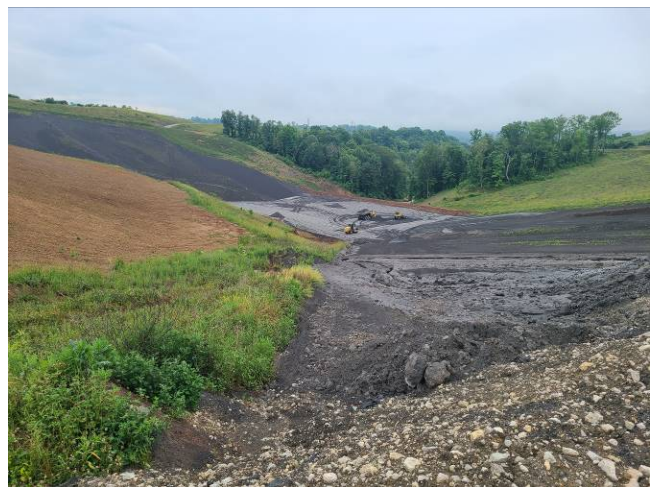
**Photo No. 5**

1. During the inspection, Phase 3 area was actively receiving CCR material for disposal. CCR material is dumped, spread out with a dozer and compacted with a smooth drummed roller. There was no evidence of standing water, erosion, slope instabilities or uncontrolled seepage (Photographs 5 through 8).

Observation 3: General Conditions:

Location: left edge of west inboard slope  
of Phase 3

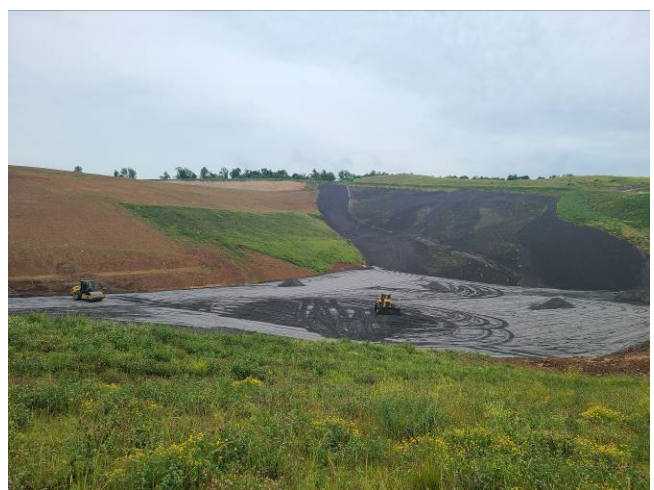
**Photo No. 6**

Observation 4: General Conditions: Fly ash  
placement in phase 3.

Location: Floor area of Phase 3.

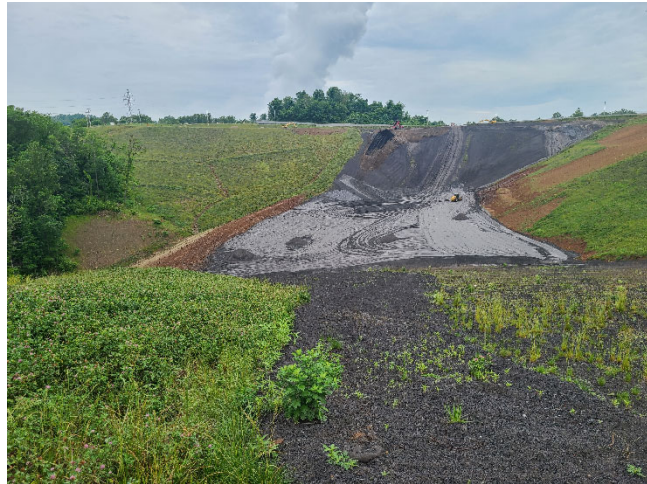
**Photo No. 7**

Observation 4: General Conditions

Location: left edge of east inboard slope of Phase 3

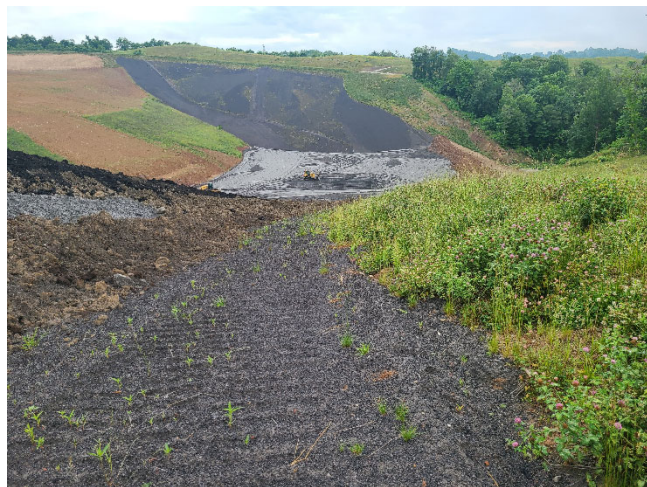
**Photo No. 8**

Observation 5: General Conditions

Location: Right edge of west inboard slope of Phase 3

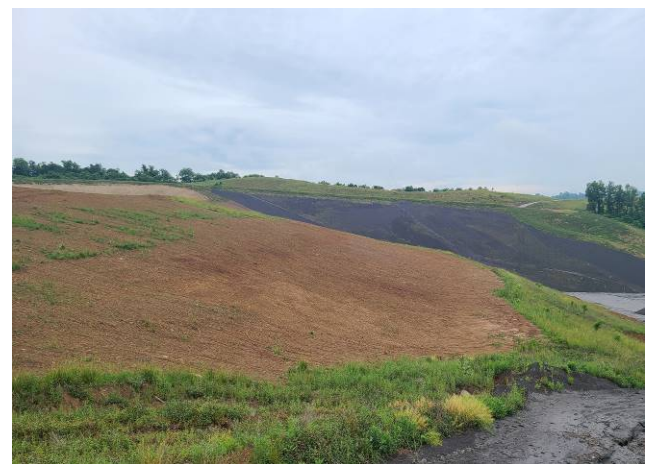
**Photo No. 9**

1. At the time of inspection, the clay berm south of phases 1 and 2 was recently mowed with good established grass cover. At some areas, the clay was harvested to be used in constructing the phase 3 Berm (photograph 9 and 10).
2. There was no evidence of uncontrolled leachate, slope instability or ponding water on the clay berms area.

Observation 7: Clay harvested from Berm

Location: Phase 1&2.

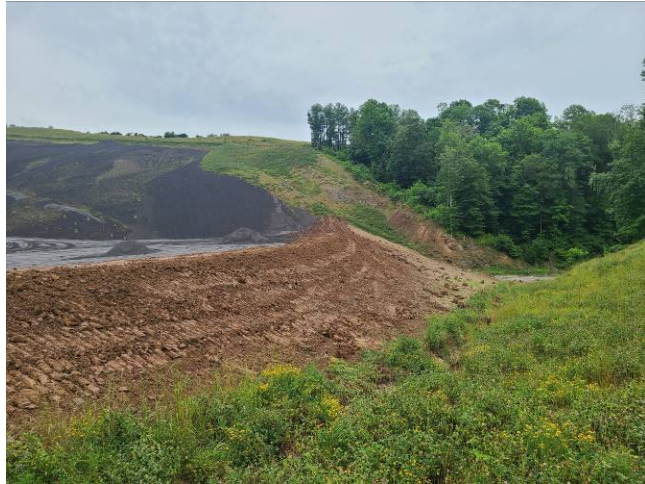
**Photo No. 10**

Observation 7: General Conditions.

Location: Recently raised clay berm Phase 3.

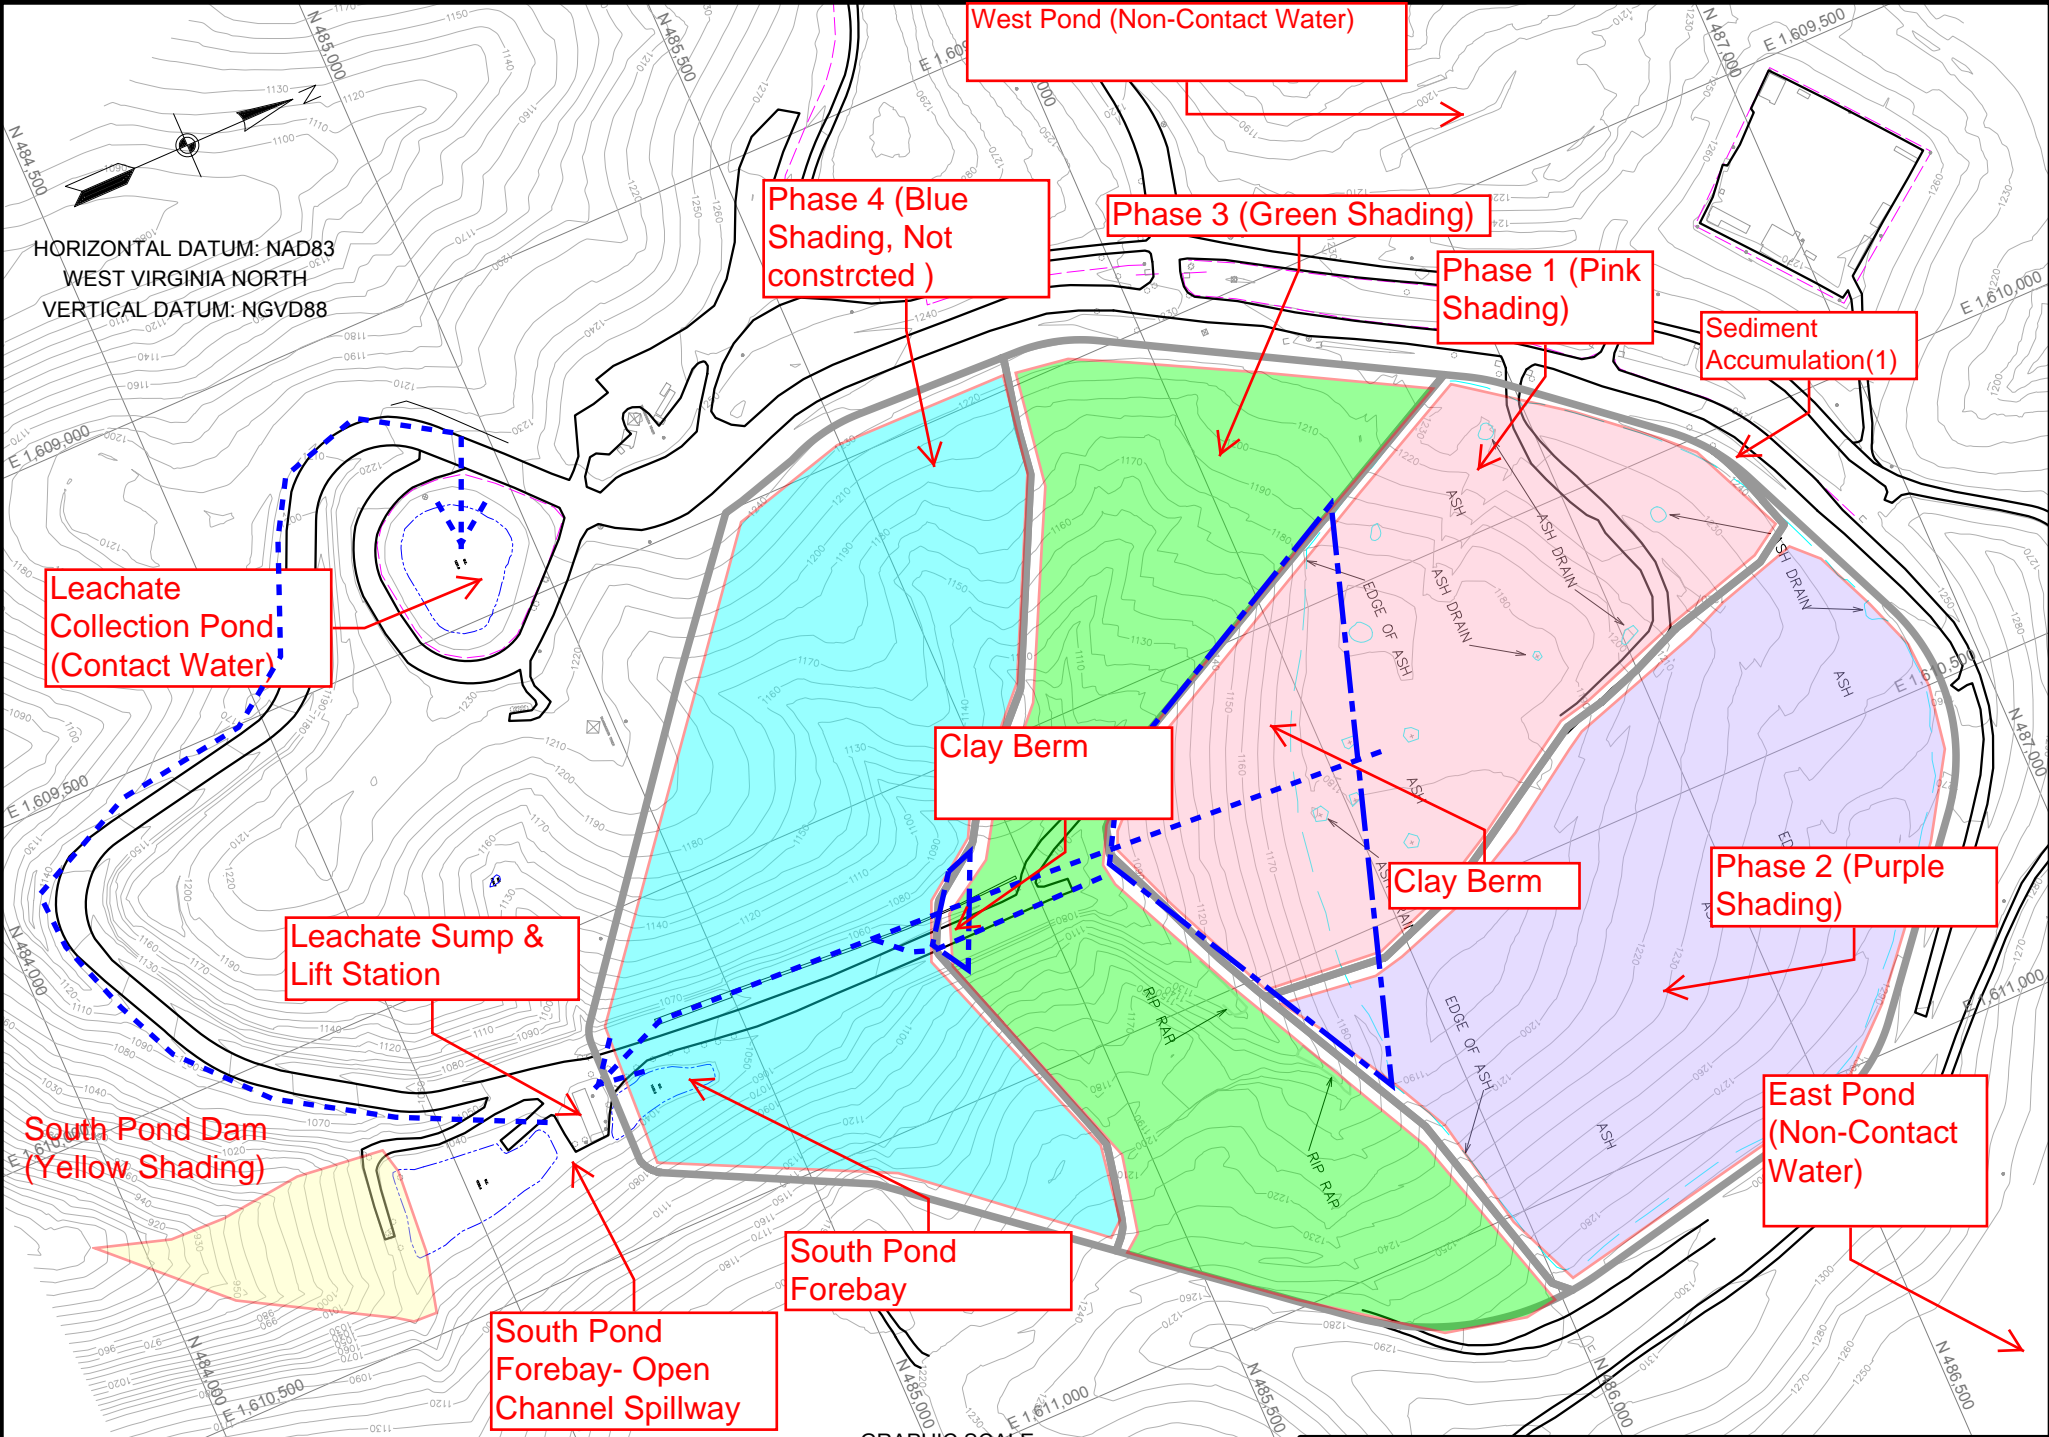
**Inspection Map**

Sediment Accumulation(1)
