# 2021 Annual Landfill Inspection Report

**Little Broad Run Landfill**

**Mountaineer Plant  
New Haven, West Virginia**

**2021 Annual Landfill Inspection Report  
(CCR Landfill)**

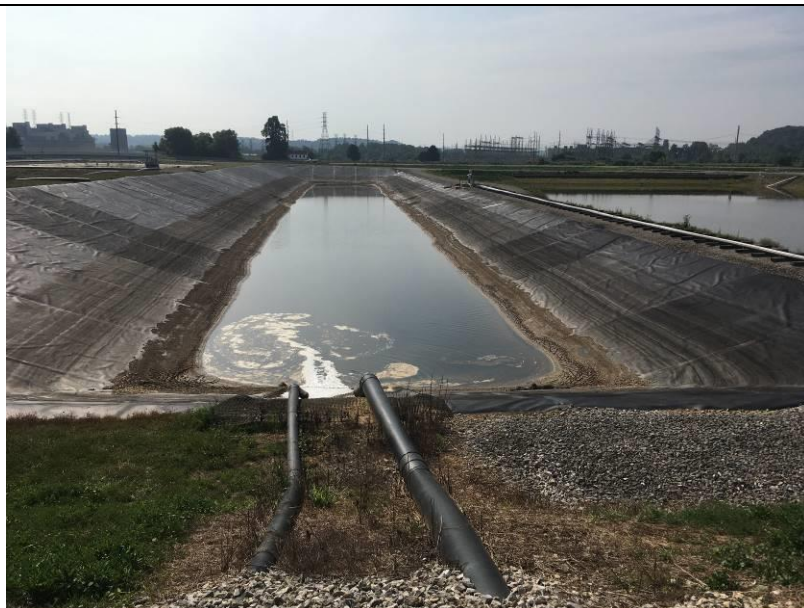
Photo # 1

1. Photograph No. 1 illustrates the leachate surge pond as part of the entire bottom ash complex. The leachate water from the landfill after going through the leachate collection pond system is discharged into the leachate surge pond located at the power plant. The two discharge HDPE pipes (8" and 16" in diameter) are located on the west dike of the pond illustrated in the photograph appeared in good functional condition.

This photograph illustrates landfill leachate surge pond and discharge pipes.

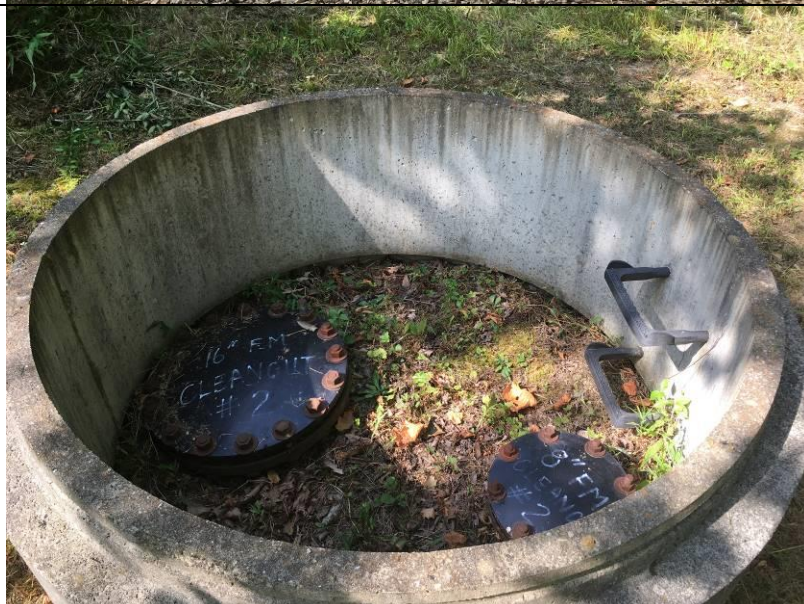
Photo # 2

2. These two discharge pipes are installed between the leachate collection pond and the wastewater pond. There are numerous cleanouts for the discharge pipes between the wastewater and leachate pond. Typical condition of the cleanout and concrete manhole for protection of the cleanouts are illustrated in Photographs No. 2 & 3. All the cleanouts were accessible inside the manhole and appeared in satisfactory.

Typical condition of the cleanout #2 and protective concrete collar.

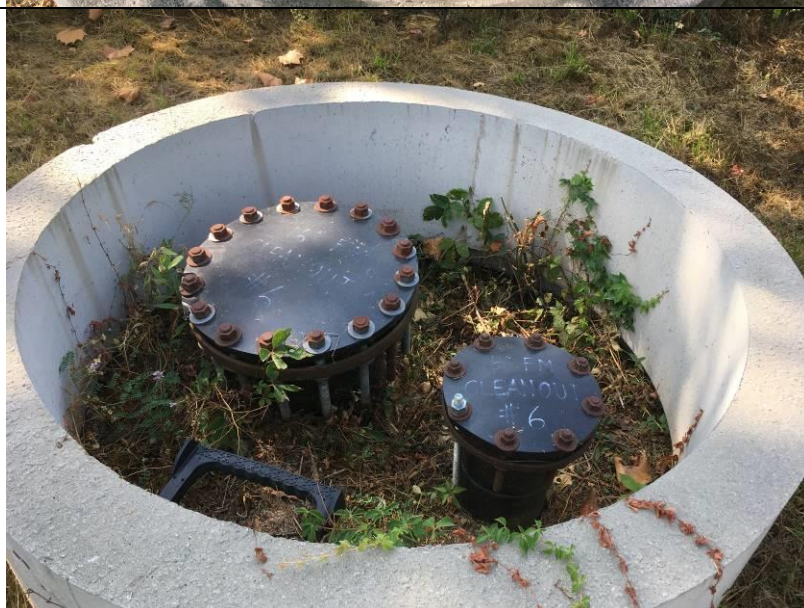
Photo # 3

Typical condition of the cleanout #6 and protective concrete collar.

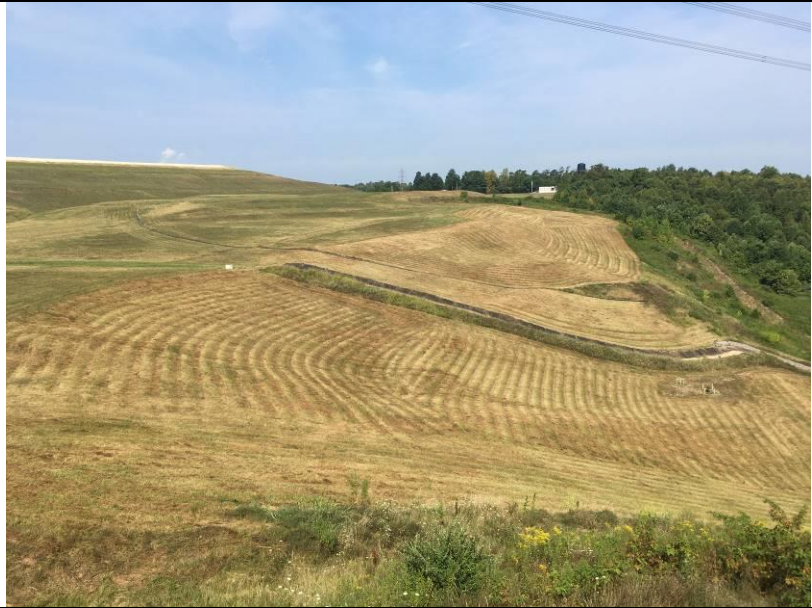
Photo # 4

3. Typical condition of landfill Areas 6 and 7 is illustrated in Photographs No. 4 through 7. Overall, landfill Areas 6 and 7 appeared in satisfactory and stable condition with adequate vegetative cover. The centerline drainage ditch through Areas 6 and 7 is in satisfactory condition but is sparse on vegetation cover (Photograph No. 6). The perimeter ditches were observed to be in satisfactory and functional condition (Photograph No. 7) with some overgrown vegetation among the rip rap. No standing water was observed in the perimeter ditches.

Typical condition of landfill Area 7 vegetative cover and let down chute.

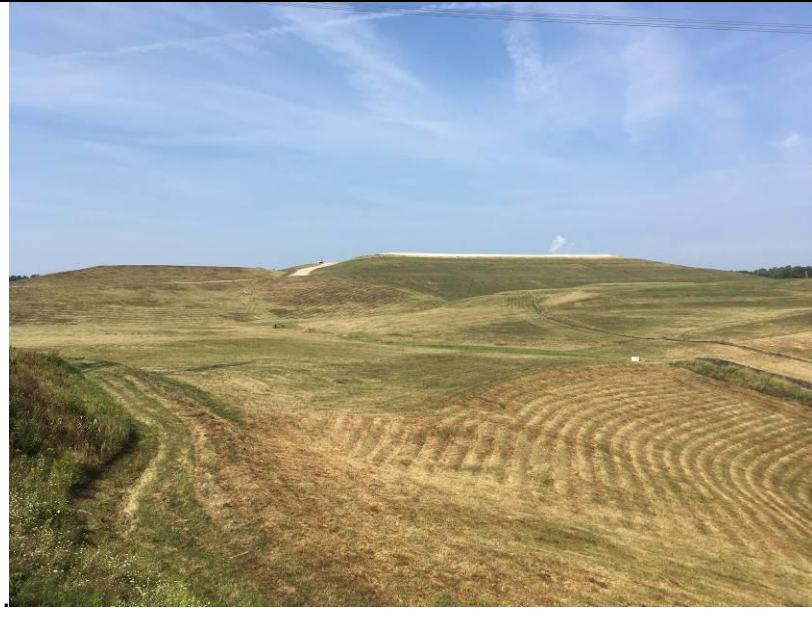
Photo # 5

Typical condition of landfill Areas 6 and 7 vegetative cover.

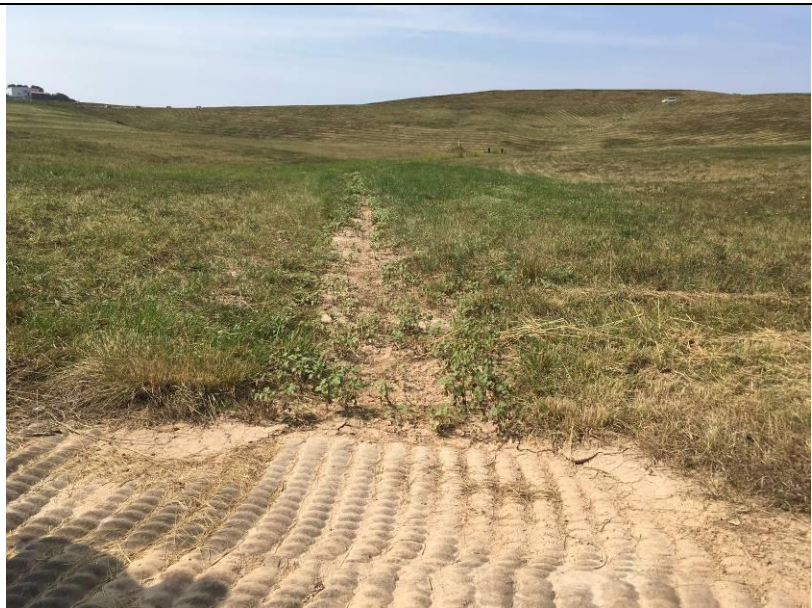
Photo # 6

View along Areas 6 and 7 cover centerline ditch leading to let down chute in Area 7.

1. Clear any excessive vegetation from the landfill areas and along the leachate discharge pipes and cleanouts as noted.
2. Reseed the centerline ditch through Areas 6 and 7 and remove the overgrown vegetation from the perimeter ditch on the east side of Area 6.
3. Perform maintenance on the Area 1 outside slope berm scarp area. Regrade and seed as necessary to establish good vegetation.
4. Remove overgrown vegetation from the rip rap along the Area 2 groin ditch near the toe.
5. Clean out the excessive cattail growth from the northwest sediment pond.
6. Remove excess gypsum from the stacker pad sump and sump area and backfill, regrade, and compact low areas of the stacker pad for positive drainage.
7. Clean out the excessive cattail growth from the Area 7 letdown chute plunge pool area.

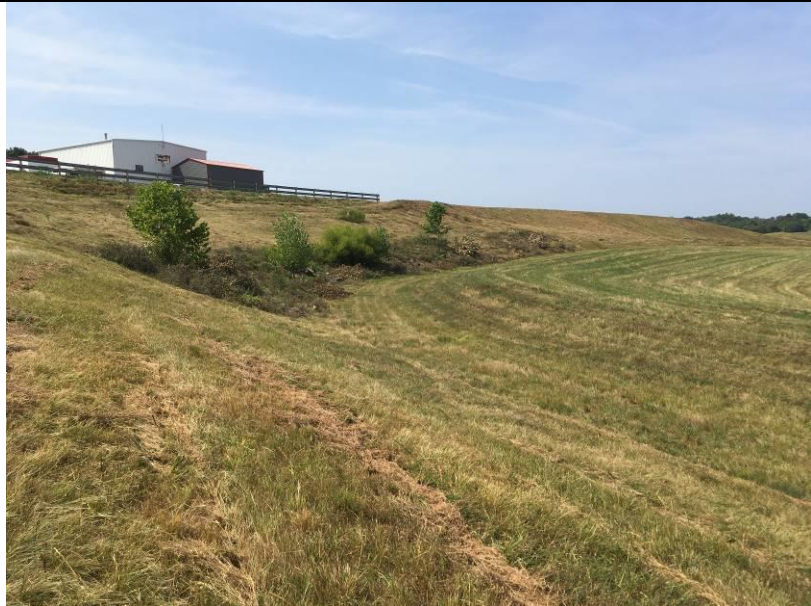
Photo # 7

View along the perimeter ditch of Areas 6 (looking east).

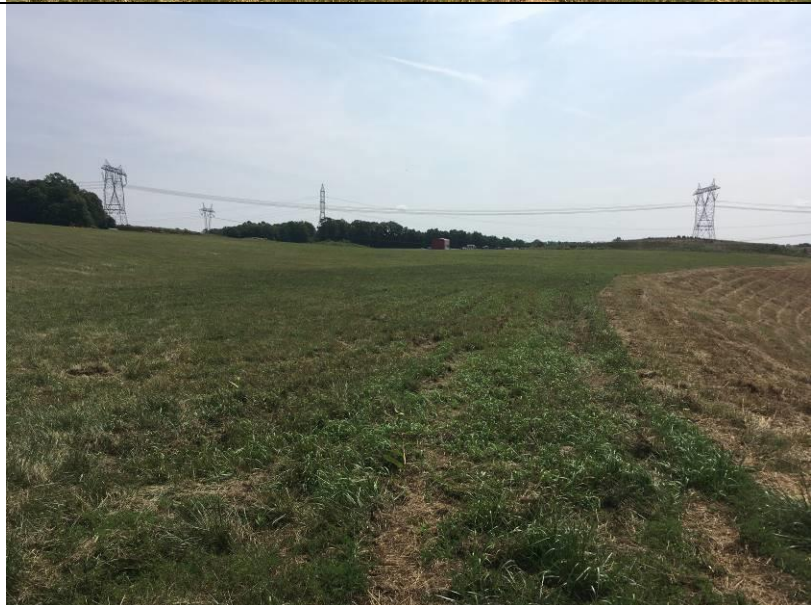
Photo # 8

4. Landfill Area 1 appeared in satisfactory and stable condition (illustrated in Photographs No. 8 and 9). A minor scarp that was repaired last year is showing signs of minor movement (Photograph No. 9).

Overall view of Area 1, top of the landfill.

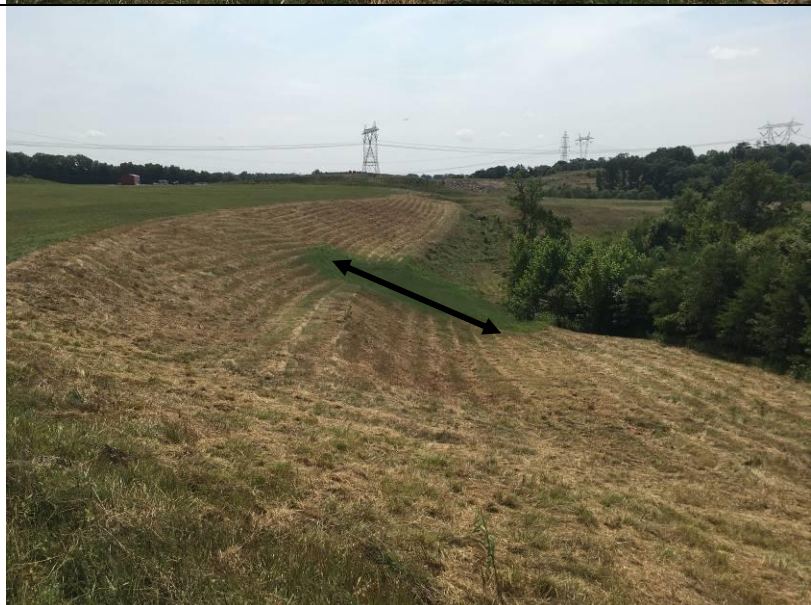
Photo # 9

Overview of Area 1 side slope cover. Notice repair area of minor scarp in the cover soils.

1. The interim remediation work at Area 3 of the landfill is complete, but should continue monitoring and inspecting the performance of remedial work and seepage management system until a permanent remediation plan is in place.
2. Monitor poor drainage issues at the gypsum stackout pad to reduce the amount of sediment build up in the sump structure.
3. Monitor the scarp area on the Area 1 outside slope berm until it has been completely stabilized.

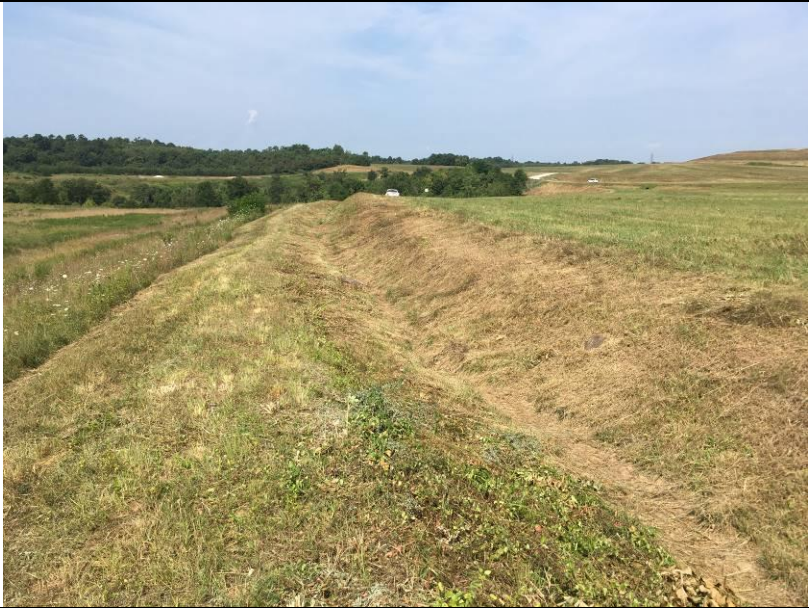
Photo # 10

5. The perimeter ditch around Area 1 is in satisfactory and stable condition (Photograph No. 10).
6. Overall Area 2 slopes appeared in satisfactory and stable condition (Photograph No. 11). The scour area along the left groin ditch near the toe area has been repaired, but it has overgrown vegetation throughout the rip rap protection (Photograph No. 12). The soil cover and vegetation on top of Area 2 are in satisfactory and stable condition (Photograph No. 13).

Overall view of Area 1 Perimeter Ditch.

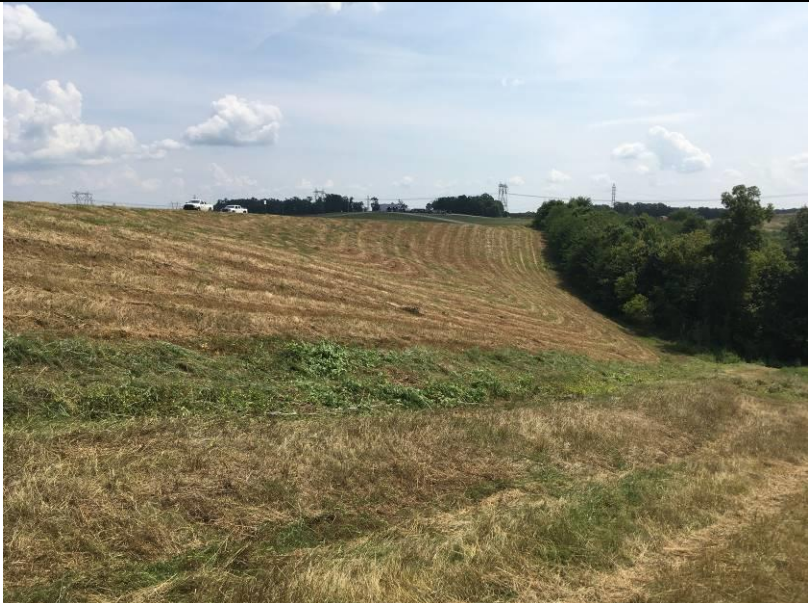
Photo # 11

Overview of Area 2 Vegetative Cover.

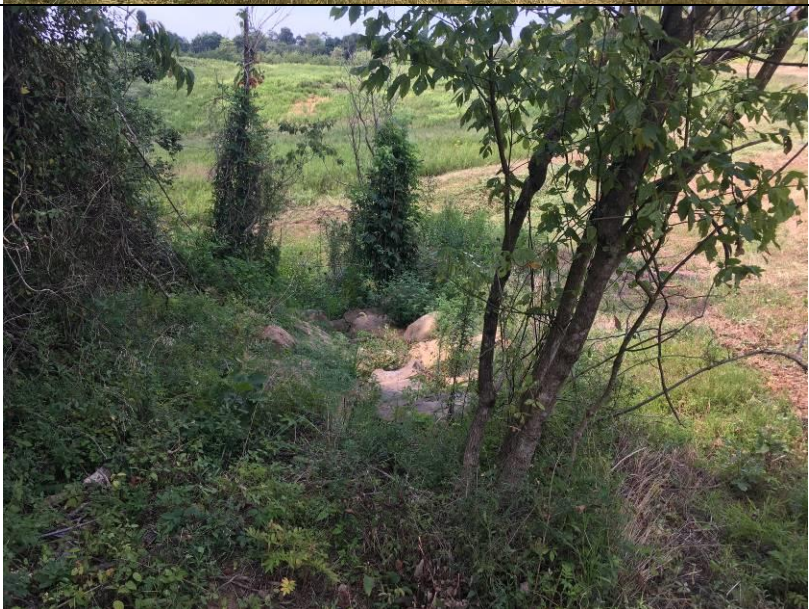
Photo # 12

Overview of Area 2 Side Slope Groin Ditch Near the Toe. Notice excessive vegetative growth along rip rap.

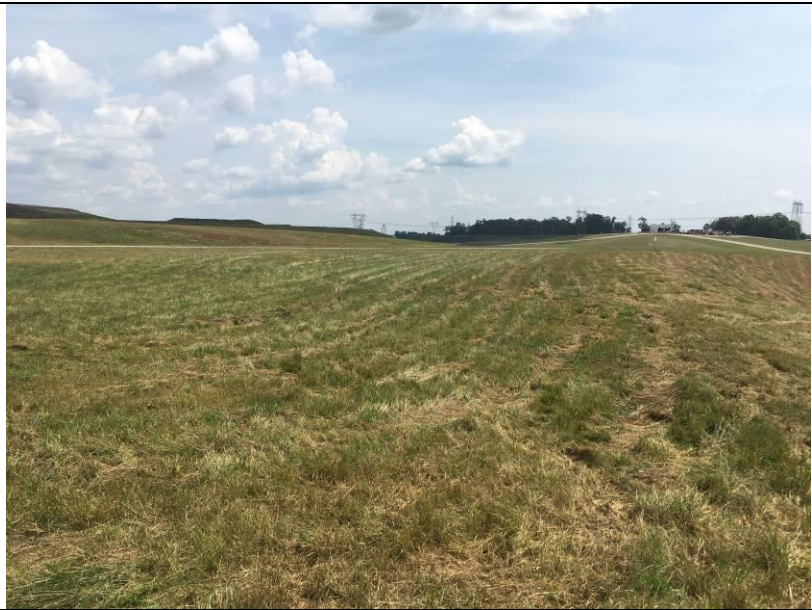
Photo # 13

Overview of Area 2 Vegetative Cover.

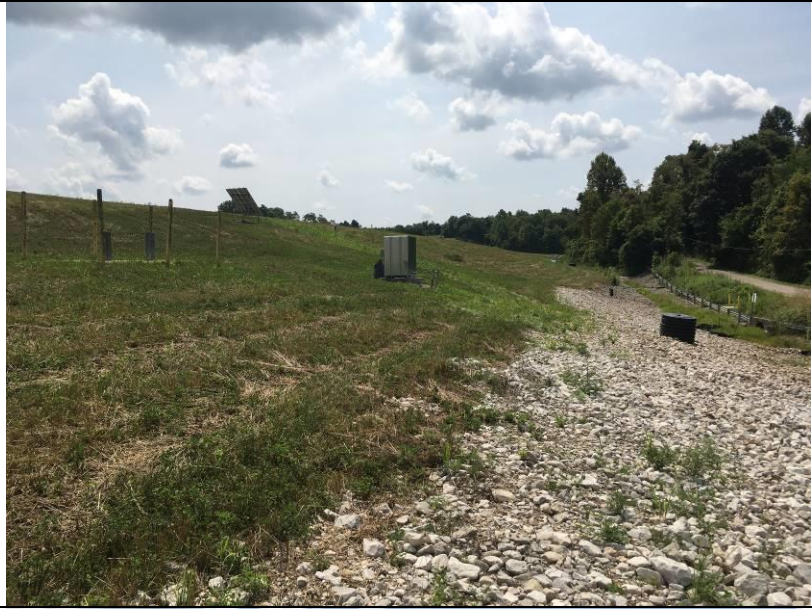
Photo # 14

7. Overall Area 3 appeared in satisfactory and stable condition with good vegetative cover and the perimeter ditches around Area 3 were in satisfactory and functioning condition with no standing water (Photographs No. 14, 15, 17 and 18). The toe drains and sump collection pits recently installed along the bottom of Area 3 slopes appeared to be in satisfactory and functional condition. A picture of the sump structure is shown in Photograph no. 16. There were no signs of seepage or wetness along the outside slope areas.

Overview of Area 3 Vegetative Cover with Rip Rap Toe Area.

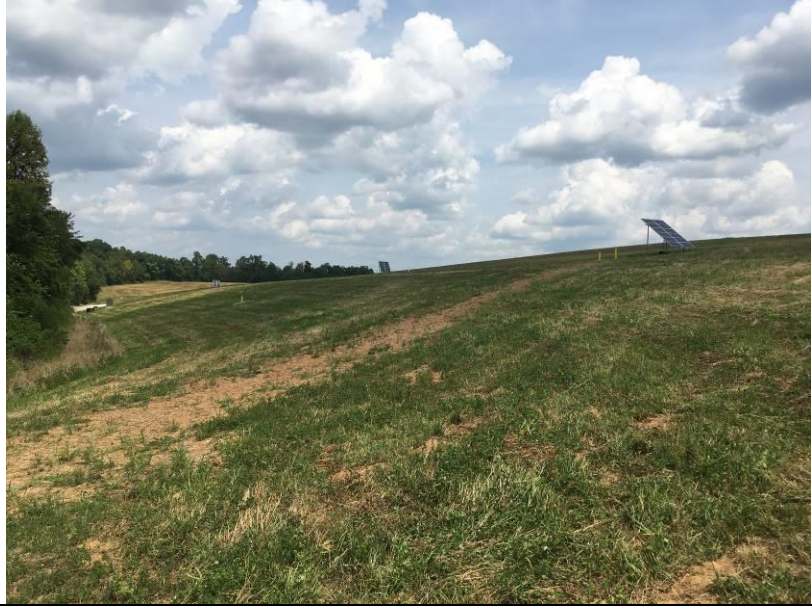
Photo # 15

Overview of Area 3 Vegetative Cover.

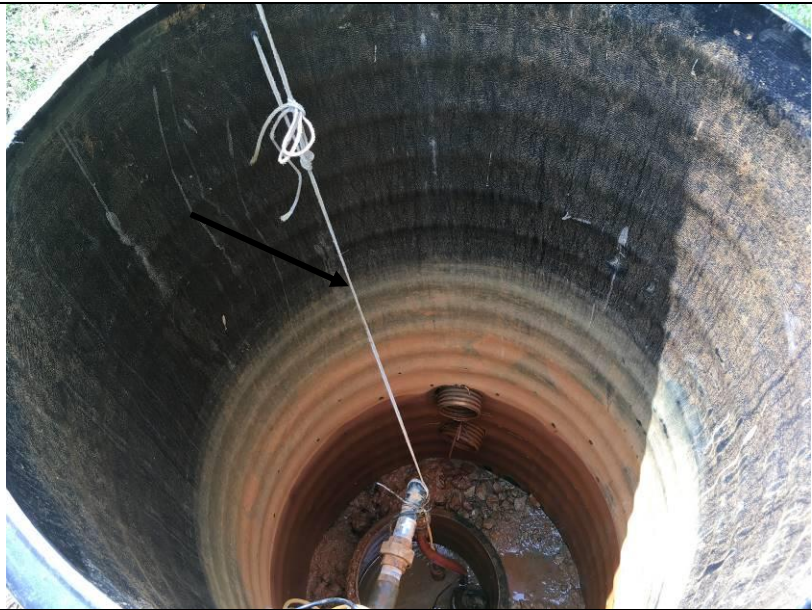
Photo # 16

There is, however, a noted deficiency pertaining to leachate seepage and buildup in Area 3 of the existing landfill. The deficiency related to seepage from the cover soils of Area 3 was identified as part of regular monitoring and inspections on July 9, 2020. An interim seepage control plan for Area 3 was developed that consisted of installing several shallow toe drains and sump structures to intercept the seepage before it could daylight through the toe areas of the cover soils. The sump structures pump the collected seepage to a storage tank that is then emptied back into the landfill leachate collection system. A permanent remediation plan for the seepage build up in Area 3 has been developed and will include a multipoint well system for dewatering and removal of excess leachate and a detailed evaluation of the cap/cover materials to determine the effectiveness of the current cap system.

Typical View of Area 3 Toe Drain Sump Pit.

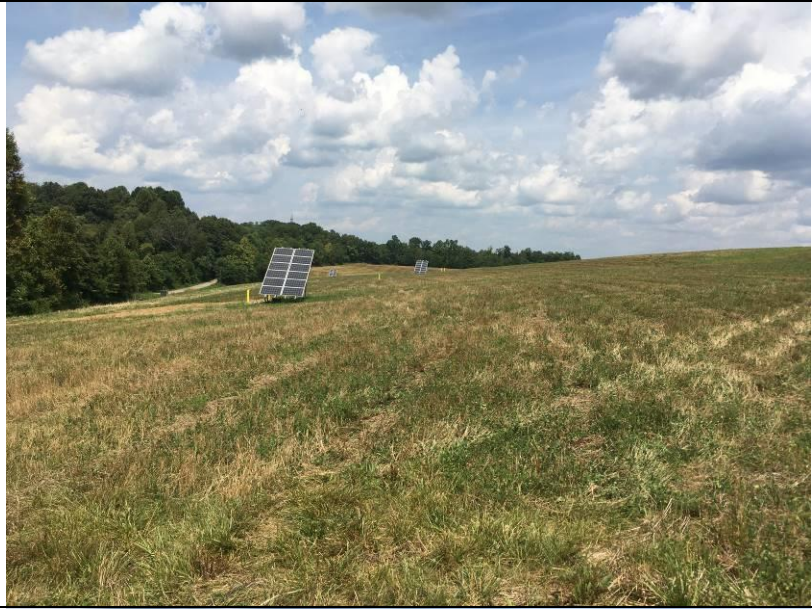
Photo # 17

Overview of Area 3 Cover with Solar Panels for Sump Pit Power.

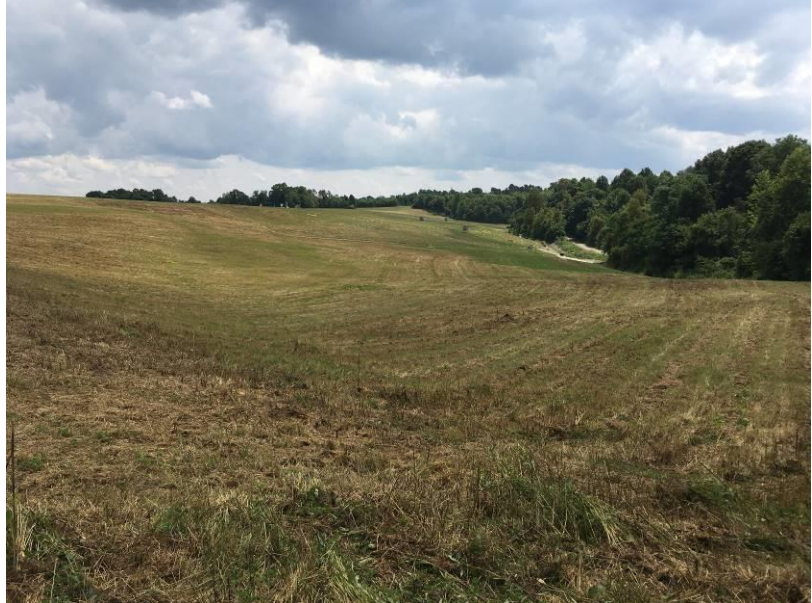
Photo # 18

9. Overall Area 4 appeared in satisfactory and stable condition (Photograph No. 18, 20 and 21). The soil cover, vegetation and rip rap drainage channel appeared to be in satisfactory condition.

Overview of Area 3 and 4 Vegetative Cover, Top of Landfill.

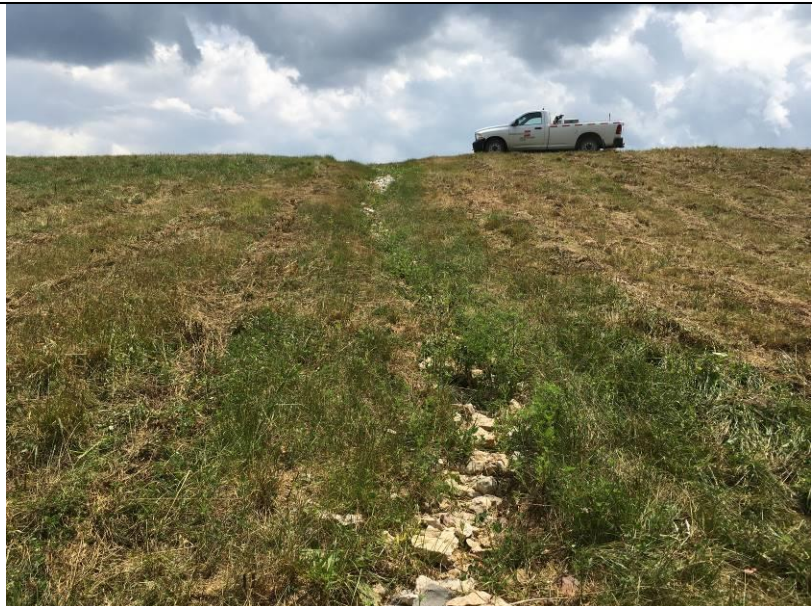
Photo # 19

8. There was a significant erosion rill that was recently repaired with rip rap in Area 4 that appears to be stable and in satisfactory condition with good vegetation growth around the repair area. (Photograph No. 19).

Overview of Area 4 Erosion Rill Repaired with Rip Rap.

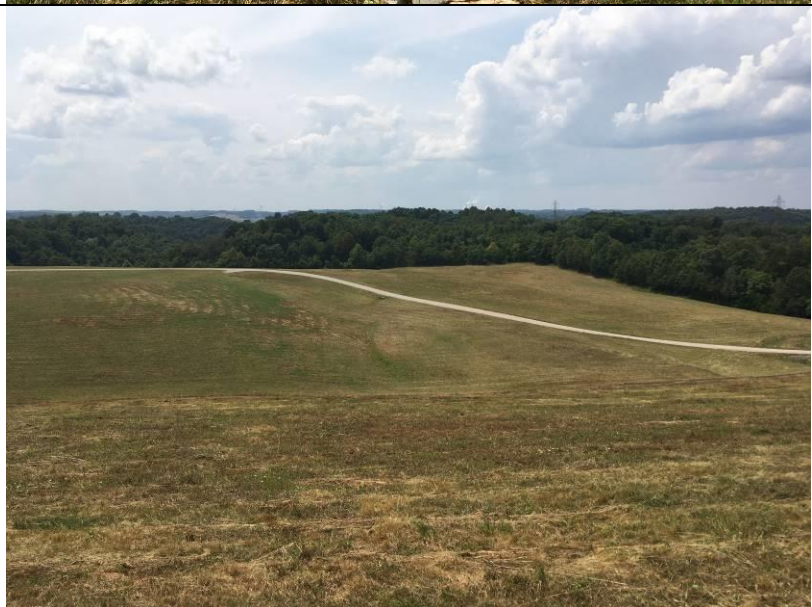
Photo # 20

Overview of Area 4 Cover Soils.

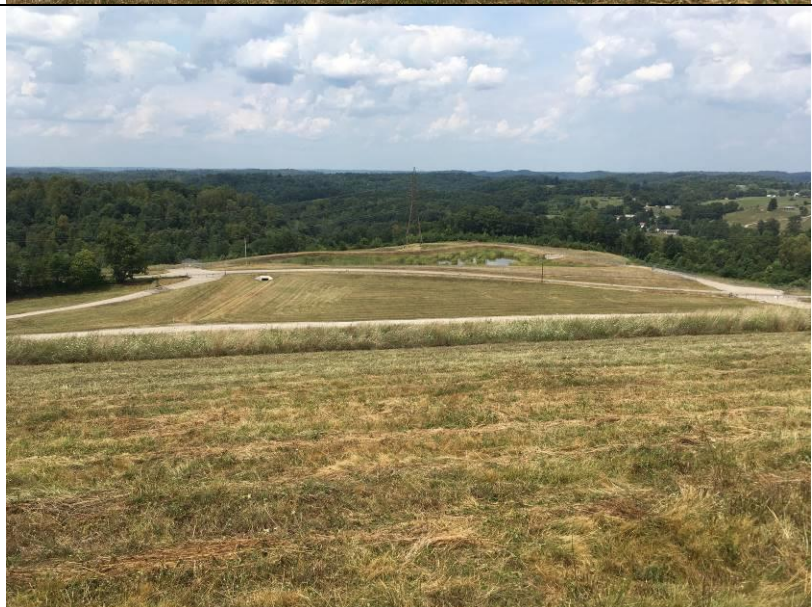
Photo # 21

Overview of Area 4 Cover Soils Looking across Northwest Sediment Pond.

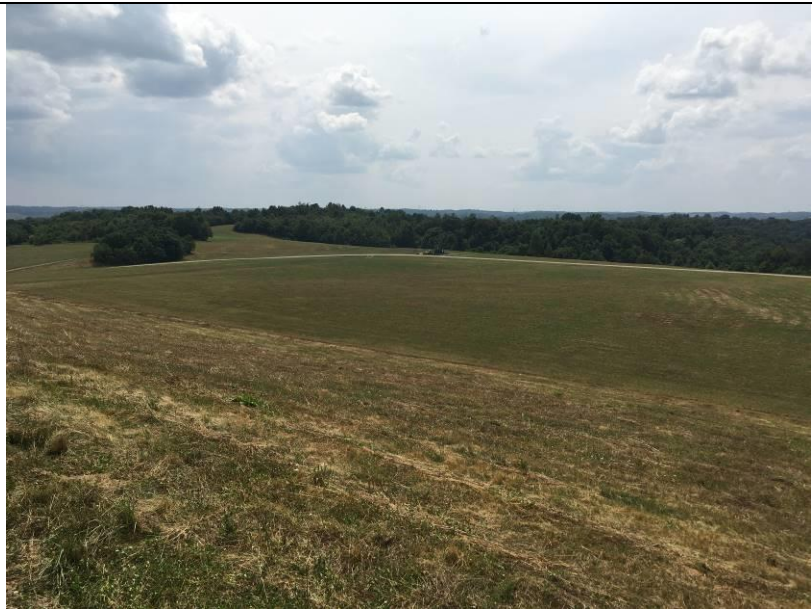
Photo # 22

10. Landfill Area 5 is illustrated in Photograph No. 22. Area 5 and the perimeter access road was in satisfactory and stable condition with controlled vegetation.

Overview of Area 5 Cover Soils.

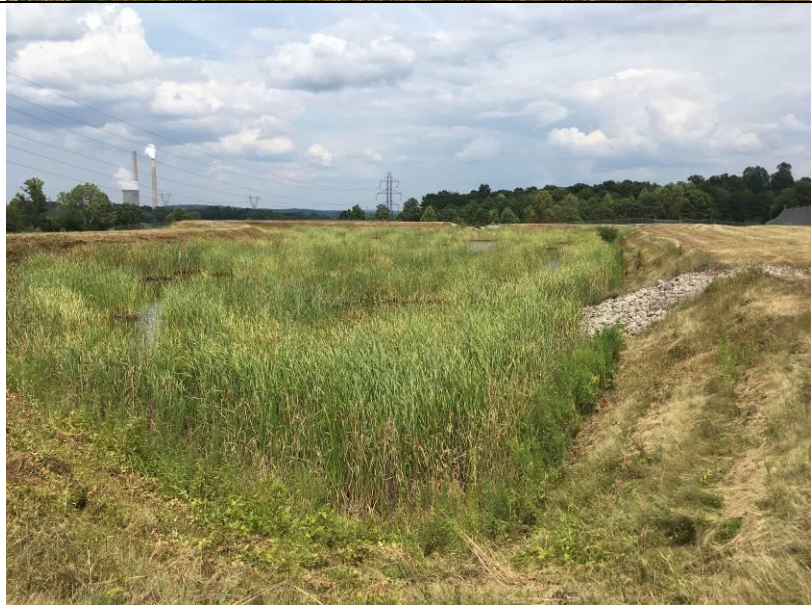
Photo # 23

11. Photograph No. 23 illustrates the northwest sediment pond. Overall, the pond appeared to be functioning as designed and the dikes were in satisfactory and stable condition. Cattail growth was observed throughout the pond area and needs to be cleared.

Overview of Northwest Sediment Pond. Notice Overgrown Cattails.

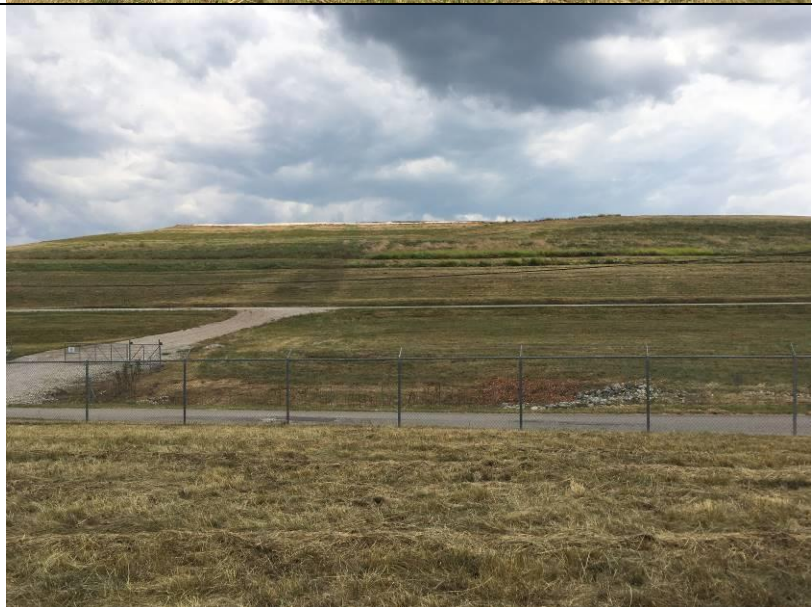
Photo # 24

12. The outside side slope areas of vertical expansion Phase 1A is illustrated in Photograph No. 24. The perimeter ditches (Photograph No. 25) and access road were in satisfactory and stable condition with controlled vegetation.

Overview of Side Slope Area of Vertical Expansion Phase 1A Area.

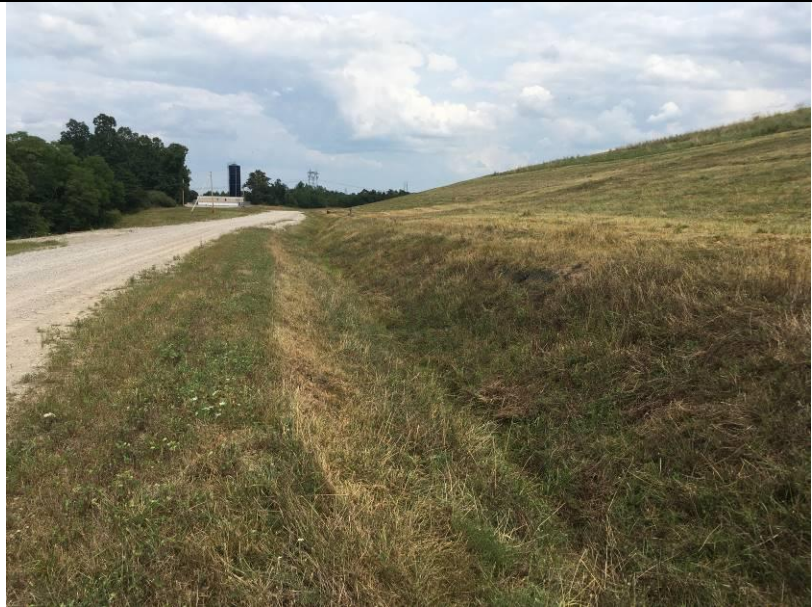
Photo # 25

Typical Conditions of Perimeter Ditch of Vertical Expansion Areas 1A and 1B.

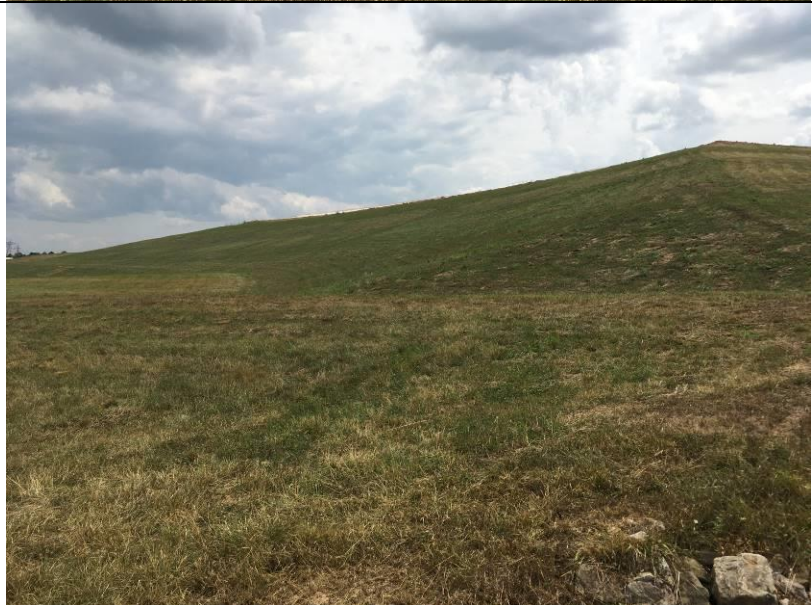
Photo # 26

13. The outside side slope areas of vertical expansion Phase 1B is illustrated in Photograph No. 26. The slope area and perimeter access road were in satisfactory and stable condition with controlled vegetation.

Overview of Side Slope Area of Vertical Expansion Phase 1B.

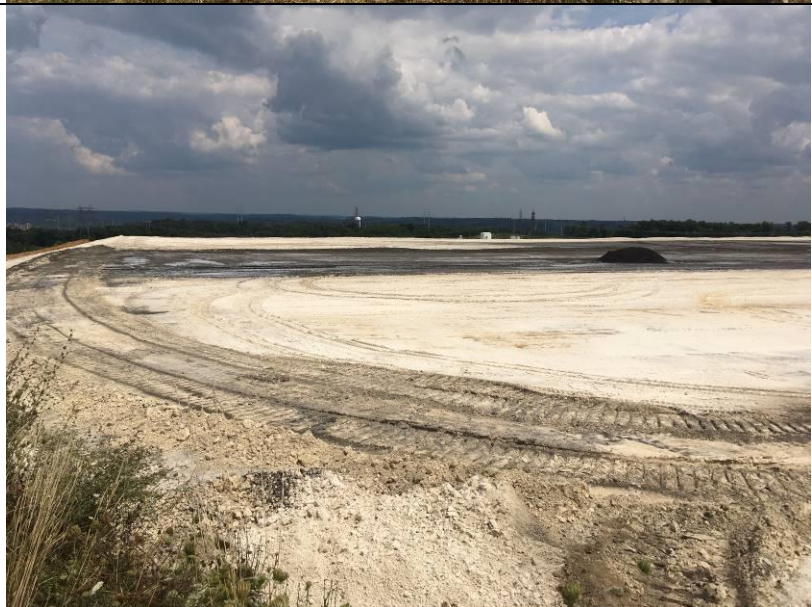
Photo # 27

14. Photograph No. 27 and 28 illustrates Phase 1B of the active landfill which is part of the vertical expansion. This area appeared satisfactory and in compliance with the permit requirements.

Active landfill - Vertical Expansion Phase 1B. Looking North.

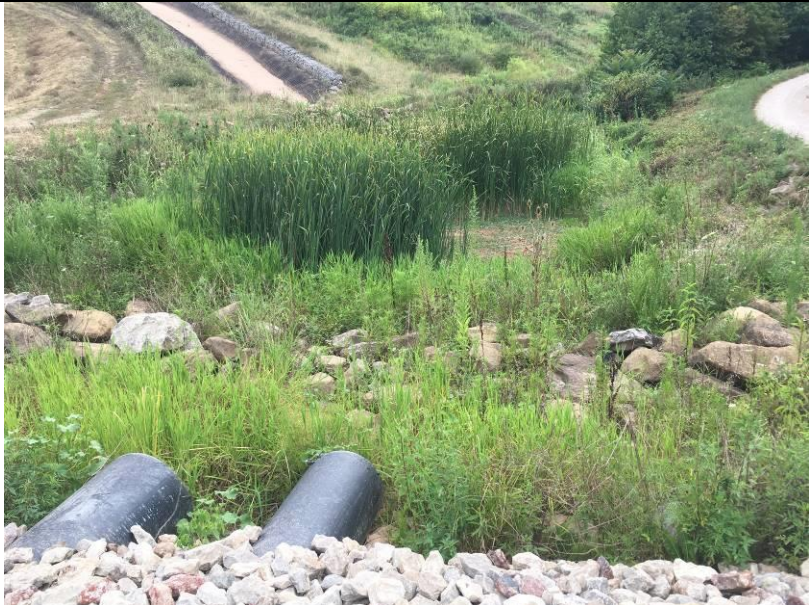
Photo # 31

16. The plunge pool at the bottom of Area 7 discharge chute was in satisfactory and functioning condition (Photograph No. 31). The pool area and rip rap protection had excessive vegetation and will need to be maintained.

Plunge Pool at the Bottom Of Area & Let Down Chute Leading to Area 7 Sediment Pond.

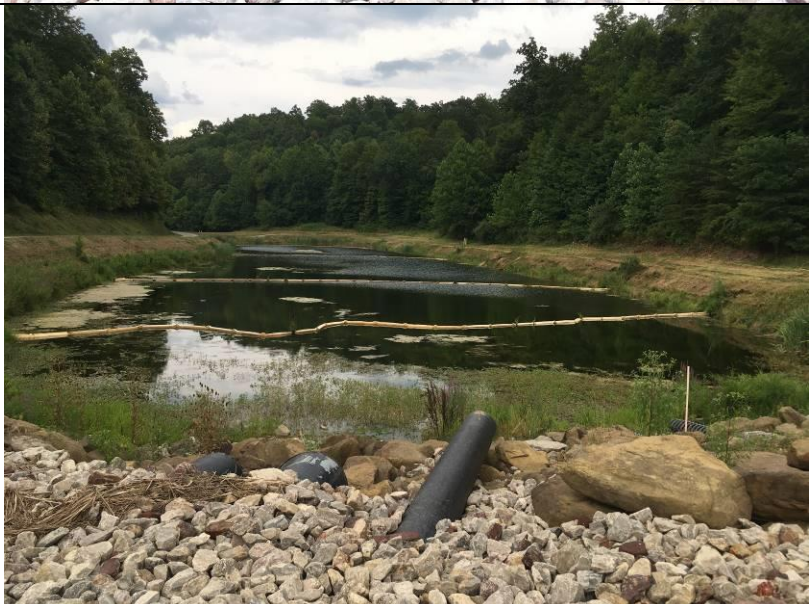
Photo # 32

17. Landfill Area 7 sediment pond is illustrated in Photograph No. 32 appeared to be functioning as designed and in satisfactory condition.

Overview of Area 7 sediment Pond Interior Conditions.

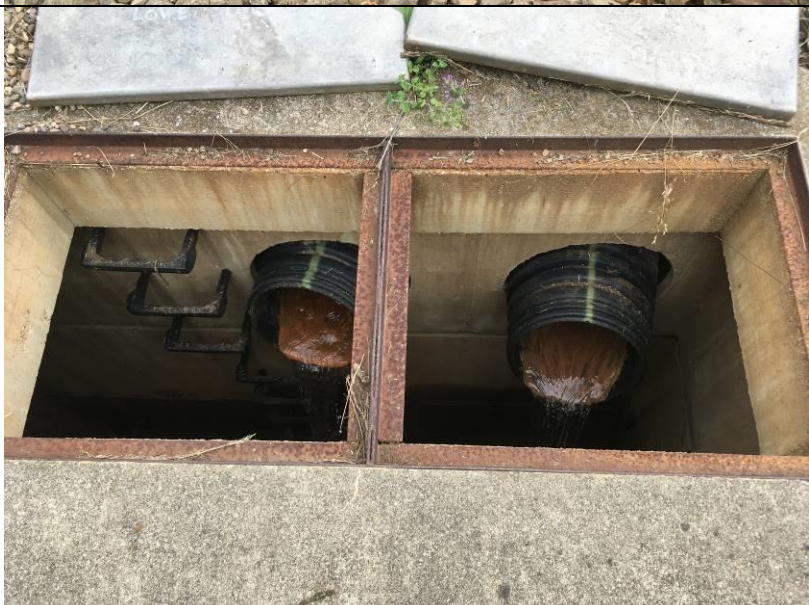
Photo # 33

18. The leachate collection system of the landfill is collected in a manhole at the east side of the landfill. Photograph No. 33 illustrates interior of the manhole as a collection point for all the leachate pipes. The leachate pipes appeared satisfactory and in compliance with the permit requirements. Photographs No. 34 and 35 illustrates the two leachate ponds. The ponds appeared in satisfactory and functional condition.

Landfill Leachate Pipe Collection Manhole MH-1.

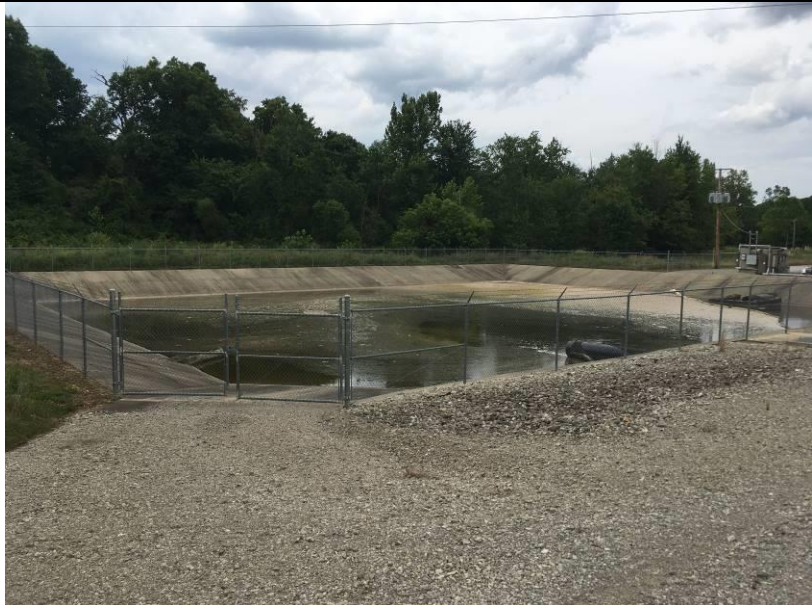
Photo # 34

Leachate Pond 1.

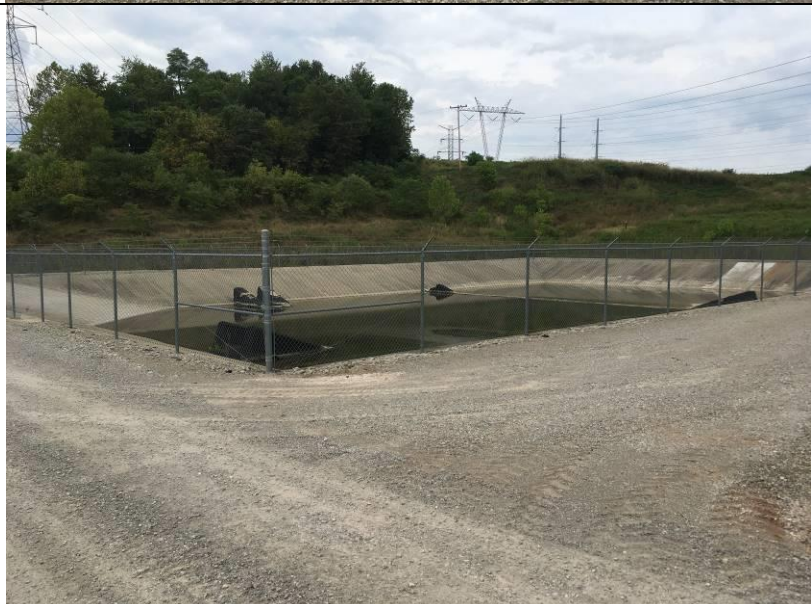
Photo # 35

Leachate Pond 2.
