2021 Dam and Dike Inspection Report

Bottom Ash Pond

**Northeastern 3&4 Plant
Public Service Company of Oklahoma
Oologah, OK**

Document Number: GERS-21-065

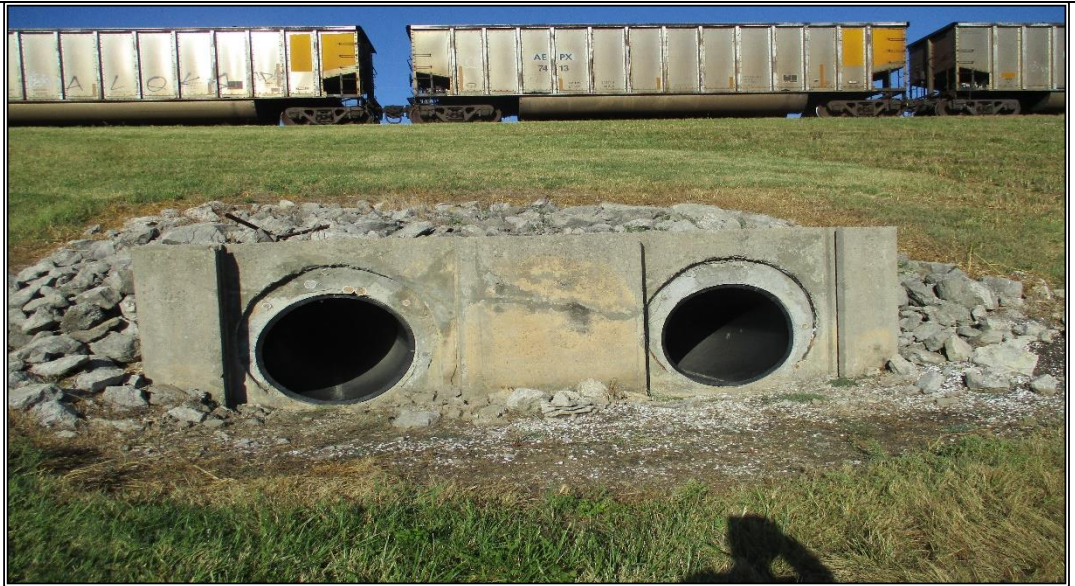
1. Photograph No. 1 illustrate the main concrete section of the spillway and Photograph No. 2 illustrate the chute section of the spillway. The concrete control section and discharge chute were in good and functional condition as designed without any obstruction to flow. There were no signs of movement, settlement, or misalignment of the spillway. There were no signs of seepage along the contacts between the concrete training walls and downstream slope of the embankment, or at the end of the concrete chute.
2. The energy dissipater concrete blocks and riprap located at the toe of the spillway were clear of sediment and vegetation and were in good condition (Photograph No. 3).
3. The drainage pipe culverts present slightly downstream of the spillway under the railroad (Photograph No. 4). The pipe culverts appeared clear of obstruction, no standing water, and in good and stable condition.

Photograph No. 4
Drainage pipe culverts
under the railroad.

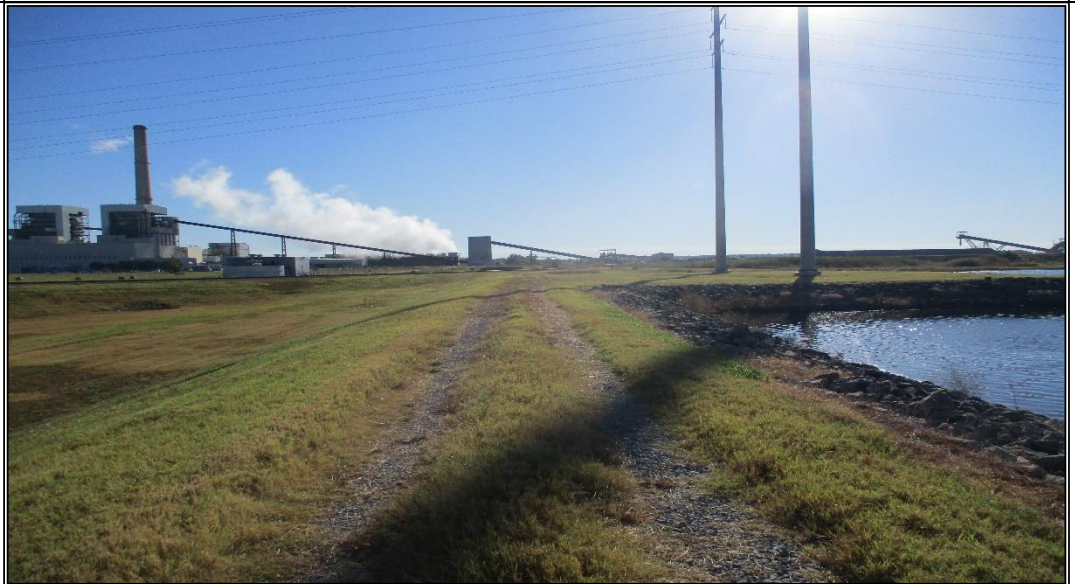
1. Photograph No. 5 illustrate typical condition of the crest. The crest appeared in good and stable condition with no sign of settlement, misalignment, cracks, rutting, or noticeable sign of distress.
2. The downstream slope of the embankment was well vegetated and controlled. The grass along the downstream slope was recently mowed. There were no signs of sloughing, significant erosion, or slope movement observed (Photograph No. 6).

Photograph No. 5
Typical condition of the
crest of the northwest
dike section (looking
east).

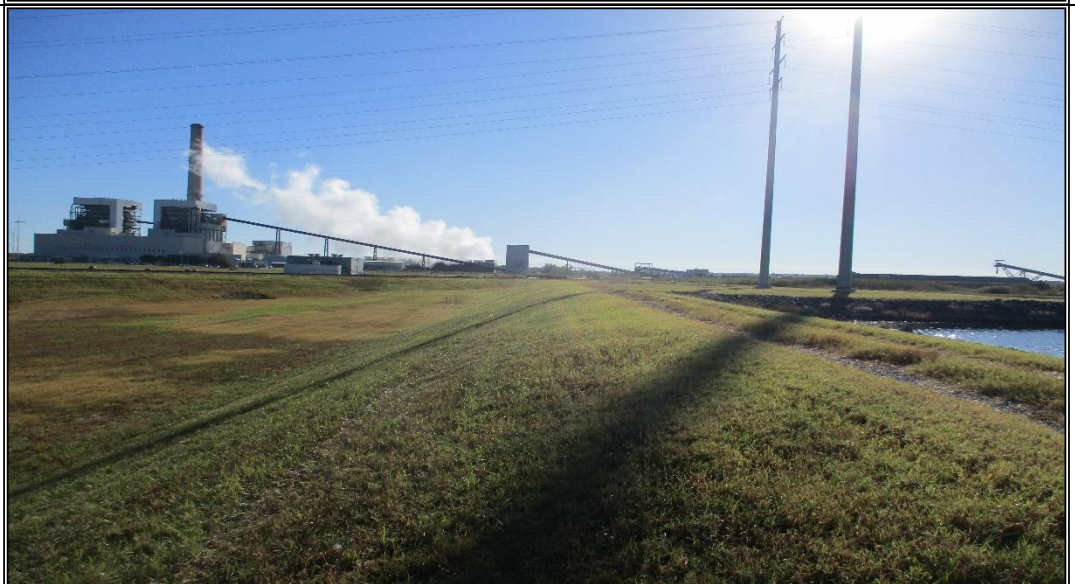
Photograph No. 6
Typical condition of the
downstream slope of
the northwest dike.

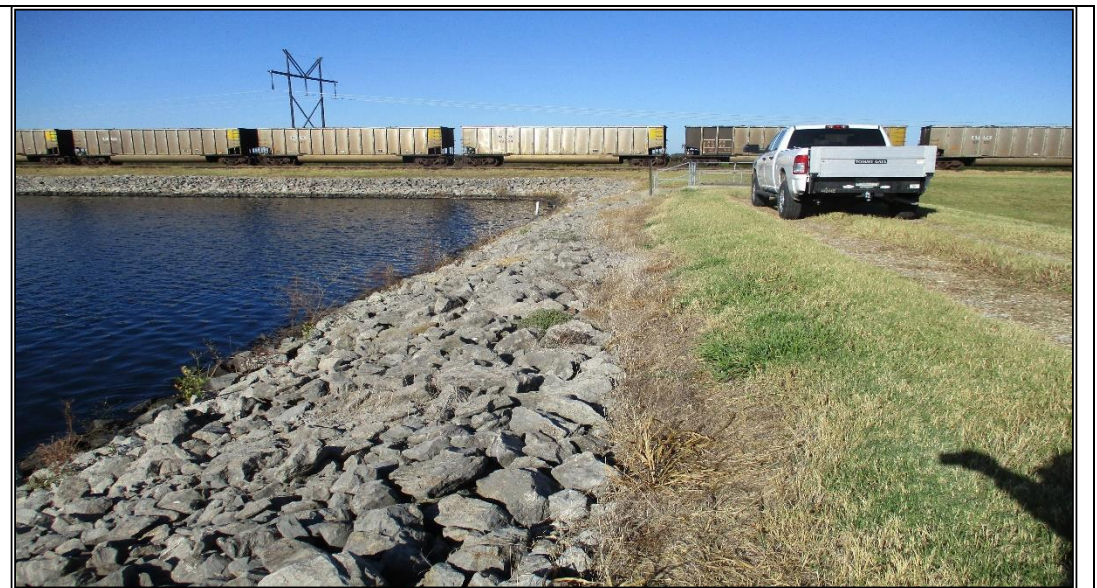
3. The upstream slope indicated no signs of sloughing or bulges. The riprap protection along the slope was intact in-place and was in good and stable condition. There was no significant grassy vegetation growing within the riprap. (Photograph Nos. 7 and 8).
4. The ash water intake structure was in good structural condition. The metal platform and concrete structure show no signs of deterioration. The intake was clear of debris and appeared to be in good functional condition (Photograph No. 9).
5. Photograph Nos. 10 and 11 illustrate the natural ground that forms the northeast and east portions of the pond. This area exhibited scattered, excessive vegetation, but was fairly accessible and appeared in good stable condition.

<p>Photograph No. 7 Typical condition of the upstream slope of the northwest dike (looking west).</p>

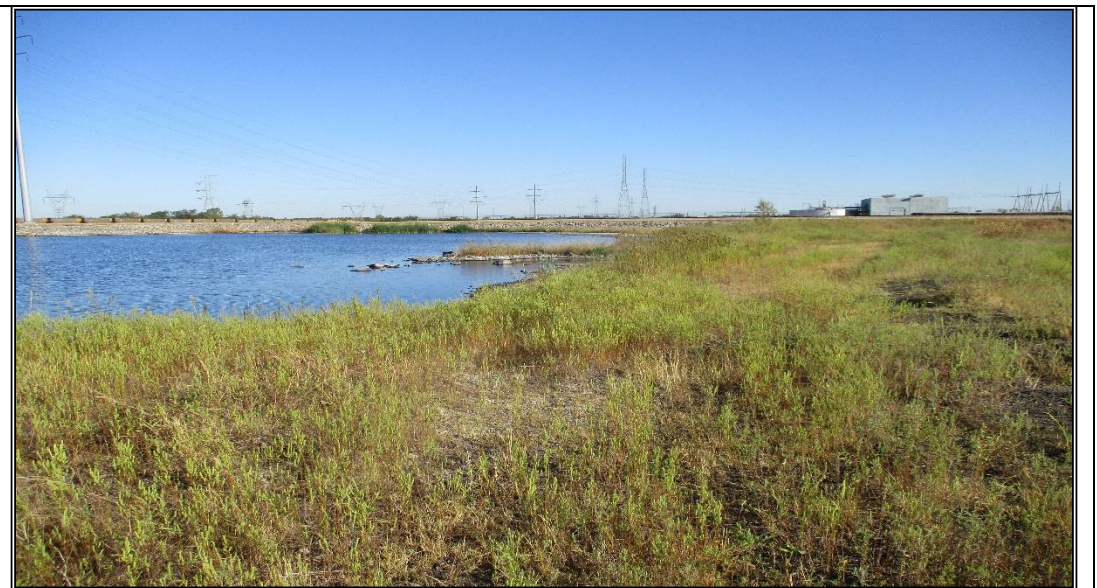
<p>Photograph No. 10 Natural ground at the northeast area of the pond.</p>

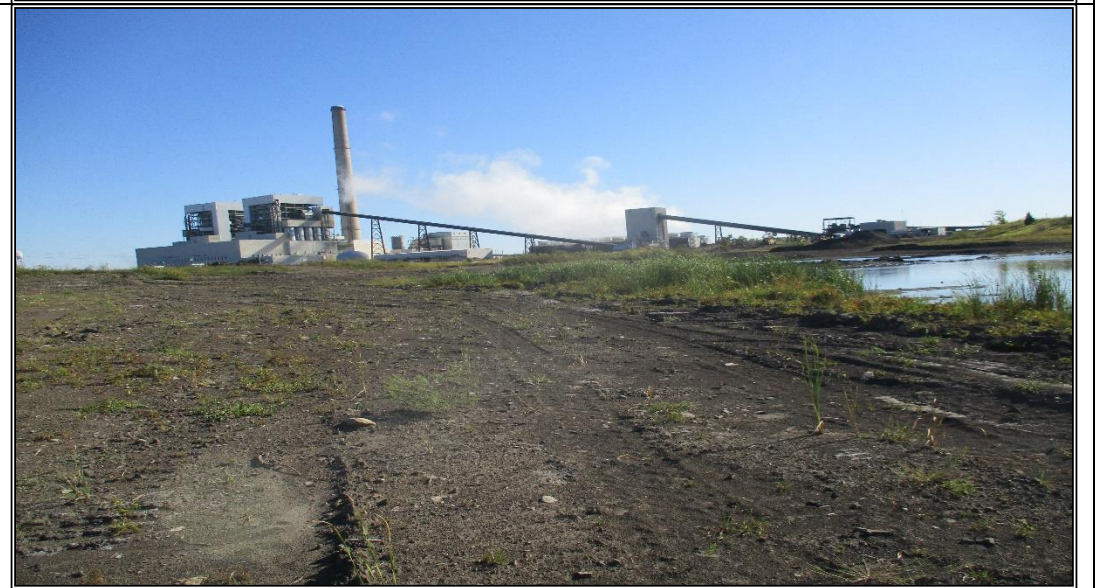
<p>Photograph No. 11 Another view of the natural ground area (looking north).</p>

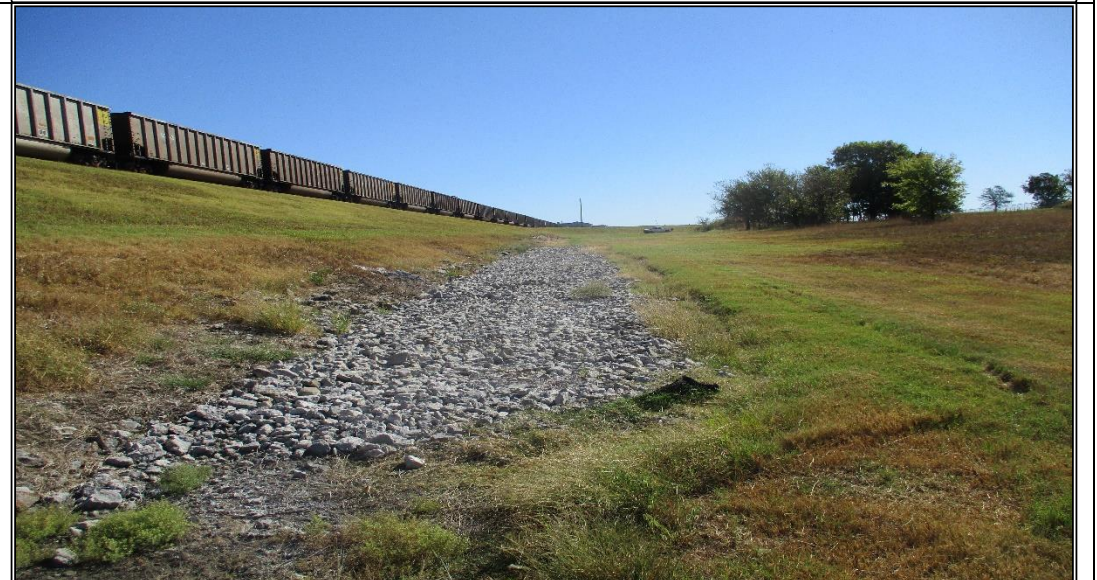
1. The downstream slope is well vegetated and maintained. There was no observed seepage, wet or damp areas along the slope (Photograph Nos. 12, 13 and 15). The area beyond the toe of the embankment has been well maintained to prevent heavy and/or woody vegetation within the regulatory 30-foot setback. The downstream slope is well vegetated and controlled. No signs of seepage noted along the toe of the west embankment.

<p>Photograph No. 12 Typical condition of the downstream slope</p>

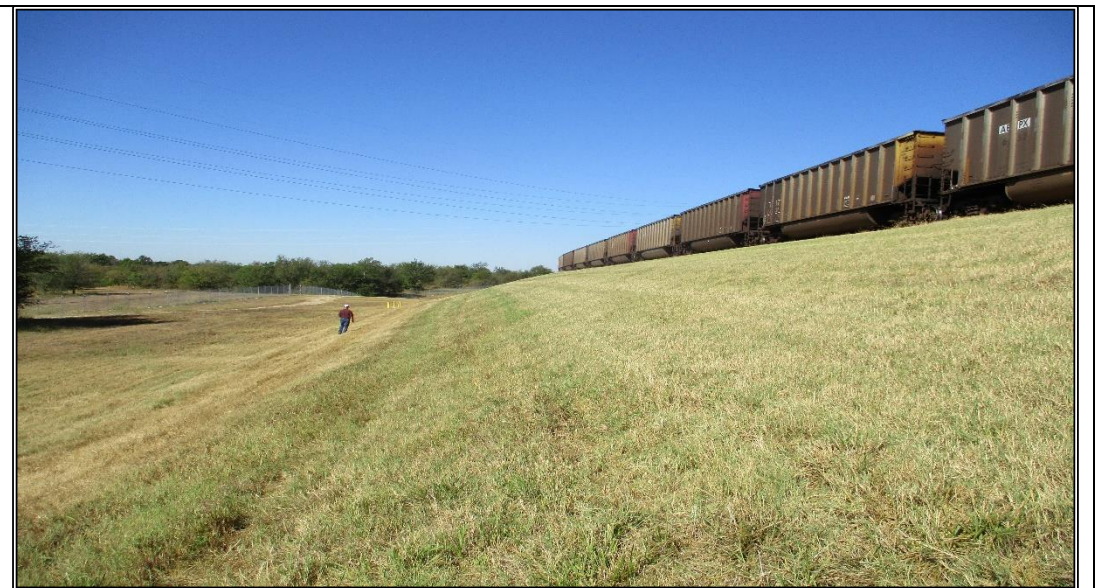
<p>Photograph No. 13 Downstream slope.</p>

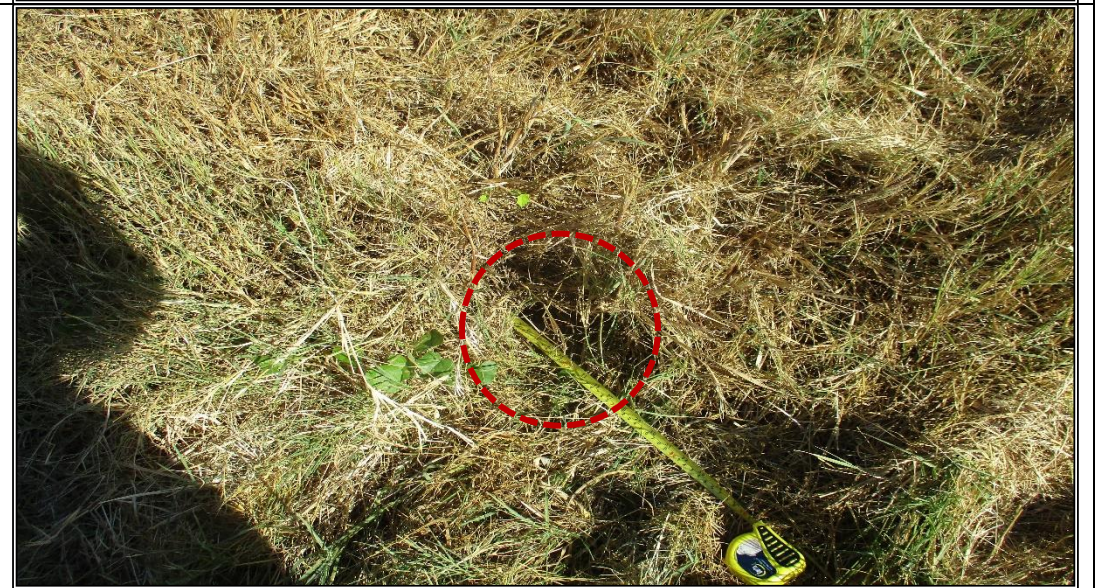
3. One rodent hole was observed at the south embankment section on the downstream slope (Photograph No. 14).
4. The upstream slope of the embankment was in good condition. There were no signs of bulges, cracks, sloughing or other deficiencies. There was minor vegetation growing within the riprap in the low area of the slope. The crest and railroad tracks do not show any signs of settlement or misalignment. Reportedly, the tracks are inspected monthly by an outside company to ensure no misalignment or settlement (Photograph Nos. 17 and 18).

<p>Photograph No. 14 Animal borrow.</p>

- 1) Repair the observed rodent hole. Mitigate hole by filling with compatible material and compaction. Any additional holes if encountered during routine plant inspection should also be mitigated in similar manner.
- 2) Continue to clear vegetation growing in the riprap.

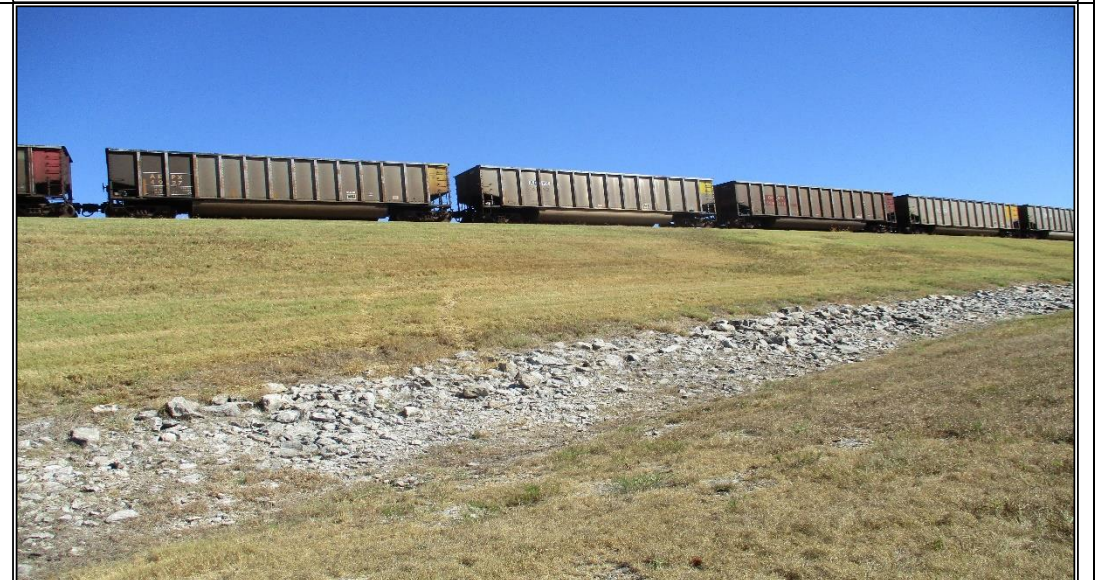
<p>Photograph No. 15 Riprap at the toe of the downstream slope.</p>

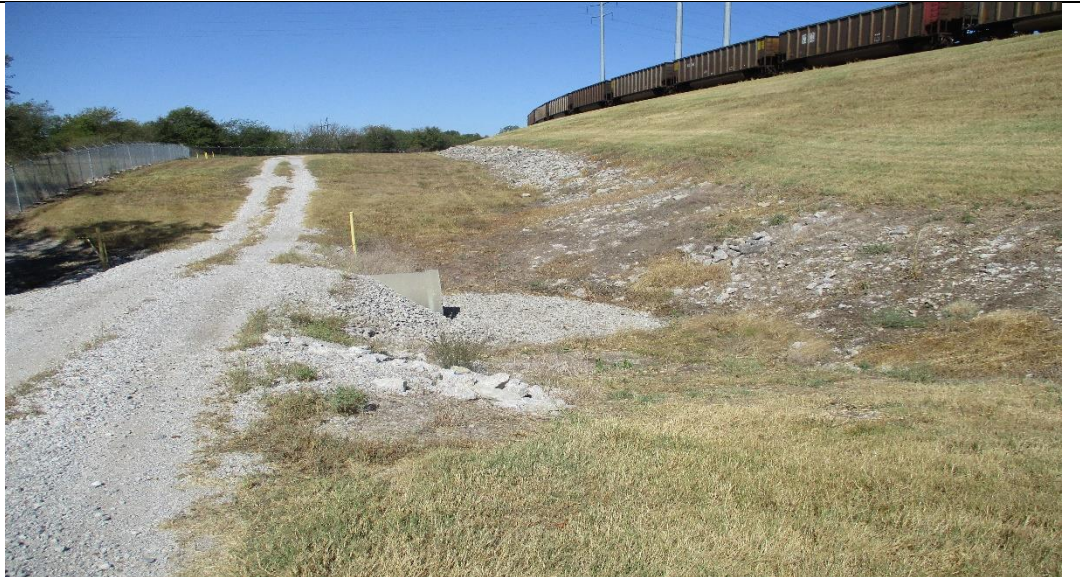
2. The seepage collection blanket appears to be functioning as designed. Seepage is directed to the low area below the embankment and is typically discharge through a pipe below an access drive. No seepage or moisture was observed at the outlet of the pipe during the inspection (Photograph No. 16).

Photograph No. 16
Drainage collection pipe
culvert.

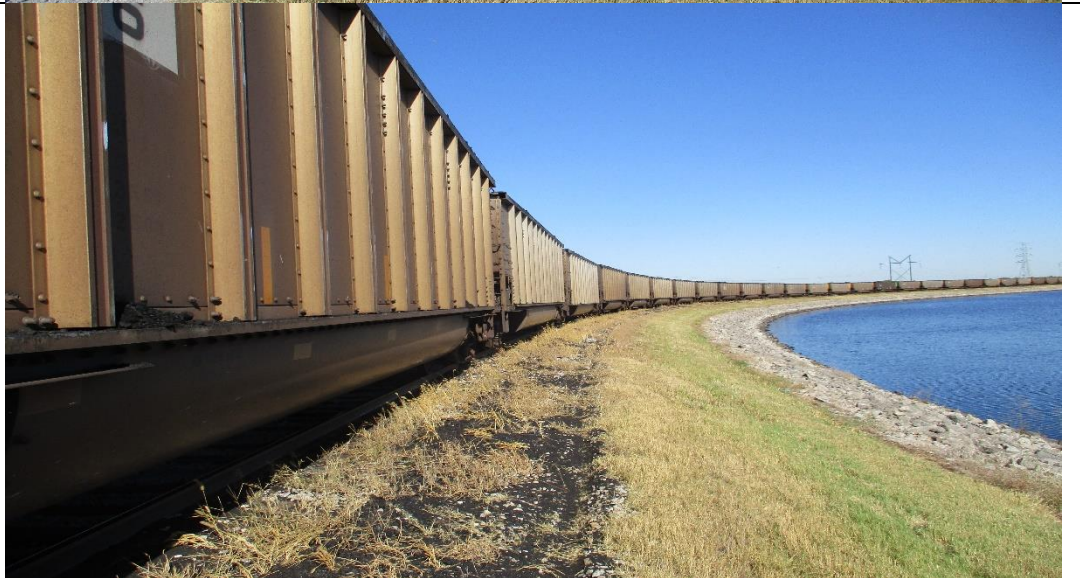
Photograph No. 17
Upstream slope (looking
north).

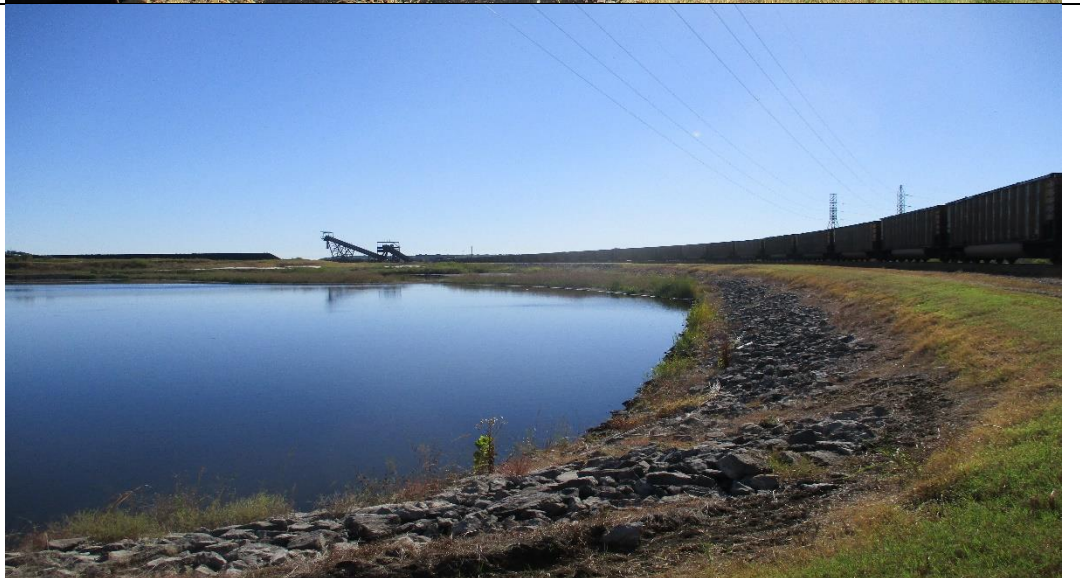
Photograph No. 18
Upstream slope (looking
south).

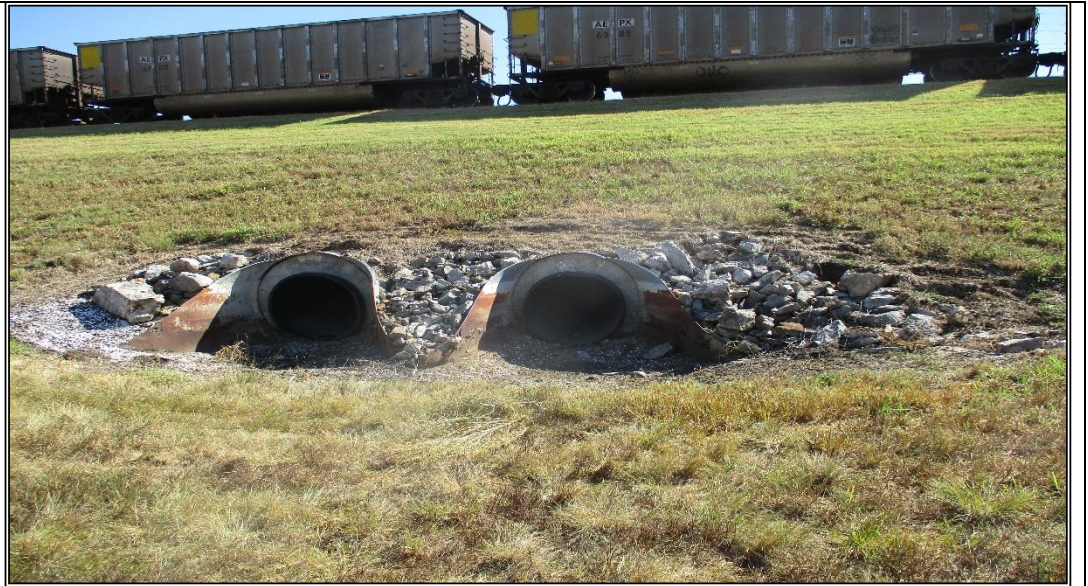
5. The outlet end of the pipe culverts located under the railroad is illustrated in Photograph No. 19. The pipe culverts were clear of any obstruction and in good functional condition.

Photograph No. 19
Pipe culverts under the
railroad outlet end.
