# 2021 Annual Landfill Inspection Report

**Northeastern Plant**

**Northeastern Plant  
Landfill**

**Document Number:** GERS-21-064

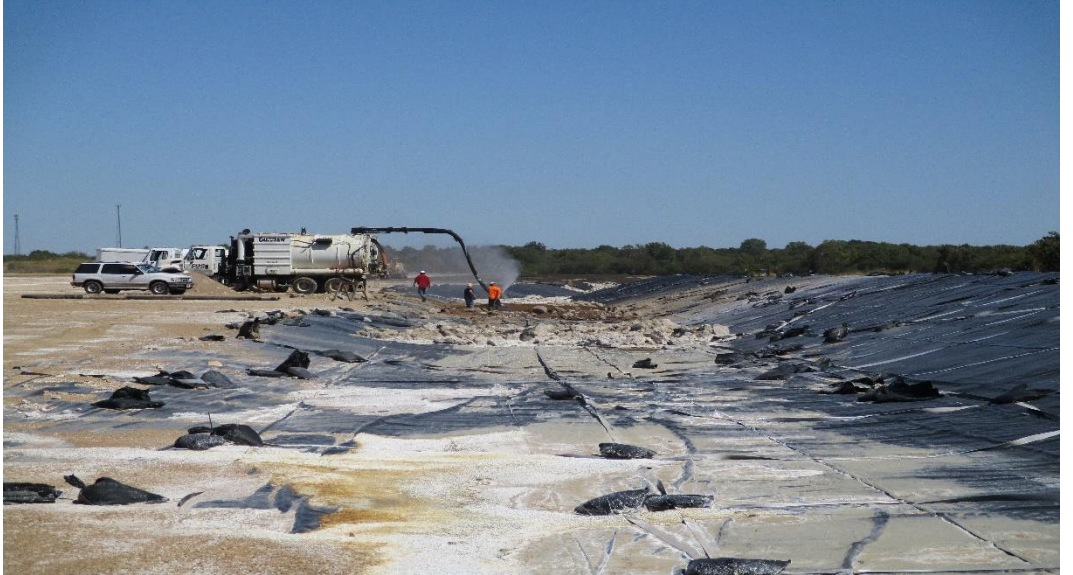
3. Photograph No. 4 illustrate cleaning the existing geosynthetic liner in an anticipation of preparation for the installation of temporary geomembrane (impermeable cover) in Cell 3 in order to minimize leachate generation. There was no water ponding or erosion and the surface was in good and stable condition.

<p>Photograph No. 4 Cleaning existing liner at Cell 3.</p>

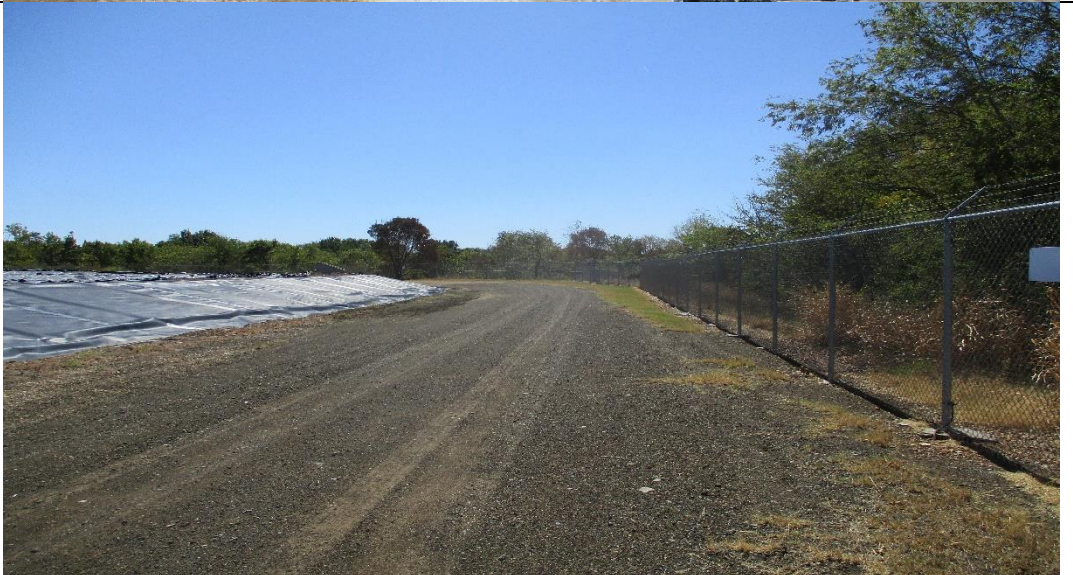
4. The access road adjacent to Cell 4 is illustrated in Photograph No. 5. The road was in good condition with no sign of misalignment, settlement, or excessive erosion. The perimeter ditch was functioning as designed and the liner was intact and in good condition. The exterior slope adjacent to the Cell 4 appeared in good and stable condition (Photograph No. 6).

A large white industrial truck with a long discharge pipe is positioned on a gravel area, spraying water onto a large, dark, wrinkled liner that has been partially cleaned. Several workers in orange safety gear are visible near the truck. The background shows a clear blue sky and some distant trees.
<p>Photograph No. 5 Access road adjacent Cell 4 (looking south).</p>

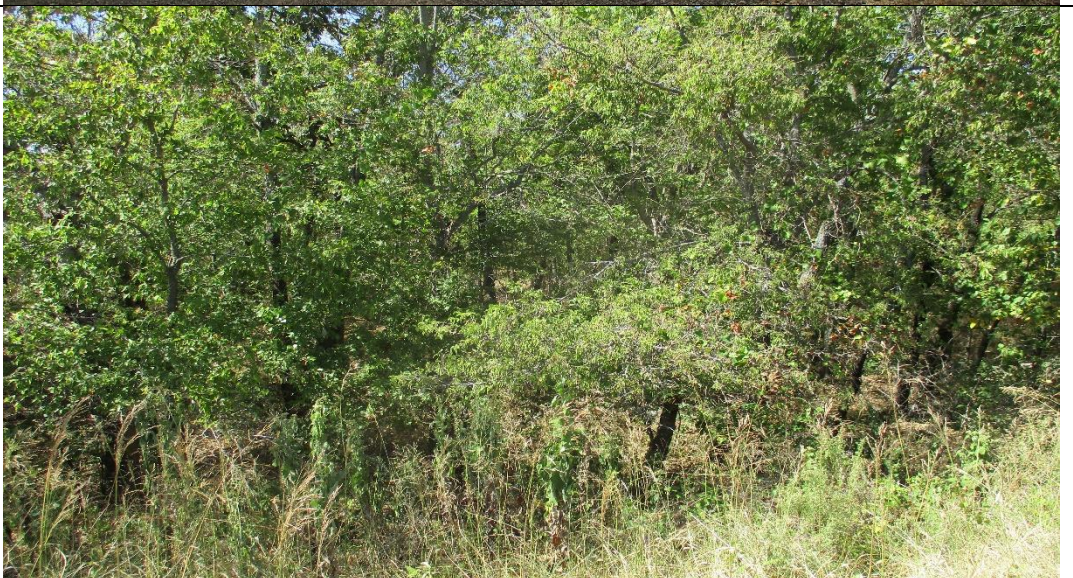
A wide, gravel-paved access road stretches into the distance. To the left, a large area of land is covered with a dark, wrinkled liner. To the right, a chain-link fence runs parallel to the road, with trees and vegetation behind it. The sky is clear and blue.
<p>Photograph No. 6 Area outside the fence.</p>

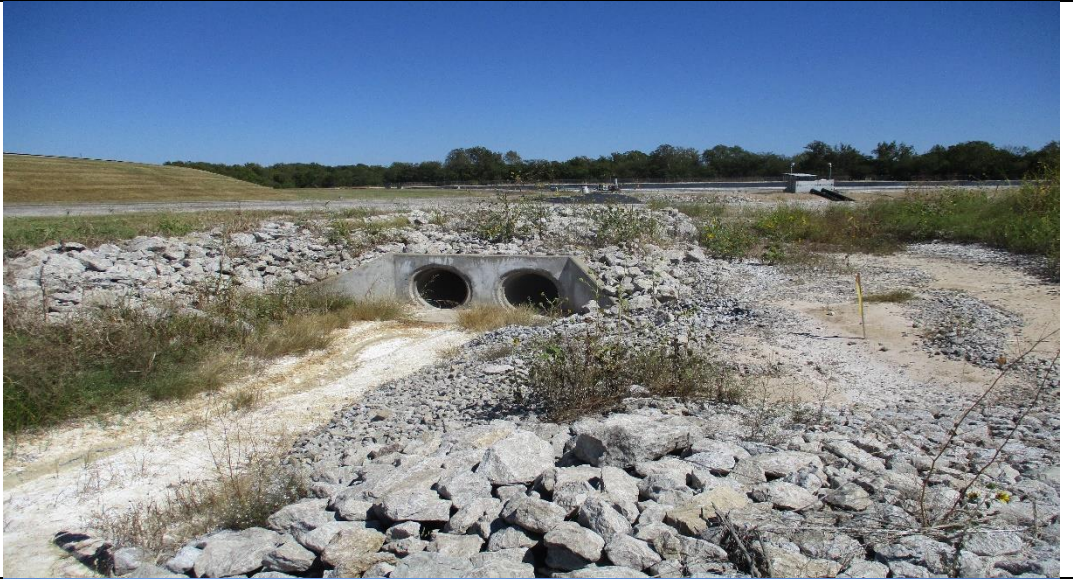
Photograph No. 13  
North side perimeter  
runoff ditch pipe  
culvert inlet.

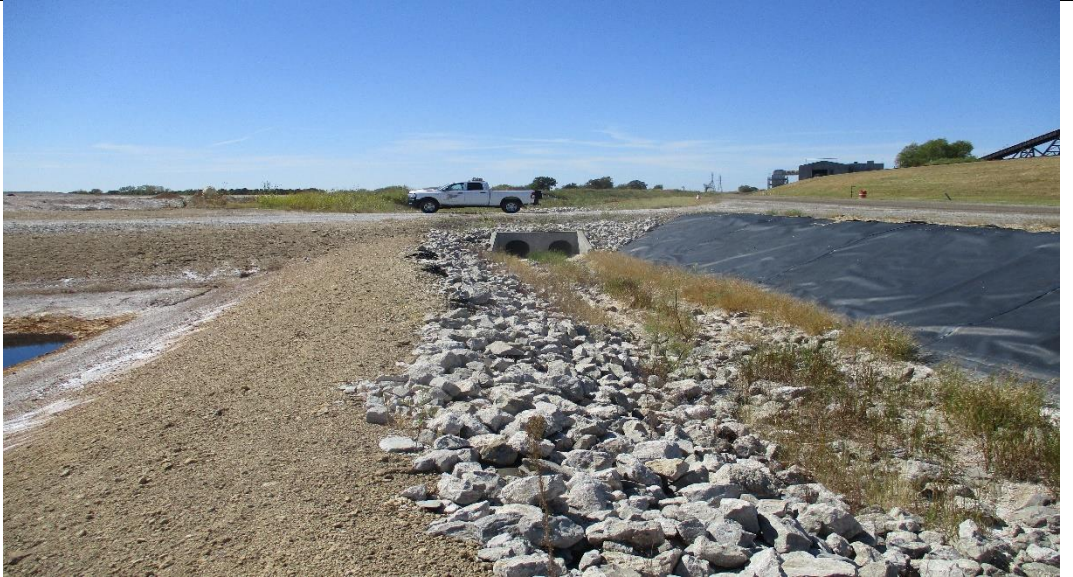
Photograph No. 14  
North side perimeter  
runoff ditch pipe  
culvert outlet.

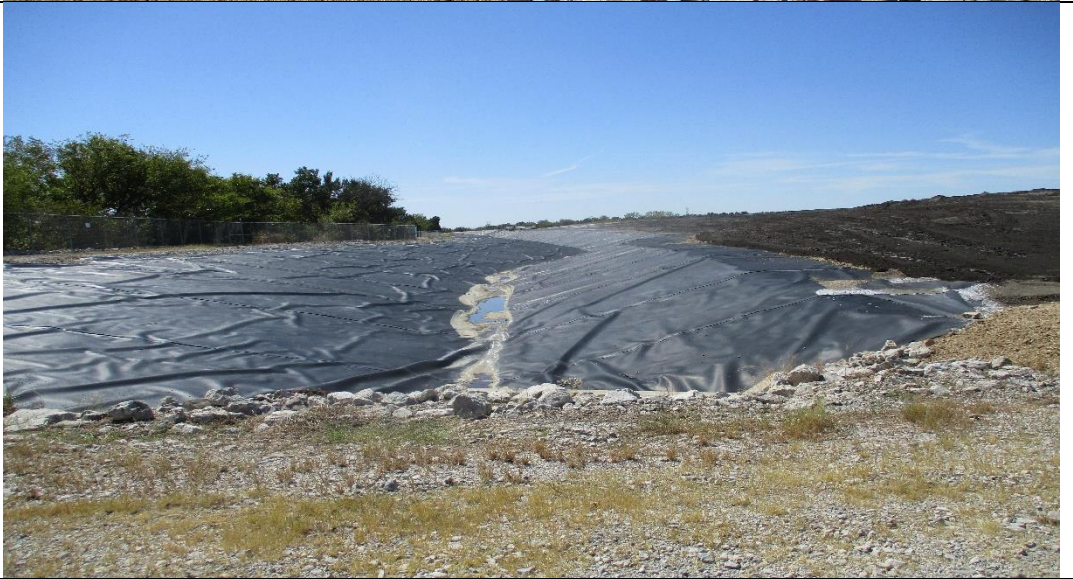
8. Overall the perimeter ditches were in good condition and functioning as designed. The ditches are currently lined with geomembrane. There were some local areas of very shallow ponding due to either minor sediment or small wrinkles in the geomembrane. Photograph Nos. 11 and 12 illustrates the north ditch with excessive vegetation but no water ponding was observed.
9. The north and south perimeter ditches also includes pipe box culverts at the east end of the landfill limit (Photographs Nos. 13-16). These pipe box culverts were clear of any debris and indicated no obstruction to flow. Minor water ponding was observed in the south ditch (Photograph No. 15).

Photograph No. 15  
South side perimeter  
runoff ditch.

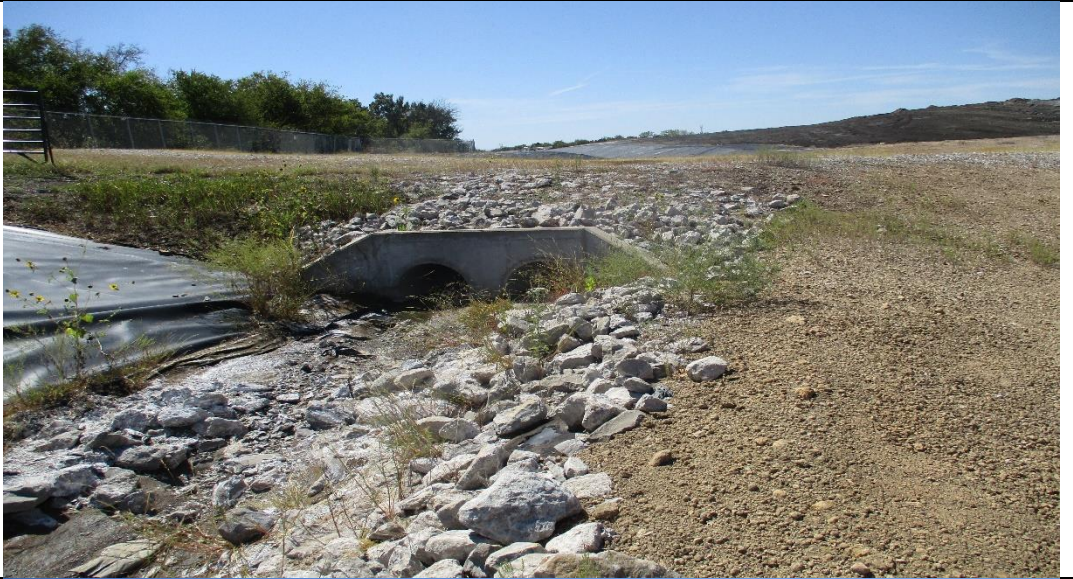
Photograph No. 16  
South side perimeter  
runoff ditch pipe  
culvert outlet.

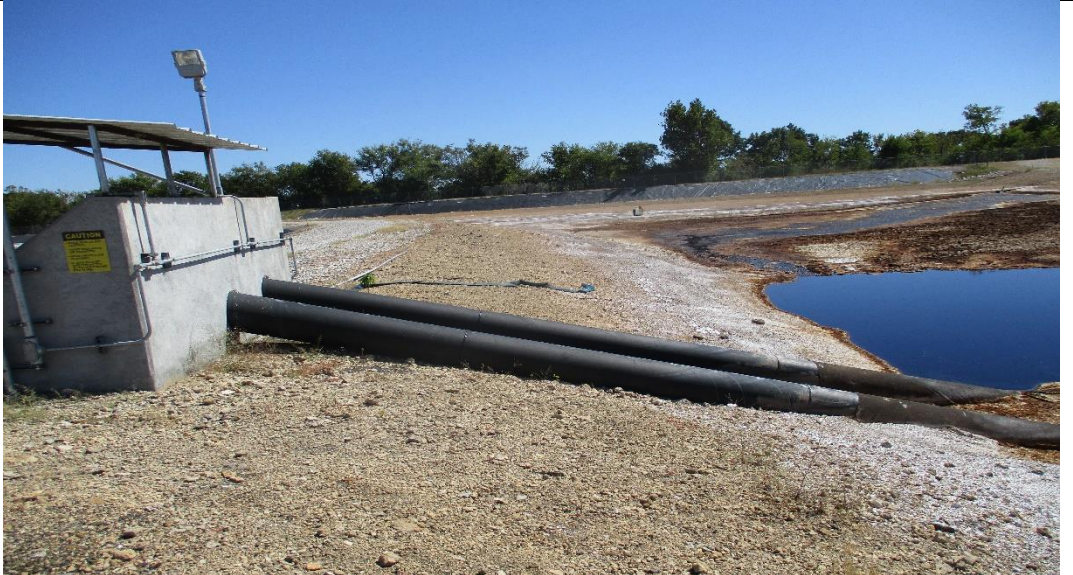
10. Photograph No. 17 illustrate the leachate pump station. As needed a portable pump is used to pump leachate from the leachate pond instead of the pump station (Photograph No. 21). The interior slope of the pond was in fair condition (Photograph Nos. 19-21). The northwest and the southeast dikes of the leachate pond (Photograph Nos. 16 and 20) consists of a very small crest (< 1-foot). The pond had about 2-feet of water. The outlet of the two leachate pipes that discharge into the pond were visible (Photograph Nos. 19 and 21).
11. The splitter dike between the leachate pond and Basin C is illustrated in Photograph No. 18. The splitter dike appeared in good and stable condition without any settlement or misalignment.

Photograph No. 17  
The leachate pump  
system.

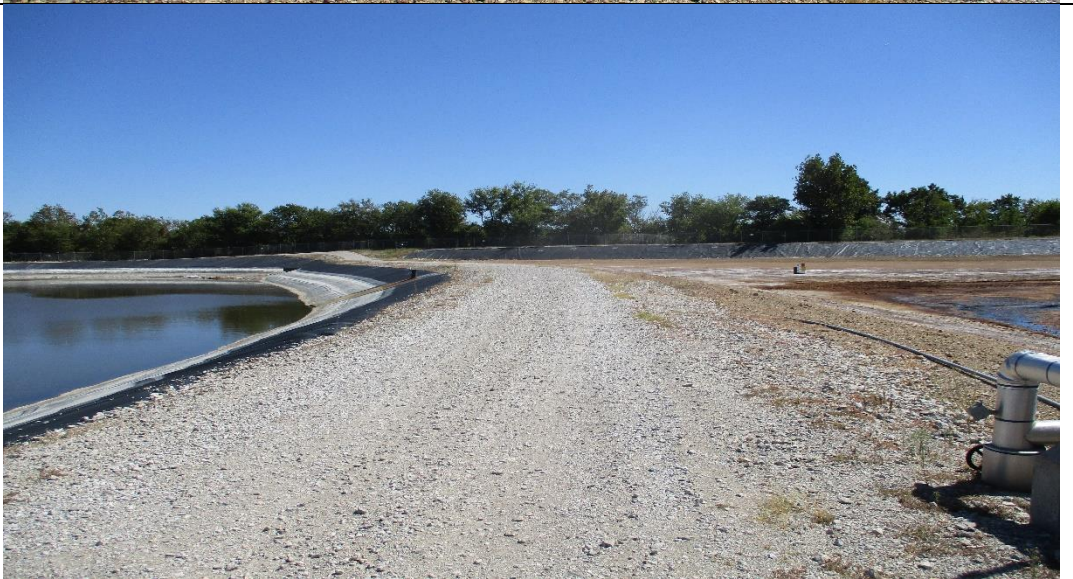
Photograph No. 18  
Splitter dike between  
the leachate pond and  
Basin C.

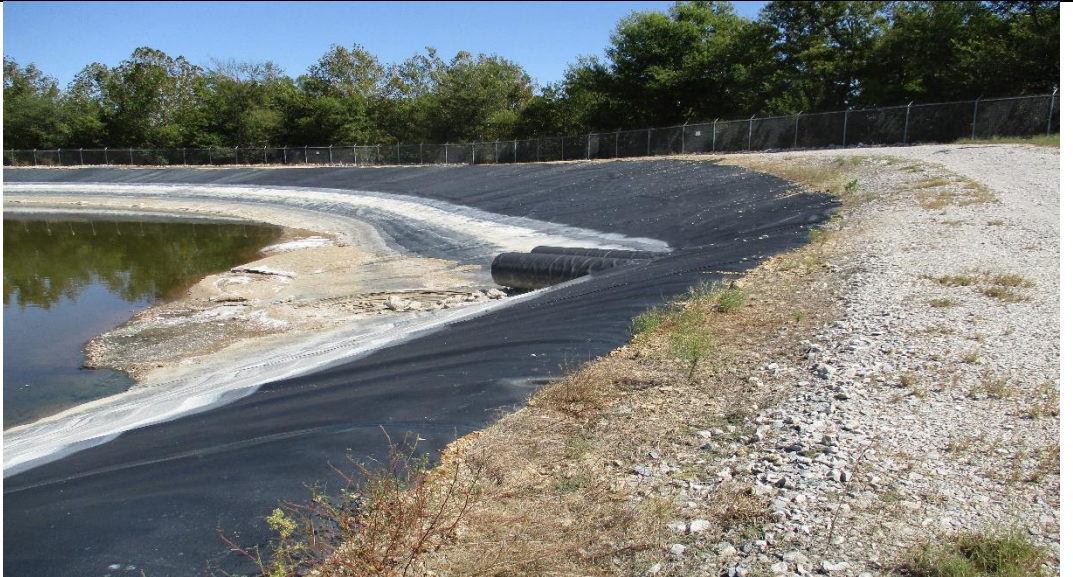
12. The runoff from the landfill is discharged into Basin C. Photograph Nos. 22 and 23 illustrates the inlets of the north and the south discharge pipes. At the time of inspection, the condition was dry and no water flowing from the pipes.
13. The crest and interior slope of Basin C appeared in good condition (Photograph Nos. 24 and 25). The geosynthetic liner was in place, intact and in good condition without any tear or damage. The crest also used as haul road of the north dike appeared in good and stable condition (Photograph No. 26)

Photograph No. 22  
Interior slope and  
south runoff water  
pipe at Basin C.

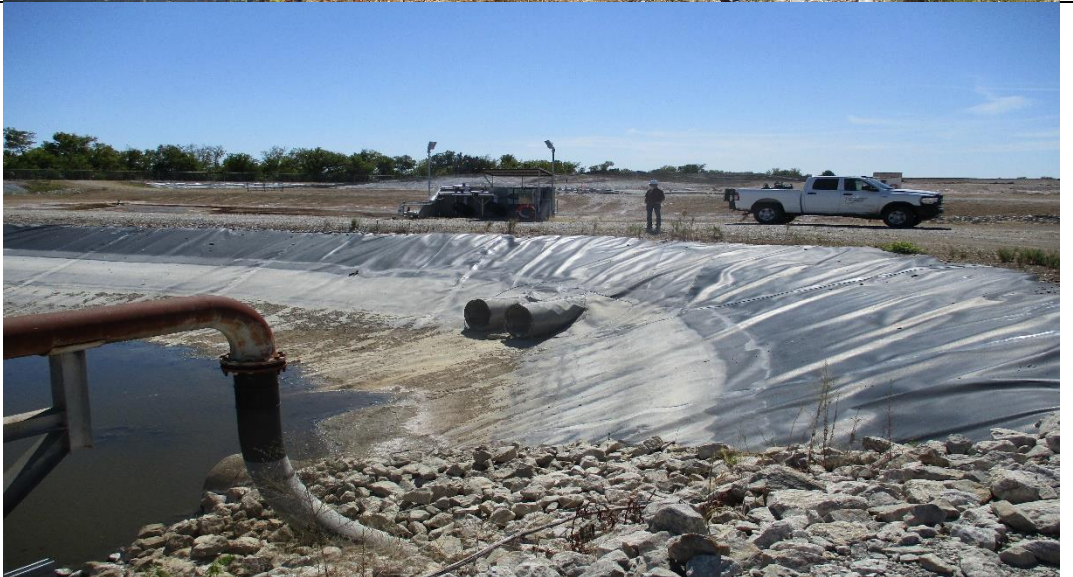
Photograph No. 23  
Interior slope and  
north runoff water  
pipe at Basin C

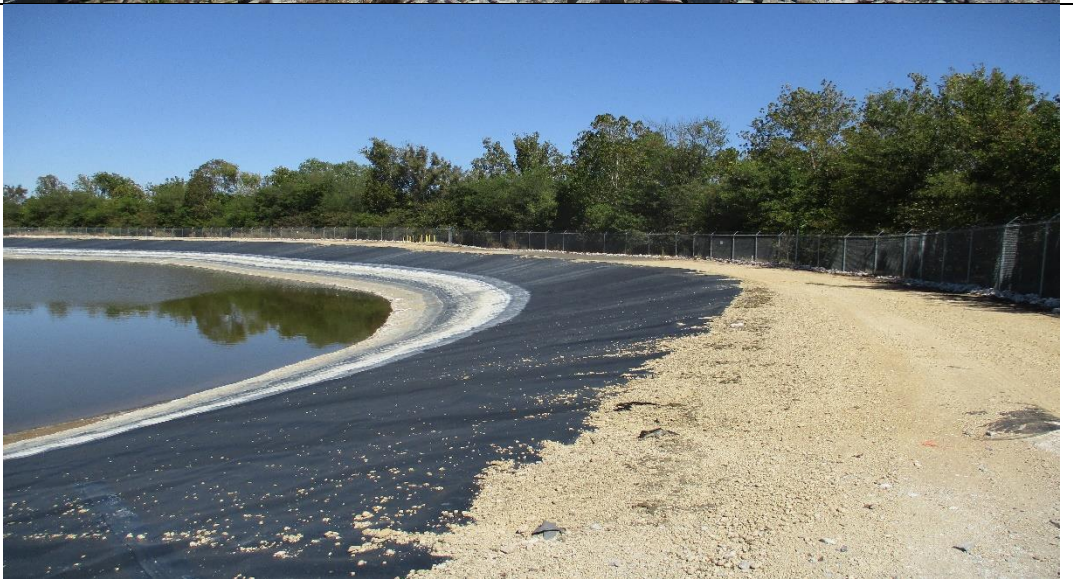
Photograph No. 24  
Typical Interior Slope  
and crest of Basin C.
