# 2021 Annual Landfill Inspection Report

**H.W. Pirkey Plant  
Southwestern Electric Power Company  
Hallsville, Texas**

**Document ID: GERS-21-023**

**Date of Inspection:** August 18, 2021

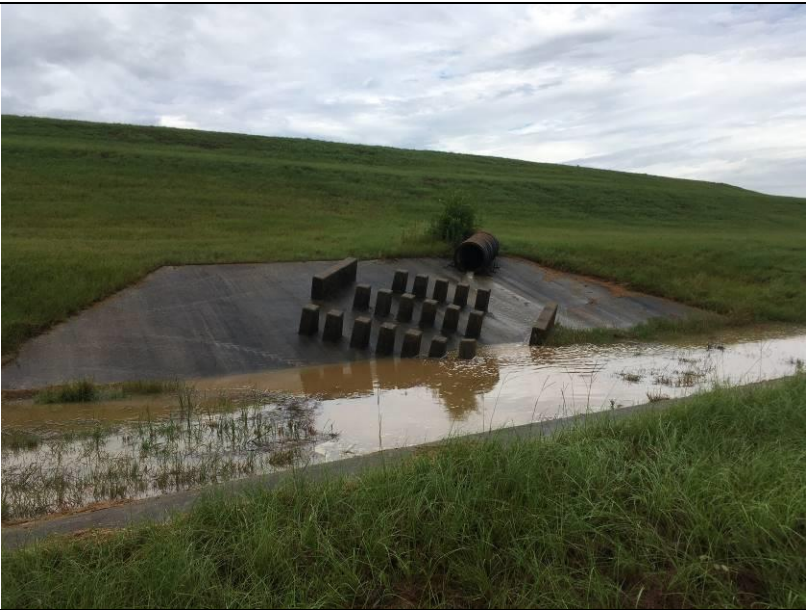
4. Minor brush and some cattails were observed to be growing in the perimeter ditches and around the energy dissipater structures for the “let down” piping on the eastern edge of the landfill area.

<p style="text-align: center;">Photo # 1</p> <p>View of the storm water let-down pipe on the east side of the landfill area.</p>

- 2) Remove the brush and/or cattails growing around the outlets of the “let down” piping on the east side of the landfill. Establish grass cover on any disturbed areas.

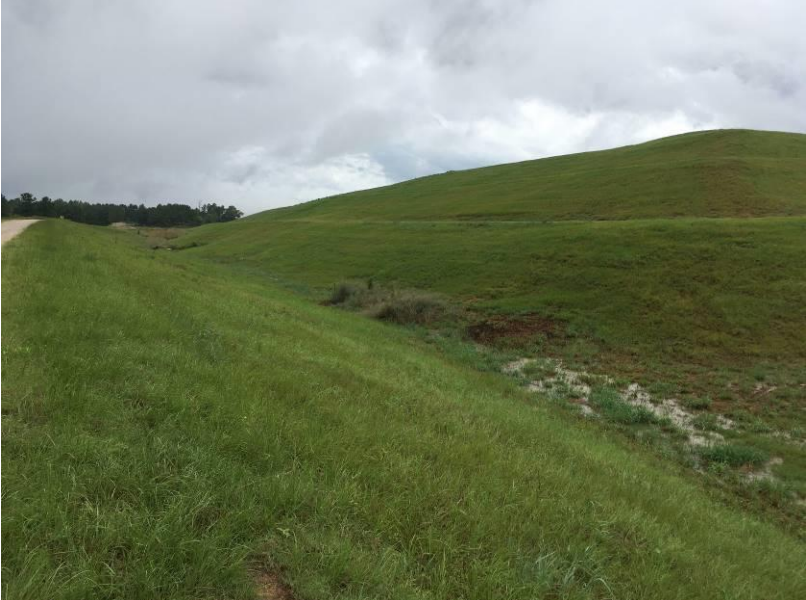
16. A non-contact water ditch runs along the eastern edge of the landfill area. The vegetation along this ditch was good with some areas being slightly overgrown with cattails. There was no evidence of erosion, obstructions or poor drainage conditions. There was flowing water without obstruction in the ditches at the time of inspection due to recent rain event.

<p style="text-align: center;">Photo # 3</p> <p>View of the non-contact water perimeter ditch and side slope conditions on the east side of landfill area.</p>

- 3) Remove any excess brush and cattails from the perimeter ditches around east and western sides of the landfill. Establish grass cover on any disturbed areas.

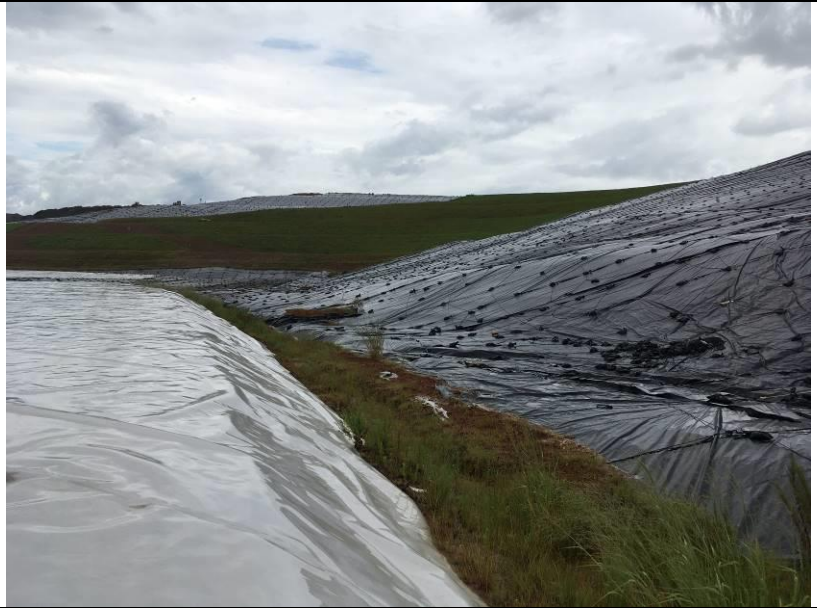
Photo # 4

View of the non-contact water perimeter ditch on the south side of landfill between the 1993 and 2018 cell.

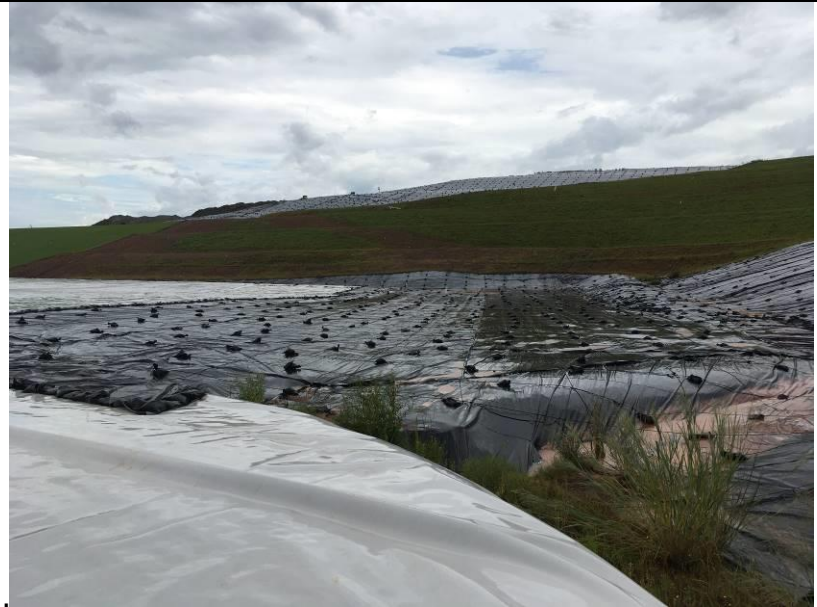
Photo # 5

View of the rain flap material covering the 1985 pond area between the 1993 and 2018 cells.

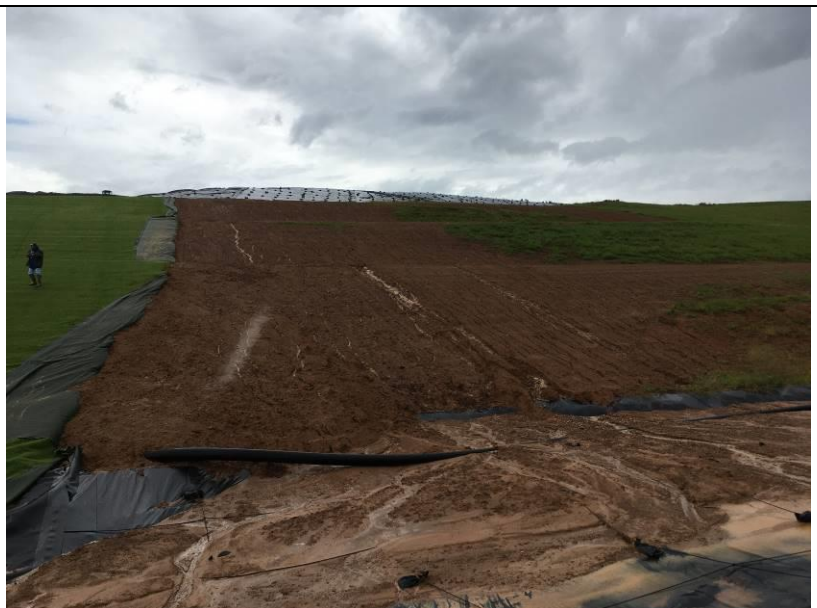
Photo # 6

7. A temporary soil cover consisting of a red clay material has been placed for an erosion protection measure on a portion of the side slopes of the 2012 cell. The soil cover has been seeded but most of the area still has no vegetative cover and there is sediment buildup in the ditches. In addition, minor erosion rills have developed in the bare soils cover due to lack of vegetation. In addition to the soils cover, other adjacent areas of the 2012 cell, 1985 pond cell and 1993 cell have been covered with closure turf material or with a 20-mil geo-membrane rain flap material for erosion protection.

View of the temporary soil cover on the 2012 cell side slopes. Need to establish vegetation to control erosion.

- 1) Repair the erosion rills, re-seed and mulch the temporary soil cover on the lower portion of the 2012 cell near the 1985 pond area on the south side.

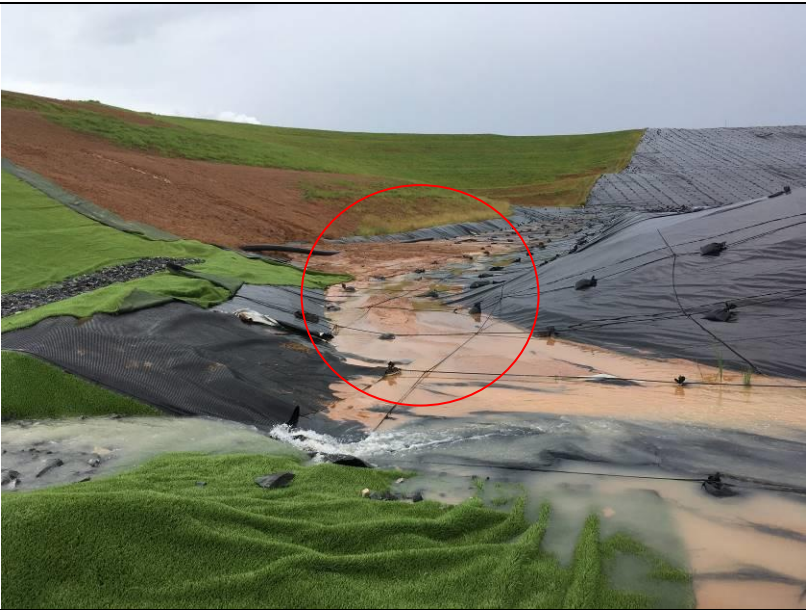
<p>Photo # 7</p> <p>View of the non-contact water perimeter ditch between the 2012, 2015 and 2018 cells. Notice the sediment in the flowing water.</p>

- 5) Operate the check valve drain in the ground water interceptor manhole periodically to maintain its function.
- 6) Install proper erosion and sediment controls on the recently graded areas on the south side of the landfill to minimize the amount of sediment build up in the storm water runoff ditches.

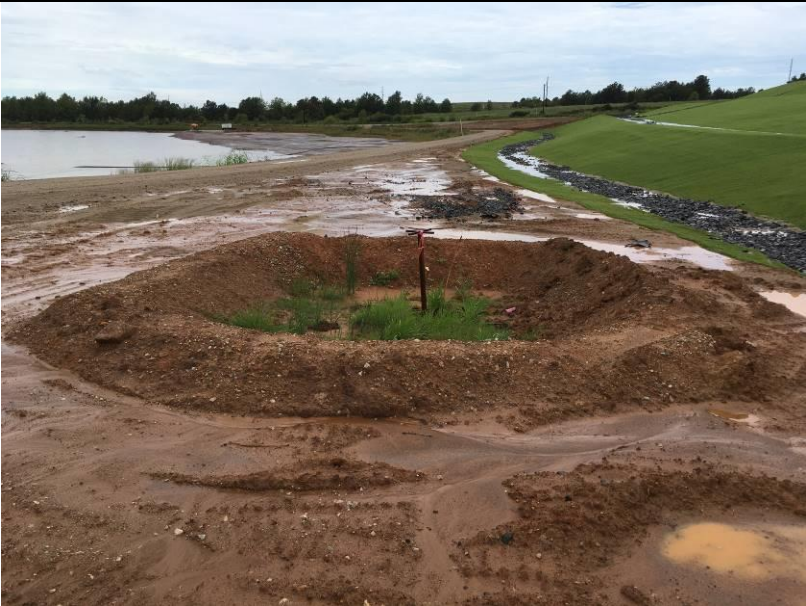
8. The final Cap and Cover system of the remaining top portions of the 2012 cell consists of Closure Turf material.
9. The area around groundwater interceptor drain manhole on the southern side of the landfill has been recently graded. The check valve drain line leading from the manhole has been extended and is open allowing water to discharge directly into the landfill pond. The area surrounding the manhole and check valve drain line needs to be vegetated for erosion protection.

<p>Photo # 8</p> <p>View of groundwater interceptor drain manhole cover and the check valve drain box. Area needs to be vegetated.</p>

- 4) Seed and mulch the recently graded areas on the south side of the landfill near the ground water interceptor drain manhole and toe areas of the 2015 cell.

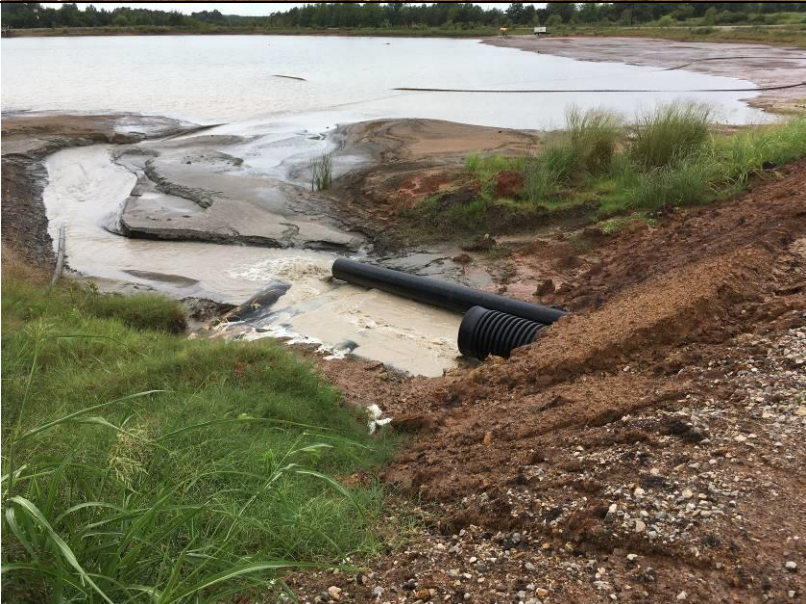
<p>Photo # 9</p> <p>View of the 24-inch diameter leachate pipe and 12-inch diameter ground water interceptor pipe coming out of southern end of landfill into the landfill pond.</p>

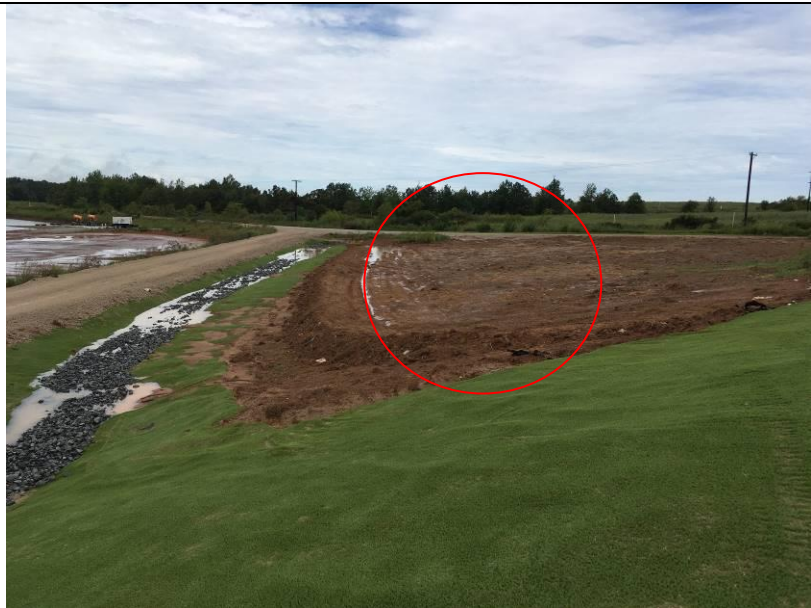
Photo # 10

Landfill Cover – View of recently graded area on the south side of the 2015 cell area. Area needs to be vegetated.

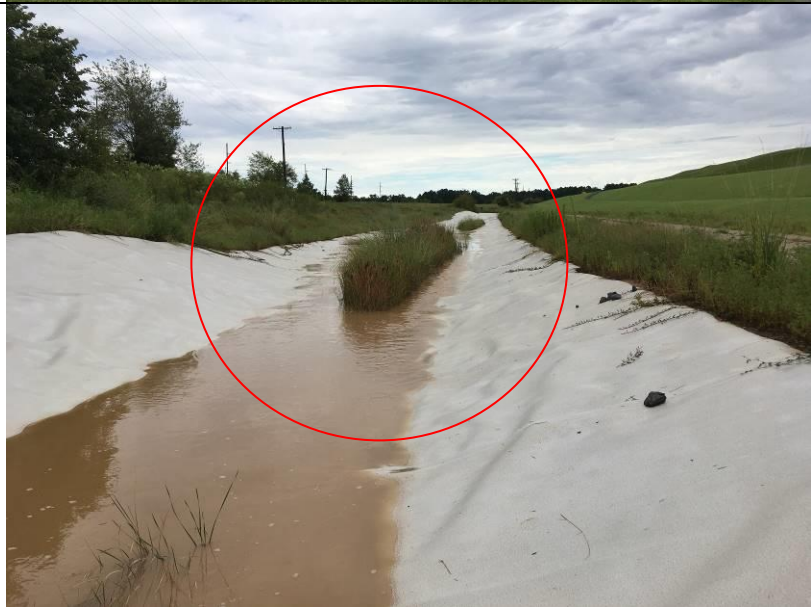
Photo # 14

View of the non-contact water perimeter ditch on the west side of landfill. Vegetation is growing over liner material covered with silt.

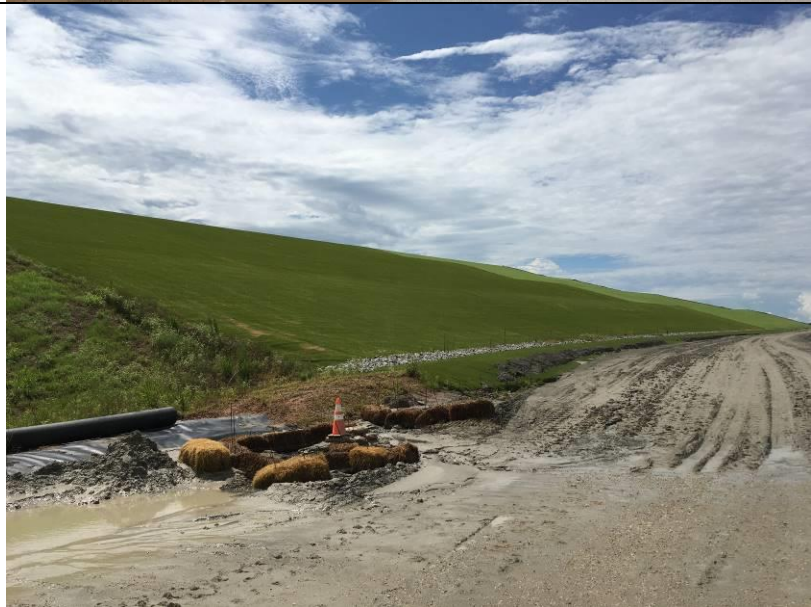
Photo # 15

View of the old haul road on west side of landfill where the old cap and cover vegetation meets the new closure turf material. This section of haul road will be closed with final cap and cover.

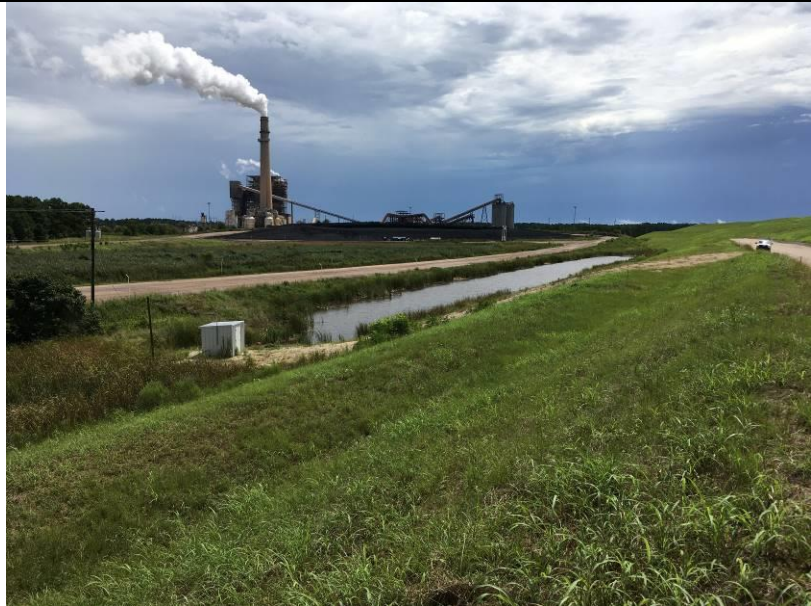
Photo # 19

5. There is ponded water in the downstream end of the perimeter ditch on the north side of the landfill. However, a pump and piping system had recently been installed to pump this water into non-contact water perimeter ditches on the west side of the landfill.

Typical condition of the northern slope areas below the haul road. Notice the ponded water at the downstream end of the perimeter ditch.

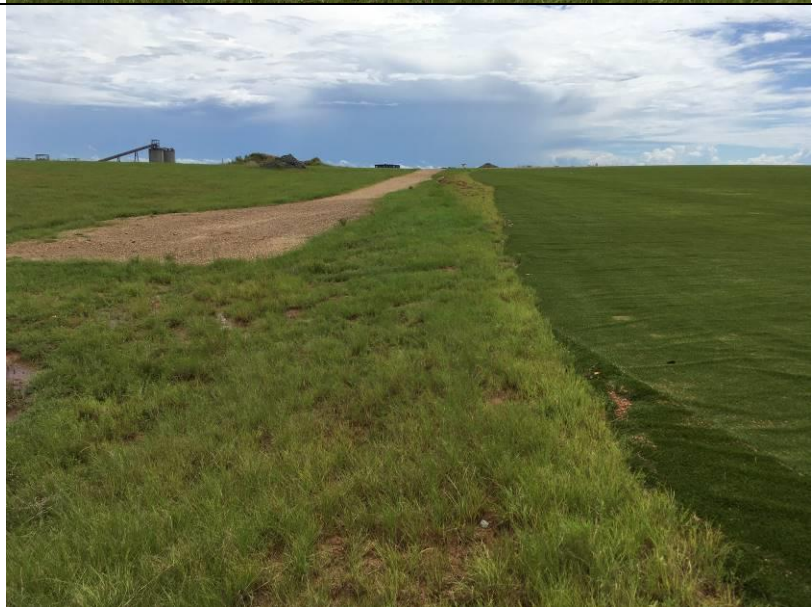
Photo # 24

View of final cover on the landfill central western areas. Notice break between vegetative cover and closure turf material.

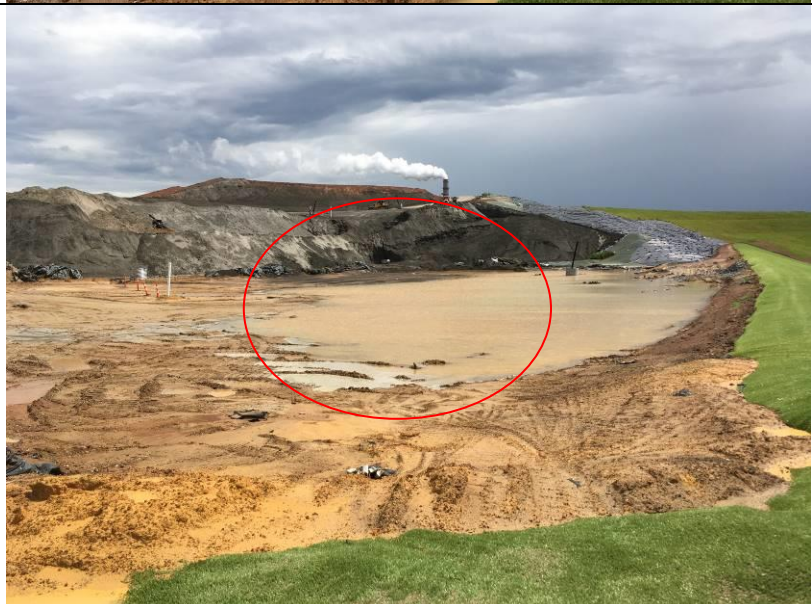
Photo # 29

View of the active 2015 Cell with some temporary soil cover and chimney drains in the ash areas. Area is inundated from recent rains events.
