# **2021 Annual Dam and Dike Inspection Report**

**Bottom Ash Pond Complex**

**Rockport Plant  
Indiana Michigan Power Company  
Rockport, Indiana**

**Document ID: GERS-21-076**

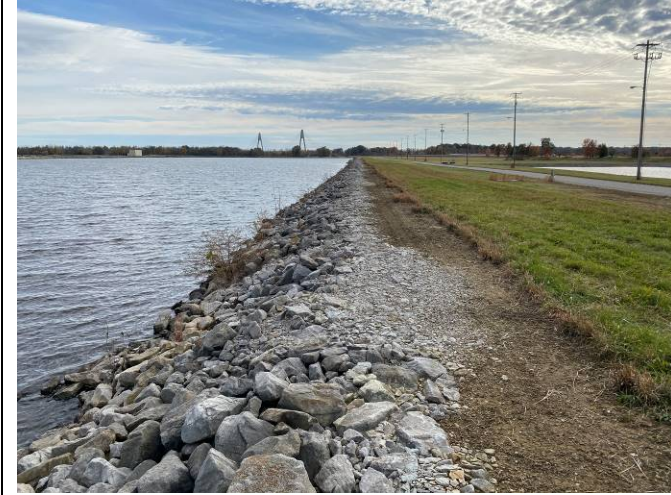
Photograph 1: #W

7. The crest of the west dike appeared in good and stable condition with no signs of distress such as settlement or ruts, and no erosion.
8. The primary discharge structure was in good condition and functioning properly. Flow was entering from all 3 sides of the box weir structure. The skimmer structure was in good condition. A small patch of cattails was observed growing on the inside of the skimmer structure.

View of the crest of the west dike of the West Bottom Ash Pond.

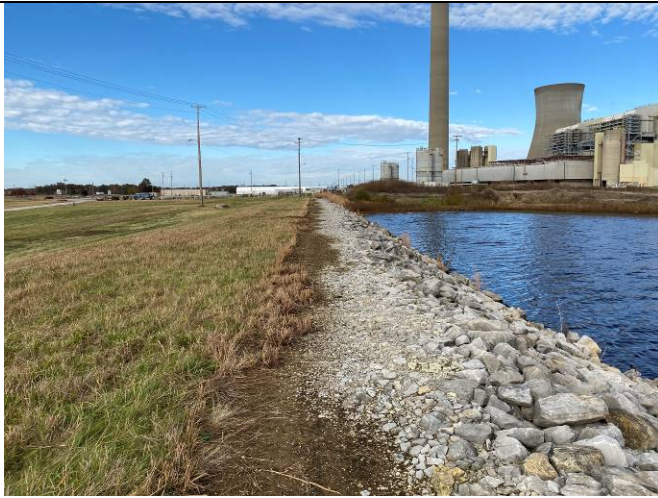
Photograph 2: #W

Another view of the crest of the dike of the West Bottom Ash Pond.

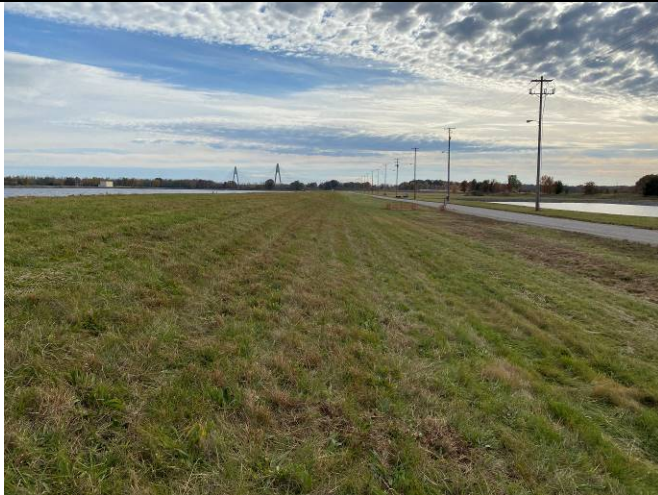
Photograph 3: #W

5. The outboard slope of the WBAP was in good condition. There were no signs of movement or misalignment, sloughing or bulges. The grass cover is in good condition.

View of the downstream slope of the western dike of the West Bottom Ash Pond.

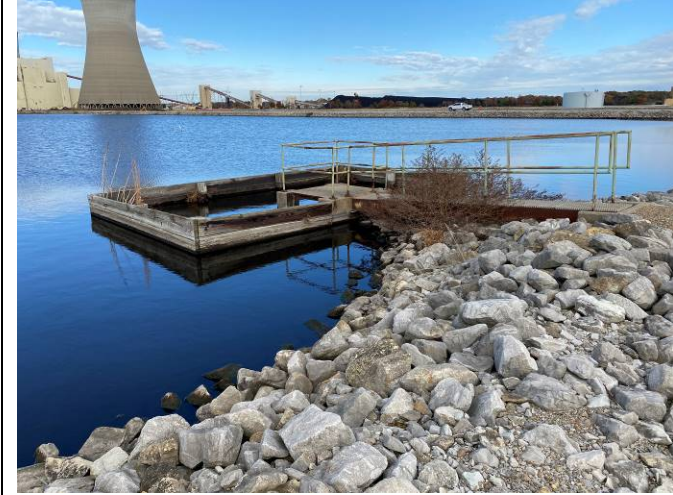
Photograph 4: #W

View of the inlet of primary discharge structure for the West Bottom Ash Pond.

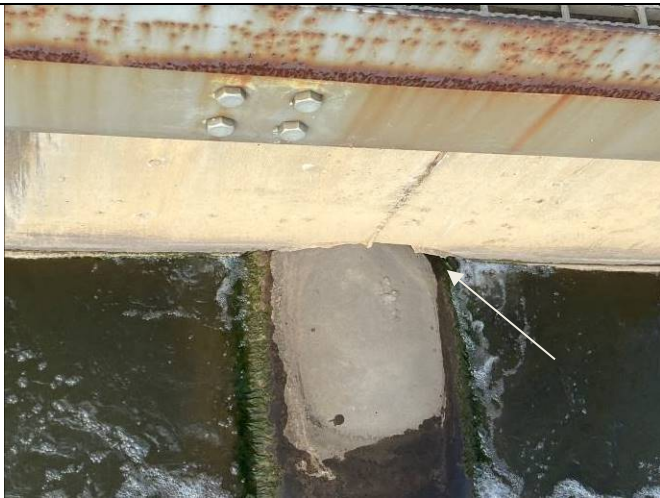
Photograph 5: #W

4. At the outlet of the WBAP discharge structure (coming from the WBAP into the WWWP), some deterioration was observed at the horizontal pipe/concrete wall interface. The deflections of the pipe as noted in past inspections were not detectable.

View of the outlet of the primary discharge structure for the West Bottom Ash Pond.

Concrete deterioration was noted at the interface between the metal pipe and concrete wall.

- 1) Monitor the deterioration of pipe penetration and deflection of the horizontal outlet pipe at the outlet of the west bottom ash pond structure, flowing into the west wastewater pond for further deterioration or excessive movement.
- 2) Monitor the fiberglass pipe between the Reclaim Pond and the Clearwater Pond for signs of soil migration through the open joints.
- 3) Monitor the interior slope of the East Wastewater Pond in the area of the leaking header pipe for signs of erosion. There are nearby discharge structures and walkway platforms that may complicate repairs to the interior slopes in this area.
- 4) Monitor the offset joint at the discharge structure for the East Wastewater Pond. A permanent white reference line has been placed at the joint to identify any future movements.
- 5) Monitor the sinkhole next to manhole 13-A for increased subsidence.

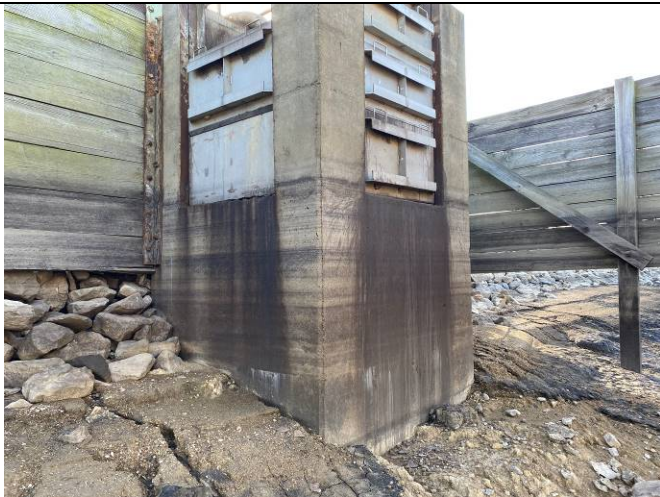
Photograph 6: #E

6. The primary discharge structure was in good condition and normally submerged components could be inspected. There were signs of corrosion noted along the stop log seals that are embedded in the concrete walls of the structure. The skimmer structure was in good condition. A pump discharge line for ongoing dewatering efforts to clean out the East Bottom Ash Pond was temporarily discharging through the primary discharge structure.

View of the primary discharge structure for the East Bottom Ash Pond.

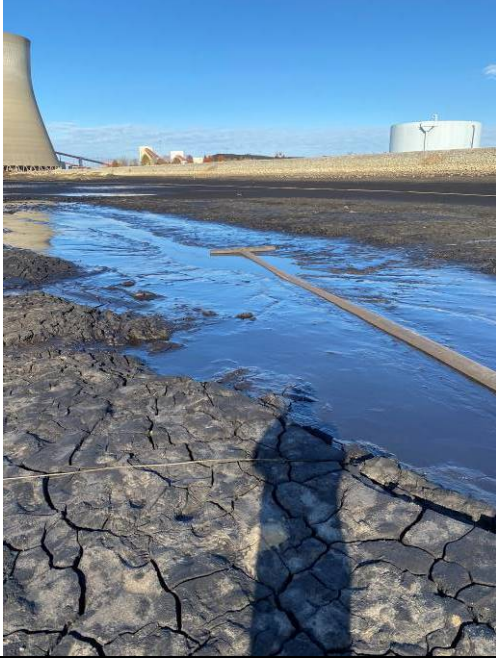
Photograph 7: #E

View of a pump line for dewatering the East Bottom Ash Pond. for cleanout.

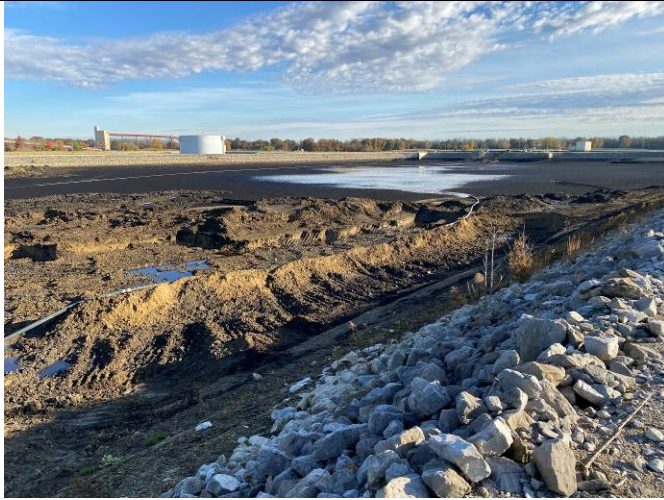
Photograph 8: #E

1. The East Bottom Ash Pond was drained during this inspection to facilitate excavation of CCR material.
2. A piece of angle iron has been installed at the diverter structure to reinforce the slide gate seal to the East Bottom Ash Pond at the diverter discharge structure. This angle iron was observed to be loose, due a concrete expansion anchor that has pulled out.

View of the cleanout operating in the East Bottom Ash Pond.

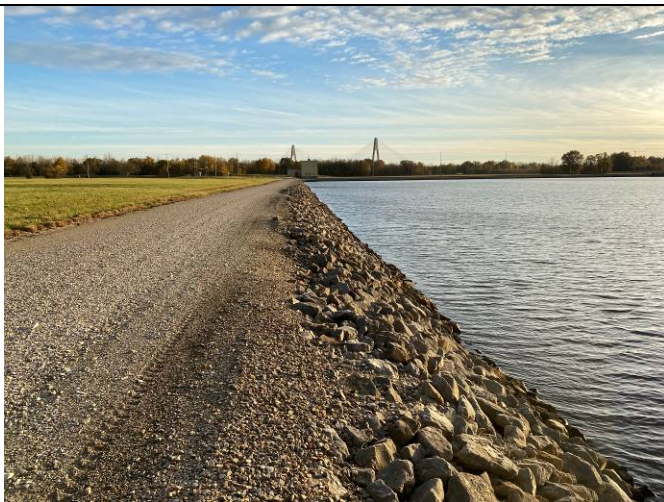
Photograph 9: #EW

2. The interior slopes of the EWWP and WWWP Ponds were in good condition. The riprap showed no signs of deterioration or weathering. Some minor areas with patches of vegetation were observed.

View of the shoreline along the East Wastewater Pond, looking south.

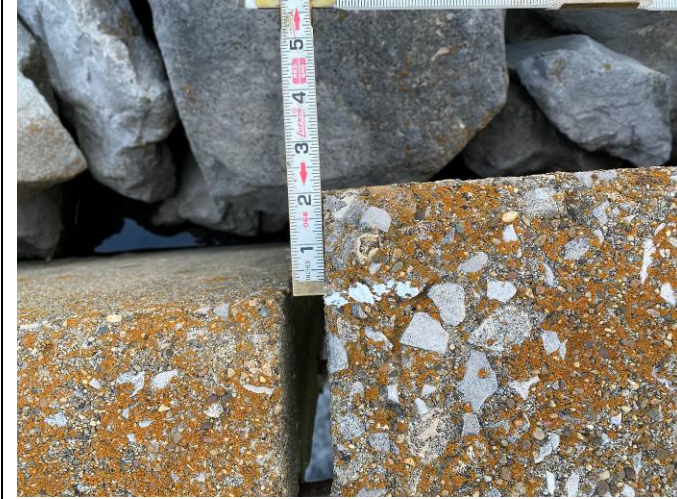
Photograph 10: #EW

6. The separation of the rectangular concrete weir channels in the EWWP does not appear to be any different from the conditions noted in previous inspection reports. During this inspection, a white line was marked at the joint to observe any additional movement.

View of the separated joint at the weir channel located inside the East Wastewater Pond

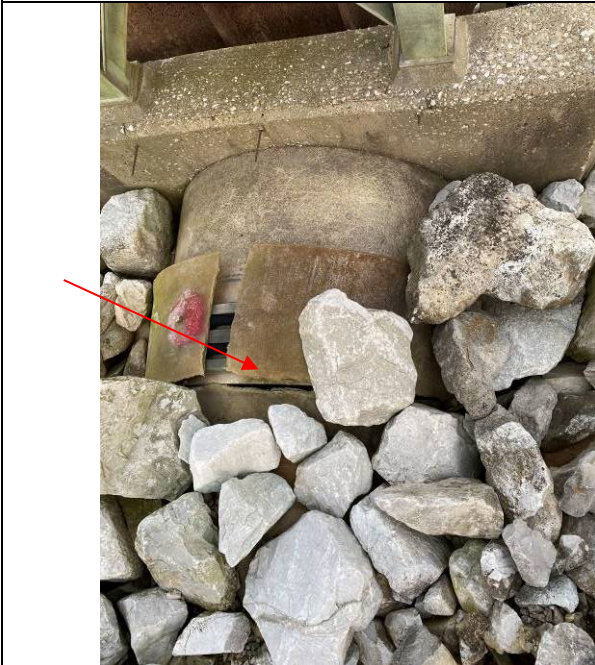
Photograph 11: #Reclaim

4. The reclaim pump structure was in good condition and appeared to be pumping properly.
5. The 42-inch-diameter fiberglass pipe between the Reclaim Pond and the Clearwater Pond was observed to have two open joints on the crown of the pipe, at both ends where the pipe is exposed.

View of the open joint at the fiberglass pipe between the Reclaim Pond and the Clearwater pond.

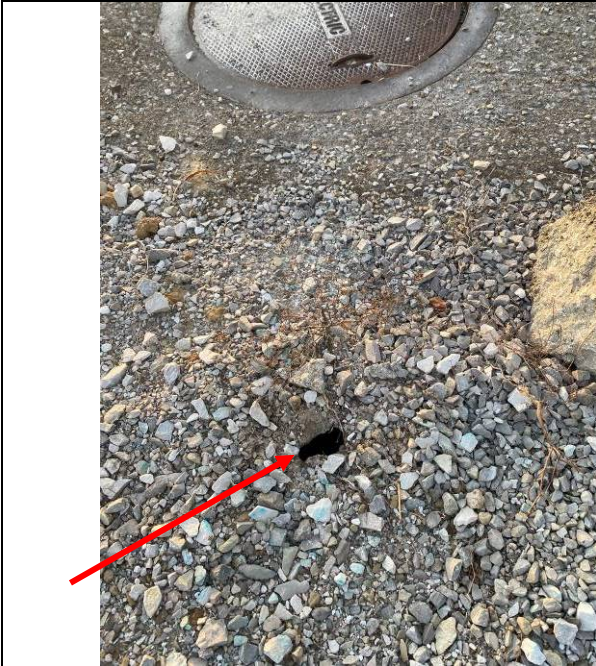
Photograph 12: #Clearwater

7. A small sinkhole feature was observed at manhole 13-A, which provides access to the corrugated metal pipe conduit for outfall 001. A tape measure was inserted into the sinkhole, measuring a depth of roughly 42 inches, and the diameter of the hole on the surface was about 4 inches. Stone has been placed around the manhole to repair the sinkhole since the last inspection, however it has reappeared. Based on discussions with plant personnel, this manhole has been repaired in the past.

View of the small diameter, 42 inch deep sinkhole adjacent to the manhole 13-A.

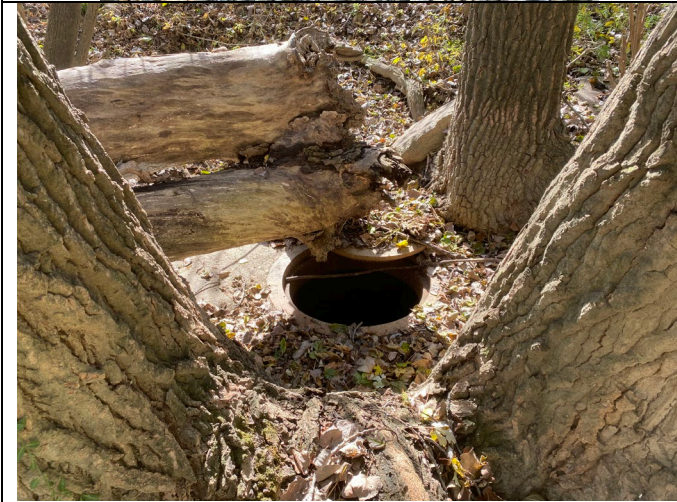
Photograph 13: #Clearwater

Manhole 13-F was found with the lid removed, and it appears the lid may have been removed by nearby farmer to provide surface drainage to cropland. This was found during the last inspection, and subsequently the manhole was closed by Rockport plant staff. However, the manhole has been removed once again.

View of the removed manhole lid at 13-F.

- 1) Continue with the vegetation maintenance & mowing efforts at the facility.
- 2) Consider repairing the deteriorated skimmer structure at the Clearwater Pond discharge structure.
- 3) Repair the loose angle iron in diverter structure for the bottom ash ponds.
- 4) Replace the lid to Manhole 13-F. Consider installing an open-grated lid at this manhole to allow surface drainage from the cropland area.
- 5) It is recommended to perform a camera inspection/investigation of the corrugated metal conduit for outfall 001. This is based on the presence of a sinkhole around manhole 13-A, the potential for tree roots to have entered into the pipe, the age of the pipe, manholes which have shifted out of level, and the overall importance of this conduit to the pond complex.

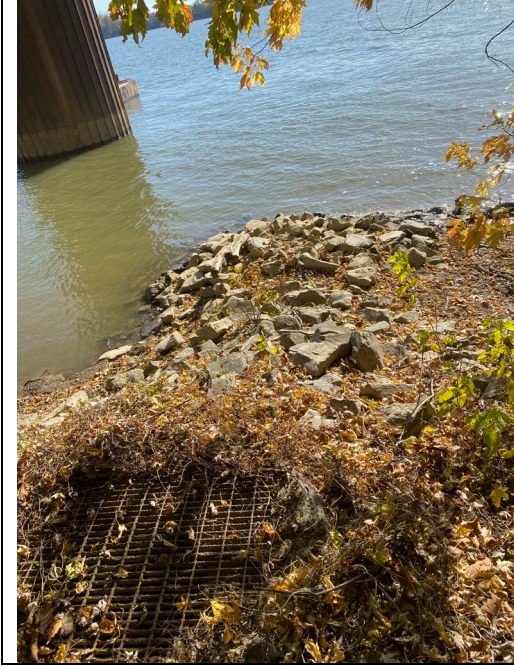
Photograph 14: #Clearwater

View of the final outlet  
for the pond complex into  
the Ohio River.
