2022 Dam and Dike Inspection Report

Bottom Ash Pond

**Northeastern 3&4 Plant
Public Service Company of Oklahoma
Oologah, OK**

Document Number: GERS-22-018

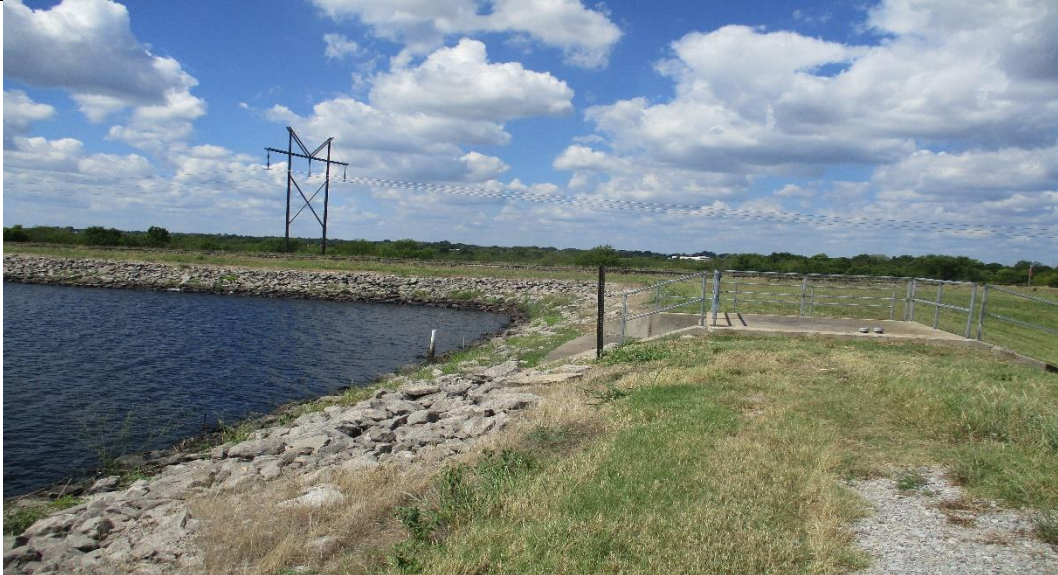
1. Photograph No. 1 illustrates the auxiliary spillway located at the northwest corner of the pond. Overall, the spillway appeared to be in good and functional condition as designed without any obstruction to flow. There were no signs of movement, settlement, or misalignment of the spillway. There were no signs of seepage along the contacts between the concrete training walls and downstream slope or at the end of the concrete chute.
2. The energy dissipater baffles (Photograph No. 2) at the toe of the spillway were clear of sediment and were in good condition. The drainage pipe culverts downstream of the spillway appeared clear of obstruction, dry, and in good functional condition.

<p>Photograph No. 1 Auxiliary spillway of the ash pond.</p>

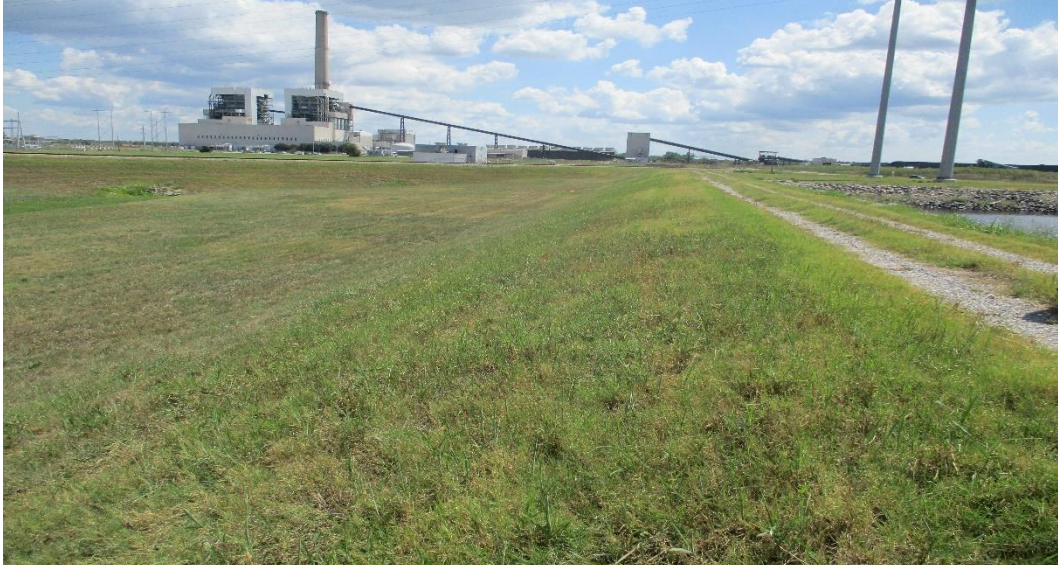
1. Typical condition of the downstream slope of the dike was well vegetated. The grass along the exterior slope was recently mowed. There were no signs of sloughing or other slope movement observed (Photograph No. 3).

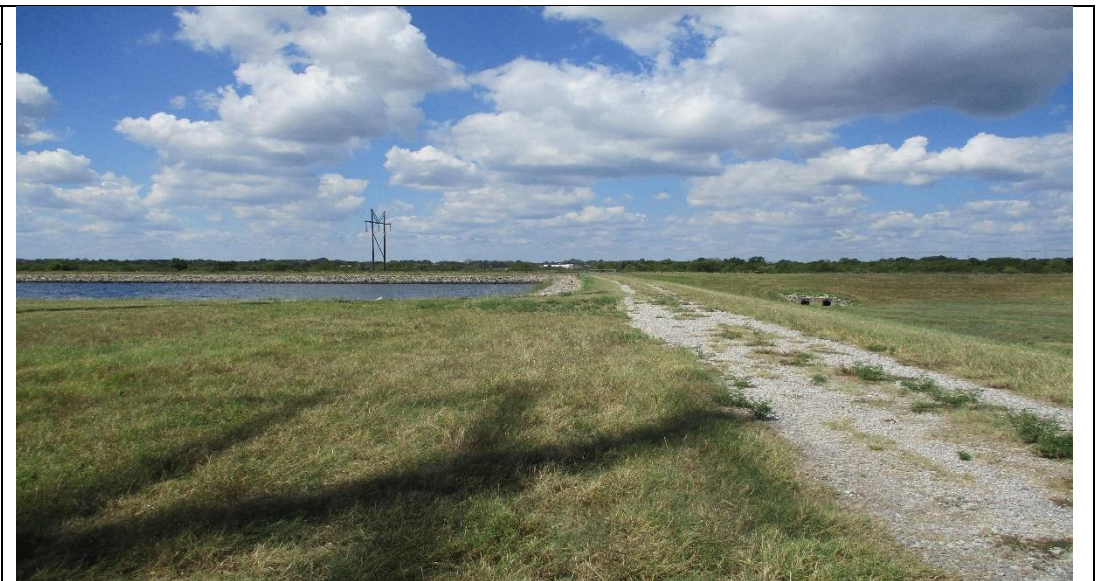
2. Photograph No. 4 illustrate the crest and upstream of the north dike. The crest appeared in good and stable condition with no significant settlement, misalignment, or noticeable sign of distress. The interior slopes show no signs of sloughing or bulges. The riprap protection along the slope was in good condition and no significant grassy vegetation was noticed within the riprap.

<p>Photograph No. 4 Typical condition of the crest of the northwest dike.</p>

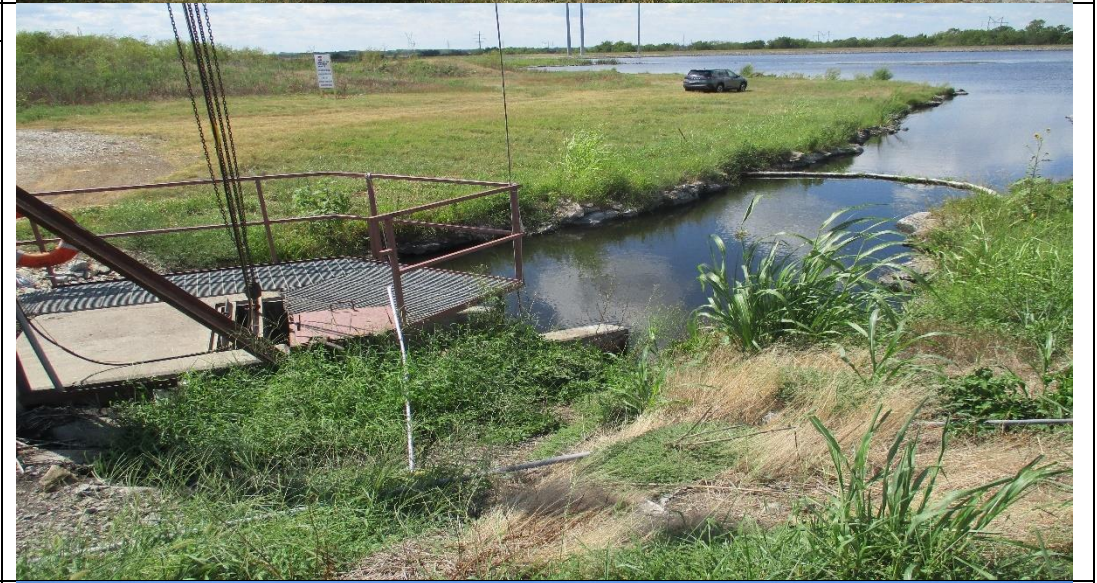
3. The intake structure was in good functional condition. The metal platform and concrete structure show no signs of deterioration. The intake screen was clear of debris. The staff gauge was in good condition (Photograph No. 5).

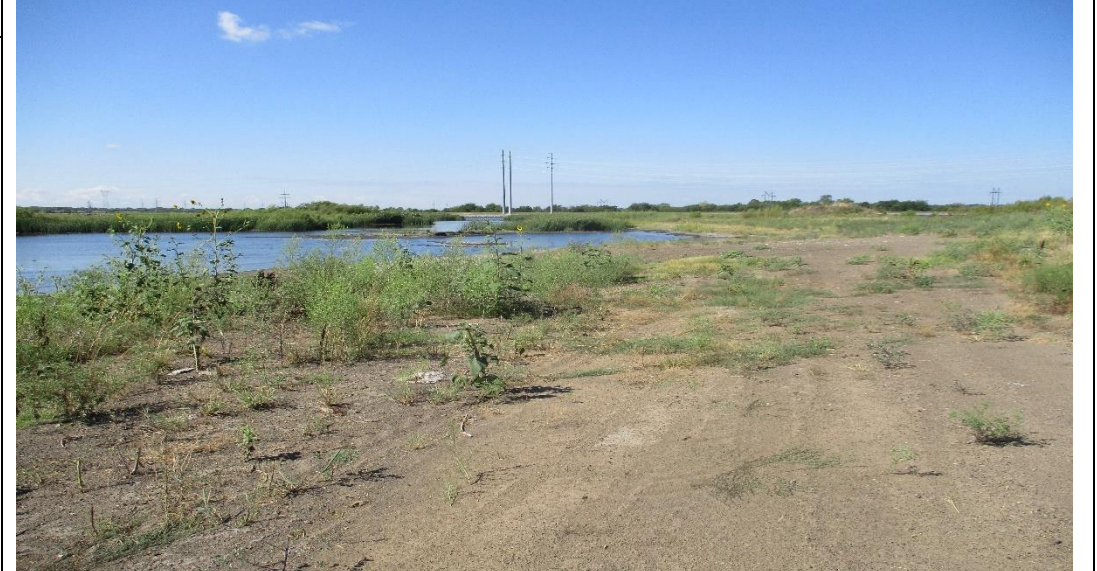
4. Photograph No. 6 illustrate the natural ground and ash built-up along the northeast area of the pond. Minor vegetation was noticed in this area, but the ash deposits were well maintained and in stable condition.

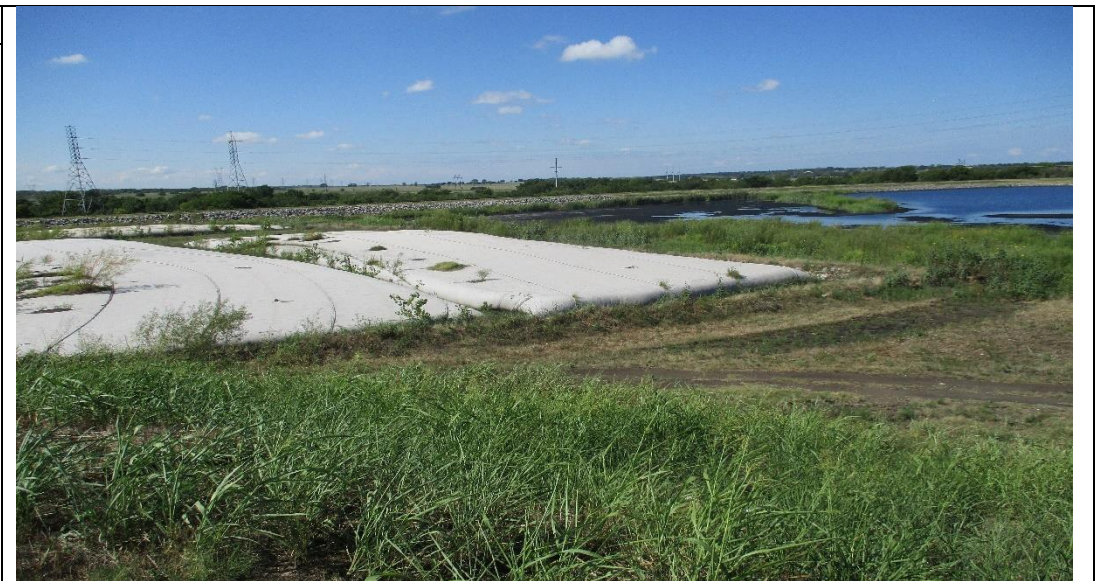
<p>Photograph No. 10 Bottom ash collected in geotubes.</p>

1. A dredge cell is located to the east within the bottom ash pond footprint. Photograph No. 9 illustrates an overall view of the dredge cell. Dredge cell is located at a higher elevation compared to the pond. Dredge cell consists of bottom ash fill and appeared to be contained and in stable condition. Bottom ash is stored in the geotubes located in the southeast area of the pond (Photograph No. 10).
2. The upstream slope of the southeast corner of the south dike is illustrated in Photograph No. 11. A runoff ditch is located at the toe of the upstream slope. The upstream slope with the riprap appeared in good condition. Excessive vegetation was present in the ditch.

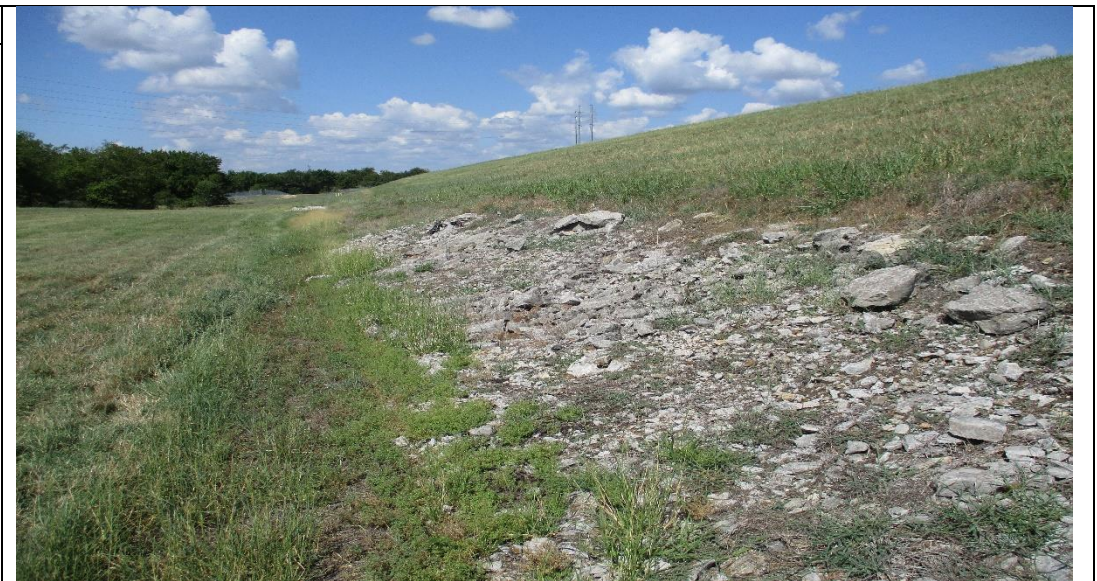
3. The seepage collection blanket (Photograph Nos. 12 and 13) at the toe of the downstream slope of the south and west dike appeared in good and functional condition. No water was noticed in the seepage blanket at the time of inspection.

<p>Photograph No. 13 Seepage collection toe drain (looking west).</p>

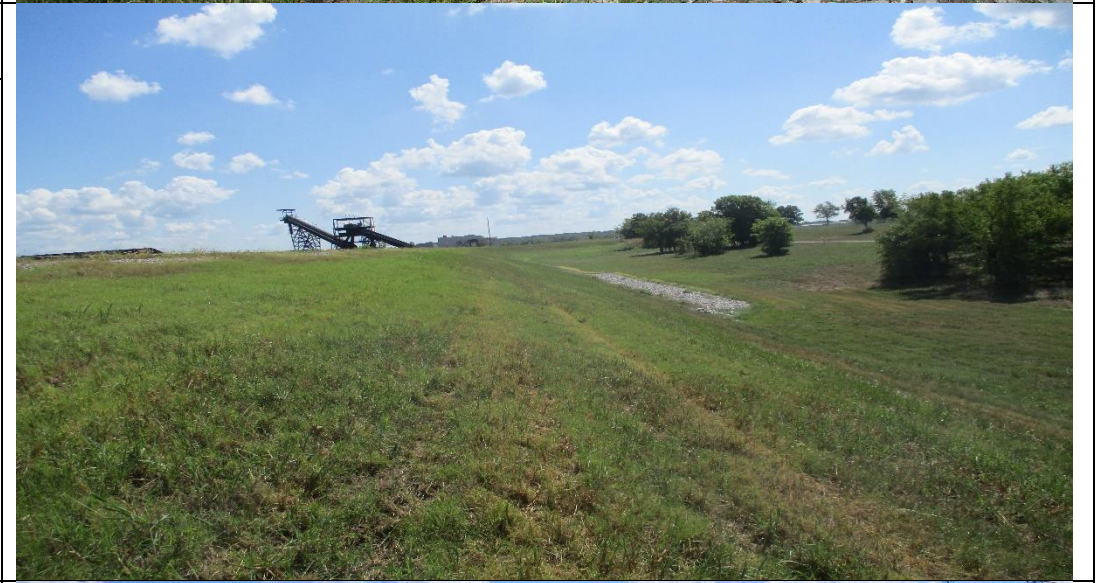
4. The downstream slope (Photograph No. 14) was well vegetated and maintained in a controlled manner. There was no observed seepage, wet, or damp areas along the slope. The area about 30-feet beyond the toe of the dike is well maintained and free from overgrown trees.

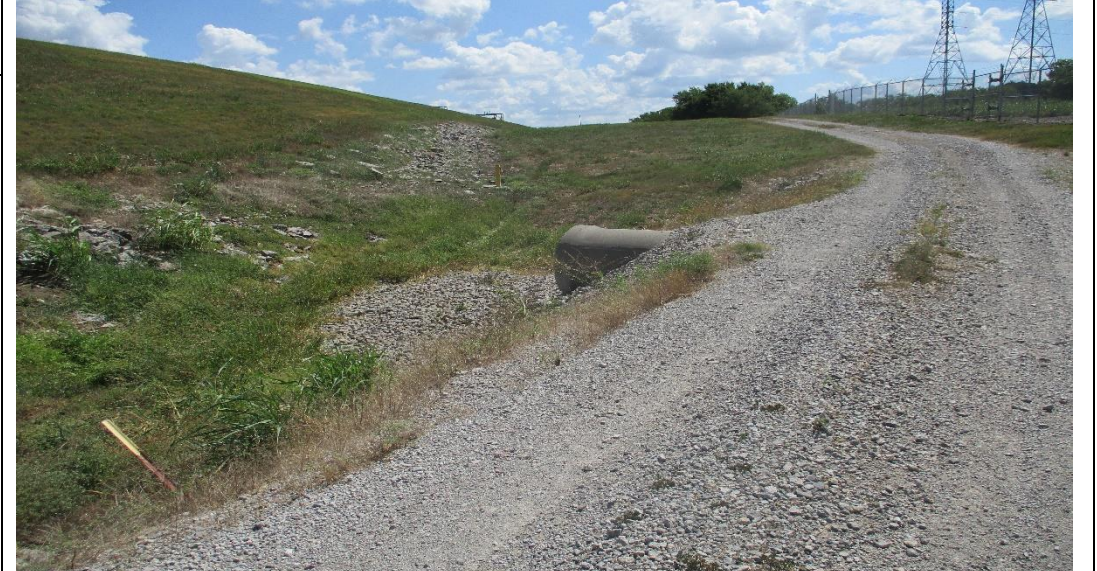
5. Typical view of the downstream slope, access road, seepage blanket, toe ditch, and pipe culvert are illustrated in Photograph Nos. 15 and 16. There was no signs of sloughing, settlement, animal holes, or other deficiencies.

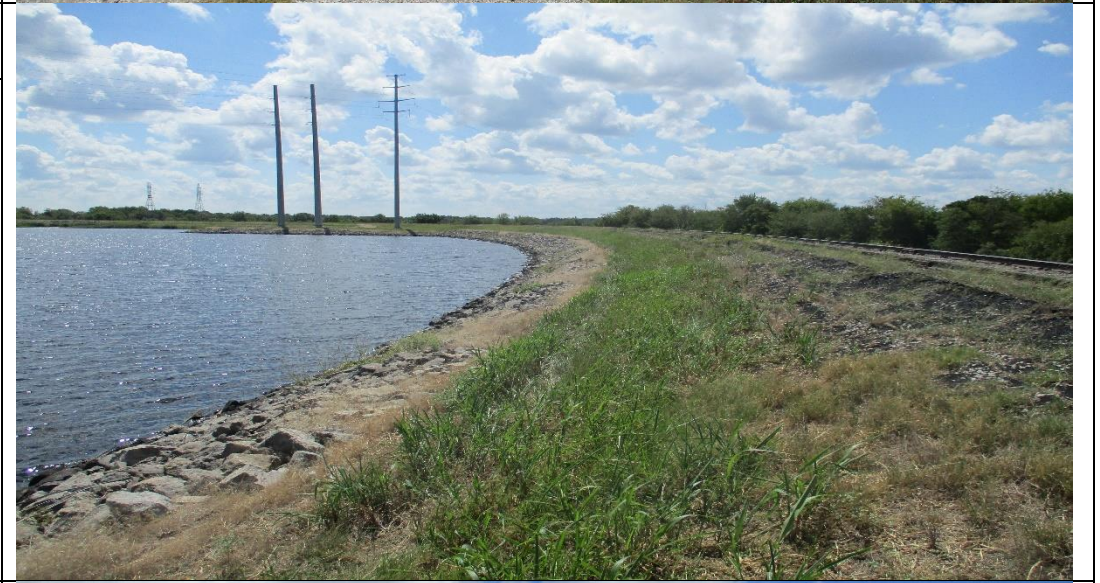
6. The upstream slope and crest of the south dike is illustrated in Photograph Nos. 17 and 18. The crest including the railroad appeared in good condition. The upstream slope was good without any signs of sloughing or settlement. The riprap in the lower section of the slope appeared in good and stable condition.
