# **2022 ANNUAL DAM AND DIKE INSPECTION REPORT**

**CCR ASH PONDS**

**WELSH POWER PLANT  
CASON, TEXAS**

DOCUMENT ID: GERS-22-043  
Revision 0

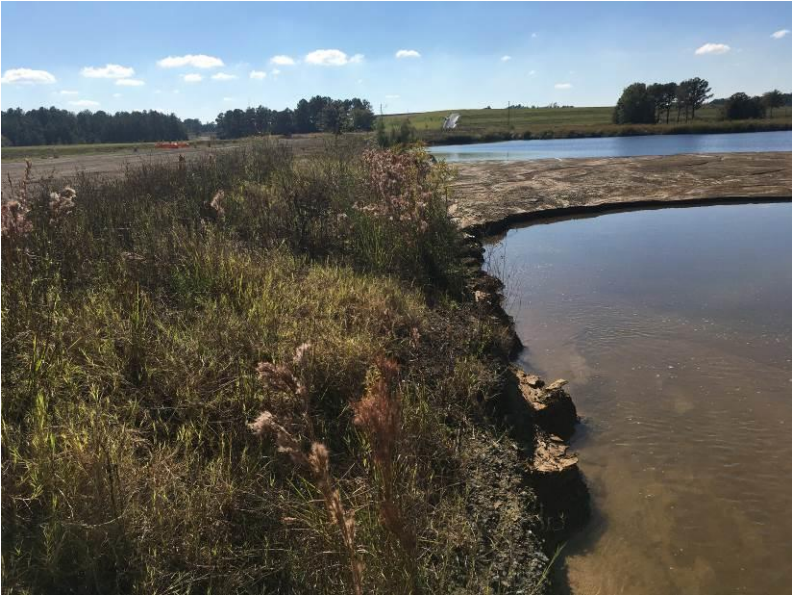
<p>Photo # 1</p>

- (i) Typical condition of the upstream slope, crest, and downstream slope is illustrated in Photographs No. 1-4. The dike appeared in satisfactory and stable condition. There were no signs of settlement, misalignment, sloughing or erosion. Slightly overgrown vegetation was noticed along the upstream slope and on the downstream slope near the rock rip rap. There was some significant damage of the downstream slope near the crest from hog rutting activities (Photograph No. 3)

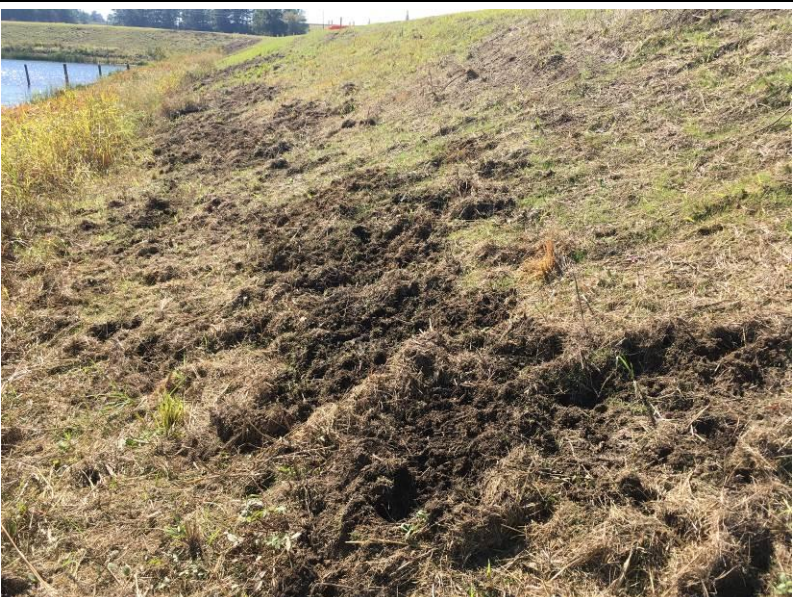
- There was significant hog rutting damage on the downstream slope of the Primary Bottom Ash Pond.
- Overgrown vegetation was noticed throughout the pond areas and should be maintained accordingly.

- As noted, all the excessive vegetation should be cut down and maintained consistently to control and properly manage it.
- The damaged slope area from hog rutting activities on the downstream slope of the primary ash storage pond should be repaired and seeded.
- The sediment buildup in the principal spillway basin area of the bottom ash storage pond should be cleaned out to promote un-obstructive flows through the basin area to the outlet pipe.

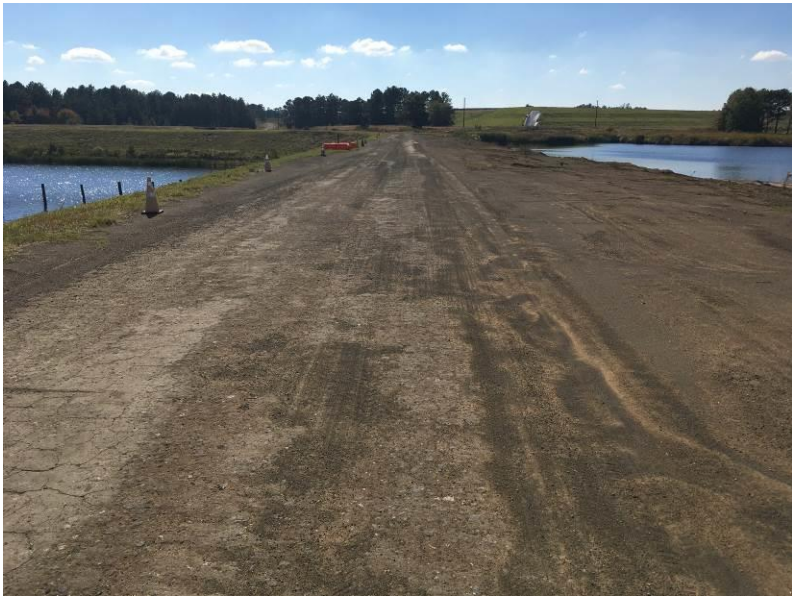
Photo # 4

Typical crest area of Primary Bottom Ash Pond.

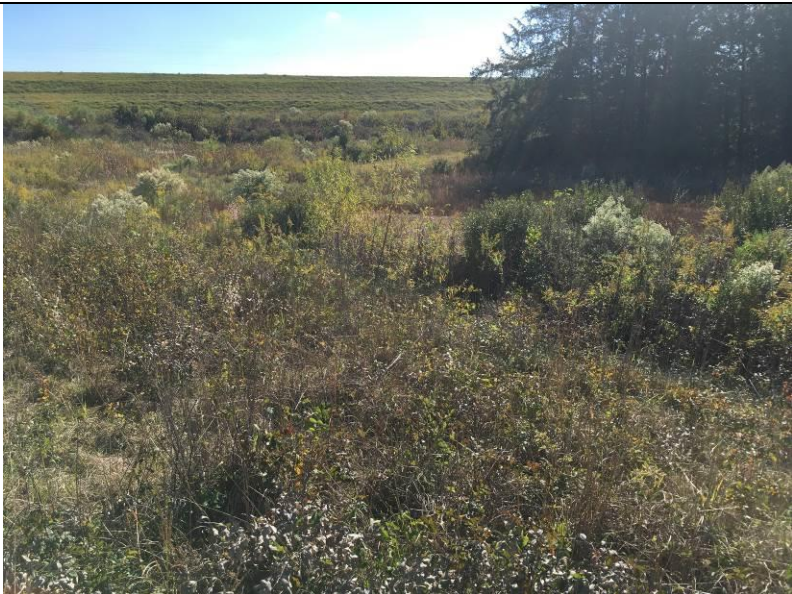
Photo # 5

- (iii) Photograph No. 5 illustrates the primary emergency spillway located towards the southeast section of the south dike. The primary emergency spillway appeared to be in satisfactory condition but was covered with overgrown vegetation preventing a full inspection of the area. The secondary emergency spill way was in satisfactory condition an showed no signs

Emergency spillway channel of Primary Bottom Ash Pond.

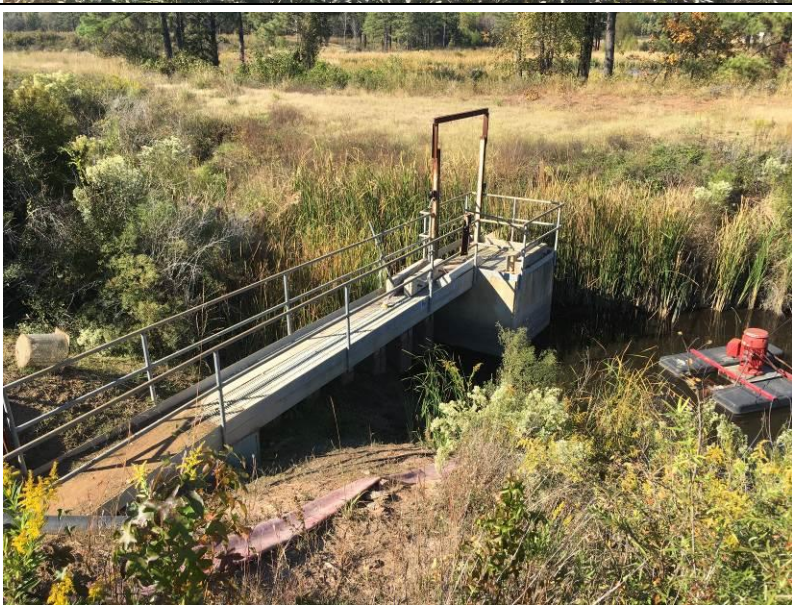
Photo # 6

- (iv) A canal is located at the south end of the pond. A typical view of the discharge canal concrete weir box is illustrated in Photograph No. 6. The canal conveys water from southwest corner of the ash pond to the Clearwater Pond located at the west southeast end. The canal indicated positive drainage condition. Excessive vegetation was noticed along the banks of the canal.

View of the Primary Bottom Ash Pond discharge canal concrete weir box.

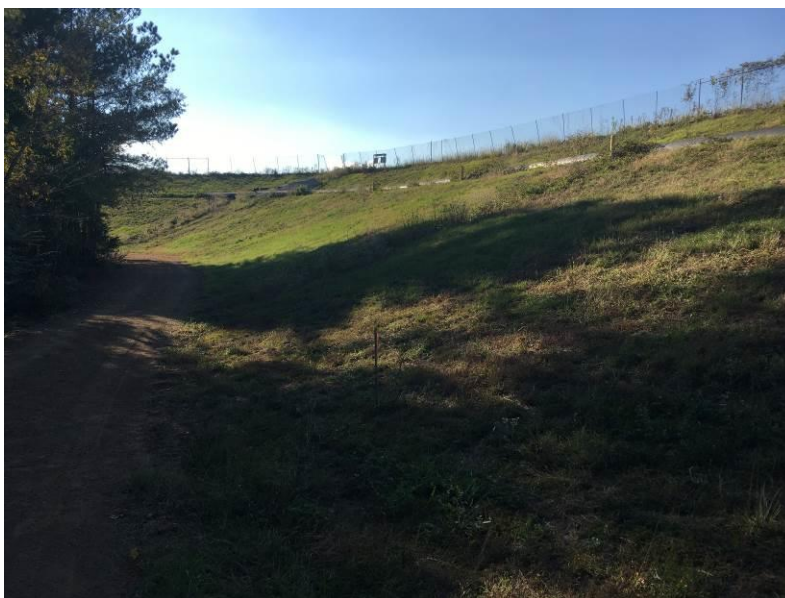
Photo # 7

- (i) The east portion of the downstream slope is illustrated in Photographs No. 7 and 8. Slightly overgrown vegetation was noticed on these slopes. The slope appeared in satisfactory and stable condition with no signs of settlement, misalignment, sloughing or erosion.

Bottom Ash Storage Pond (Winston Pond) looking at downstream slope conditions on east side.

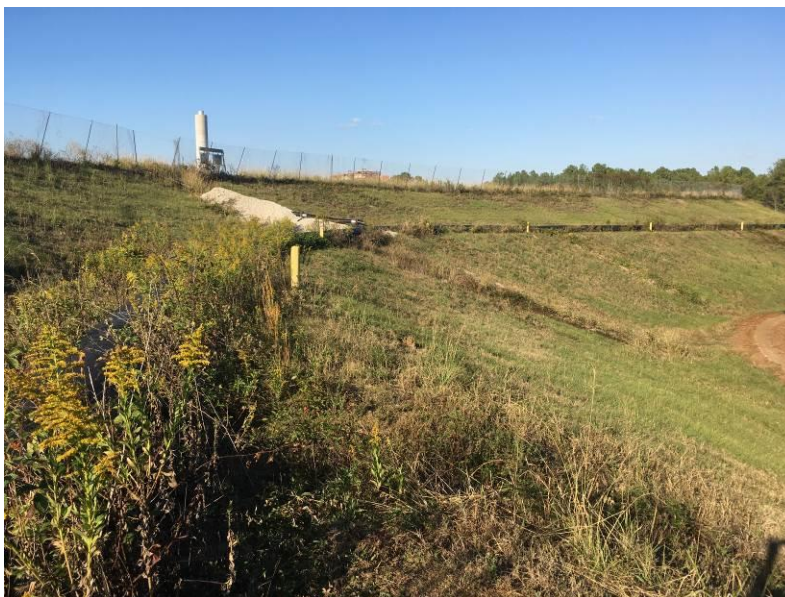
Photo # 8

Bottom Ash Storage Pond (Winston Pond) looking at downstream slope conditions on southeast side.

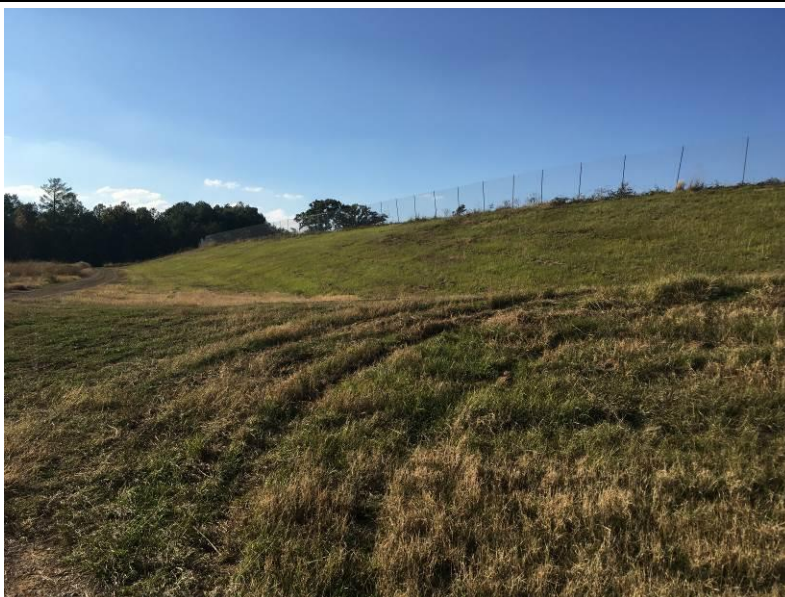
Photo # 9

- (ii) Photographs No. 9 and 10 illustrate the south downstream slope areas. The slopes appeared in satisfactory and stable condition with some minor overgrown vegetation. There were no signs of settlement, misalignment, sloughing or erosion.

Bottom Ash Storage Pond (Winston Pond) Looking at downstream slope conditions on south side.

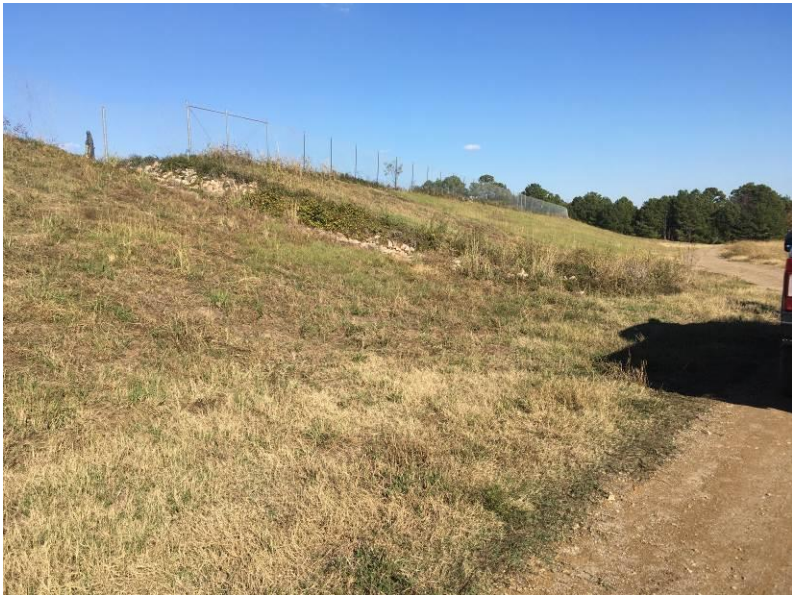
Photo # 10

Bottom Ash Storage Pond (Winston Pond) Looking at downstream slope conditions on southwest side.

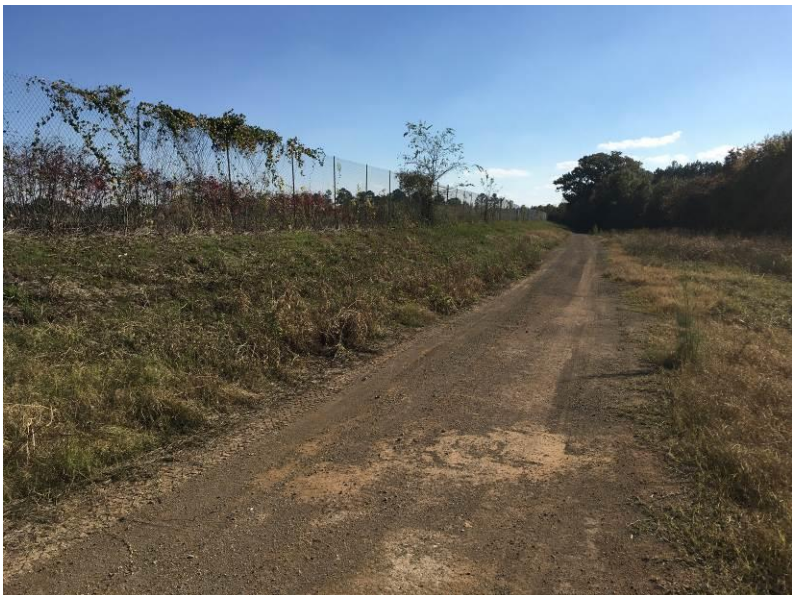
Photo # 11

- (iii) The northwest section of the west dike downstream slope is illustrated in Photograph No. 11. The slope appeared in satisfactory and stable condition with slightly overgrown vegetation preventing a full inspection of the slopes. There were no signs of settlement, misalignment, sloughing or erosion.

Bottom Ash Storage Pond (Winston Pond) looking at downstream slope conditions on west side.

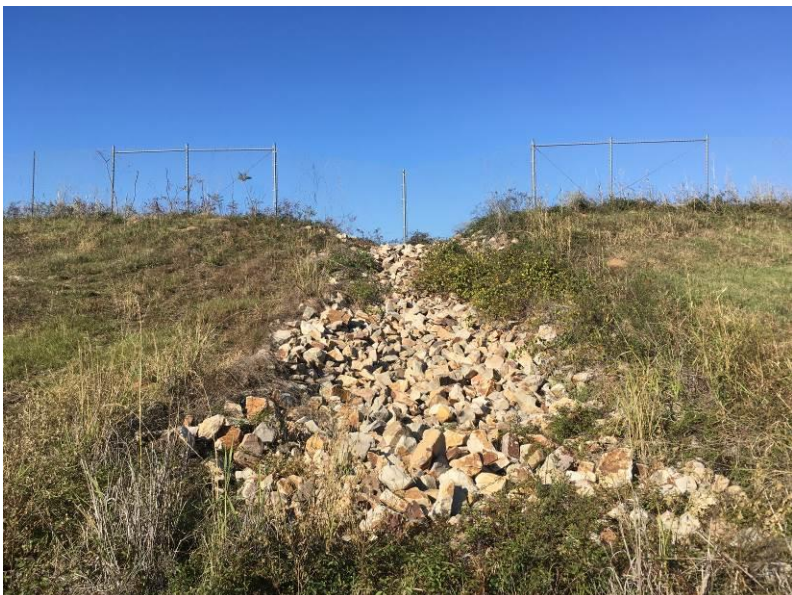
Photo # 12

- (iv) Photograph No. 12 illustrates the emergency spillway location at the southwest section of the south dike. The spillway riprap was in satisfactory condition with some vegetation near the edges of the rock rip rap.

Bottom Ash Storage Pond (Winston Pond) downstream slope looking at emergency spillway channel.

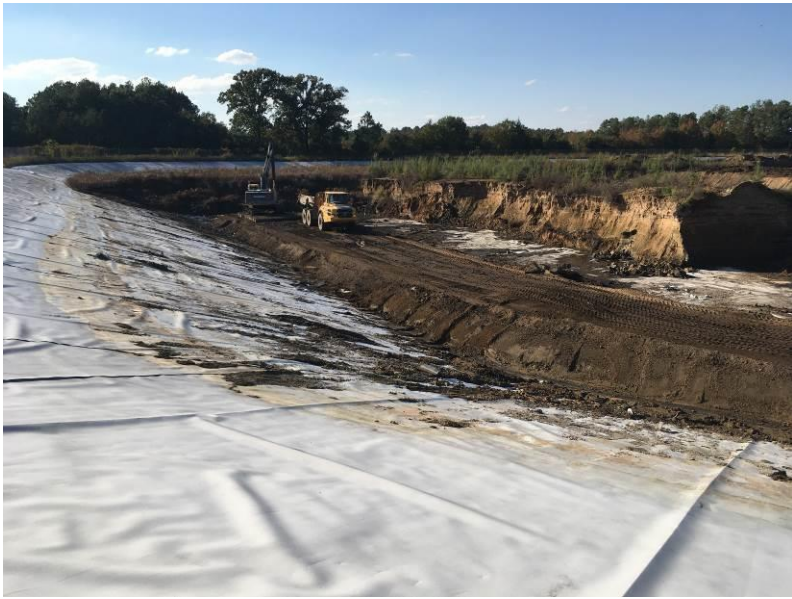
Photo # 13

- (v) Photographs No. 13 and 14 illustrate the interior conditions, upstream slope, and crest areas of the pond. The upstream slope appeared to be in good and stable condition and mostly buttress with ash. The geosynthetic liner appeared intact and in good condition. The crest appeared in good and stable condition. Overgrown vegetation was noticed throughout the interior of the pond and on the crest area.

Bottom Ash Storage Pond (Winston Pond) looking at typical interior conditions.

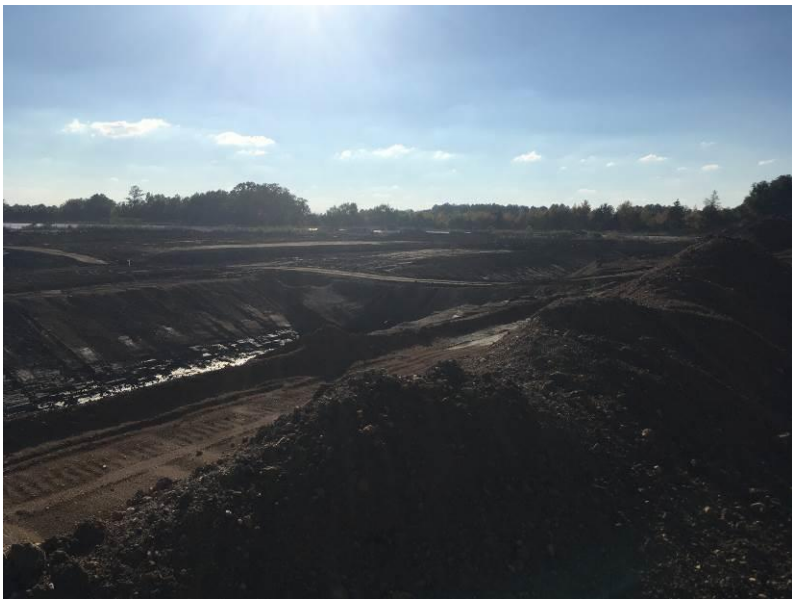
Photo # 14

Bottom Ash Storage Pond (Winston Pond) looking at typical interior conditions.

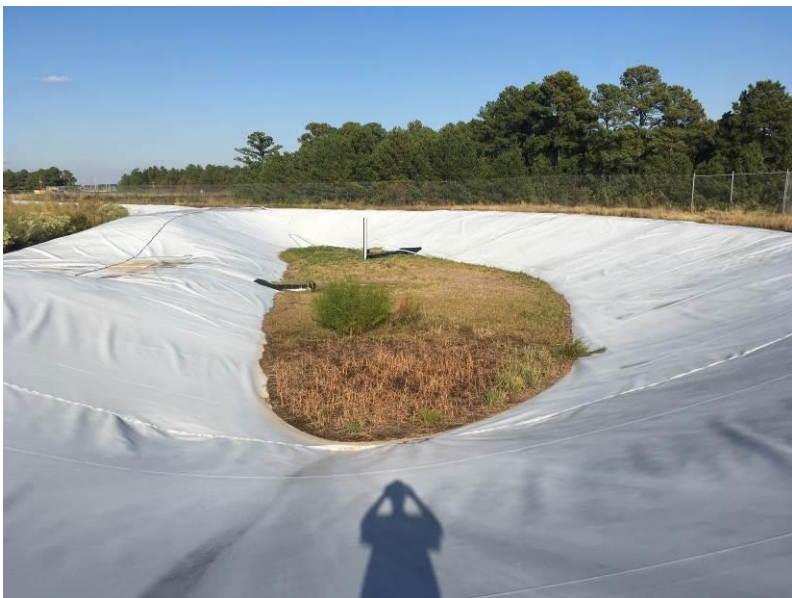
Photo # 15

- (vi) A small area within the pond is used as a control weir with a principal spillway inlet and outlet pipe located in southeast corner (Photograph No. 15). The principal spillway basin was dry at the time of inspection with no flow through the inlet or outlet pipes. The basin is silted up with ash sediment to the flow line of the inlet and outlet pipes and could possibly restrict flows when passing water from the main pond through the basin to the outlet pipe.
- (vii) There are two pipe culverts located at the northwest corner of the pond that used to convey storm water from the landfill and surrounding areas into the pond. The storm water runoff channel and inlet pipes have been plugged to prevent storm water runoff from entering the pond (No Photograph was Taken).

- There is no evidence of distress that would indicate the possibility of immediate sliding, slope instability, settlement, misalignment or cracking of the bottom ash pond embankments. As such it is concluded that the dam and dikes are performing as designed.
- Vegetation management for the facilities is considered satisfactory. However, some areas are overgrown and should be maintained accordingly.
- The principal spillway basin is silted up with ash sediment to the flow line of the inlet and outlet pipes and could possibly restrict flows when passing water from the main pond through the basin to the outlet pipe.

Bottom Ash Storage Pond (Winston Pond) interior area looking at principal spillway outlet pipe and control weir at southeast corner.

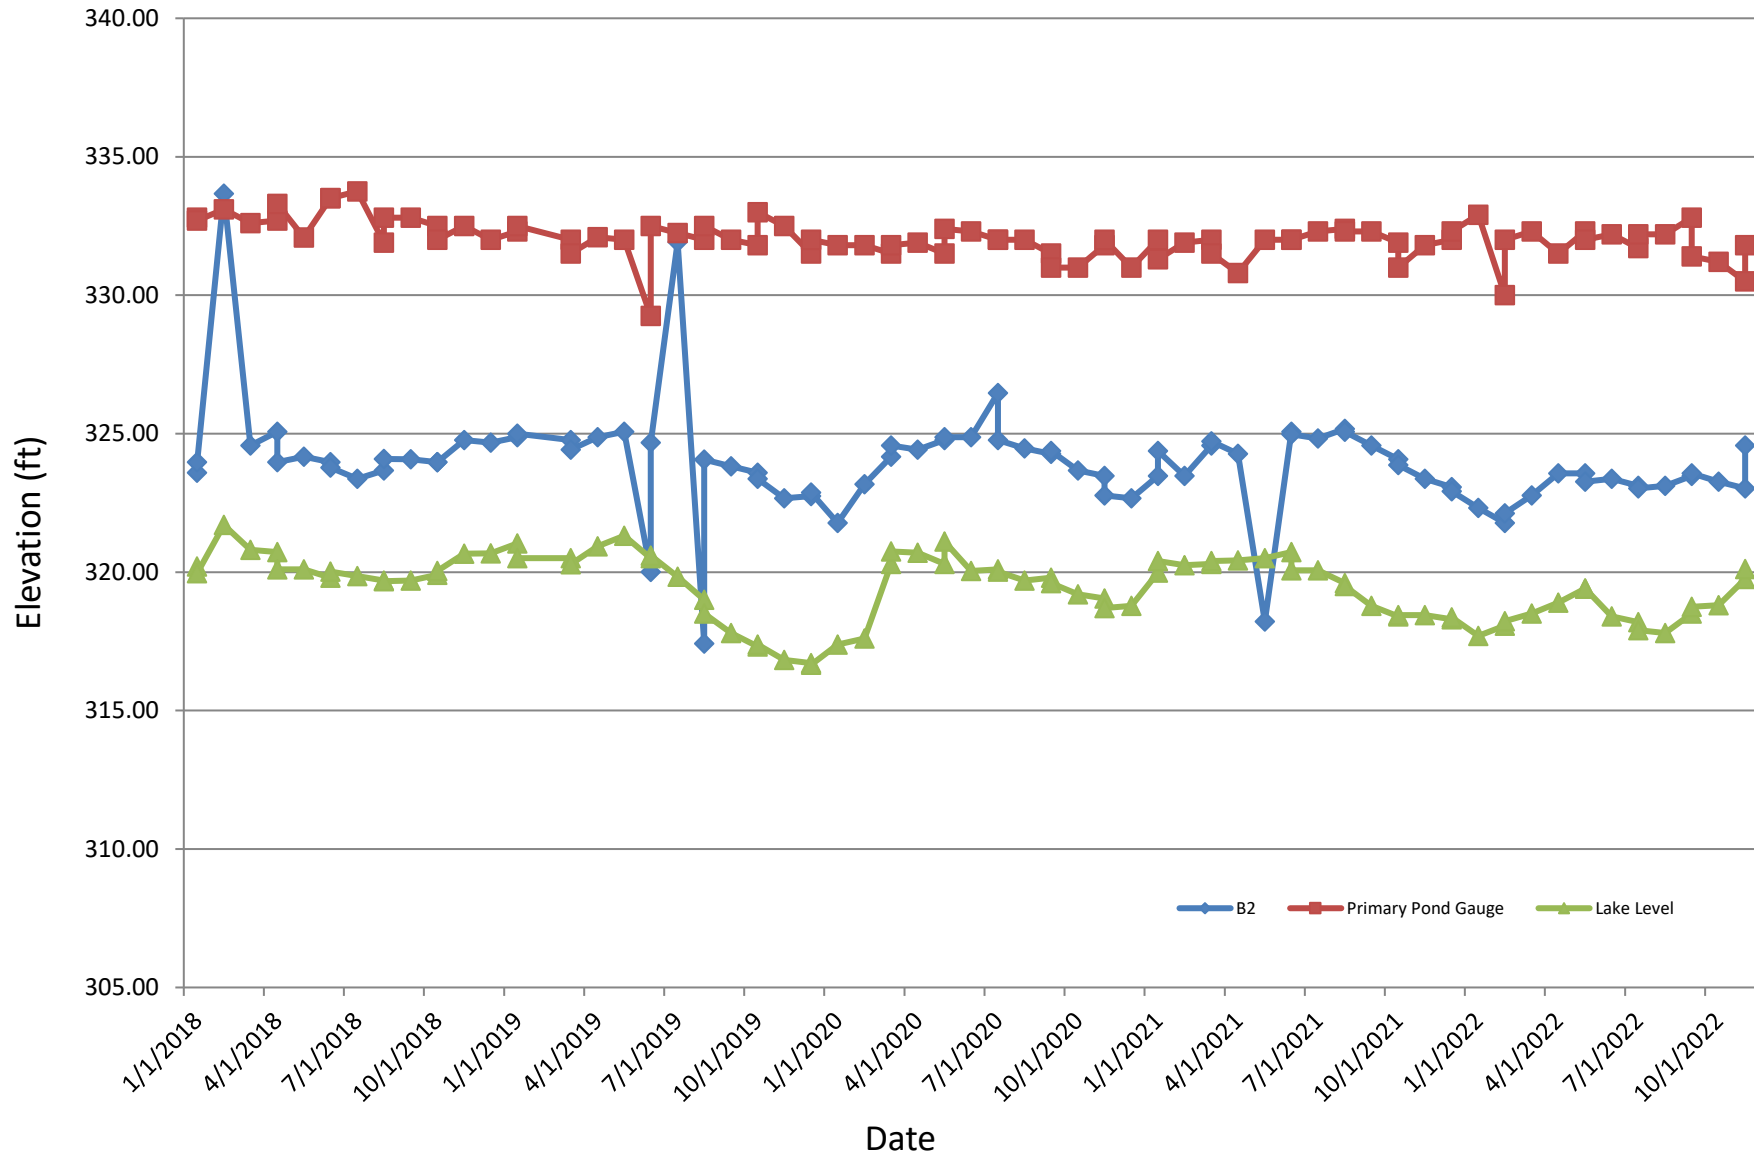
Figure 4B - Primary Pond Piezometer Readings

The monitoring instrumentation for the Primary Bottom Ash Pond consists of the one (1) active piezometer (B-2) located through the main embankment area. There is no monitoring instrumentation for the Bottom Ash Storage Pond (Winston Pond). The location of the instrumentation is shown in Attachment D, Figure 4A. The maximum and minimum readings of Piezometer B-2 since the last annual inspection, a time of October 2021 to November 2022, were 323.57 ft msl and 321.77 ft msl, respectively. Piezometer B-2 levels appeared consistent from month to month and reacted to the fluctuation in tail water levels (i.e., main lake). The results of the measurements of the piezometer are shown in Appendix D, Figure 4B.
