# **2022 ANNUAL CCR LANDFILL INSPECTION REPORT**

**Ash Landfill**

**Welsh Plant  
American Electric Power Service Corporation  
(SWEPCO)  
Cason, Texas**

**December 2022**

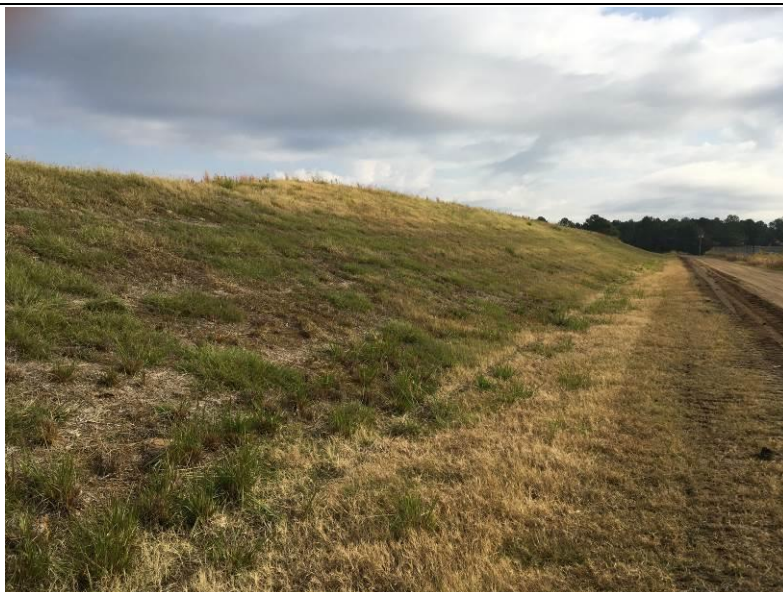
Photo # 1

1. The south slope of the landfill and the toe ditch is illustrated in Photograph No. 1. The slope appeared in satisfactory condition with no signs of seepage, erosion, or sloughing. The toe ditch at the time of inspection appeared mostly dry.

View of the Southern Berm Outside Slope Looking East.

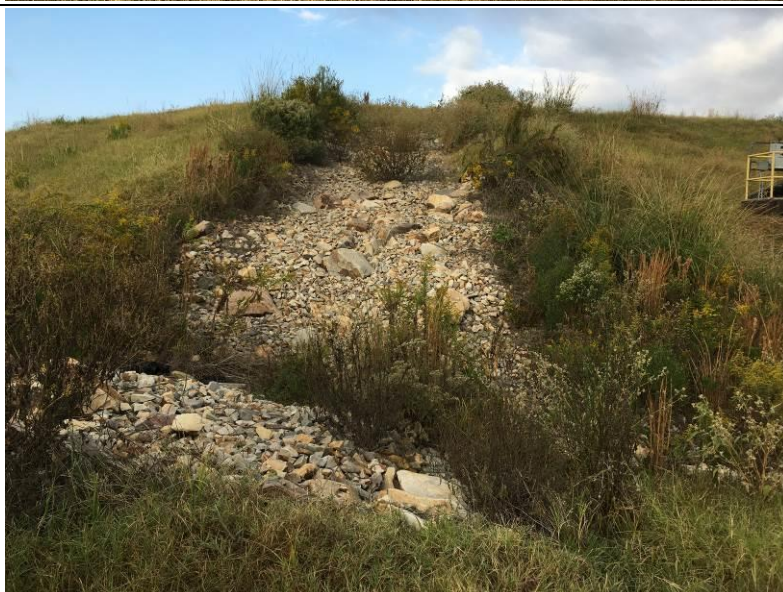
Photo # 2

2. Photograph No. 2 illustrates the southeast corner of the landfill where the riprap lined letdown channel is located. The channel appeared in satisfactory and functional condition. There was some overgrown brush and woody vegetation protruding through the rock lined channel.

View of the Southeast Berm Let Down Channel. Notice Some Overgrown Vegetation in Rocks.

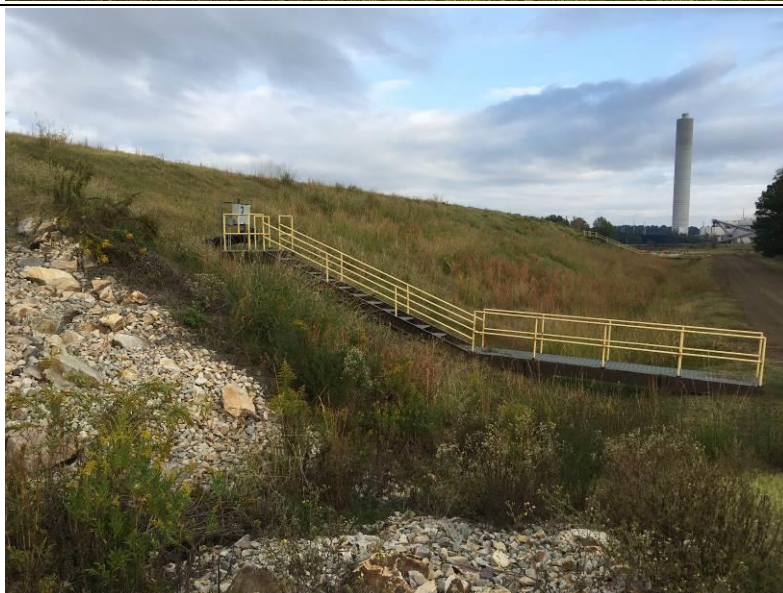
Photo # 3

3. The east slope of the landfill and the toe ditch is illustrated in Photographs No. 3 - 6. The slope appeared in satisfactory condition with no signs of seepage, erosion, or sloughing. The upper terrace and the toe ditch at the time of inspection appeared mostly dry. The perimeter ditch below the access walkway on the northern end was bare from vegetation indicating that there had been standing water (Photograph No. 5) in this section of the ditch. The perimeter ditch on the north end showed signs of head cutting activity from erosion (Photograph No. 6).

View of the East Berm Outside Slope Looking North. Notice Overgrown Vegetation.

- 1 Positive drainage shall be maintained over the landfill and in the perimeter ditches. The low spots in the east side and north side perimeter ditches should be graded and fill in to maintain positive drainage.

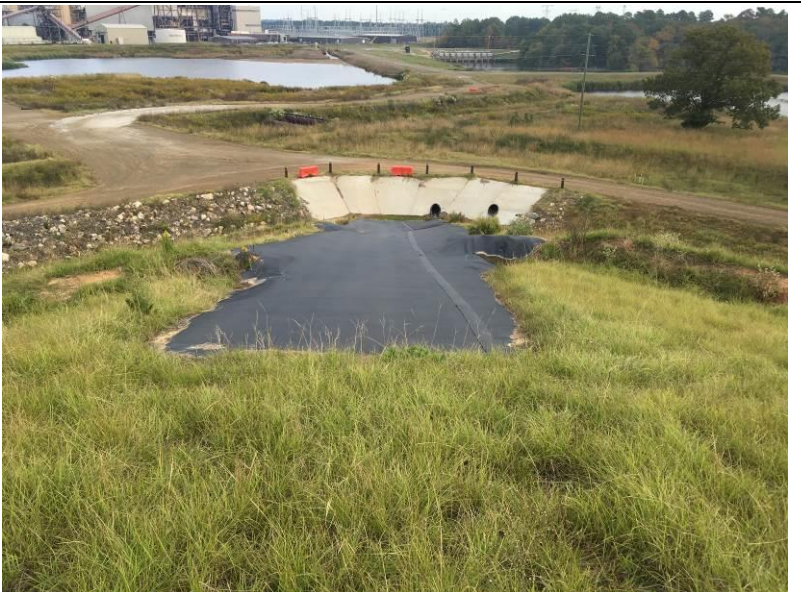
4. Photograph No. 7 illustrates the HDPE lined letdown channel in the northeast corner of the landfill. The channel appeared to be in satisfactory and functional condition. The bottom section of the letdown channel is lined with concrete with energy dissipater blocks to slow water down before it enters the perimeter ditch. There is sediment buildup in the bottom of the ditch near the inlets to the 30-inch and 36-inch pipes (Photograph No. 8).

Photo # 7  
View of the Northeast Corner Berm Let Down Ditch.

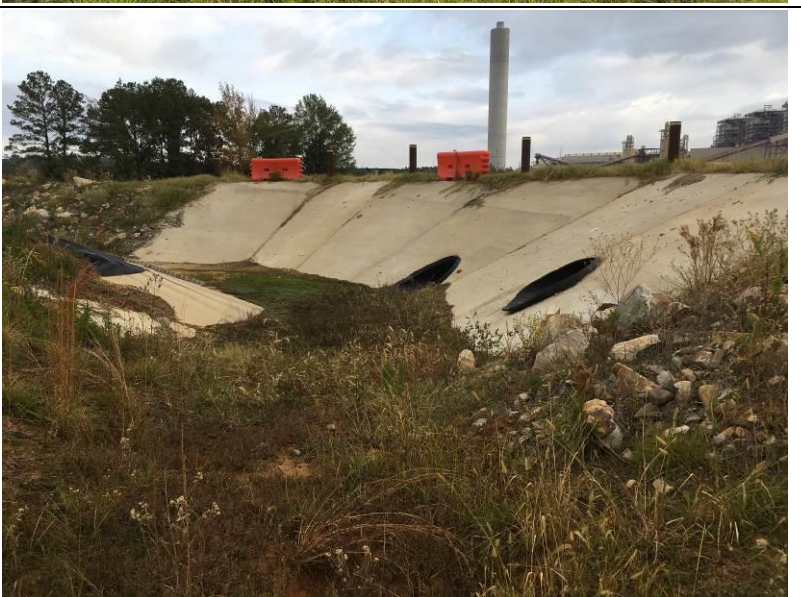
Photo # 8  
View of the 30- and 36-inch Storm Water Pipes Located in Northeast Corner of Landfill Perimeter Ditch. Notice Sediment Buildup in Ditch and In Front of Pipe Inlets.

- 2 The sediment builds up in the northeast corner perimeter ditch near the 30- and 36-inch pipes needs to be cleared to prevent any pipe flow blockage from additional sediment build up.

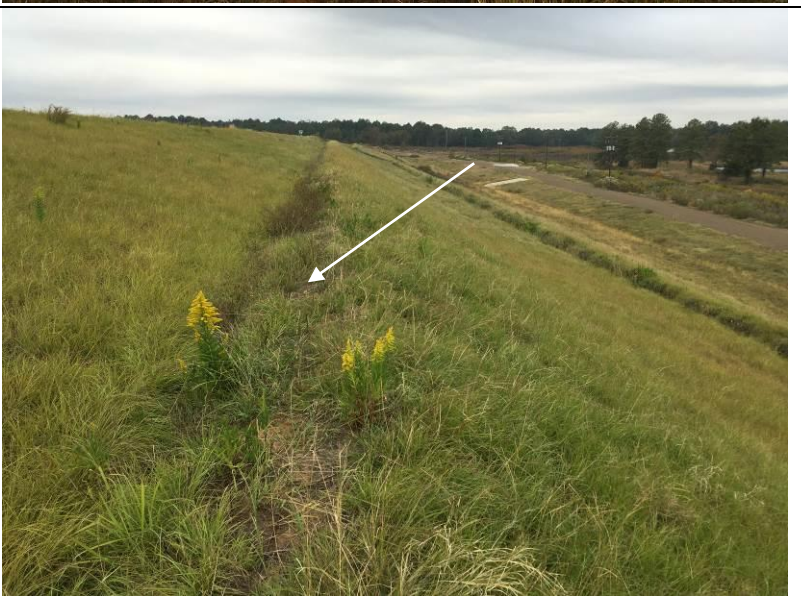
5. Photographs No. 9 – 15 illustrates the outer slopes, northern let down channel and perimeter ditch on the north side of the landfill. Most of the slopes appeared in

Photo # 9  
View of the North Berm Outside Slope Upper Terrace Looking West.

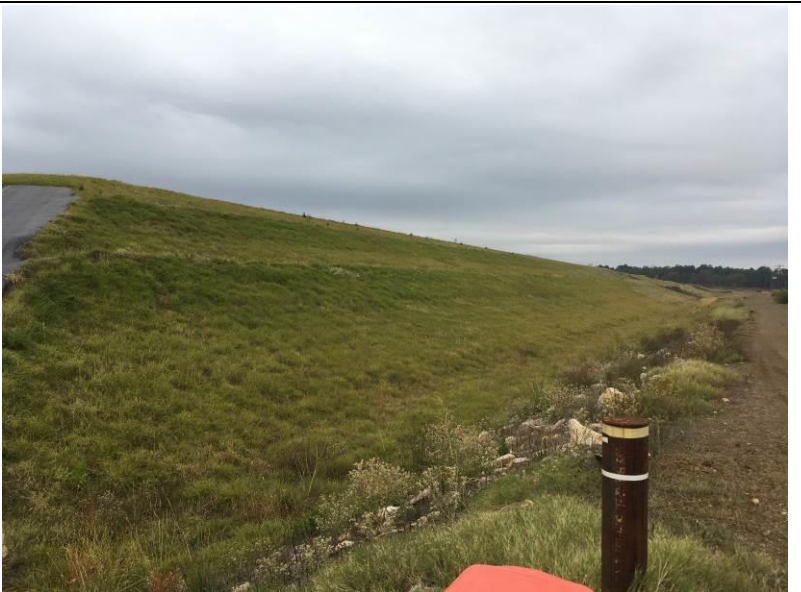
Photo # 10

View of the Northern Berm  
Outside Slope Conditions  
Looking West.

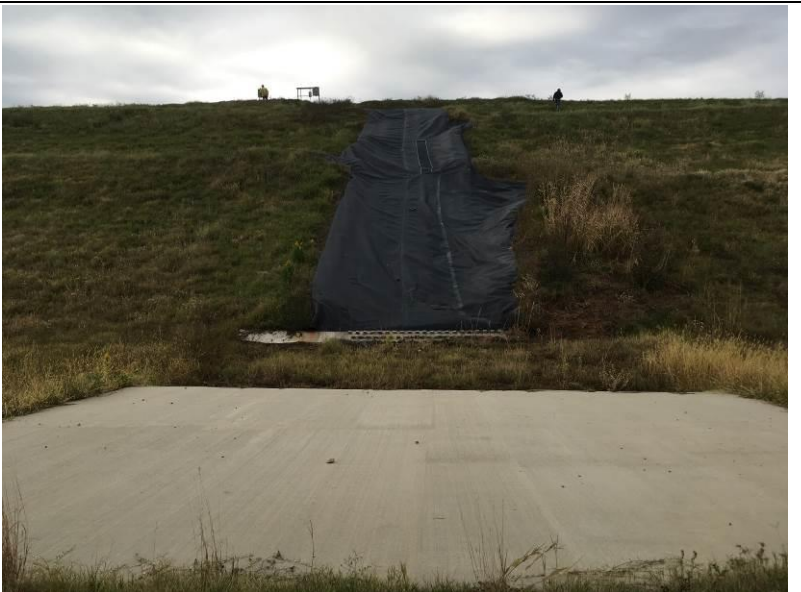
Photo # 11

satisfactory condition with no signs of seepage, erosion, or sloughing. Vegetation cover is satisfactory except for some overgrown areas adjacent to the northern let down channel (Photograph No. 11). The perimeter ditch on the north side was mostly dry at the time of inspection except for some standing water in the mid-section (Photograph No. 12). The west end of the northern berm is in poor condition with overgrown vegetation (Photograph No. 13). Photograph No. 14 shows the view of culvert #2 located in the northwest corner of the landfill. The culvert basin area is in satisfactory condition with some minor overgrown vegetation on the slopes. The outlet pipe to the primary ash pond from the culvert basin area is shown in Photograph No. 15. The pipe was in satisfactory condition with overgrown vegetation in the discharge area.

View of the Northern Berm  
Central Let Down Channel.

- 3 Vegetation growth on the newly capped and covered slopes (South, East and North) is satisfactory, but some areas had either sparse vegetation that needs to be re-seeded or overgrown vegetation that needs to be maintained. There were a few areas of vegetation growth on the inside of the landfill needs to maintain as well (culvert #2).

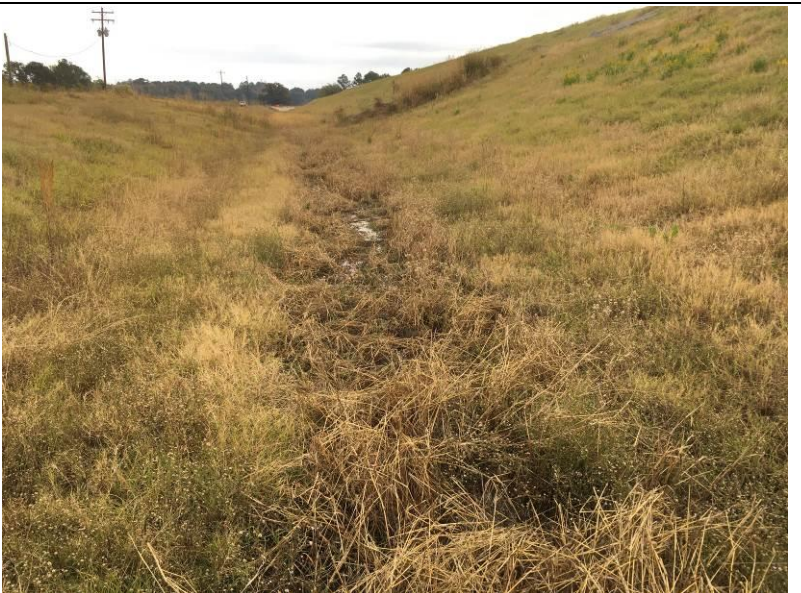
Photo # 12

Typical View of the Northern  
Berm and Perimeter Ditch Slope  
Conditions Looking East. Notice  
Some Standing Water from  
Recent Rains Event.

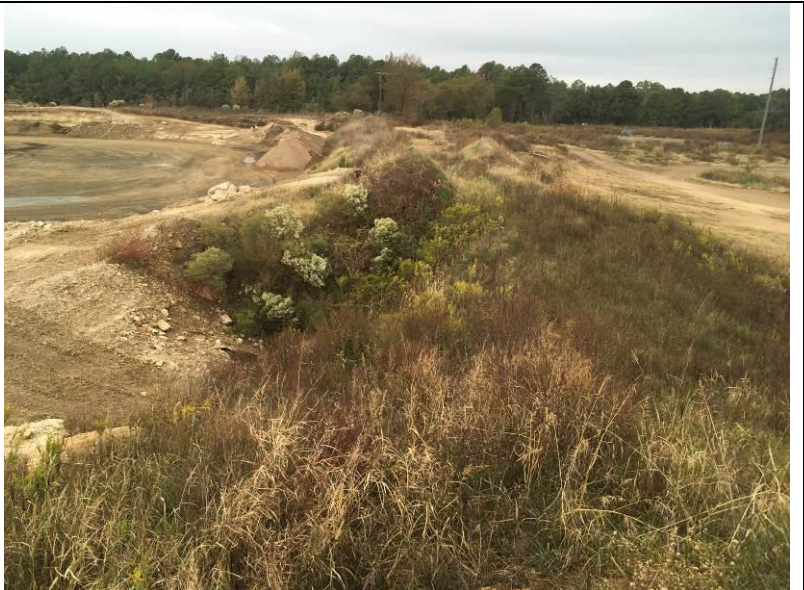
Photo # 13

View of the West End of the Northern Berm. Notice Vegetation is Overgrown, and Berm is in Poor Condition.

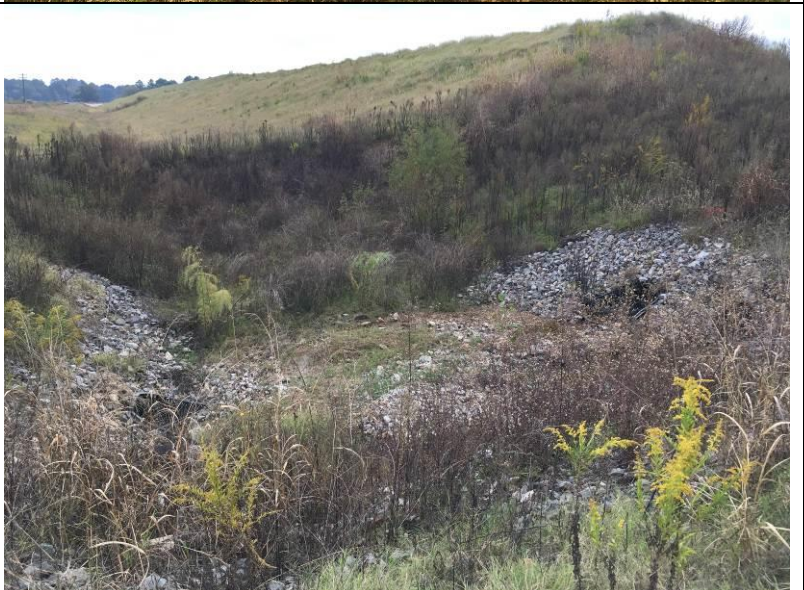
Photo # 14

Typical View of the West End Northern Berm Outside Slope Conditions Looking East. Notice Culvert No. 2 Discharge Basin Area.

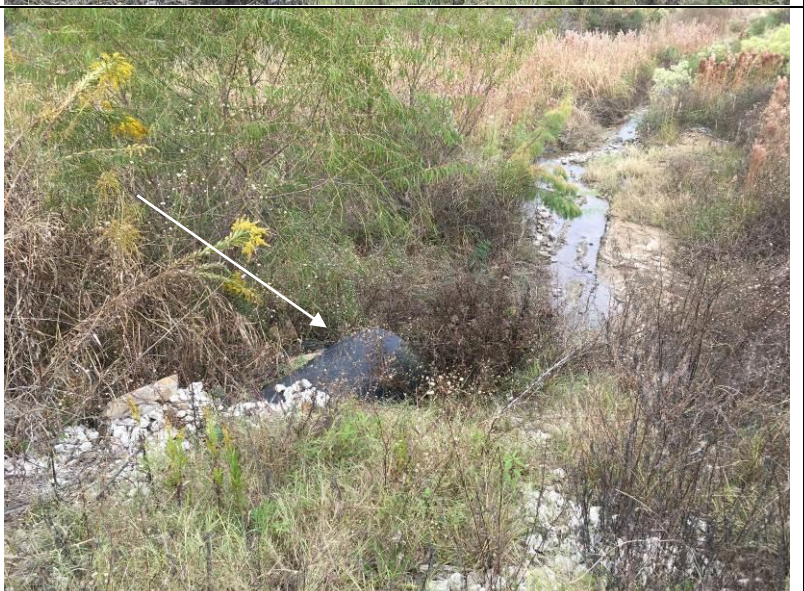
Photo # 15

View of Outlet Pipe from Culvert No. 2 Basin Area to the Primary Ash Pond.

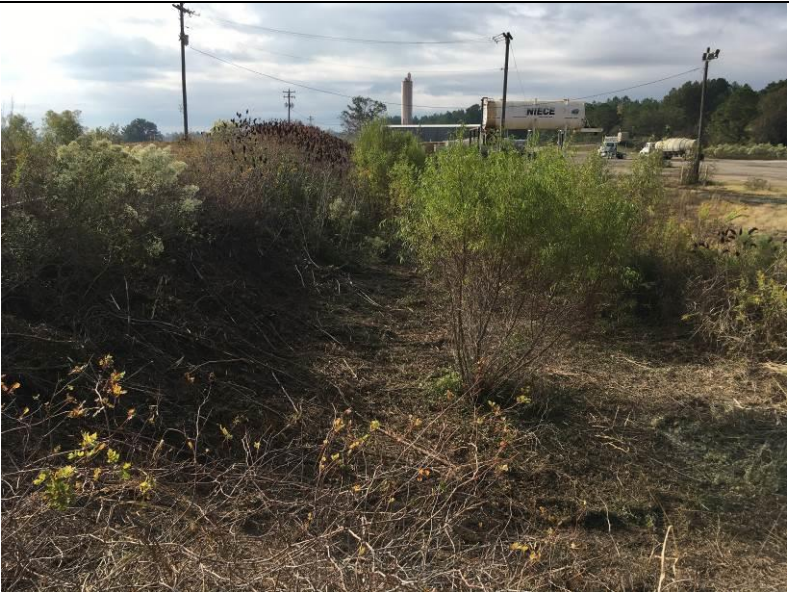
Photo # 16

6. The outer slopes of the western berm of the landfill are partially constructed of temporary soil cover and CCR material and have overgrown vegetation on the cover. Photographs No. 16 illustrates the condition of the exterior slope and toe ditch. The outer slopes appeared to be in poor, but functioning condition with no signs of seepage, erosion, or sloughing. However, excessive vegetation and tree growth was noticed on the slope and in the toe ditch.

View of the Western Berm Outside Slope Conditions. Notice the Overgrown and Weedy Vegetation on the Slope Areas.

- 4 The inner and outer slopes of the western berm are in poor, but functioning condition. Since this area is primarily an ash processing area, little ash is stacked up against the berm. The west berm will have to be re-built and the slope vegetation cleared and maintained before any active disposal operations can occur in the western end of the landfill.

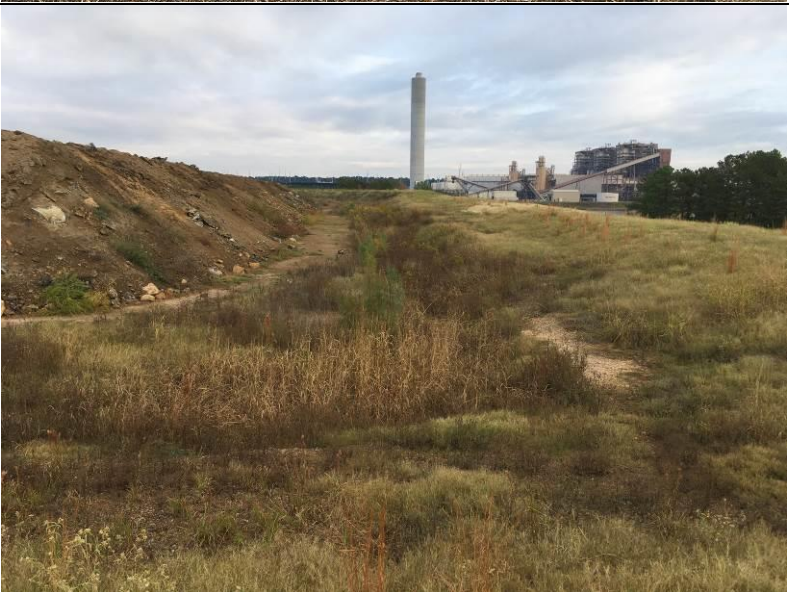
Photo # 17

7. During the inspection the active disposal area (eastern 2/3 area) was being used for waste placement. The inside perimeter ditches and leachate collection sump drains were functioning as designed and there was no ponding of water in the disposal areas (Photographs No. 17 through 19). All the storm water inside the landfill (active areas) is directed to a diversion ditch which leads to a detention basin before it exits the landfill through Pipe Culvert #2 located in the ash processing area (Photographs No. 20 – 23). There is some overgrown vegetation near Pipe Culvert #2 that needs maintenance and clearing.

View of the East Interior Perimeter Ditch for the Active Disposal Area Located on the East Side of Landfill.

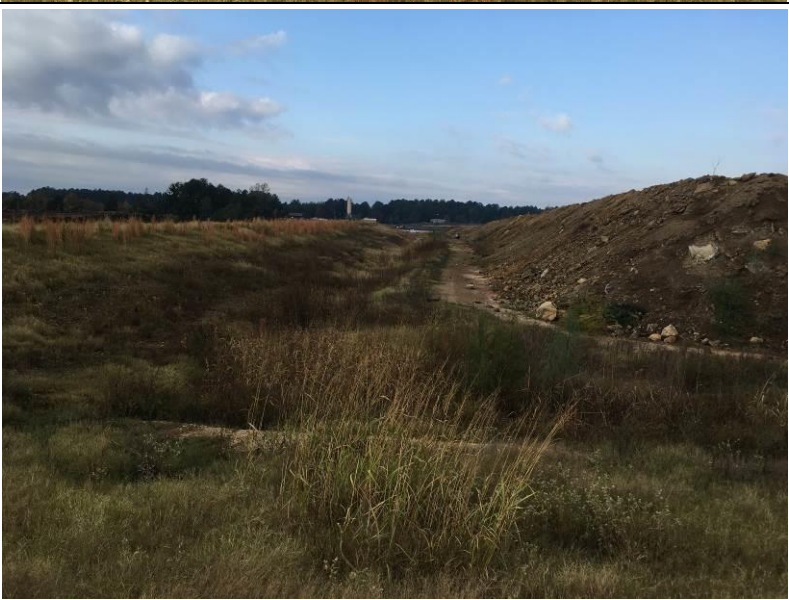
Photo # 18

View of the South Interior Perimeter Ditch for the Active Disposal Area Located on the East Side of Landfill.

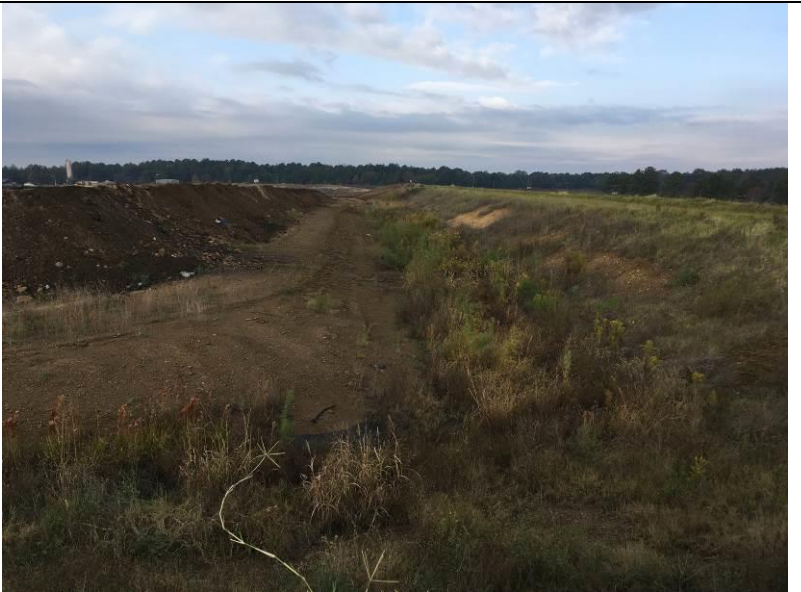
Photo # 19

View of the North Interior Perimeter Ditch for the Active Disposal Area Located on the East Side of Landfill.

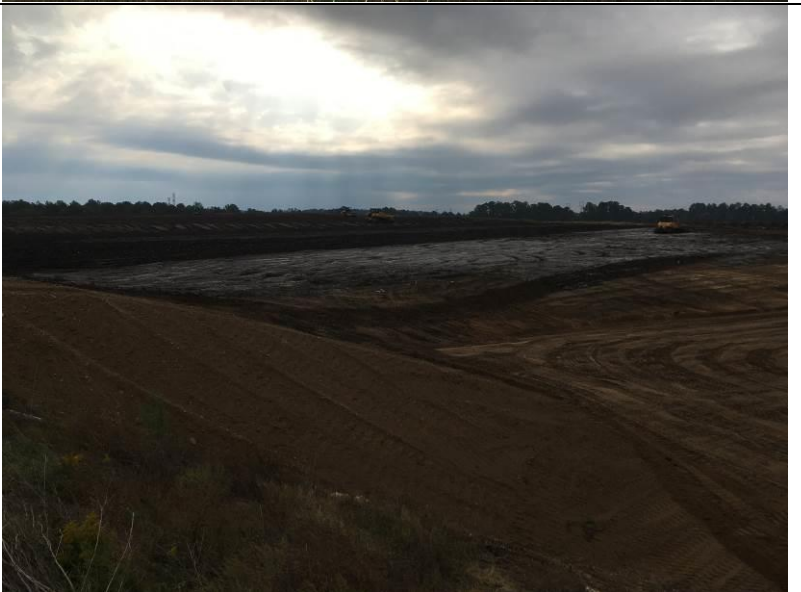
Photo # 20

View of the Active Disposal Area East Section of the Landfill.

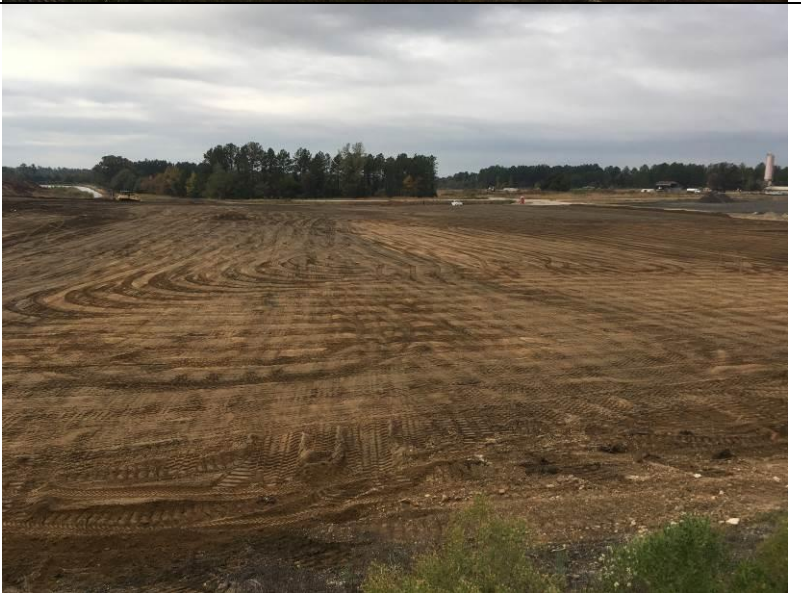
Photo # 21

View of the Active Disposal Area Middle Section of the Landfill.

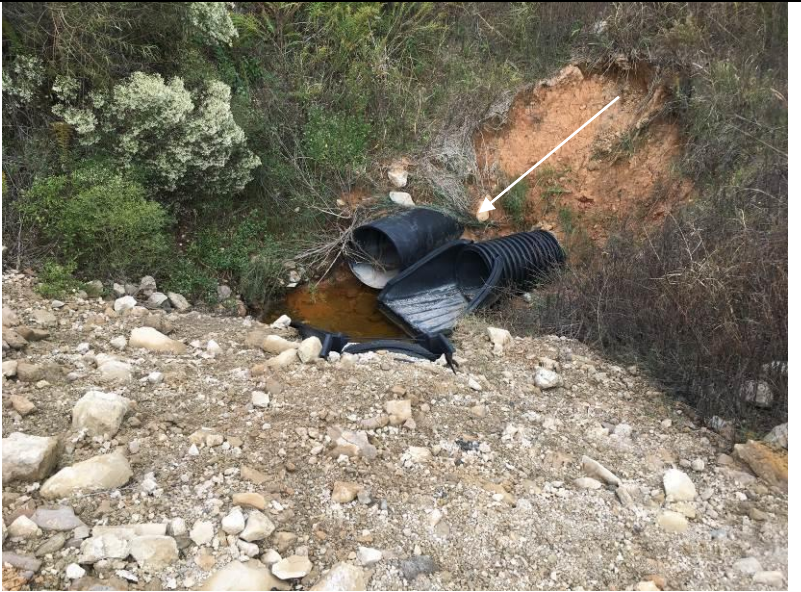
Photo # 23

View of Culvert #2 Pipe from Inside the Landfill Ash Processing Area.

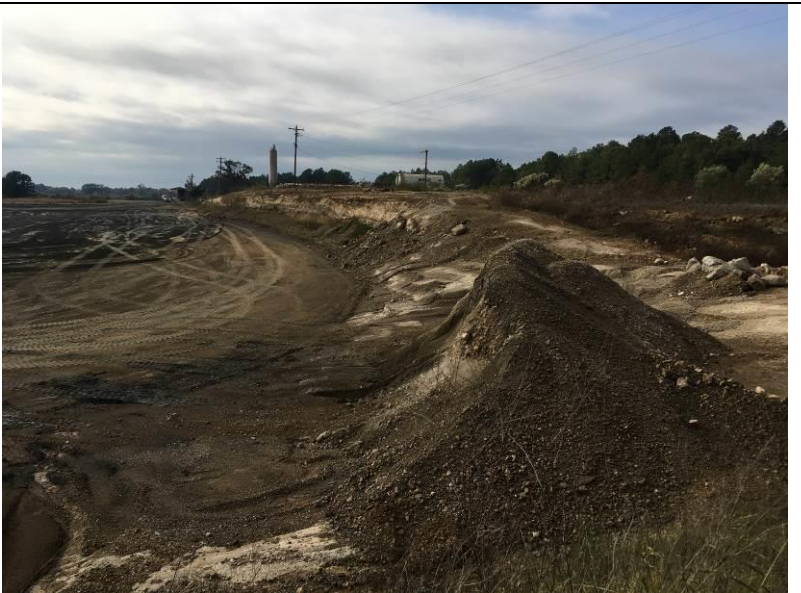
Photo # 24

out of soil and ash and have a temporary cover system. The area is bound on the south by a series of perimeter ditches, driveways, and culverts to collect the storm water runoff and direct it towards the low water crossing to exit the landfill (Photographs No. 24 – 27).

View of the Interior Western Berm of the Ash Processing Area. Looking South.

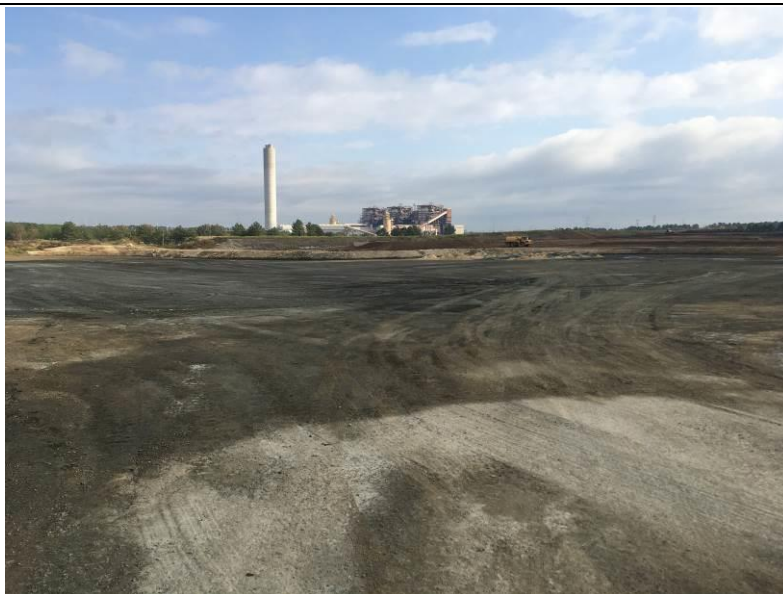
Photo # 25

View of the Ash Processing Area  
Typical Conditions. Looking  
East.

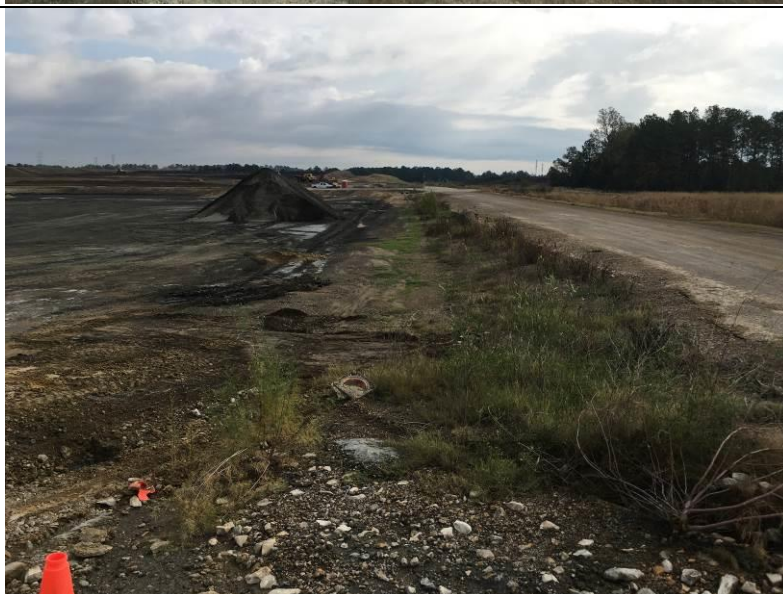
Photo # 26

View of the South Interior  
Perimeter Ditch Located Along  
the Ash Processing Area.

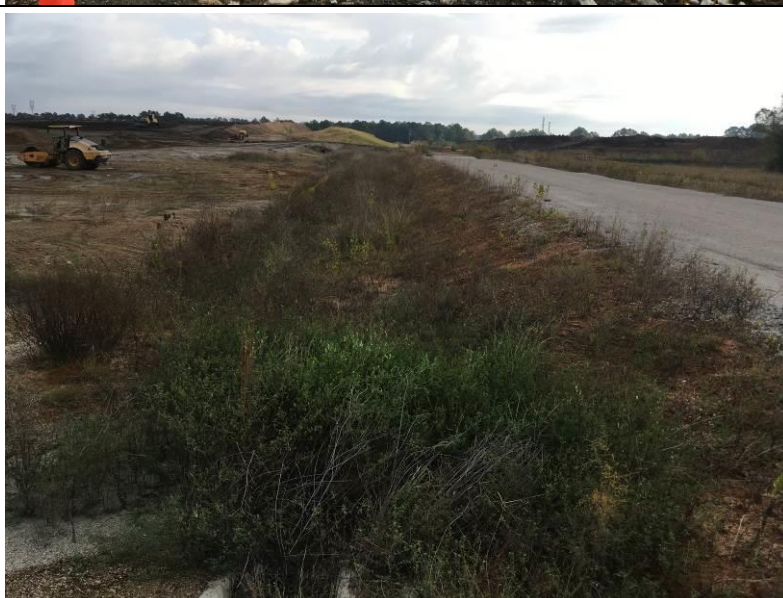
Photo # 27

View of the South Interior  
Perimeter Ditch Along the Mid-  
Section of the Landfill.

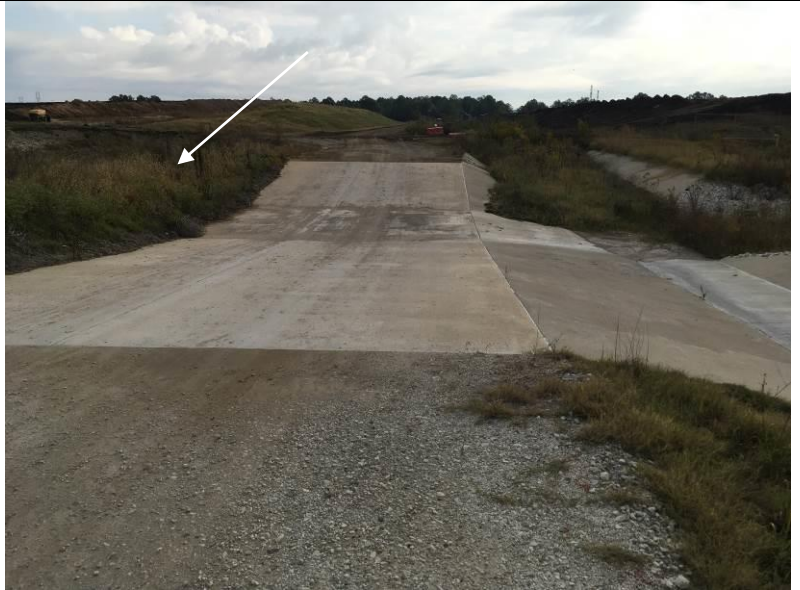
Photo # 28

9. The low water crossing is constructed of reinforced concrete pavement and was in good and functional condition at the time of inspection (Photograph No. 28). Typically, storm water runoff from the active disposal areas used to be directed towards the western end of the disposal area where it is channeled into a low water crossing on the south side that flows into the Bottom Ash Storage Pond. However, since the notice of intent to close the Bottom Ash Storage Pond (April 6, 2021), a clay soil berm has been placed inside the landfill to prevent contact storm water from entering the low water crossing structure. In addition, the south side access road ditch has been plugged with a clay soil berm to prevent non-contact storm water from the access road, low water crossing and the access road ditch from entering the Bottom Ash Storage Pond (Photograph No. 29).

View of the Low Water Crossing Located on South Side of Landfill Active Disposal Area. A Soil Berm Has Been Placed Along the Interior of the Landfill to Divert Contact Storm Water Away from the Low Water Crossing.

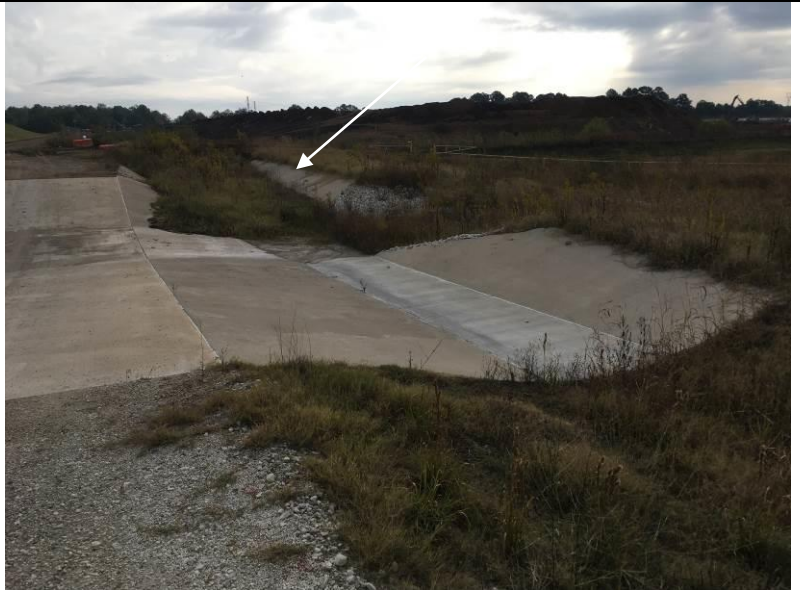
Photo # 29

View of the South Side Low Water Crossing and Access Road Ditch Looking East. The Access Road Ditch Been Plugged with Soil to Prevent Non-Contact Storm Water from the Low Water Crossing and Access Road Ditch from Entering the Bottom Ash Storage Pond.
