# 2023 Annual Landfill Inspection Report

**Amos FGD Landfill**

**John E. Amos Plant  
Appalachian Power Company  
Putnam County, West Virginia**

**Document ID: GERS-23-048**

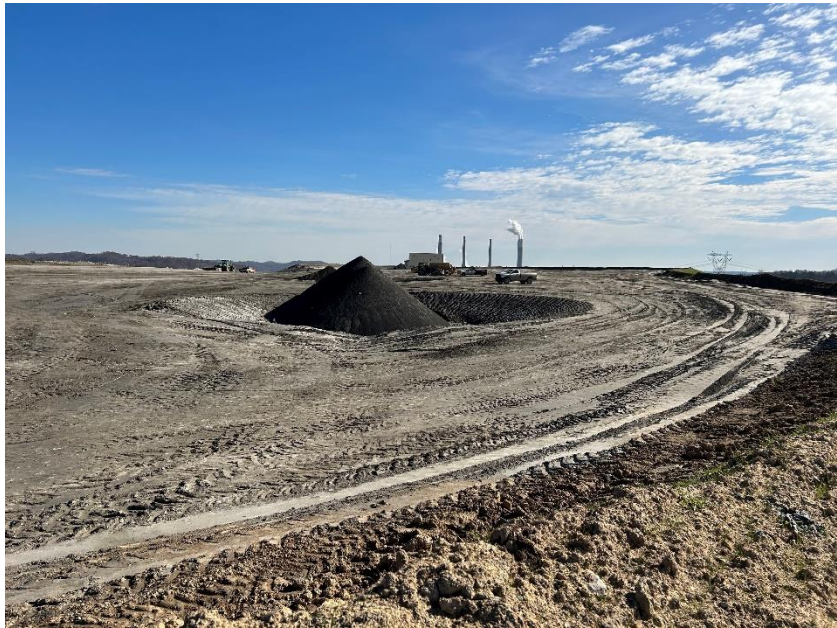
1. Used to store waste materials and soils. The chimney drains were functioning as designed and there was no pooling of contact water around the drain (photos 1).
2. Utilized for placing waste as planned (photo 2).
3. Lined with the designed liner on the subgrade (photo 3).
4. Some areas within the landfill had temporary or interim cover, which was in good shape and free of erosion.
5. Sequence 4 north valley embankment slope, the surface runoff had caused erosion between the leachate pipe and the embankment (Photos 4-7).

Photo #1 – Chimney Drain in Active Area

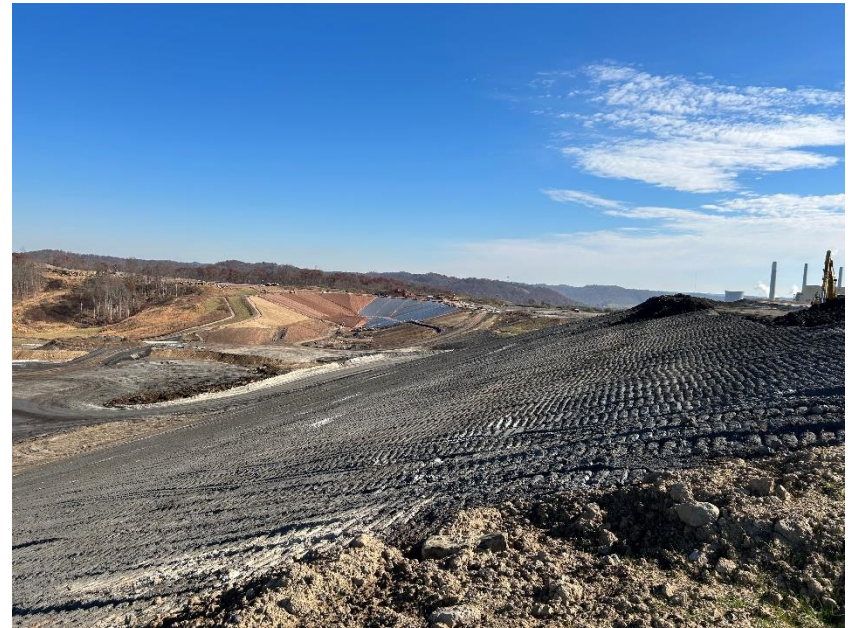
Photo #2 – Crest and Slope in Active Area

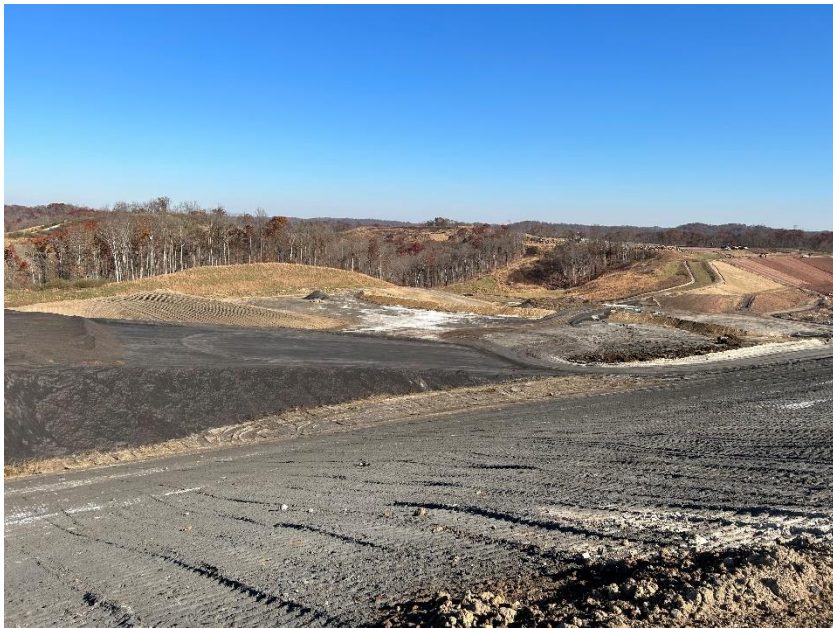
Photo #3 – Seq 4 Active Area in 2023

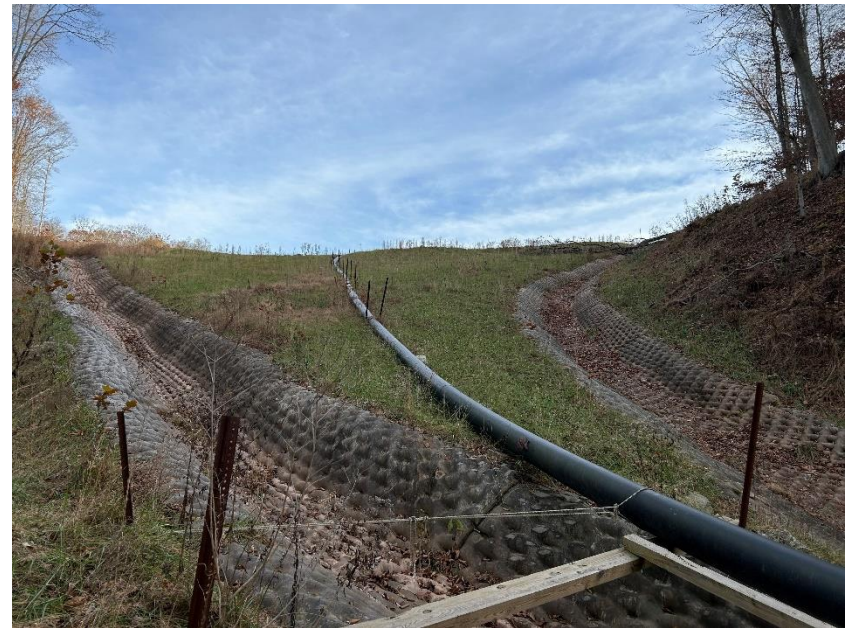
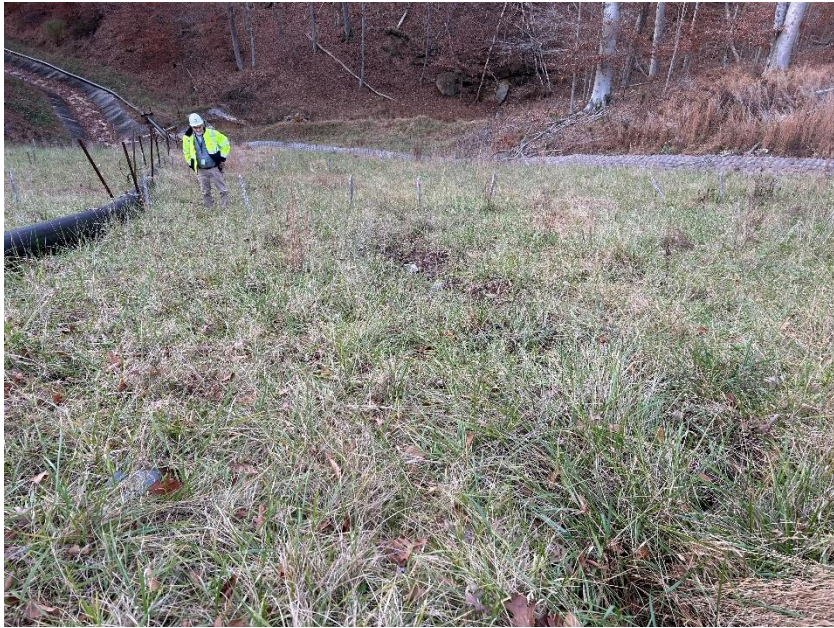
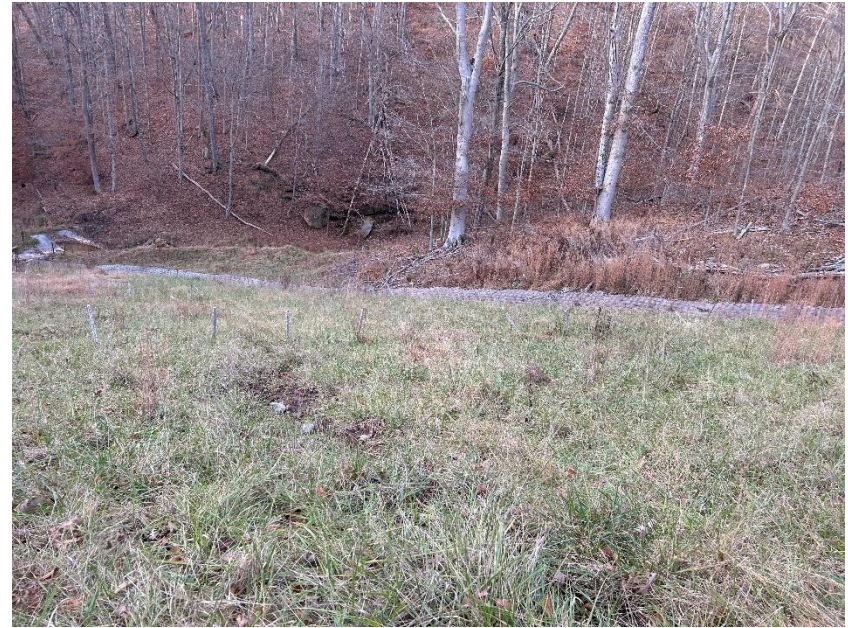
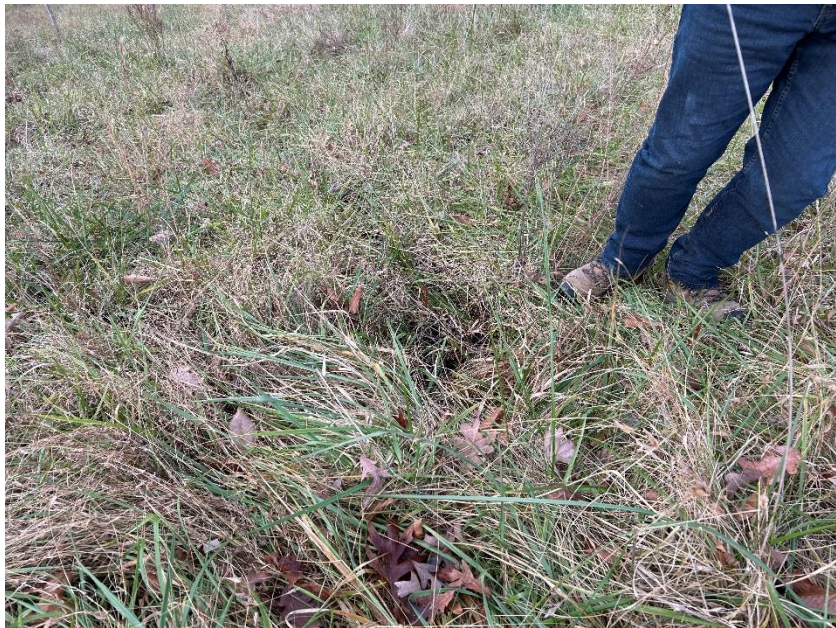
Photo #4 – Photo #4 –Sequence 4 North Valley Embankment Slope

Photo #5 –Sequence 4 North Valley Embankment Slope

Photo #6 – Sequence 4 North Valley Embankment Slope

Photo #7–Sequence 4 North Valley Embankment Slope/Erosion

- 3) Continue routine mowing of final and temporary covers to ensure proper vegetative growth.
- 4) Address issues like animal burrows and erosion rills as they are found.
- 5) Repair the erosion of sequence 4 north valley embankment slope using appropriate materials and methods to restore the area. (The AEP field staff has already provided documentation of the repaired the erosion).

- 6) Continue to monitor the flowrate and appearance of flow from the leachate collection pipes and underdrain pipes entering the respective ponds for any unusual changes.
- 7) Continue to monitor the repaired area of sequence 4 north valley embankment to ensure that it is stable and secure. Continue to look for any evidence of seepage or further erosion that might compromise the integrity of the area.

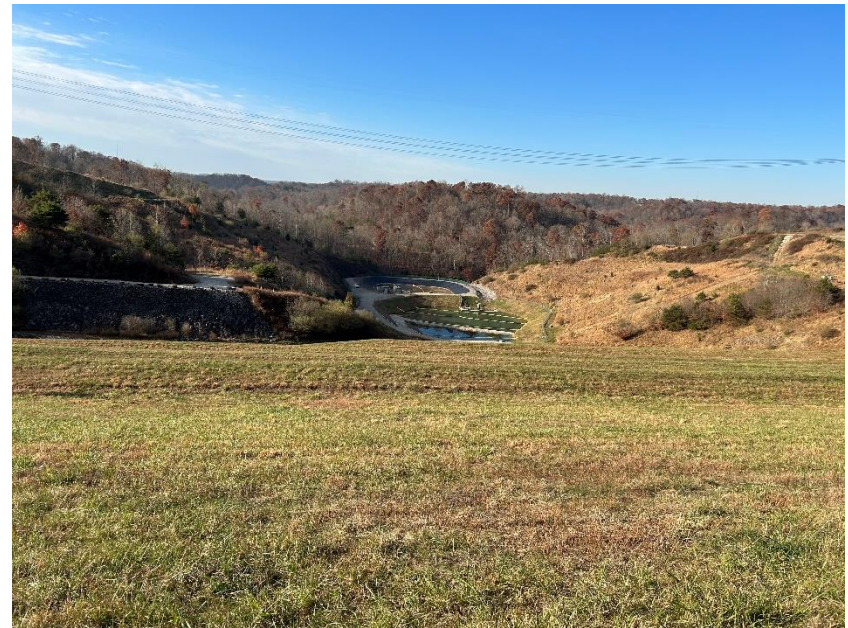
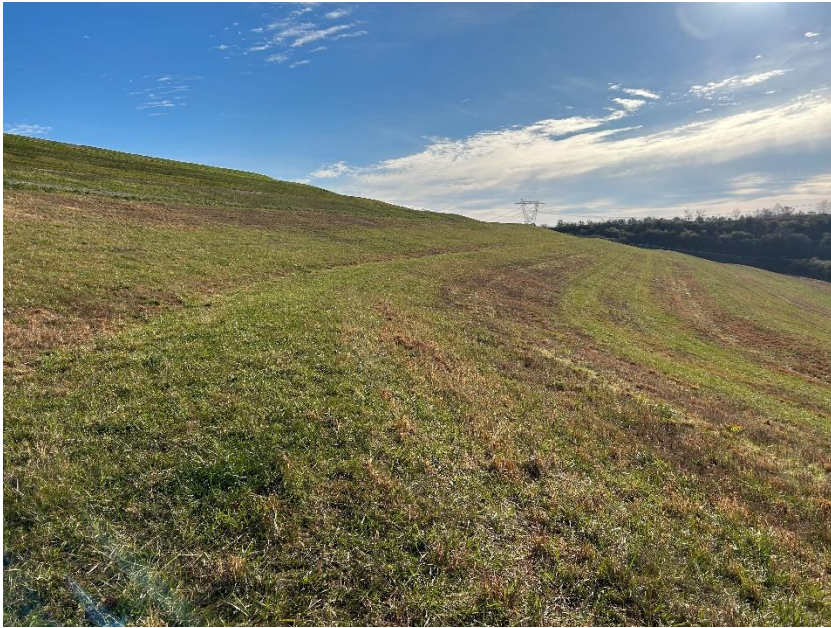
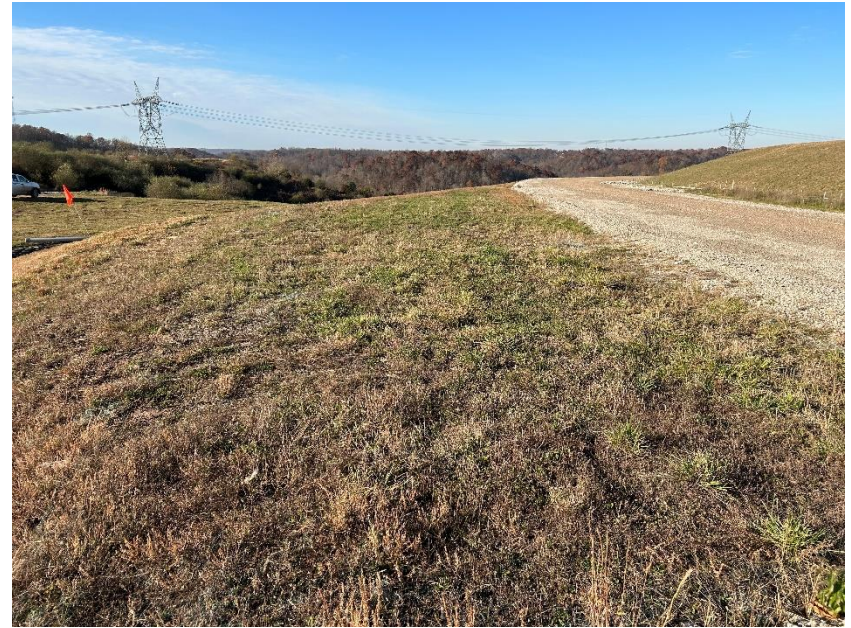
6. The final cover on the southwest slope of the South Valley is in good condition, and dense grass cover vegetation is established (photos 8-10). There were no signs of erosion or instabilities observed.
7. The final cover soil area drain pipe outlets at the fabric-formed concrete ditch were in good condition with no signs of obstructions or problems. The fabric-formed ditches along both right and left abutments were in good condition (photos 11-14).
8. The final cover along the area referenced as 950 bench of the South valley has been seeded and mulched in 2022. It is in fair/ satisfactory condition, and grass cover vegetation is established.
9. There were some signs of erosion and improper surface runoff observed on the 950 bench area. The site should continue to work with AEP Construction to have areas remedy.
10. There were no signs of instabilities observed (photos 15-16).

Photo #8–Closed Slope of South Valley and Ponds

Photo #9 – Covered South Slope-Looking West

Photo #10 – Covered South Slope-Looking West

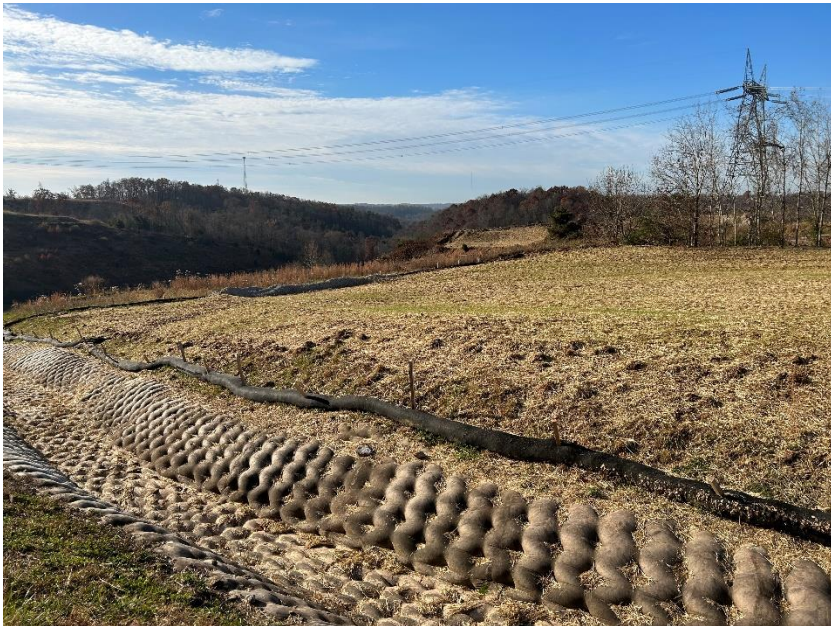
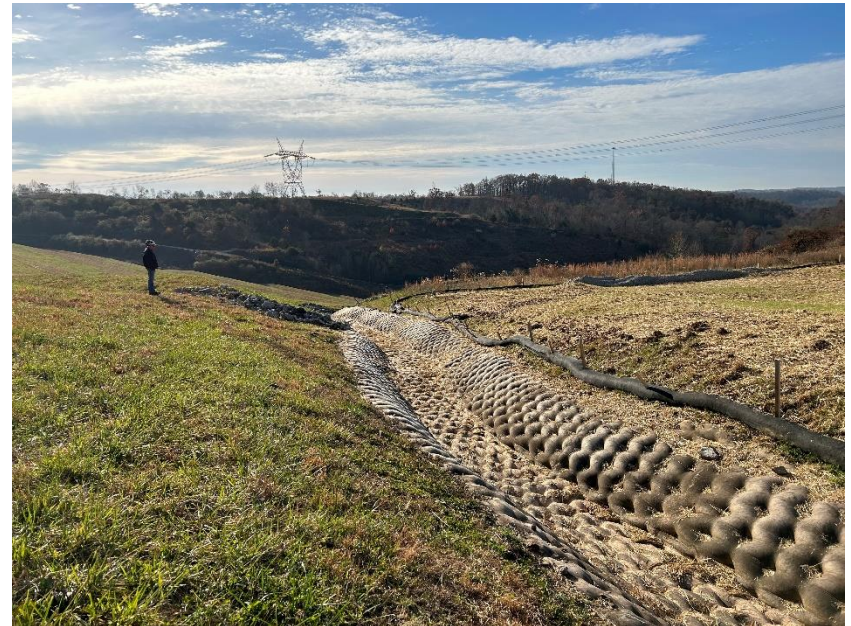
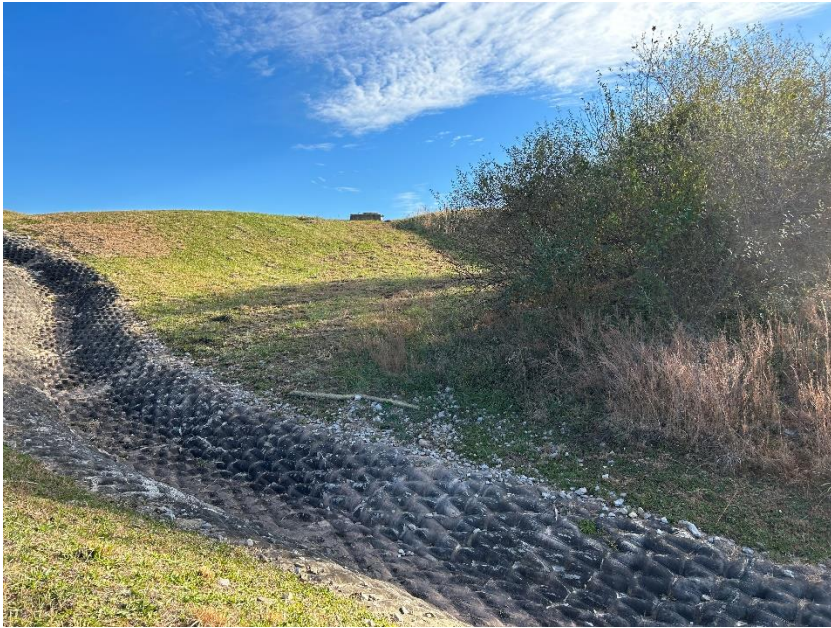
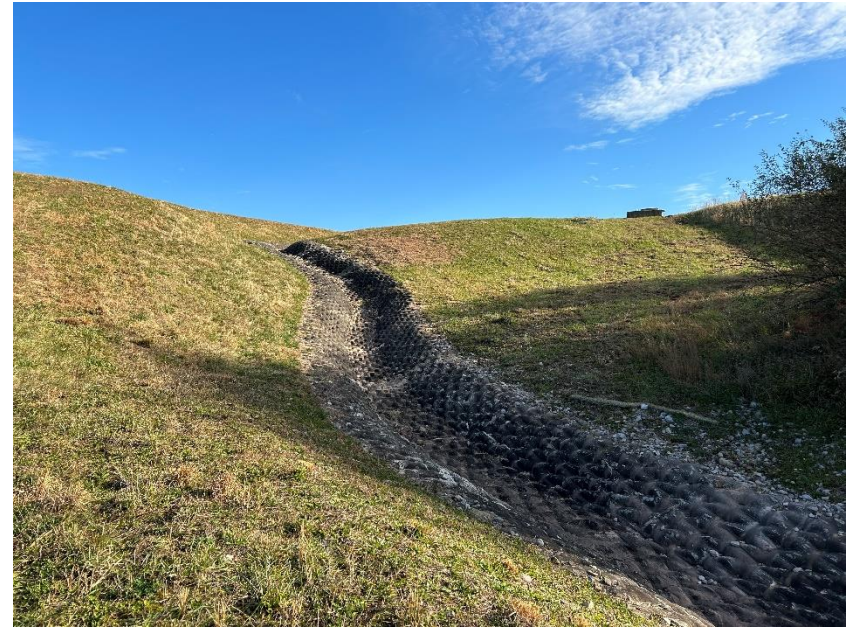
Photo #11 – South Valley Perimeter Ditch-Right Abutment

Photo #12 – South Valley Perimeter Ditch-Right Abutment

Photo #13 –South Valley Perimeter Ditch-Left Abutment

Photo #14 – South Valley Perimeter Ditch-Left Abutment

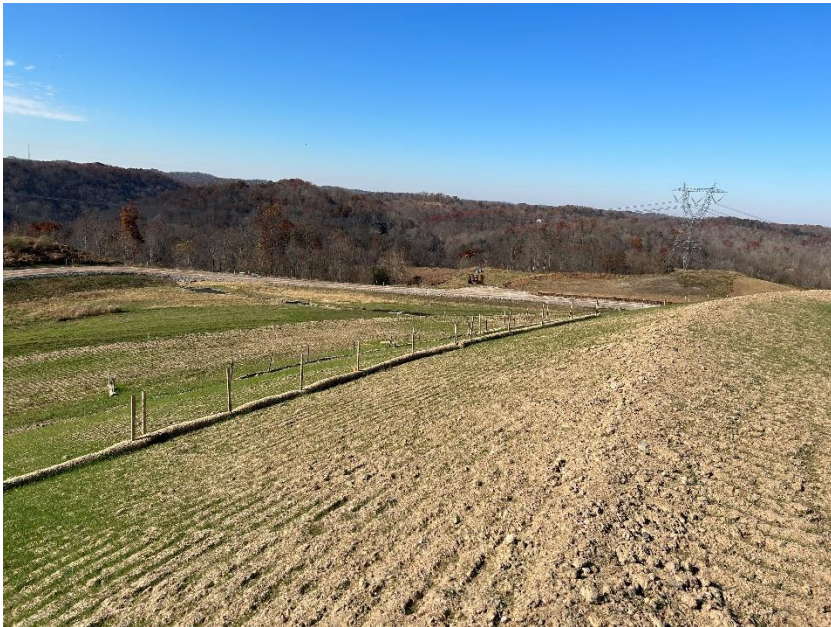
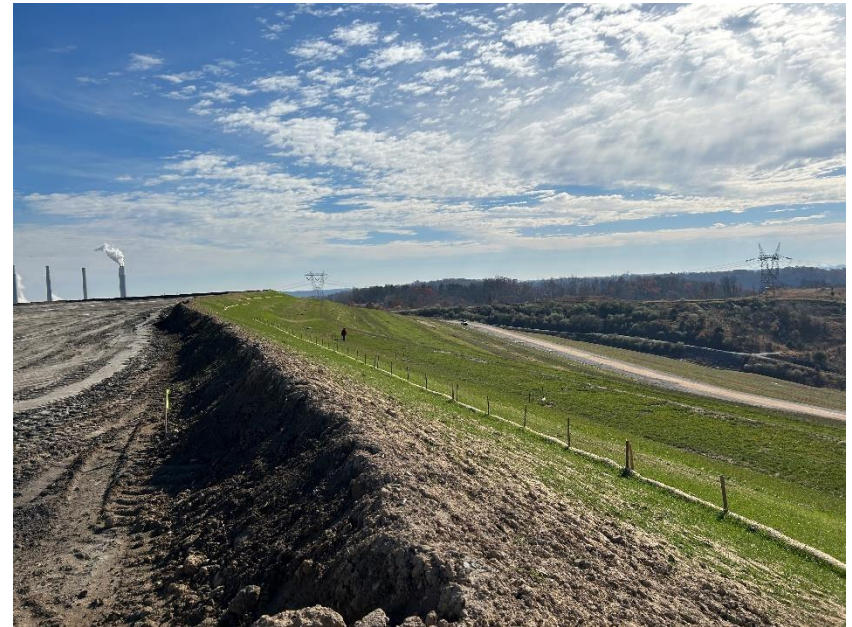
Photo #15 – New Cap/Cover Along 950 Bench

Photo #16 – New Cap/Cover Along 950 Bench

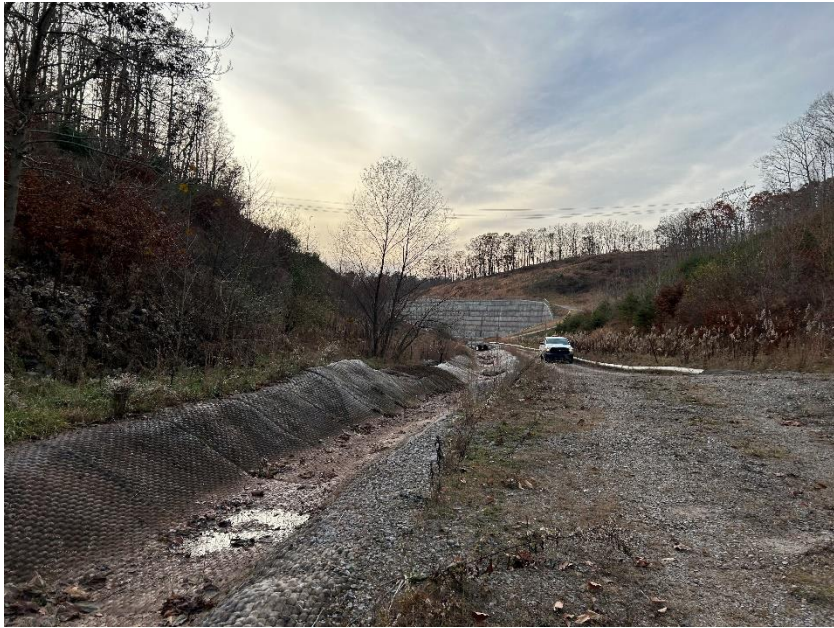
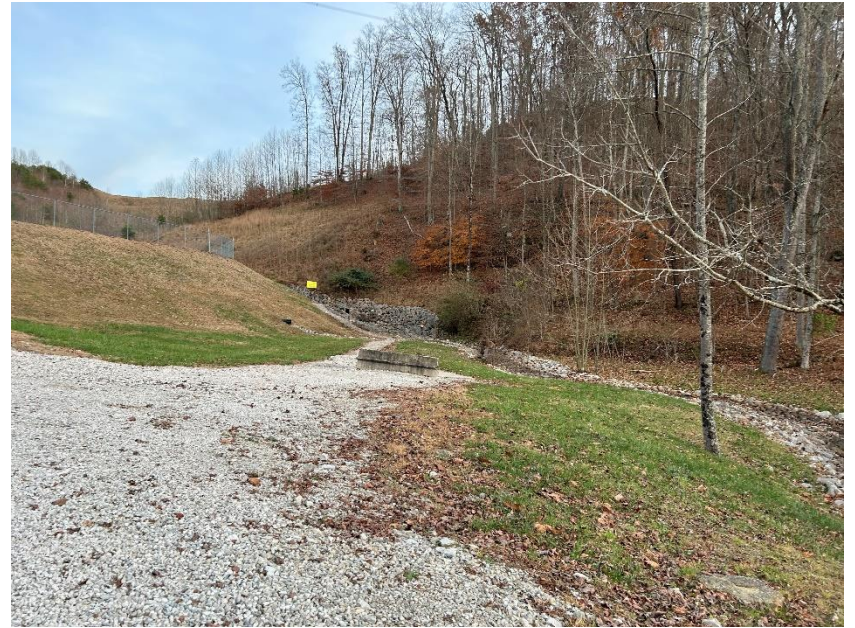
13. The sediment collection ponds were in good condition with no signs of erosion or blockage and appeared to be functioning as designed. Photos 17-18 show the lined channel and outlet channel from the North Valley.
14. The Plateau Sediment Collection Pond was in good condition appeared to be functioning as designed.

Photo #17 –Lined Chanel from North Valley

Photo #18 – Outlet Channel from North Valley

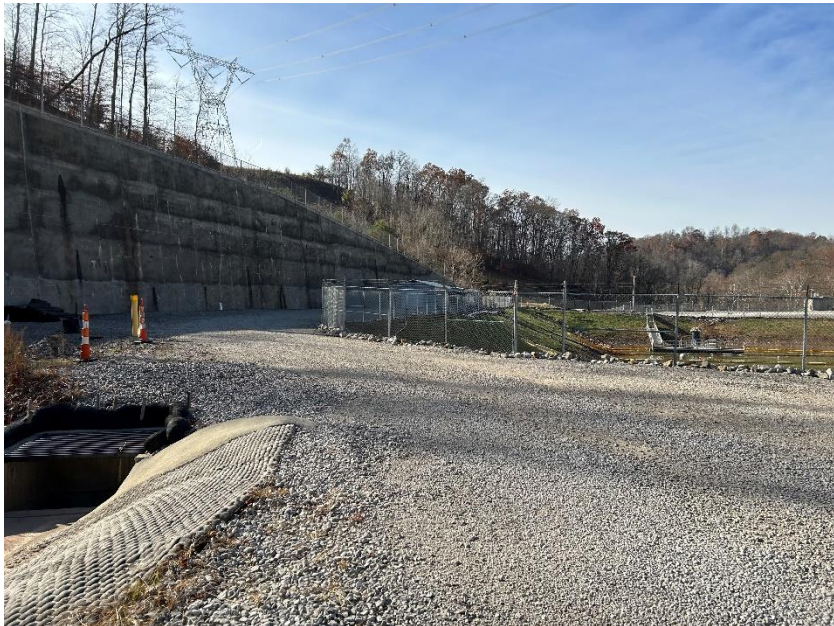
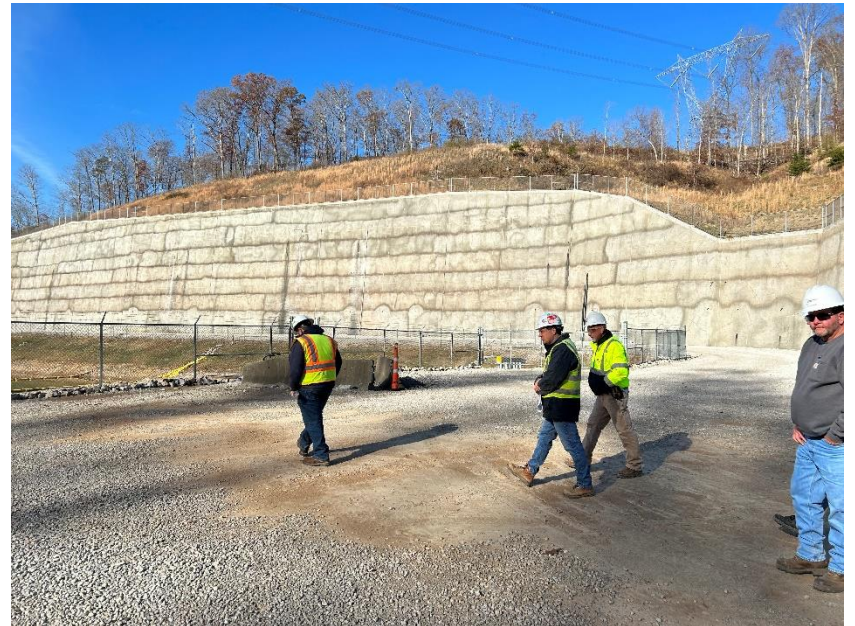
15. The soil nail walls in the North Valley appeared to be in good condition with no visible displacement, spalling or damage based on a view from the toe of the walls. Photos 19-20 show the north valley sediment pond and soil nail wall.

Photo #19 – Soil Nail Wall and Sediment Pond –North Valley

Photo #20 – Soil Nail Wall and Sediment Pond –North Valley
