# 2023 Annual Landfill Inspection Report

**H.W. Pirkey Plant  
Southwestern Electric Power Company  
Hallsville, Texas**

**2023 Annual Landfill Inspection Report  
(CCR Landfill)**

**Date of Inspection: October 11, 2023**

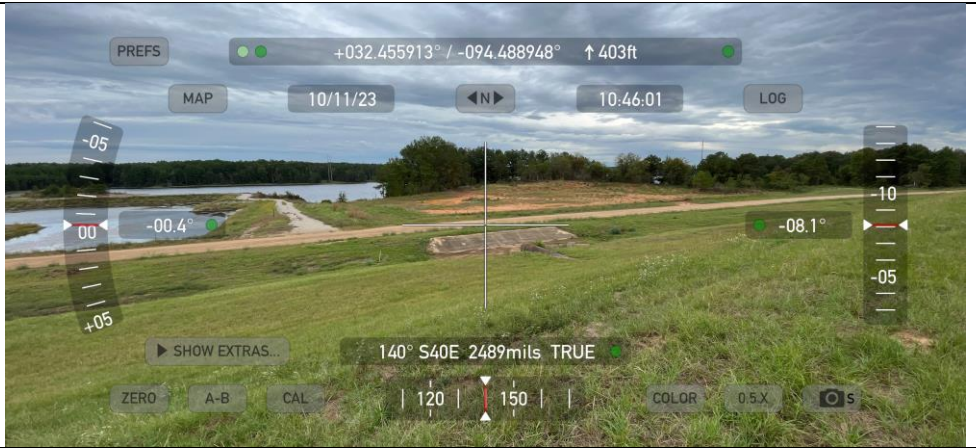
**Photograph No. 1**  
View of the storm water let-down pipe on the east side of the landfill area. (looking southeast)

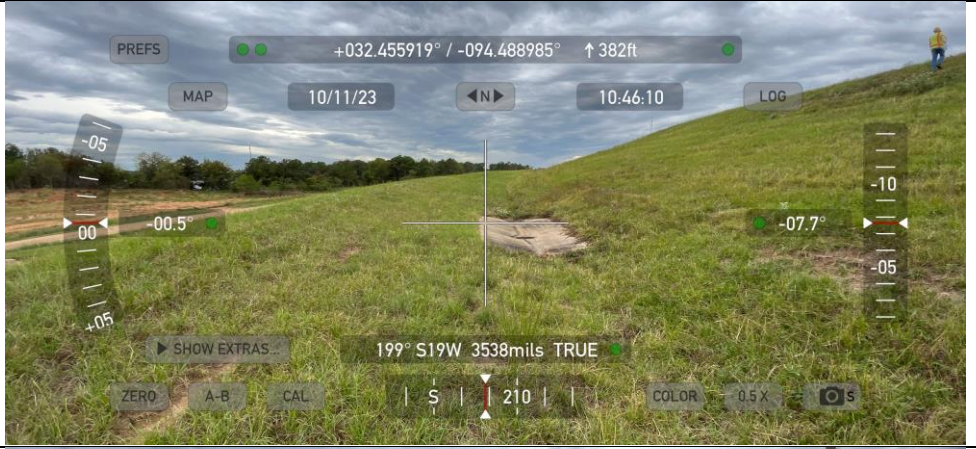
**Photograph No. 2**  
View of the Cell 1984 let-down catch basin at bench location (looking southwest)

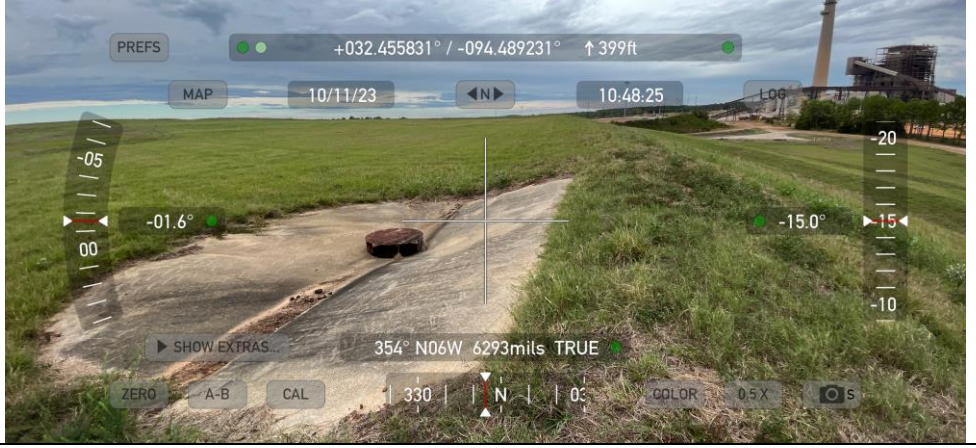
**Photograph No. 3**  
Typical condition of the vegetative cover over the northwestern areas of the landfill cap. View of the Cell 1984 let-down catch basin (looking northwest)

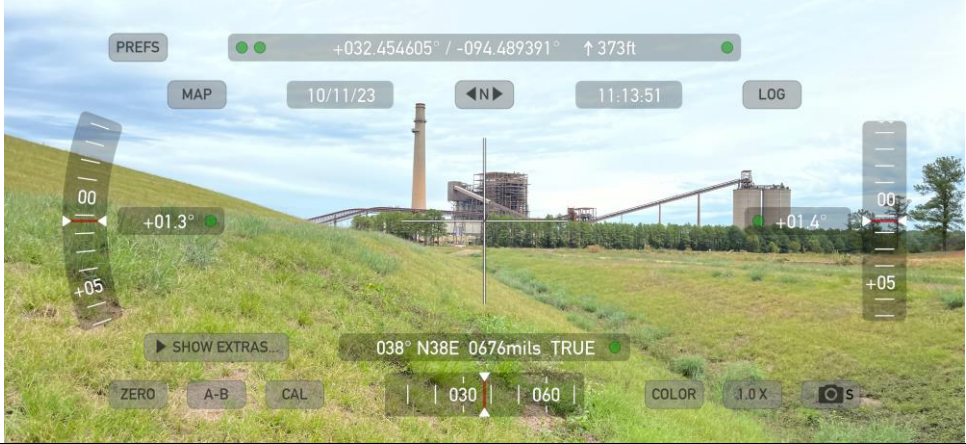
<p><b>Photograph No. 4</b> View of the non-contact-water perimeter ditch and side slope conditions around the Mohan Well site on the south side of the landfill area. (looking northeast)</p>

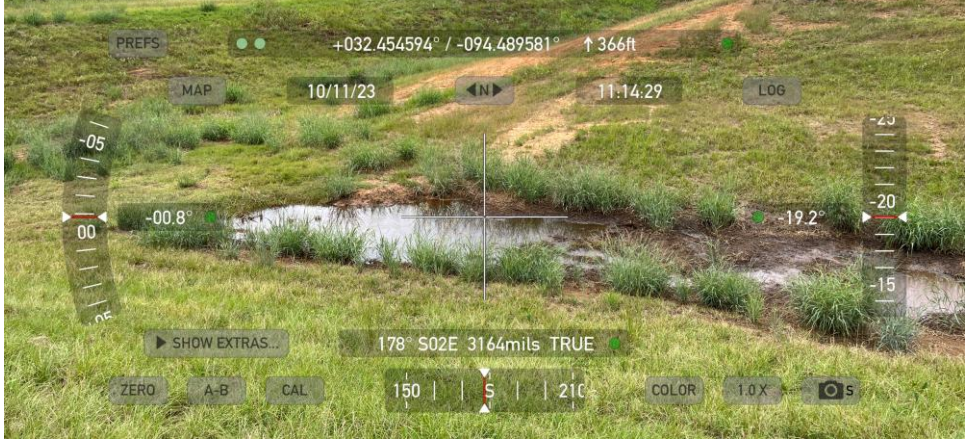
<p><b>Photograph No. 5</b> View of the non-contact-water perimeter ditch condition around the Mohan Well site on the south side of the landfill area. (looking southeast)</p>

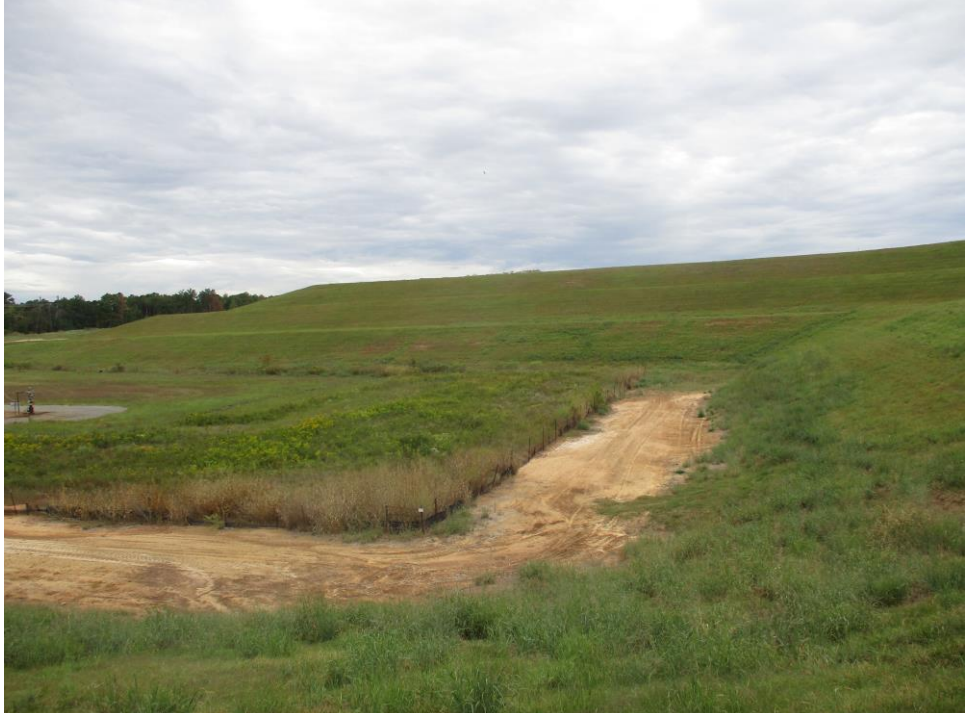
<p><b>Photograph No. 6</b> View of the non-contact-water perimeter ditch condition around the Mohan Well site on the north side of the landfill area. (looking west)</p>

<p><b>Photograph No. 7</b>                  Notice damage from hog activity at exterior slope of Cell 1987</p>	
<p><b>Photograph No. 8</b>                  Erosion was observed at exterior slope of Cell 1987 (looking northwest).</p>	
<p><b>Photograph No. 9</b>                  View of the non-contact-water perimeter ditch condition around the Mohan Well site on the south side of the landfill area. (looking southeast)</p>

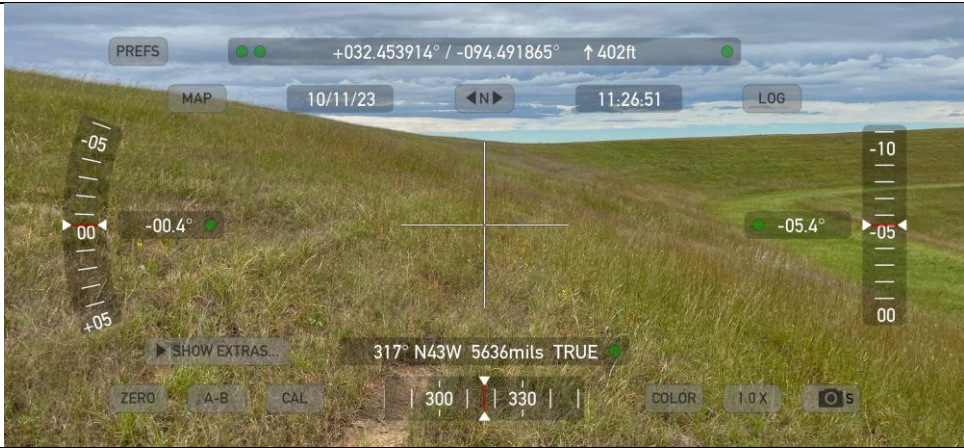
<p>Photograph No. 10</p> <p>Typical condition of southeast slope intermediate bench- Cell 1987 (looking northwest)</p>

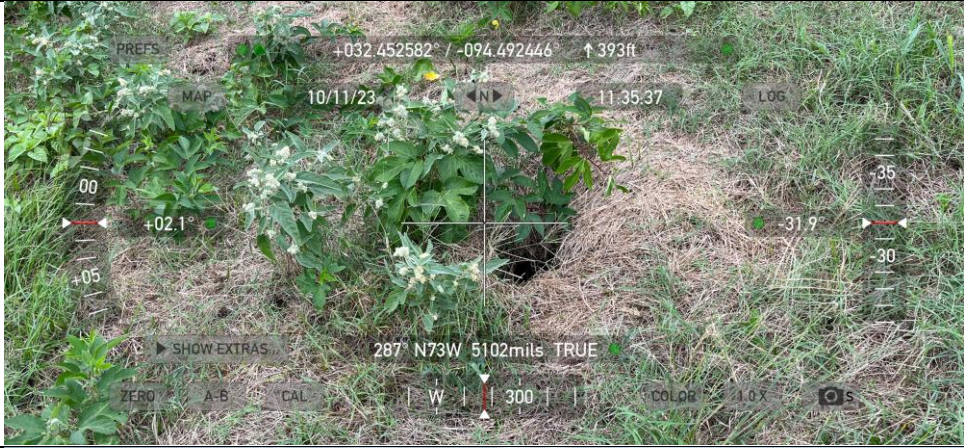
1. In general, surface water runoff from the cap was draining as designed. There were no signs of erosion, undermining, scarps, or sloughs in the surface vegetation covering the top and side slope areas except cells 1987 and 1993.
2. The closed landfill areas were observed to have a thick stand of grass cover over most of the capped area. The landfill cover of cells 1984, 1987, 1993, 1995, 1999 and 2005 were well vegetative.
3. There were no signs of settlement, signs of movement or distress of the landfill area. Access roads on top and adjacent to the landfill area were in good condition.
4. Most of the perimeter ditches indicated positive flowing water without obstruction.
5. There were several areas along the exterior slopes of the 1987, 1993, 1995, and 2005 cells that had damage from hog activity.

<p>Photograph No. 11</p> <p>Notice damage from hog activity at exterior slope of Cell 1993</p>

- 1) Repair the damaged slope areas from hog activity (cell 1987, 1993, 19955, and 2005).
- 2) Repair the erosion rills, re-seed and mulch the temporary soil cover on the lower portion of the 2012 cell near the 1985 pond area on the south side.

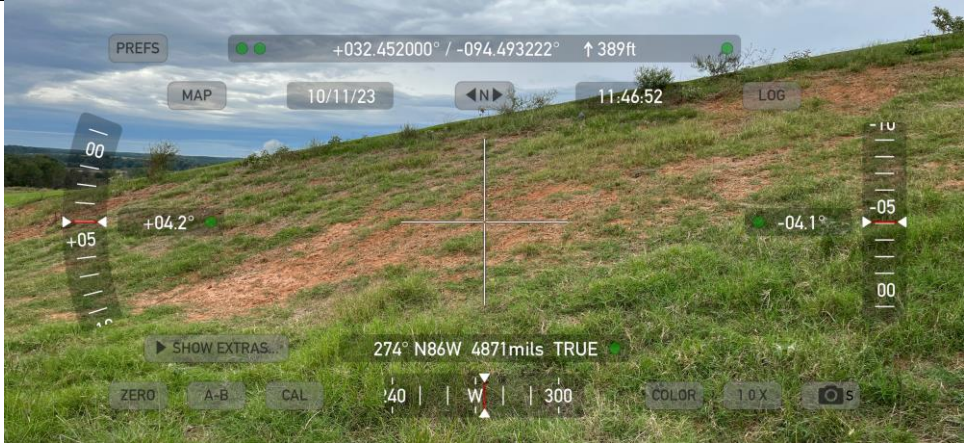
<p>Photograph No. 12</p> <p>Erosion was observed at exterior slope of Cell 1993 (looking northwest). Need to establish vegetation to control erosion.</p>

- 6) Repair the erosion on the side slope of the south face of the 1987 cell and 1993 cell.
- 7) Repair the broken and misaligned drain outlet at cell 2018.

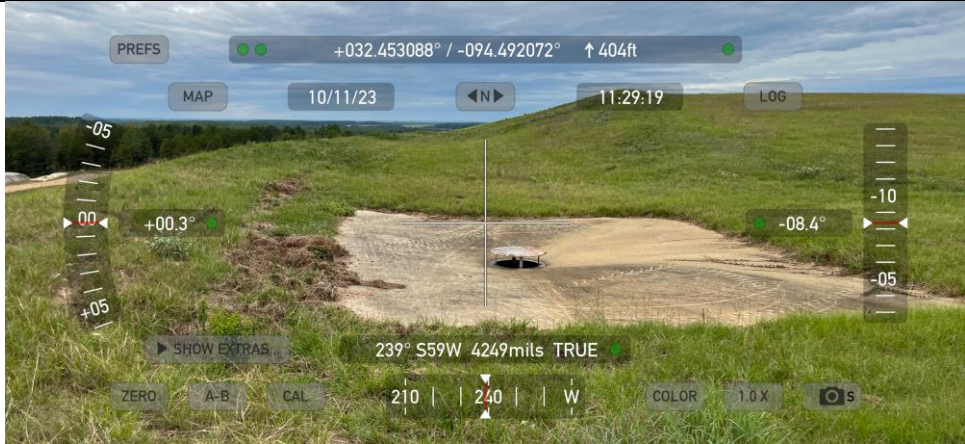
Photograph No. 13  
Landfill Cover – view of one of the let-down catch basins inlet on top of Cell 1987.

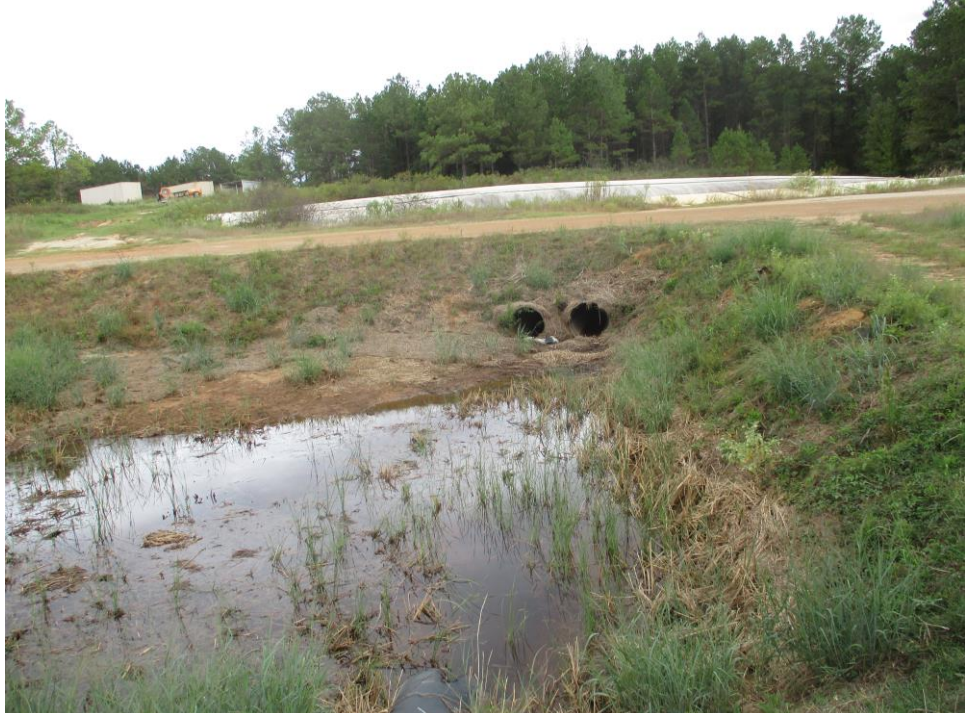
Photograph No. 14  
View of the 36” diameter culverts from the 1993 cell.

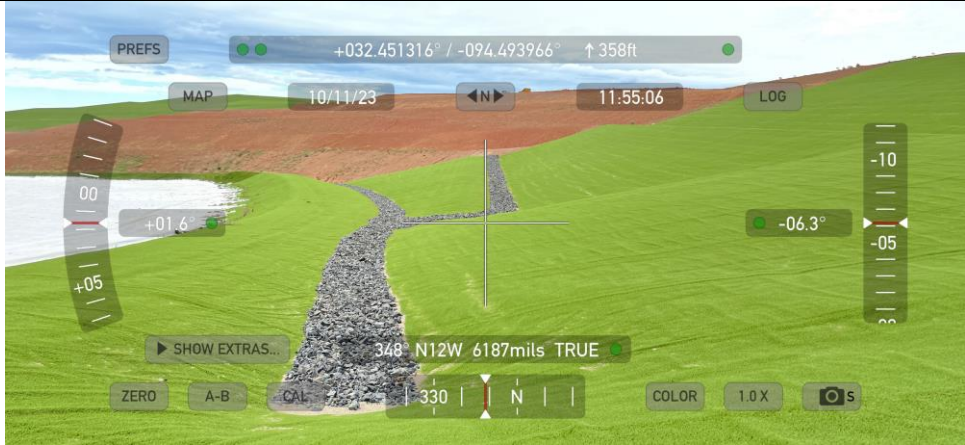
Photograph No. 15  
Typical condition of the Cell 1993 slopes with closure turf material. (looking northwest)

<p><b>Photograph No. 16</b> View of the 36” diameter culverts from the 1993 cell. Vegetation is growing over liner material covered with silt.</p>	
<p><b>Photograph No. 17</b> View of 2018 cell area. Minor siltation is noticed.</p>	
<p><b>Photograph No. 18</b> Significant erosion rills and sediment buildup were noted near 24-in diameter storm sewer pipe culvert (adjacent areas of the 2012 cell, 1985 pond cell and 1993 cell).</p>

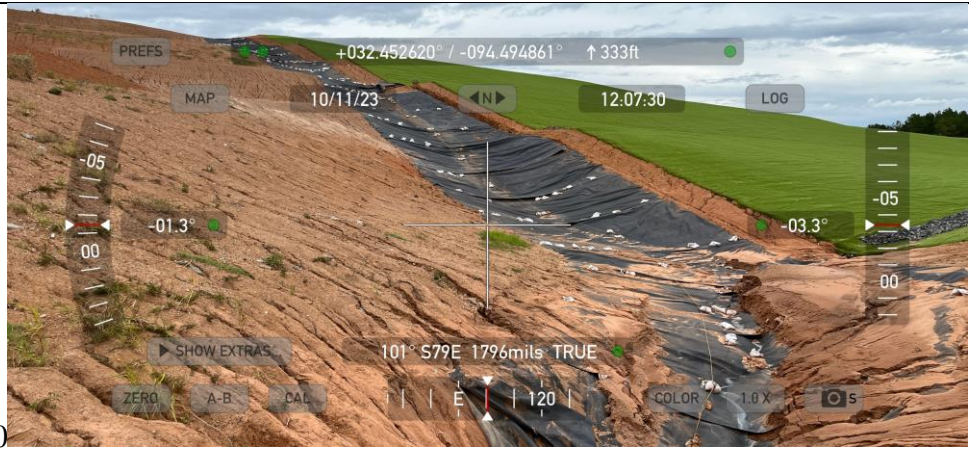
<p>Photograph No. 19</p> <p>Sediment was observed over 20-mil geo-membrane rain flap material. (looking southeast)</p>

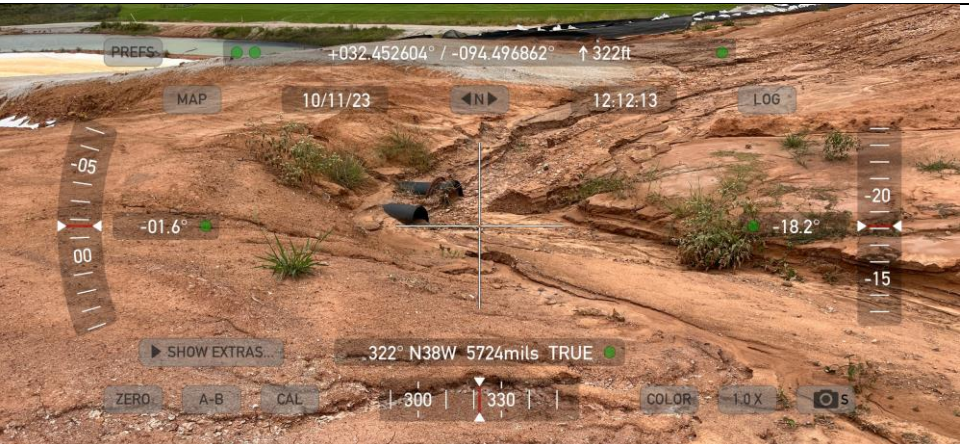
<p>Photograph No. 20</p> <p>Sediment buildup partially covered the culvert drain. (looking northwest)</p>

- 4) Operate the check valve drain in the ground water interceptor manhole periodically to maintain its function.
- 5) Remove the soil accumulation in front of the outlet of the 18-inch-diameter leachate collection discharge pipe on the south side of the 1985 Pond Cell., 24-inch-diameter storm sewer pipe of 1993 Cell. Install proper erosion and sediment controls to minimize the amount of sediment build up in the storm water runoff ditches.

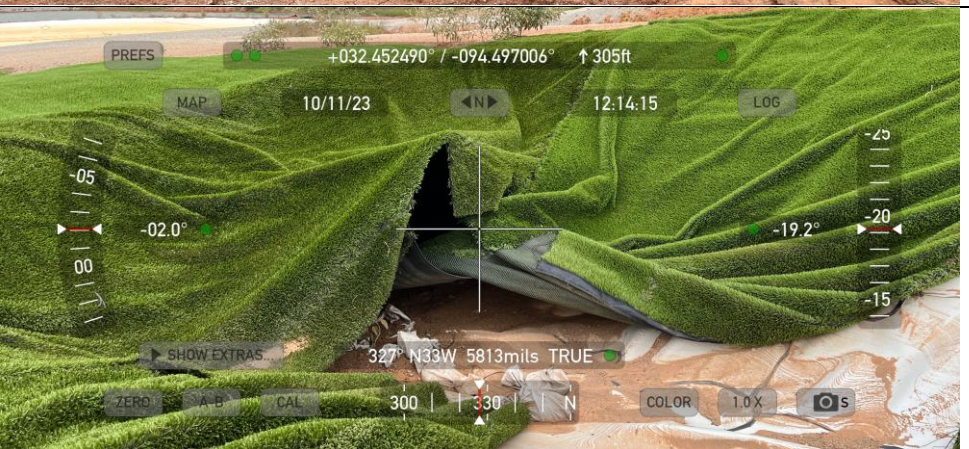
<p>Photograph No. 21</p> <p>24" diameter culvert was noticed misaligned at 2018 cell.</p>

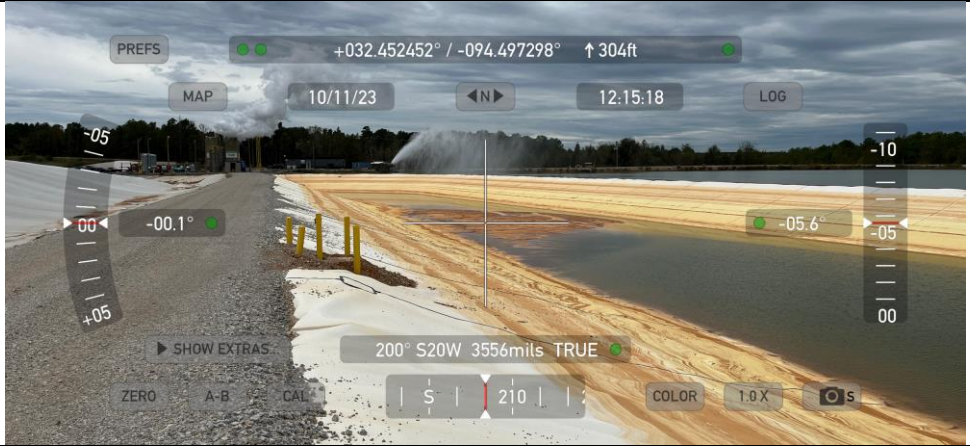
**Photograph No. 22**  
 View of new Brine Pond. Construction was completed in June 2023.

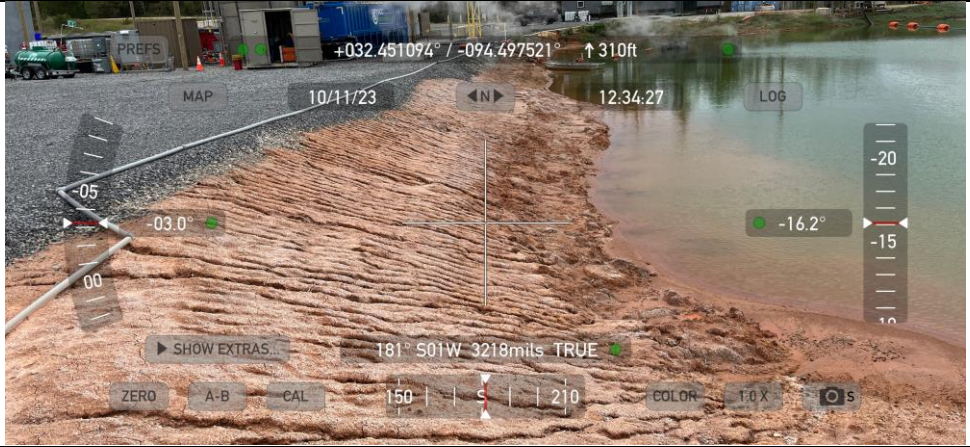
19. Construction of a brine pond was completed in June 2023 inside the footprint of the landfill runoff pond. Side slopes are covered with geomembrane to prevent the migration of brine. Surface erosion was observed at the side slopes of the landfill storm water runoff pond.

**Photograph No. 23**  
 Excessive surface erosion was observed on the side slope of Landfill Storm Water Runoff Pond.

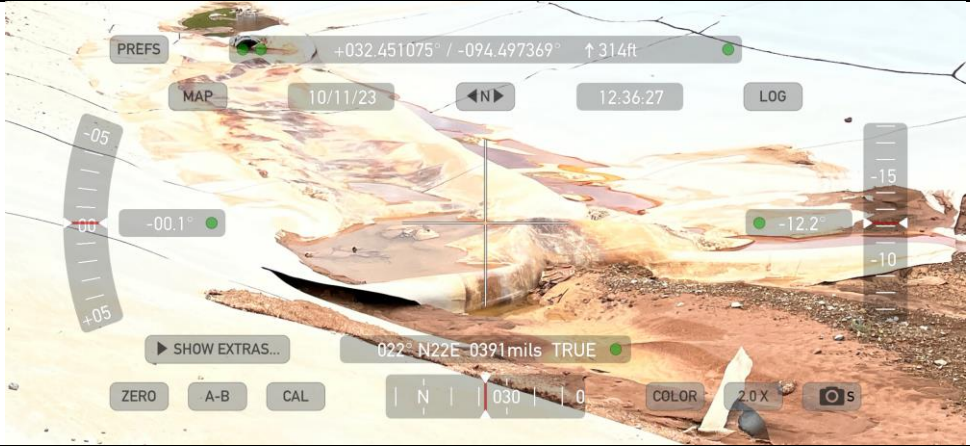
**Photograph No. 24**  
 A gap was noticed between geosynthetic and soil. Fixation of the geosynthetic will reduce erosion of soil from underneath of the geosynthetic.

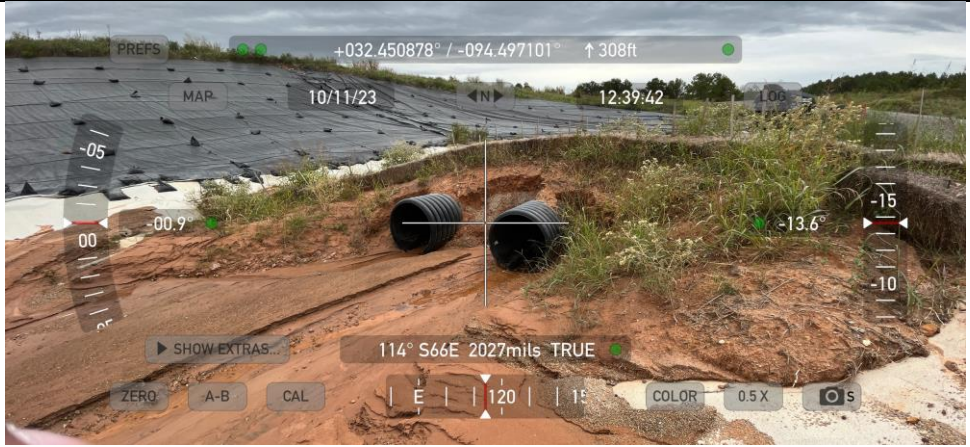
**Photograph No. 25**  
 Surface erosion was observed at the let down ditch on the southern end of 2018 cell.

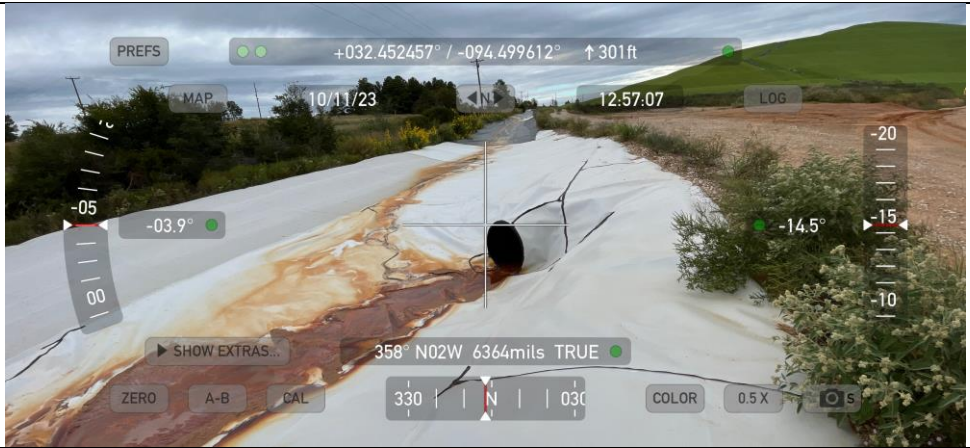
**Photograph No. 26**  
 View of the non-contact water perimeter ditch on the west side of landfill. Note iron stain in geosynthetic.

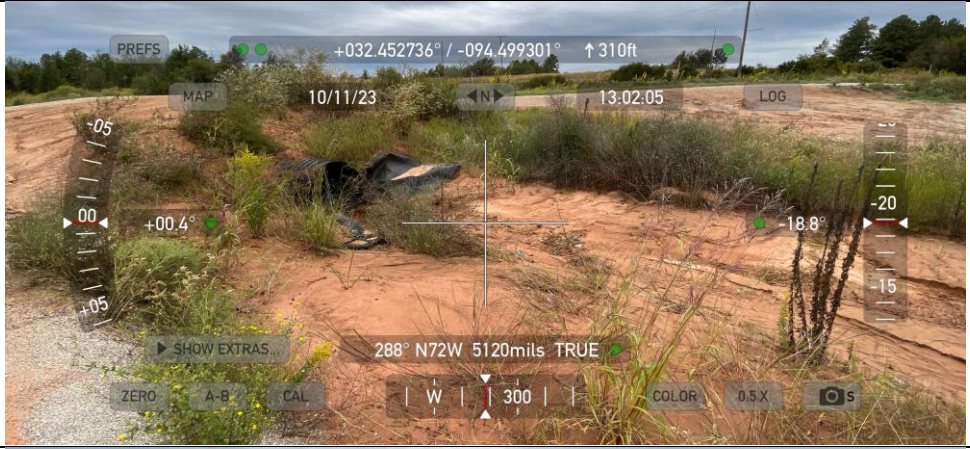
**Photograph No. 27**  
 Vegetation and sedimentation build up was observed at western side of let down ditch near cell 2015.

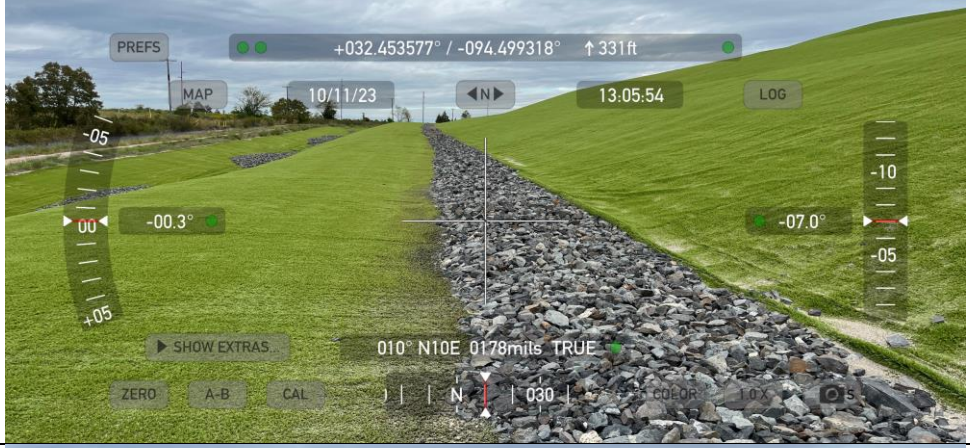
**Photograph No. 28**  
 View of cell 2015 showing final cap and cover with a rock lined bench on the closure turf material. (looking northeast)

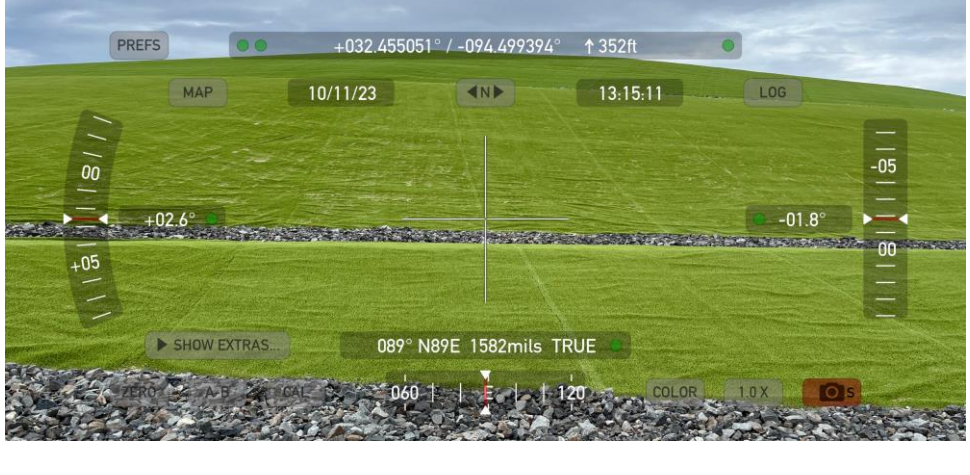
**Photograph No. 29**  
 View of cell 2015 showing final cap and cover. (looking northeast)

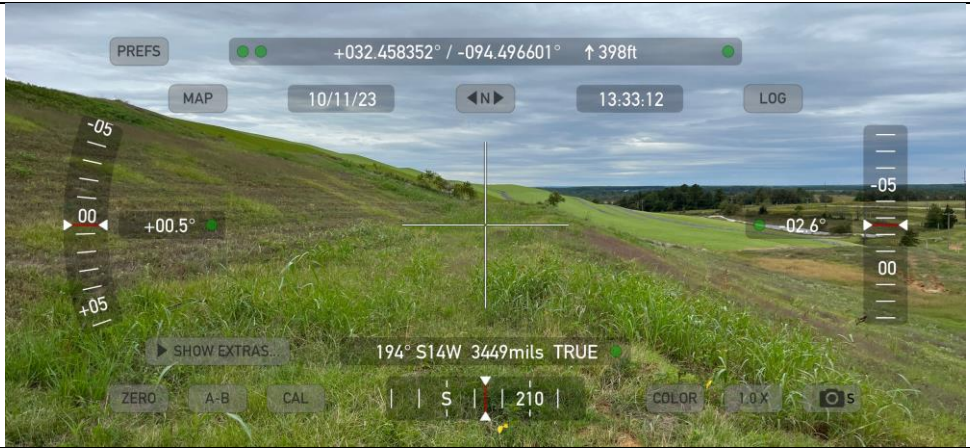
Photograph No. 30  
 View of cell 2005 showing vegetative final cover. (looking southwest)

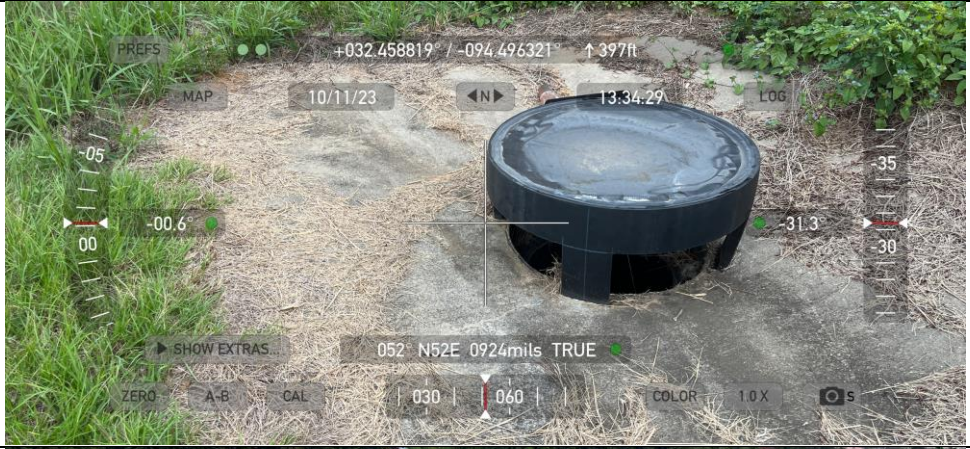
Photograph No. 31  
 View of one of the let-down catch basins inlets on top of 2005 area.

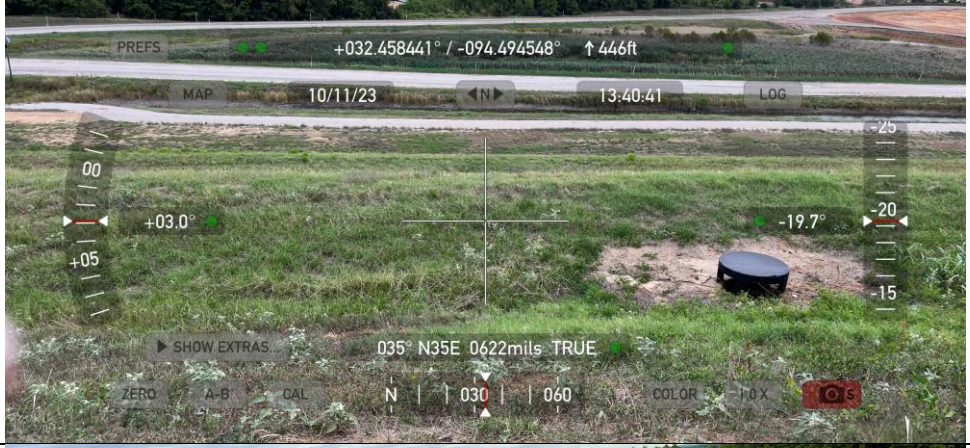
Photograph No. 32  
 Landfill Cover – view of one of the let-down catch basins inlets on top of 1999 area.

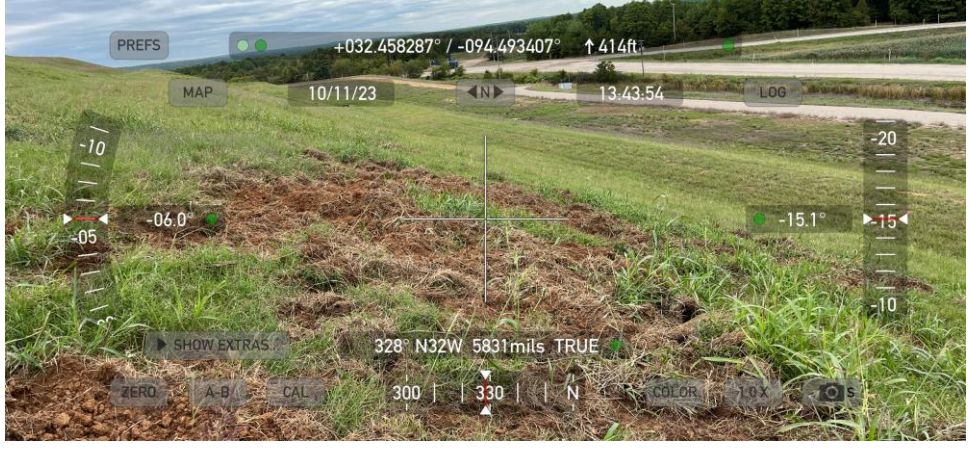
Photograph No. 33  
 Damage from hog activity was observed at exterior slope of Cell 1995. (looking northwest)

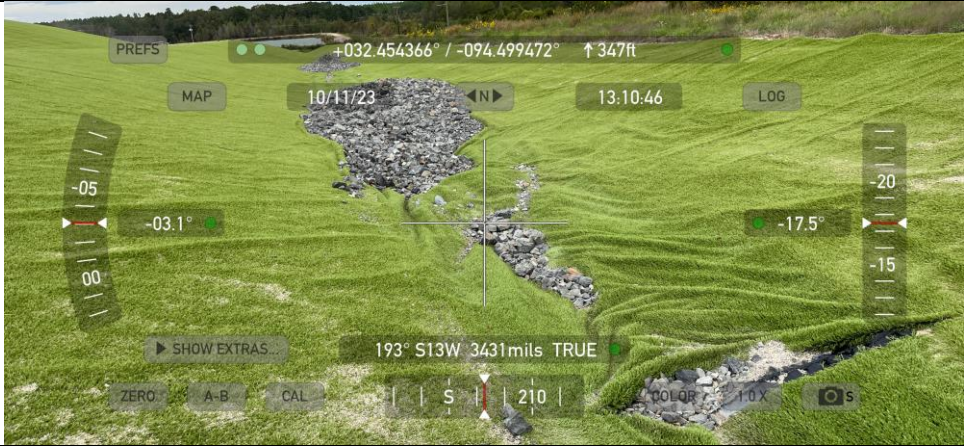
16. A non-contact water ditch runs along the toe of the western edge of the landfill area and is lined with final Cap and Cover Closure Turf material. Runoff from the lower outside slope of the 2015 cell Closure Turf is collected into this ditch and then flows through a culvert located in the southwest corner of the landfill perimeter ditch and discharges onto the geomembrane lined non-contact water ditch that goes around the landfill pond. The non-contact water ditch geomembrane has been undermined from excessive flowing water from rain event.

Photograph No. 34  
Ditch geomembrane was undermined from excessive flowing water of Cell 2015. (looking southwest)

- 3) Repair the geomembrane liner in the non-contact water ditches on the west side of the landfill where culvert pipes have undermined the liner from excessive flows and pipe extensions have penetrated through the liner to enter the ditch.
