2015 INITIAL ANNUAL LANDFILL INSPECTION
MITCHELL LANDFILL

KENTUCKY POWER COMPANY
d/b/a AMERICAN ELECTRIC POWER SERVICE CORPORATION
1 Riverside Plaza
Columbus, Ohio 43215

CIVIL & ENVIRONMENTAL CONSULTANTS, INC.
5899 Montclair Blvd
Cincinnati, OH 45150
(513) 985-0226

December 2015

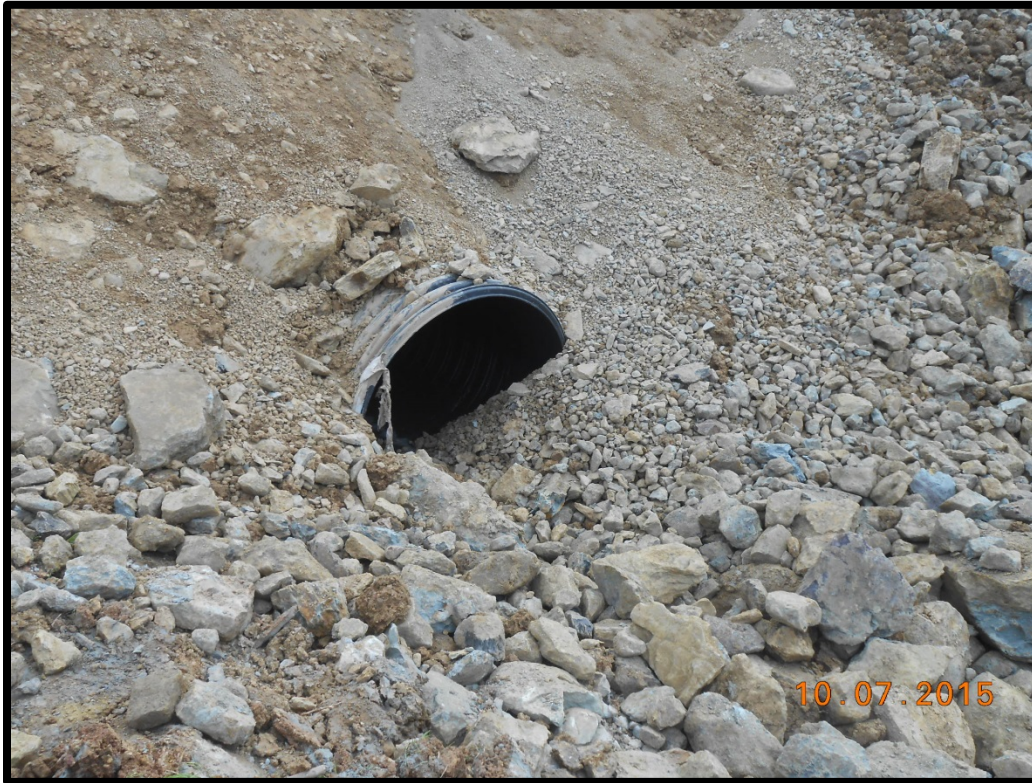
PHOTOGRAPH NO. 1

View of stormwater culvert on the east side of the exterior slope of the phasing berms with an outlet partially blocked with aggregate and soil.

- It is recommended that the three culverts noted in Section 3.3.5 (Refer to Photograph Nos. 1, 5, and 12 in Appendix B) be evaluated to determine if adequate flow capacity in the channels exists. It is also recommended that inlet/outlet protection be constructed and that existing sediment and blockages be removed from the upstream and downstream ends. Subsequent to final repairs, it is recommended that the ground surface near these structures be stabilized.

1) It is suggested that the localized collection of soil and riprap at the above noted catch basin near the south pond (Photograph No. 7) and at a culvert on the eastern side of the Phase 1 phasing berms exterior slope (Photograph No. 1), should be removed to eliminate the current partial blockages. Following removal, channel linings should be reestablished as necessary.

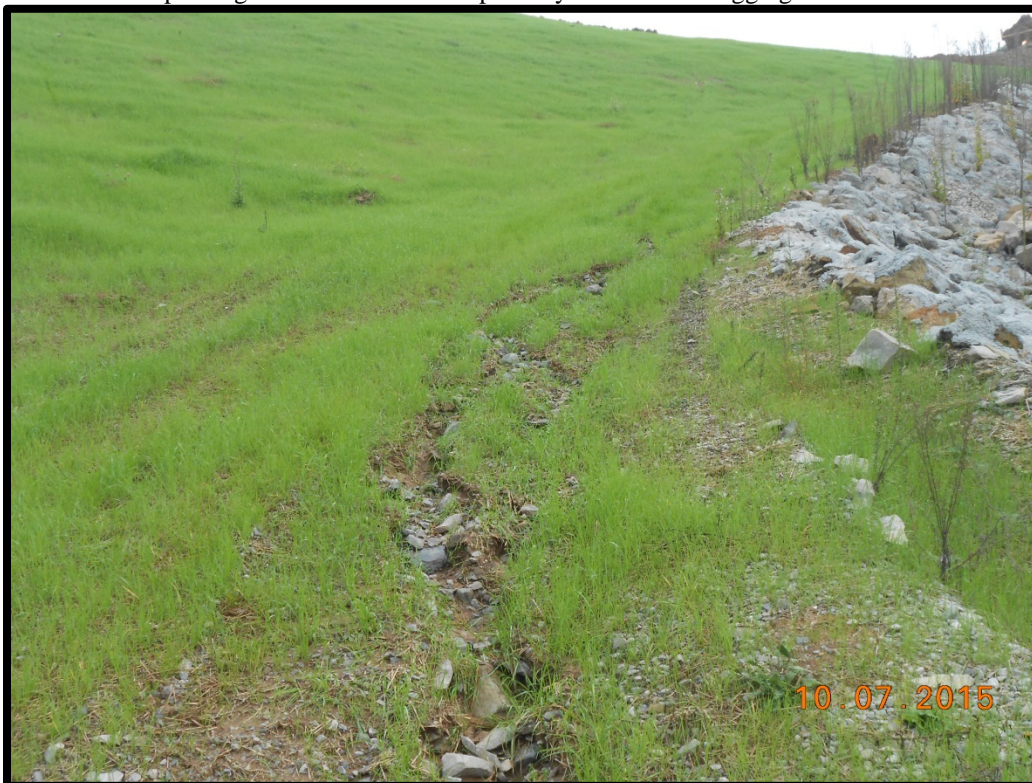
PHOTOGRAPH NO. 2

- Localized erosion and erosion rills were observed (Refer to Photograph Nos. 2 and 10 in Appendix B).

View of localized erosion rill on the east side of the Phase 1 phasing berm exterior slope.

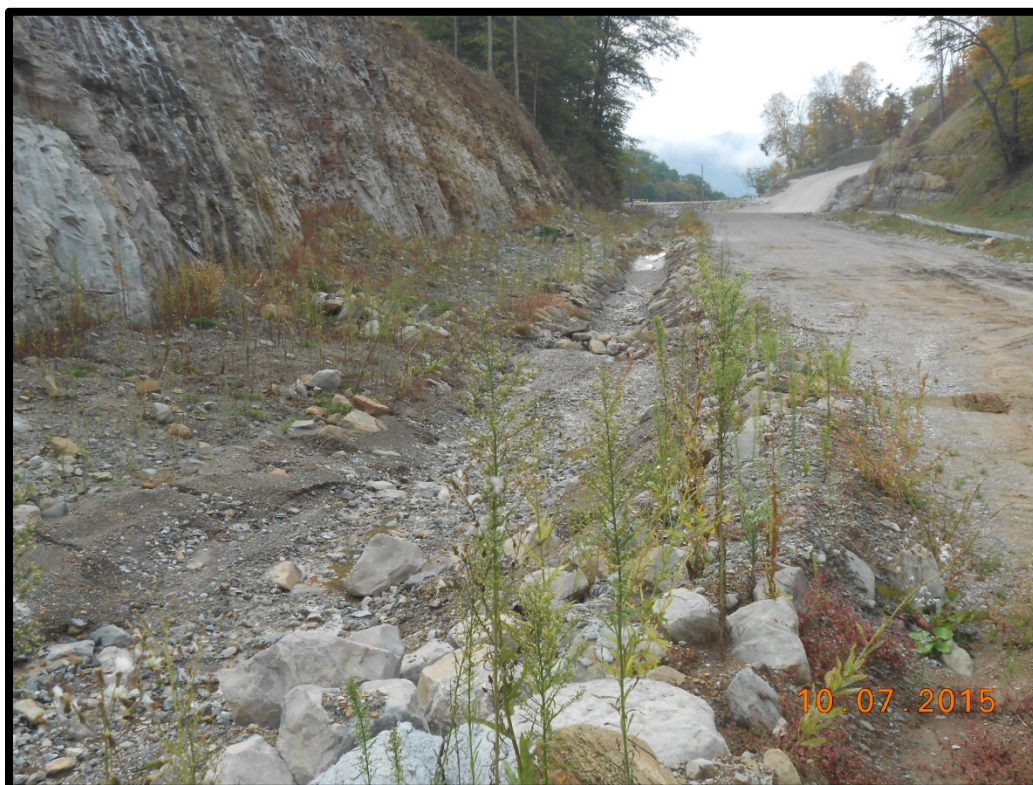
PHOTOGRAPH NO. 3

View of stormwater drainage swale south of Phase 1 waste disposal area leading to south pond forebay. Some sediment build-up and washout was observed.

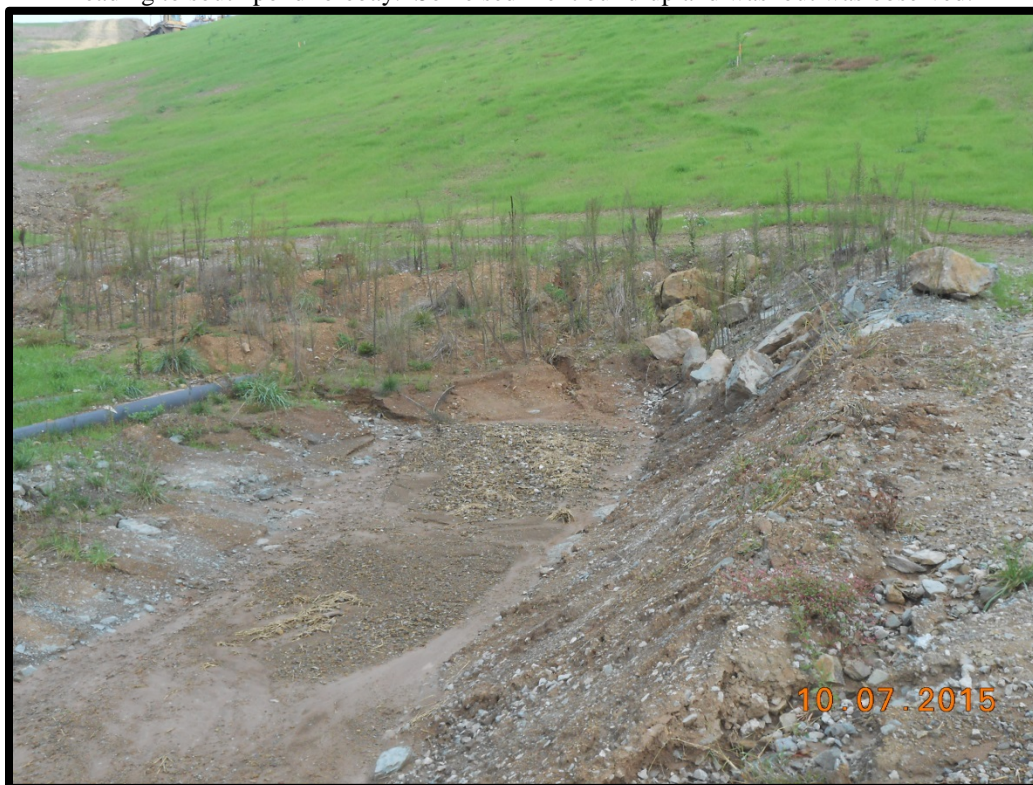
PHOTOGRAPH NO. 4

View of accumulated sediment and un-stabilized soil at beginning of southern toe of Phase 1 toe berm slope.

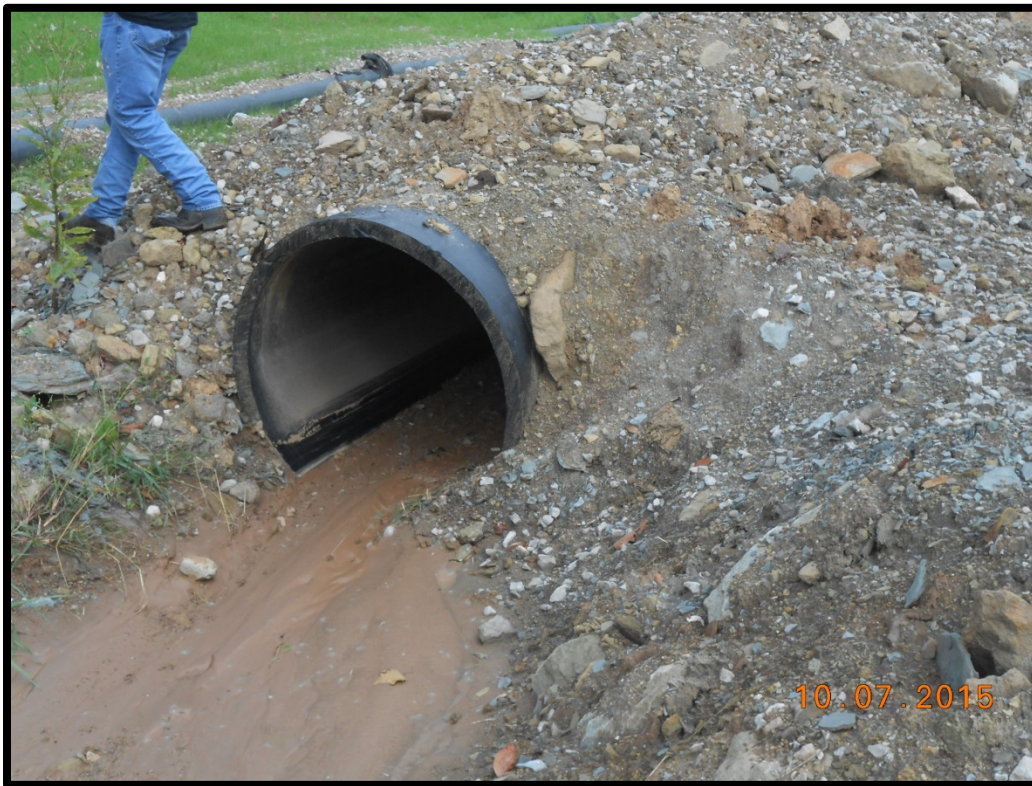
PHOTOGRAPH NO. 5

View of accumulated sediment near entrance to a drainage culvert approximately 150 feet from the toe of the Phase 1 temporary covered slope. Soil material shown in the photograph needs stabilized.

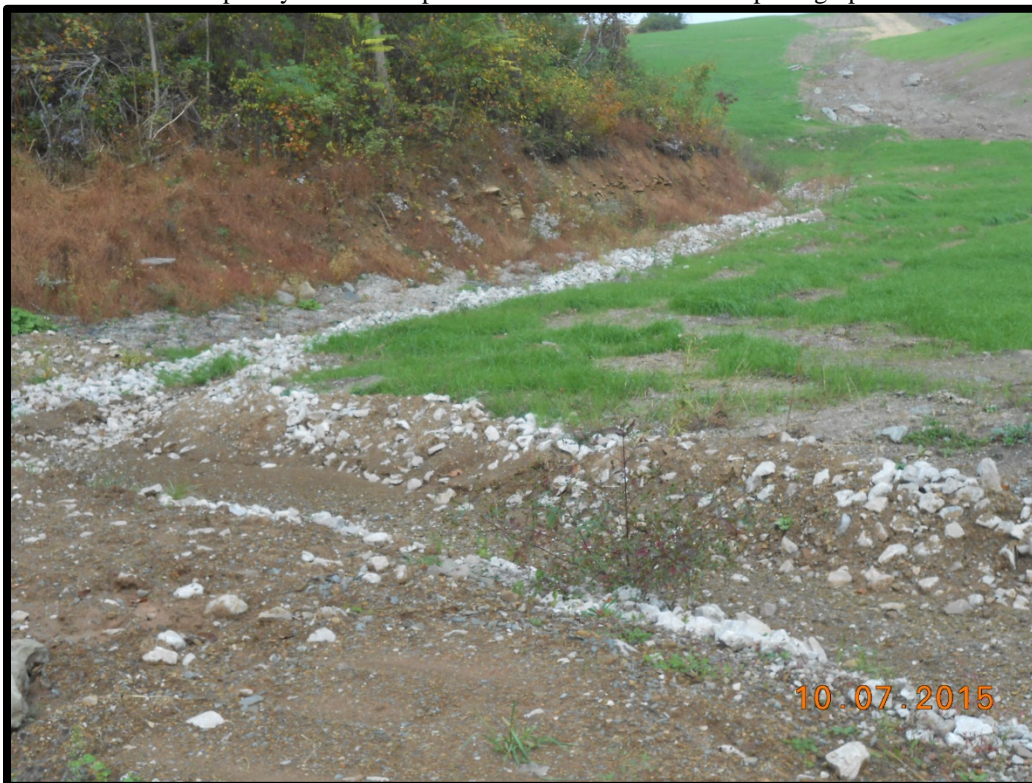
PHOTOGRAPH NO. 6

View of accumulated sediment and un-stabilized soil beyond the Phase 1 toe berm slope.

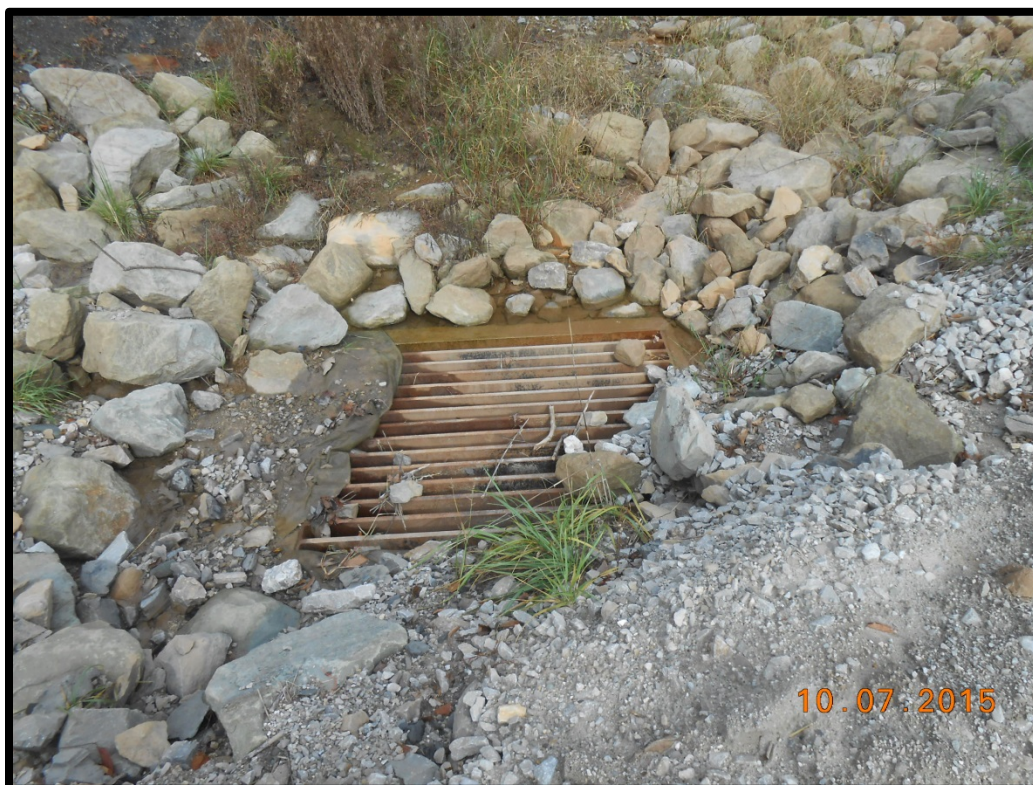
- Partial blockage of the catch basin near the south pond was noted (Refer to Photograph No. 7 in Appendix B).
- Erosion of vegetated and development of erosion rills have developed in the drainage arears positioned near the base of the Phase 1 exterior slope (Photograph Nos. 2, 9, and 10 in Appendix B).
- Localized areas of the stormwater channels located between the toe limits of Phase 1 and 2 and the south pond forebay contained sediment build up (Refer to Photograph Nos. 3, 4, 5, and 6 in Appendix B).
- The three referenced culverts (Refer to Photograph Nos. 1, 5, and 12 in Appendix B) were not included in the construction drawings and are functioning properly.

PHOTOGRAPH NO. 7
View of catch basin inlet near the south pond, with a partially blocked inlet.

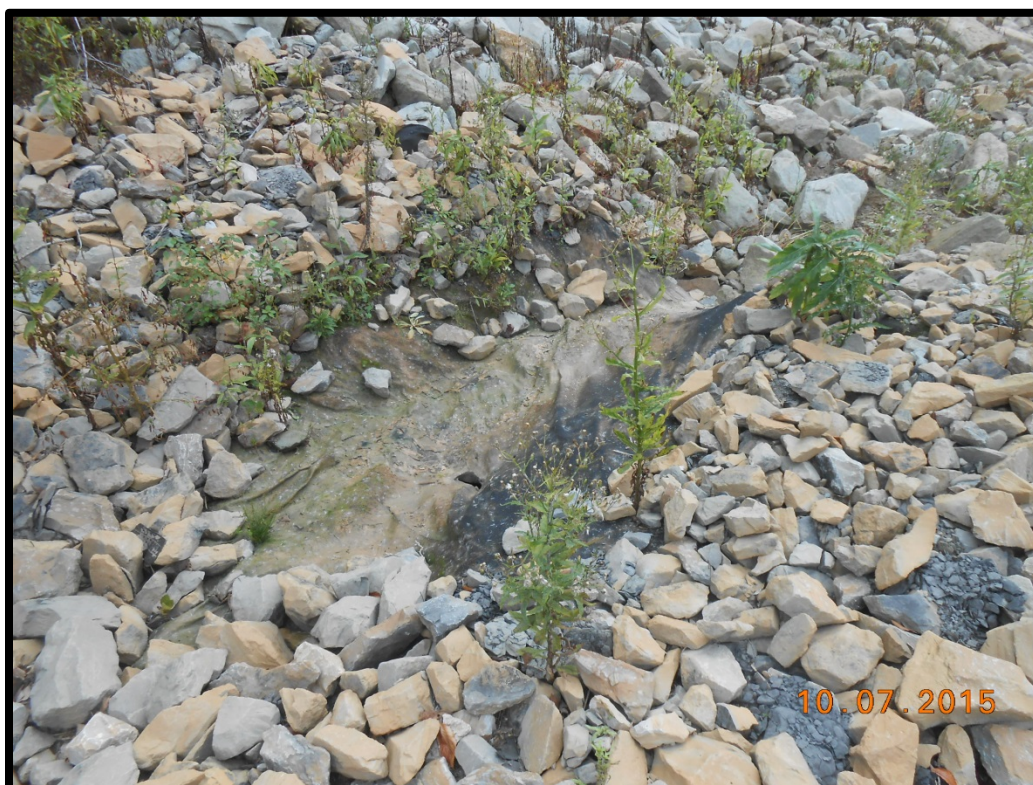
PHOTOGRAPH NO. 8
View of exposed geotextile at the riprap lined inlet channel to the south pond main settling chamber.

- It is recommended that the riprap armoring for the channel from the south pond forebay to the south pond be repaired (Refer to Photograph No. 8 in Appendix B). New riprap material should be placed as required to re-establish the design thickness.

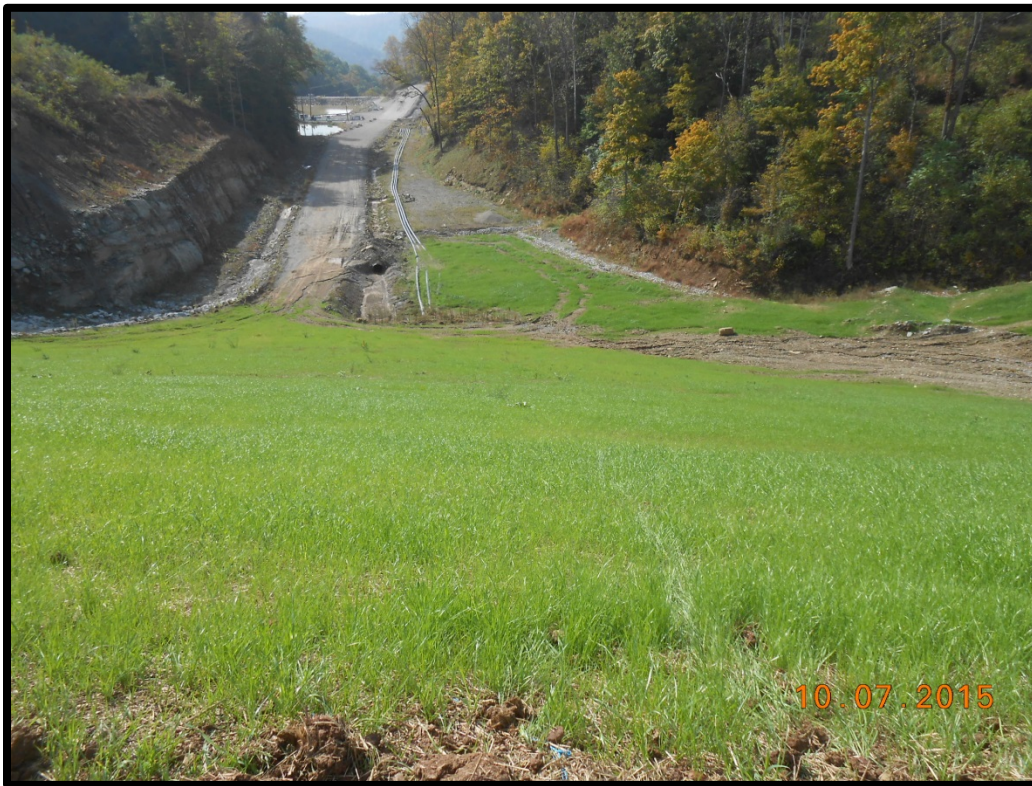
PHOTOGRAPH NO. 9

View of the temporary cover vegetated slope of the Phase 1 exterior slope. Area in background depicts drainage and vegetation deficiencies in Photograph Nos. 4, 5, and 6.

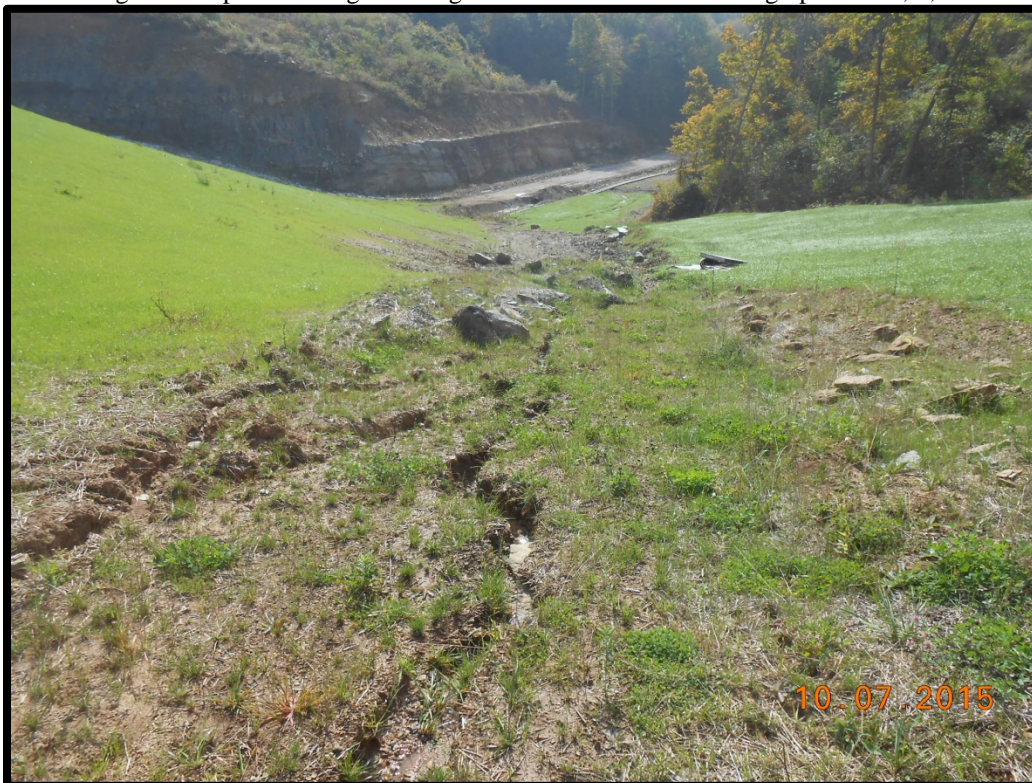
PHOTOGRAPH NO. 10

View of erosion rills along toe of the west exterior slope of the active Phase 1 waste disposal area.

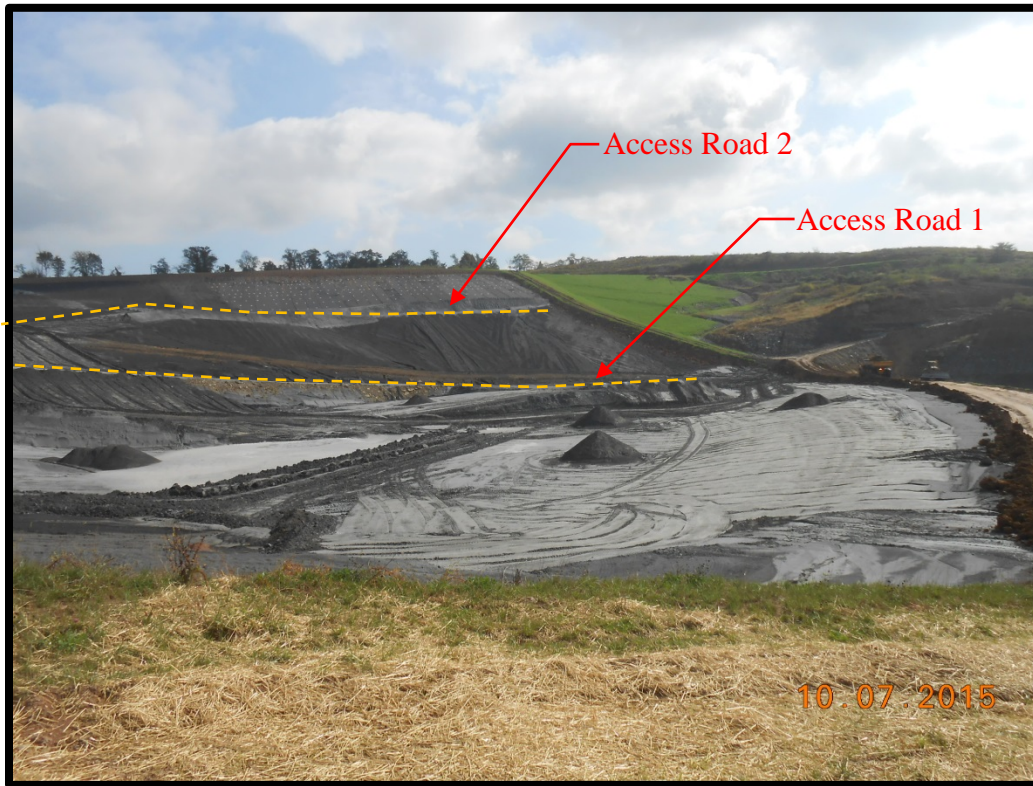
PHOTOGRAPH NO. 11

View of Phase 1 waste disposal operations looking east. Note the embankment constructed for the temporary access road mid-slope of Phase 2. A second access road is also shown on the Phase 2 slope.

- It is recommended that AEP obtain confirmation that the liner stability is sufficient to accommodate the two haul roads extending from the northern end of the waste limits through Phases 1 and 2 (Refer to Photograph No. 11 in Appendix B).

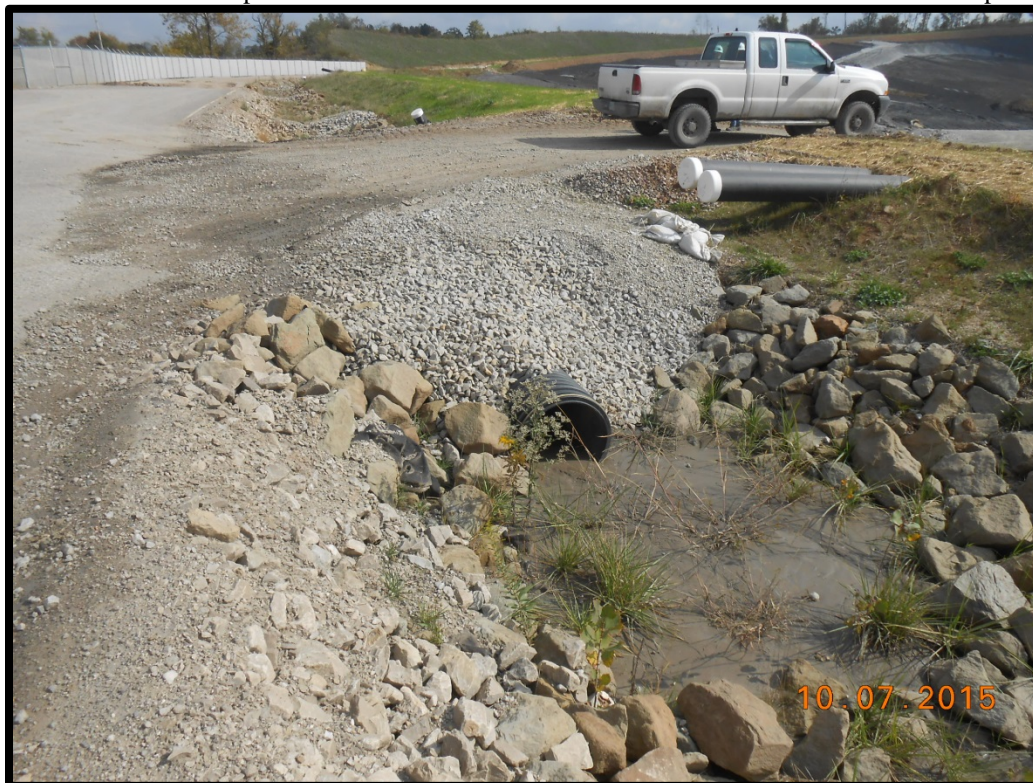
PHOTOGRAPH NO. 12

View of entrance to the Phase 1 waste disposal area from haul road with culvert crossing over inboard ditch. This culvert or roadway was not in the permit of construction drawings.

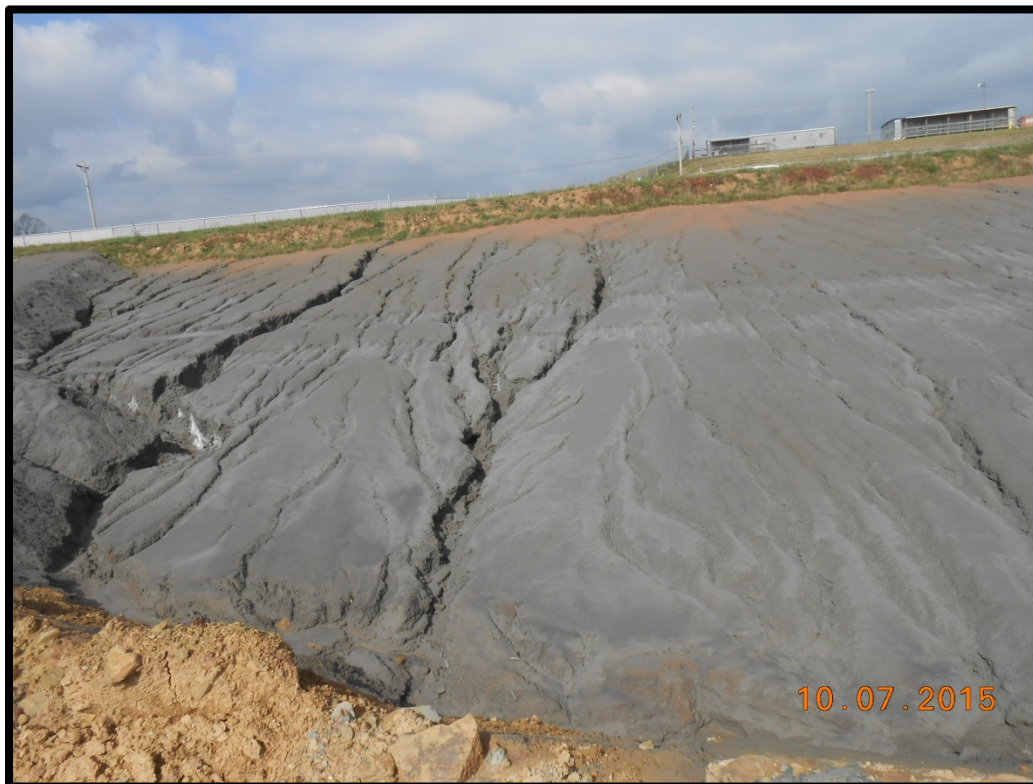
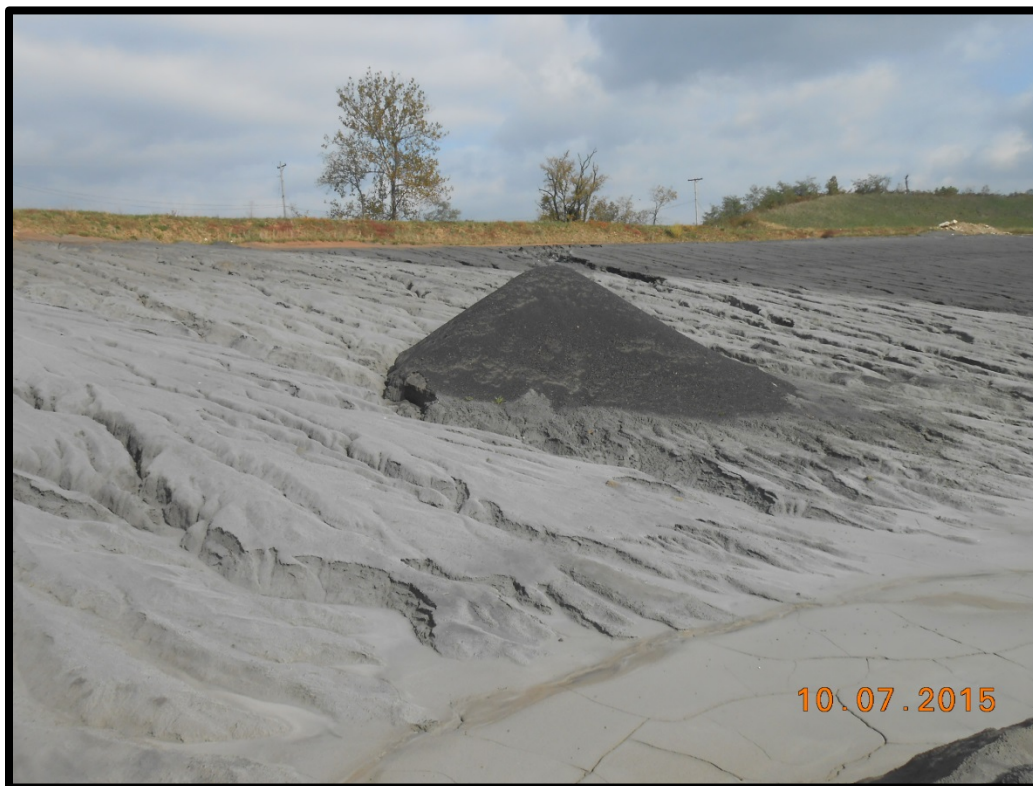
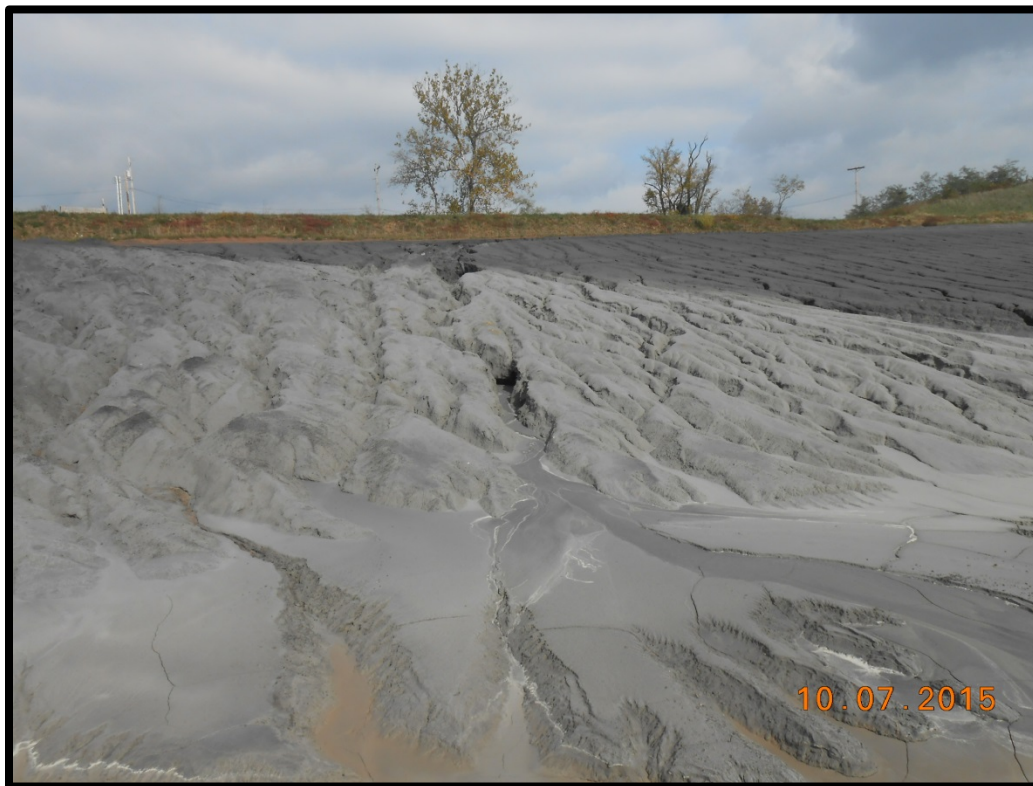
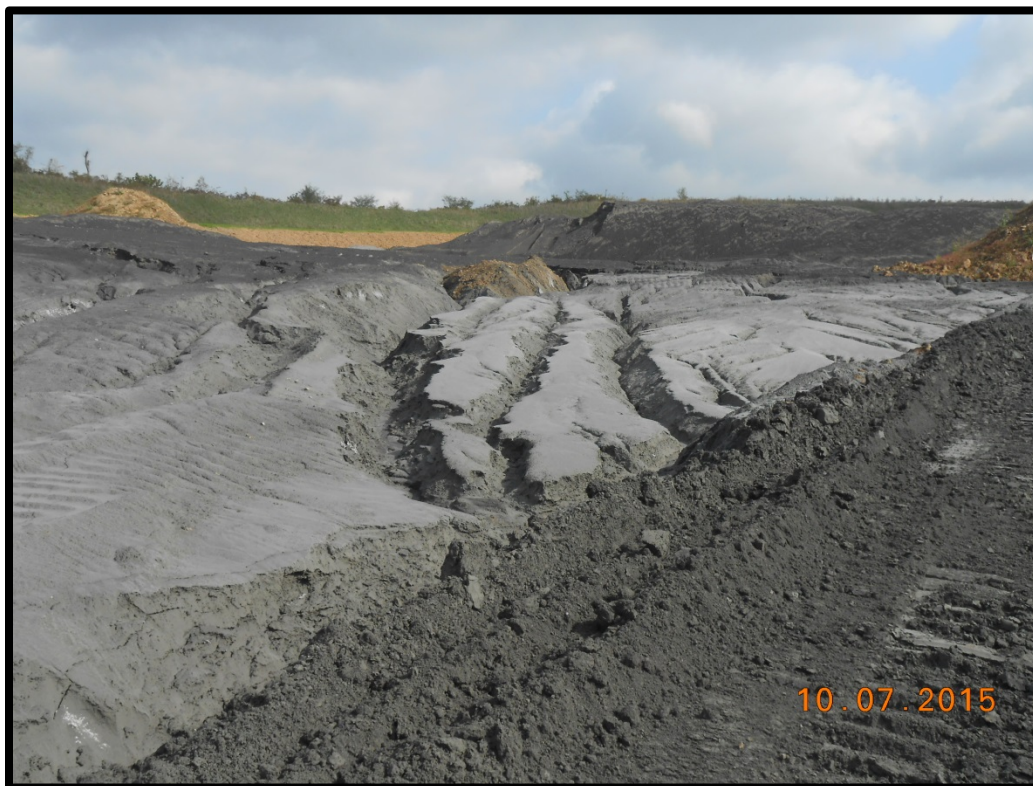
- Excessive erosion of the composite liner protective cover material was observed in the non-active landfill areas. The erosion was more prevalent on the northern slope as compared to the eastern slope (Refer to Photograph Nos. 13, 14, 15, and 16 in Appendix B).
- The haul roads observed traversing the composite liner protective cover materials within the landfill (Refer to Photograph No. 11 in Appendix B) may cause instability of the liner system.

View of erosion rills in the protective cover material near the northern end of the landfill.

View of erosion rills in the protective cover material near the northeastern end of the landfill.

- It is recommended that the eroded composite liner protective cover materials on the north and east sides of the non-active waste disposal areas be repaired or re-established (Refer to Photograph Nos. 13, 14, 15, and 16 in Appendix B). New cover materials should be used to fill in the depressions and the exposed surface regraded to the design thickness. AEP should also consider using bottom ash for the protective cover material and/or should consider means to limit erosion in the future (i.e., sacrificial geotextile, Posi-shell application, etc.).

1) The protective cover materials that have eroded should be repaired (Photograph Nos. 13, 14, 15, and 16). To correct these erosion rills in the protective cover, it is suggested that new cover materials be placed to fill in the depressions and the exposed surface be regraded. Additionally, AEP should consider means to protect the exposed surface in order to limit erosion in the future (i.e., sacrificial geotextile, Posi-shell application, etc.).

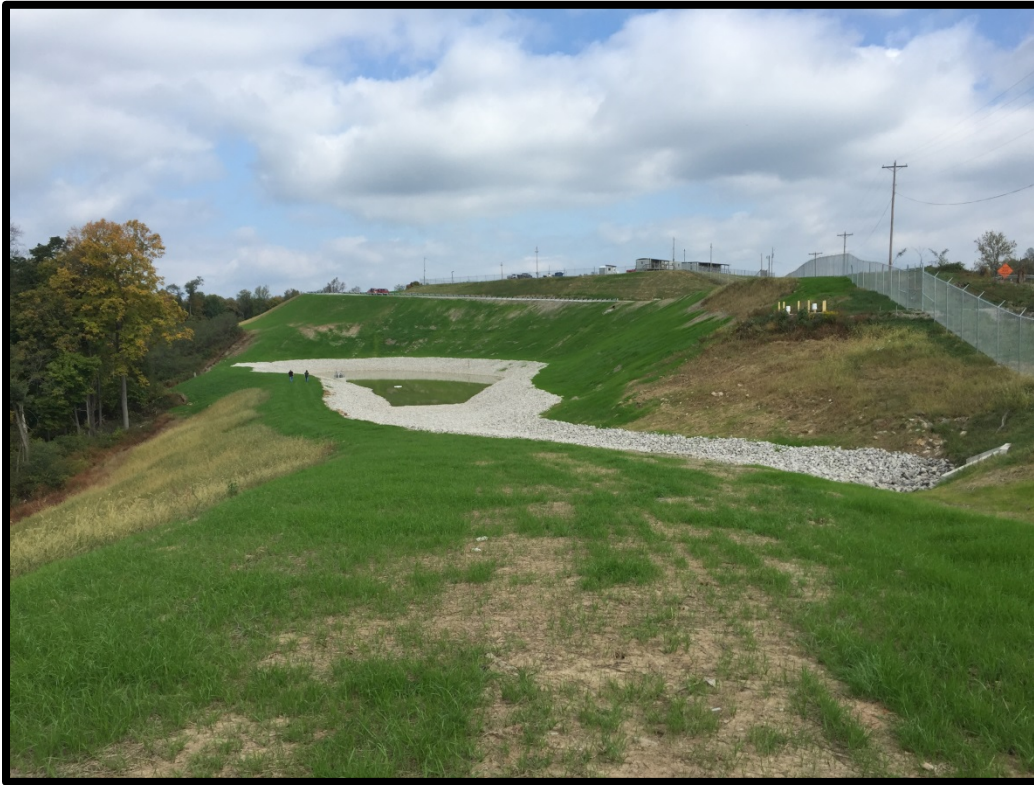
PHOTOGRAPH NO. 17

Overall view of the west pond. Some vegetation “bare spots” were noted.

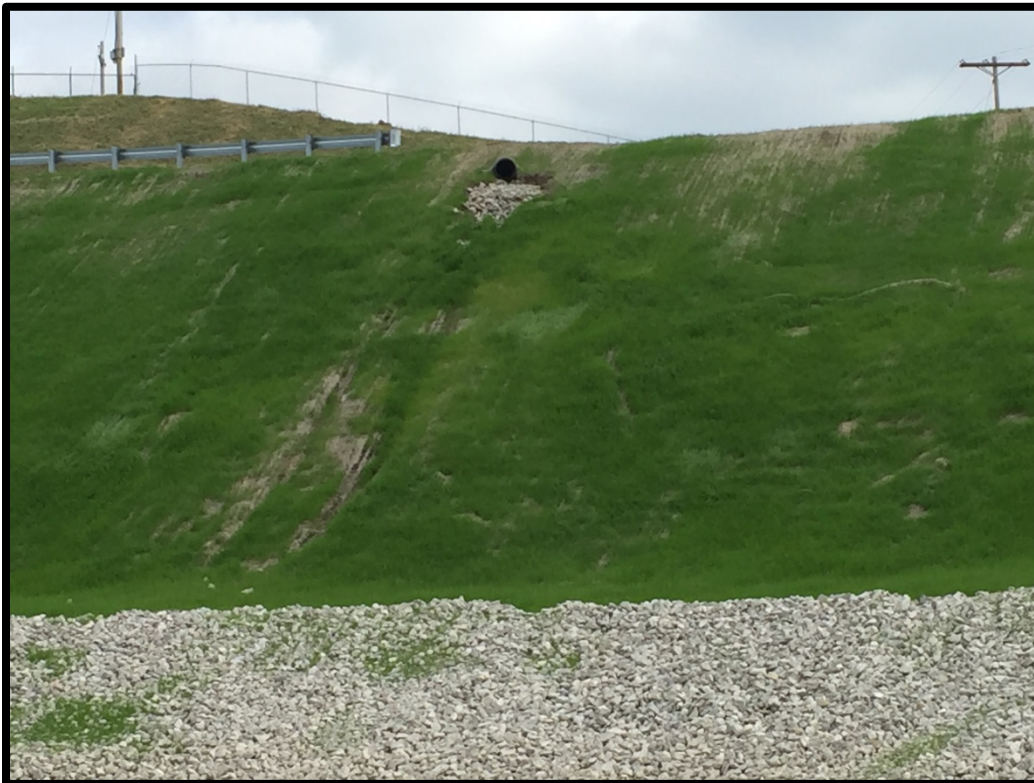
PHOTOGRAPH NO. 18

- The outlet of the culvert pipe noted in the southeast quadrant of the pond (near top of the cut slope) is causing erosion of the newly vegetated steep slope (Refer to Photograph No. 18 in Appendix B).
- Some of the newly seeded areas around the pond did not establish full vegetative growth (Refer to Photograph No. 17 in Appendix B).
- The west pond did not have a staff gauge to readily determine the water elevation in the pond.

View of culvert discharge point above the west pond. Culvert discharge onto the very steep slope is eroding the vegetation.

- It is recommended that a designated armored channel be constructed from the inlet pipe headwall located in the southeast quadrant of the west pond (near the top of the steep slope) to the west pond (Refer to Photograph No.18 in Appendix B).
