2015 Initial Landfill Inspection Report

Northeastern Units 3&4 Ash Landfill
Oologah, Oklahoma
NHIW Landfill Permit No. 3566010

December 2015
Project No. 35157169

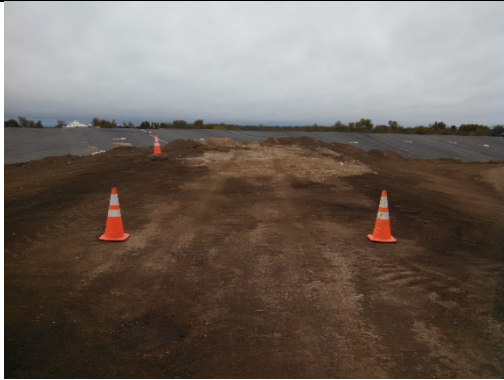
Text			
Photograph ID #	Description	Comments	Photo
1	Looking southeast at west ramp onto constructed perimeter berm	Begin counterclockwise walk-down of the entire landfill boundary and the Basin C boundary

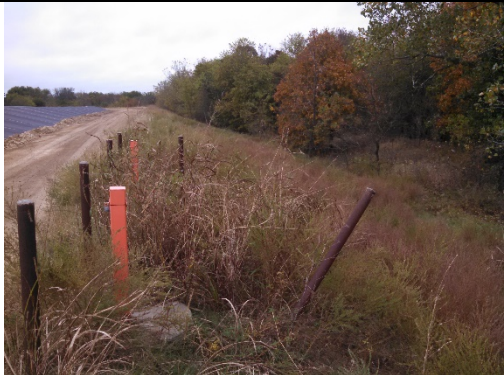
6	Looking at perimeter embankment – MW-5 area	No vegetative distress noted along this southwest embankment (emb) area. Emb appears flatter than 3:1

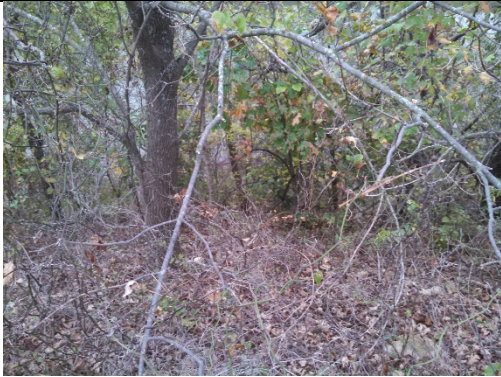
21	Looking downslope toward Verdigris River	Upper slope estimated at approximately 4:1

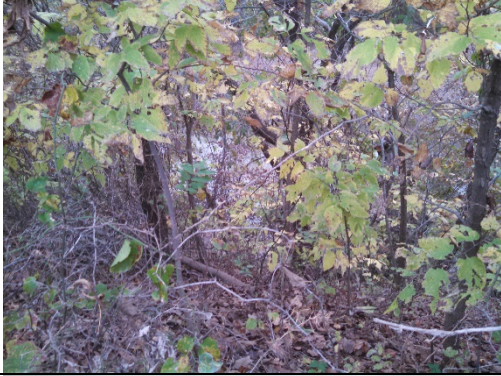
3. The outer bank (downslope from the perimeter road at the top of the dike) was heavily wooded with trees and brush and leaf-fall. (Photos 22 and 30) Observation of small-scale pre-movement cracking, sloughing and/or saturated conditions may be obscured by the heavy ground cover. However, none was noted.

22	Looking downslope toward Verdigris River	Lower slope estimated at approximately 1:1

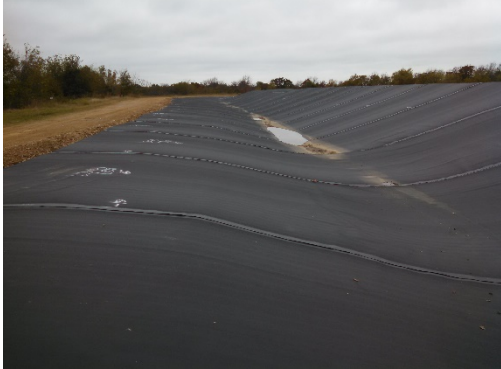
1. The landfill intermediate liner design includes a perimeter berm that will prevent run-on of stormwater into the fill area during operations and will convey stormwater outside the perimeter berm to the stormwater collection basin – Basin C. (Photo 35)
2. Stormwater conveyances are presently in an interim stage during construction. However, at this time no blockages of stormwater flow, erosion, or deterioration are noted.
3. Occasional minor occurrences of pooling water within the GM lined perimeter ditch were noted. Trampolining of GM was noted within the perimeter ditch (Photo 26). However, these occurrences do not inhibit general run-off of stormwater into basin C.

26	Looking southwest along perimeter stormwater ditch

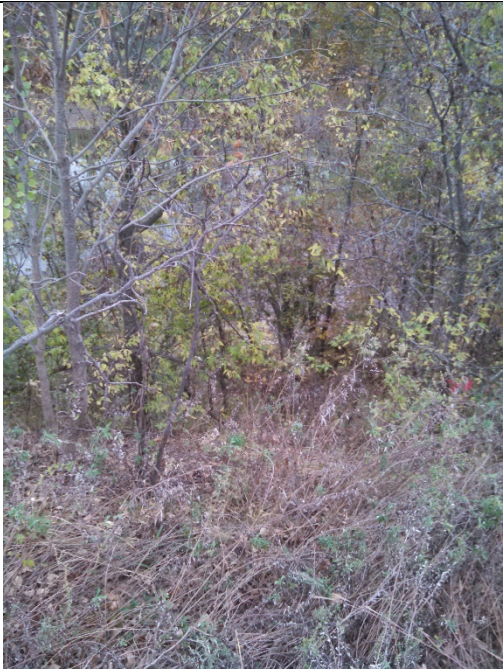
40	Looking downslope toward the Verdigris River approximately half way between MW-6 and MW-3	Steep slope at around 1:1 extends up to perimeter road on top of dike

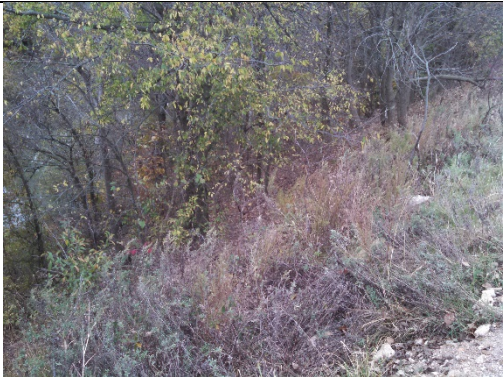
41	Looking south at downward slope of perimeter dike	Note repelling rope in picture

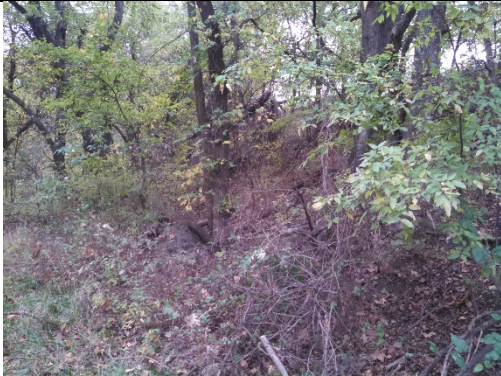
62	Looking south at perimeter dike below Basin C from the access road leading to wastewater mixing structure

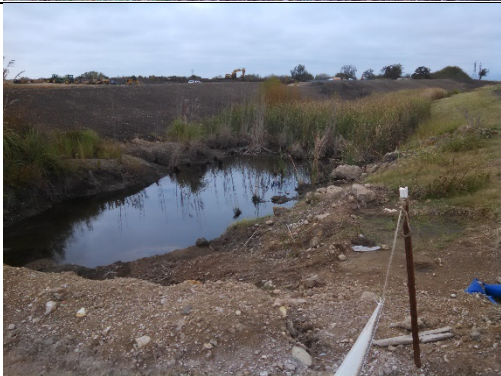
3. It was noted that there is an area of wetting at the toe of slope of the landfill perimeter berm in the vicinity of the coal car unloading building. (Photos 78, 80 and 83) This area will be monitored during future inspections following the completion of construction at the landfill.

78	Looking west at standing water upstream from the leachate impoundment area in the north ditch

- Continue formal inspections, monitoring and maintenance as required by the CCR and ODEQ Solid Waste Management rules.
- Continue to monitor water levels in piezometers still in place in the slurry wall area to determine if excess pore water pressure is building in the outside slope of the perimeter dike.
- Monitor wet areas historically noted in the dike/bedrock interface within the Verdigris River stream area.
- Monitor wet areas at the toe of slope of the landfill perimeter berm in the area of the coal car unloading building.

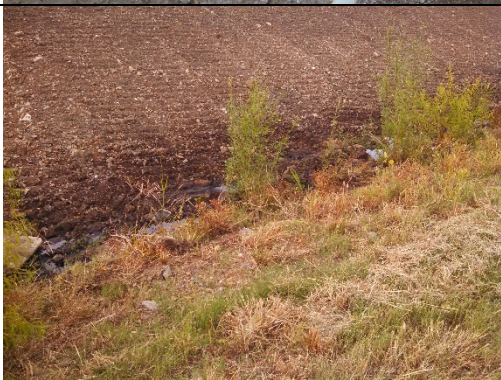
80	Looking southwest at the toe of the landfill perimeter berm	Note saturated condition

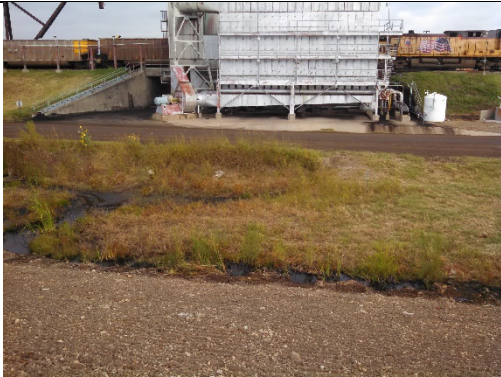
83	Looking north down the landfill perimeter berm toward the coal unloading building	Note flow of water from the coal unloading building area south toward the landfill berm toe
