# DAM & DIKE INSPECTION REPORT

GERs – 15 – 029

PIRKEY POWER PLANT

BOTTOM ASH POND COMPLEX  
AMERICAN ELECTRIC POWER  
(SWEPCO)  
HALLSVILLE, TEXAS

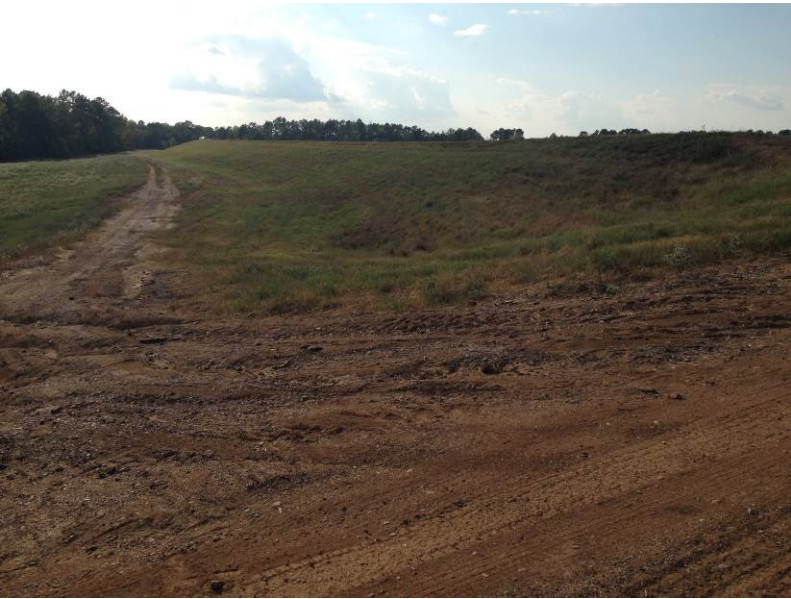
At the time of inspection the west bottom ash storage pond was out of service and the current pool elevation is approximately 350.5 feet amsl. In general the downstream slopes of West Bottom Pond were in fair condition with no observed signs of seepage or instability. Most slope areas previously noted as being bare now have good vegetation cover with some sparse areas still observed on the west side. (Photographs No. 1, and No. 2). The crest and interior slopes were in fair and stable condition with no signs of instability (Photograph No. 3, 4, 5 and 6). The West Bottom Ash Pond outlet structure appeared in fair and functional condition (Photograph No. 7).

<p>Photo # 1</p> <p>Downstream slope of West Bottom Ash Pond.</p>

- Areas of sparse vegetation need to be reseeded and fertilized in order to establish adequate cover on the outside slopes of the west bottom ash pond.

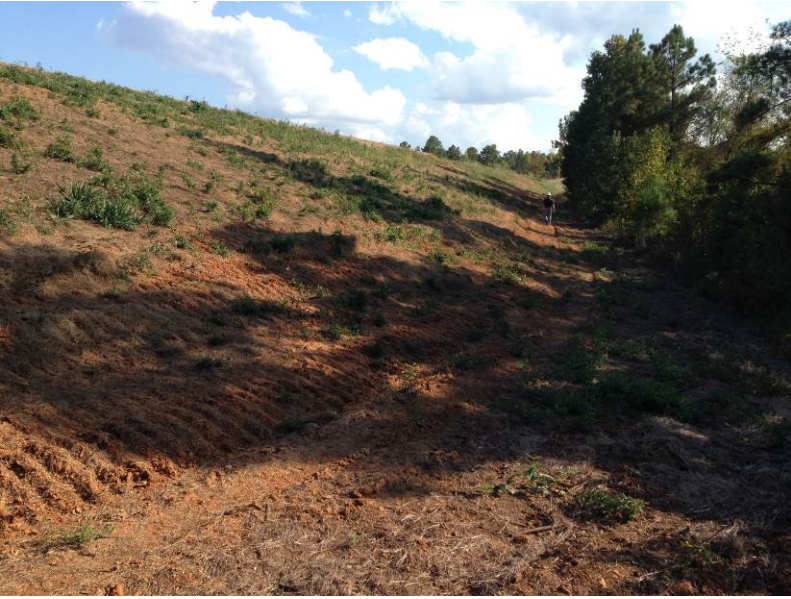
A wide-angle photograph showing a dirt path leading up a grassy and eroded slope under a cloudy sky.
<p>Photo # 2</p> <p>Downstream slope of West Bottom Ash Pond.</p>

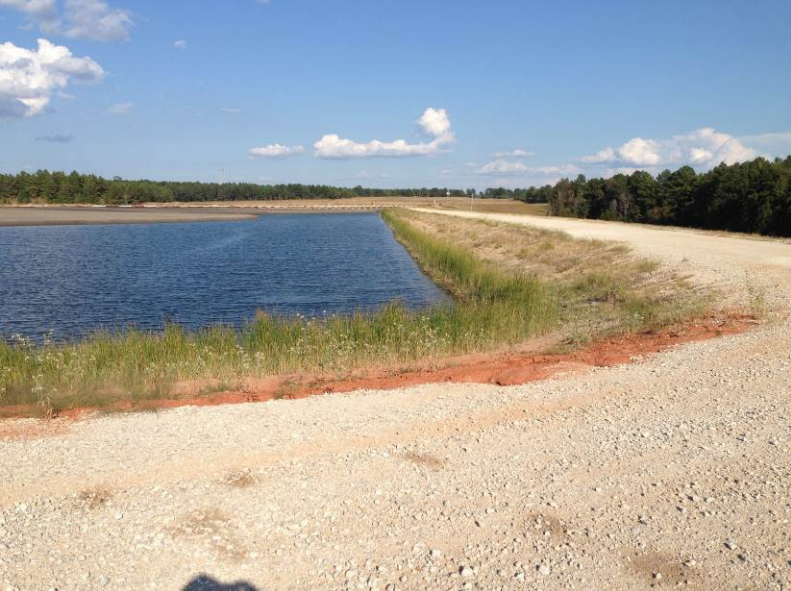
A photograph of a steep, eroded dirt slope with sparse vegetation, with trees visible on the right side.
<p>Photo # 3</p> <p>Typical inside slope area and crest conditions West Bottom Ash Pond.</p>

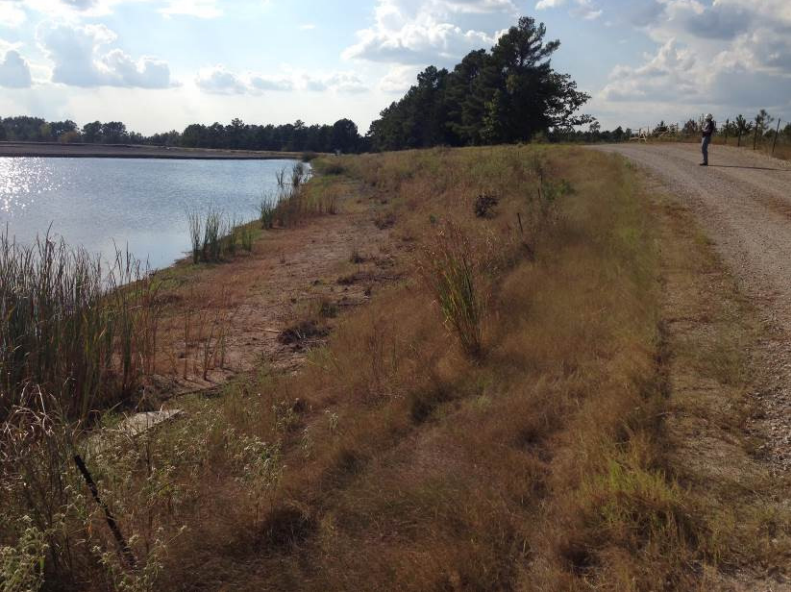
<p>Photo # 4</p>

A photograph showing the interior slope of the West Bottom Ash Pond. The slope is covered in dry, brownish grass and some reeds. A gravel path runs along the top of the slope, and a person is visible walking on it in the distance. The pond water is visible on the left side of the slope.
<p>Interior slope of West Bottom Ash Pond.</p>	
<p>Photo # 5</p>

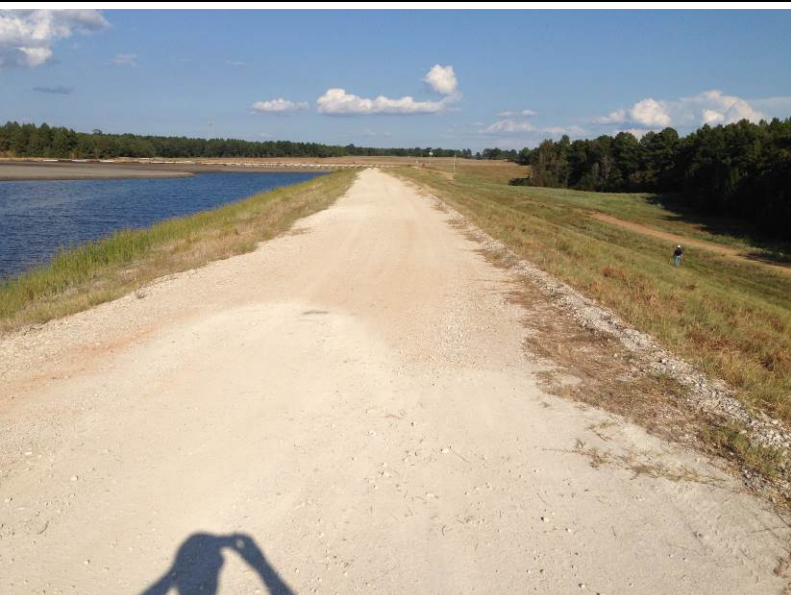
A photograph showing a typical crest area of the West Bottom Ash Pond. A wide, gravel-covered path runs along the crest of the dike. The path is flanked by dry grass and some trees. The pond water is visible on the left side of the path.
<p>Typical crest area of the West Bottom Ash Pond.</p>	
<p>Photo # 6</p>

<p>Typical crest area of the West Bottom Ash Pond.</p>

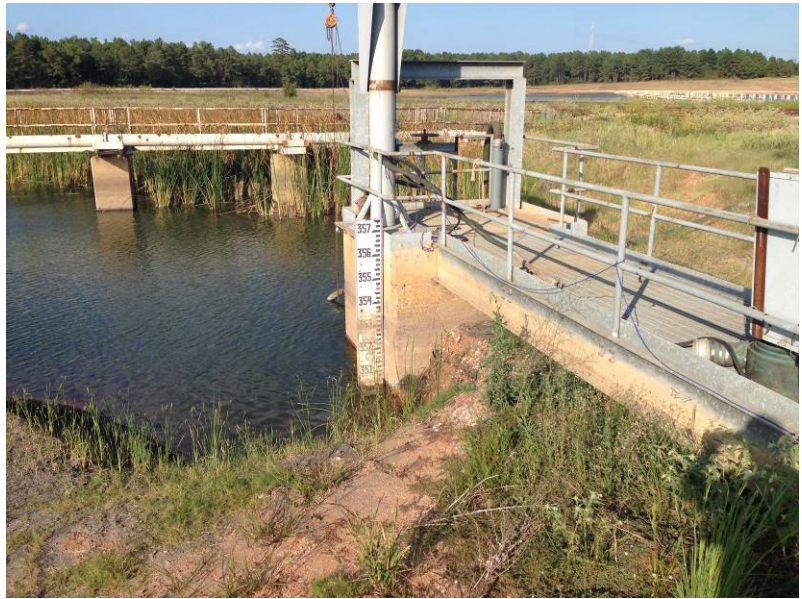
Photo # 7

Interior West Bottom Ash Pond outlet structure.

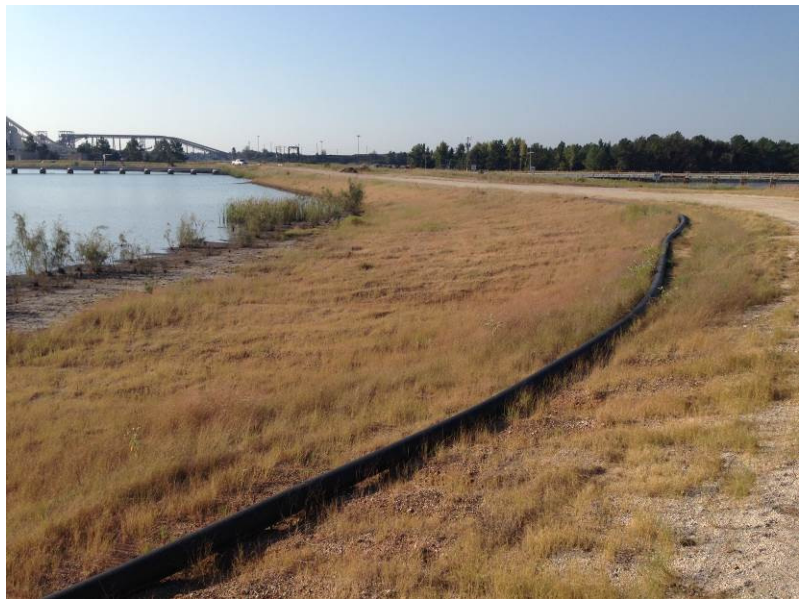
Photo # 8

At the time of inspection the east bottom ash storage pond was in service and the current pool elevation is approximately 353.25 feet amsl. The interior slopes and the crest areas of the East Bottom Ash Pond were in fair and stable condition with no signs of erosion or instability (Photograph No. 8, 9 and No. 10). The dikes of the East Bottom Ash Pond are typically 3 to 4 feet tall related to the exterior ground. A portion of the outside slope of the north embankment is heavily vegetated, but because it serves as a perimeter drainage ditch, tree removal would be detrimental from an erosion control standpoint. Also, considering the low heights of these dikes and the low pond operating level compared to the ground surface elevation at the toe, there is low risk to the integrity of the pond by leaving the vegetation in place. The rest of the exterior slopes also act as a perimeter drainage ditch with controlled vegetation cover (Photograph No. 11 and No. 12). The perimeter ditch is very flat and does hold water after heavy rains. The outlet structure appeared to be in fair and working condition (Photograph No. 13).

Typical interior condition of East Bottom Ash Pond.

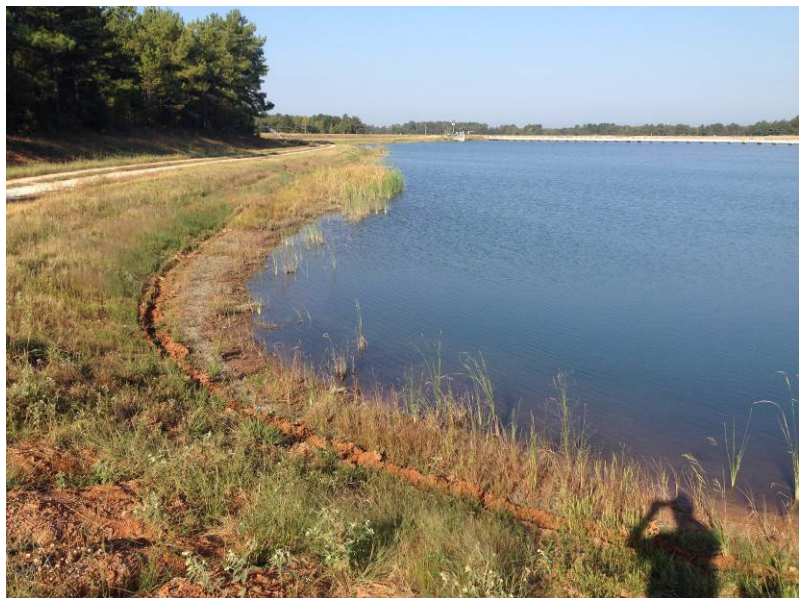
Photo # 9

Interior slope condition of East Bottom Ash Pond.

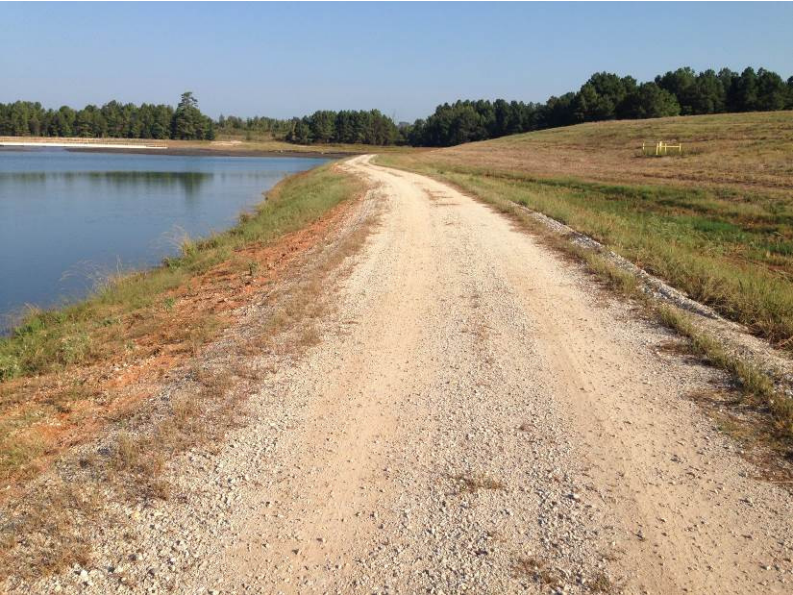
<p>Photo # 10</p>

<p>Crest area of East Bottom Ash Pond.</p>	
<p>Photo # 11</p>

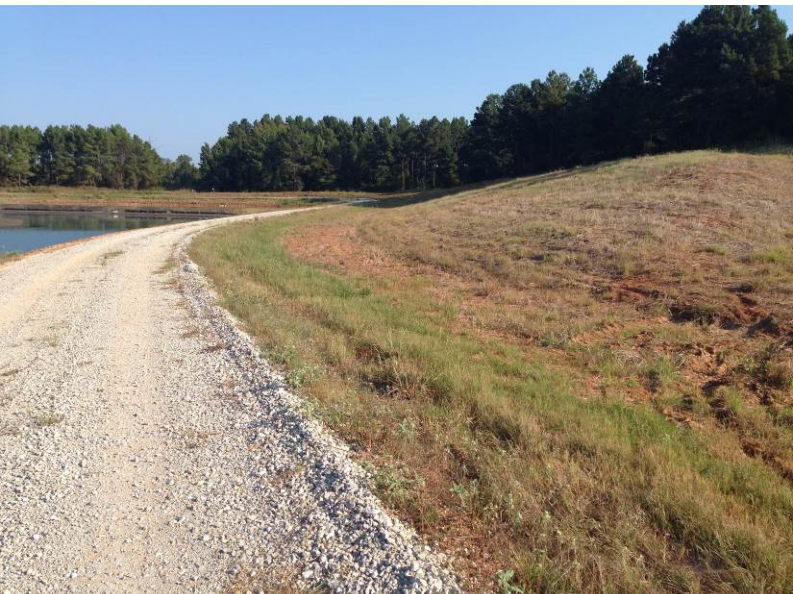
<p>Crest area and exterior perimeter ditch of East Bottom Ash Pond.</p>	
<p>Photo # 12</p>

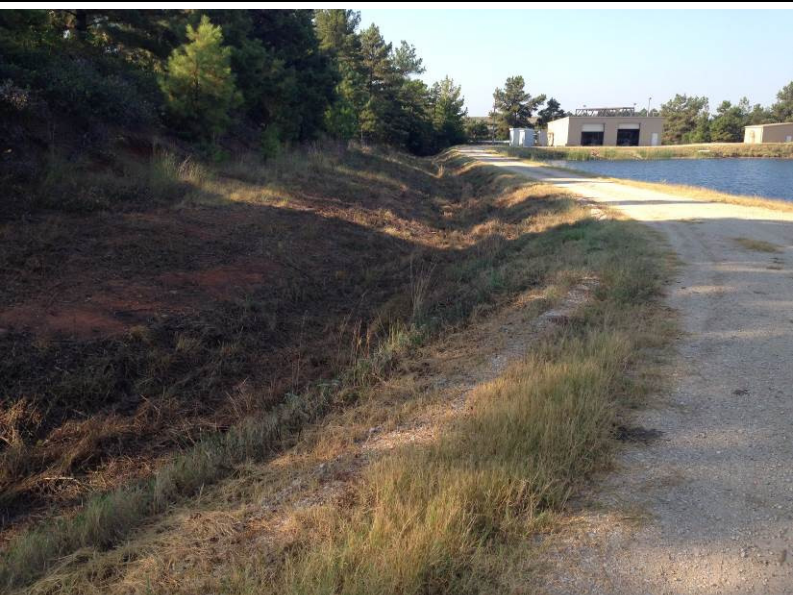
<p>Crest and perimeter ditch of east Bottom Ash Pond.</p>

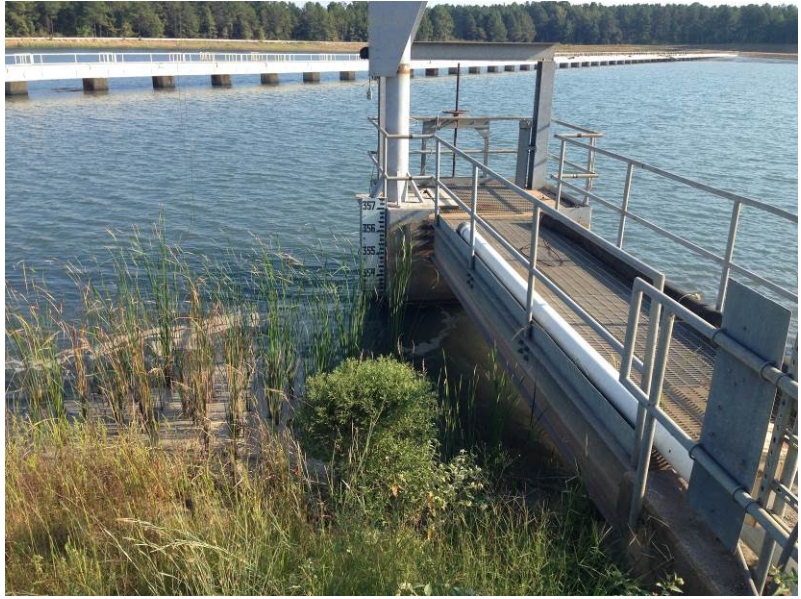
Photo # 13

East Bottom Ash Pond outlet structure.

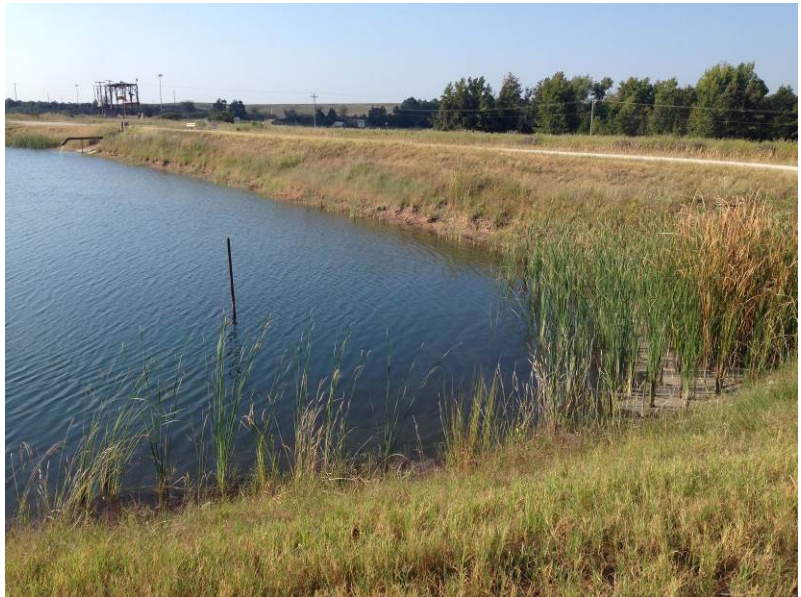
Photo # 14

Interior slope conditions of Secondary Ash Pond.

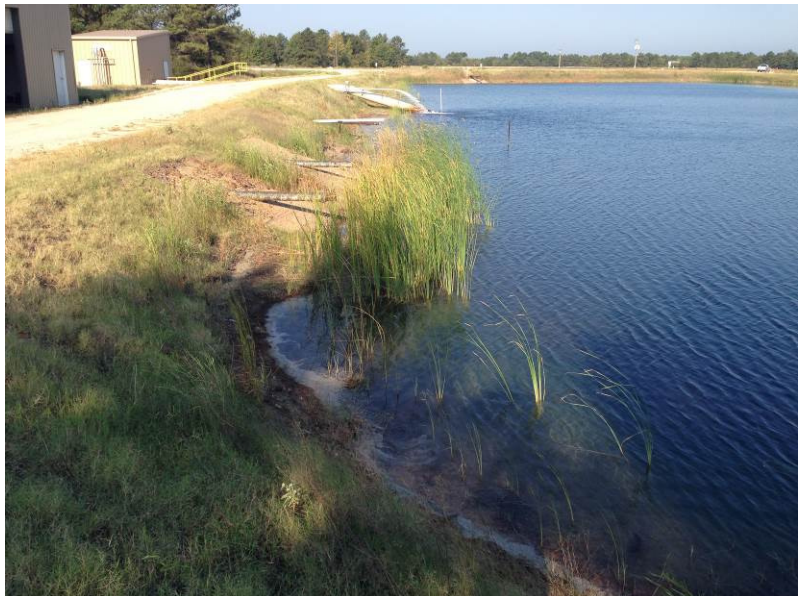
Photo # 15

Interior slope of Secondary Ash Pond showing discharge pipes from various sources.

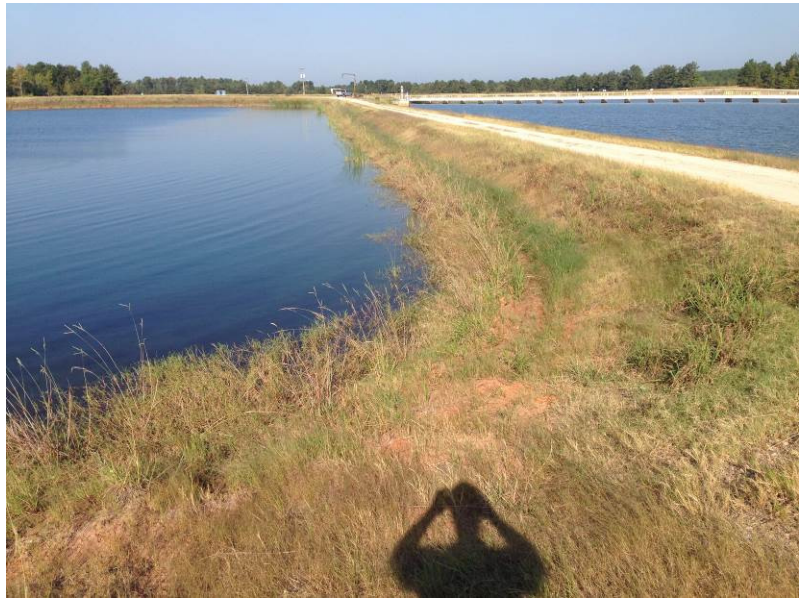
Photo # 16

Typical interior slope conditions of Secondary Ash Pond.

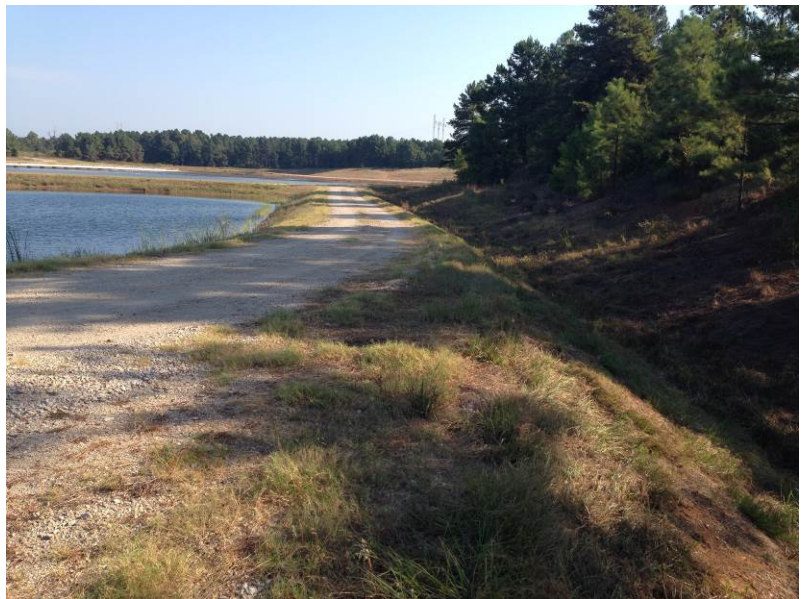
Photo # 17

Typical crest conditions of Secondary Ash Pond.
