ANNUAL LANDFILL INSPECTION REPORT
Rockport Plant
Indiana-Michigan Power Company
Rockport, Indiana

December 09, 2015

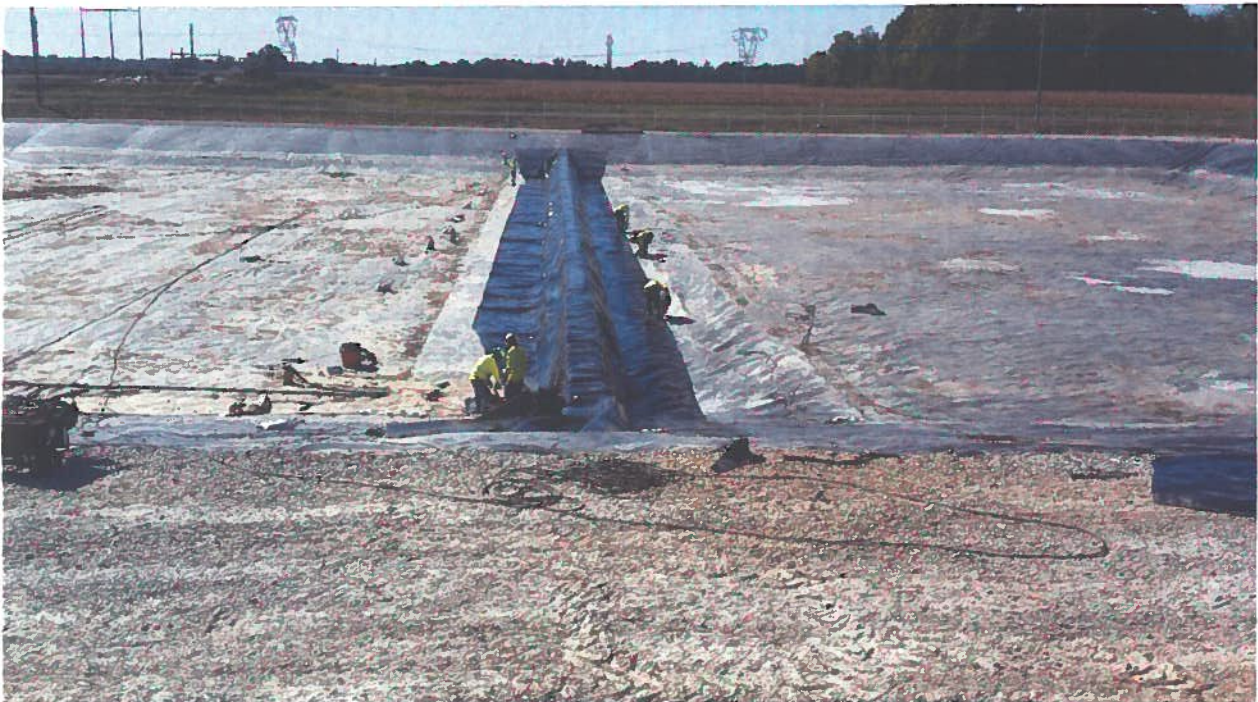
The West Leachate Pond and all its components are in good condition. All the berms are covered in stone and the concrete forebay is free of holes and cracks. The liner in the settling bays is in good shape. The perimeter fence is stable with no unplanned entry points. The dewatering systems and structures are operating adequately. The splitter dikes are in good shape with the faulty one currently under repair.

Pictures 006, 007, and 008 show the settling bays and the splitter dikes.

- Regularly inspect and monitor the newly installed splitter dike in the West Leachate Pond. Watch for signs of instability or leaning of the new wall and watch for signs of leaks that could develop at the seams of the liner patch. (Picture 008 below)

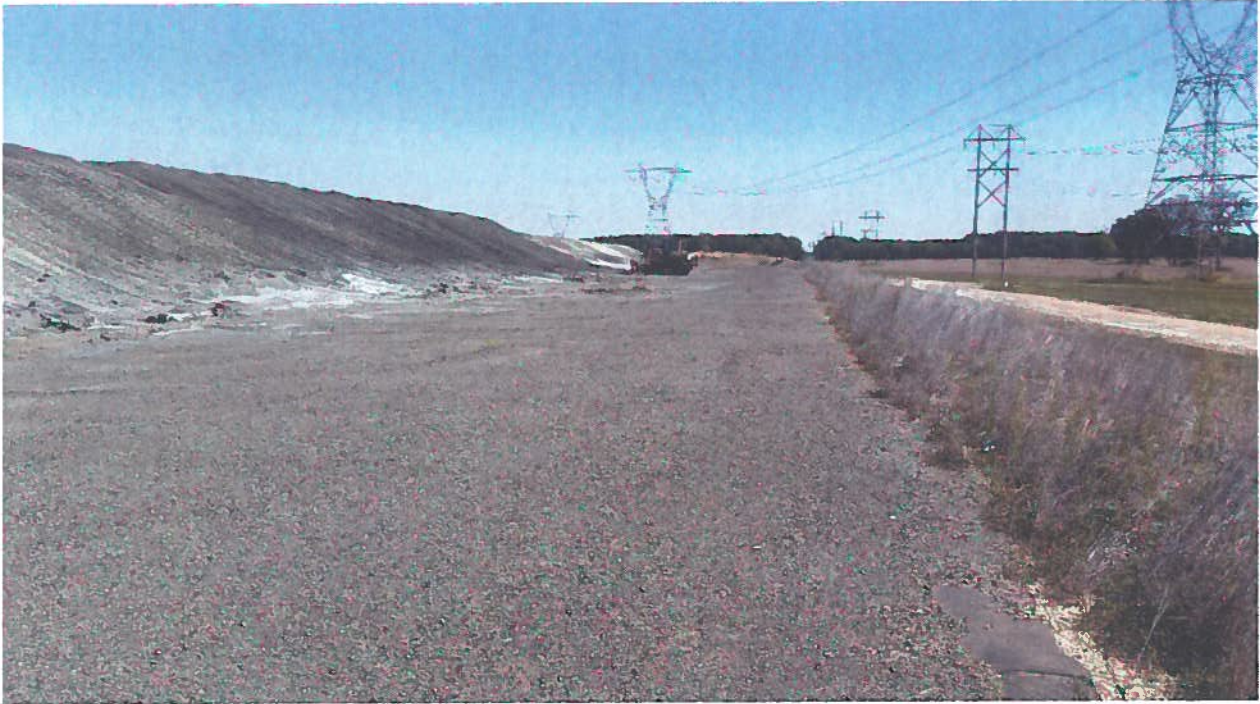
Picture 016 shows the ash slope and berm on the south side of the Cell 3 fill.

- Clean out the accumulated ash between the toes of the ash fill and the cell berms. Reclaim capacity in the swales and make sure to establish proper flow lines. Also, and most importantly, be diligent to not damage any components of the liner system or the leachate collection system during maintenance activities. (Picture 016 below)

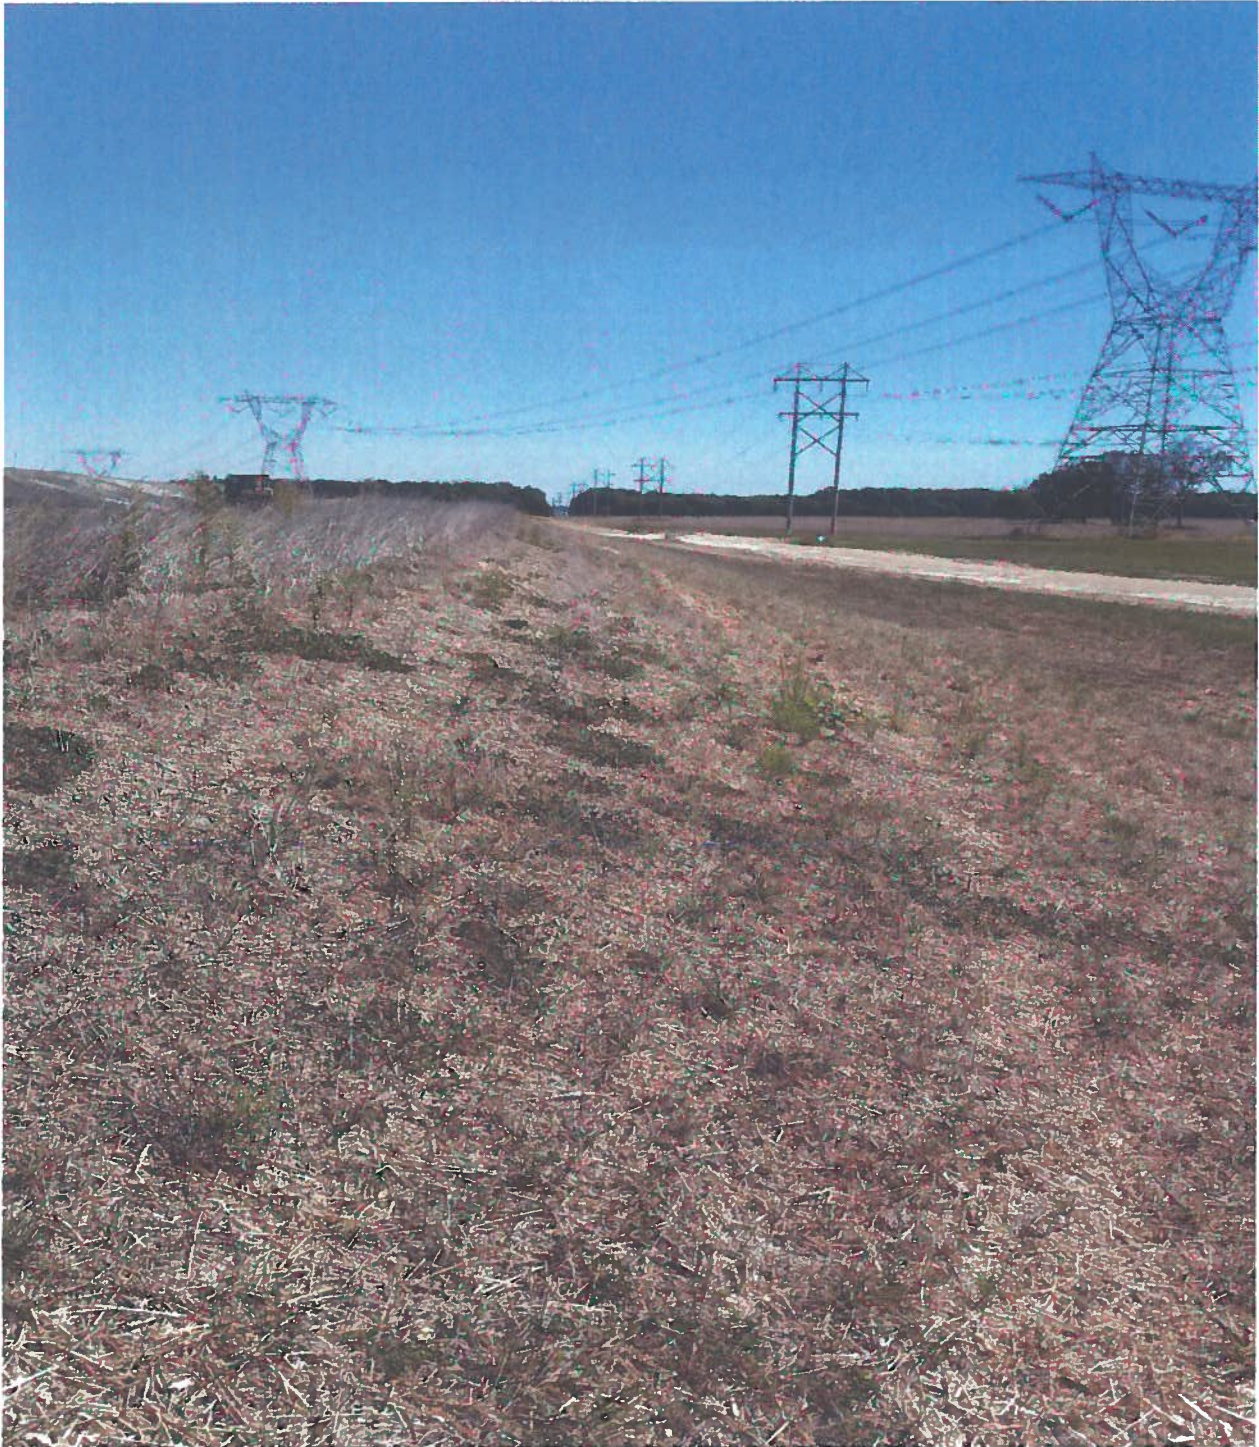
Picture 017 shows permanent outer slope condition on the south side of Cell 3.

- Regularly inspect and monitor the areas of poor vegetation that have been reseeded to insure that this is enough to promote better plant growth. If not, other measures, like adding fertilizer or taking soil tests, may need to be implemented to achieve the proper cover. If cover conditions do not improve, grading operations will have to be performed to repair erosion on the slopes. (Picture 017 below)
