**2015 DAM & DIKE INSPECTION REPORT  
Rockport Plant  
Bottom Ash Pond Complex**

**GERS-15-013**

**ROCKPORT POWER PLANT**

**August 13, 2015**

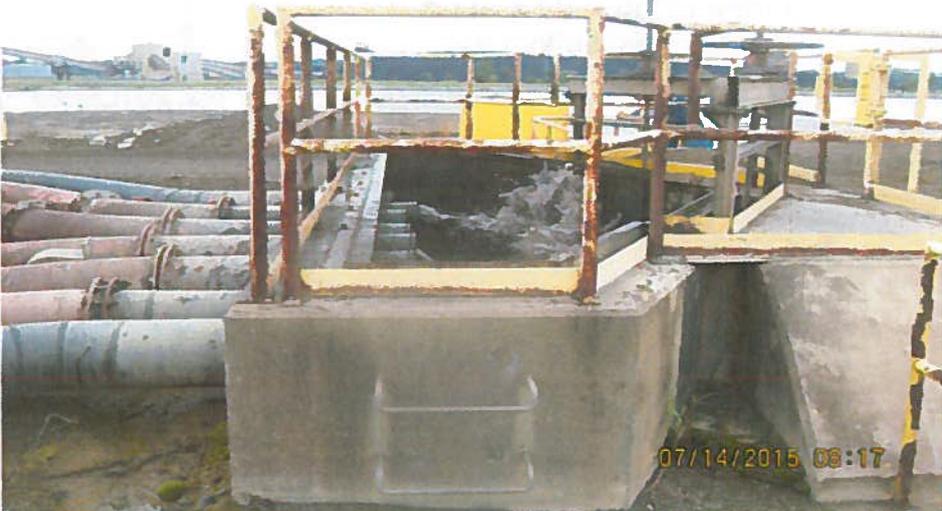
1. The diverter structure controlling the flow of bottom ash into the pond complex was observed to be functioning properly and in good condition (Photograph No. 1).

<p><u>Photo # 1</u></p> <p>View of bottom ash being discharged into diverter structure.</p>

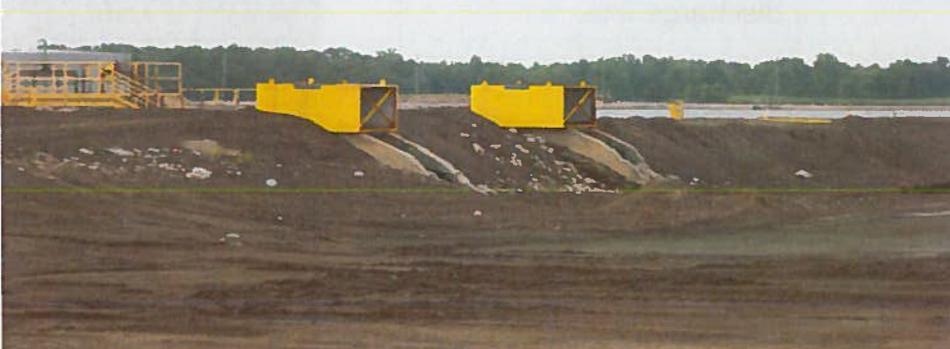
2. The west bottom ash pond discharge structures into the pond show significant deterioration of the wing walls. No undermining of the structure or erosion of adjacent embankments was observed (Photograph No. 2).

<p><u>Photo # 2</u></p> <p>Typical view of interior embankment showing good condition of embankment slopes and discharge chutes into the pond. The west bottom ash pond was out of service that allowed a good inspection of the pond's structures.</p>

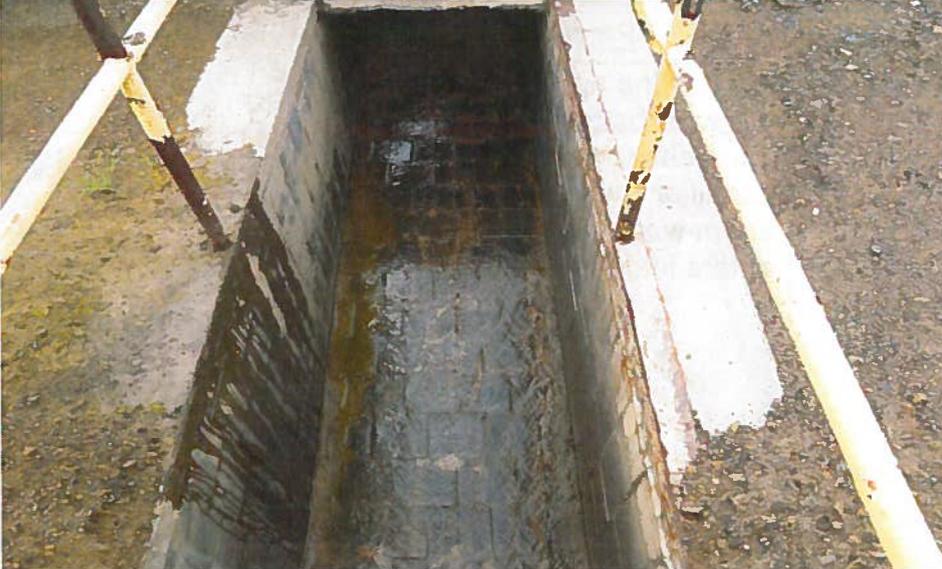
3. The channel between the diverter valve / energy dissipater and the discharge chute appeared to be in good condition (Photograph No.3).
4. The crest and interior slopes of the west bottom ash pond dike were observed to be in good condition with no evidence of significant settlement, misalignment or erosion. Typical conditions of the crest and interior slopes are shown in Photograph Nos. 4 and 5.

<p><u>Photo # 3</u></p> <p>View of discharge chute between the dissipater and the discharge structure into the bottom ash pond showing good conditions.</p>

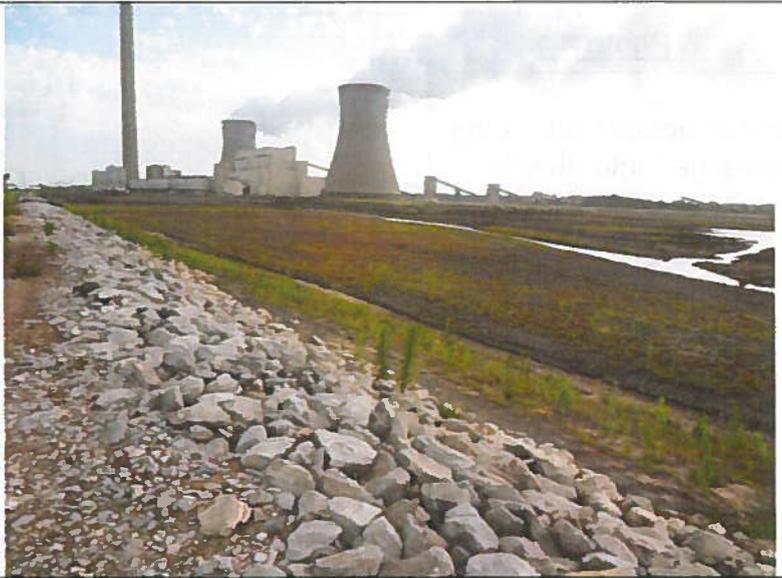
Photo # 4

View of the interior slope for the west bottom ash pond.

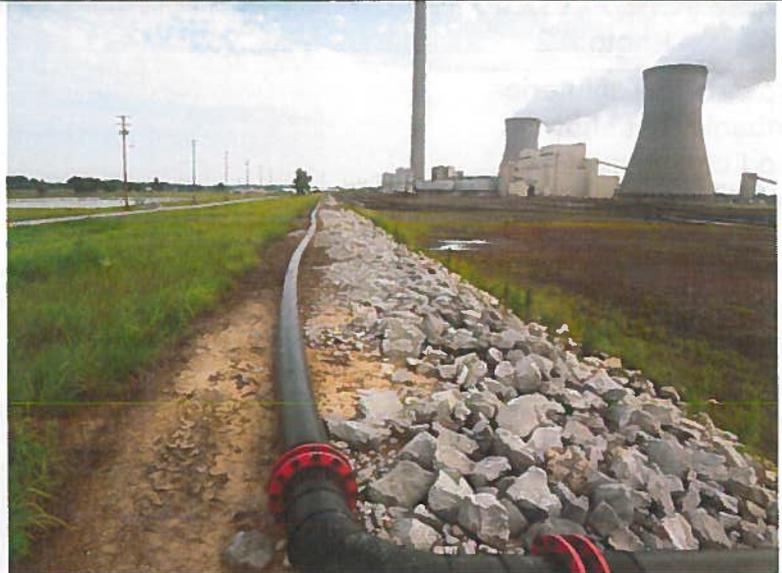
Photo # 5

Typical view of west bottom ash pond showing the crest and the southwest storm water discharge line.

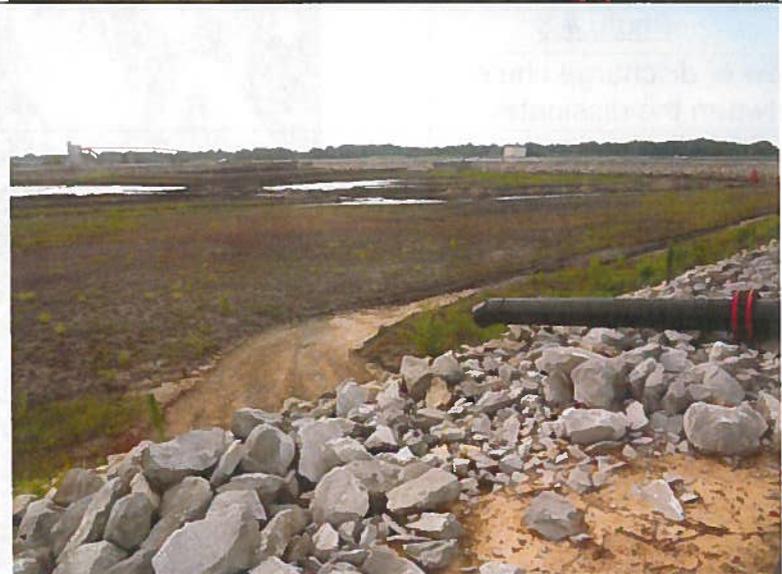
Photo # 6

5. The southwest pond's storm water discharge pipe into the bottom ash pond shows good conditions with no erosion of the embankment or scouring of the bottom of the pond (Photograph No. 6).

View of the rip rap along the west bottom ash pond showing good conditions where the storm water discharge enters the pond.

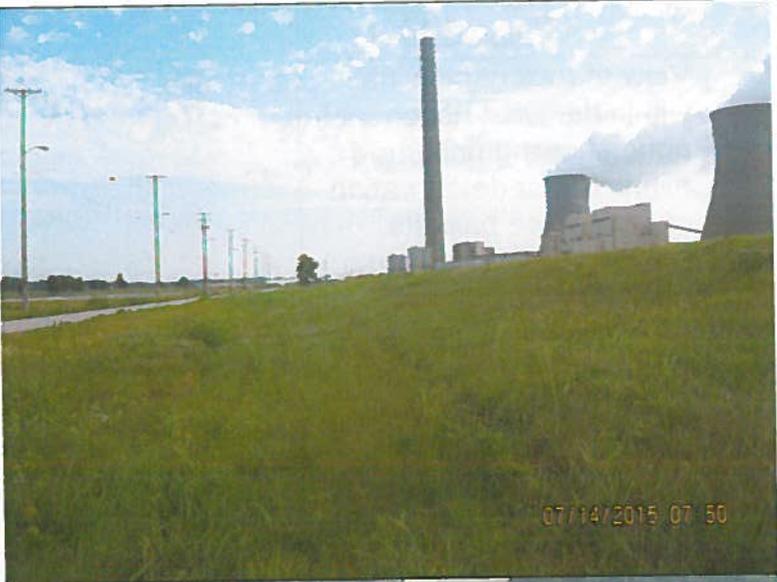
6. The exterior dike for the west bottom ash pond appeared to be in good and stable condition with vegetative growth established and controlled (Photograph No. 7).

<p><u>Photo # 7</u></p> <p>Typical view of the exterior slope for the west bottom ash pond. No bulges, slumping or other defects were observed. Vegetative growth was established and regularly controlled with periodic mowing.</p>

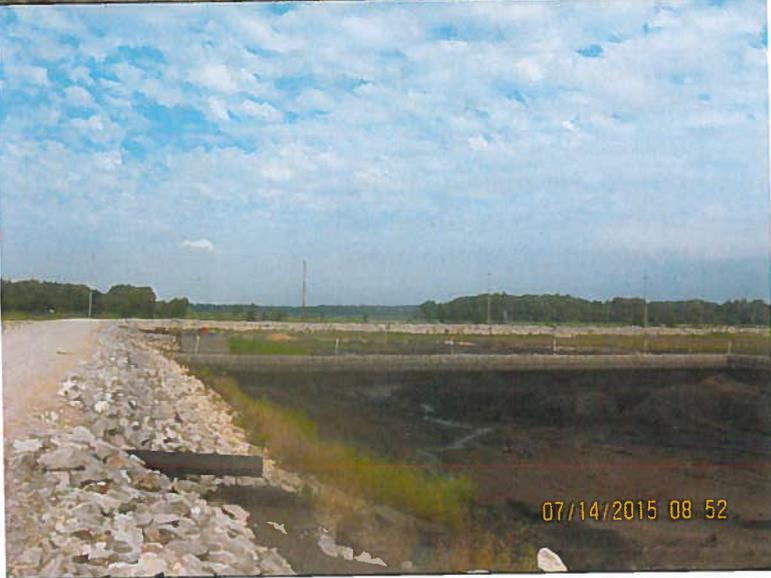
<p><u>Photo # 9</u></p> <p>Typical view of the storm water discharge pipe from the coal yard collection ponds and the rock gabion wall used to contain the entrained coal fines. No scouring, slumping or bulging along the embankment was observed.</p>

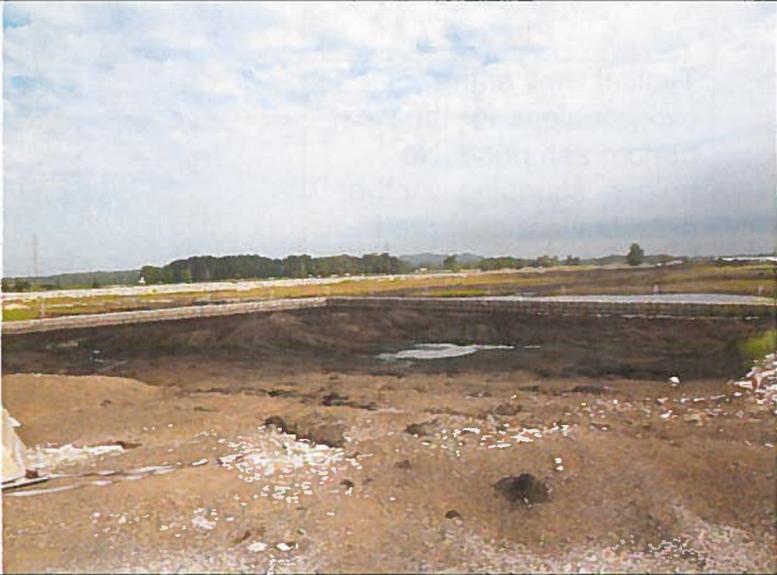
9. The discharge of coal fines (entrained within the coal yard storm water collection basins) is now contained to the southeast corner of the west bottom ash pond thru the construction of the gabion basket wall (Photograph No. 10).

<p><u>Photo # 10</u></p> <p>View of rock gabion wall within the west bottom ash pond showing uniform alignment or deterioration of the gabion baskets.</p>

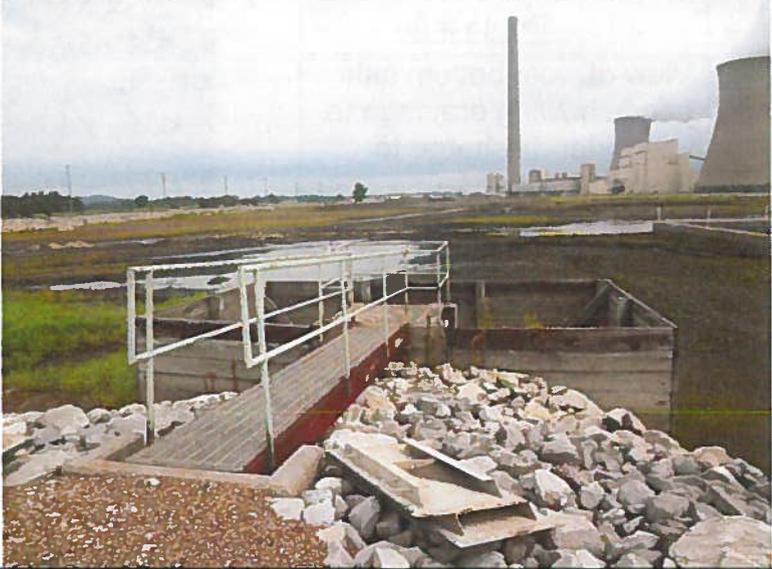
<p><u>Photo # 11</u></p> <p>View of skimmer Structure No 5 for the west bottom ash pond.</p>

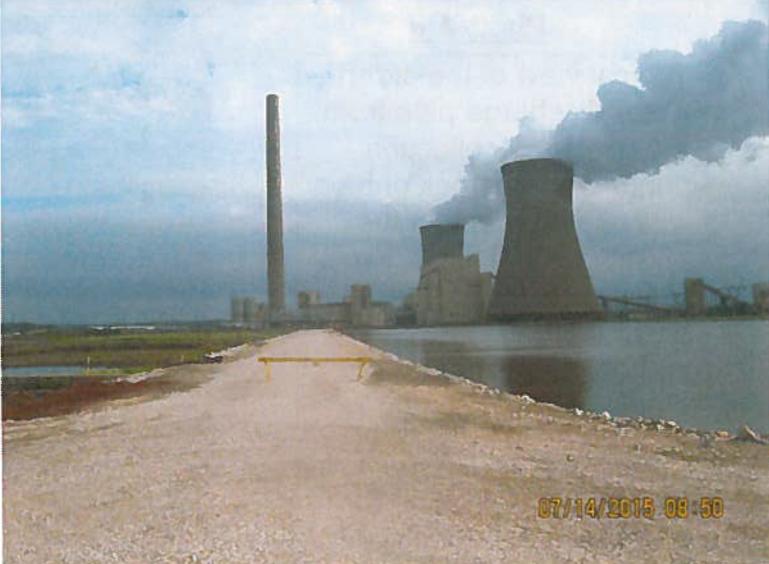
<p><u>Photo # 12</u></p> <p>Typical view of the splitter dike between the west and east bottom ash ponds. No misalignment, of the dike was observed or rutting along the crest.</p>

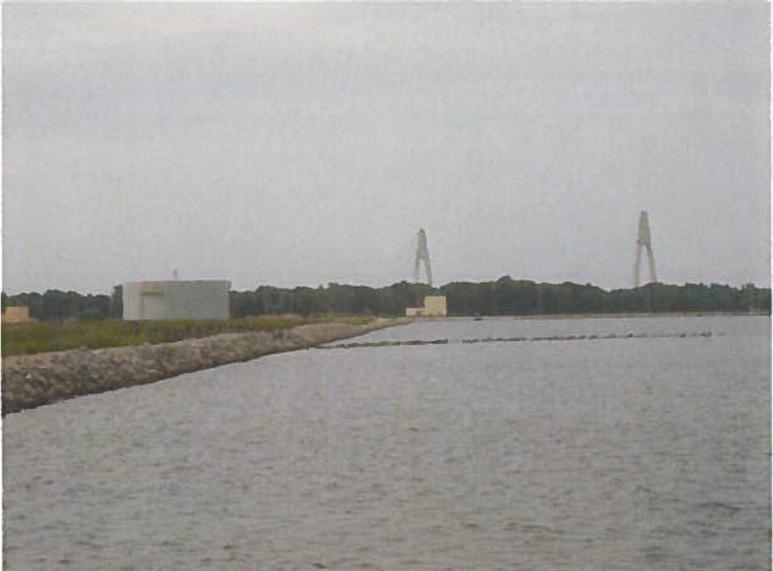
12. The east bottom ash pond was operational and appeared to be in good condition. No visible embankment erosion, sloughing or other indications of instability were observed. Geese were entering into the pond (Photograph No. 13).

<p><u>Photo # 13</u></p> <p>Typical view showing good condition of the east bottom ash pond embankments (and geese entering into the pond).</p>

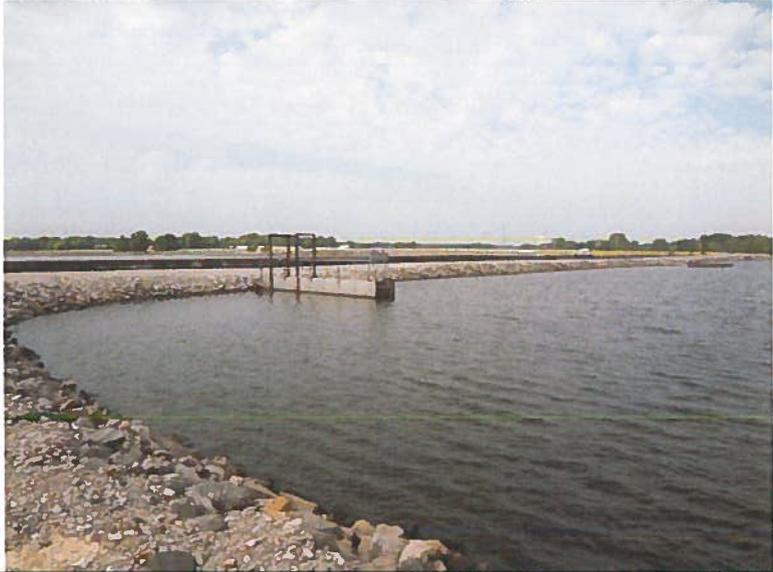
13. The east bottom ash pond low water discharge structure # 3 appeared to be in good condition and the skimmer structure # 5 appeared to be fully functional (Photograph No. 14).

A wide-angle photograph of a large, calm body of water, likely an ash pond. The water is a greyish-brown color. In the background, there are two tall, thin structures, possibly cranes or towers, and a line of trees. The sky is overcast.
<p><u>Photo # 14</u></p> <p>Typical view showing the low water discharge structure No 3 in the east bottom ash pond.</p>

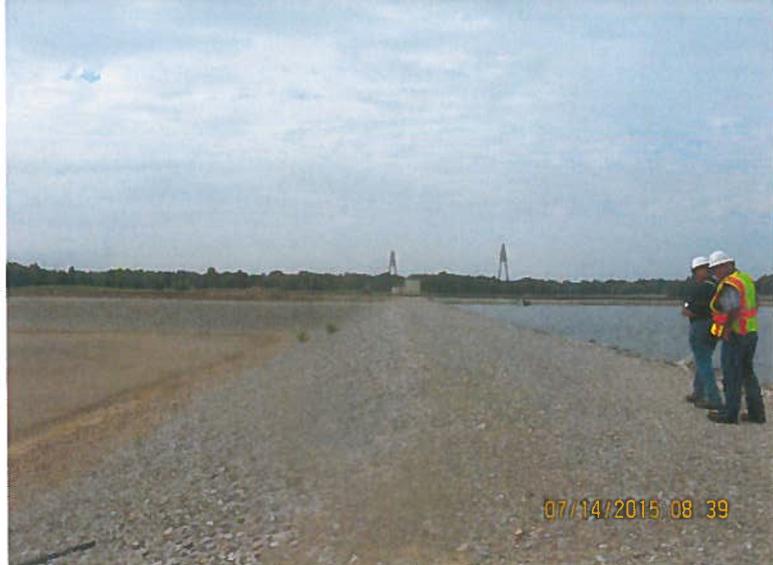
14. The splitter dike between the east bottom ash pond and the metal cleaning waste tank basin appeared to be in good condition. No seepage through the embankment was observed, nor any erosion, slumping or misalignment of the dike (Photograph No. 15).

A photograph showing a low water discharge structure, a concrete wall with a gate, extending into the water. The water is dark and calm. The sky is blue with scattered white clouds. The foreground shows a rocky embankment.
<p><u>Photo # 15</u></p> <p>Typical view of splitter dike between the east bottom ash pond and the metal cleaning waste tank basin. Mr. Massey-Norton and Mr. Ingram are standing along the road.</p>
