2016 Annual Dam and Dike Inspection Report

Fly Ash Pond

**John E. Amos Plant
Appalachian Power Co.
Putnam County, West Virginia**

Document Number: GERS-16-148

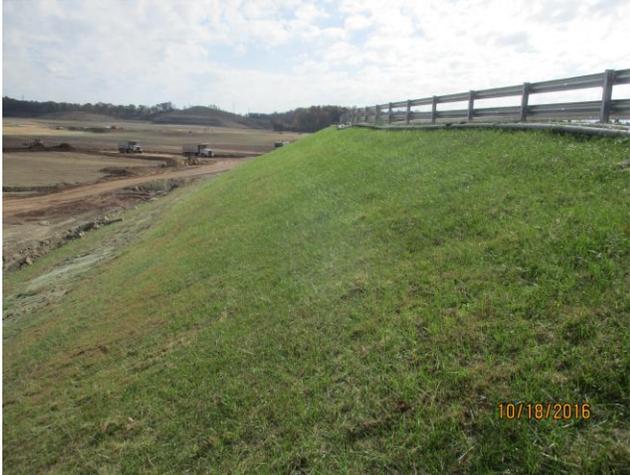
1. There were no visual signs of settlement, misalignment, erosion, or bulging on the crest or the upstream slope that was above the pool level. No animal burrows were noted on the upstream slope. The upstream slope was well vegetated and is controlled by timely mowing. (Photo 1). The guard rail was installed in January/February 2014 and was also observed to be in excellent condition.

Photo 1 Typical upstream face showing good vegetative cover. Capping and closure activities are seen in the background.

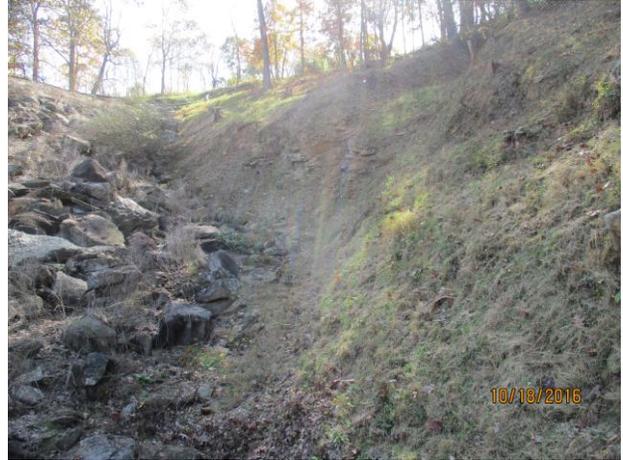
Photo 2 – Typical view of the left groin showing good conditions.

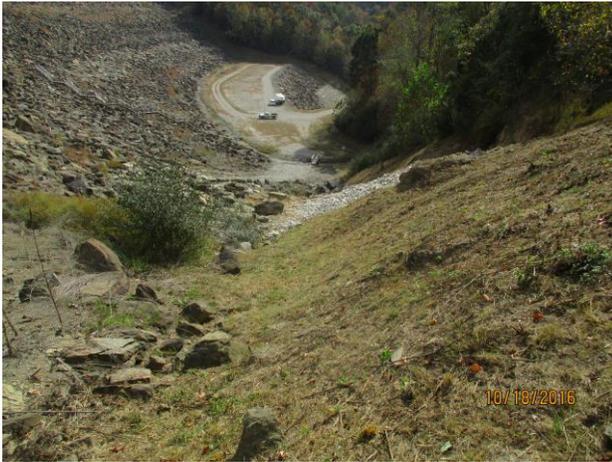
2. No erosion was observed along the upstream left and right groin ditches or the abutments above 716 feet bench (Photos 3 and 4). Both of the abutments within 25 ft from the center of any of the groin ditches have been cleared of shrubs and small trees.

Photo 3 – Typical view of the right groin showing good conditions.

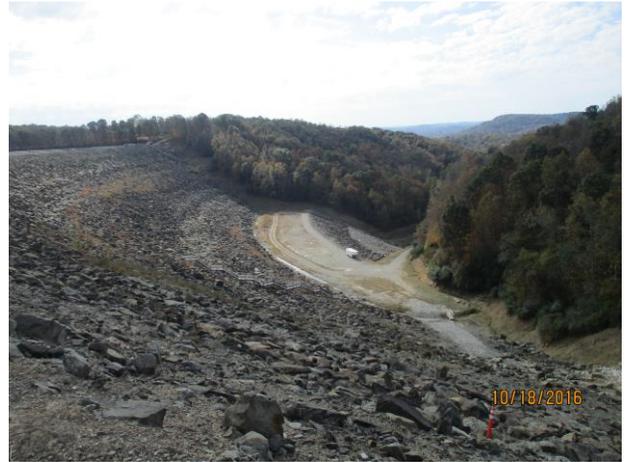
Photo 4 – Typical view of the downstream slope looking towards the left groin showing good conditions.

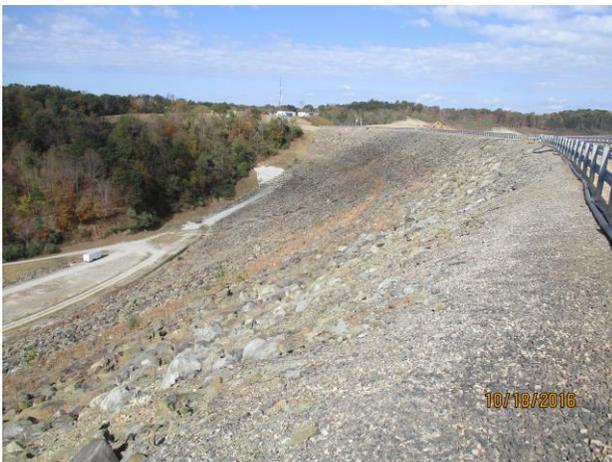
3. The entire face of the downstream slope was well protected from erosion with large-boulder size sandstone and shale riprap and was generally in fair to good conditions (Photos 5, 6 and 7). There were no noticeable signs of movement or slides in the oversize riprap. Most of the vegetation on the downstream slope had been controlled by the application of a herbicide.

Photo 5 – Typical view of the downstream slope looking towards the right groin showing good conditions.

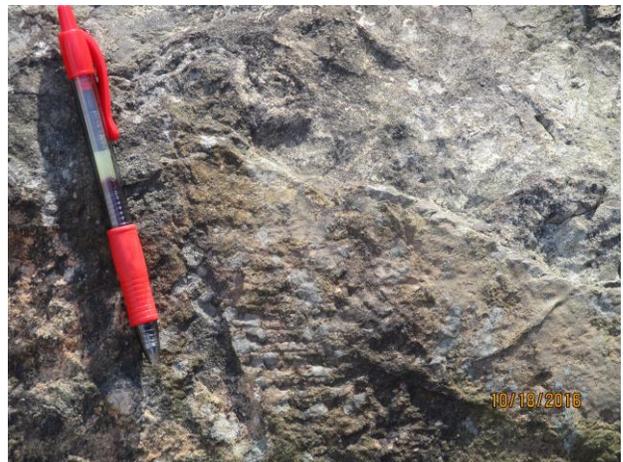
Photo 6 – Typical view of rip rap showing excellent condition (i.e. very little weathering) as noted by the presence of the fern fossil.

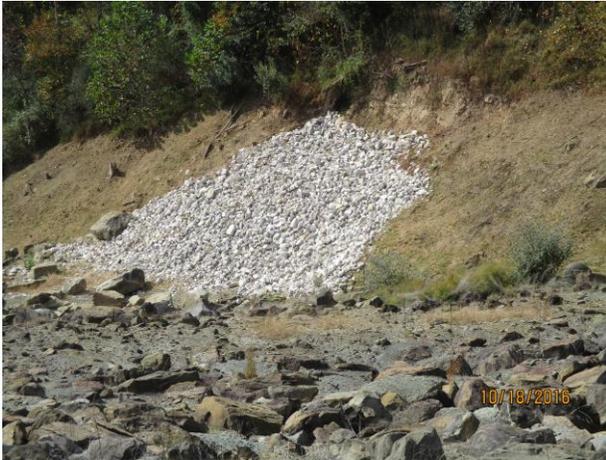
4. The seepage areas near the right groin ditch were still present. The seeps are believed to be originated from the abutment bedrock based on the 2007 geotechnical investigations that revealed a permeable layer of sandstone at about the same elevation. The surficial slip within this seepage area has been

repaired and stabilized (Photo 7). Another seep at a higher elevation was noted and the seepage water was observed to be clear (i.e. no suspended sediment) (Photo 8) with an estimated discharge of 0.5 gpm.

Photo 7 – Typical view of the repairs to the seep along the right groin ditch performed this year showing excellent conditions.

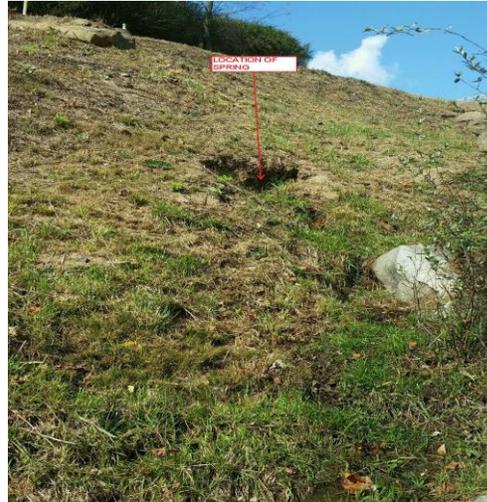
Photo 8 – Typical view of spring seepage at Elevation 794 ft with minor slumping along the right groin above the repaired area.

The seepage along the right groin and located above the repaired slip area should continue to be monitored on a periodic basis to ensure that groin ditch remains free draining.

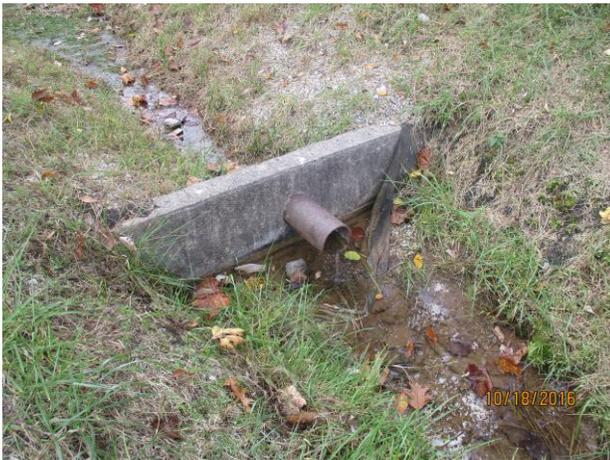
7. The right and left weirs were free flowing and clear. The discharged was estimated to be 3 to 5 gpm for the left weir and 4 to 6 gpm for the right weir (Photos 9 and 10).

Photo 9- Typical view of the left weir showing a visually clear discharge of 3 to 5 gpm.

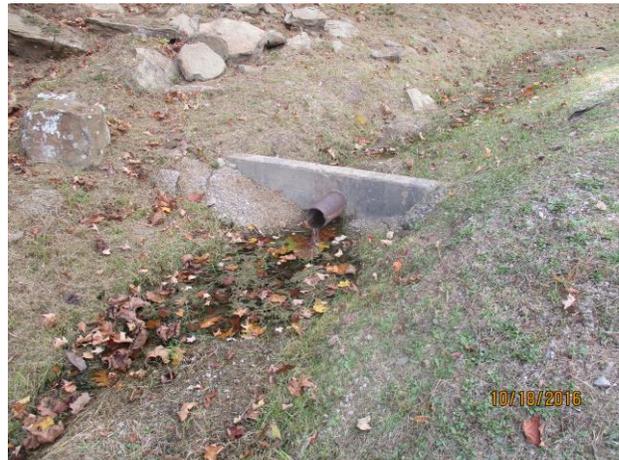
Photo 10- Typical view of the right weir showing a visually clear discharge of 4 to 6 gpm.
