**2016 DAM & DIKE INSPECTION  
REPORT  
RECLAIM POND  
ASH POND 1A & 1B  
POND 2**

**CLINCH RIVER PLANT  
CARBO, VA**

**INSPECTION DATE** October 19 & 20, 2016

**QA/QC DOCUMENT NO.**  
GERS-16-157

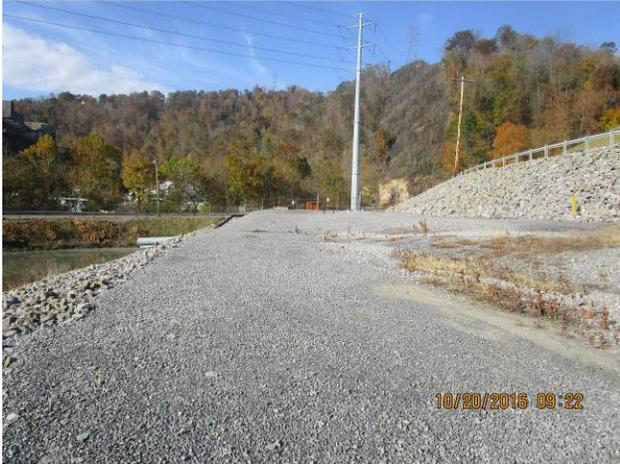
1. The north slope of the pond is in good condition. The riprap and gravel surface appeared stable. (Photo 1)
2. An erosion gully which has been observed during the past several annual inspections has been repaired. (Photo 1)
3. The V-notch weir boxes referenced as Nos. 3, 5 and 5A were in good condition. Flow was discharging from all three weirs, see table on page 6 for flow rates. Since the plant has stopped sluicing to the pond and the pool level has dropped the flow rates at each weir box have declined from normal levels. All flows were clear. The vegetation around the weir boxes was mowed and did not restrict flow. (Photos 2-4)

Picture 1 – Reclaim Pond, gravel surface at crest

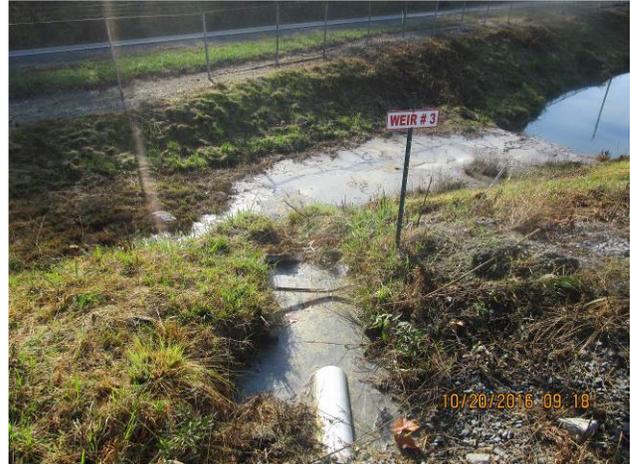
Picture 2 – Reclaim Pond, Weir box #3

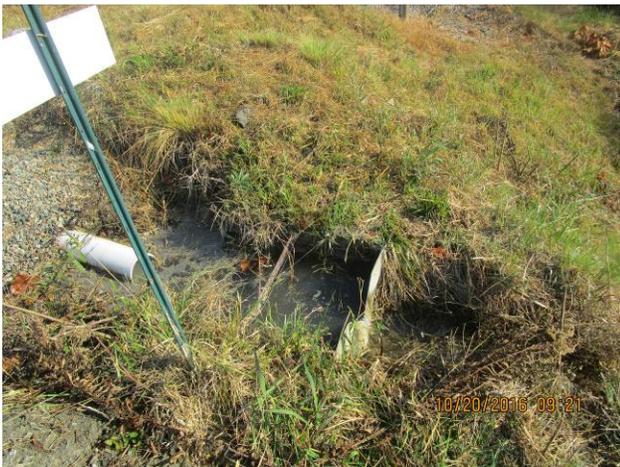
Picture 3 – Reclaim Pond, Weir Box #5

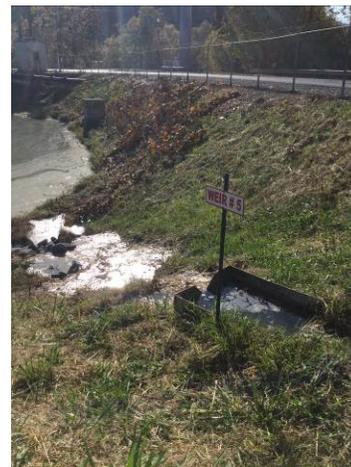
Picture 4 – Reclaim Pond, Weir Box #5A

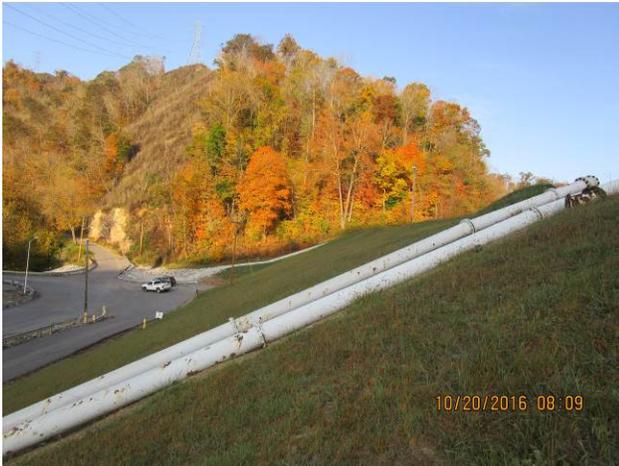
1. The exterior slope of the west 1A dike was well vegetated and the cover was recently mowed. In general the slope is in good condition. (Photo 5) The groin ditch at the west abutment was in good condition and recently mowed. The area around the concrete channel, culvert and energy dissipater has good vegetation. The vegetation on the abutment section was clear of woody vegetation within 25 feet of the groin (as per the VA Dam Safety requirements). The abutment was stable and no seepage was observed. An underdrain that collects water under the surface of the diversion channel and outlets into the concrete channel was discharging. (Photo 6)

Picture 5 – Pond 1A, outboard slope of west dike

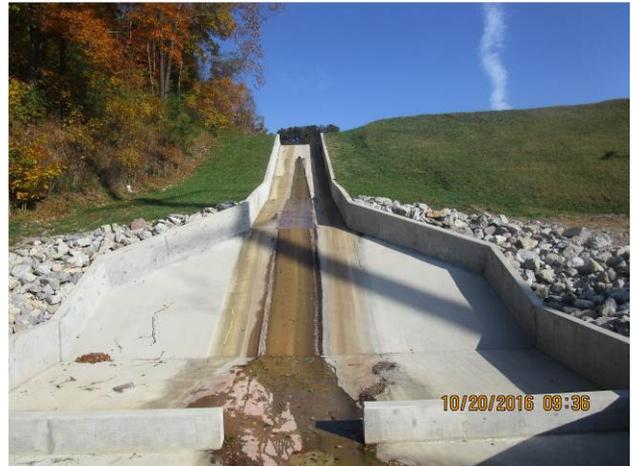
Picture 6 – Pond 1A, abutment and concrete discharge channel

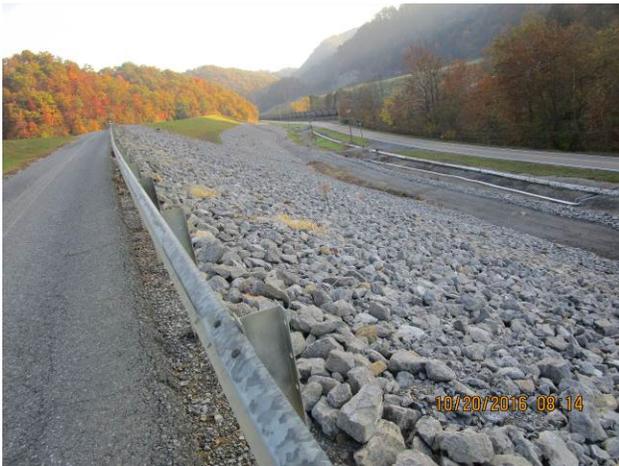
2. The exterior slope of the south 1A dike below the access road is covered with riprap which is part of the seepage control project implemented in 2006. The surface of the riprap did not show any signs of instability or other slope movement. The overall slope surface is in good condition. (Photo 7-8)

Picture 7 – Pond 1A, outboard slope of south dike

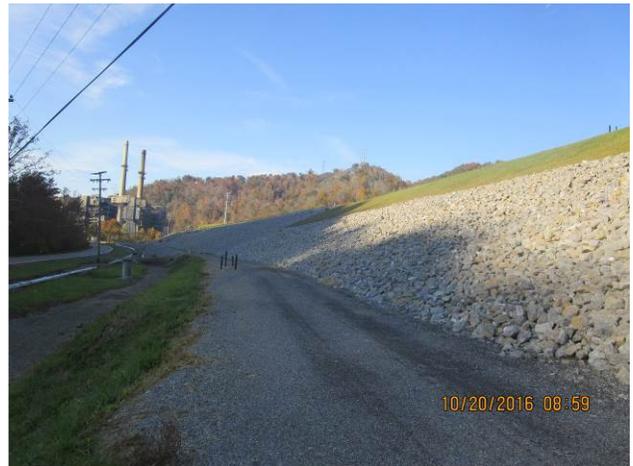
Picture 8 – Pond 1A and 1B, outboard slope of south dike

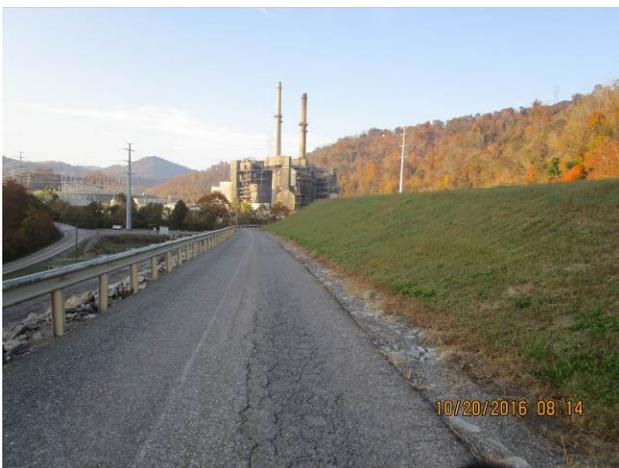
3. The exterior slope of the south 1A dike above the access road was also well vegetated and recently mowed. There were no signs of sloughing, bulging or settlement on the upper section of the slope. The general condition of the upper section was satisfactory. The access road was in good condition. The pavement has minor surface cracking but did not show signs of movement. (Photo 9)

Picture 9 – Pond 1A, access road and outboard slope of south dike above access road

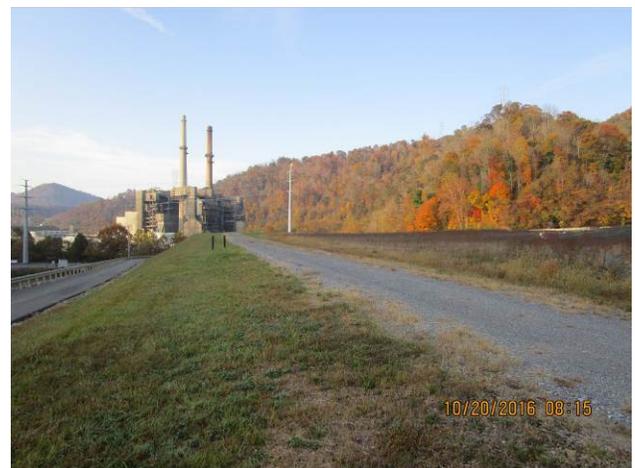
4. The crest of the south 1A dike showed no signs of settlement or movement. There were no ruts observed. (Photo 10)
5. The 18” stormwater diversion pipe located on the face of the dike was in good condition. There did not appear to be any leaking or soil erosion around the pipe. The pipe appeared to be functioning properly. (Photo 11)

Picture 10 – Pond 1A, crest of dike

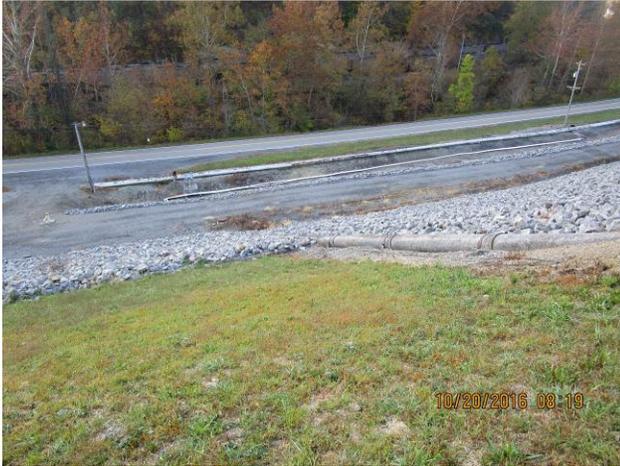
Picture 11 – Pond 1A, 18” stormwater diversion pipe along outboard slope of south dike

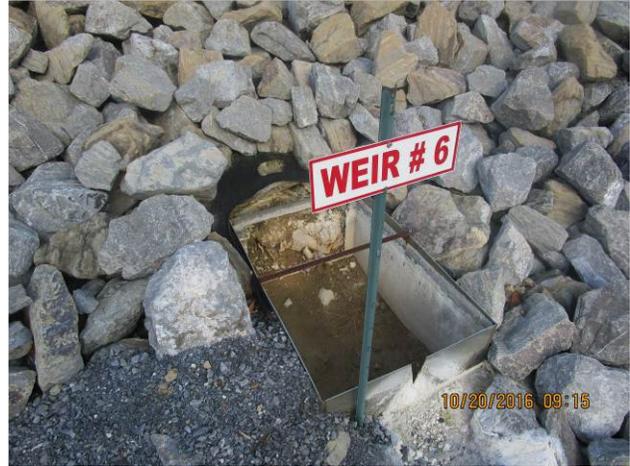
10. Weir #6, located on the South 1A dike, was completely dry and has appeared to not be flowing for some time. (Photo 12)

Picture 12 – Pond 1A, Weir Box #6

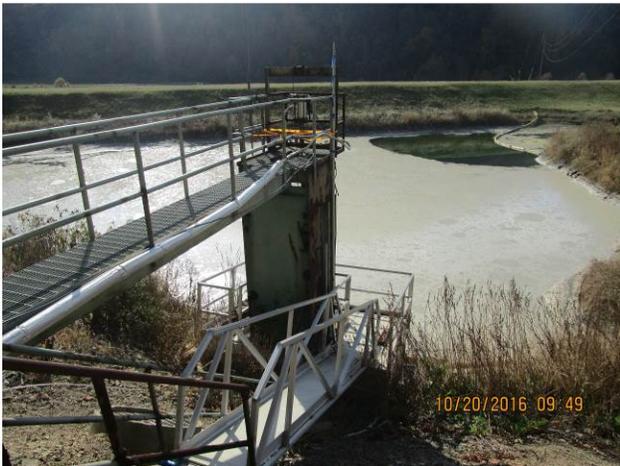
1. The outlet structure and outlet pipe were completely grouted closed and abandoned. The existing outlet structure is in fair condition however it is no longer being used. The grouted discharge pipe was inspected and no signs of leakage were observed. There was no evidence of structural weakness or seepage along the length the pipe. (Photo 13)

Picture 13 – Pond 1B, abandoned principal outlet structure

In spring of 2016 the principal outlet pipe located in Pond 1B was grouted closed as a result of a routine camera inspection which discovered increased infiltration into the pipe at the several joints. Concrete grout was pumped into the portion of the pipe that runs through the dike and up the drainage shaft. As a result, a temporary pump has been placed in the pond to convey any storm water the pond may collect. In order to pass a large storm event a temporary spillway was cut into the crest of the dam. The pump system and spillway will be removed when the pond is closed which is scheduled to begin in 2017.

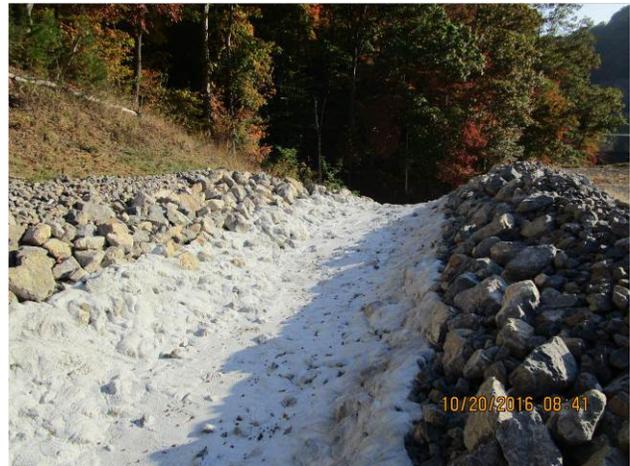
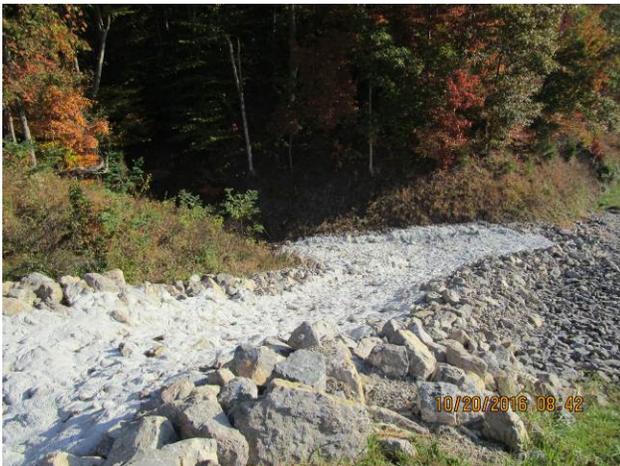
2. A temporary spillway was recently constructed by using riprap and concrete in the northeast portion of Pond 1B. The spillway was in good condition. (Photo 14-15)

Picture 14 – Pond 1B, temporary emergency spillway

Picture 15 – Pond 1B, temporary emergency spillway

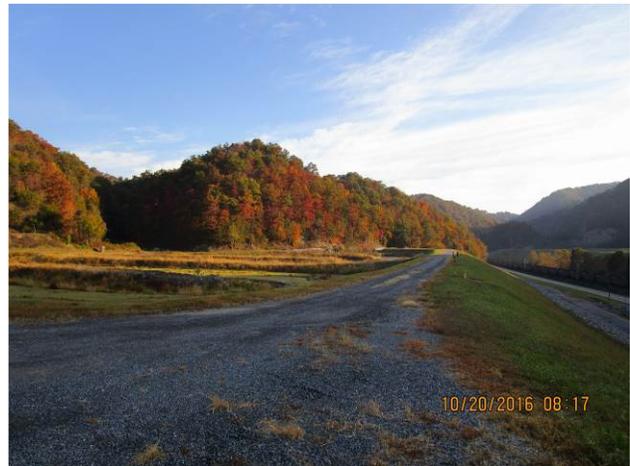
3. The south dike crest was in good condition with no evidence of settlement or misalignment. The dike road was in good condition and did not contain any ruts or standing water. (Photo 16)

Picture 16 – Pond 1B, crest of dike

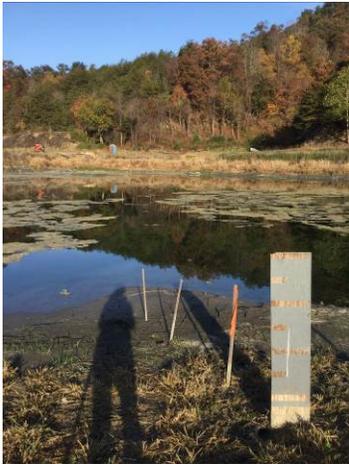
4. A temporary staff gauge was present at the time of the inspection. The pool level was read to be approximately 553. (Photo 17)
5. The exterior grassed slopes of Pond 1B dike are well vegetated and were recently mowed. Overall the outboard slope of the dike was in good condition with no signs of misalignment.

Picture 17 – Pond 1B, staff gauge

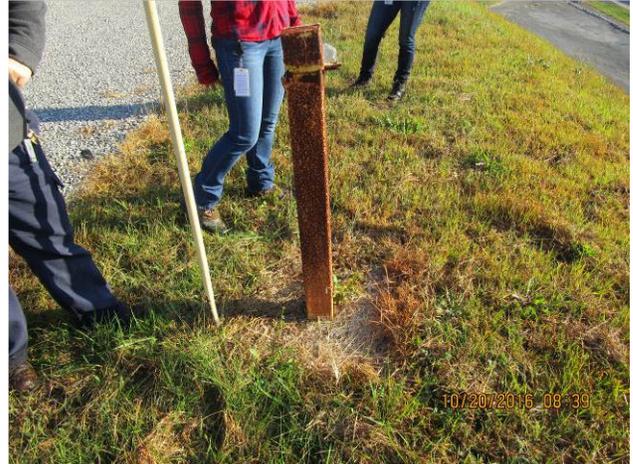
6. A protective casing of one of the monitoring wells along the crest of Pond 1B was rusty and very corroded. This was noted on the 2015 inspection; however this well is scheduled to be removed when closure work begins on the pond. (Photo 18)

Picture 18 – Pond 1B, Corroded protective casing of monitoring well

3. Repair rodent hole along the inboard slope.
4. Inspect all monitoring well casings and replace any casings that are rusted through or are not properly protecting the well.

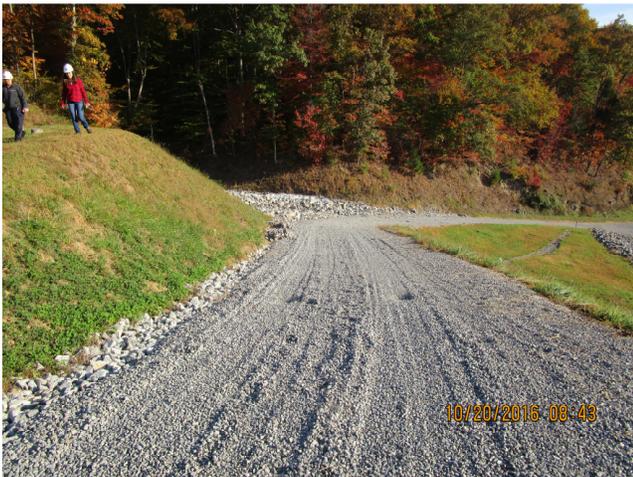
7. The gravel access road near the left abutment appears in good condition. Previous inspections have noted a history of erosion gullies along this portion of road, but presently do not have any signs of erosion. (Photo 19)

Picture 19 – Pond 1B, Gravel Access road

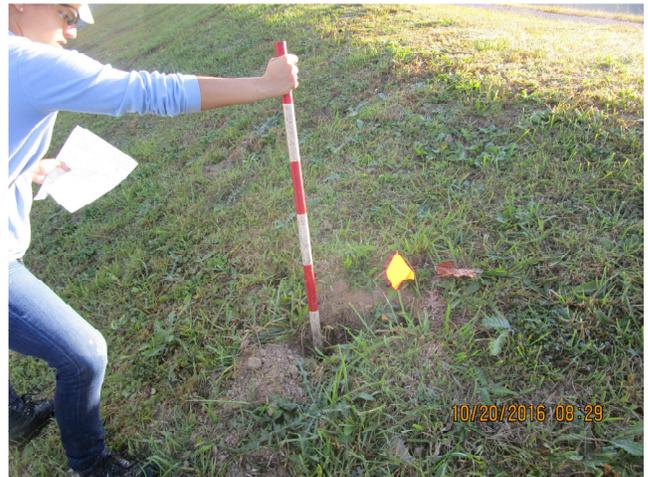
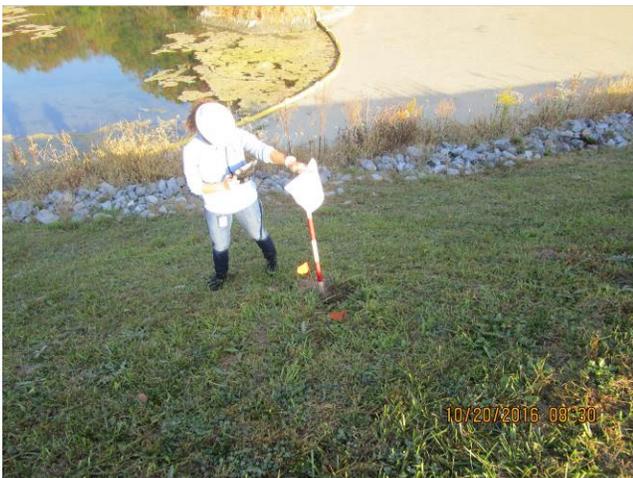
8. The inboard slopes of Pond 1B dikes were well vegetated and recently mowed. The slopes appeared stable and are in good condition. A rodent hole was observed on the inboard slope of Pond 1B approximately half way up the embankment. (Photo 20 & 21)

Picture 20 – Pond 1B, Rodent hole located on inboard slope

Picture 21 – Pond 1B, Rodent hole located on inboard slope

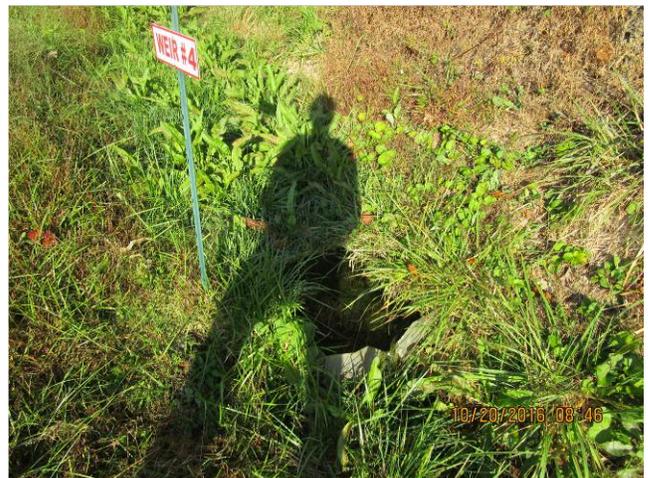
9. The left abutment (east side) groin /diversion/seepage ditch was flowing and measured with Weir #4. (Photo 22) There were no signs of erosion. The ditch is in good condition. The abutment area within 25 feet of the groin has been cleared of woody vegetation and was recently mowed.

Picture 22 – Pond 1B, Weir Box #4

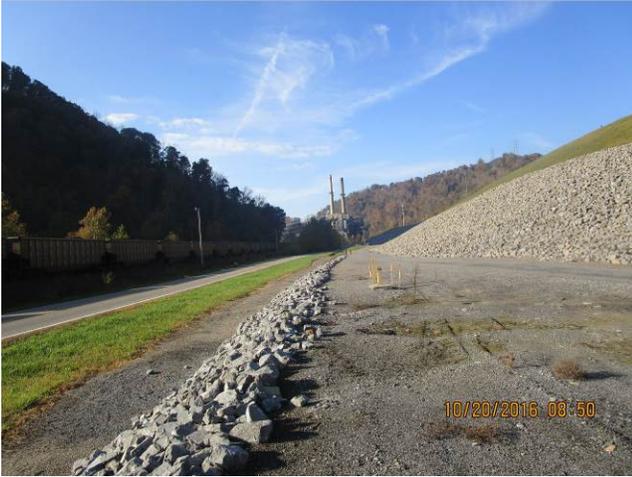
10. The access road and toe drain along the south dike appeared in stable condition. There were no signs of instability, rutting, or erosion. (Photo 23)

Picture 23– Pond 1B, access road along toe

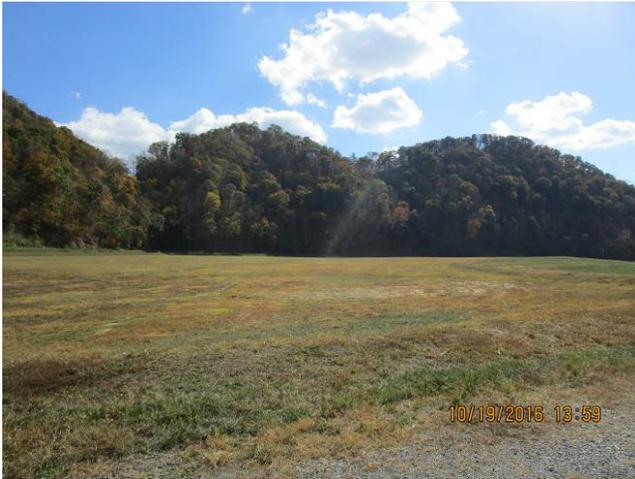
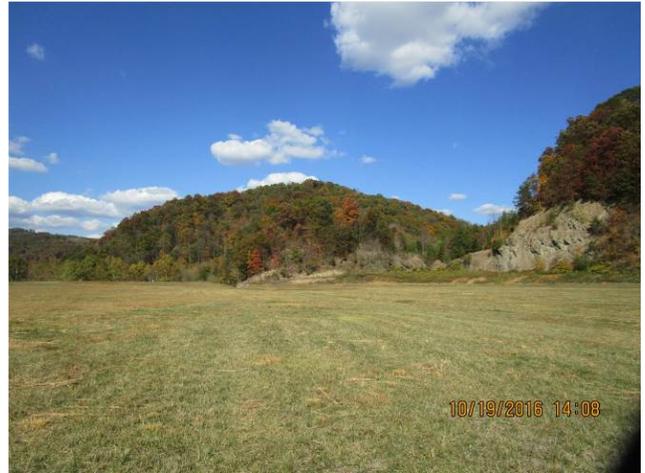
1. As noted in the Introduction Section, Pond 2 was capped and closed with work being completed in January 2014. A certification report was submitted to VDCR following the completion of this work. Overall the cap was well vegetated and has been recently mowed. There were no signs of settlement or erosion. (Photo 24 & 25)

Picture 24– Pond 2, typical view of pond cap

Picture 25– Pond 2, typical view of pond cap

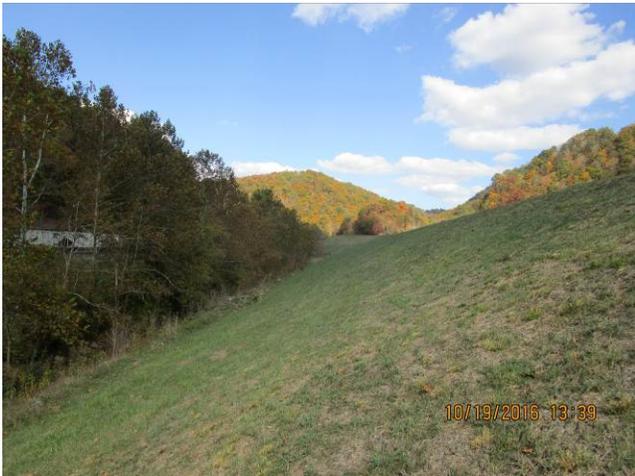
2. The exterior slopes of the lower dike system showed no signs of instability. The exterior slopes are well vegetated and were recently mowed. There was no woody vegetation noted as in previous inspections. (Photo 26)

Picture 26-Pond 2, typical view of lower dike

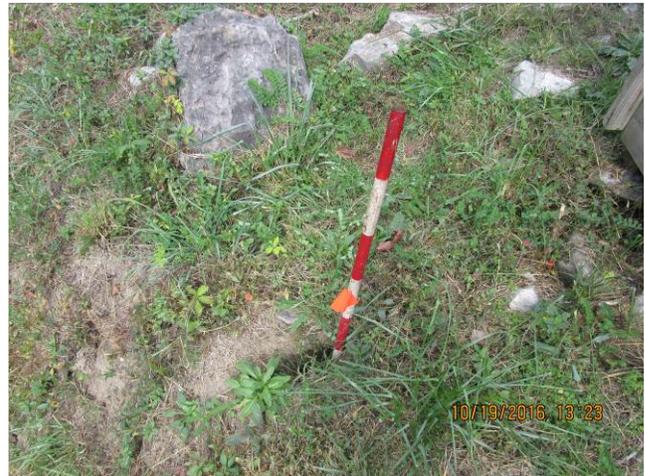
3. There were two rodent holes observed near the lower end of the second staircase. They appear abandoned and no longer active. (Photo 27)
4. The stairs leading to Dumps Creek which were constructed in 2013 are showing signs of weather deterioration. Several nails had popped up along the treads.

Picture 27 – Pond 2, Rodent hole located near lower end of middle staircase

5. Repair the rodent holes located near the toe of the lower dike.
6. The stairs leading to dumps creek should be inspected and any loose or deteriorated boards should be repaired.
7. Remove sticks and debris that has fallen in the Fabriform channel and the gabion channel.

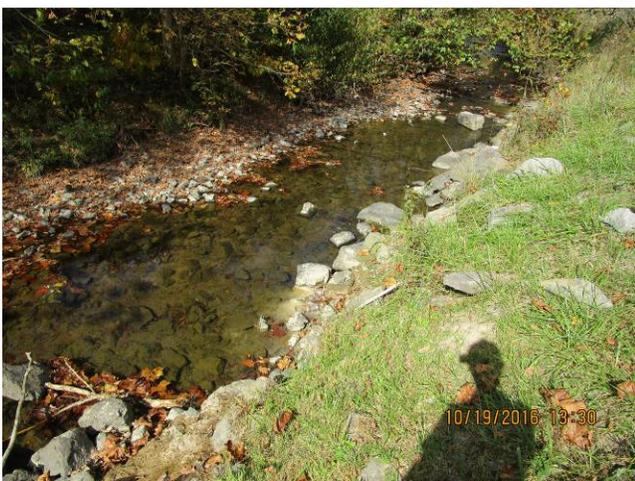
6. Seepage at the toe of the lower dike emanates at the interface with the bank of Dumps Creek. The area of seepage appeared to be only damp. The flow rate was very low and clear. (Photo 28)

Picture 28-Pond 2, view of seepage area

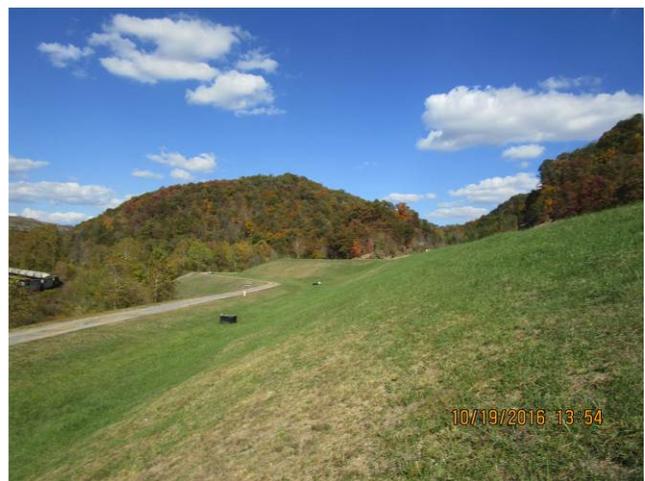
7. The slope and crest of the middle dike are in good condition. The exterior slope was well vegetated but recently mowed. There were no signs of misalignment, cracking or settlement. (Photo 29)

Picture 29-Pond 2, typical view of middle dike

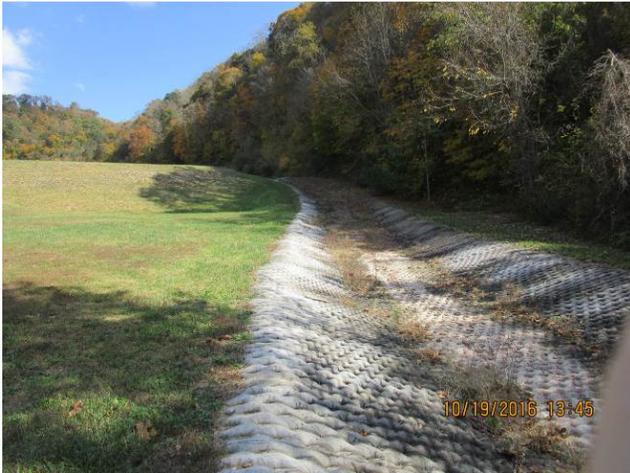
8. The Fabriform ditch constructed as part of the closure was working as designed. Minor debris was observed in channel from nearby trees. No erosion was observed on the sides of the ditch or at the outlet. (Photo 30)

Picture 30-Pond 2, Fabriform ditch

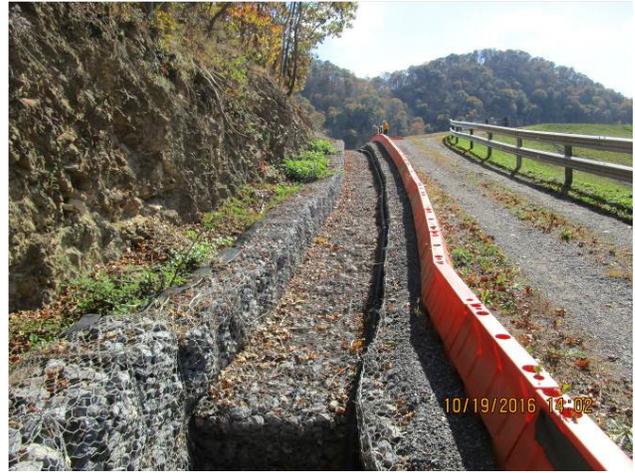
9. The east gabion discharge channel constructed as part of the closure project was working properly. The channel has some minor debris but was overall in good condition. (Photo 31)

Picture 31-Pond 2, Gabion Channel

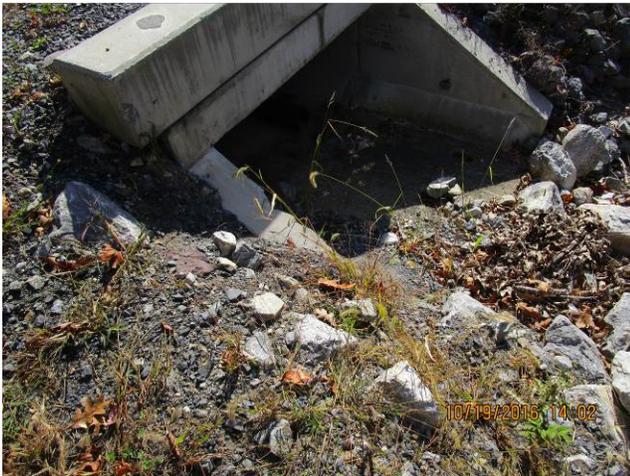
10. The outlet downstream of the east gabion discharge channel appears stable. There was no observed erosion of the riprap as observed in previous inspections. There was minor debris at the outlet of the culvert. (Photo 32)

Picture 32-Pond 2, Culvert below gabion channel
