# DAM & DIKE INSPECTION REPORT

## Primary Ash Pond Dam Flint Creek Power Plant Gentry, AR

**INSPECTION DATE** November 3, 2016

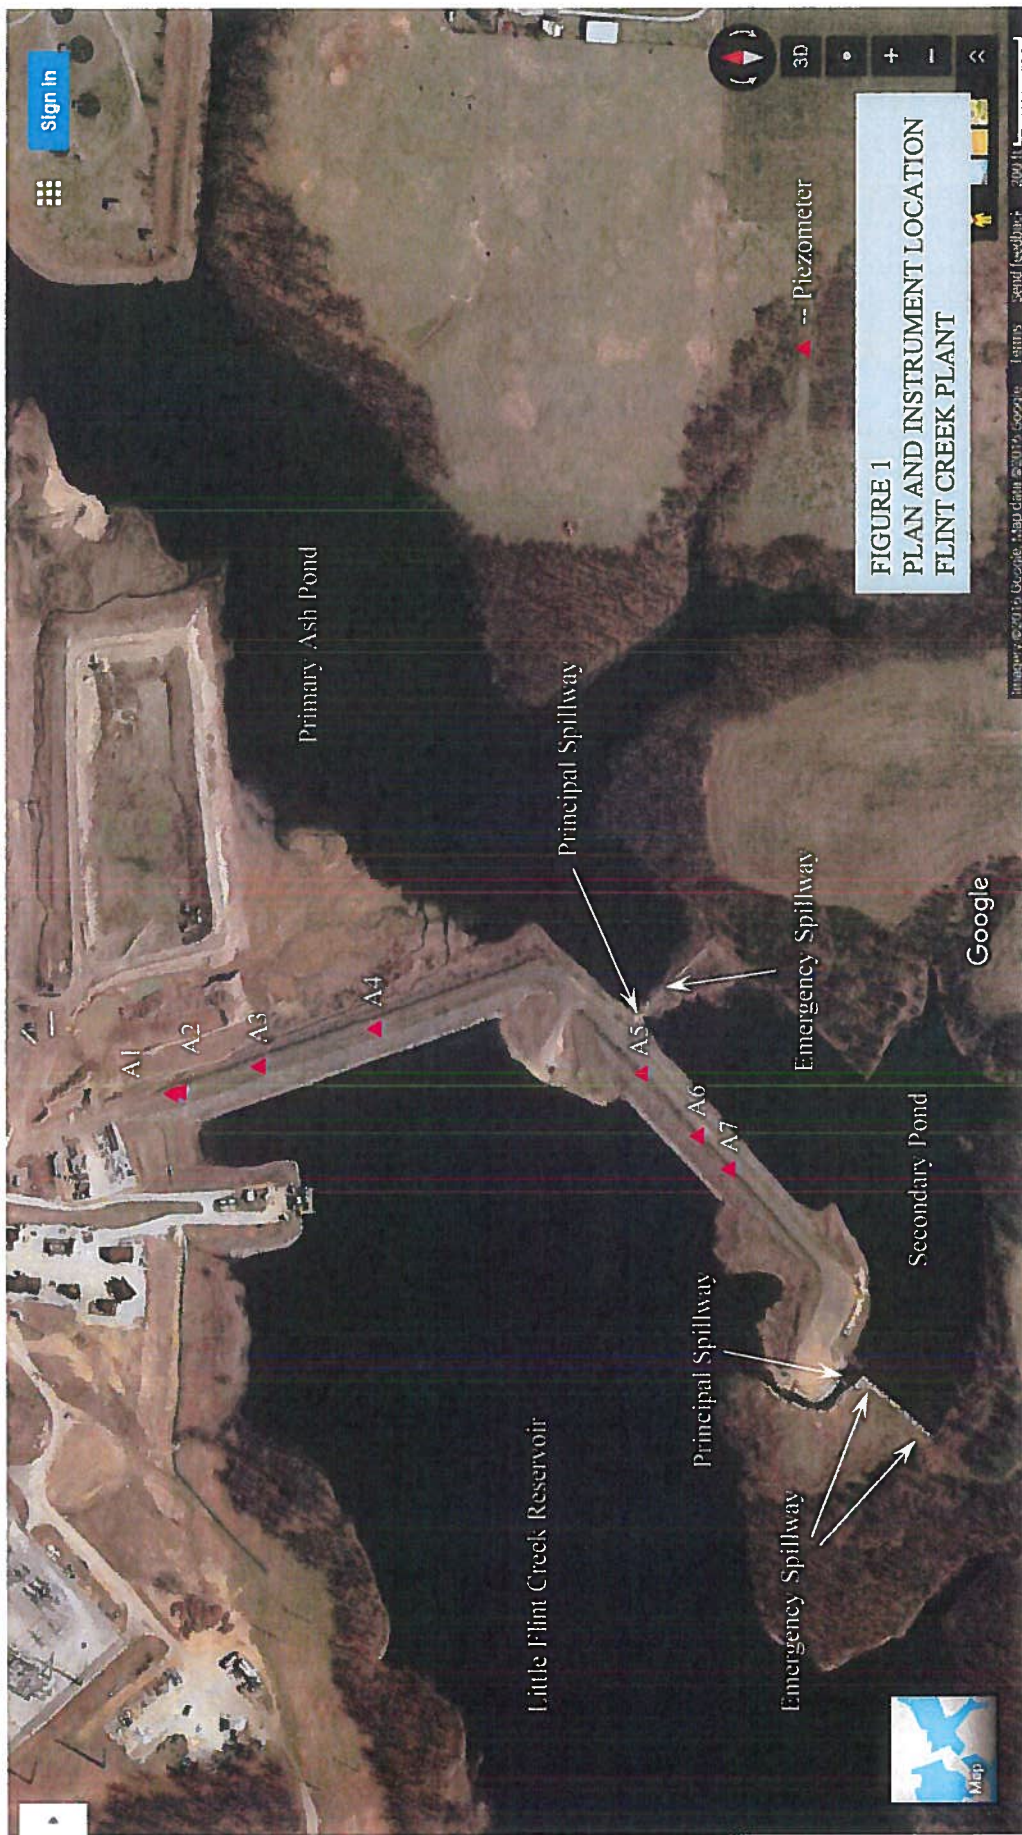
**FIGURE 1**  
**PLAN AND INSTRUMENT LOCATION**  
**FLINT CREEK PLANT**

Figure 1 provides a plan view of the primary ash pond. The primary ash pond dam is an 820-foot long cross-valley dam on an unnamed tributary to Little Flint Creek. The primary ash pond is used for the settling and storage of bottom ash, and is considered a CCR surface impoundment. Periodically, the bottom ash is excavated/dredged for beneficial use. Flow from the reservoir discharges into the Secondary pond. The maximum depth of saturated ash noted in the table below does not fluctuate throughout the year.

In November 2009, two additional piezometers (A3 and A4) were installed at the crest of the dam. These piezometers were installed as part of a geotechnical investigation to evaluate the stability and seepage characteristics of the dam. Water levels in the new piezometers are monitored along with the original piezometers on a monthly basis by plant personnel. The locations of the piezometers, and their corresponding IDs, are shown on Figure 1.

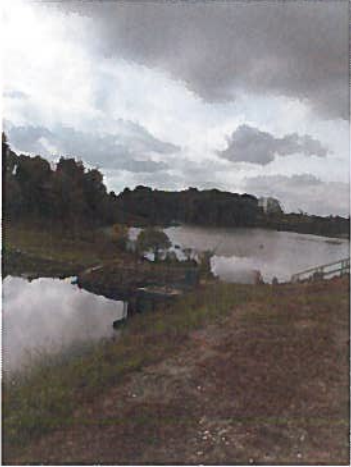
The principal spillway at the primary impoundment is a concrete drop-inlet structure with stop logs used to control the pool elevation. The spillway was in generally fair condition (photo 1).

Photo 1 – principal spillway structure

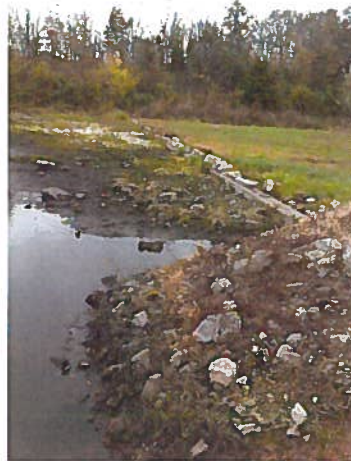
The emergency spillway at the primary impoundment is an incised channel in natural ground with a concrete weir control section, 1 ft. in height, across the channel width. The spillway was in generally fair condition at the time of inspection (photo 2). The spillway appeared to be generally stable.

Photo 2 – emergency spillway concrete weir

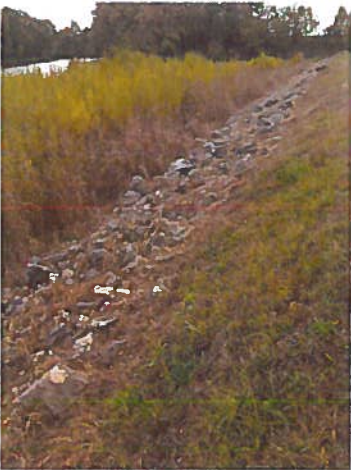
The upstream slope of the primary dam was observed to be in satisfactory condition from the visual riprap up to the crest (photo 3). Since the pond is used for settling of solids, there is an accumulation of bottom ash over the upstream slope. This area has naturally revegetated but is not mowed (photo 4).

Photo 3 – upstream slope – riprap and grassed surface.

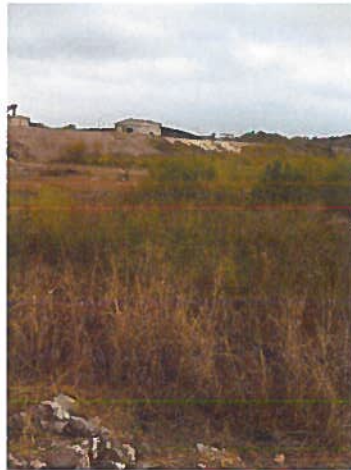
Photo 4 – upstream solids accumulation with natural vegetation

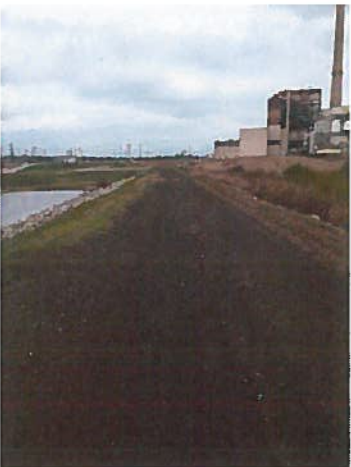
The crest surface of the primary dam is composed of hard-packed earth topped with bottom ash (photo 5). Vehicular traffic is maintained across the crest for access for monitoring. The crest is in generally satisfactory condition with no evidence of misalignment, settlement, or cracking. The rutting and erosion rills noted in the 2015 inspection report have been repaired.

Photo 5 – crest – looking towards right abutment

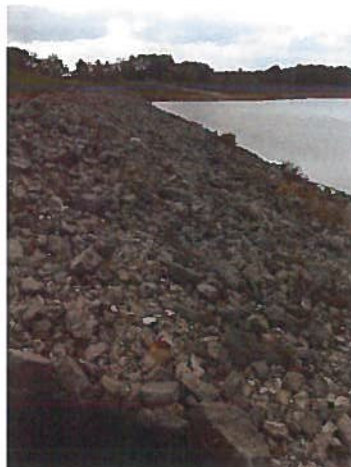
The downstream slope of the primary dam was in satisfactory condition (photos 6, 8). Most of the slope is covered with riprap except for the top 3-5 feet which is grassed. The woody vegetation within the riprap noted in the 2015 report have been sprayed but not all removed. About half of the downstream slope is inundated by the normal pool of the Little Flint Creek dam cooling lake.

Photo 6 – downstream slope – looking towards left abutment

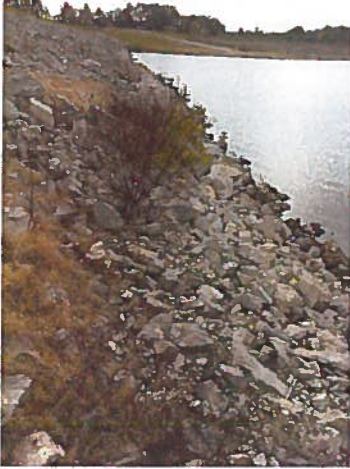
There are several remaining small diameters trees in the riprap as noted as in photo 7. There was one animal hole that was observed in the upper slope that is grassed – observation sheet #17.

Photo 7 – several dead woody vegetation to be removed on downstream slope.

- Repair rodent holes flagged during the inspection and others as discovered during the 7-day inspections.
- Continue the vegetation control plan of mowing and spraying.
- Remove dead woody vegetation after spraying process.

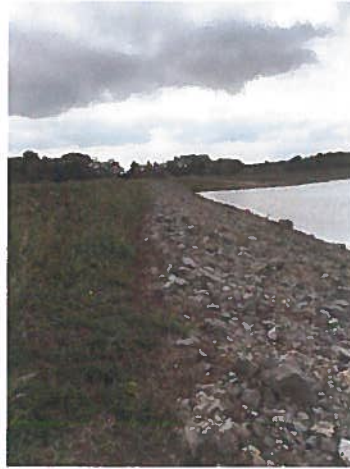
Photo 8 – downstream slope – riprap and grassed surface
