2016 Landfill Inspection Report

Northeastern Units 3&4 Ash Landfill
Oologah, Oklahoma
NHIW Landfill Permit No. 3566010

November 2016
Project No. 35167178

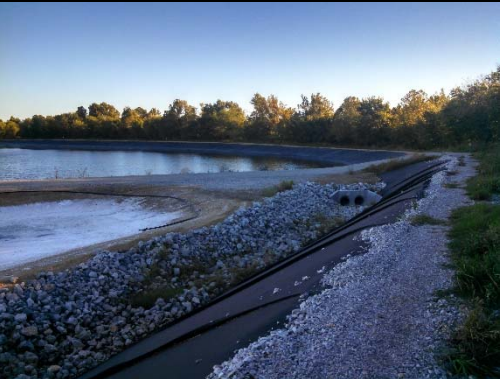
Text			
Photograph ID #	Description	Comments	Photo
1	Looking northeast toward Leachate Impoundment and Basin C	Observe entire landfill boundary and the Basin C boundary, including river-side dike structure

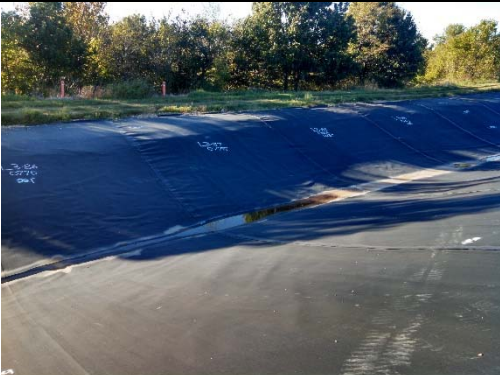
1. The landfill intermediate liner design includes a perimeter berm that prevents run-on of stormwater into the fill area during operations and conveys stormwater outside the perimeter berm to the stormwater collection basin – Basin C. (Photo 37)
2. Stormwater conveyances have been fully constructed. At this time no blockages of stormwater flow, erosion, or deterioration are noted.
3. Occasional minor occurrences of pooling water within the GM lined perimeter ditch were noted. Trampolining of GM was noted within the perimeter ditch (Photo 10). However,

these occurrences do not inhibit general run-off of stormwater into basin C. Occasional puncture damage (likely deer hoof – Photo 18) or non-penetrating blemishes to the GM liner in the outer stormwater ditch running along the river side were noted. These are outside the constructed CCR containment area located inside the perimeter berm.

10	Looking south at perimeter stormwater ditch	Minor pooling of water, along with trampolining of the geomembrane, occurs periodically in the ditch

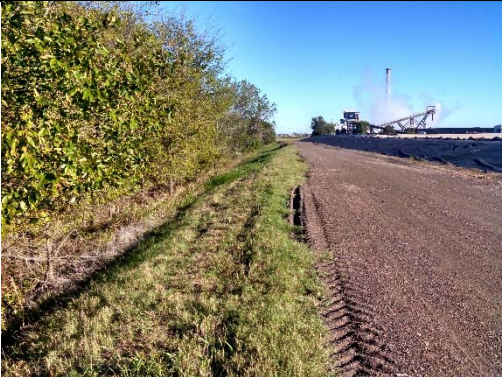
1. The landfill perimeter dike begins to reach a height of greater than five feet in the vicinity of groundwater monitoring well MW-5 (near Photo 12), and then wraps around the southernmost corner of the landfill after which it runs the full length of the landfill and Basin C along the Verdigris River (to beyond Photo 1). See also **FIGURE 2**. Typical upper slope angles along the dike appeared to be approximately 4:1 and the lower slope appeared to be about 1:1 toward the river. A flatter slope was noted and appeared to be about a 2:1 slope in the vicinity of Photo 39. Occasional, local wetting at the interface between the dike fill and the underlying rock outcrop “shelves” has been noted historically. A slurry wall and grout-curtain system has been installed through the dike along the Verdigris River side of the dike. Up-gradient and down-gradient piezometers have been installed to measure the effectiveness of the slurry wall/grout curtain system and to monitor water levels. At the time of the inspection, the Verdigris River was running high due to discharge from the Oologah Lake Dam. Therefore, it was not possible to traverse the entire bottom slope length of the dike along the relatively flat stream bank area that is typically available during periods of low flow. The dike conditions were typically observed down the slope from the top, except along Basin C where conditions allowed for observation.

12	Looking north along perimeter road adjacent to Cell 4

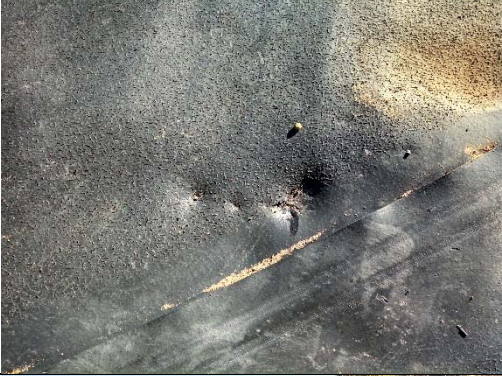
18	Puncture in geomembrane in stormwater ditch	Likely deer hoof puncture in flowline of perimeter ditch

- It is recommended that the geomembrane (GM) liner in the outer stormwater ditch running northeast along the river side should be repaired in areas where puncture damage, presumably from an animal hoof has occurred. While the GM lined ditch is not technically within the constructed CCR waste disposal unit, the GM liner is expected to provide an infiltration barrier to surface water that may percolate into the subsurface in the landfill area.

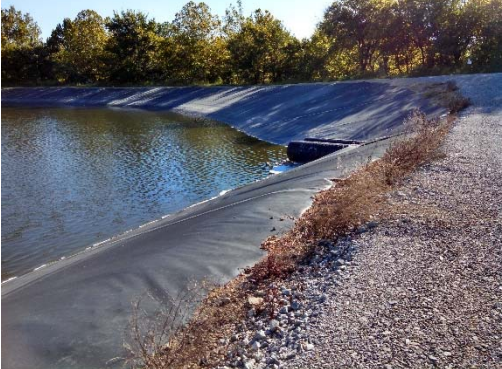
37	Looking northeast at stormwater inflow to Basin C

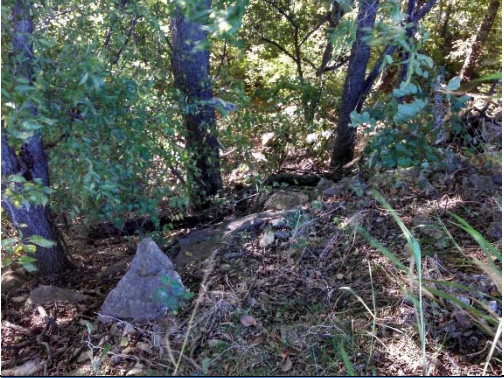
3. The outer bank (downslope from the perimeter road at the top of the dike) was heavily wooded with trees and brush and leaf-fall. (Photo 39) Observation of small-scale pre-movement cracking, sloughing and/or saturated conditions may be obscured by the heavy ground cover. However, none were observed.

39	Looking down-slope toward the Verdigris River
