Annual Coal Combustion Residuals (CCR) Landfill Inspection Report

H. W. Pirkey Power Plant
2400 FM 3251
Hallsville, Texas

Project B1606473
December 27, 2016

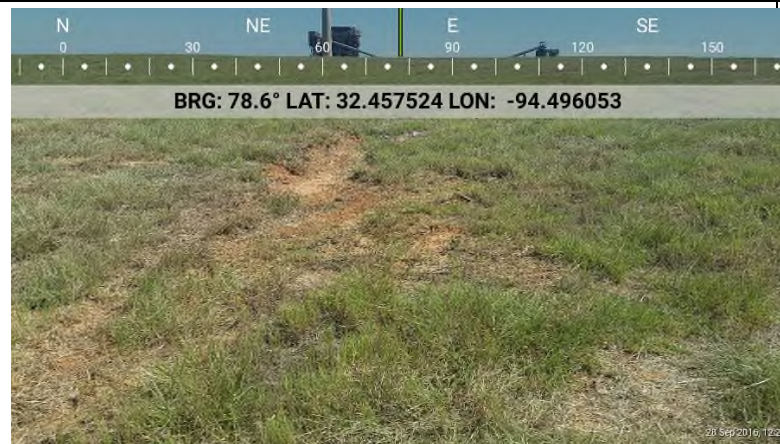
| Photograph #5 | September 28, 2016 |

| Description: | Slight erosion evident on top of 2005 cell denuded area. |

It is recommended that normal maintenance include a vegetation control program to mow and maintain the vegetative cover grasses on the permanently covered areas. Undesirable "woody" vegetation such as trees and shrubs need to be removed. Denuded areas as well as areas where erosional features have been repaired need to be covered with topsoil and reseeded with grasses.

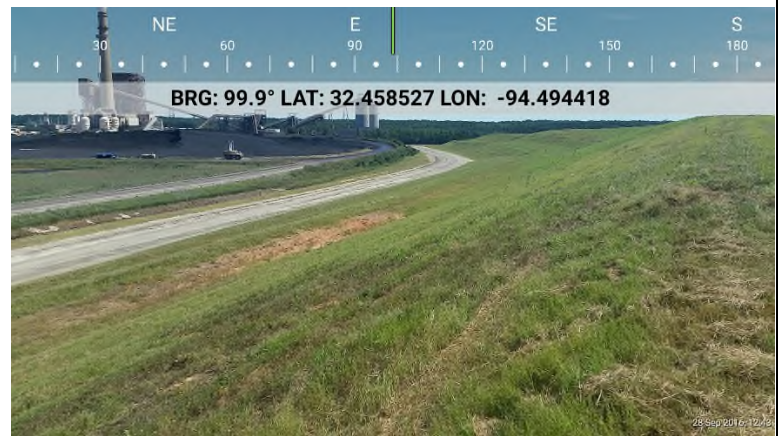
| Photograph #14 | September 28, 2016 |

| Description: | Northern toe of the slope of 1995 and 1984 cells with denuded area. |

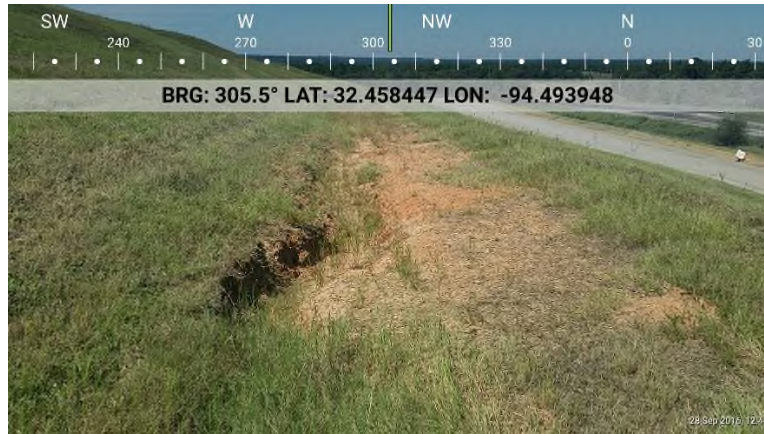
| Photograph #15 | September 28, 2016 |

| Description: | Erosional feature on northern slope of 1999 cell. |

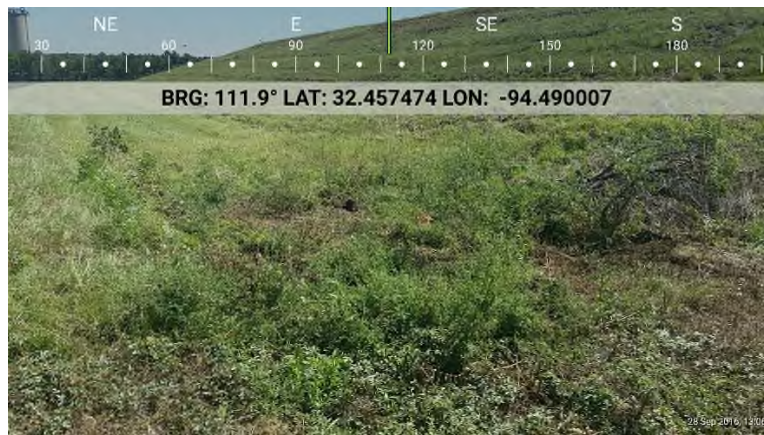
The "1984" Cell is under permanent cover and in good shape with a well-established grassy vegetative cover over its entirety (Photographs #18, #20, #22, #23, #24, #25, and #26). The "1984" Cell is shown on **Figure 2**. The north and east sides of the cell slope relatively steeply down to the natural grade while the rest of the cell is relatively flat. Some "woody" vegetation was beginning to become established near the toe of the northeast corner of the cell (Photograph #21). No concerns or issues with erosion were noted.

Photograph #21 September 28, 2016
Direction: Facing east southeast
Description: Evidence of "woody" vegetation on toe of northern slope of 1984 cell.

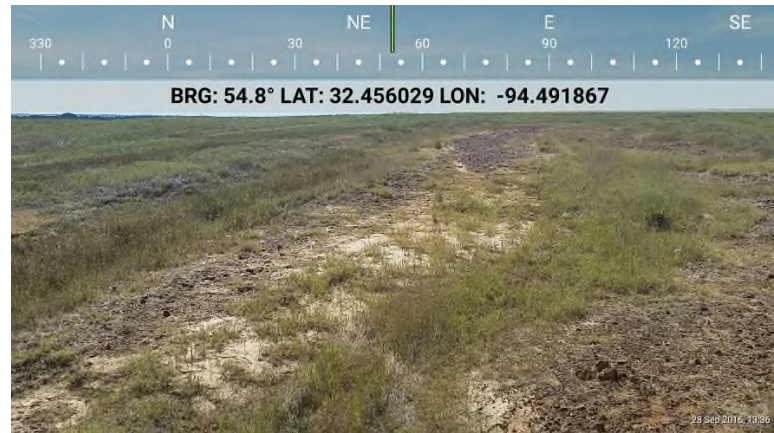
| Photograph #29 | September 28, 2016 |

| Description: | Denuded area on the plateau of the 1987 cell northwest of oil/gas well. |

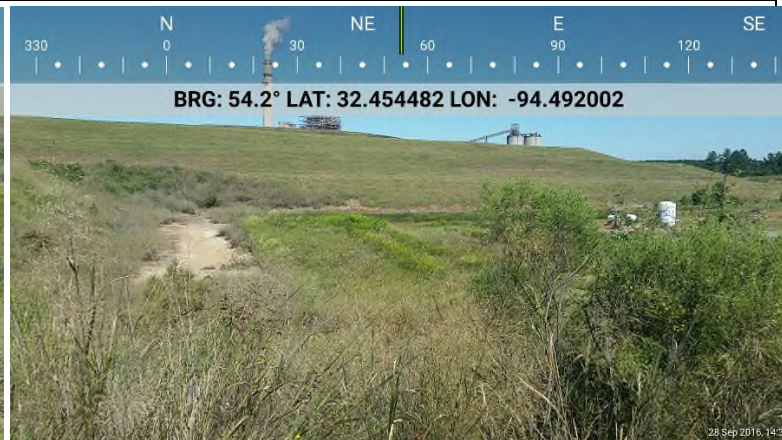
| Photograph #32 | September 28, 2016 |

The "1987" Cell is predominantly under permanent cover and in good shape with a well-established grassy vegetative cover over its entirety (Photographs #18, #23, #35, #37, and #38). The "1987" Cell is shown on **Figure 2**. The southwestern corner of the cell is in the active portion of the landfill and has no cover (photograph #43). The north, west, and south sides of the cell are on the flatter plateau of the landfill. A mound of dirt with "woody" vegetation beginning to become established was noted on the southern plateau of cell (Photograph #42) as well as around the let-down outlet of the southern section (Photograph #48). Denuded areas are evident in two separate locations on the "1987" Cell, one in the middle of the "1987" Cell plateau area (Photograph #29) and one on the eastern slope of the southern section (Photograph #39). Abandoned drainage pipe/debris (Photograph #36) was noted as well. An oil/gas well, which existed prior to the landfill being constructed, with associated tanks and appurtenances exists along the east edge of the landfill and the "1987" Cell wraps around the well site (Photographs #27 and #30). The cell topography slopes relatively steeply down from all directions toward this well pad (Photograph #28). Erosion and some woody brush is evident along the toe of the steep slopes around the oil/gas well (Photographs #31, #32, #33, and #34).

| Description: | "Woody" vegetation at toe of slope of 1987 cell near oil/gas well. |

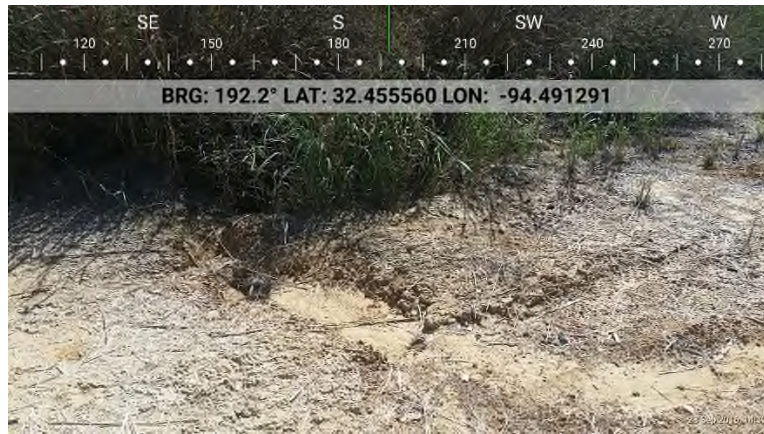
| Photograph #33 | September 28, 2016 |

| Description: | Erosion evident at toe of slope of 1987 cell near oil/gas well. |

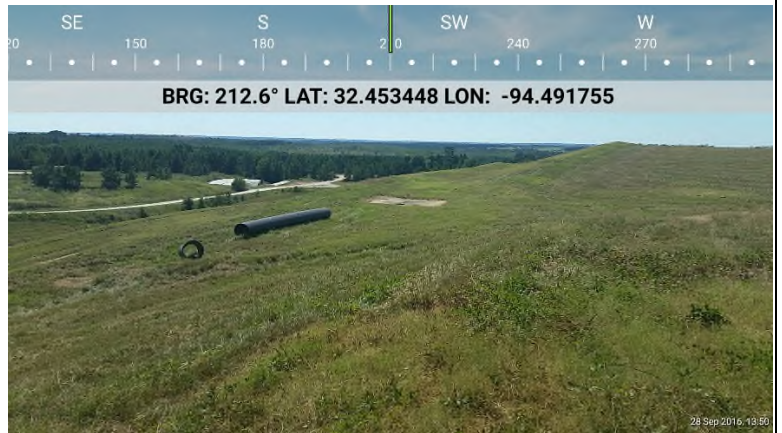
| Photograph #36 | September 28, 2016 |

| Description: | Let-down inlet and pipe debris on eastern slope of the southern section of 1987 cell. |

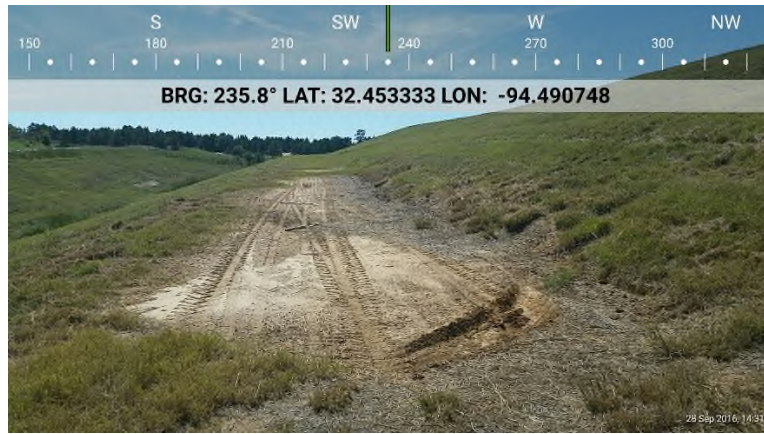
Photograph #39 September 28, 2016
Direction: Facing southwest
Description: Denuded area at the toe of the eastern slope of the southern section of 1987 cell.

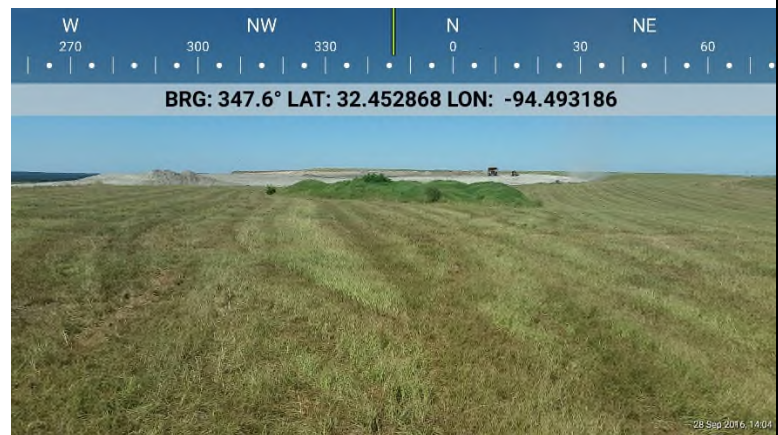
Photograph #42 September 28, 2016
Direction: Facing north northwest
Description: Top of 1987 cell. Mound with woody vegetation.

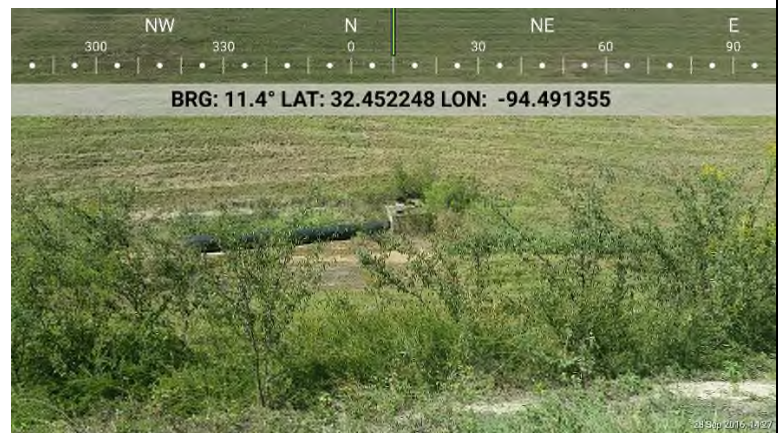
| Photograph #48 | September 28, 2016 |

| Description: | Toe east slope and let-down outlet on southern section of 1987 cell. Woody vegetation evident. |

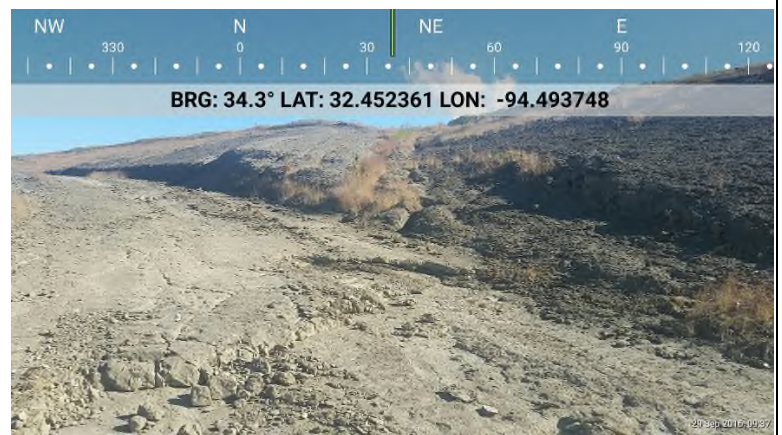
| Photograph #54 | September 29, 2016 |

| Description: | Hardened CCR with evidence of past erosion on 1993 cell. |

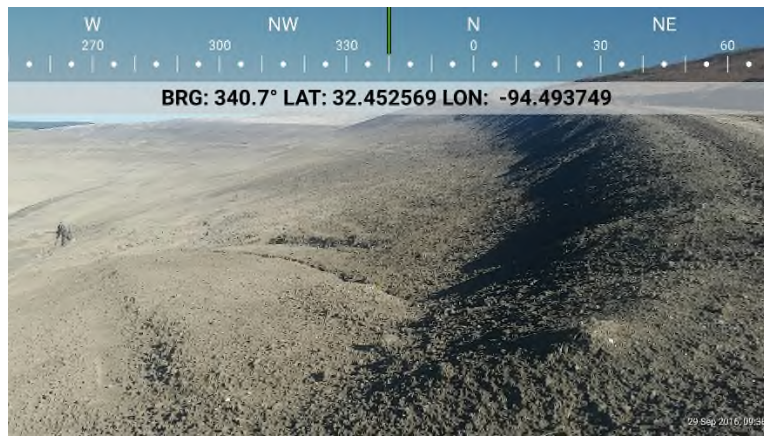
| Photograph #55 | September 29, 2016 |

| Description: | Hardened CCR and erosion on 1993, 1985 pond, and 2012 cells. |

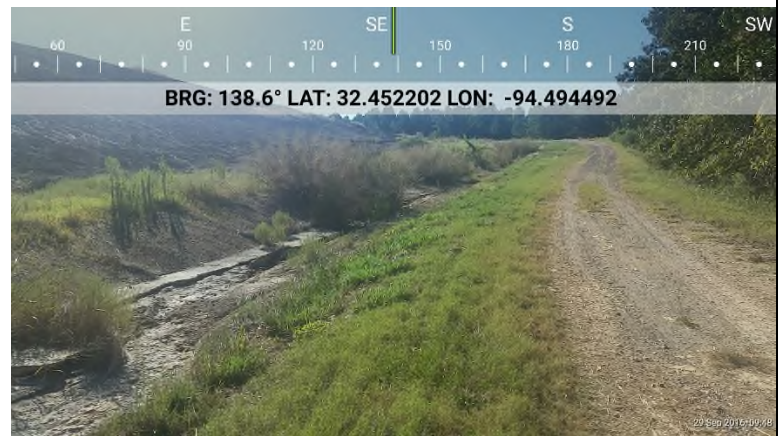
| Photograph #56 | September 29, 2016 |

| Description: | Toe of slope of 1993 cell active area. Hardened CCR and erosion. |

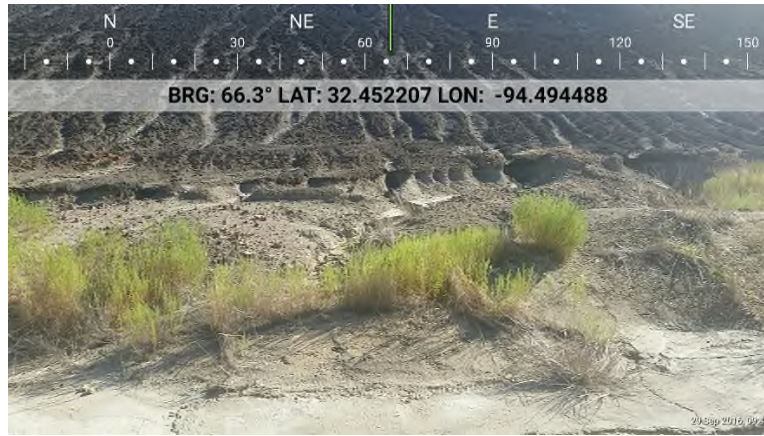
| Photograph #57 | September 29, 2016 |

| Description: | Toe of slope of 1993 cell active area. Hardened CCR and erosion. |

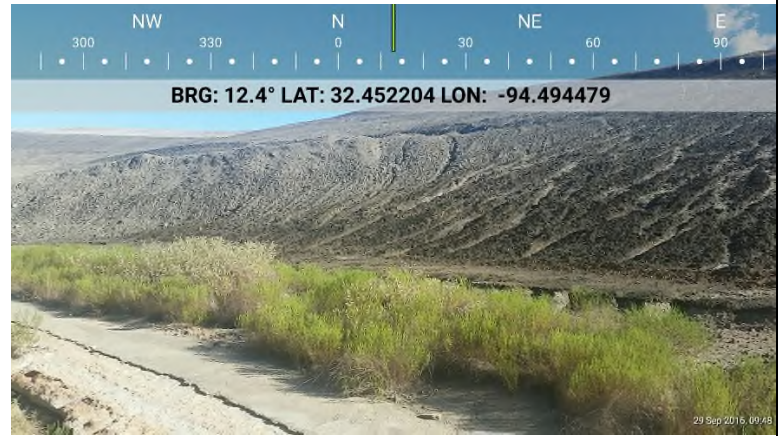
| Photograph #58 | September 29, 2016 |

| Description: | Toe of slope of 1993 cell active area. Hardened CCR and erosion. |

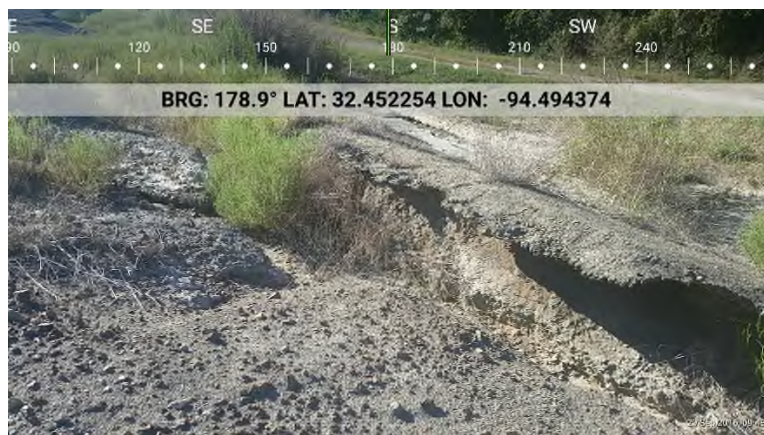
| Photograph #59 | September 29, 2016 |

| Description: | Hardened CCR and erosion at toe of 1993 slope. |

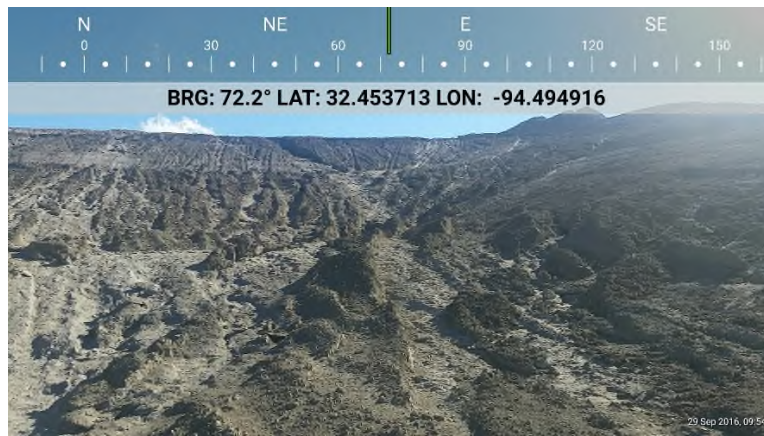
| Photograph #61 | September 29, 2016 |

| Description: | Hardened CCR and erosion on slope of 1985 pond cell. |

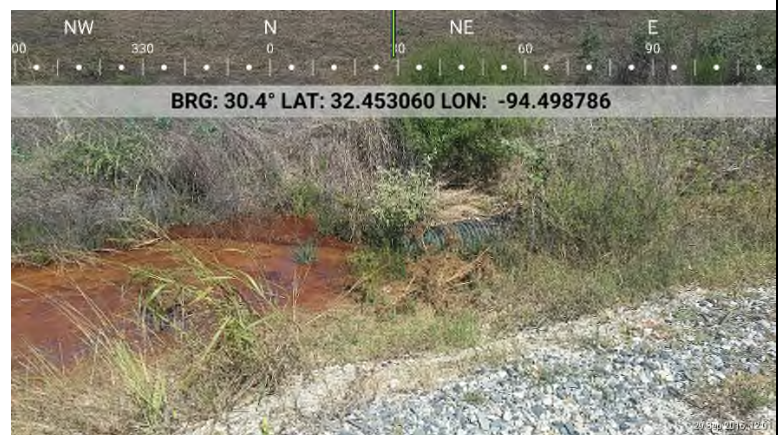
Description: Non-contact leachate outlet south of 2015 cell. Iron staining.
