# **2017 Annual Dam and Dike Inspection Report**

**Clinch River Ash Pond 1A/1B**

**Clinch River  
Appalachian Power Company  
Carbo, Virginia**

**Inspection Date: November 7-8, 2017**

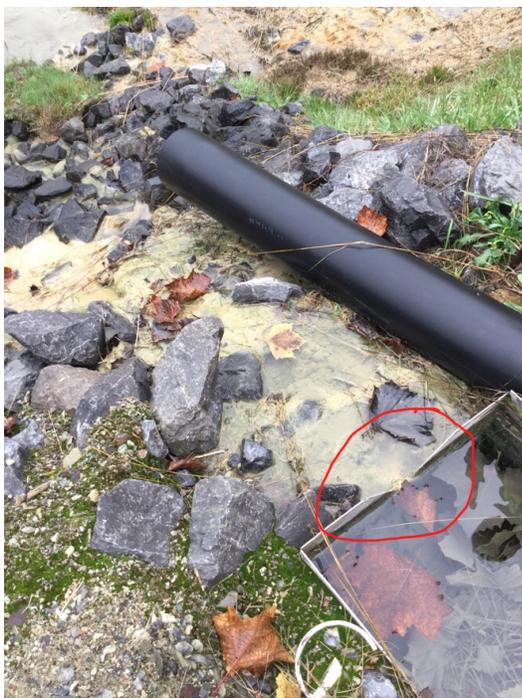
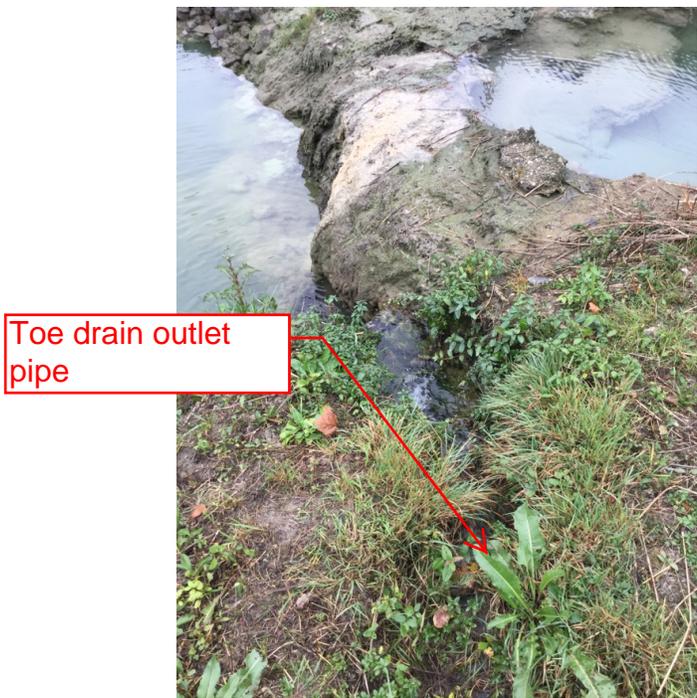
2. Sediments have accumulated downstream of Weir box #5-A, preventing the “free fall” conditions. Sediments have accumulated at the outlet of the toe drain system, near the reclaim pond, obscuring the toe drain pipe. At both locations, the sediment accumulation has not obstructed the flow.

4. Remove the sediment accumulation from the toe drain outlet near the northeast corner of the reclaim pond. See Observation #1 in Appendix A.
5. Remove the sediment accumulation downstream of V-Notch Weir #5A to create a small “free fall”. See Observation #1 in Appendix A.

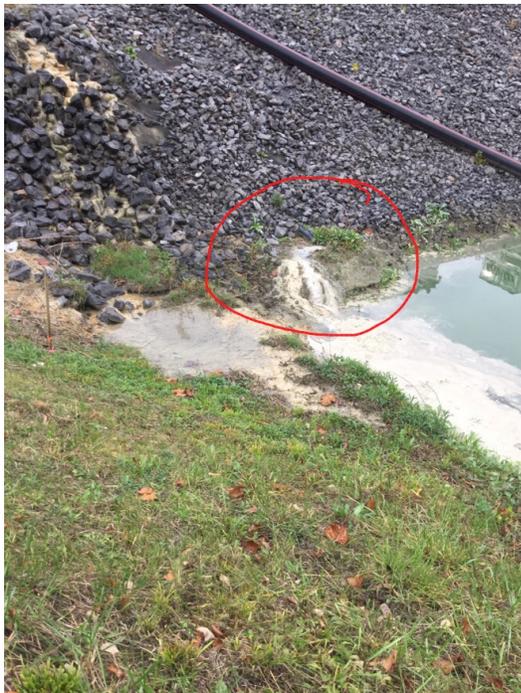
Observation #: 2

3. A 6-inch-diameter corrugated plastic pipe was observed to have sediments accumulating at the outlet.
4. Some brush/woody vegetation was observed on the right abutment, within 25 feet of the dam embankment.

Observation: Obstructed pipe outlet, circled in red.

3. Remove the sediment accumulation from the 6-inch-diameter corrugated plastic pipe near the northwest corner of the reclaim pond. See Observation #2 in Appendix A.

Recommendations: Remove the mineralization/ accumulated sediment from the outlet of the drain pipe circled in red.

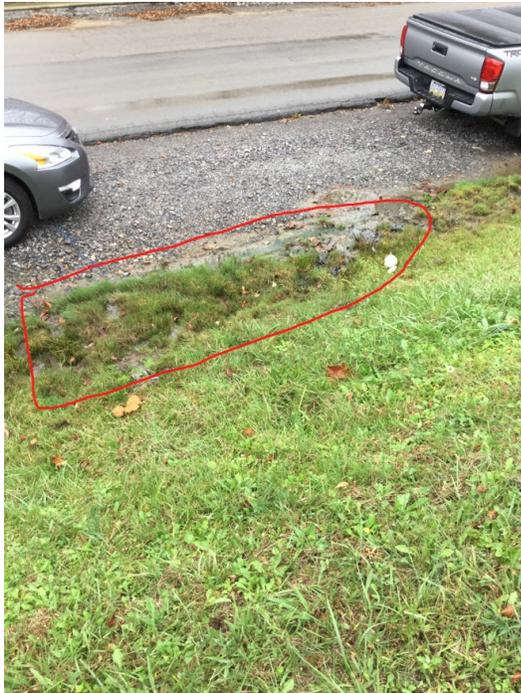
5. A soft, saturated area with rough dimensions of 4’ by 20’ near the northwestern corner of the reclaim pond was observed. This area has been identified in previous inspections and has, at times in previous inspections, contained small boils, with clear discharge. This area drains into a small swale connected to Weir Box #5 to facilitate detailing monitoring of flow rates.

1. Monitor the soft, wet area near the northwest corner of the reclaim pond for any signs of muddy seepage or increased flow rates. This wet area has been identified in previous inspections. See Observation #4 in Appendix A.
2. Monitor the outlet of the 24-inch-diameter RCP on the north bank of Dump’s Creek for any signs of increases in flow rates. See Observation #8 in Appendix A.

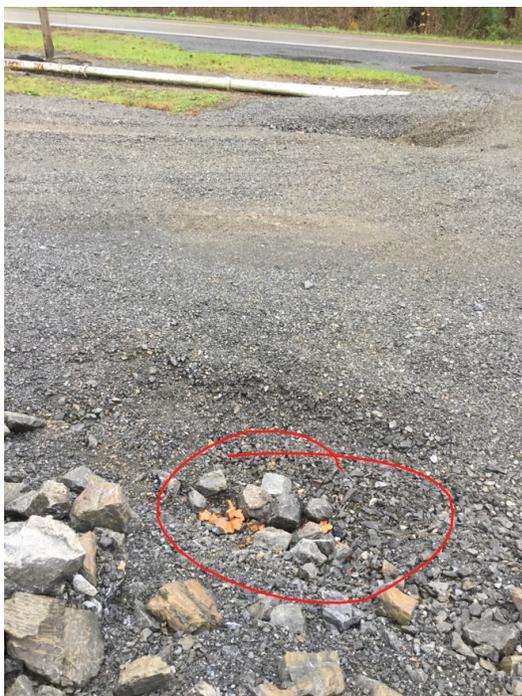
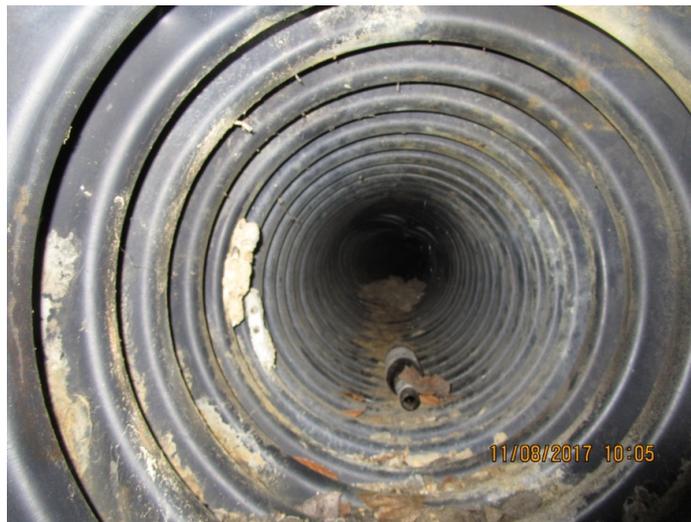
6. The inlets of two culverts underneath of access roads were observed to be obstructed by gravel/rock.
7. There was an erosion rill, about 6 inches deep on the upstream face of the reclaim pond. There were areas with displaced riprap/ exposed filter fabric on the upstream face of the reclaim pond.

2. Remove the obstructions from the culverts underneath access roads along the downstream toe to permit the passage of storm water runoff. See Observation #5 in Appendix A.

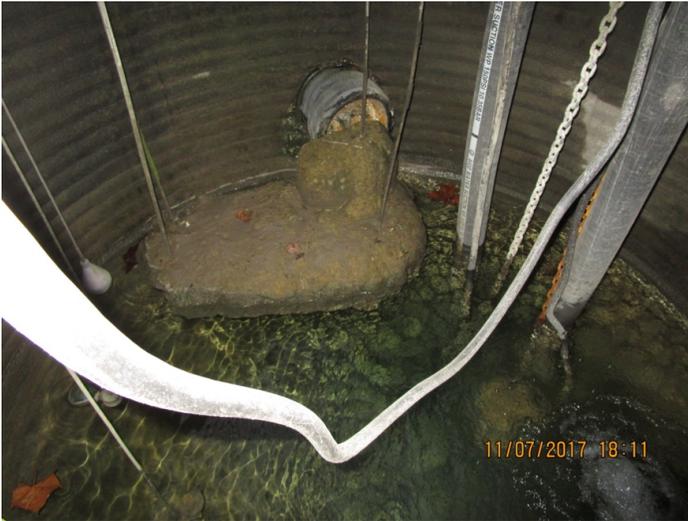
8. The right toe drain pipe was observed to have mineralization developing at the outlet of the toe drain pipe at the seepage pump station manhole. The thickness of the mineralization was observed to be about  $\frac{3}{4}$  of the pipe diameter.

1. Remove the mineralization accumulation from the right toe drain pipe at the seepage pump station to ensure free draining conditions exist at the toe drain outlet. See Observation #7 in Appendix A.

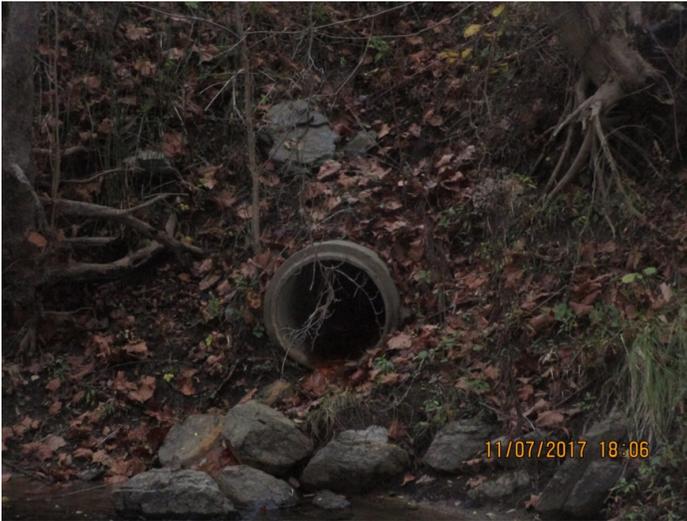
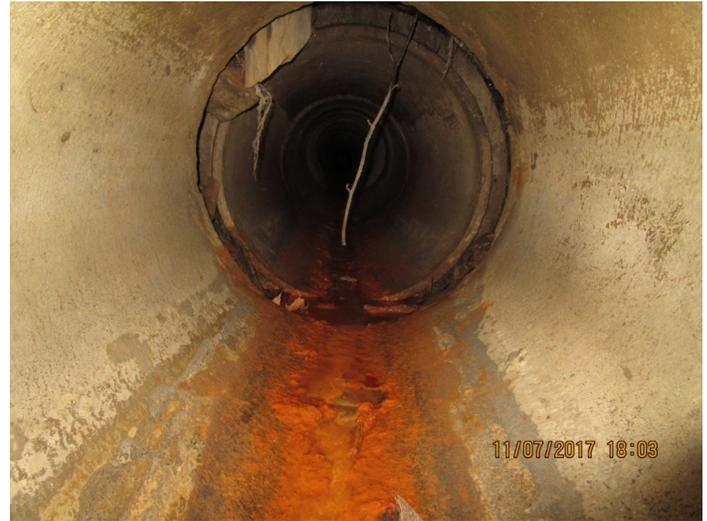
9. The 18-inch-diameter transite pipe previously for storm water conveyance, located in the splitter dike between Ash Pond 1A and Ash Pond 1B, has been abandoned via grout placement. This pipe connects to a 24-inch-diameter concrete pipe and outlet on the northern bank of Dump's creek. A trickle flow of iron stained water was observed discharging from the 24-inch-diameter concrete pipe.
