2017 Annual Dam and Dike Inspection Report

Primary Ash Dam

**Flint Creek Plant
Southwestern Electric Power Company
Gentry, Arkansas**

Document ID: GERS-17-056

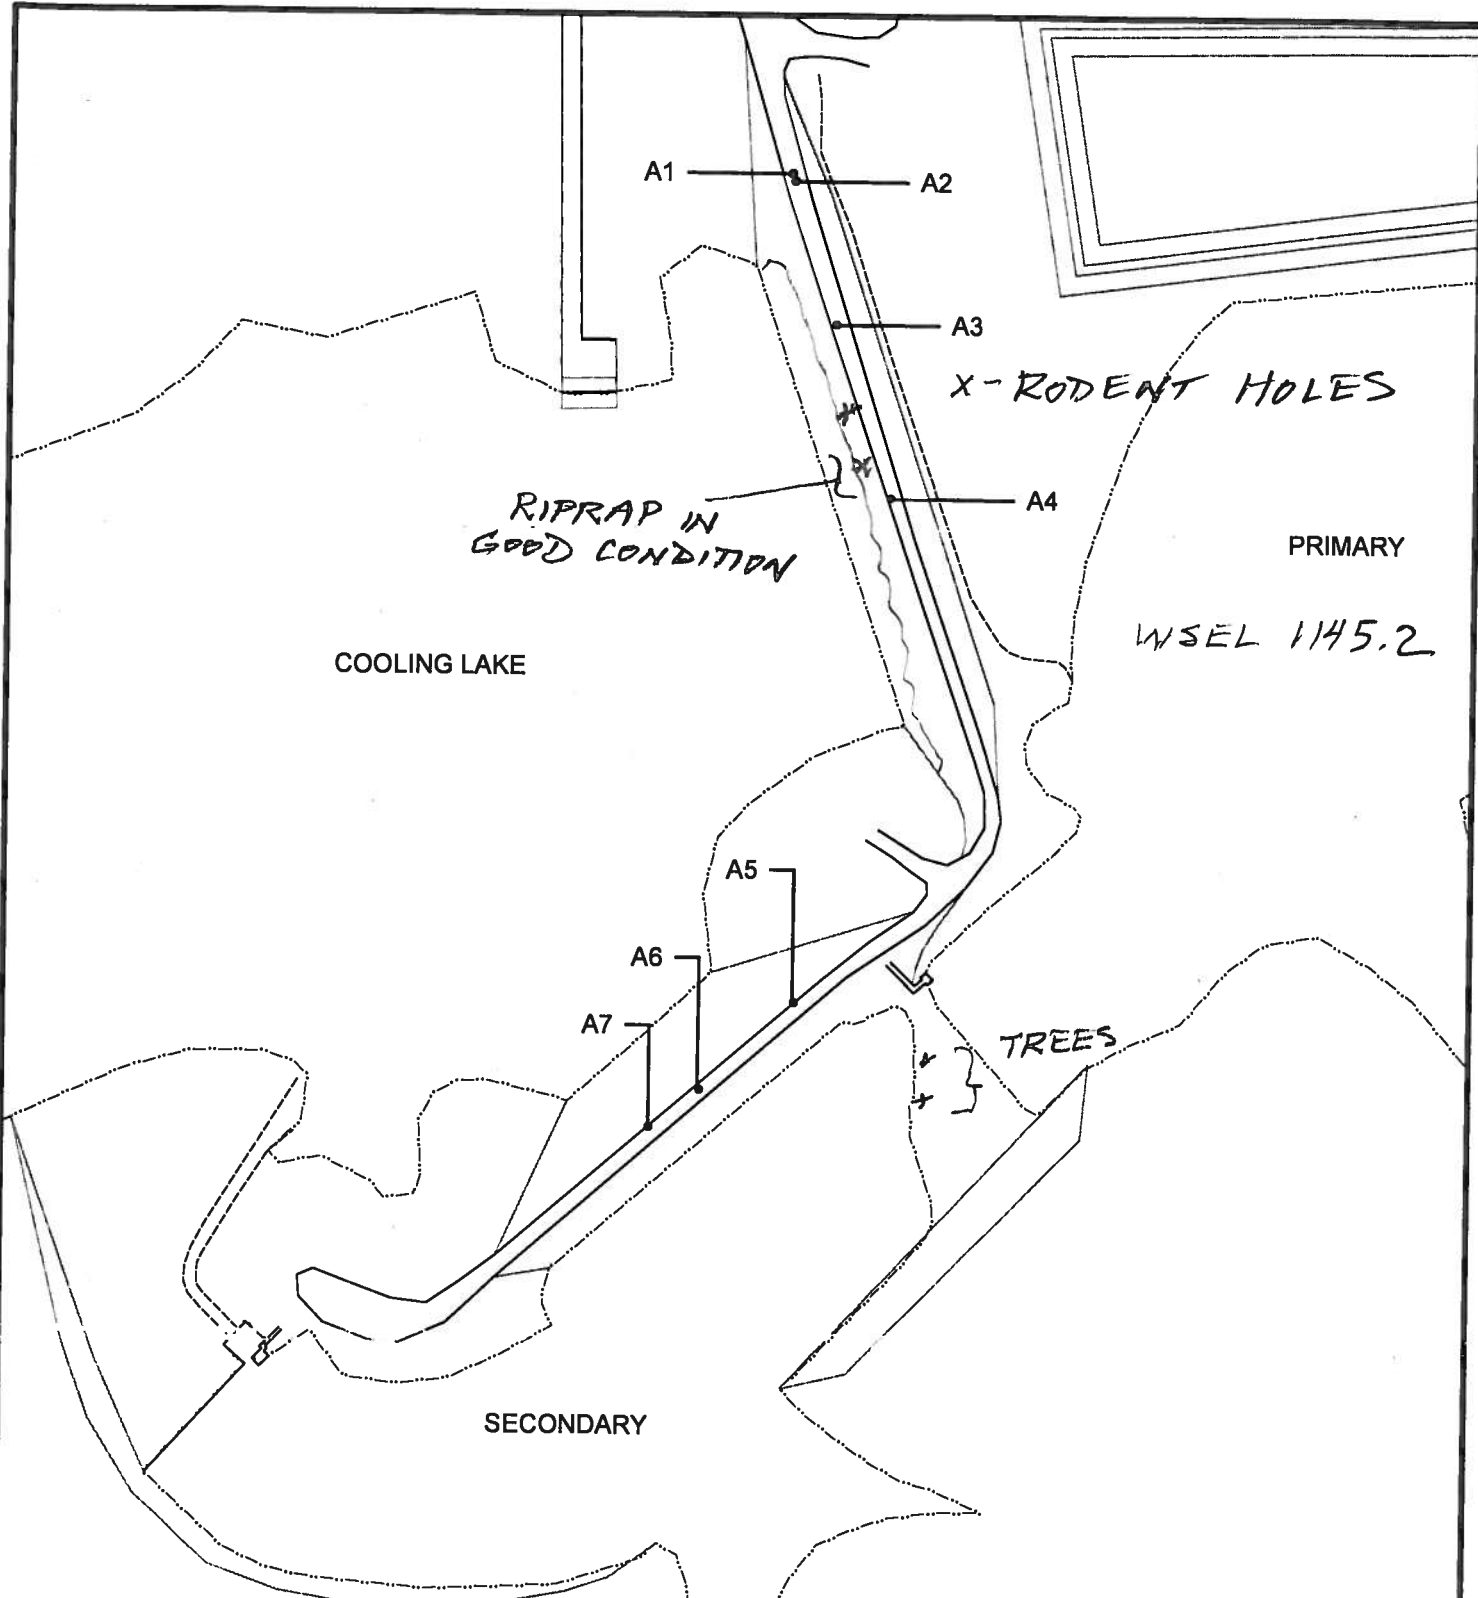
INSPECTION DATE: NOV 8, 2017, BY AEP

PLACEMENT OF DAM COMPONENTS AND IDENTIFIED DEFICIENCIES IS APPROXIMATE

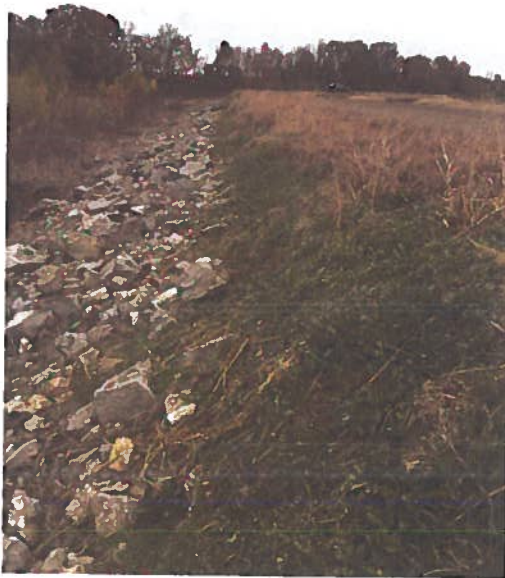
Photo #1

The upstream slope of the primary dam was observed to be in satisfactory condition from the visual riprap up to the crest (photos 1 and 2). Since the pond is used for settling of solids, there is an accumulation of bottom ash over the upstream slope. This area has naturally revegetated but is not mowed. Vegetation control was being performed on the day of the inspection.

There were no signs of sloughing or movement of the upstream slope.

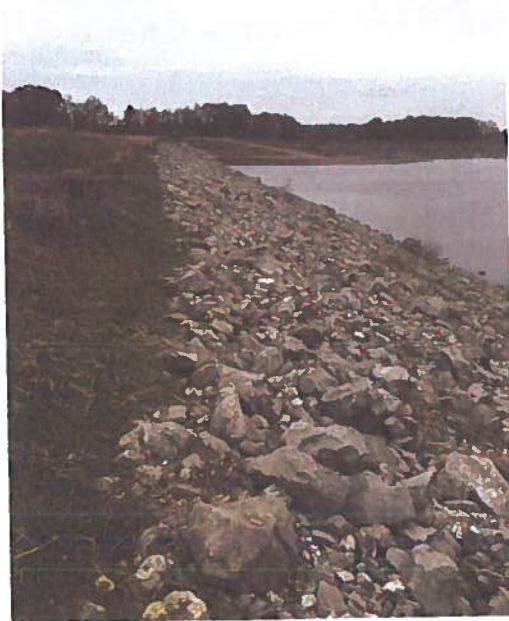
Photo #1

The downstream slope of the primary dam was in satisfactory condition (photos 1 and 2). Most of the slope is covered with riprap except for the top 3-5 feet which is grassed. Woody vegetation within the riprap is being controlled. There was no observed displacement or movement of the riprap.

There were several rodent holes that were observed in the upper slope that is grassed.

- Repair rodent holes flagged during the inspection and others as discovered during the 7-day inspections.
- Continue the vegetation control plan of mowing and spraying.
- Remove woody vegetation in the natural ground below the emergency spillway from the Primary Bottom Ash Pond.

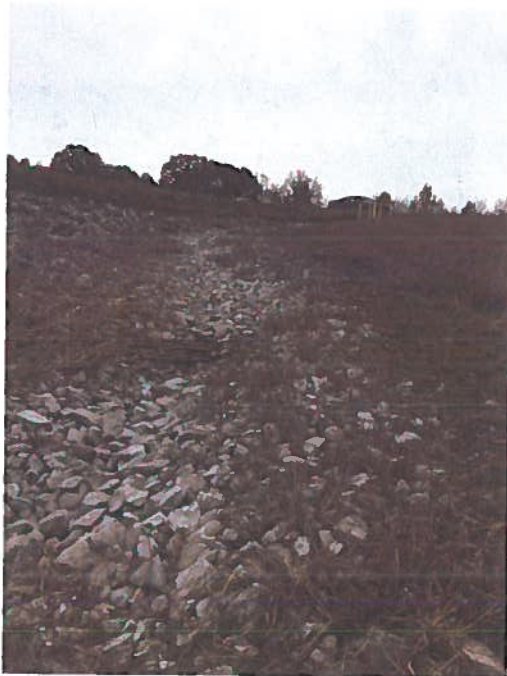
Photo #1

No erosion was observed in either of the groin ditches (Observation #3).

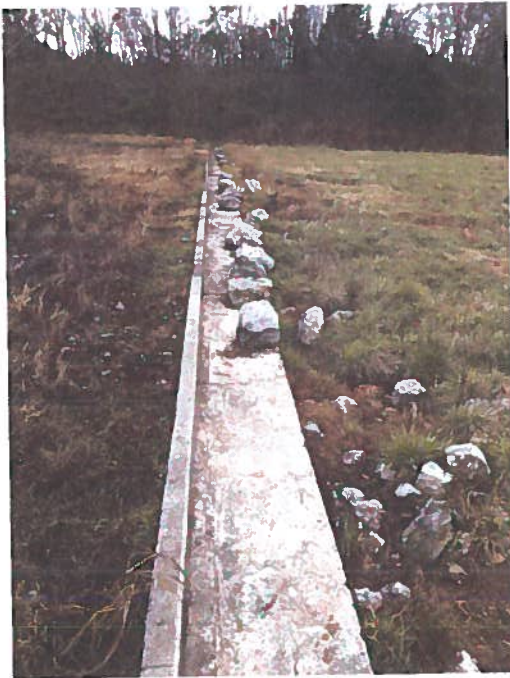
Photo #1

The emergency spillway at the primary impoundment is an incised channel in natural ground with a concrete weir control section, 1 ft. in height, across the channel width. The spillway was in generally fair condition at the time of inspection (photo 1). The spillway appeared to be generally stable.

Vegetation control in this natural ground area is adequate except for two trees that are located at the water's edge to the secondary pond.

#1 - concrete sill in emergency spillway

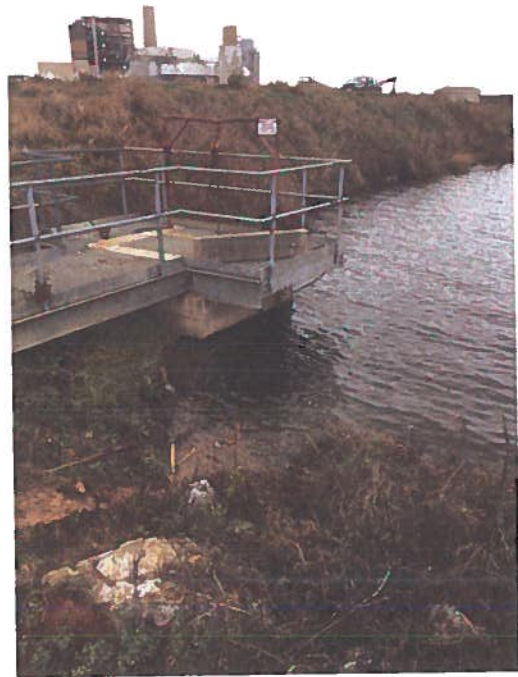
Photo #2

The principal spillway at the primary impoundment is a concrete drop-inlet structure with stop logs used to control the pool elevation. The spillway was in generally fair condition (photo 2). Flow through the principal spillway was unobstructed.

#2 - principal spillway structure
