2017 Annual Dam and Dike Inspection Report

Bottom Ash Pond Complex

Mitchell Plant

Document ID: GERS-17-035

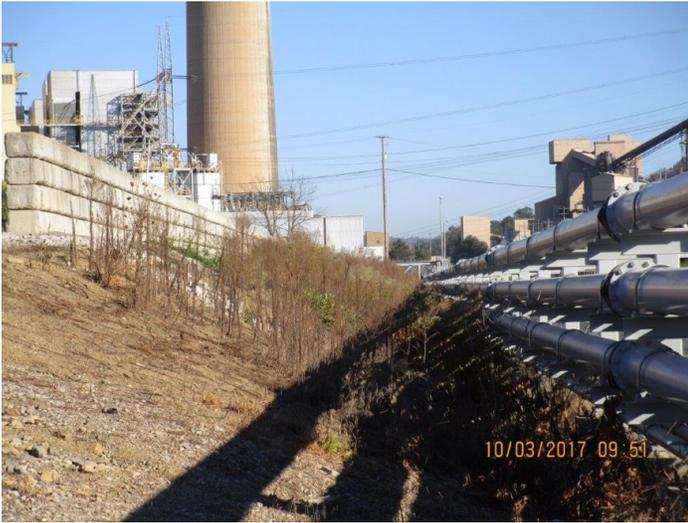
Observation #: 1

8. The exterior slopes were recently mowed, with the exception of the east dike in the area from the toe to the retaining wall (Observation 1). No signs of instability were observed. In general the vegetation was good to fair. There were areas along the west dike where vegetation was sparse (Observation 2). There was one area of minor erosion observed at the northern portion of the dike (Observation 3).

Observation: Heavy brush along outboard slope of embankment adjacent to concrete wall.

Location: East side of impoundment

- 2) Vegetation along the east embankment was not recently mowed. Periodically mow west embankment. (Observation 1).
- 3) Repair minor erosion along the west portion of the outboard slope of the Bottom Ash Pond by replacement of soil and re-seed. (Observation 3)
- 4) Repair erosion within along the south west portion of the inboard slope of the Clear Water Pond. (Observation 5)

Recommendations: Periodically mow vegetation

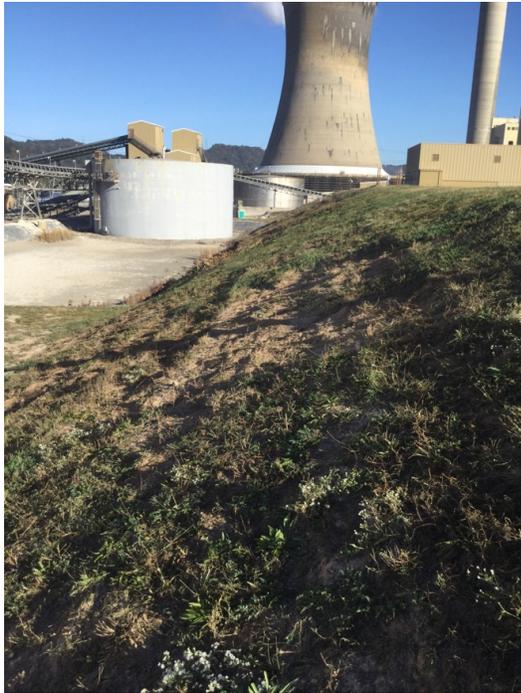
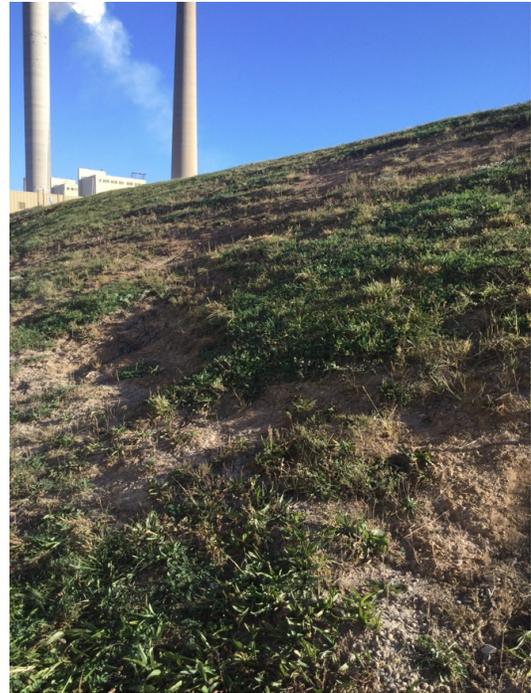
Observation #: 2

Observation: Sparse vegetation along outboard slope

Location: West embankment

- 5) Sparse vegetation was observed along the west portion of the outboard slope of the Bottom Ash Pond. These areas should continue to be monitored. If frequent maintenance is required consider placement of topsoil and over seed to prevent erosion. (Observation 2)

Recommendations: Monitor area for erosion. Consider replacement of soil with topsoil and reseed & stabilize.

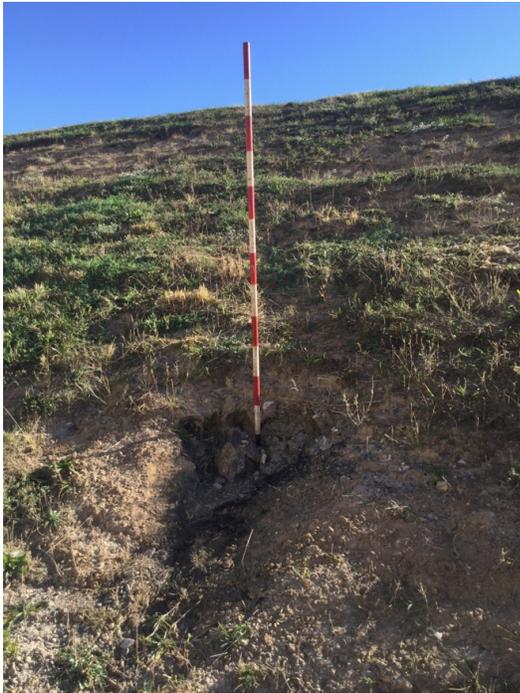
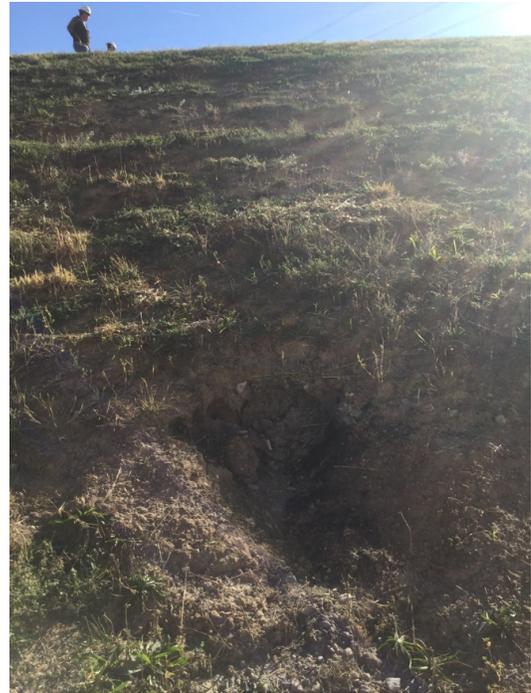
Observation #: 3

Observation: Minor Erosion

Location: West Embankment

Recommendations: Repair erosion by replacement soil and reseed.

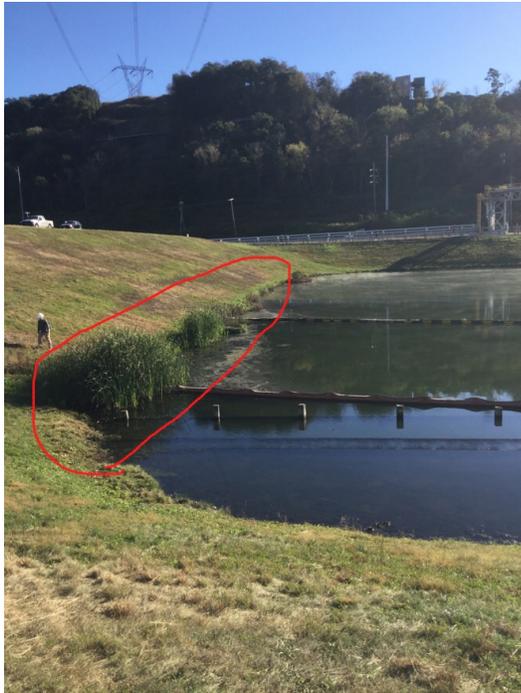
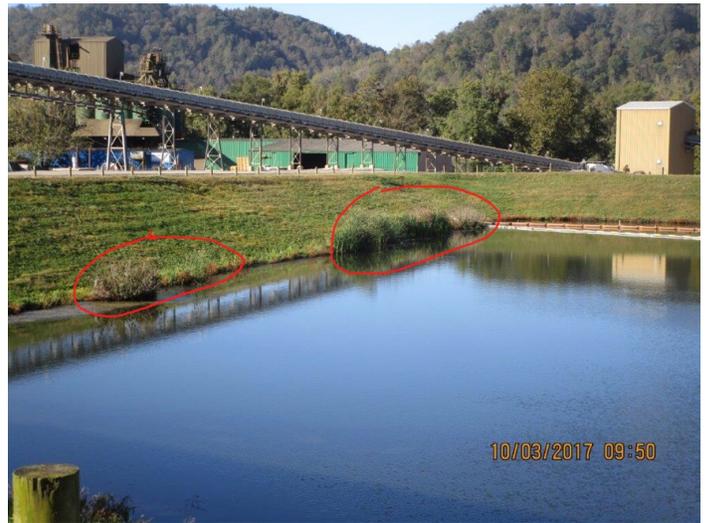
13. The interior slopes showed no signs of distress such as sloughing, bulges. The grass was recently mowed. There were several areas isolated areas of cattail vegetation present in the northern end of the pond; however, these areas did not impact operations (Observation 4). An area of erosion was present along the interior slope at the south east portion of the pond which was appeared to be from run off from the adjacent roadway (Observation 5).

- 6) Several areas of cattail vegetation were observed in the Clear Water Pond. The extent of the vegetation was minor but it could prevent inspection if the areas spread. Consider removal or continue to monitor the cattail growth. (Observation 4)

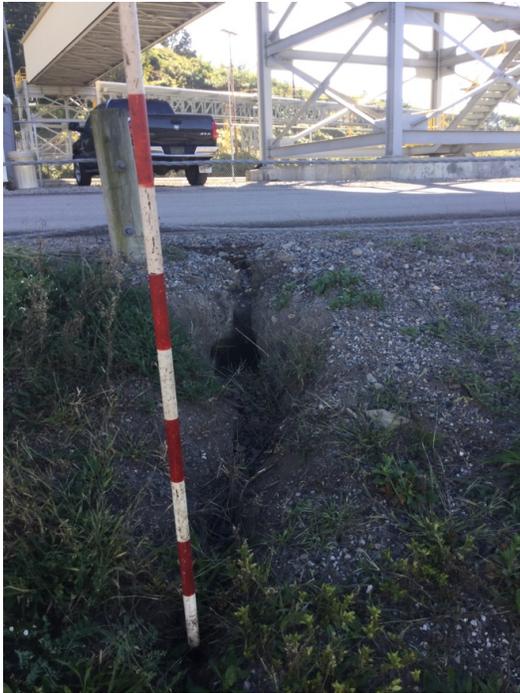
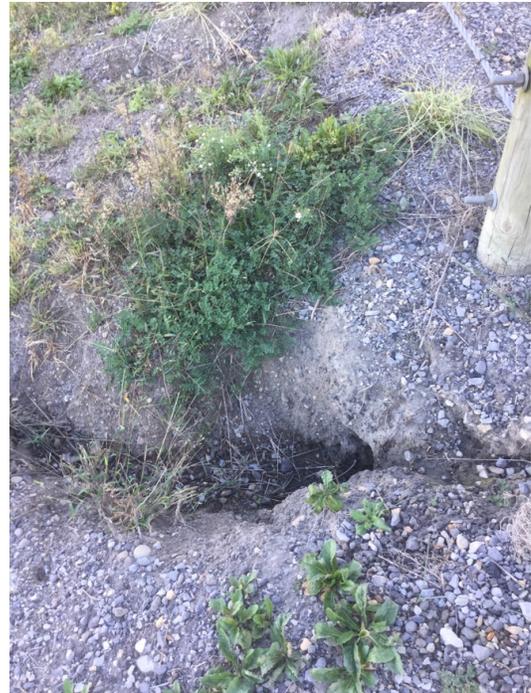
Observation #: 5

Observation: Minor erosion

Location: East inboard slope of Clear Water Pond

Recommendations: Repair erosion by replacement of soil and seed or small rip rap.
