2017 Annual Dam and Dike Inspection Report

Bottom Ash Pond

**Northeastern 3&4 Plant
Public Service Company of Oklahoma
Oologah, Oklahoma**

Document Number: GERS-17-054

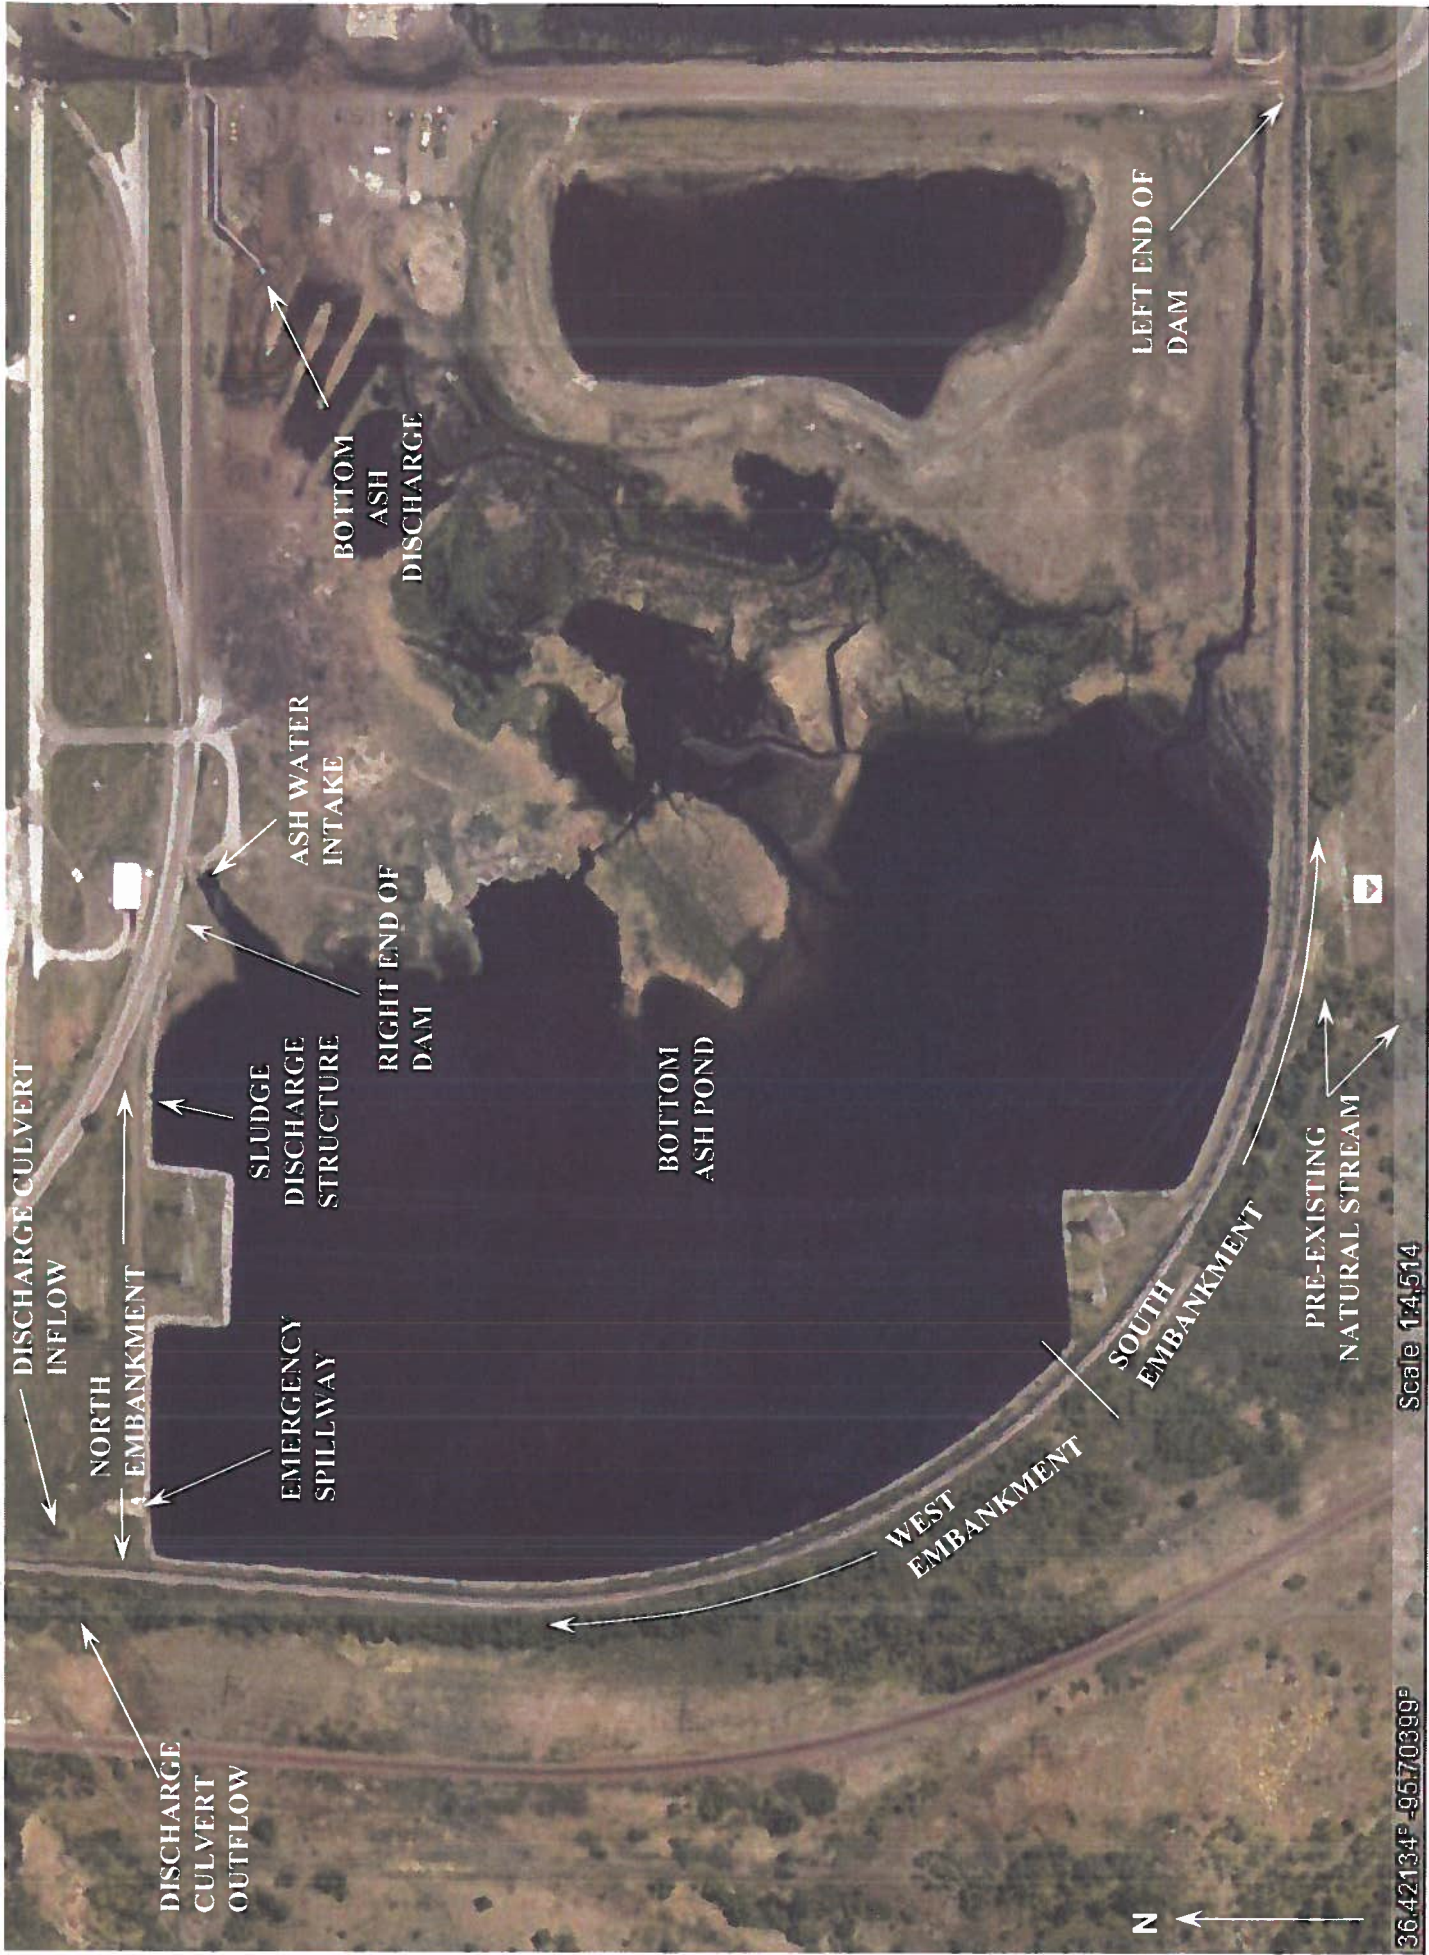
Figure 1. Satellite Image Of Bottom Ash Pond Dam, Features, And Appurtenances At Northeastern 3&4 Power Station.

Figure 1 provides a plan view, in the form of a satellite image, of the Bottom Ash Pond, the embankment structure or dam, pertinent dam features, and the dam's appurtenances. The dam is a 4,200-foot long cross-valley impoundment on an unnamed tributary to Fourmile Creek. The dam is roughly U-shaped and has been divided into north, west, and south embankments for this inspection.

There is no principal spillway at the bottom ash pond; water is typically recirculated back to the power plant for reuse. The auxiliary spillway at the bottom ash pond is a concrete overflow structure with a design invert elevation of 625.0 ft. Overflow from the spillway discharges to a low area and then flows through a culvert under a railroad and off site. Figure 1 shows the spillway and discharge culvert locations.

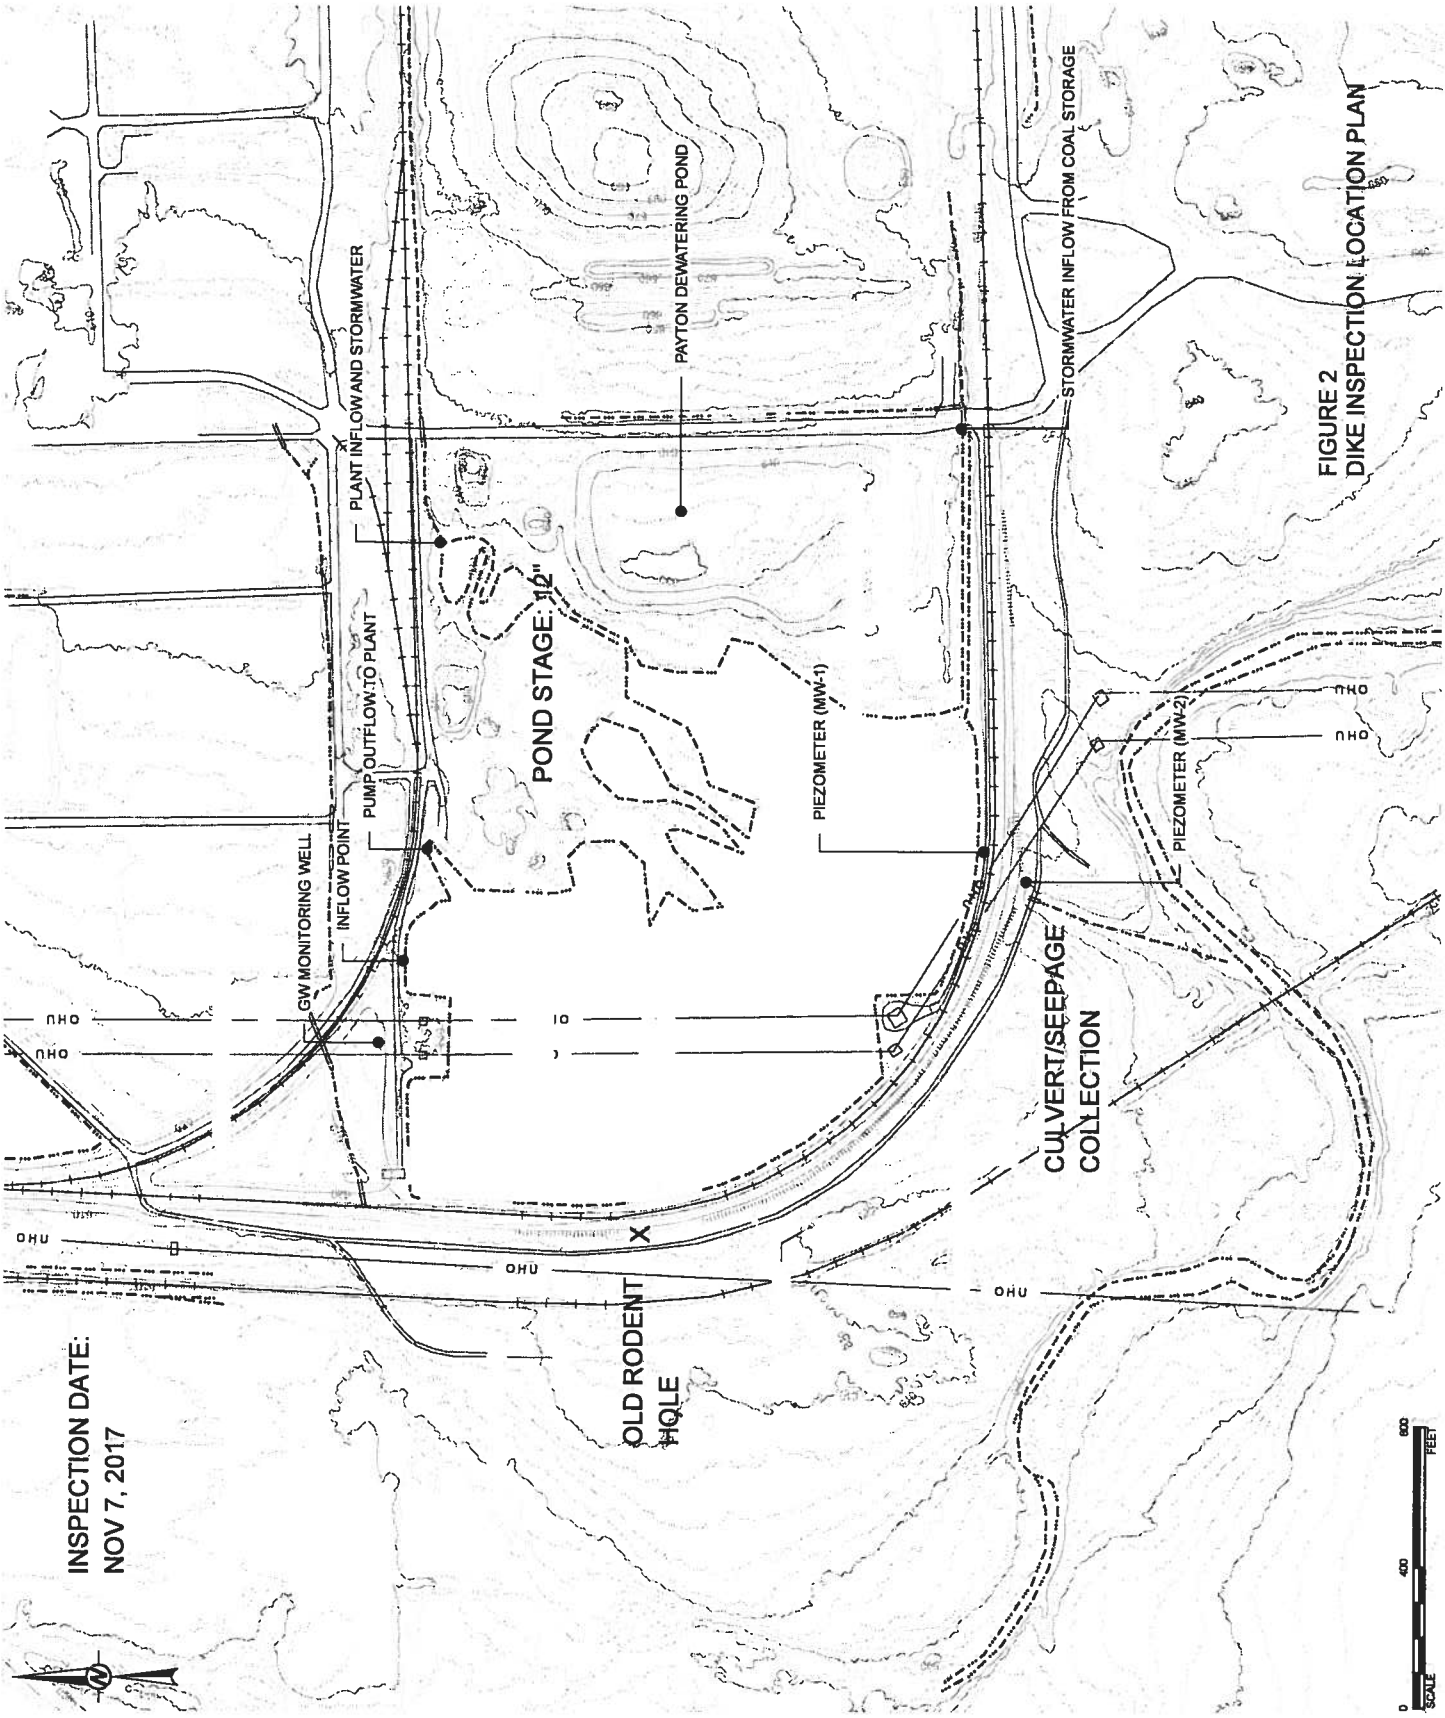
FIGURE 2
DIKE INSPECTION LOCATION PLAN

The location and type of instrumentation is shown on Figure 2. The maximum recorded readings of each instrument since the previous annual inspection is shown in Table 1 below. The readings collected since the last inspection were all within their normal safe operating ranges.
