2017 Annual Landfill Inspection Report

H.W. Pirkey Plant

FGD Stackout Area

Document Number: GERS-17-032

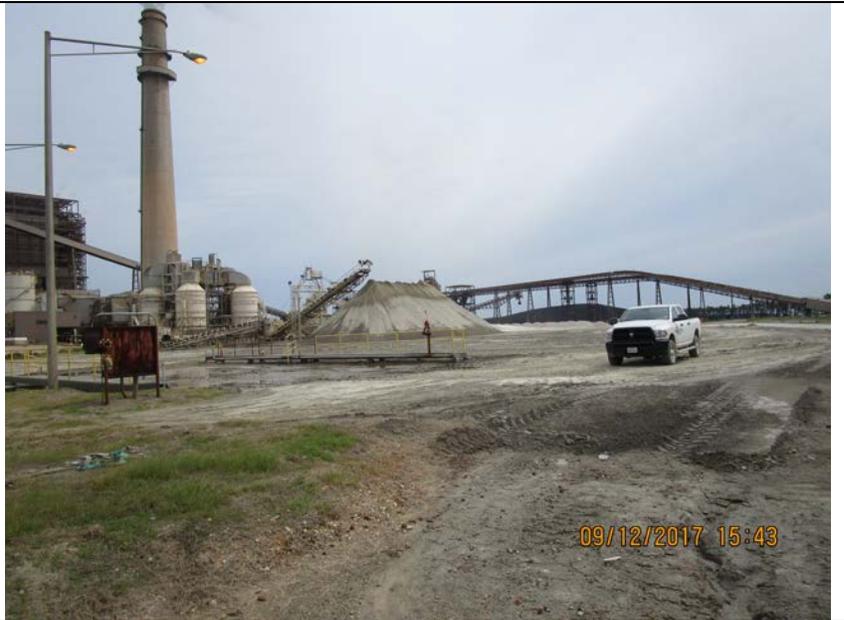
Photo # 1
View of the FGD Stackout Area.

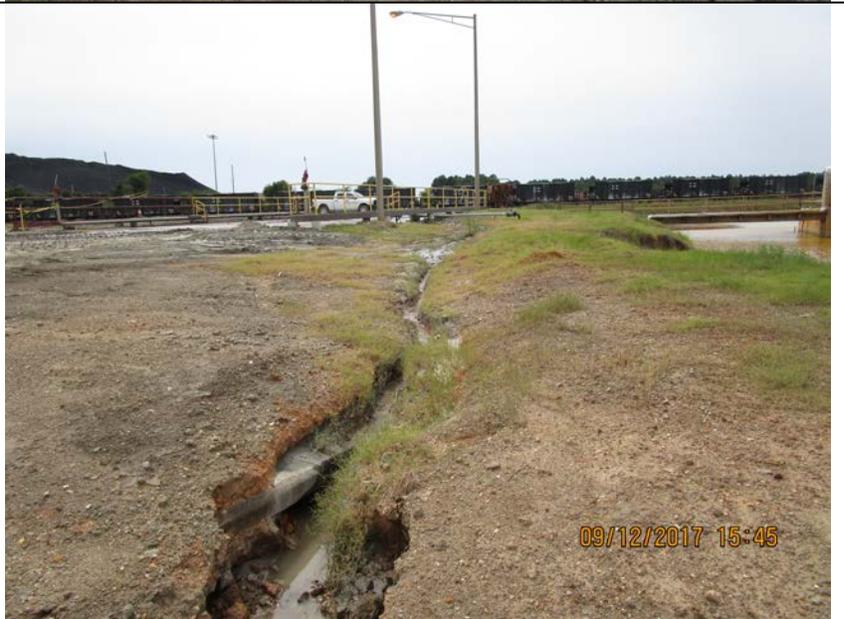
1. An erosion rill has formed on the ground surface of the FGD Stackout Area as a result of concentrated water flowing from the truck washing pad. This erosion rill was estimated to be a maximum depth of about 2.5 feet. The truck washing pad is located within the FGD Stackout Area, approximately 175 feet northwest of the radial arm stacker.

Photo # 2
View of the erosion rill which has formed on the ground surface of the FGD Stackout Area as a result of concentrated flows from the vehicle wash pad.

- 1) Repair the erosion rill which has formed from concentrated water flowing from the truck washing area to the lower surge pond. Convey water from the truck washing area via a conduit, or protect the ground surface of the FGD Stackout Area from erosion.

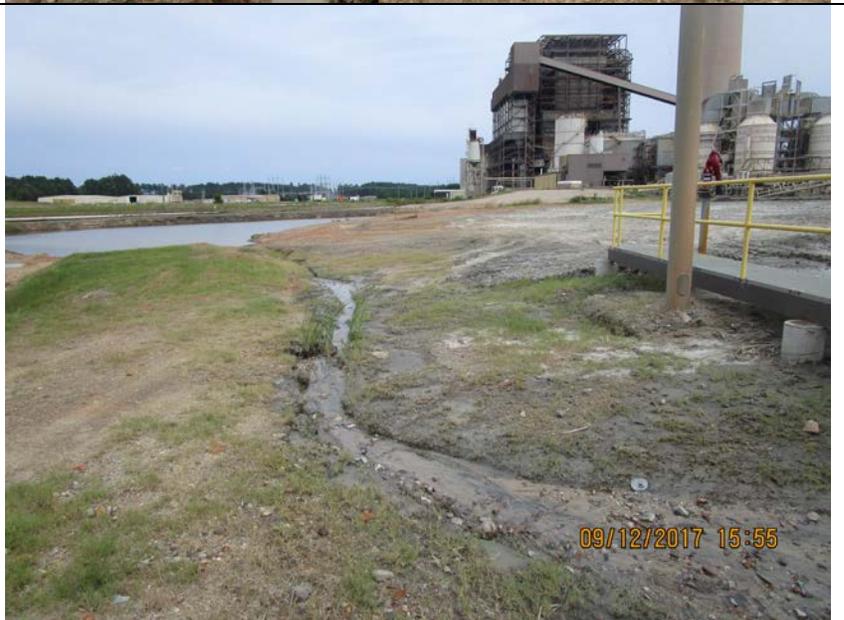
Photo # 3
Another view of the erosion rill on the ground surface of the FGD Stackout Area.

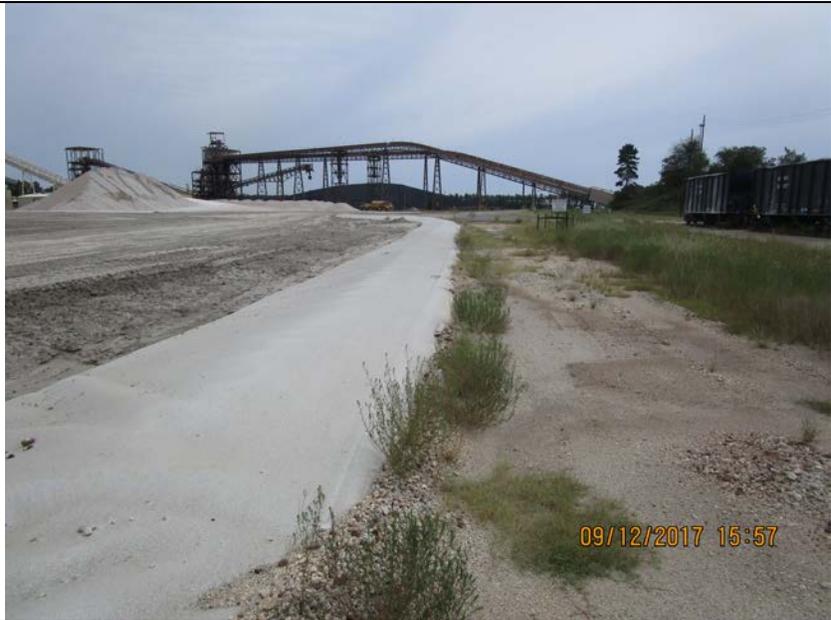
Photo # 4

2. The gravel berm with a geomembrane cover appeared to be in good condition. There was no evidence of holes, air/water pockets, or other signs of distress noted on the geomembrane.

View of the gravel berm with a geomembrane cover, facing south.

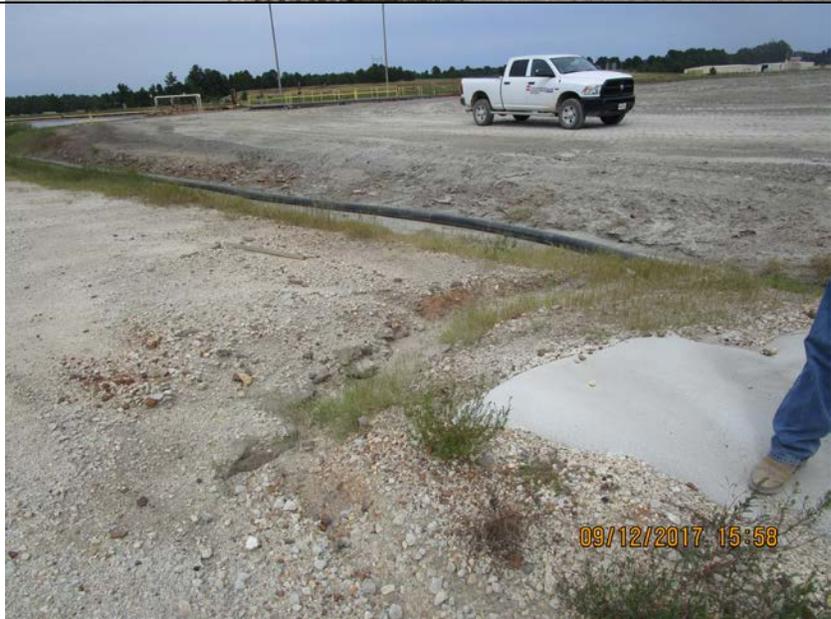
Photo # 5

3. A notch has formed at the northern end of the western gravel berm with a geomembrane cover. Non-contact water which drains along the railroad spur and the gravel berm with a geomembrane cover would enter the FGD Stackout Area and eventually end up in the surge pond. The surrounding grades and railroad spur in this area would not allow any contact water to escape through this notch and discharge off site.

View of the notch which was formed at the northern end of the western gravel berm, allowing non-contact water from a small ditch adjacent to the railroad spur to enter into the FGD Stackout Area.

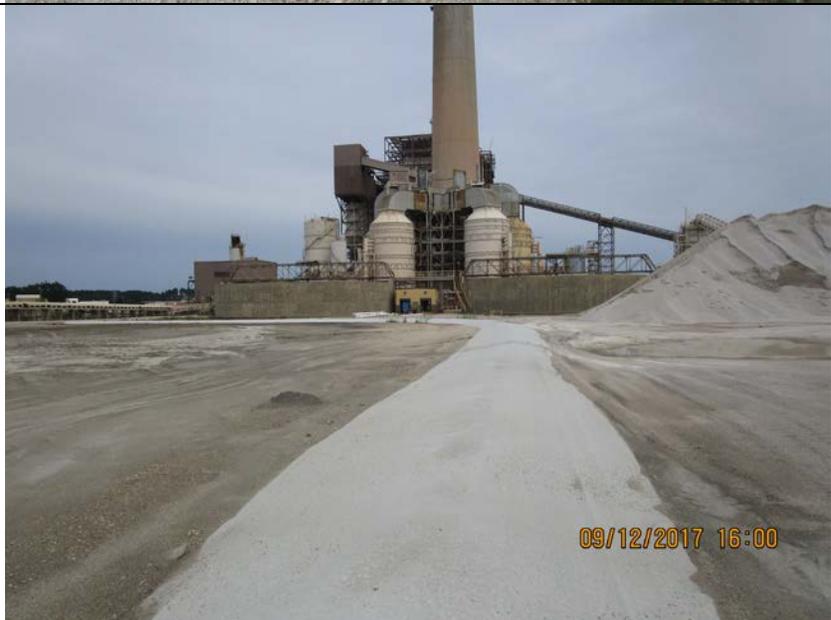
Photo # 6

View of the gravel berm with a geomembrane cover, facing east.

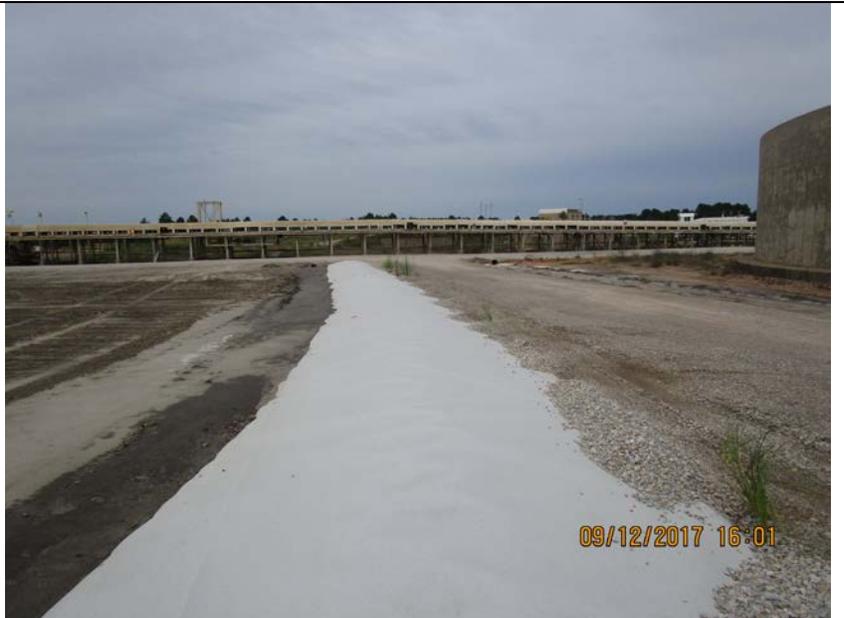
Photo # 7
View of the eastern gravel berm with a geomembrane cover, facing north.

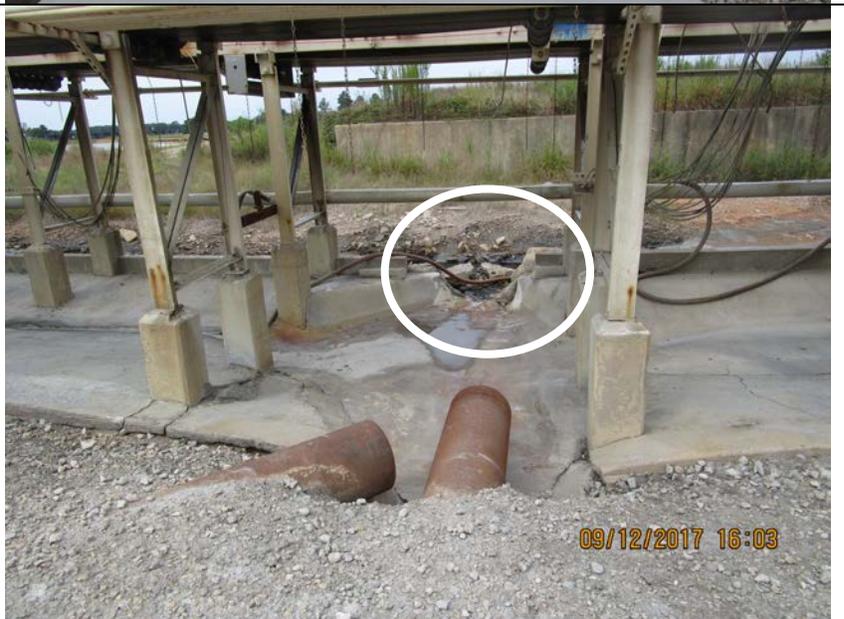
4. There is no vegetal cover on the FGD Stackout Area due to material constantly being stockpile and removed.
5. Surface water runoff from along the eastern gravel berm with a geomembrane cover is conveyed underneath an access road via a steel pipe culvert. This culvert outlets onto a concrete slab with curb walls underneath the supports for the conveyor belt which feeds the radial arm stacker. A section of these curb walls have been notched out to allow surface water runoff to drain to the auxiliary surge pond.

Photo # 8
View of the outlet area of the steel culverts under the conveyor system which feeds the radial arm stacker. The notch in the curb is circled in white.

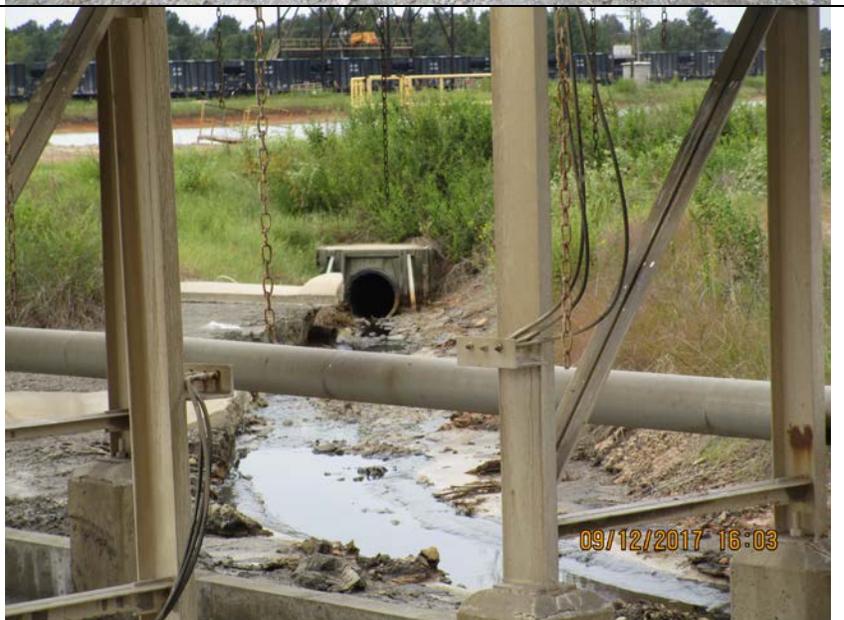
Photo # 9
View of the culvert which directs runoff into the auxiliary surge pond. This culvert is downstream of the notch in the curb shown in Photo #8.
