2017 Annual Landfill Inspection Report

H.W. Pirkey Plant

Landfill

Document Number: GERS-17-031

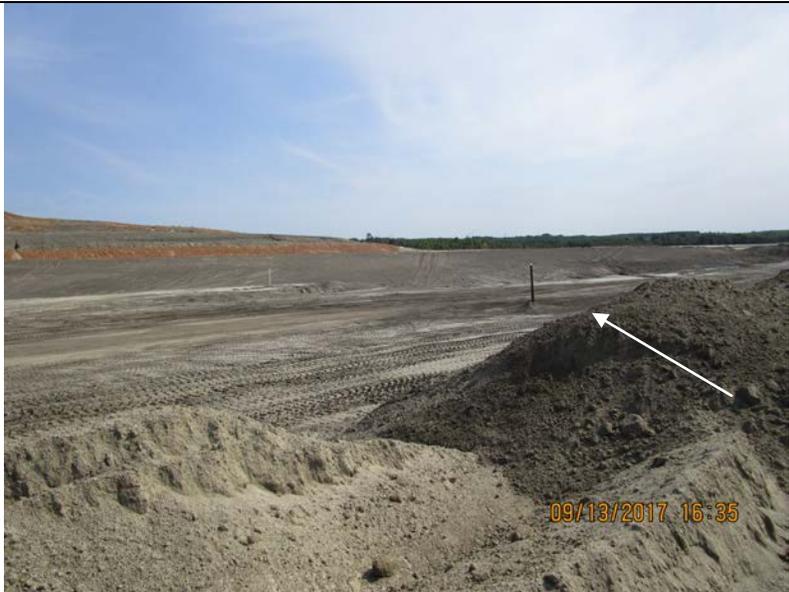
7. During the inspection the active disposal areas were being used for waste placement. The chimney drains were functioning as designed and there was no evidence of pooling water around the drains. Waste was being compacted as it was placed. In general, the chimney drain consists of bottom ash placed in a 10-foot-diameter circle centered on a perforated drain pipe wrapped in filter fabric and connected to the leachate discharge pipes.
8. The ash was placed and graded such a manner that any runoff from the active landfill area is collected, contained and drained through the chimney drain system.
9. An erosion scarp of about 2 to 7 feet in height and 50 feet in length was observed at the toe of the southern slope of the 2015 Cell. This erosion scarp appears to be occurring due to water flowing through the ditch on the southern edge of the landfill.

Photo # 1
View of the active material placement inside the 2015 Cell. Notice the chimney drain, indicated by the white arrow.

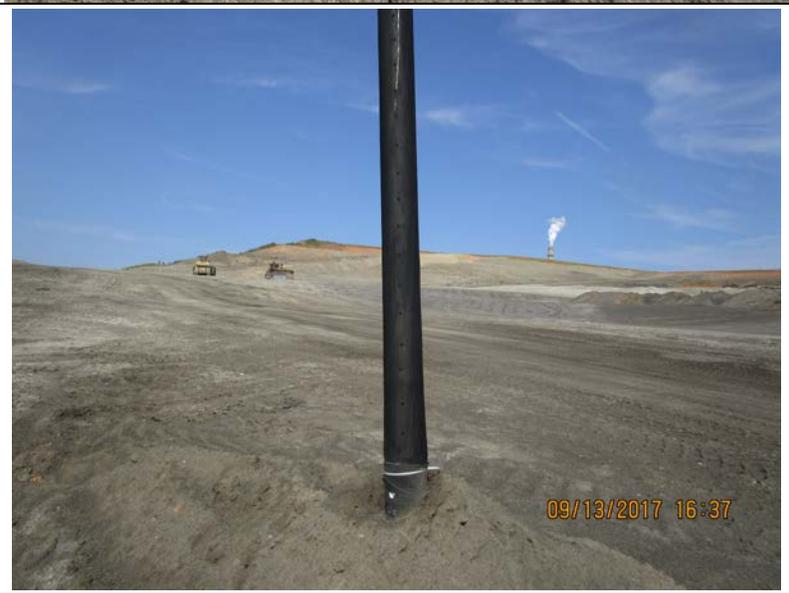
Photo # 2
Close-up view of the chimney drain.

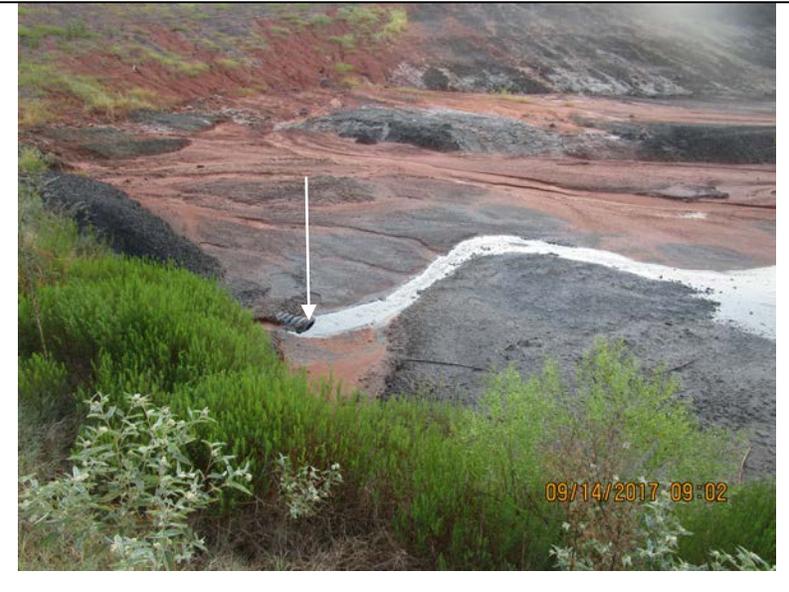
5. An 18-inch-diameter leachate collection discharge pipe was about 75% silted in near the southern edge of the 1985 Pond Cell.
6. A temporary soil cover consisting of a red clay material has been placed for an erosion protection measure. Erosion rills were noted on the temporary soil cover placed on top of the ash material, although the slope appeared stable. The maximum depth of the erosion rills was estimated to be about 9 inches.

Photo # 3
View of the silted-in 18-inch-diameter leachate collection discharge pipe on the south side of the 1985 Pond Cell.

- 1) Remove the soil/ash accumulation in front of the outlet of the 18-inch-diameter leachate collection discharge pipe on the south side of the 1985 Pond Cell so that the outlet has free draining conditions.

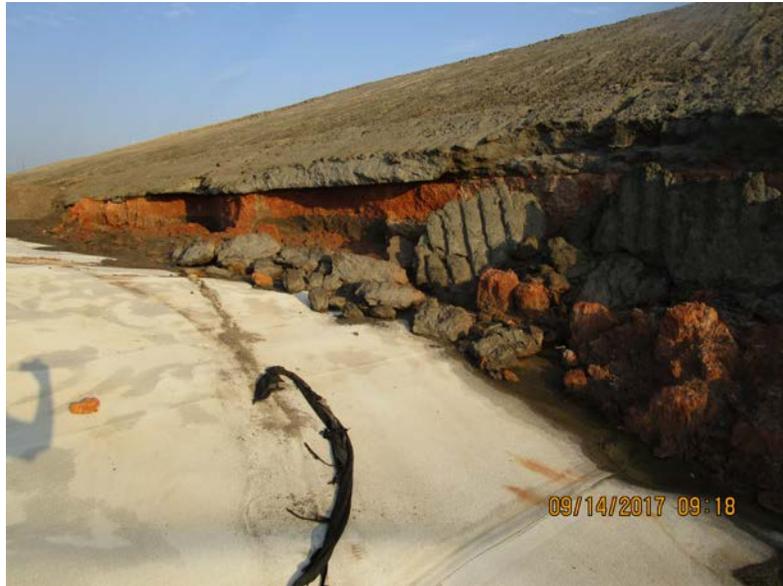
Photo # 4

View of the erosion along the southern toe of the slope of the 2015 Cell.

- 3) Repair the erosion at the toe of the south face of the 2015 cell.
- 4) Remove the broken and distressed concrete slab slope protection at the inlet of the two, 36-inch-diameter culverts. After removing the concrete slab, monitor this area for erosion. If it is deemed necessary, additional erosion protection can be re-installed.

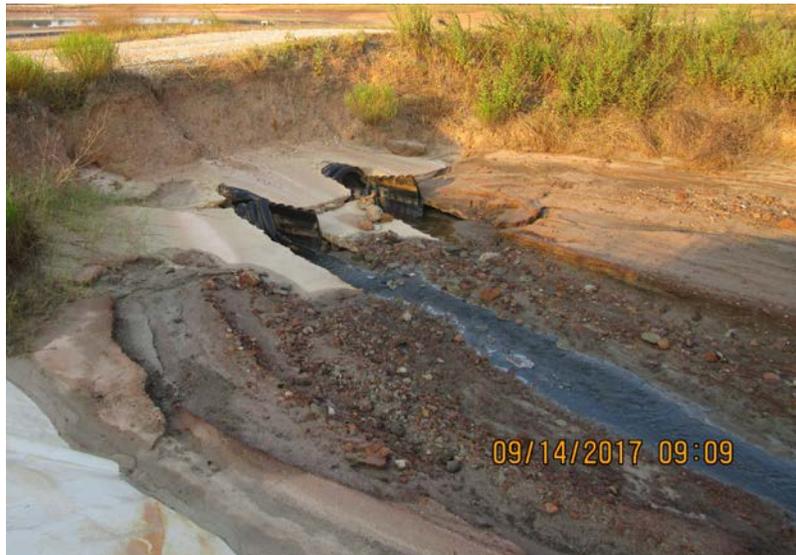
Photo # 5

12. Concrete slope protection installed on the inlet area of two, 36-inch-diameter culverts which discharge leachate and contact water into the Landfill Runoff Pond was observed to be broken and distressed. The geomembrane landfill liner extends underneath the entire length of the culverts. An access road runs over top of the culverts.

View of the distressed concrete slope protection in the area of two 36-inch-diameter culverts conveying contact water to the Landfill Runoff Pond.

- 1) After removing the broken and distressed concrete slope protection around the two, monitor the 36-inch-diameter culverts underneath the access road along the southern edge of the landfill for erosion. If excessive erosion is observed, install additional erosion protection.
- 2) Monitor the riprap armored earthen berm at the outlet of the non-contact water ditch near the southwestern corner of the landfill area after heavy rain events for erosion or overtopping of the berm.

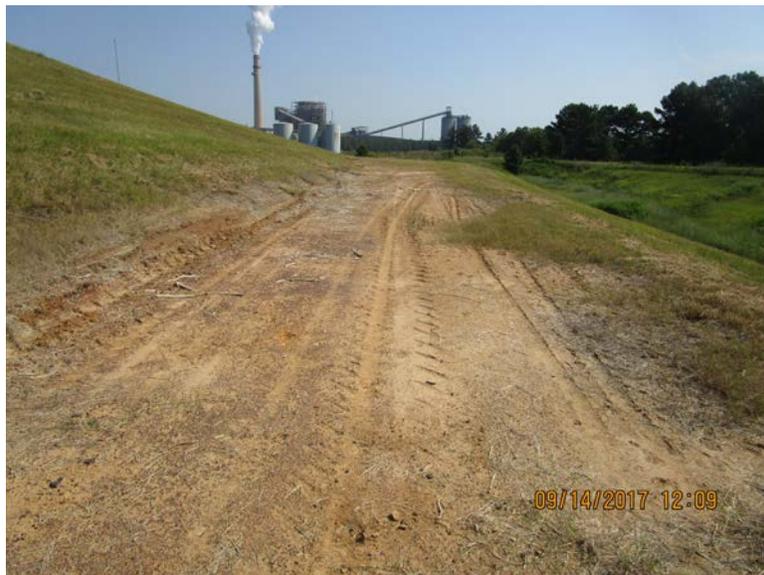
Photo # 6

2. The closed landfill area was observed to have a thick stand of grass cover over the majority of the capped area. Minor bare areas were observed on the benches on the northern face of the landfill, on the 1999 and 2005 Cells. Bare areas were noted on the lower bench of the eastern face of the 1993 and 1987 Cell. Tire ruts/dozer tracks were observed on the landfill cover of the 1987 Cell, just north of the Mohon Well. In addition, erosion rills about 2-feet deep were observed on the soil cover near the northern drainage ditch adjacent to the Mohon well, also on the 1987 Cell.

View of one of the bare areas on the lower bench of the 1987 Cell.

- 9) Establish grass cover on the bare areas noted on the east and north sides of the landfill area.

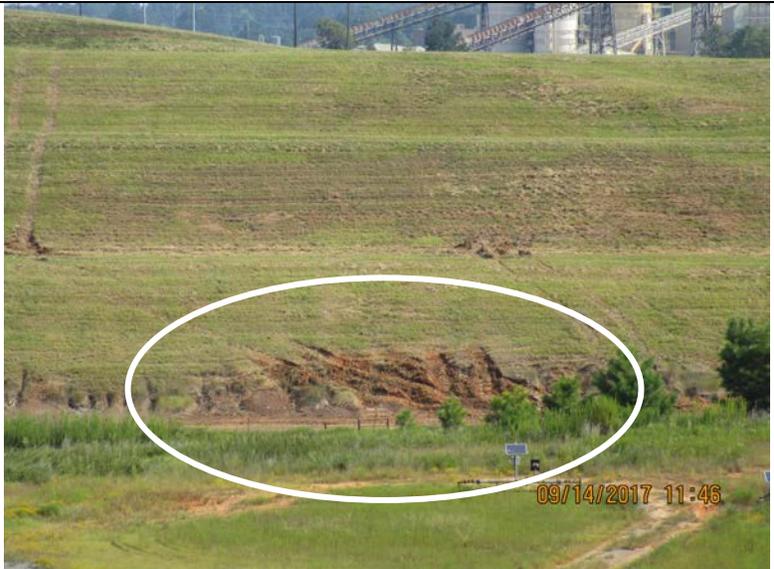
Photo # 7
View of the tire ruts on the toe of the landfill, just north of the Mohon Well Area.

- 6) Repair the tire ruts on the landfill cap north of the Mohon Well area. Establish grass cover on any disturbed areas.
- 7) Repair the erosion rills on the cap to the north of the Mohon Well area. Establish grass cover on any disturbed areas.

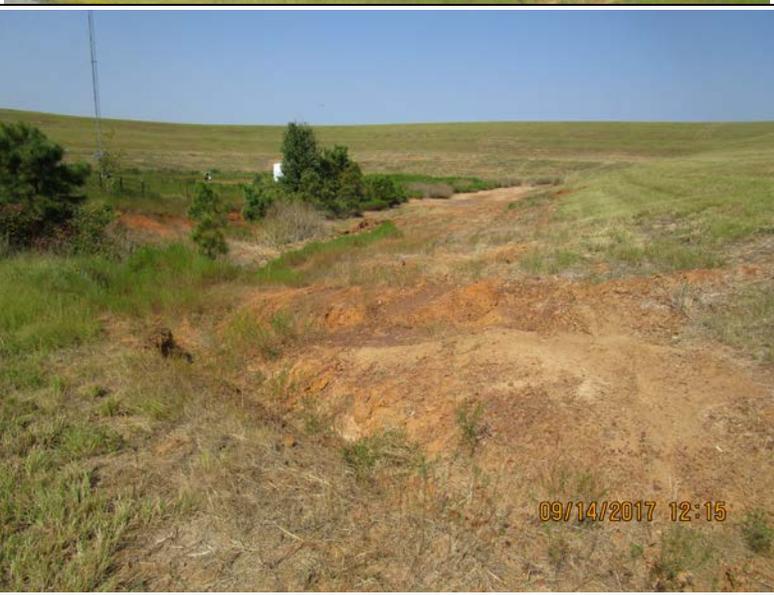
Photo # 8
View of the 2-foot-deep erosion rills near the northeastern corner of the 1987 Cell.

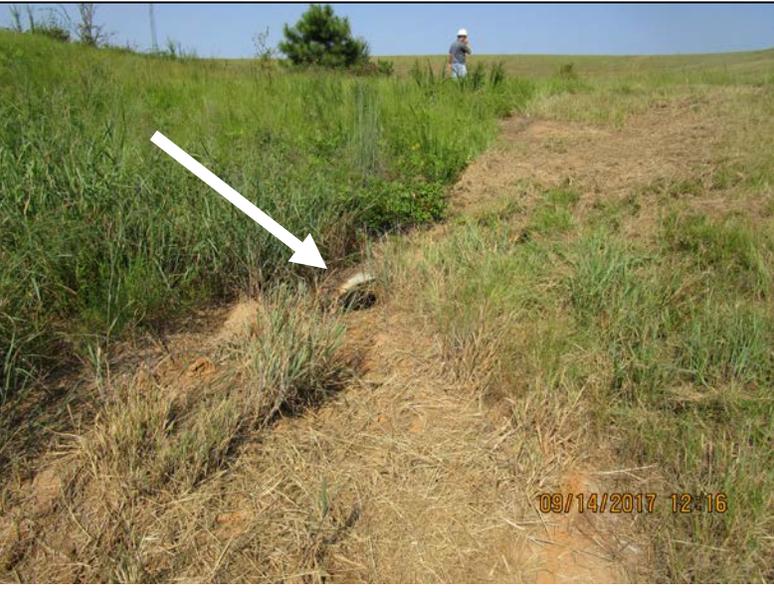
11. A corrugated metal pipe culvert, estimated to be about 30 to 36 inches in diameter, was observed to be about 80% silted-in on the northern side of the Mohon Well area. This appears to create poor drainage conditions in the ditch along the toe of the landfill slope in the area to the north of the Mohon Well.

Photo # 9
View of the silted-in corrugated metal pipe near northeastern corner of the 1987 Cell.

- 5) Remove the silt accumulation at the corrugated metal pipe culvert to the north of the Mohon Well area to improve the drainage conditions along the toe of the landfill slope.

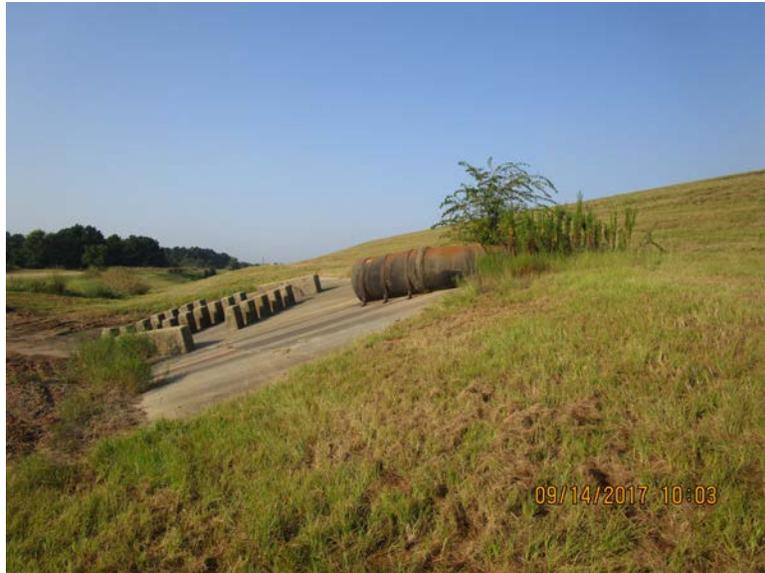
Photo # 10

4. Minor brush was observed to be growing around the energy dissipater structures for the “let down” piping on the eastern edge of the landfill area.

View of some minor brush growing around the energy dissipater structure for the “let-down” pipe on the 1984 Cell.

- 8) Remove the brush growing around the outlets of the “let down” piping on the east side of the landfill. Establish grass cover on any disturbed areas.

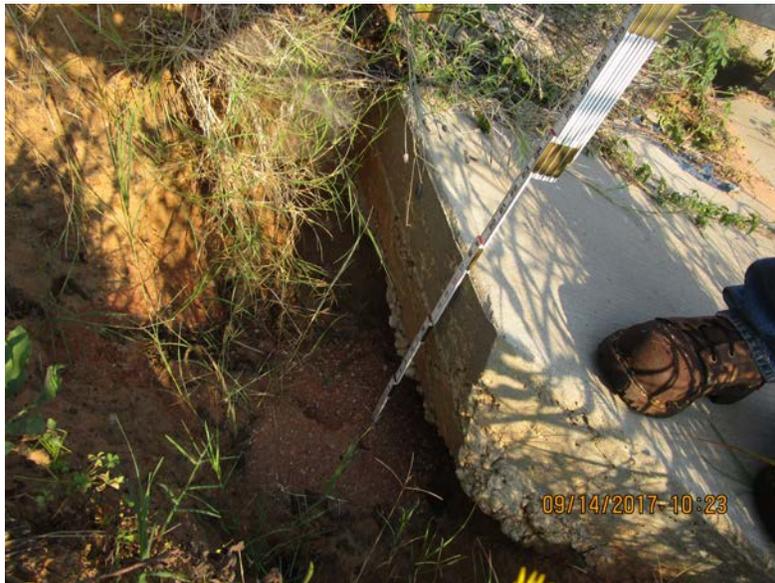
Photo # 11

1. In general, surface water runoff from the cap was draining as designed. One of the concrete slabs around a catch basin for the “let down” pipe was observed to be undermined and the soil of the cap just upslope of the catch basin is eroded. This erosion/undermining appear to be the result of concentrated water flowing down the landfill slope from a surface water drainage pipe near the top of the landfill.

View of the undermined concrete slab around a catch basin for the “let-down” pipe near the top of the 1999 Cell. A gap measuring about 8 inches was noticed at the time of the inspection.

- 2) Repair the cap erosion and the undermined concrete slab around the catch basin on the north side of the 1999 Cell. Install erosion control features or relocate the outlet of the drainage pipe to prevent future erosion.

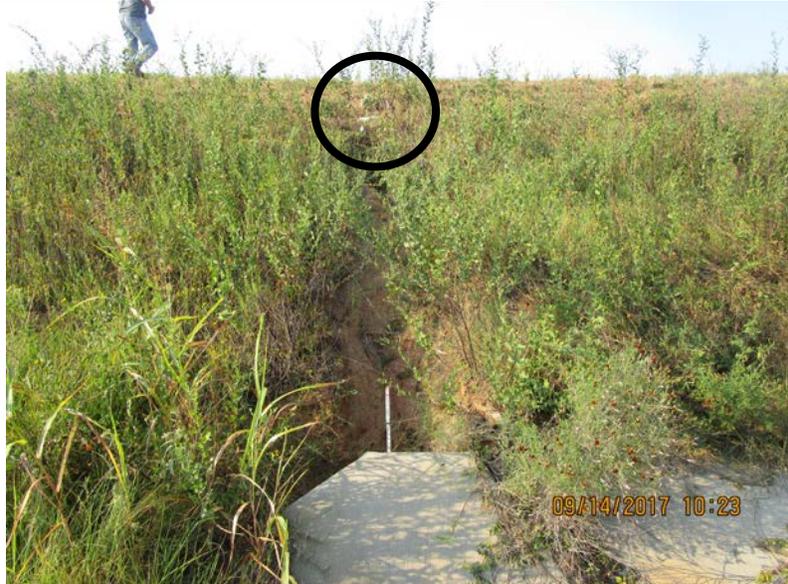
Photo # 12

View of erosion occurring just upslope of the undermined concrete slab shown in Photo #11. The surface drainage pipe outlet is circled in black.

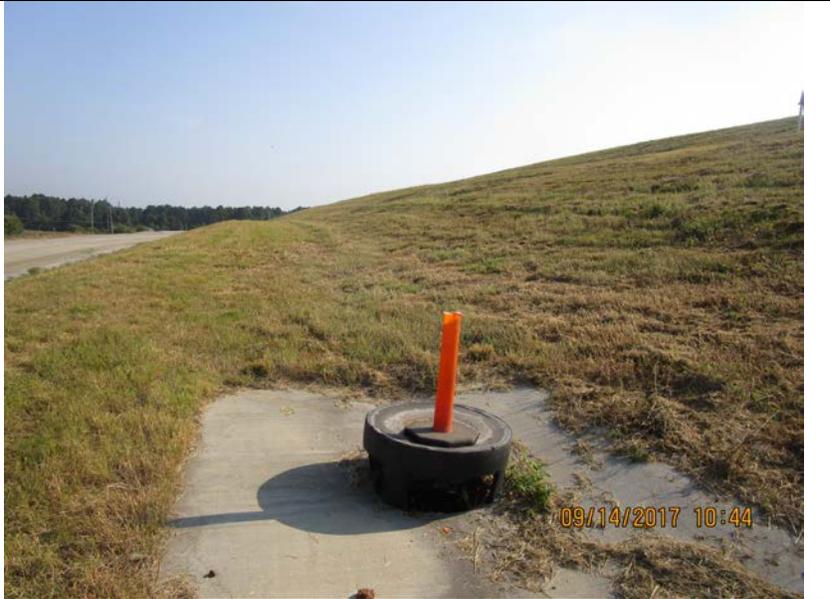
Photo # 13
Typical view of the western slope of the 2005 Cell.

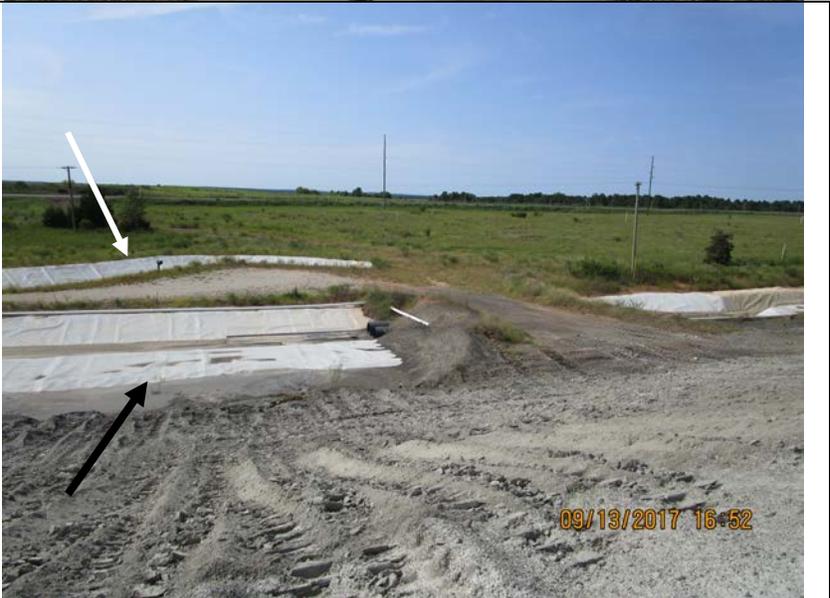
Photo # 14
View of the two, parallel ditches on the western perimeter of the landfill area. The black arrow indicates the contact water ditch, and the white arrow indicates the non-contact water ditch.

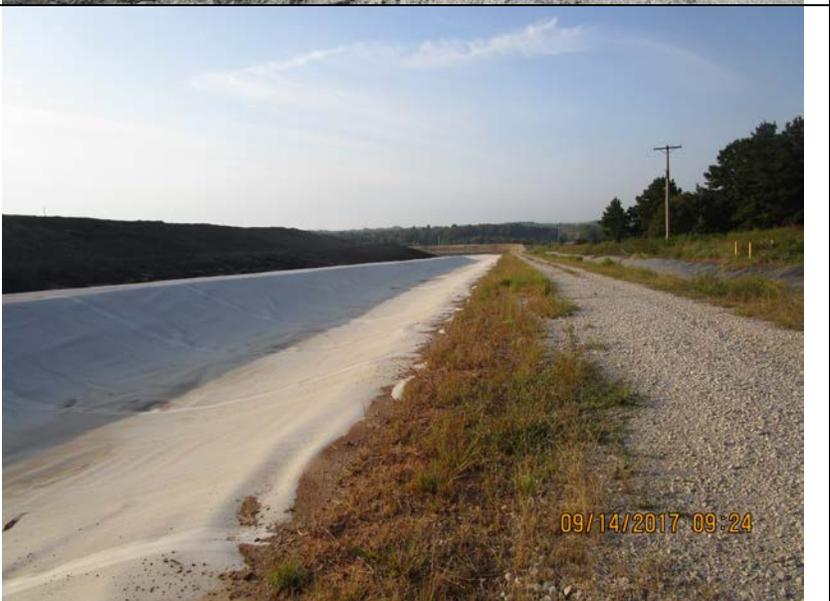
14. A contact storm water ditch runs along the western edge of the landfill area and is lined with a geomembrane. The ditch was observed to be clear of sediment accumulation and was in good condition. Water flowing through this ditch eventually ends up in the Landfill Runoff Pond.

Photo # 15
View looking south at the contact water ditch along the western perimeter of the landfill area.

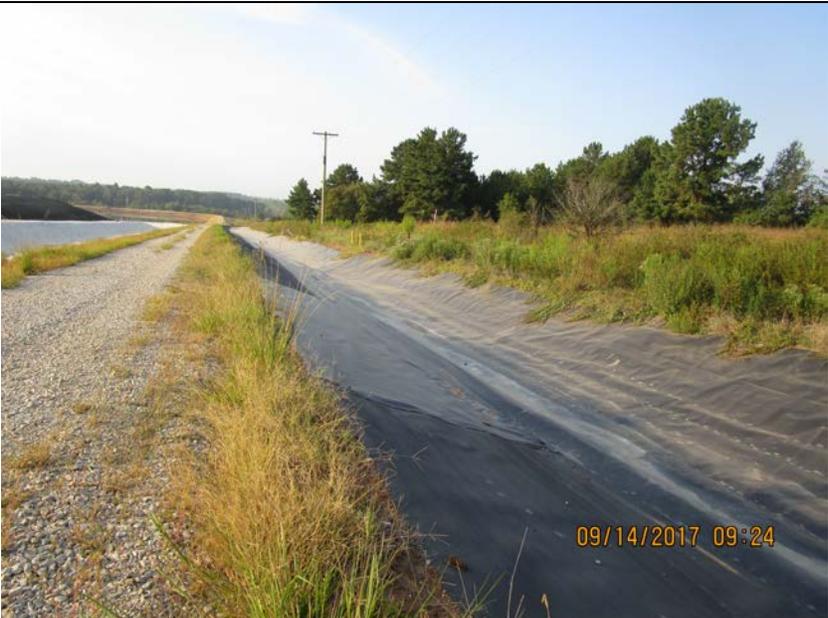
Photo # 16

15. A non-contact storm water ditch runs along the western edge of the landfill is lined with a geomembrane material. Runoff from the 2005 Cell is collected into a 36-inch-diameter conduit and this conduit discharges into the non-contact water ditch. An earthen berm armored with riprap material has been placed at the end of the non-contact water ditch to divert flows away

from the toe area of the Landfill Runoff Storm Water Pond Dam. Small holes about 2 inches in diameter have been cut into the geomembrane to allow any trapped groundwater under the geomembrane to drain and prevent floating of the geomembrane liner.

View looking south at the non-contact water ditch along the western perimeter of the landfill area.

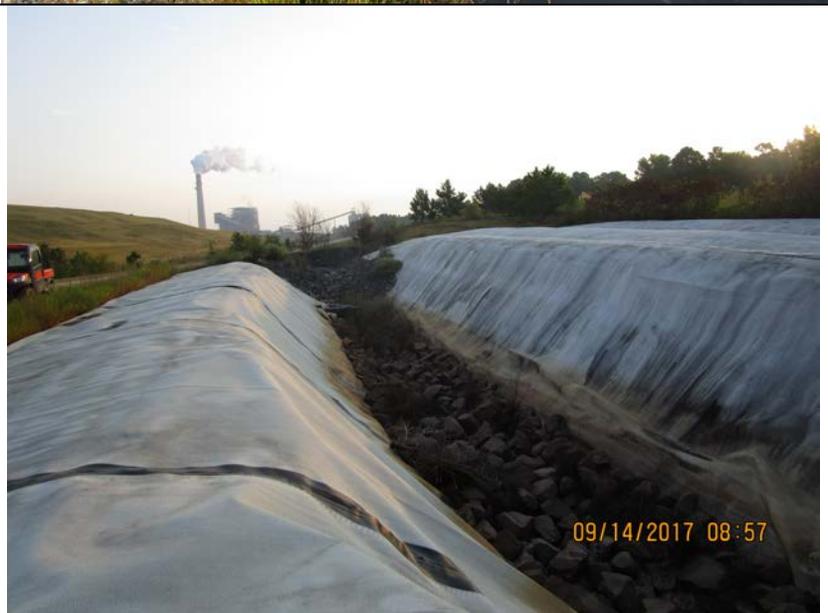
Photo # 17

View looking north at the non-contact water ditch downstream of the two 36-inch-diameter culverts near the southeastern corner of the landfill area.

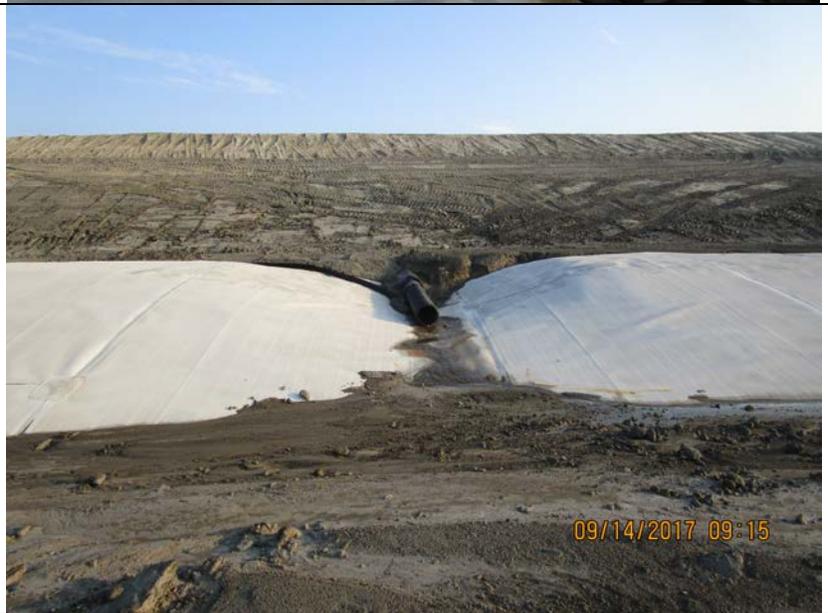
Photo # 18

View of a leachate collection system discharge pipe on the southern end of the landfill.
