# 2017 Annual Landfill Inspection Report

**Rockport Plant  
Indiana Michigan Power Company  
Rockport, Indiana**

**August 10, 2017**

**Document ID: GERS-17-020**

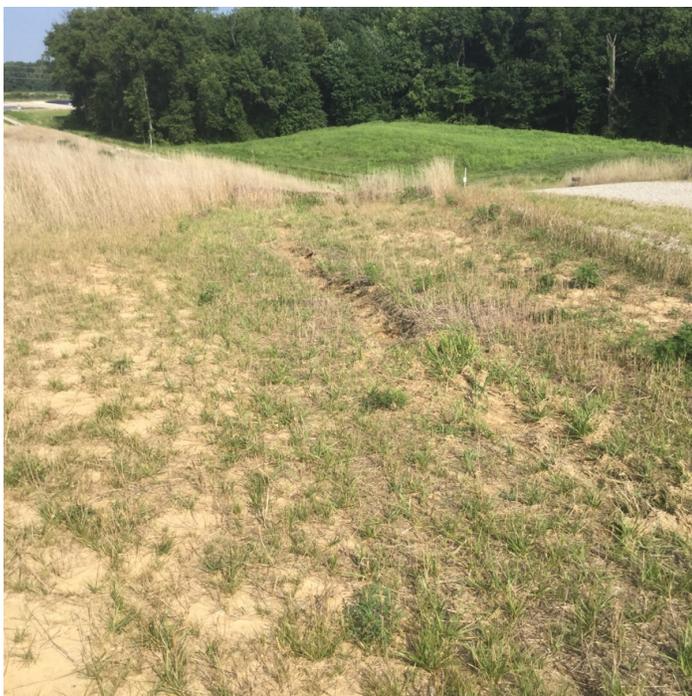
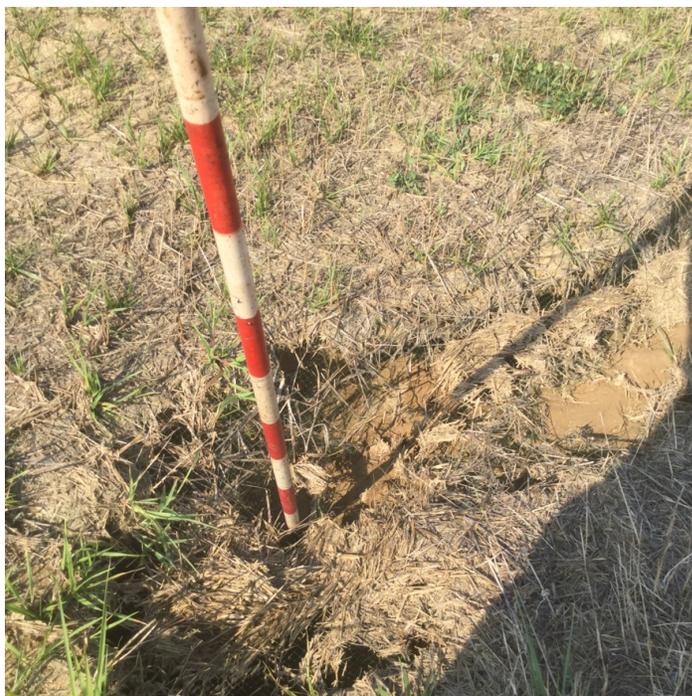
1. The closed landfill area was observed to have a thick stand of grass cover over the entire capped area. Runoff from the cap was draining as designed. There were no signs of settlement, signs of movement or distress of the landfill area. Access roads on top and adjacent to the landfill area were in good condition.
2. At the north west side of the Closed Landfill Area adjacent to Cell 4A along the south side of the haul road there was minor erosion discovered along the drainage channel (Observation 1).
3. At the south east side of the landfill there was an area of minor erosion observed on the cap (Observation 2).

- 2) Repair eroded channel along the north west of the Closed Landfill Area adjacent to Cell 4A along the haul road. (Observation 1)
- 3) Repair erosion at the south east portion of the Closed Landfill Area by placement of soil and vegetative cover. If necessary install erosion control blankets. (Observation 2)
- 4) Repair erosion located along the north east side of Cell 1B by placement of rip rap within the channel and seed adjacent areas. (Observation 3)
- 5) Reseed thin and bare areas of vegetation and repair any erosion along the perimeter berm of

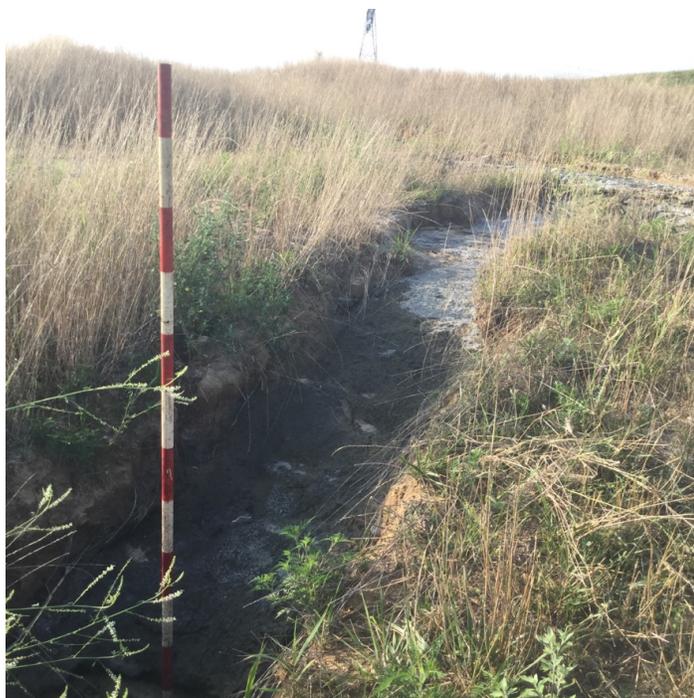
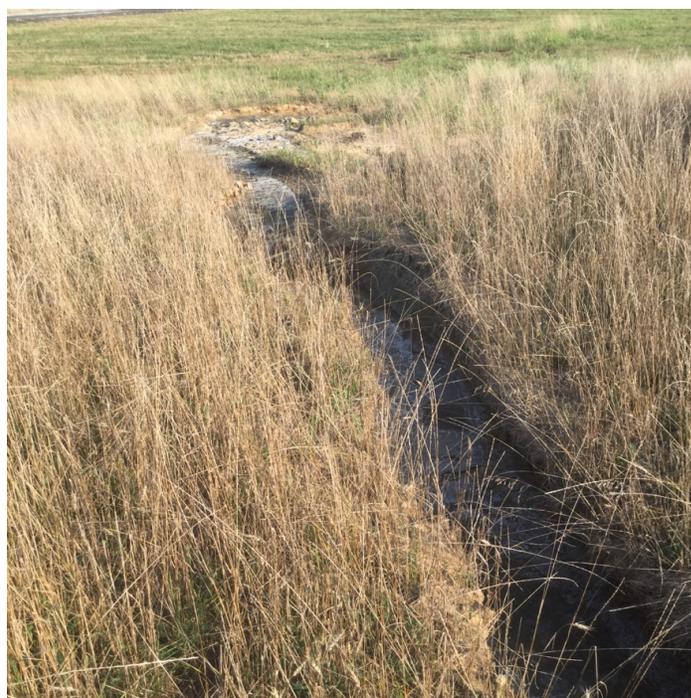
5. At an area to the north and west of Cell 1B minor erosion was observed. The erosion extended approximately 50-feet along a steepened section where drainage collects off the face of the cell. In several isolated areas the erosion was over 12-inches deep and has eroded the intermediate cover. (Observation 3)

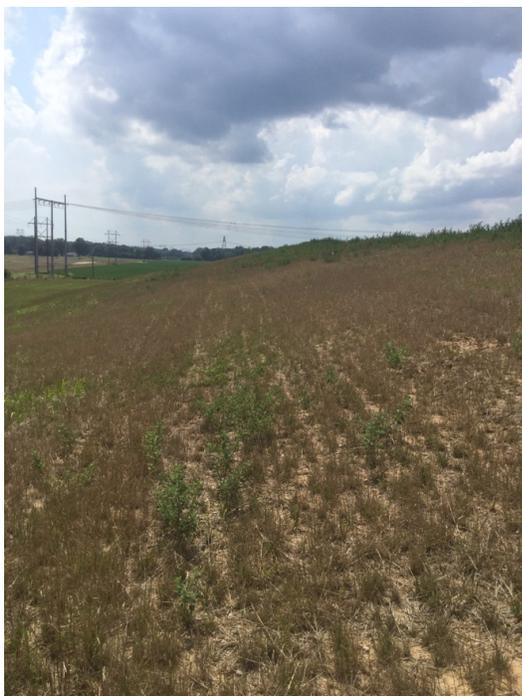
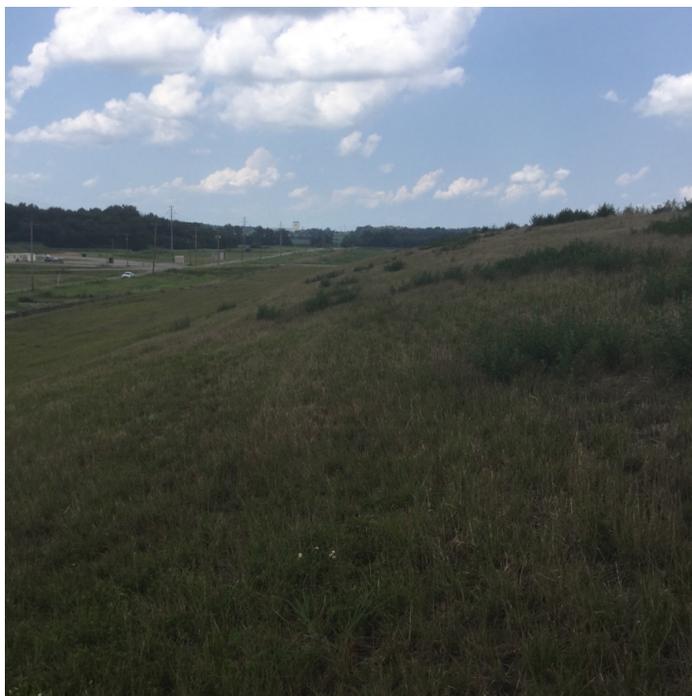
6. The perimeter berms of Cell 2 and 3 were vegetated in 2016. The areas appear to have been seeded with a mixture of perennial and annual grasses to help promote initial growth. It was observed that the annual grasses were in general well established to prevent erosion but have now died. The establishment of the perennial grasses is currently thin. (Observation 4) In several areas the soil is bare and is experiencing minor erosion. (Observation 5)

- Cell 2 and 3. If necessary perform an agriculture soil analysis for specific soil amendment recommendations. (Observation 4 & 5)
- 6) Within the Active Landfill Disposal Areas provide positive drainage to areas that currently pool runoff. Runoff should be directed to the West Pond. (Observation 6)

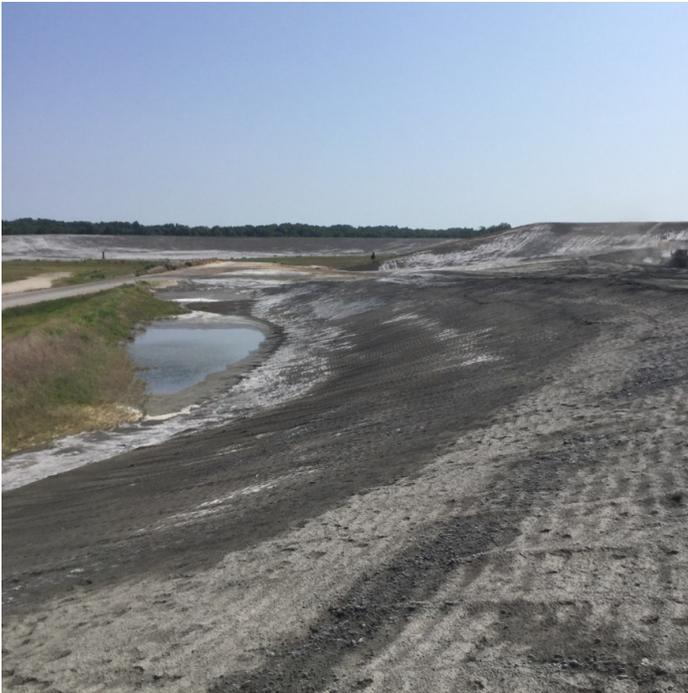
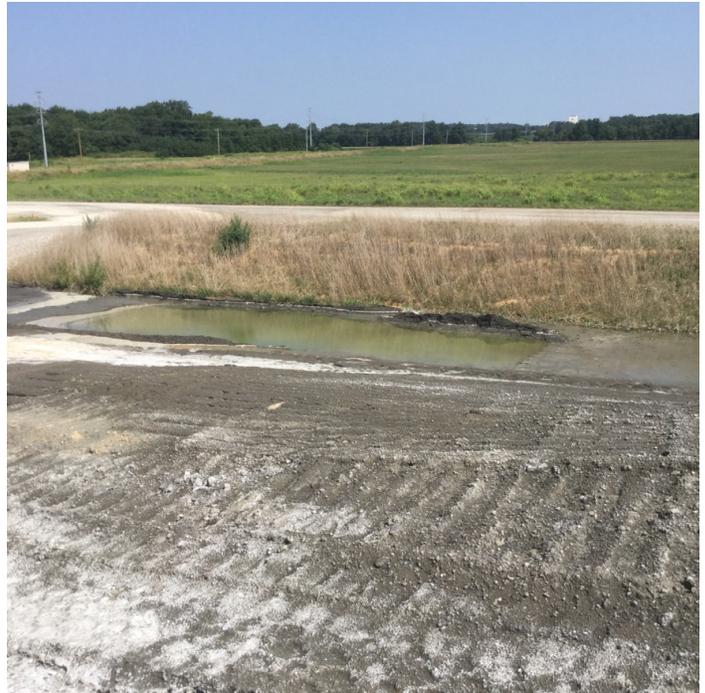
7. Due to heavy rains several days prior to the inspection ponding water was observed in the lower pockets of the active area along the north side of Cell 2 and Cell 3. (Observation 6)

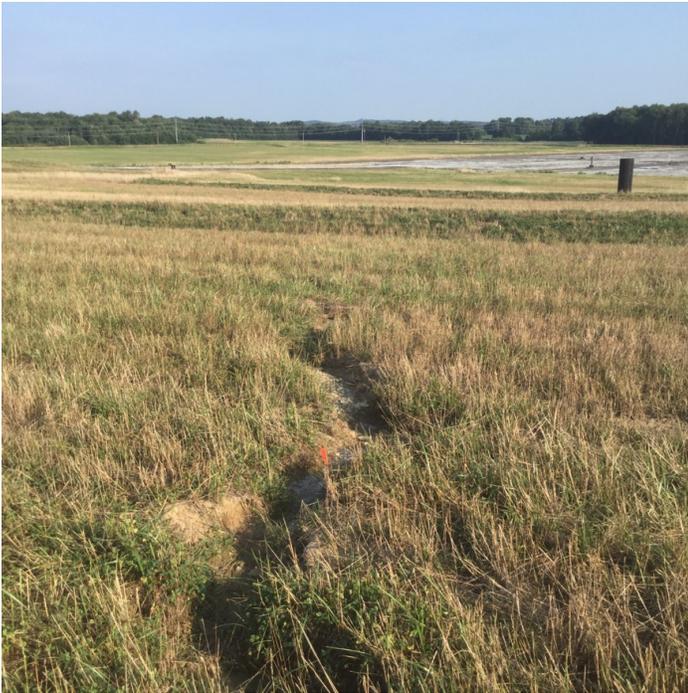
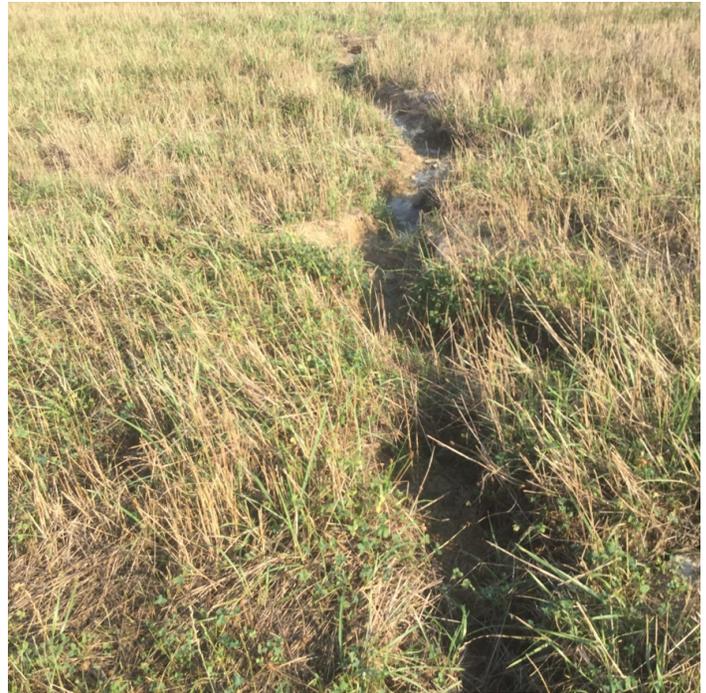
8. Cell 1A was well vegetated and was recently mowed. There were no signs of depressions, cracks, sloughs or other signs of distress. In general the area was in good condition.
9. There was an area of minor erosion observed on the west edge of Cell 1A. The erosion was approximately 6" in depth and isolated to the temporary cover soil. (Observation 7)

- 7) Repair erosion located on within the intermediate cover of Cell 1A by regrading and placement of soil and vegetative cover within the erosion rill. If necessary install erosion control blankets. (Observation 7)

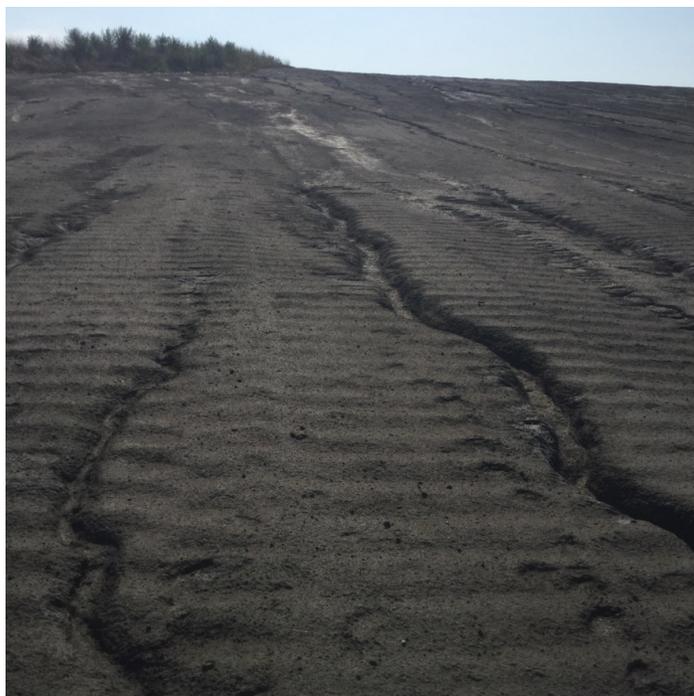
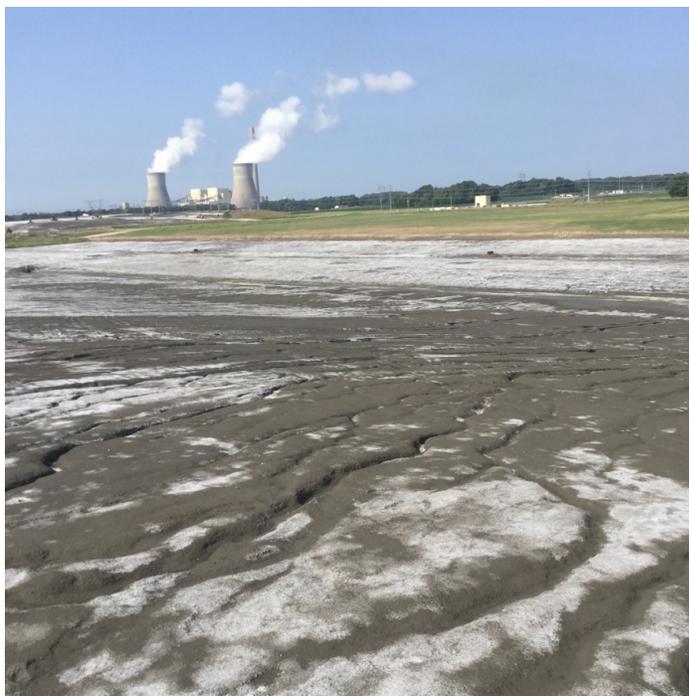
10. A majority the surface of Cell 5 and 4A consisted of ash which was placed as protective cover over the newly constructed cells. In general the ash surface was in fair condition with minor erosion rills observed in the surface of the protective cover (Observation 8).

- 8) Periodically regrade exposed ash protective cover within Cell 4A and Cell 5 to repair and prevent erosion. As planned, place intermediate soil cover and vegetate surface over exposed ash. (Observation 8)

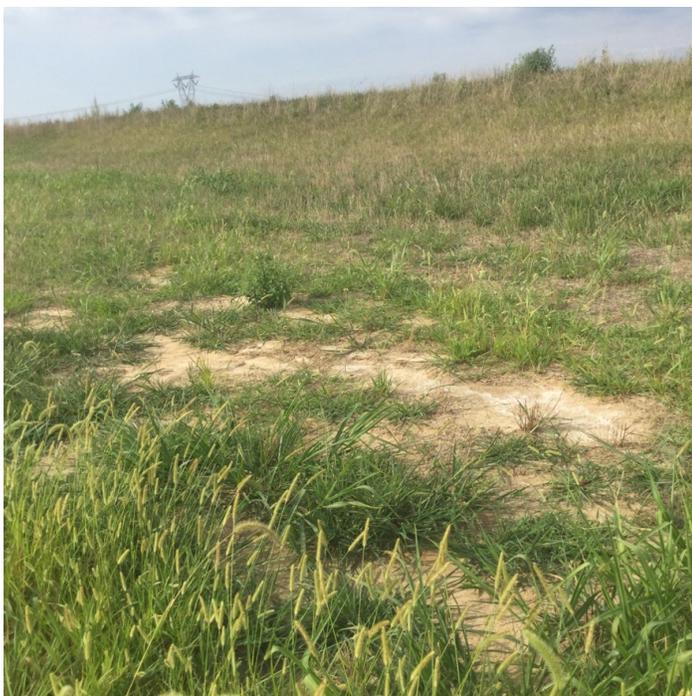
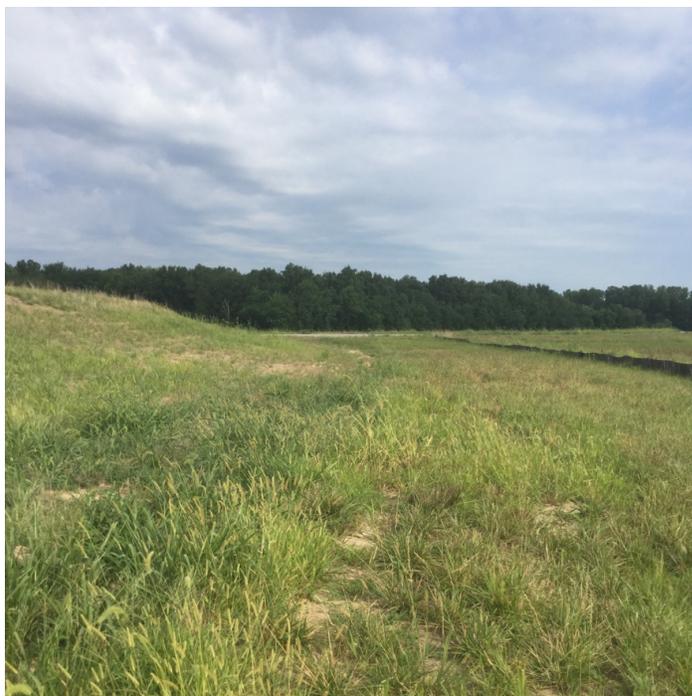
11. The perimeter berm located on the eastern side of Cell 5 and Cell 4A ties into the final cover of the Closed Landfill Area. There were no signs of depressions, cracks, bulges or other signs of distress. The area was seeded in 2016 and in general the area was well vegetated however there were several thin areas of vegetation (Observation 9). A silt fence used during construction is damaged in several areas and does not appear to be need any longer. (Observation 10).

- 9) Reseed thin and bare areas of vegetation cover along the perimeter berm of Cell 4A and 5. (Observation 9)
  - 10) Repair or remove silt fence located along the perimeter berm of Cell 4A and 5. Contact plants environmental representative to determine if silt fence can be removed. (Observation 10)

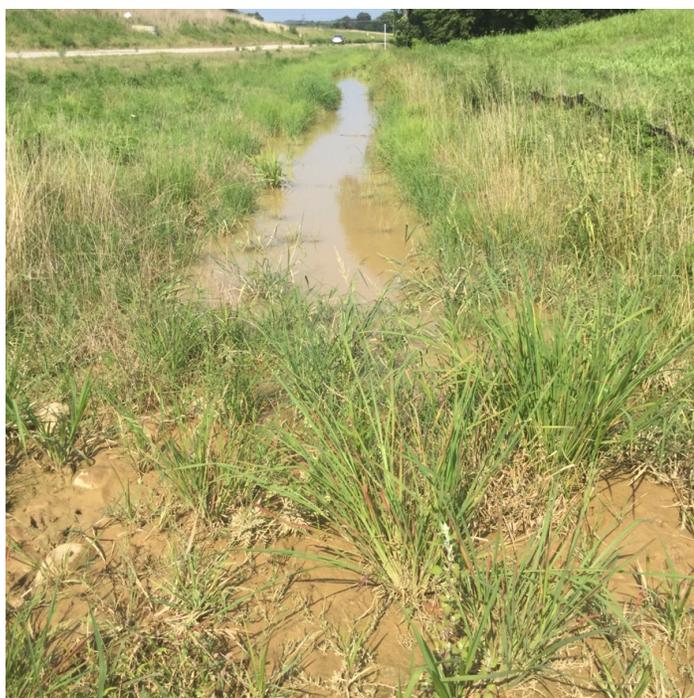
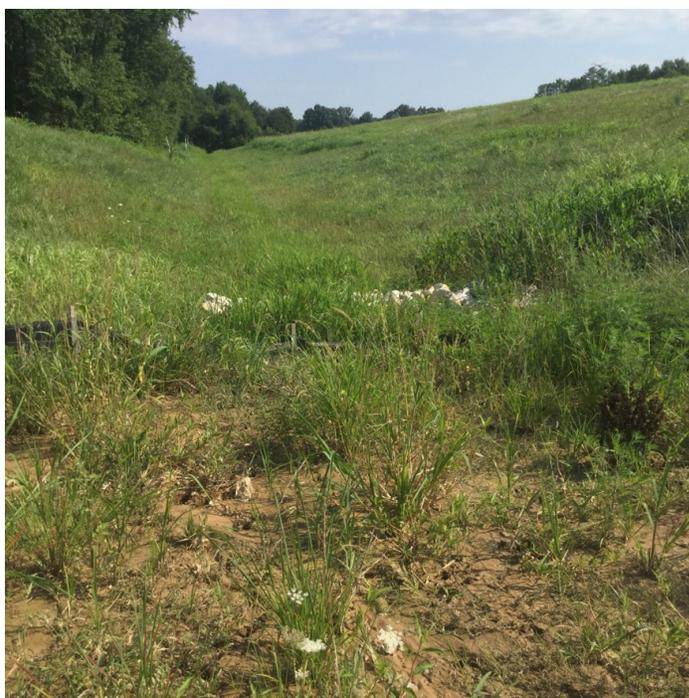
18. The perimeter ditches to the West and South were in good condition with no signs of erosion or blockage and appeared to be functioning as designed.
19. The drainage ditch to the north of Cell 4A at the corner near the Closed Landfill Area was partially blocked with sediment. The energy rip rap apron were covered with soil that appears to be from erosion of the upstream ditch. The partial blockage created ponding in this area. Sediment fence in this area was damaged and full of sediment (Observation 12).

- 11) Remove sediments in the channel at the corner of Cell 4A and the Closed Landfill Area to allow for positive drainage. Repair sediment fence in channel or remove once upstream areas have been stabilized. (Observation 12)

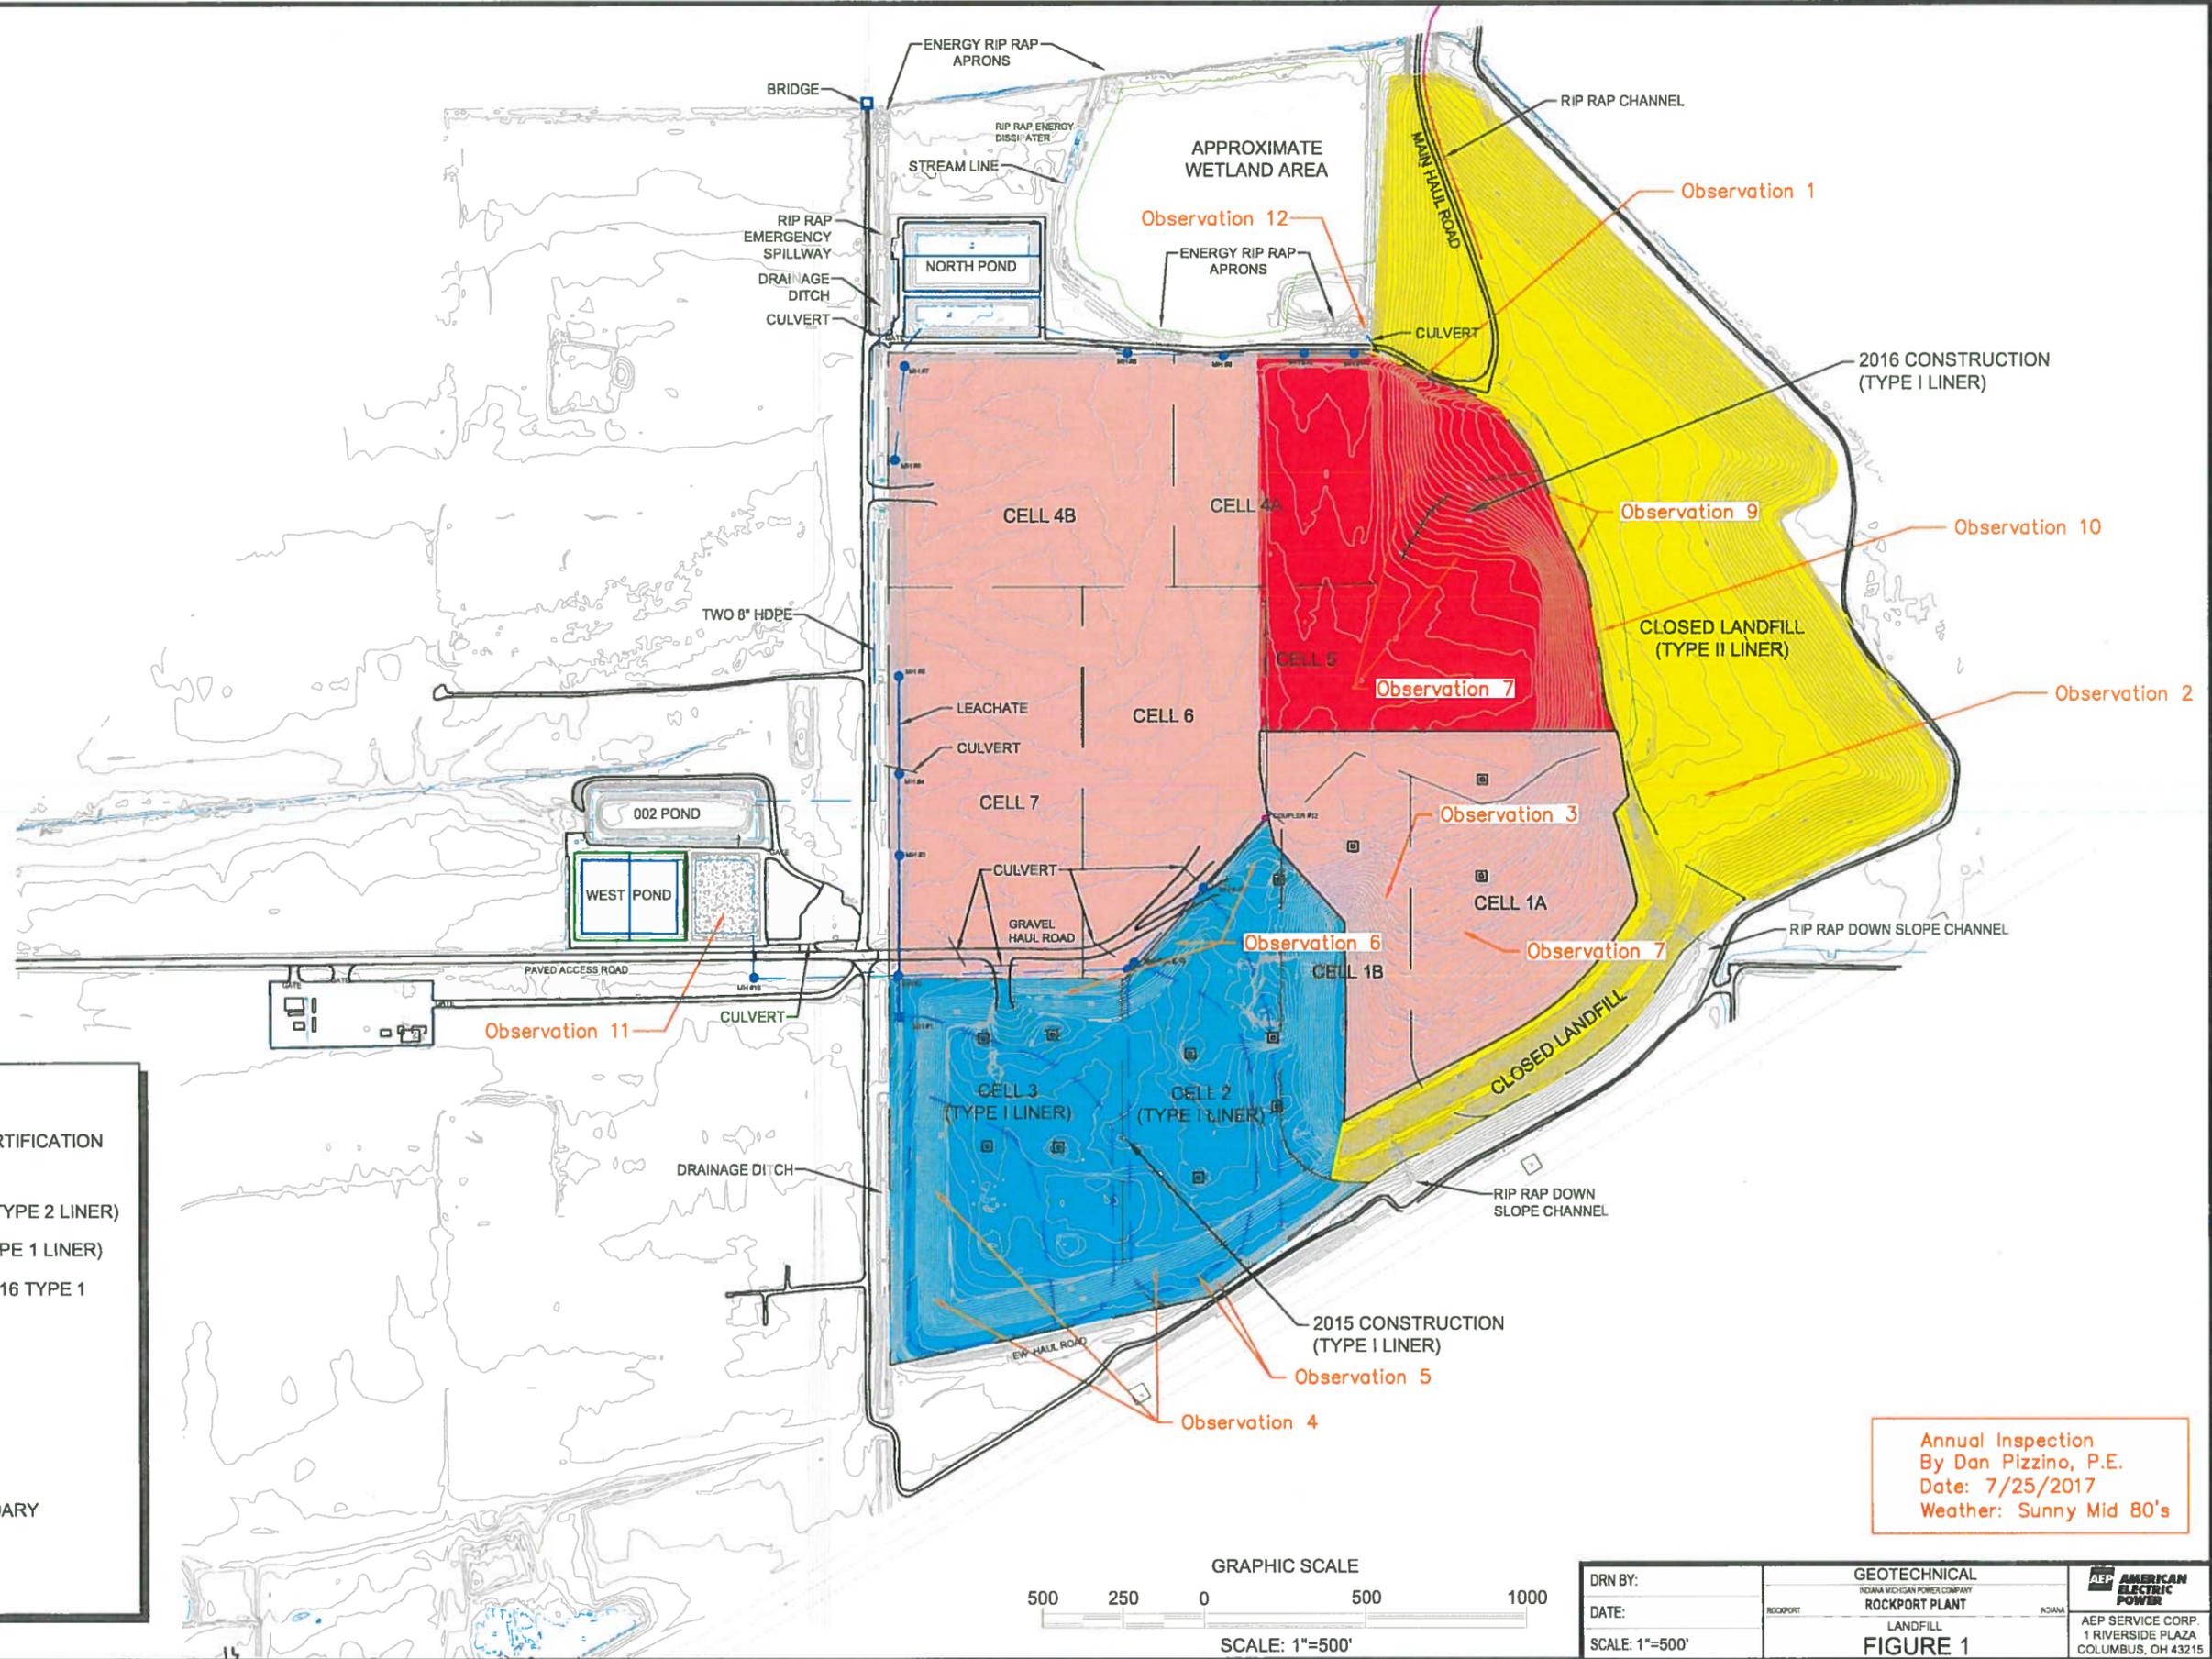
DRN BY:	GEOTECHNICAL	
DATE:	INDIANA MICHIGAN POWER COMPANY ROCKPORT PLANT	
SCALE: 1"=500'	LANDFILL	AEP SERVICE CORP. 1 RIVERSIDE PLAZA COLUMBUS, OH 43215
<b>FIGURE 1</b>

Overall the facility is in good condition. The landfill is functioning as intended with no signs of potential structural weakness or conditions which are disrupting to the safe operation of the landfill. Inspection photos are included in Attachment A. Additional pictures taken during the inspection can be made available upon request. A map presenting locations of the inspection observations is included in Attachment B.
