2017 Annual Landfill Inspection Report

Ash Landfill

**Welsh Plant
American Electric Power Service Corporation
(SWEPCO)
Cason, Texas**

Document No. GERS-17-049

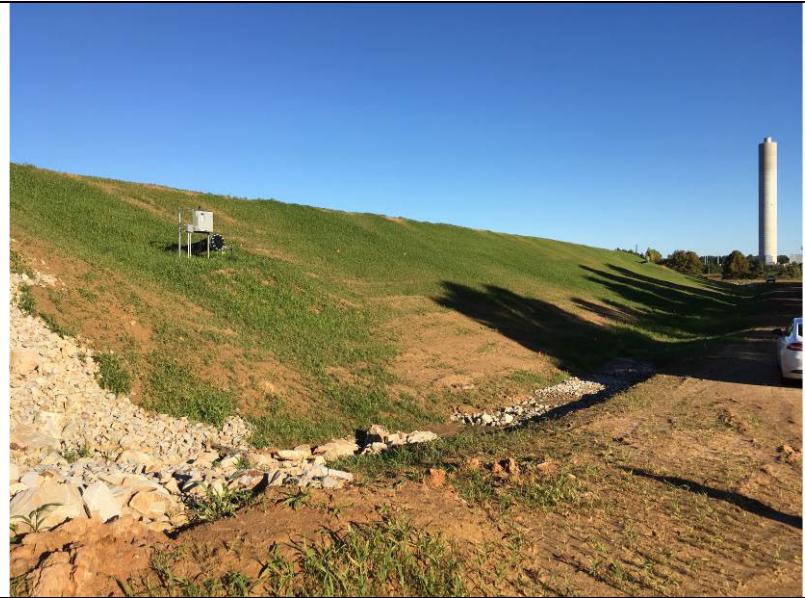
<p>Photo # 1</p> <p>View of the Eastern Berm Outside Slope Looking North. Final Cover Has Just Been Placed.</p>

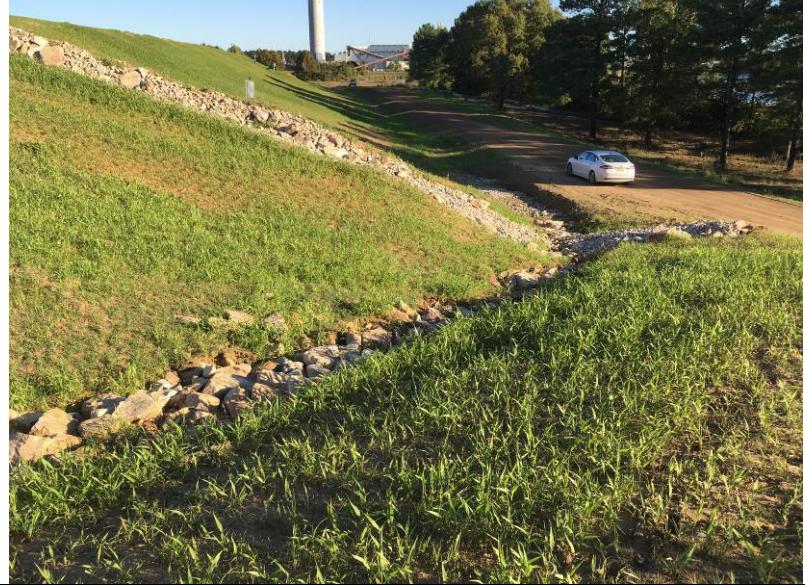
1. The final cap/cover system has been placed on the lower portions of the east and southern berm outside slopes. This final cover extends along the eastern berm for approximately 680 linear feet and along the southern berm for approximately 750 linear feet. In general, the final cover was in good condition with vegetation growth and minimal erosion. The most recent areas of final cover placement cover have been seeded and mulched and vegetation is starting to develop (Photographs No. 1 through 7).
2. The perimeter ditch along the toe of the southern and eastern berm was in good shape with no signs of erosion or debris build up. The installation of riprap let down channels in the southeast corner and the northeast corner were in good condition with no signs of erosion or instability (Photographs No. 2, 4 and 5).

A photograph showing a grassy hillside with a rocky retaining wall at the bottom. A small white structure is visible on top of the hill. In the background, a tall white industrial chimney stands against a clear blue sky. A car is parked on a dirt road to the right.
<p>Photo # 2</p> <p>View of the Southeast Corner Berm Outside Slope. Notice Rock Let Down Ditches.</p>

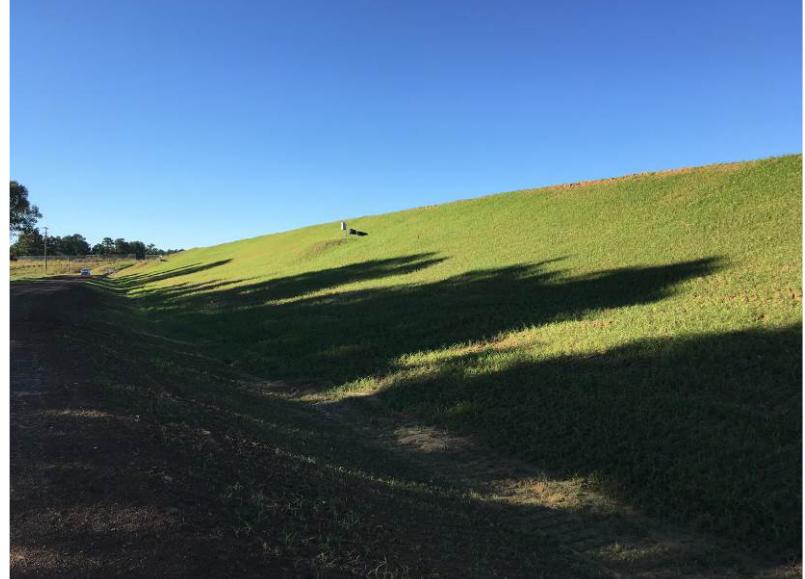
A photograph showing a grassy hillside with a rocky retaining wall at the bottom. A white car is parked on a dirt road to the right. In the background, a tall white industrial chimney stands against a clear blue sky. The hillside shows some exposed soil and rock.
<p>Photo # 3</p> <p>View of the Eastern Berm Outside Slope Looking South. Notice Final Cover Has just Been Placed.</p>

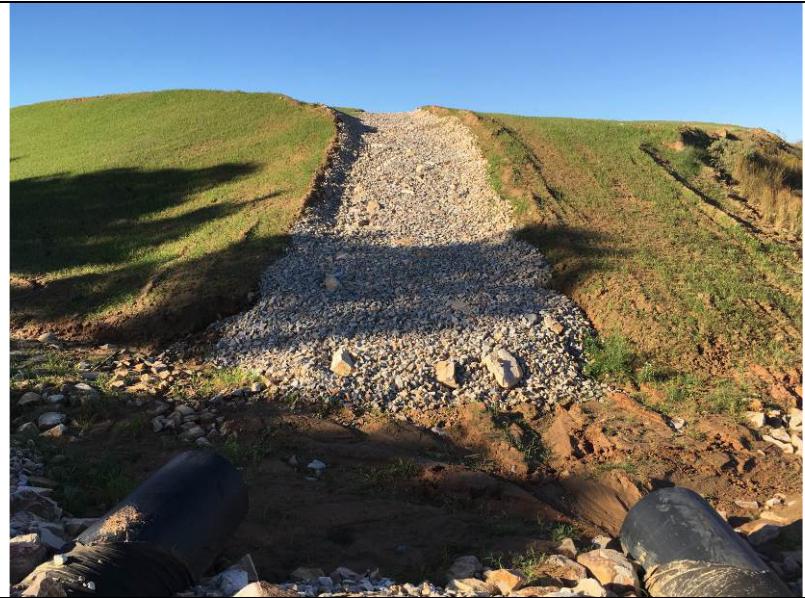
<p>Photo # 4</p> <p>View of the Northeast Berm Let Down Ditch.</p>

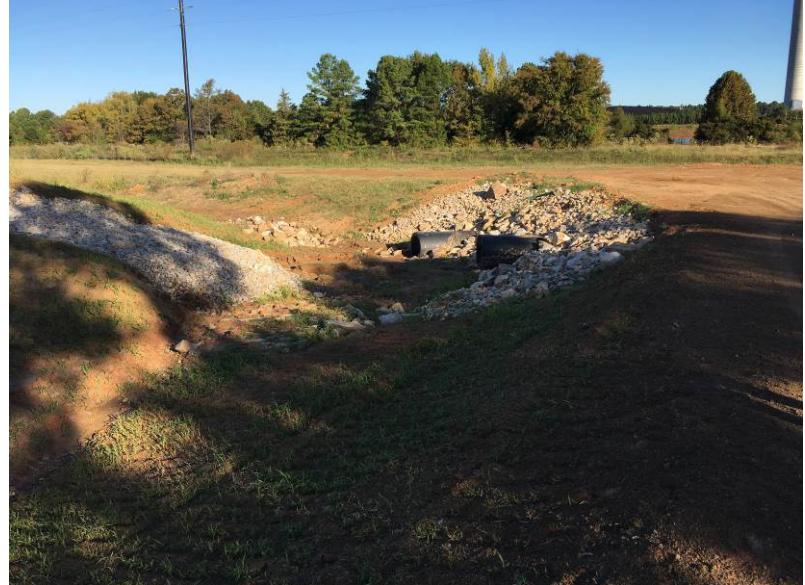
<p>Photo # 5</p> <p>View of the 30 and 36 inch Storm Water Pipes Located in Northeast Corner of Landfill Perimeter Ditch.</p>

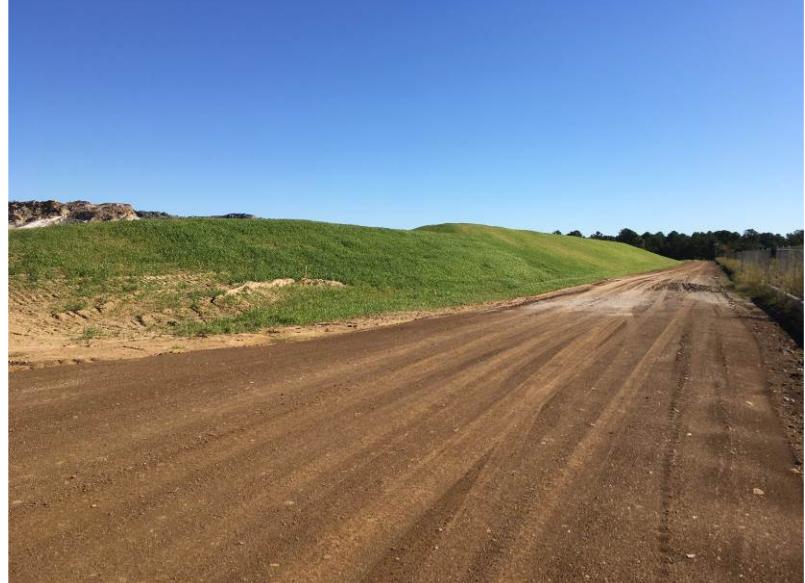
<p>Photo # 6</p> <p>View of the South Berm Outside Slope Looking East.</p>

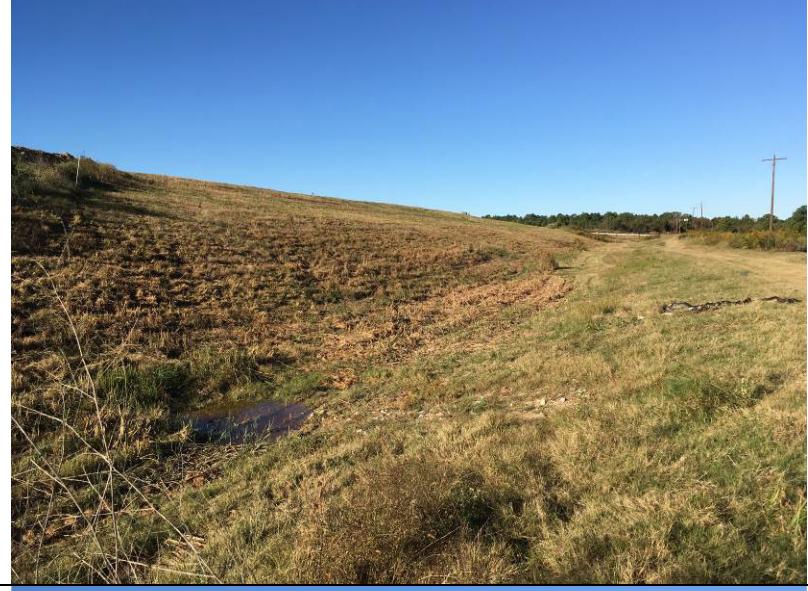
A photograph showing a grassy hillside with distinct erosion rills running down its surface. The ground appears dry and textured.
Photo # 8

4. The northern berm and western berm outer slopes of the landfill are partially constructed of soil and CCR material with no engineered cover system and sparse vegetation cover. The outer slopes appeared to be in satisfactory and functioning condition with no signs of seepage, erosion or sloughing (Photographs No. 8, 9 and 12, 13, 14).
5. The perimeter ditch along the toe areas of the northern berm and western berm appeared to be in satisfactory condition. There were signs of minor erosion and sediment build up causing the relatively flat ditch to pond water (8, 9 and 12, 13).
6. The culvert pipe located in the north outer berm appeared to be in satisfactory and functional condition. The opening to the culvert pipe located on the inside area of the north berm appeared to be overgrown with vegetation, but flow was able to reach to the outlet channel. (Photographs No. 10 and 11).

- 1 Vegetation growth on the newly capped and covered slopes is good, but several erosion

rills have developed where the vegetation is still sparse. These erosion rills need to be re-graded and seeded as needed.

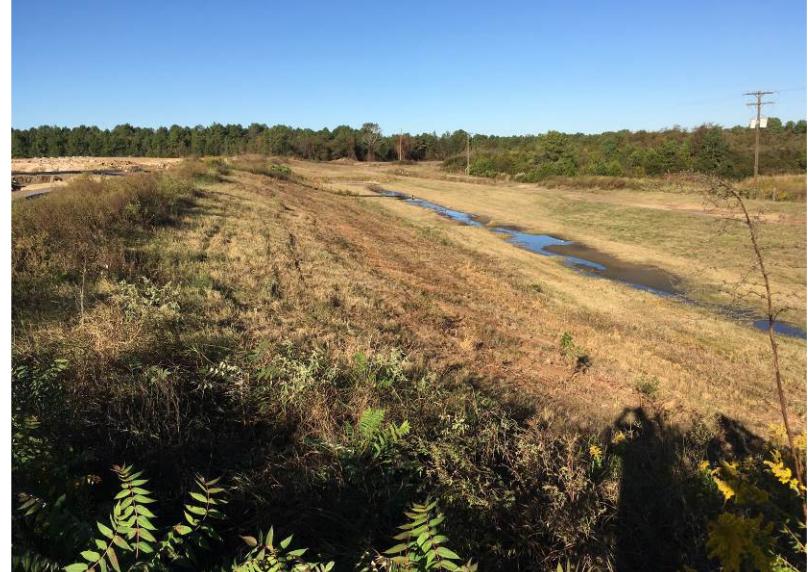
A photograph of a grassy hillside looking towards a flat, open field. The slope shows signs of erosion and sparse vegetation.
Photo # 9

- 2 Ponding water was observed along the flow line sections of north berm perimeter ditch. The sediment in the ditch needs to be cleaned out and a positive flow line established to prevent future ponding of water.

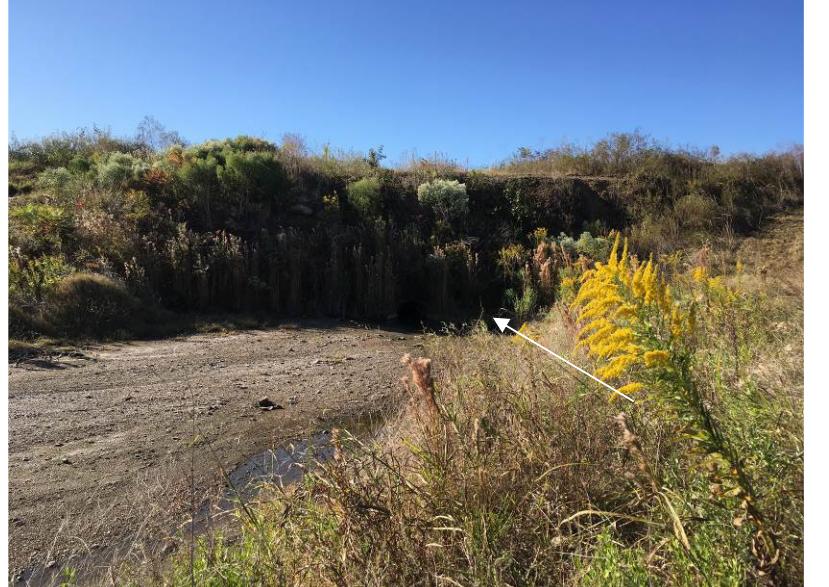
<p>Photo # 10</p> <p>View of Culvert #2 Outlet Pipe. Located on the Outside Slope in the Northwest corner of the Northern Berm</p>

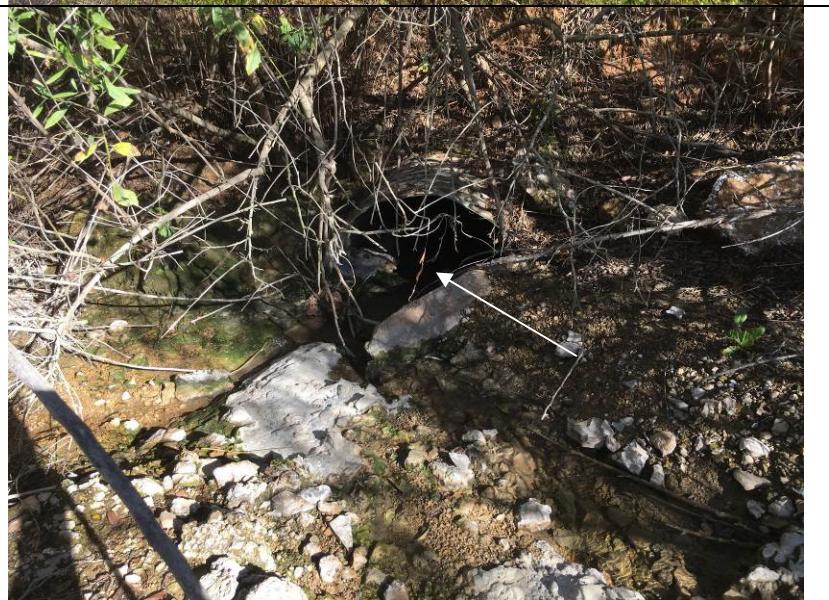
<p>Photo # 11</p> <p>View of Culvert #2 Pipe From Inside the Landfill Ash Processing Area.</p>

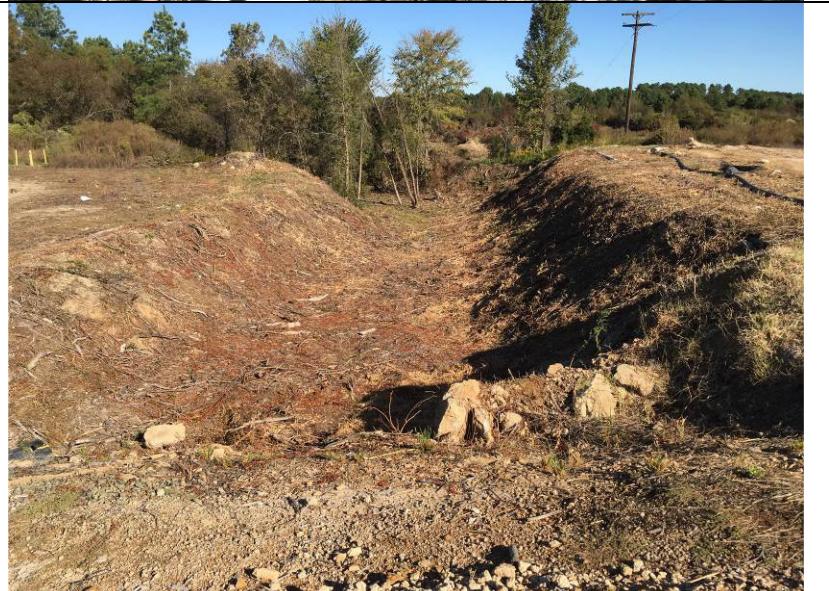
<p>Photo # 12</p> <p>View of the Western Berm Outside Slope and Perimeter Ditch Looking North.</p>

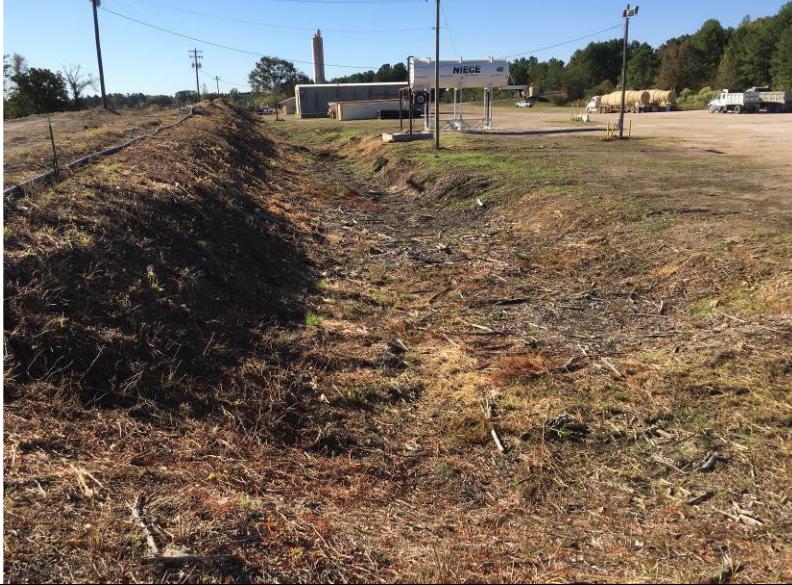
Photo # 13	<p>Typical of the Western Berm Outside Slope and Perimeter Ditch Looking South.</p>

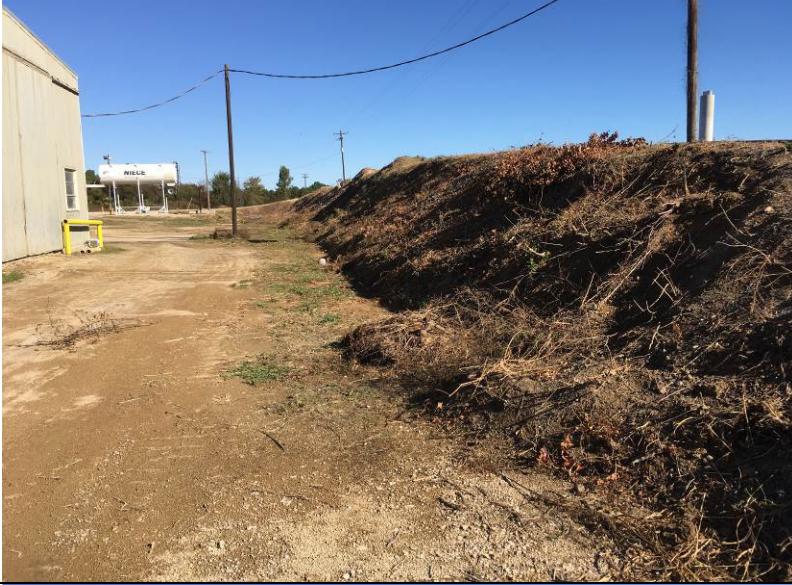
Photo # 14	<p>View of the Western Berm Outside Slope Looking North.</p>

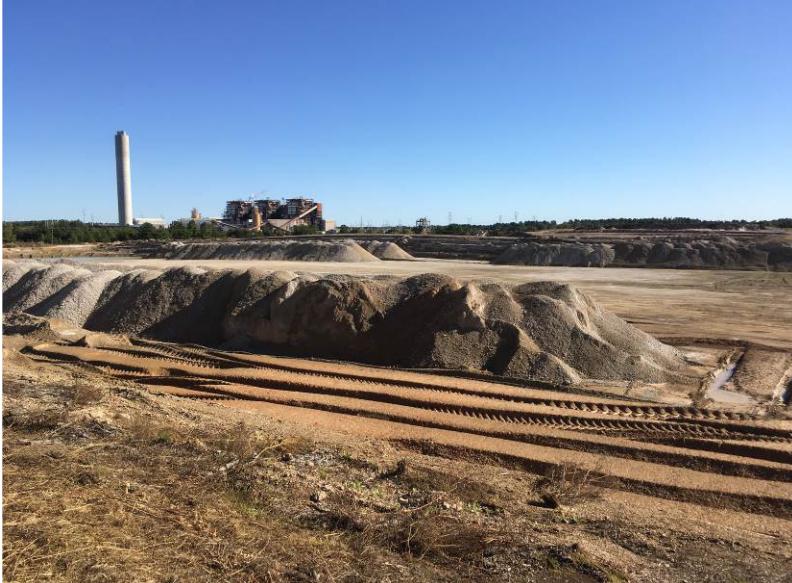
7. The western 2/3 of the landfill area is primarily utilized for the processing and sales of CCR materials. At the time of inspection the area was being used for ash processing. The areas are bound on the north and west sides by berms constructed out of soil and ash and have a temporary cover system. The area is bound on the south by a series of

perimeter ditches, driveways and culverts to collect the storm water runoff and direct it towards the low water crossing to exit the landfill (Photographs No. 15 through 20).

Photo # 15	<p>View of the Ash Processing Area. Typical Conditions.</p>

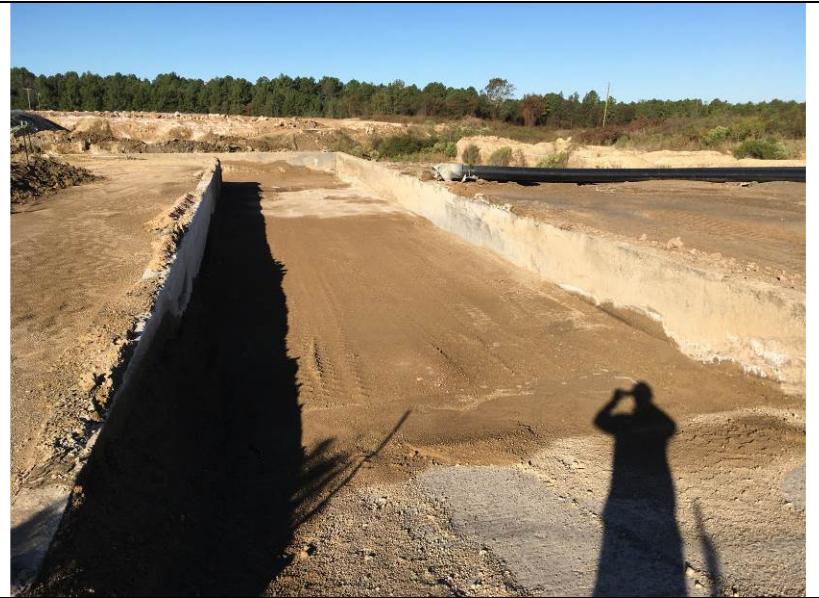
<p>Photo # 16</p> <p>View of the Bottom Ash Dewatering Pit Located in Ash Processing Area.</p>

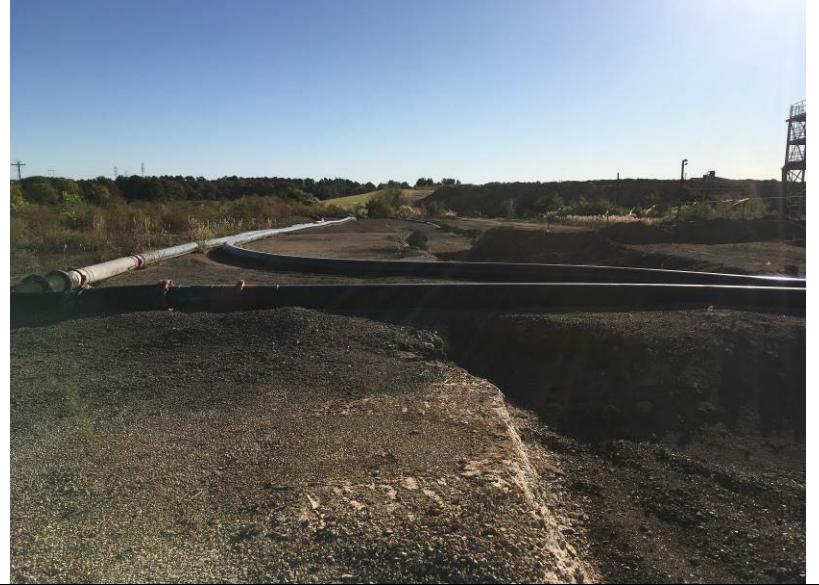
<p>Photo # 17</p> <p>View of the Bottom Ash Sluicing Lines Located in the Ash Processing Area.</p> <p>These Line were Out of Service at Time of Inspection.</p>

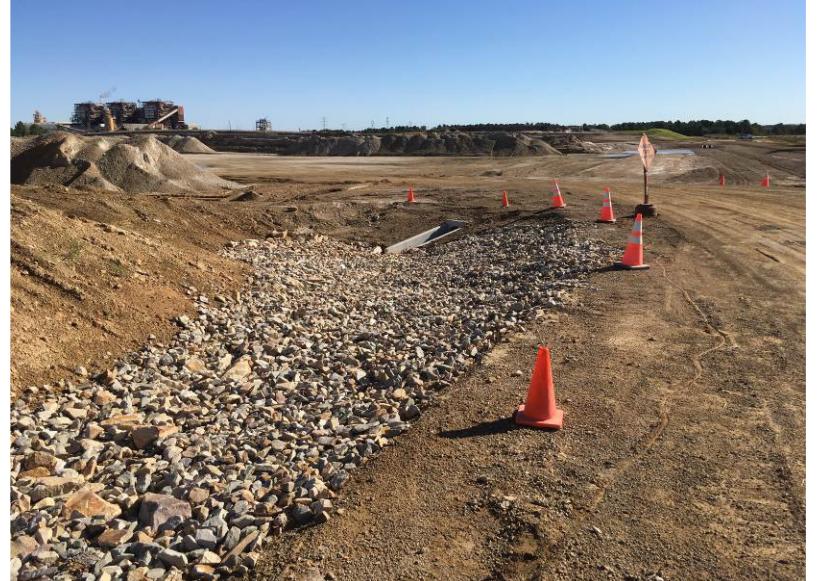
<p>Photo # 18</p> <p>View of the Ash Processing Access Driveway with Culvert.</p>

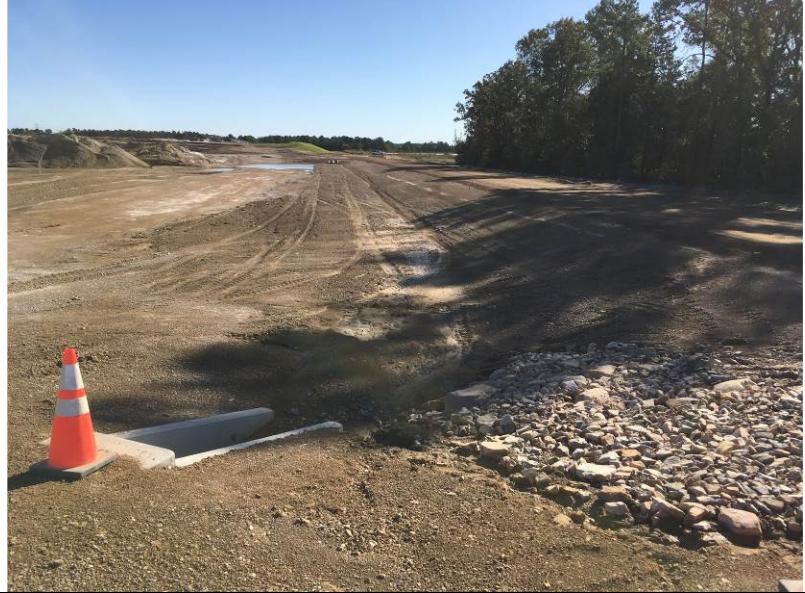
<p>Photo # 19</p> <p>View of the South Interior Perimeter Ditches for the Ash Processing Area.</p>

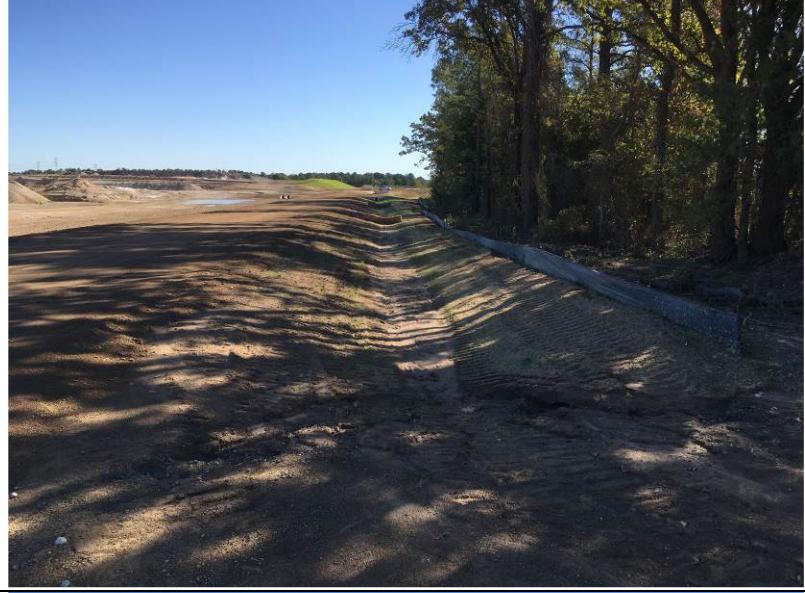
<p>Photo # 20</p> <p>View of the South Side Access Road Ditch Looking East.</p>

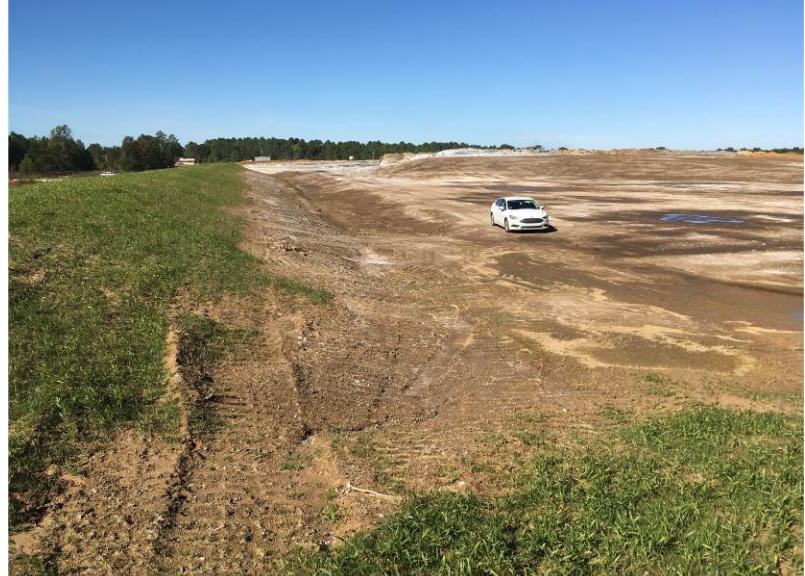
8. During the inspection the active disposal area (eastern 1/3 area) was being used for waste placement. The leachate collection sump drains were functioning as designed and there was no ponding of water in the disposal area (Photographs No. 21 through 23).

<p>Photo # 21</p> <p>View of the Active Disposal Area Located on the East Side of Landfill. Looking West.</p>

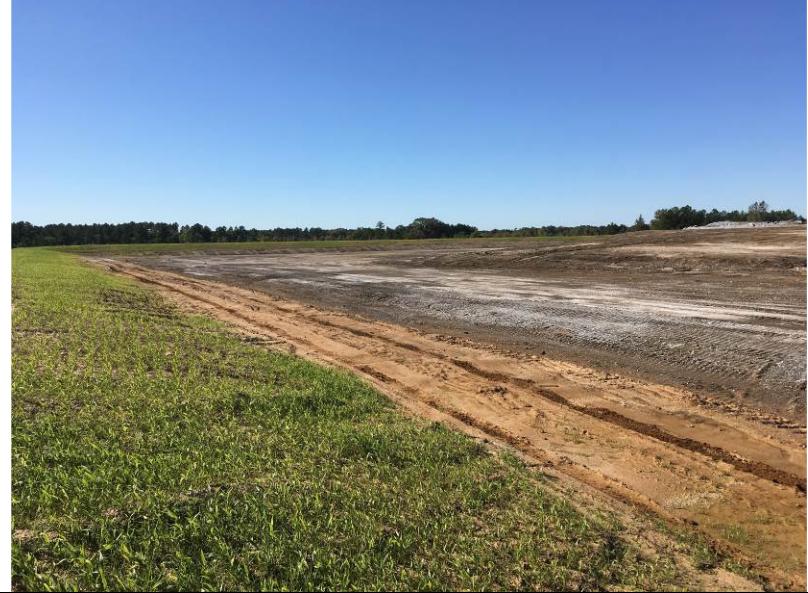
<p>Photo # 22</p> <p>View of the Active Disposal Area Located on the East Side of Landfill. Looking south.</p>

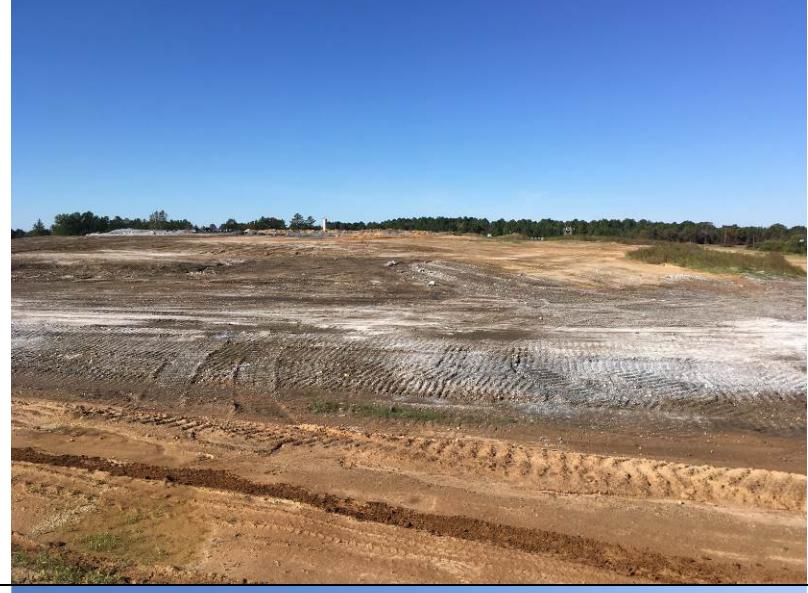
<p>Photo # 23</p> <p>View of the Active Disposal Area Located on the East Side of Landfill. Looking West.</p>

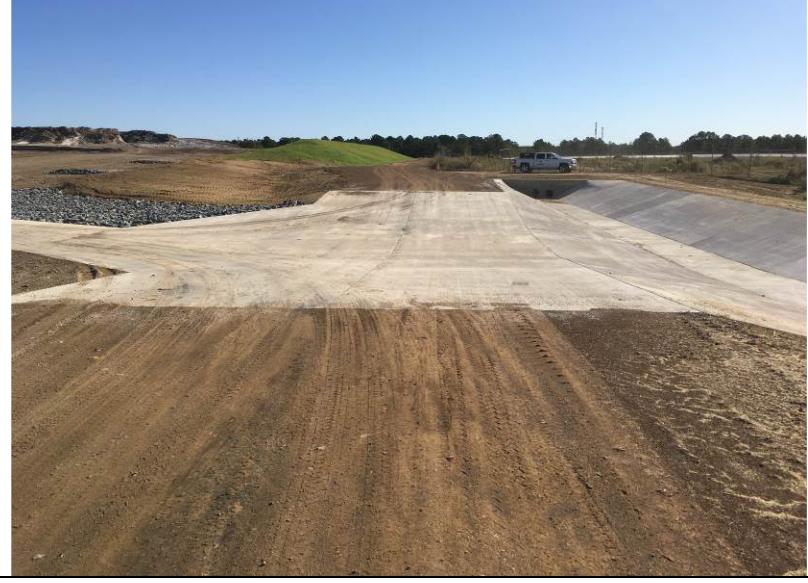
9. The Storm water runoff from the disposal areas is directed towards the western end of the disposal area where it is channeled into a low water crossing on the south side that flows into the Bottom Ash Storage Pond (Photograph No. 24).
10. The low water crossing is constructed of reinforced concrete pavement and was in good and function condition at the time in inspection.

<p>Photo # 24</p> <p>View of the Low Water Crossing Located on South Side of Landfill Active Disposal Area.</p>
