2018 Annual Dam and Dike Inspection Report

Primary Ash Dam

Flint Creek Plant

Southwestern Electric Power Company

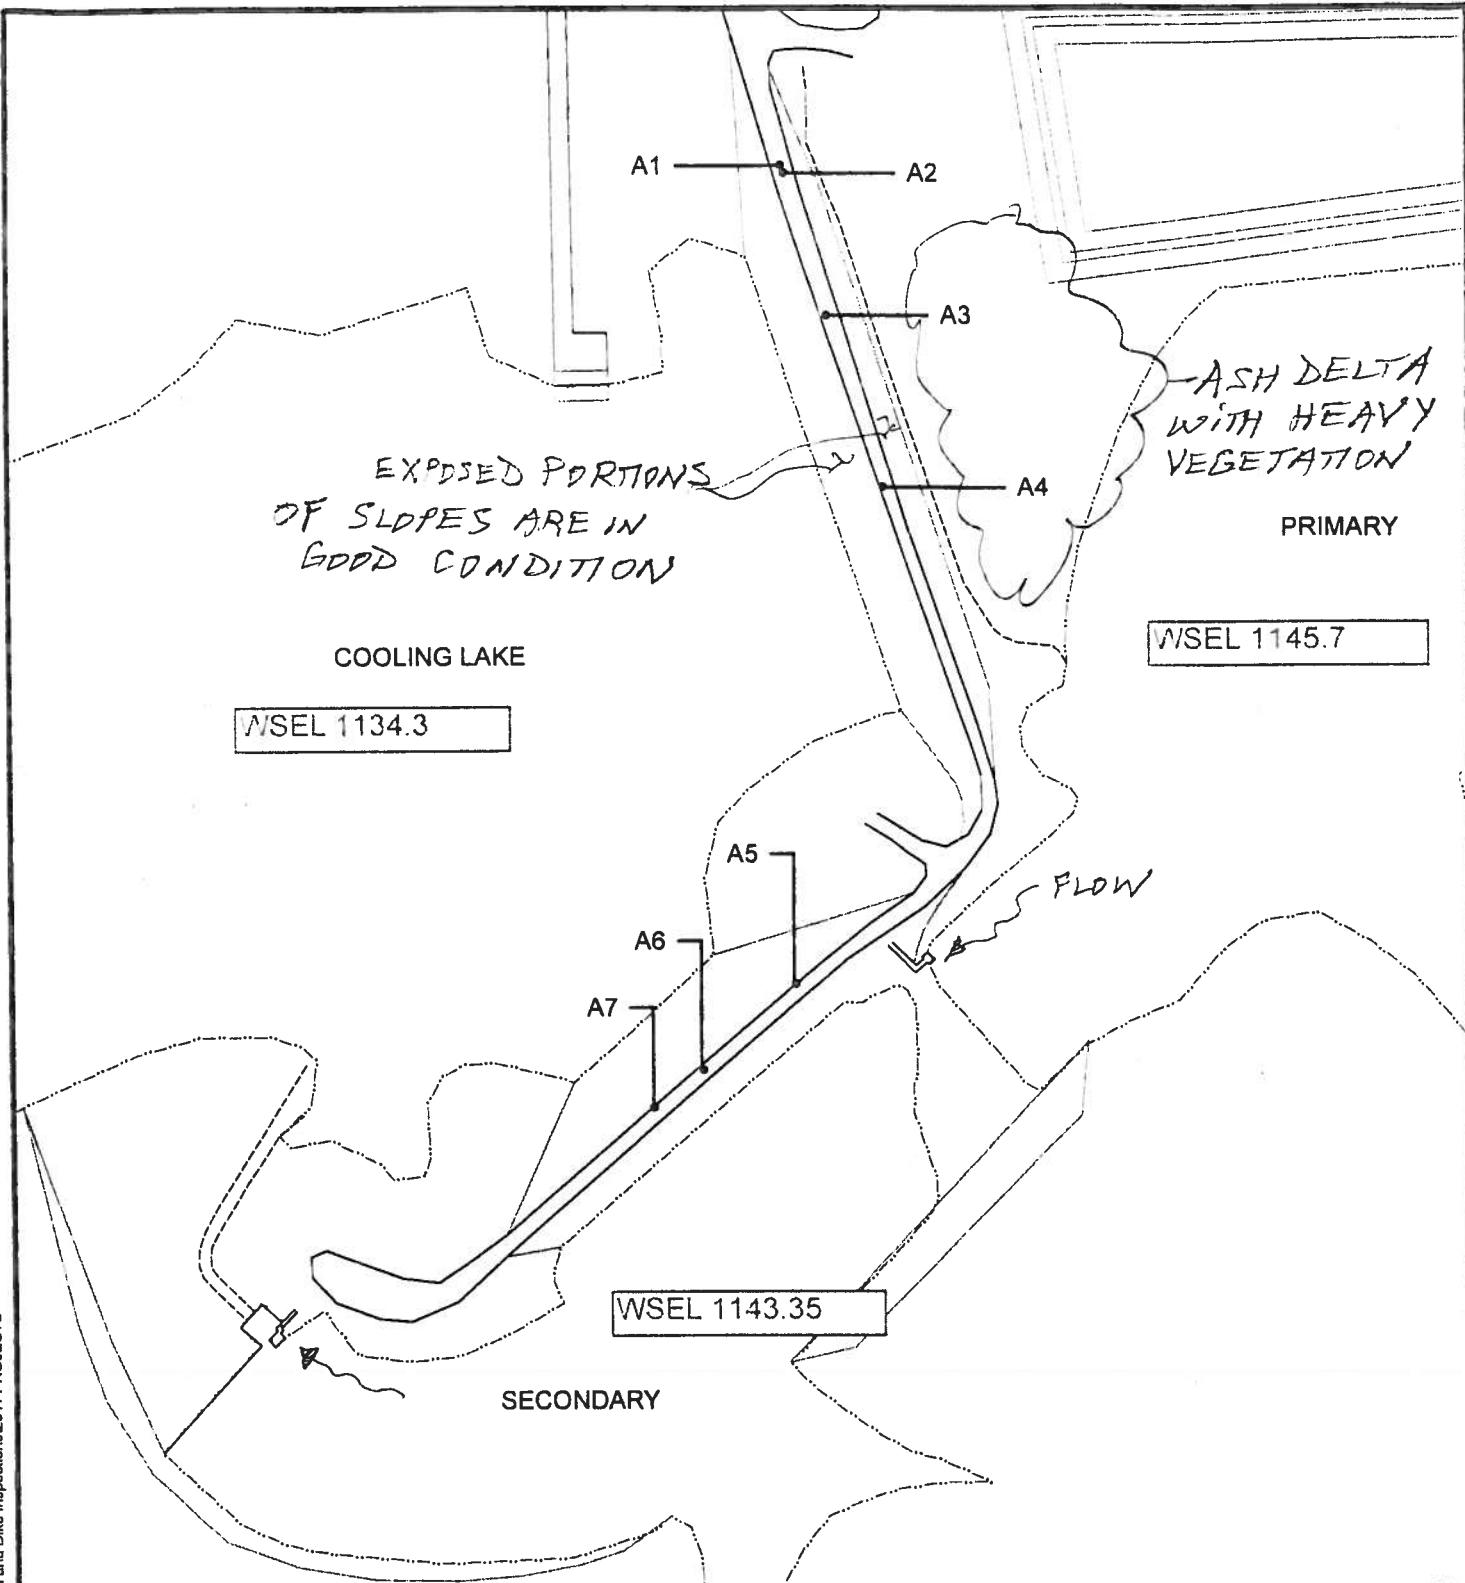
TITLE
**PRIMARY ASH POND DAM
 LOCATION OF PIEZOMETERS**

EXPOSED PORTIONS OF SLOPES ARE IN GOOD CONDITION

ASH DELTA WITH HEAVY VEGETATION

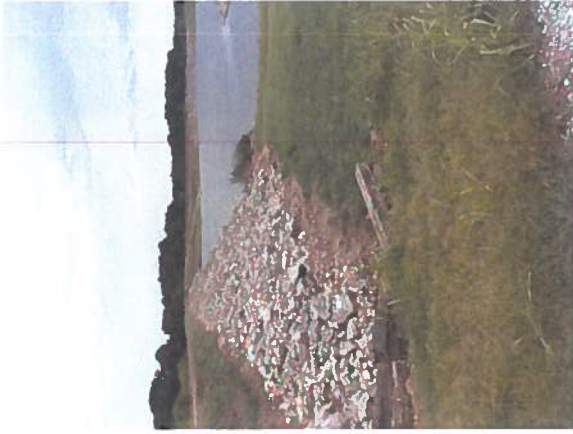
Photo #1 – d/s slope from right abutment

The downstream slope of the primary dam was in satisfactory condition (photos 1 & 2). Most of the slope is covered with riprap except for the top 3-5 feet which is grassed. Woody vegetation within the riprap is being controlled. There was no observed displacement or movement of the riprap. There was no seepage observed along the face of the slope.

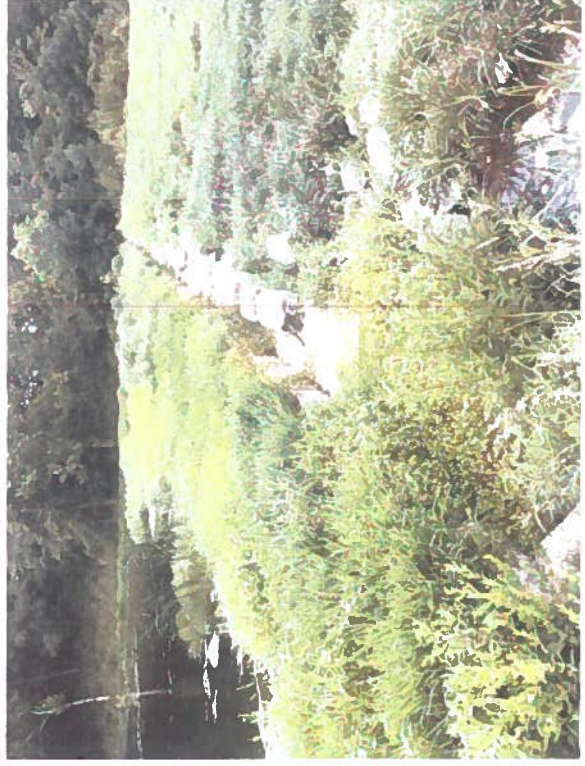
Photo #3 – emergency spillway weir area

The emergency spillway at the primary impoundment is an incised channel in natural ground with a concrete weir control section, 1 ft. in height, across the channel width. The spillway was in generally fair condition at the time of inspection (photo 3). The spillway appeared to be generally stable.

Vegetation control in this natural ground area is fair except for two trees that are located at the water's edge to the secondary pond.

- Continue the vegetation control plan of mowing and spraying.
- Remove woody vegetation in the natural ground below the emergency spillway from the Primary Bottom Ash Pond.
