# **2018 Annual Landfill Inspection Report**

**Northeastern Plant  
Landfill**

**Public Service Company of Oklahoma  
Oologah, OK**

**Document ID: GERS-18-043**

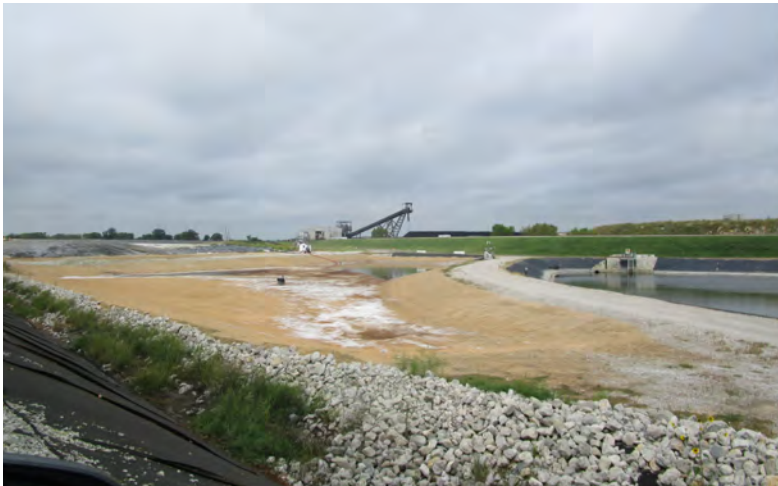
Photo #: 1

Location: Leachate collection

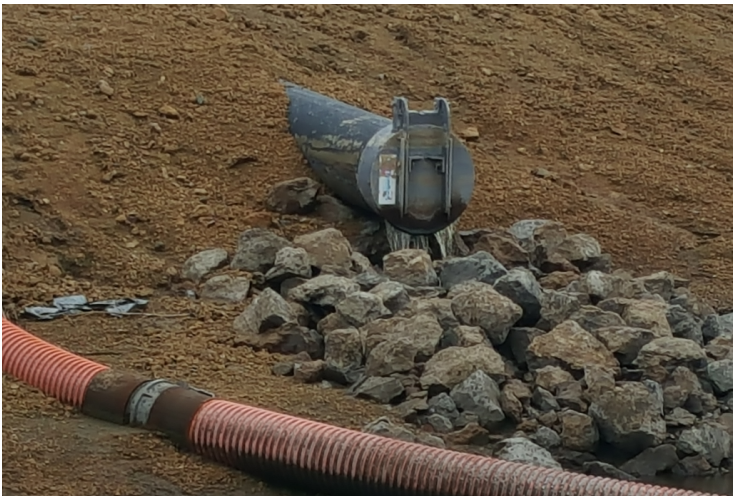
Photo #: 2

6. There are two leachate collection pipes that flow into the pond. The pipes were visible and only a small volume of leachate was flowing out of the pipes. The leachate was clear.
7. The plant has switched to a manual pumping system instead of the existing leachate pumping system. Generally, the leachate is used for dust control and compaction water for the CCR material placed in the active area. The pond was empty at the time of this inspection.

Notes: Leachate collection pipe -  
Minimal flow.

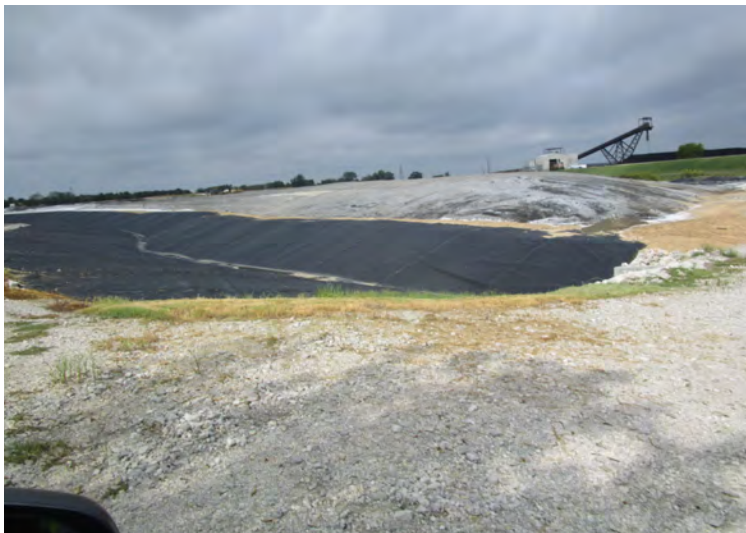
3

4. Exposed geomembrane is the surface of the inactive disposal areas. This area was observed only from the perimeter of the cells. A complete walk down of the area will be performed prior to placing CCR to ensure the integrity of the liner.
5. There was no ponding of water on the surface of the inactive areas. The areas drain to the perimeter stormwater channels. The channels flow into Basin C which is periodically pumped to the plant's permitted outfall.

Exposed geomembrane liner as intermediate liner . Also used as temporary cover over CCR slope

Inactive cells

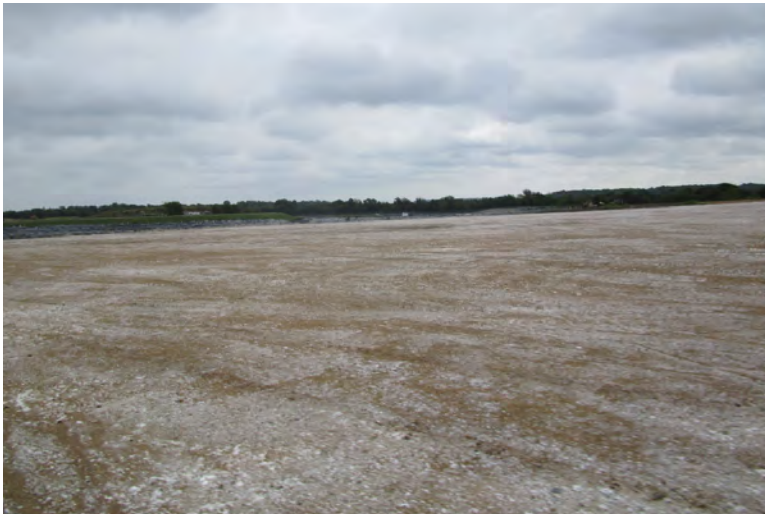
Photo #: 5

1. Cell 2 is the active disposal area. No ponding of surface water was observed on the surface. The material in the Cell is separated from the inactive areas by a low splitter berm.
2. There was no erosion of the CCR material in the active area. The height of the fill above the intermediate liner is relatively small (< 10 feet).
3. No slopes or other areas of the landfill have received permanent cover. The west end of the landfill has exposed geomembrane as a temporary cover. No damages to the temporary cover were observed.

Notes: Active cell 2

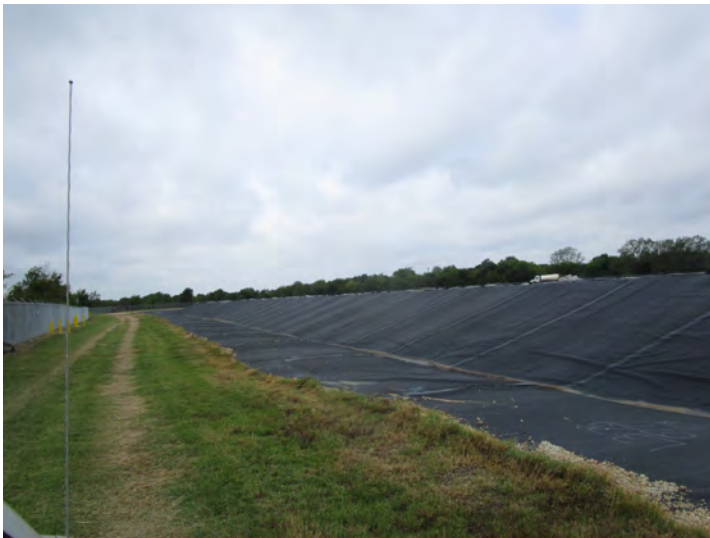
Photo #: 7

8. The perimeter ditches were in good condition. The ditches are currently lined with exposed geomembrane. There were some local areas of very shallow ponding either due to minor sediment or small wrinkles in the geomembrane.

9. No damage to the geomembrane was observed during the inspection.

Notes: Exposed geomembrane liner  
- stormwater channels

Location: Storm water channels along  
crest of containment dike
