2018 Annual Dam and Dike Inspection Report

Bottom Ash Pond Complex

**Rockport Plant
Indiana Michigan Power Company
Rockport, Indiana**

Document ID: GERS-18-053

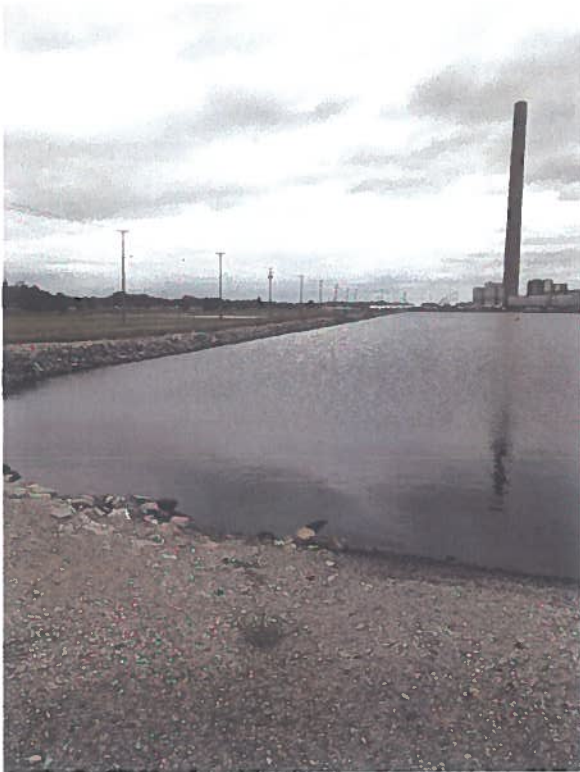
9. The interior slopes showed no signs of distress such as sloughing, bulges or erosion. The rip rap protection along the slope that was visible appeared in good condition and has not deteriorated.

Photo #1W – interior slope of west dike

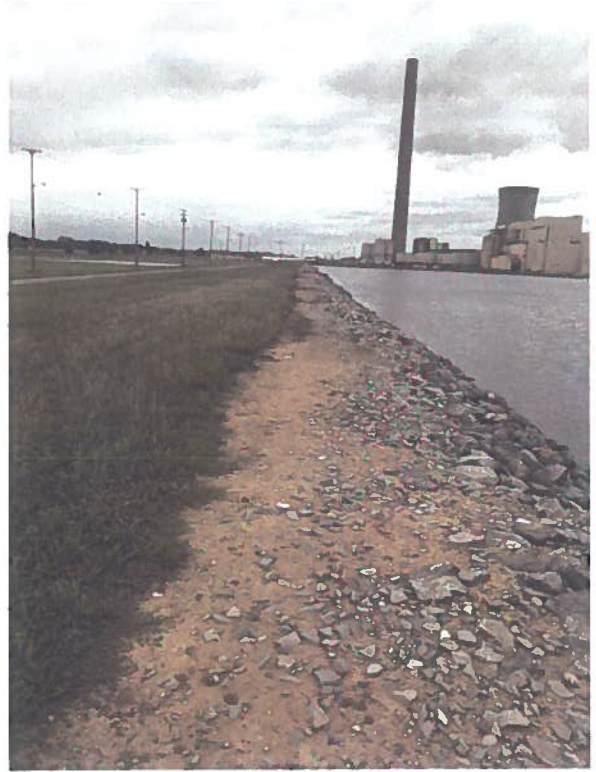
14. The crest of the west dike appeared in good and stable condition with no signs of distress such as settlement or ruts, and no erosion.
15. Flow was discharging into the low level drain structure. While this structure is typically used for draining the pond it appears to be functioning properly as part of the primary discharge for the pond. The structure appeared in good condition. Flow was unobstructed.

Photo #2W – crest of west dike

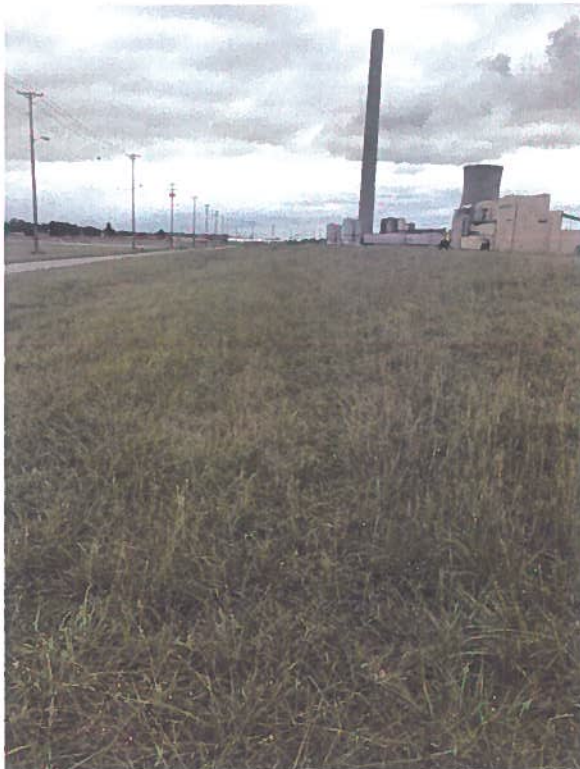
11. The outboard slope of the WBAP was in good condition. There were no signs of movement or misalignment, sloughing or bulges. The inspection was conducted prior to mowing, but the vegetation was not excessively high.

12. There were no seepage or wet areas observed along the embankment.
13. The isolated erosion noted in the previous report was not observed during this inspection.

Photo #3W – toe of west dike

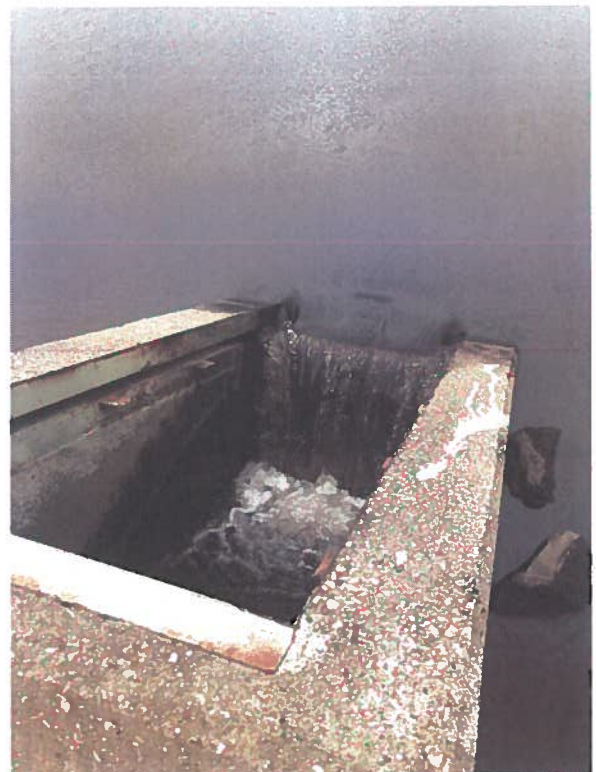
Photo #4W – low level drain operation at full pond

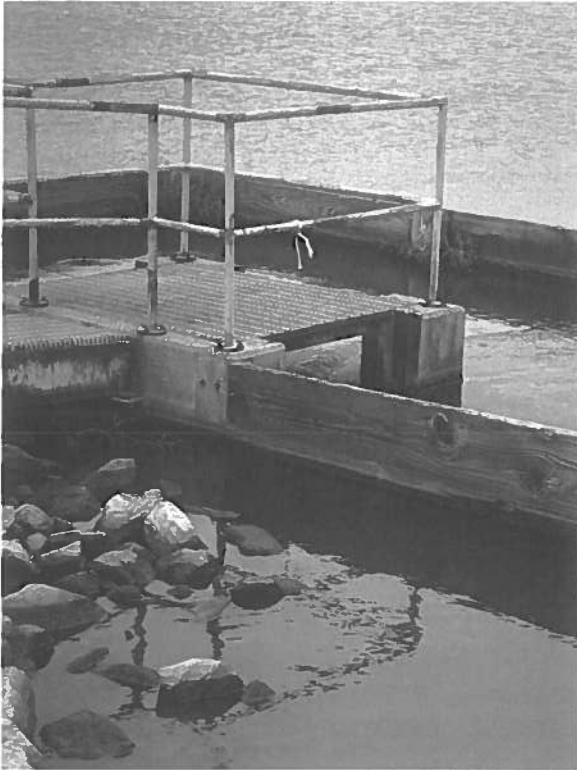
16. The primary discharge structure was in good condition and functioning properly. Flow was entering from all 3 sides of the box weir structure. The skimmer structure was in good condition.

Photo #5W – main discharge structure

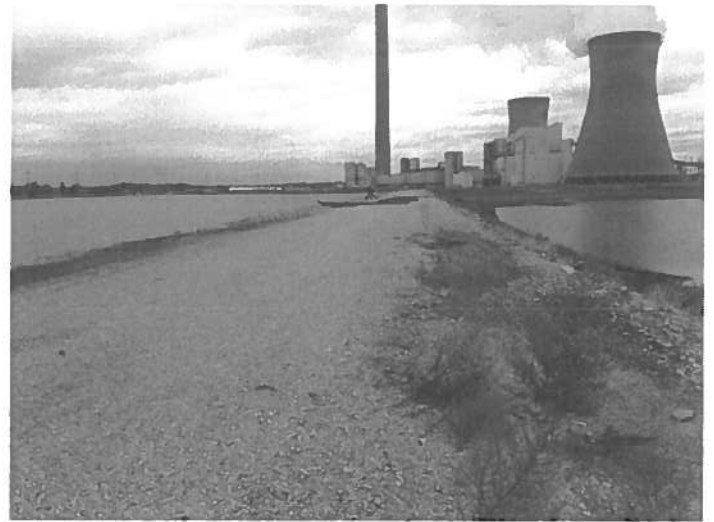
10. The splitter dike between the two ash ponds appeared to be in good condition and showed no signs of distress. The splitter dike separating the WBAP from the WWWP was also in good condition and showed no signs of distress.

Photo #6W– splitter dike between ash ponds

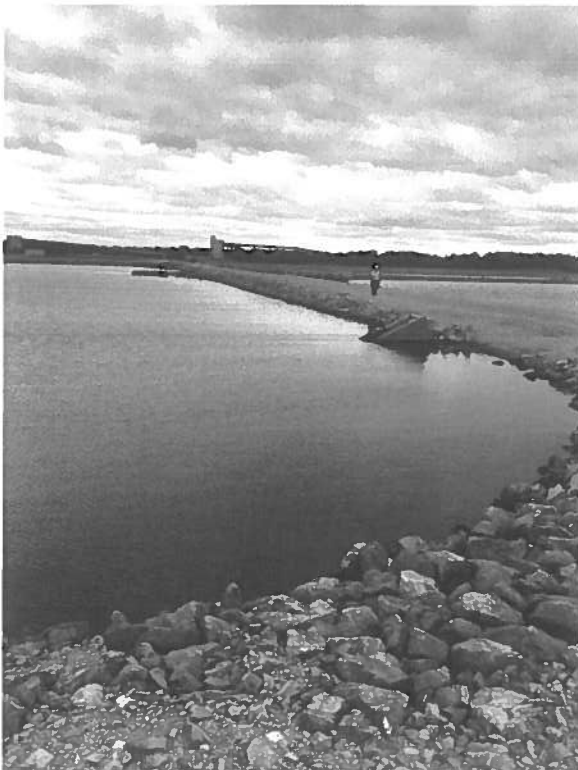
Photo #7W– discharge structures at full pond

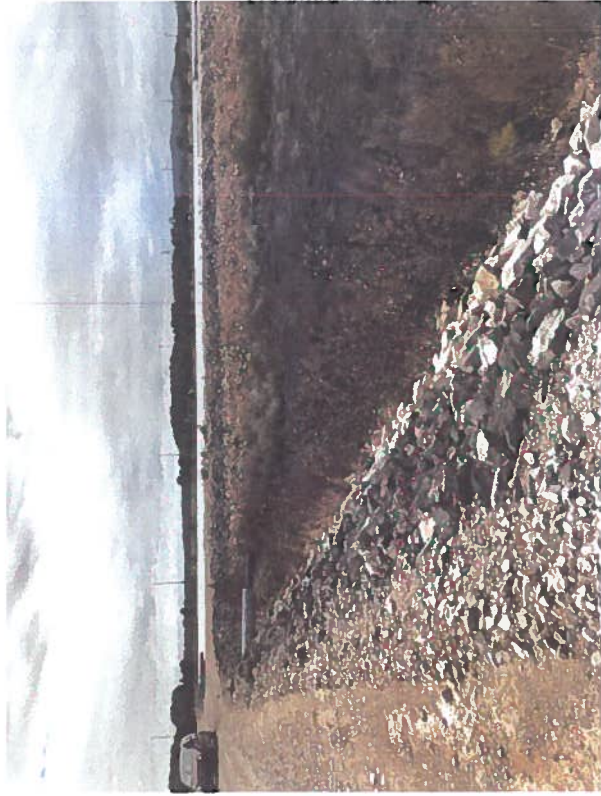
1. The EBAP was out of service at the time of the inspection. Almost all flow has been removed from the impoundment as part of routine operations of the pond for cleaning out of bottom ash.

7. There are areas within the pond and side slope where vegetation is starting to grow due to the pond being out of service for the long period.

Photo #1E – interior of inactive East ash pond

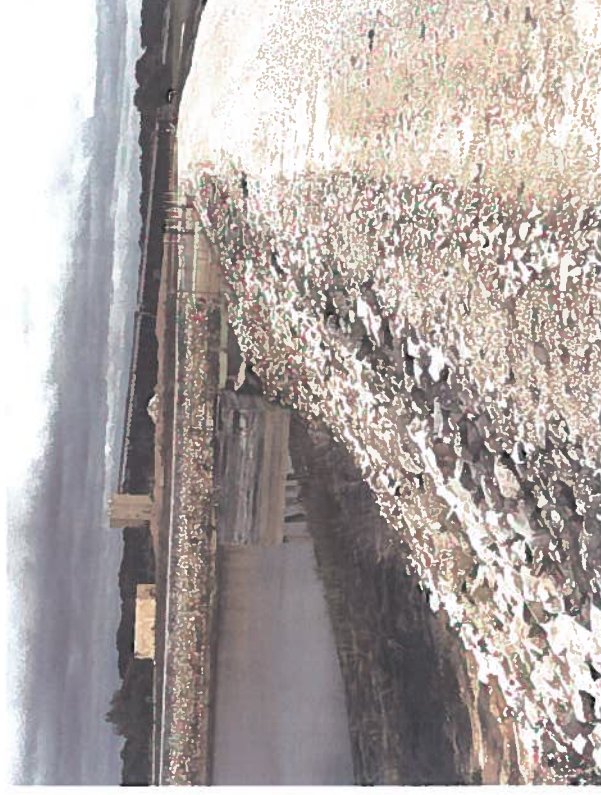
5. The principal spillway structure was not being utilized because the pond was drained. This structure was also completely exposed. It appeared in good condition. The concrete structure and skimmer boards showed minor signs of wear but were in fair condition.

Photo #2E – discharge structures

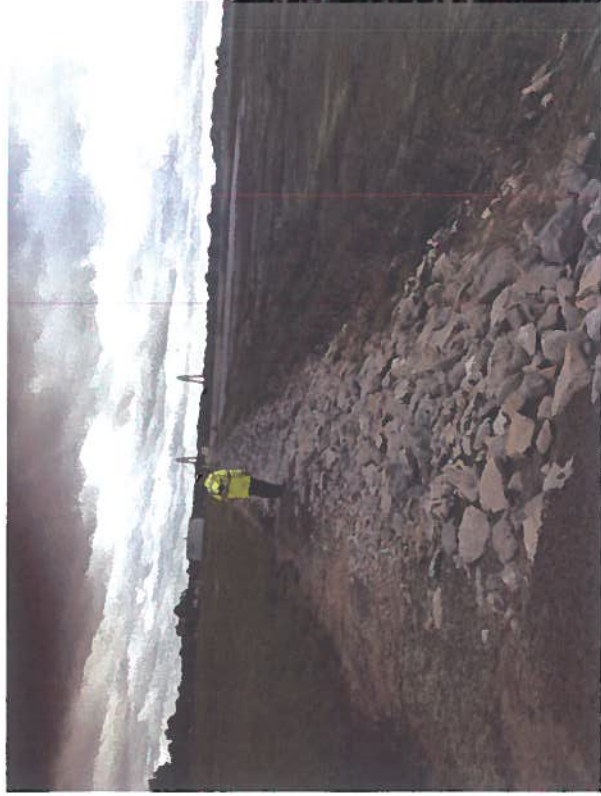
2. The interior slopes showed no signs of distress such as sloughing, bulges or erosion. The rip rap protection along the slope was visible to the toe and appeared in good condition and has not deteriorated.

Photo #3E – interior of east slope and ash pond

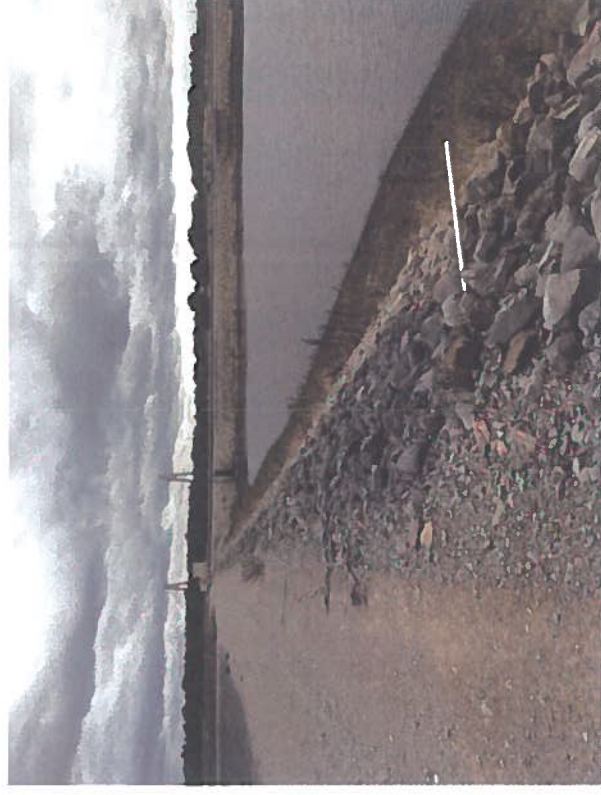
Photo #4E – interior of east slope at low water

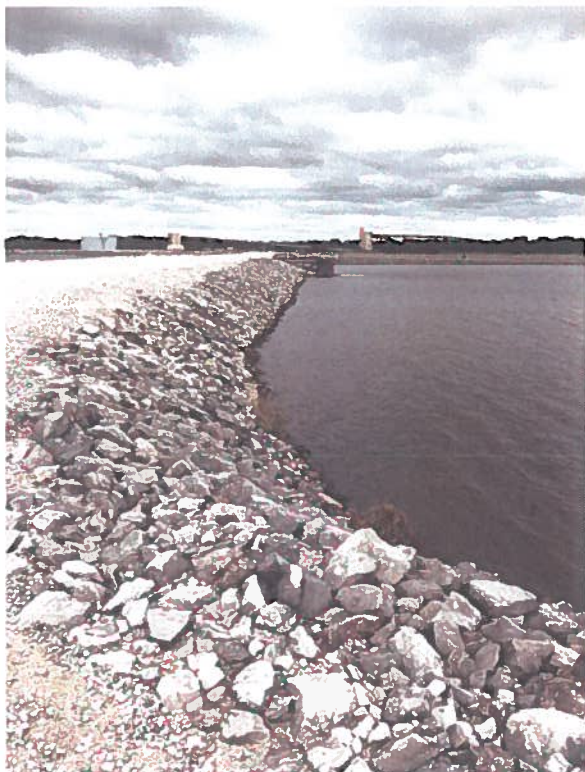
Photo #1WW – interior north slope of West WW pond

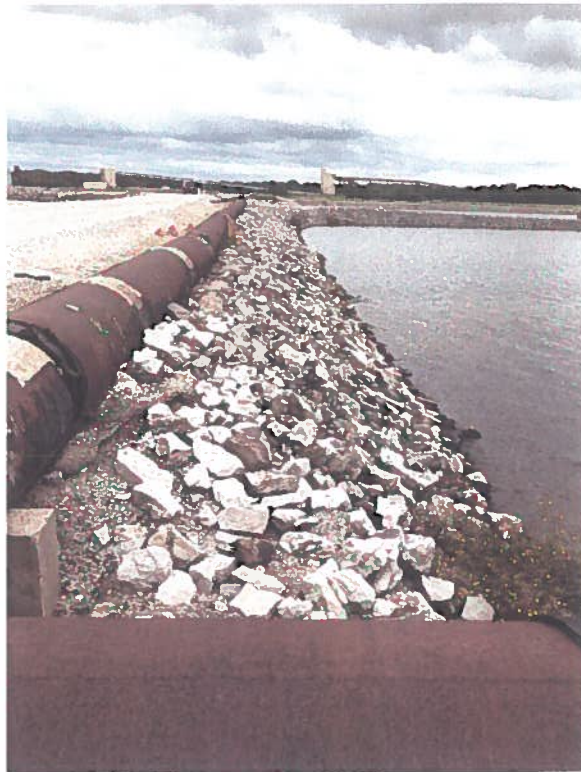
Photo #2WW– interior north slope of West WW pond

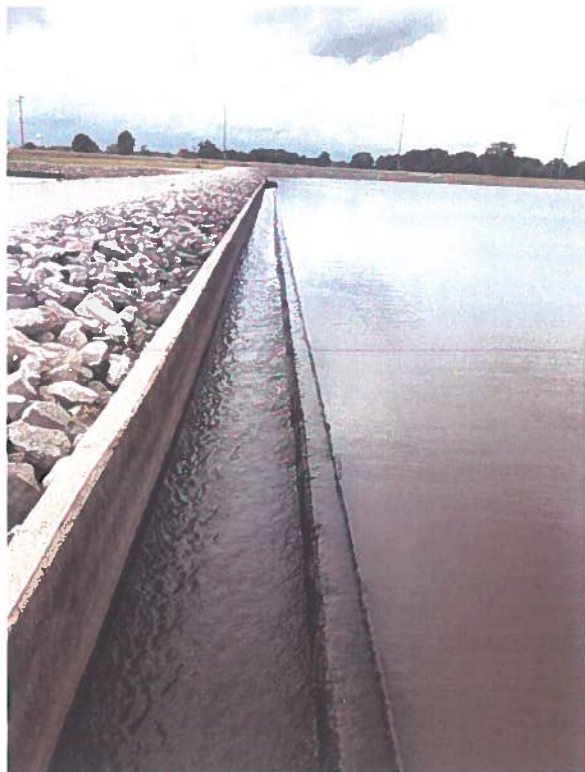
Photo #3WW – operating discharge structure in West WW pond

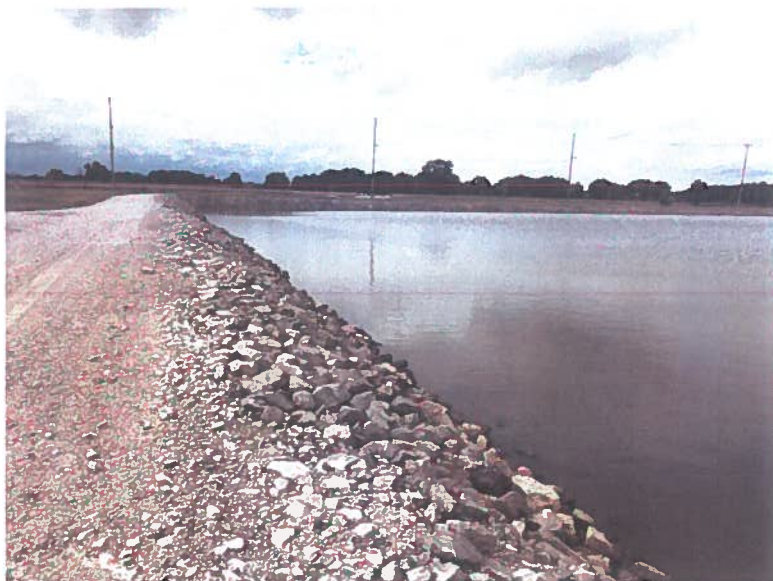
Photo #4WW – interior south slope Of West WW pond

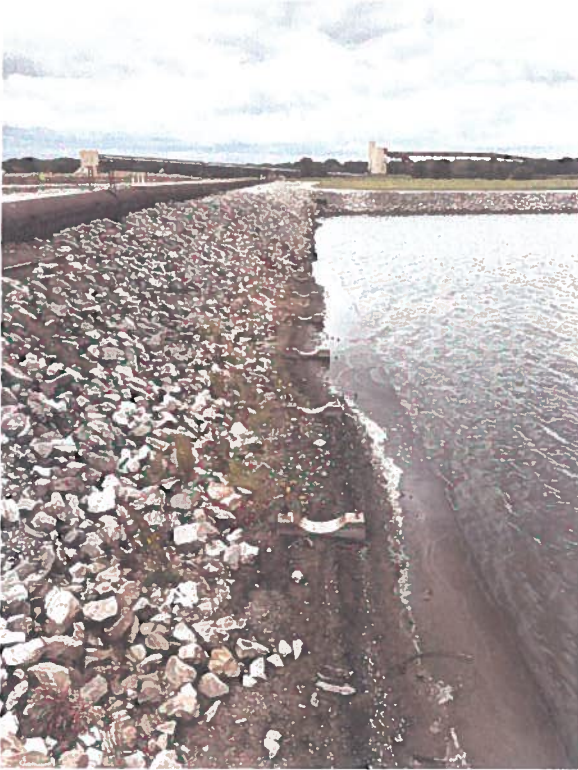
Photo #5WW – interior north slope of East WW pond

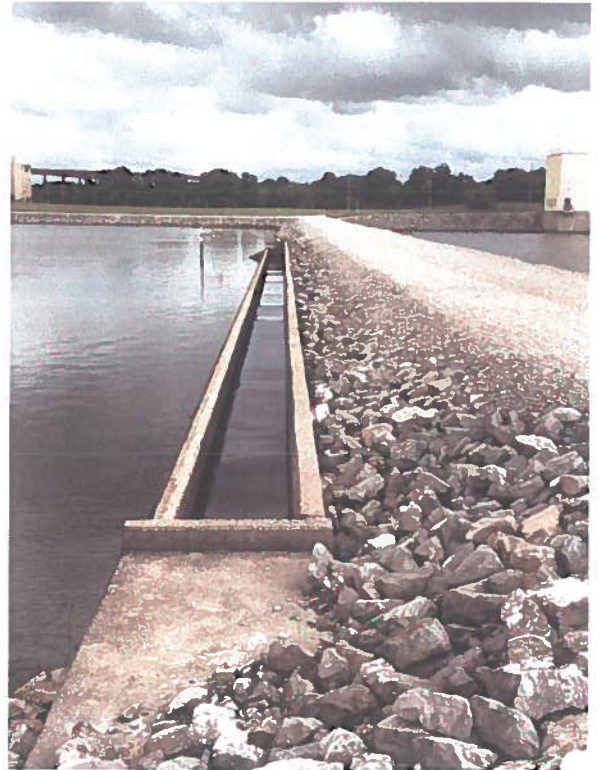
Photo #6WW– discharge weir structure at East WW pond

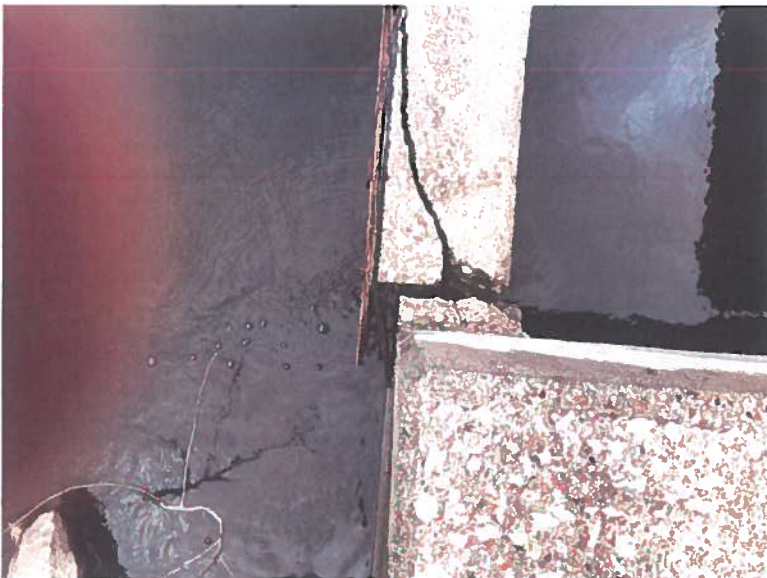
20. The separation of the rectangular concrete weir channels in both ponds does not appear to be any different than the conditions noted in previous inspection reports.

Photo #7WW – old displacement of concrete weir – rebar is still engaged.

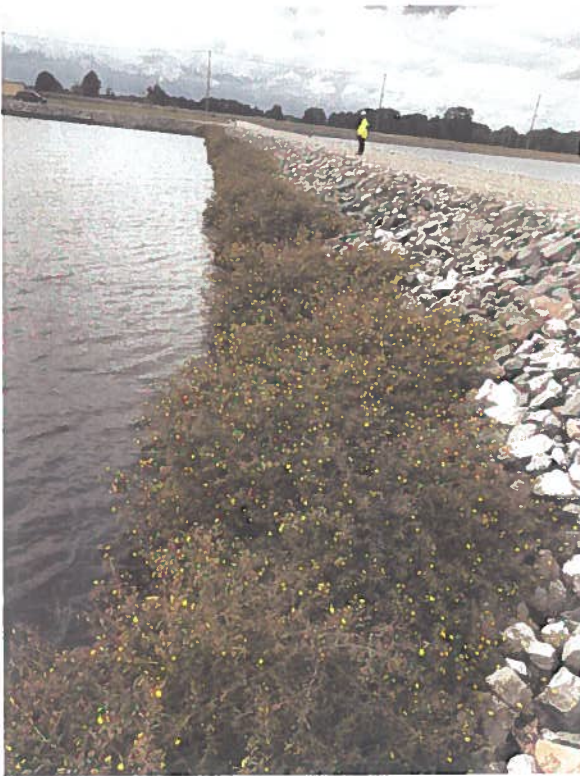
25. The interior of the north slope of the Clear Water Pond had vegetation growing out of the riprap near the water surface. This was the condition along the entire length of the slope.
26. The reclaim pump structure was in good condition and appeared to be pumping properly.
27. The outlet structure between the Reclaim Pond and Clear Water Pond appeared in good condition with no obstruction.
28. The outlet structure of the Clear Water Pond was in fair condition with no obstructions. The skimmer board and weir structure was in fair condition and there was some vegetation growing at the entrance to the weir structure.

Photo #1 – interior slope of north clearwater pond

- 2) Maintain vegetation growth within rip rap areas using herbicide.

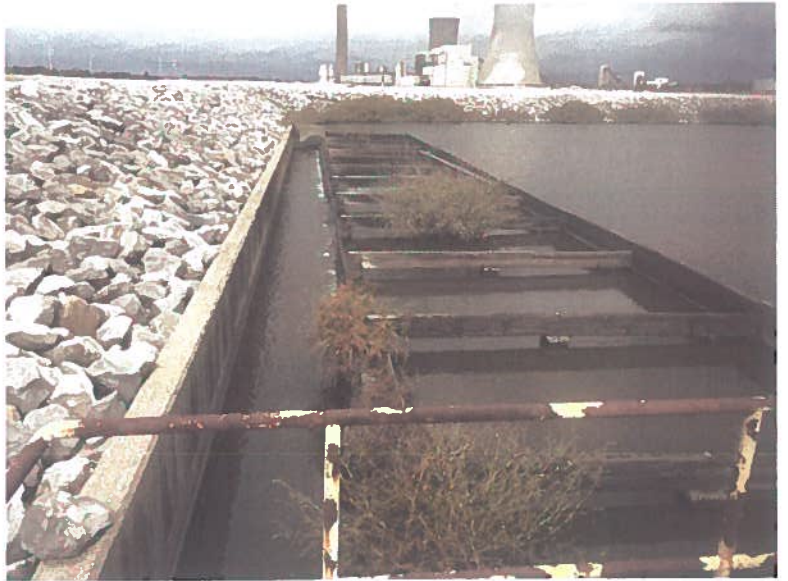
Photo #2– discharge structure at clearwater pond

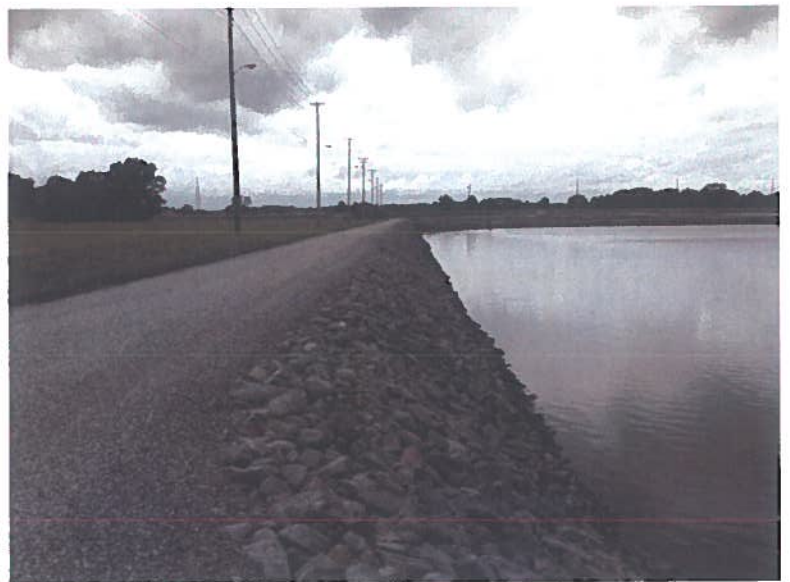
Photo #3 – interior south slope of clearwater pond

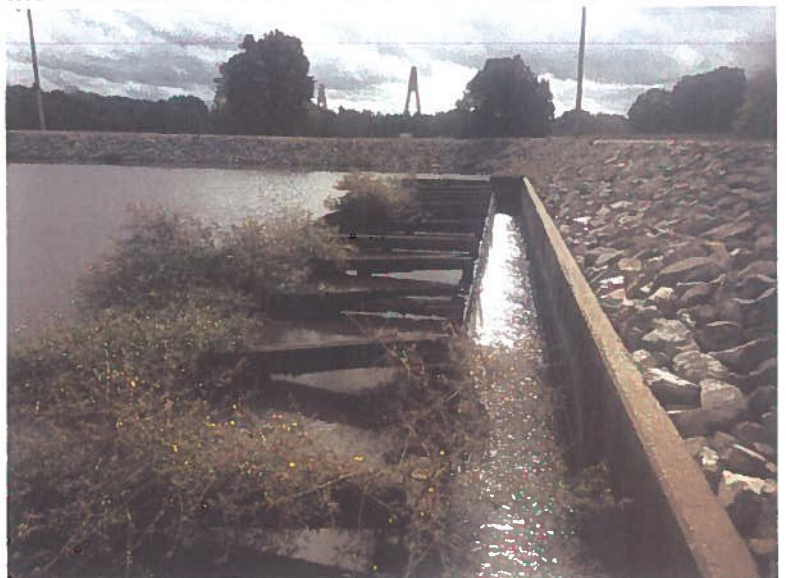
Photo #4 – discharge structure at clearwater pond
